# Anamosa Dillion Military (Cemetery) Road Bridge Anamosa, Iowa

## 2024 Bridge Inspection Report

Bridge Inspection By: Modjeski and Masters, Inc.

June 30, 2024

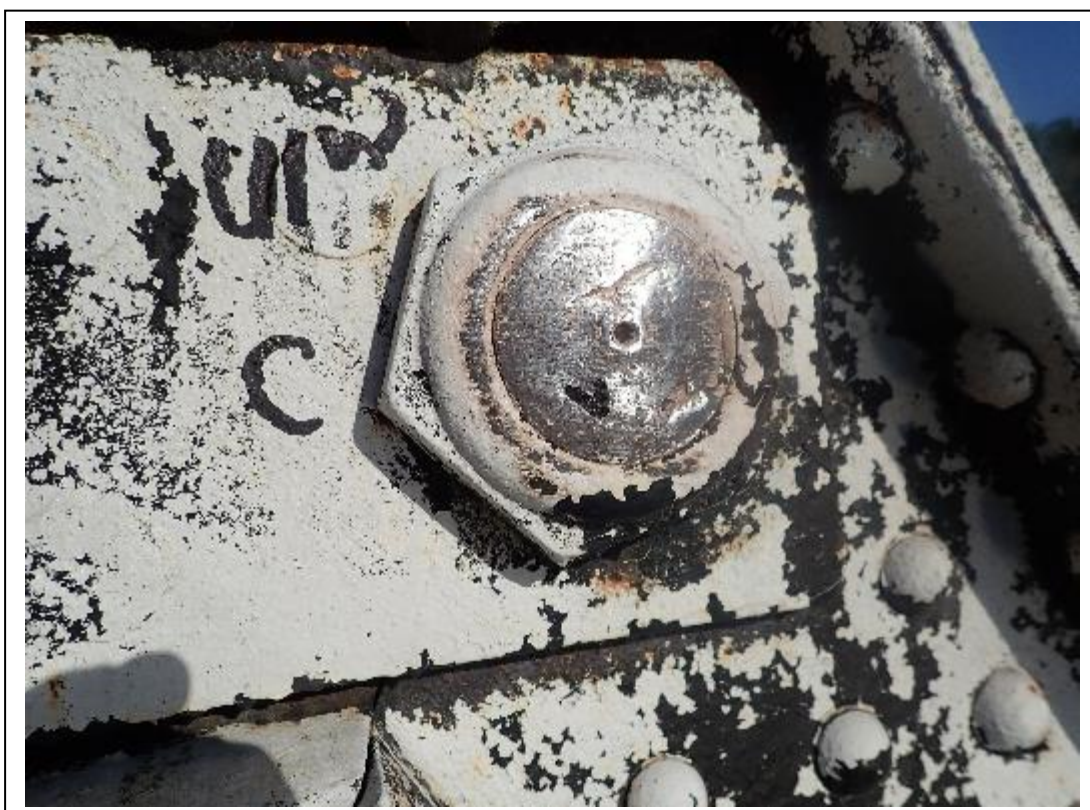
PHOTO 08

- All bridge pins appeared to be tight in their respective joints with no apparent movement or shifting of the pins within the joints.
- Once the paint was removed from the pin faces, visual cracks were revealed in five pins (U1W, L4W, U5W, U6W and L9E). These cracks are extremely tight with no fretting corrosion and they were not evident prior to removal of the paint. It seems likely that these cracks have existed for quite some time. Due to the fact that the paint was not cracked and that there isn't any fretting corrosion at the crack surfaces, these cracks appear to be inactive.

U1W – TRUSS, UPPER PIN

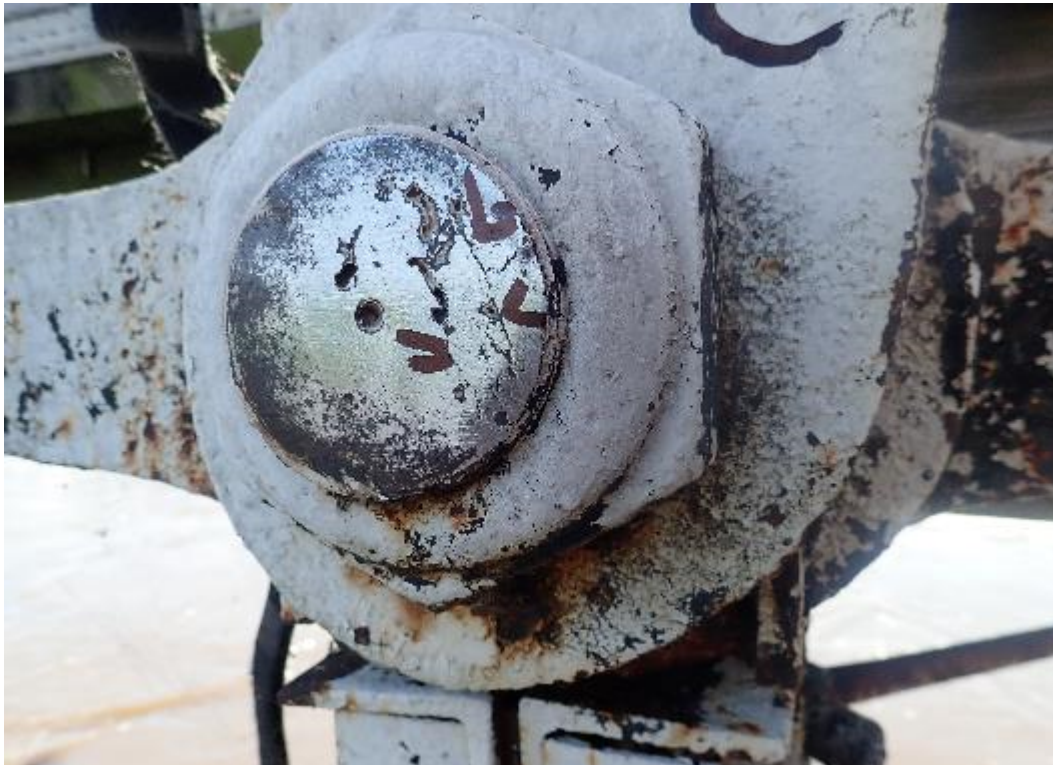
PHOTO 09

L4W – TRUSS, LOWER PIN

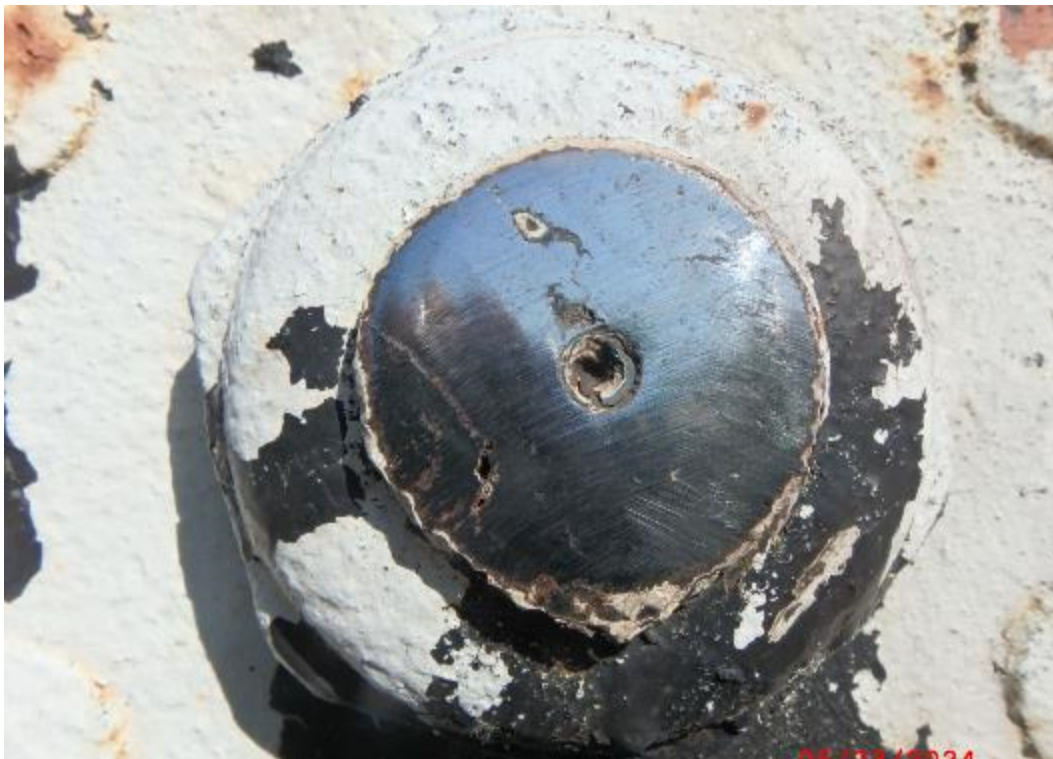
PHOTO 10

U5W – TRUSS, UPPER PIN

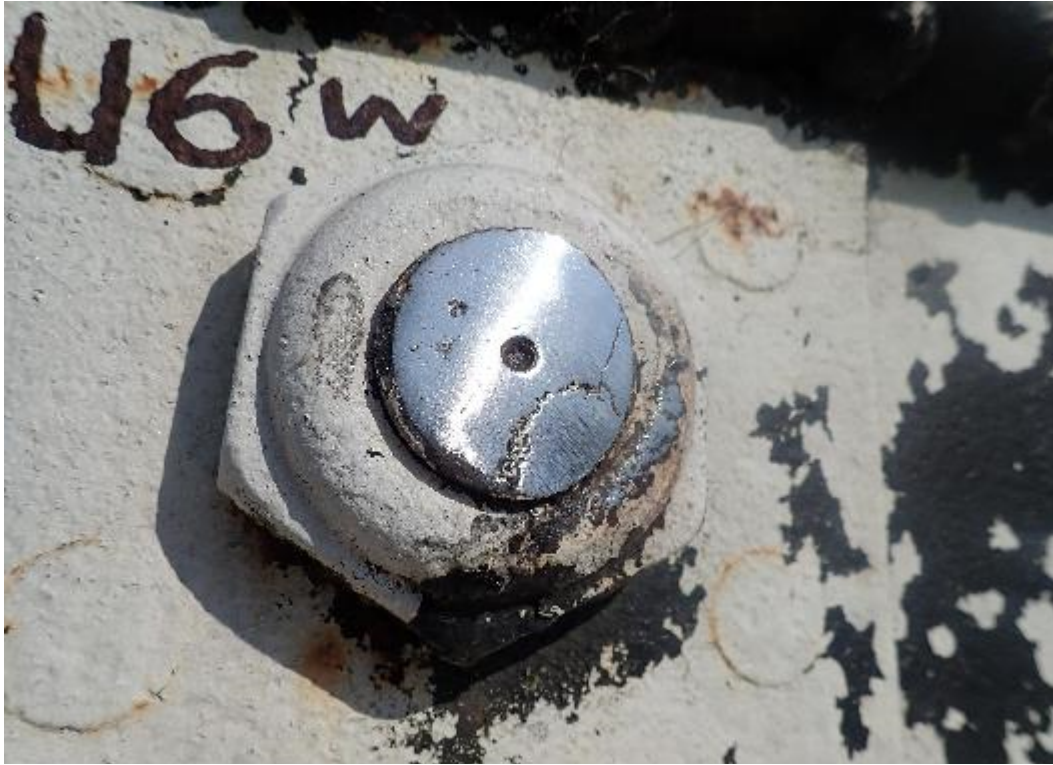
PHOTO 11

U6W – TRUSS, UPPER PIN

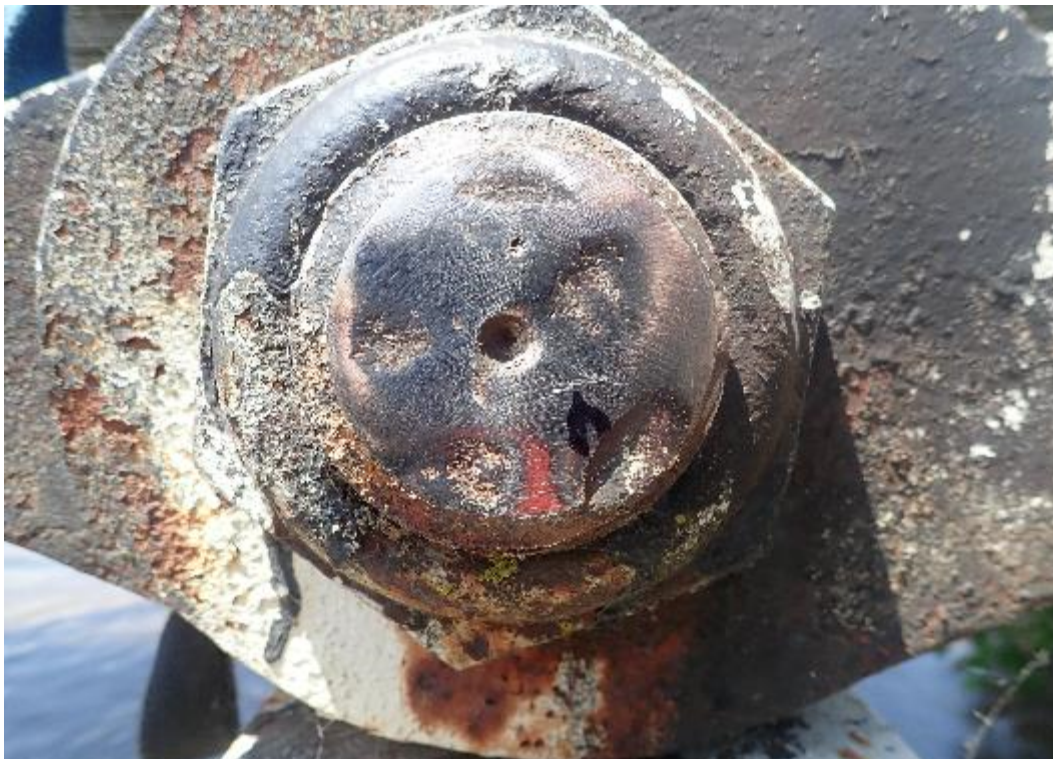
PHOTO 12

L9E – TRUSS, LOWER PIN

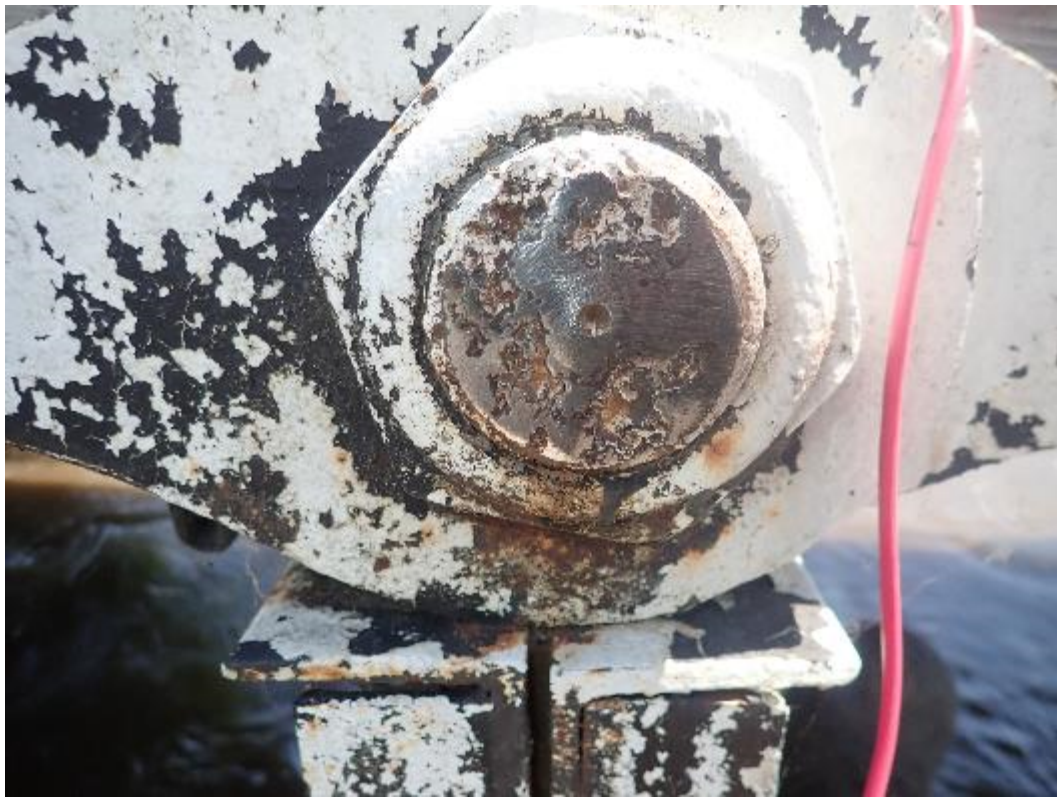
PHOTO 13

L9W – TRUSS, LOWER PIN

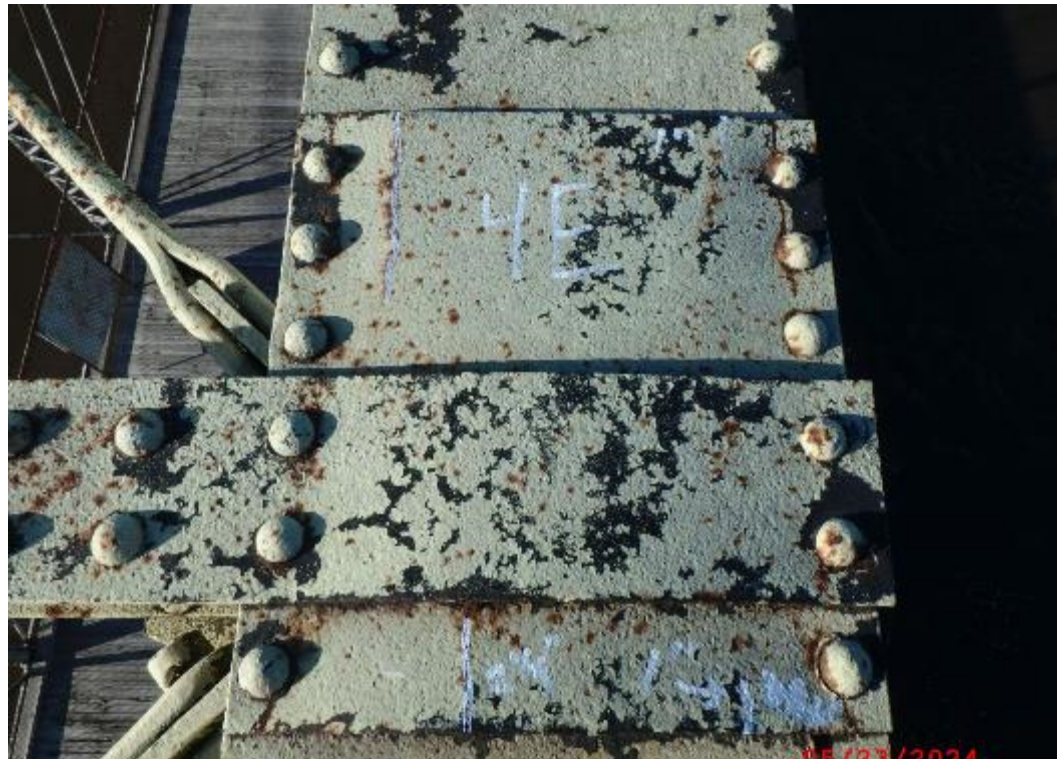
PHOTO 14

U4E – TRUSS, TOP CHORD CONNECTION PLATE

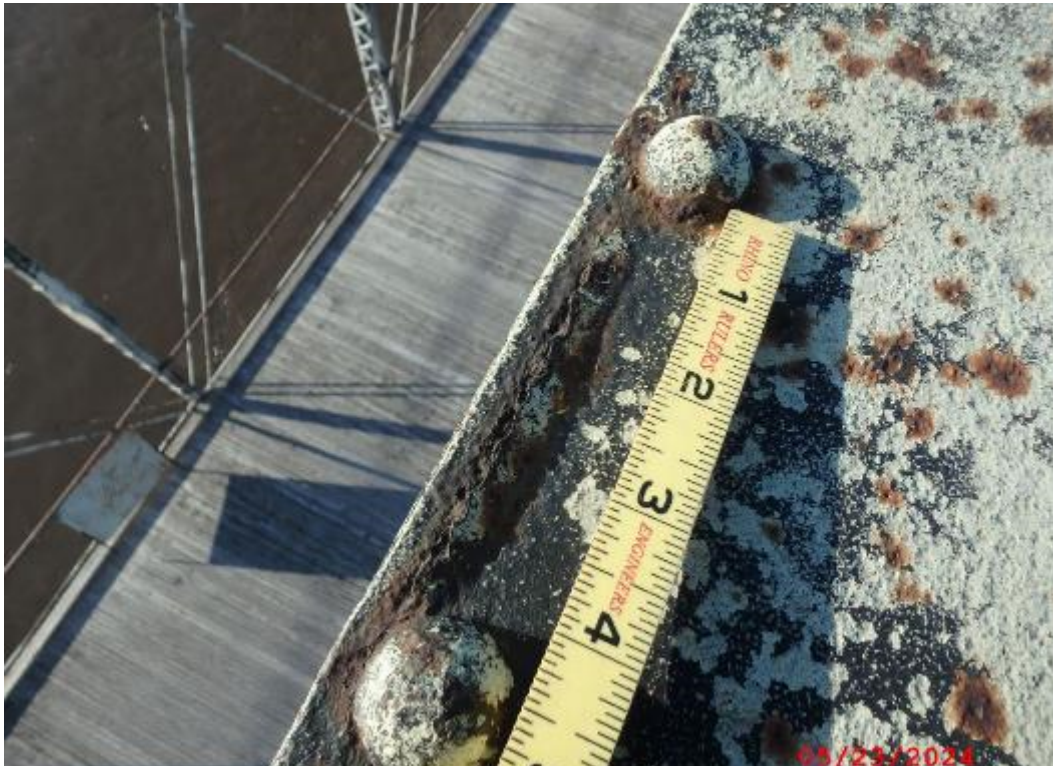
PHOTO 15

U4E-U5E, PANEL 5 – TRUSS TOP CHORD

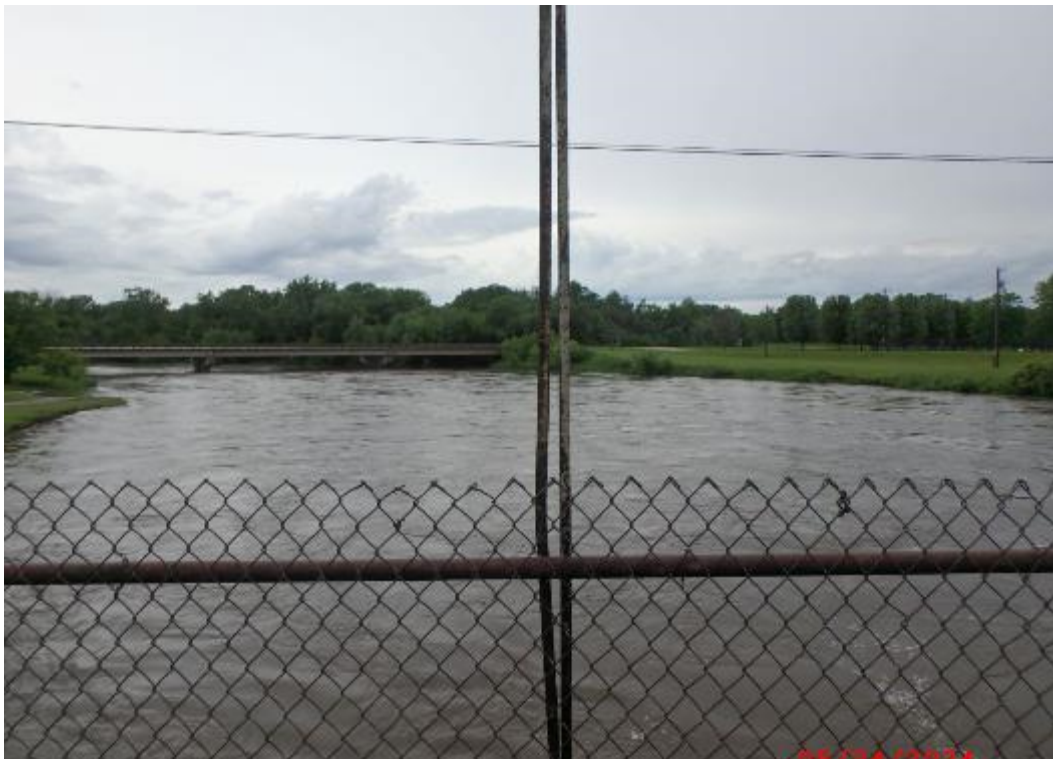
PHOTO 16

U1W-L1W – TRUSS, VERTICAL EYEBAR

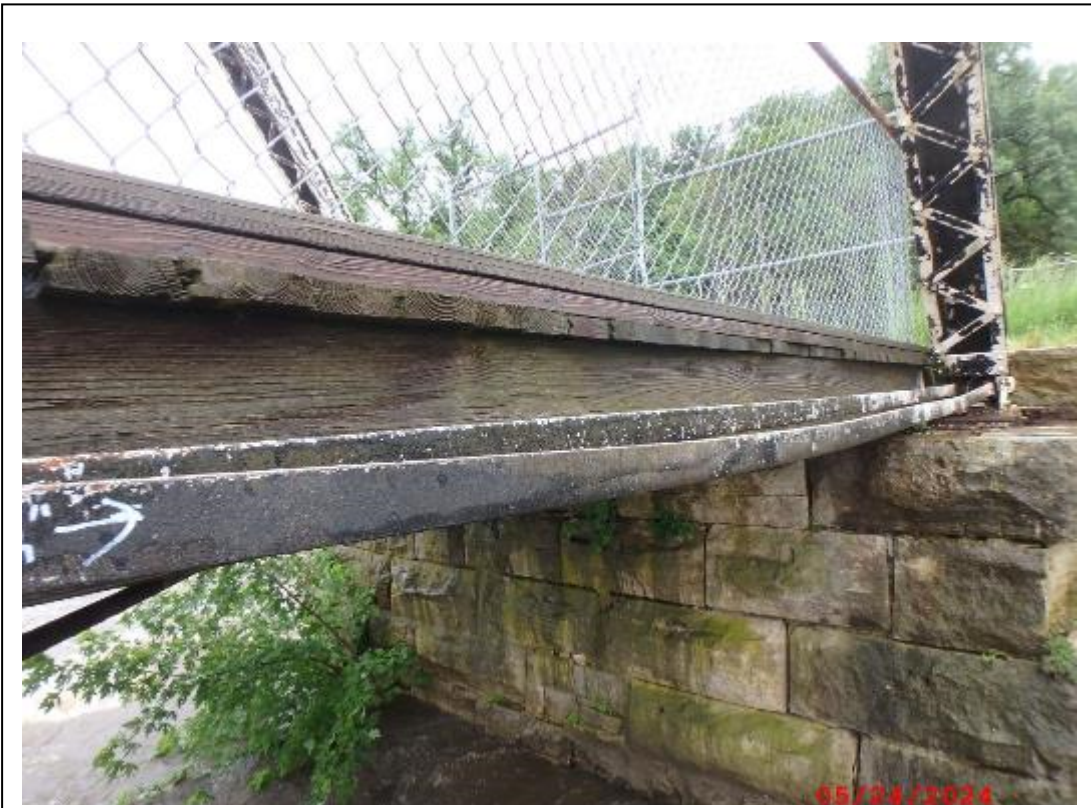
PHOTO 17 PANEL 1 – TRUSS, WEST BOTTOM CHORD EYEBARS

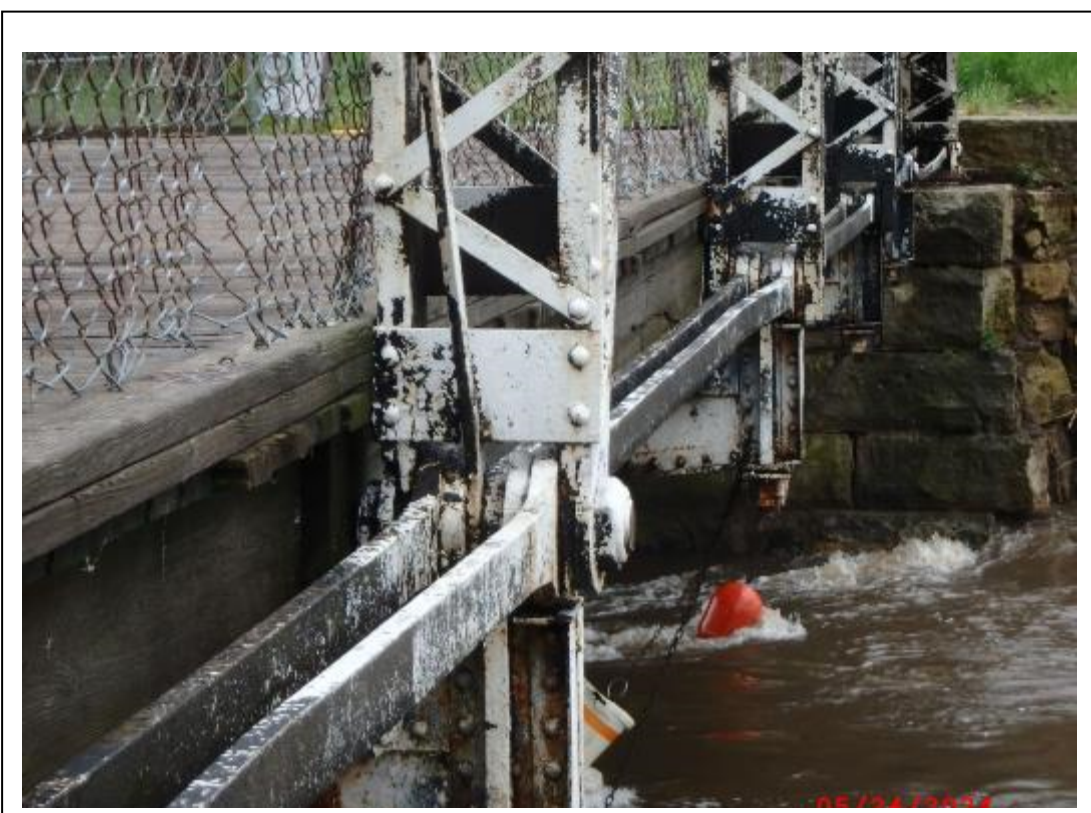
PHOTO 18 PANELS 1-5 – TRUSS, WEST BOTTOM CHORD EYEBARS

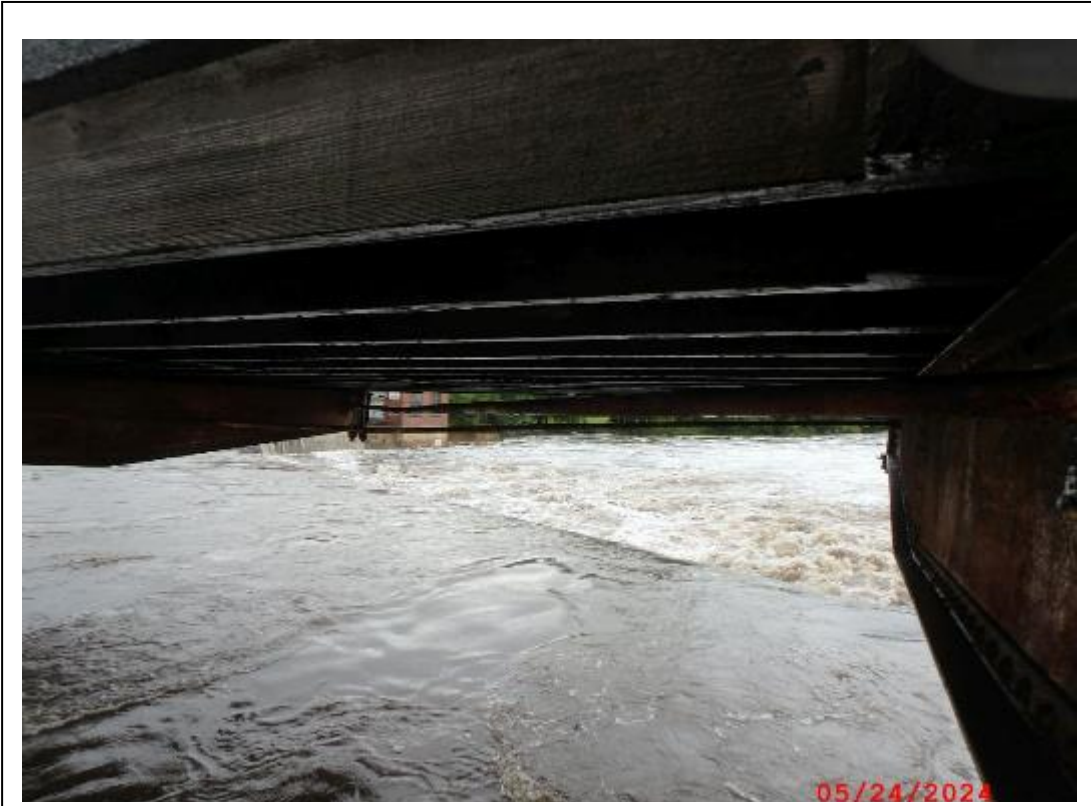
PHOTO 19

PANEL 3 – TRUSS, LOWER LATERAL BRACING

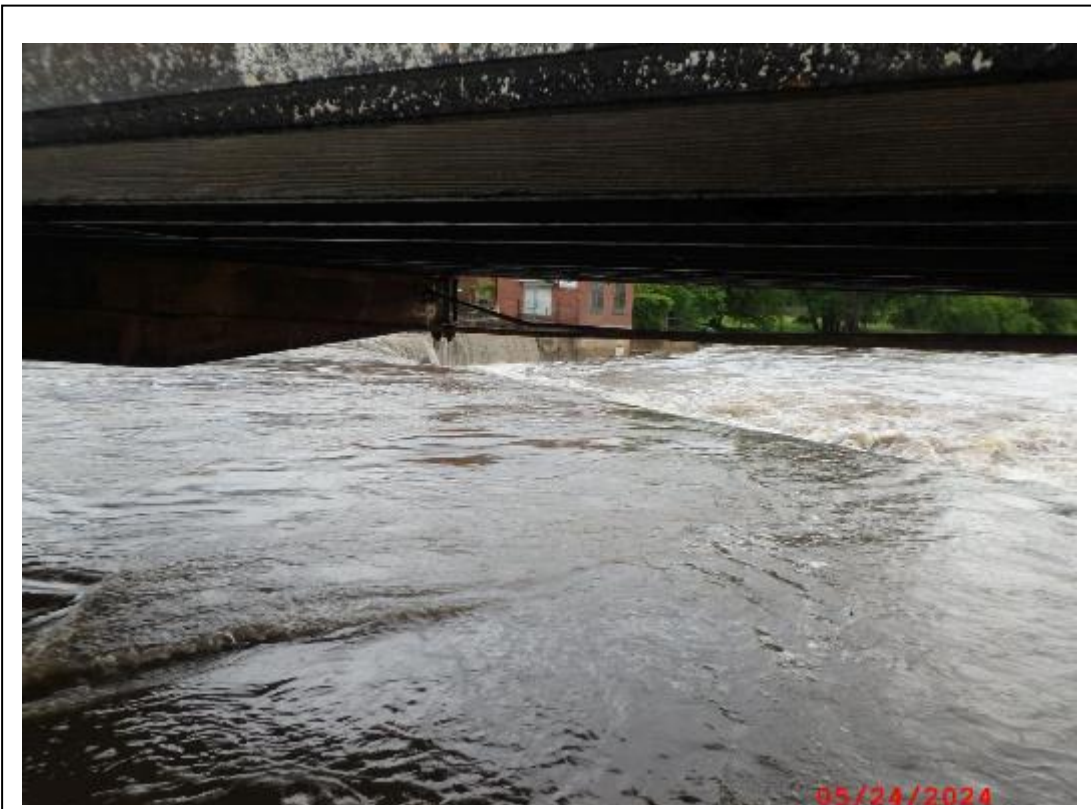
PHOTO 20

PANEL 5 – TRUSS, LOWER LATERAL BRACING

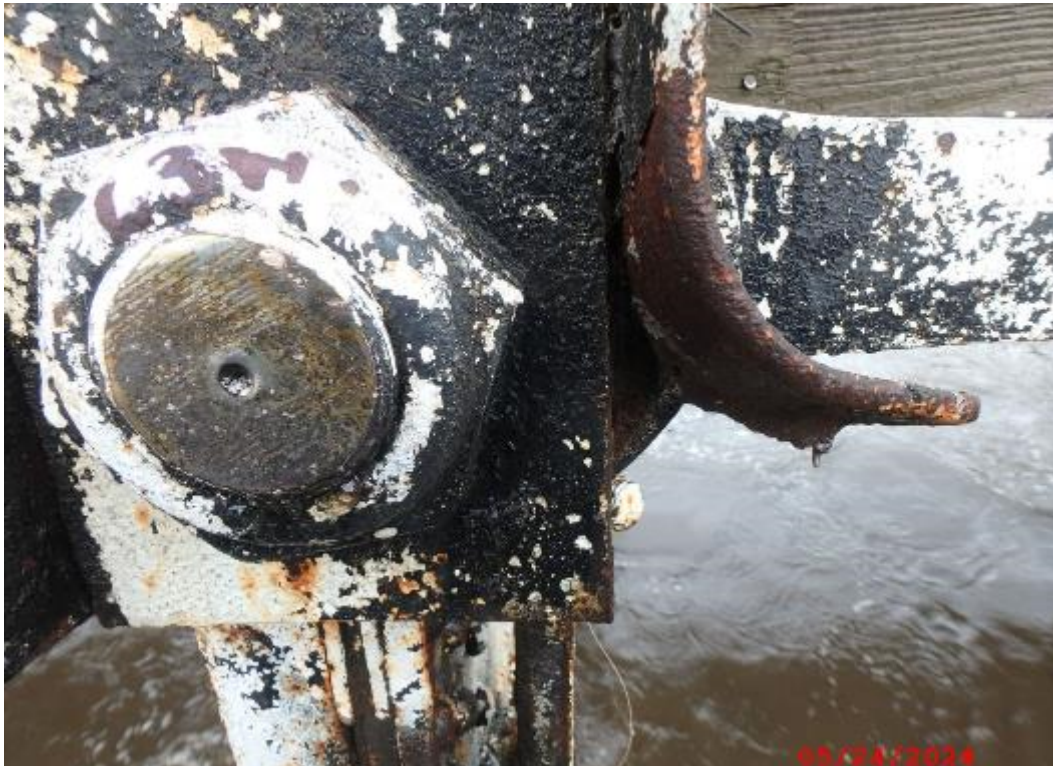
PHOTO 21      L3W – TRUSS, VERTICAL BUILT-UP C-CHANNEL

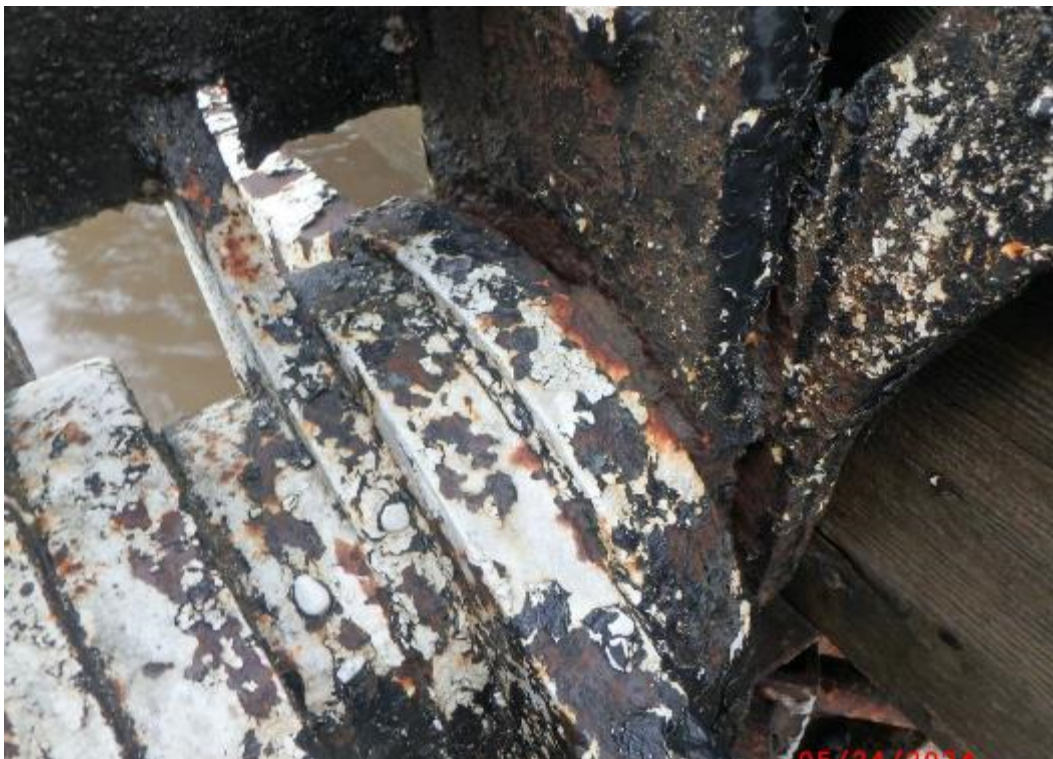
PHOTO 22      L4W – TRUSS, EYEBAR / PIN ASSEMBLY

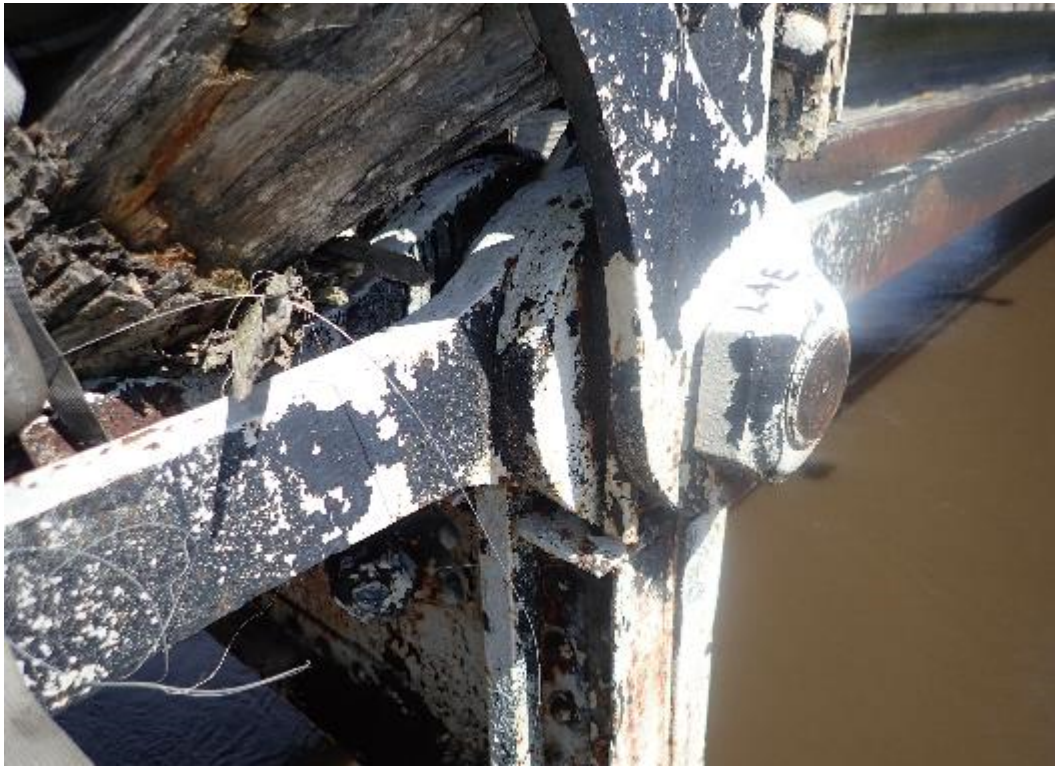
PHOTO 23

L4E, PANEL 4 – TRUSS, BOTTOM CHORD

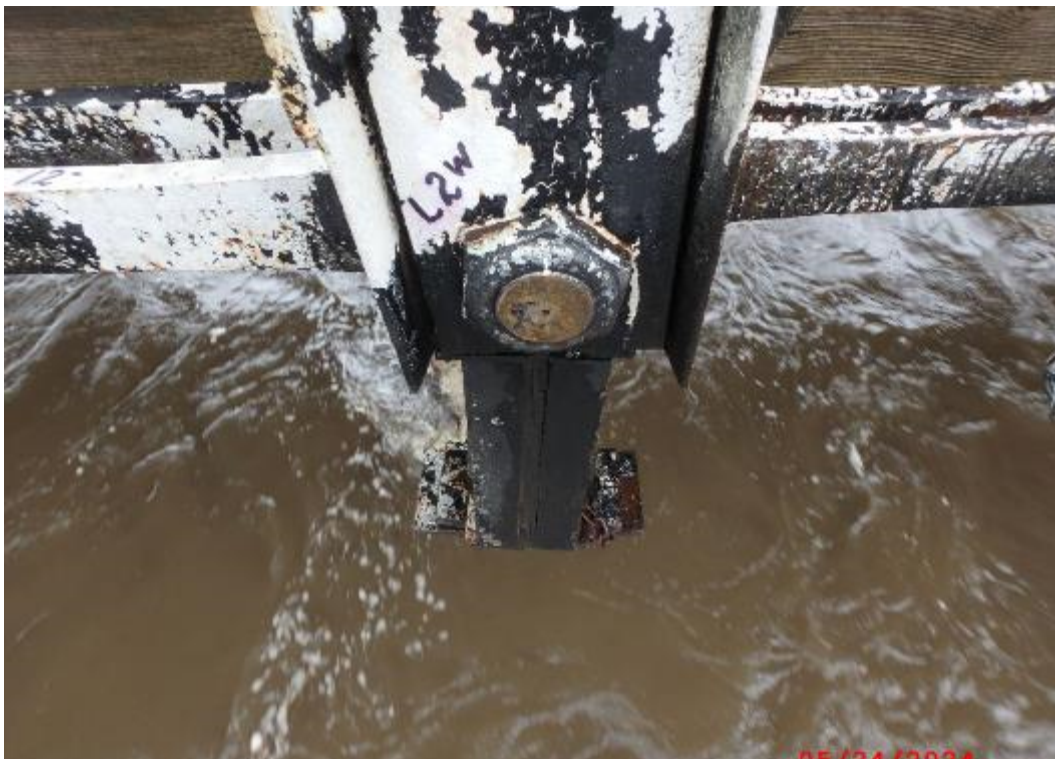
PHOTO 24

L2W – FLOORBEAM

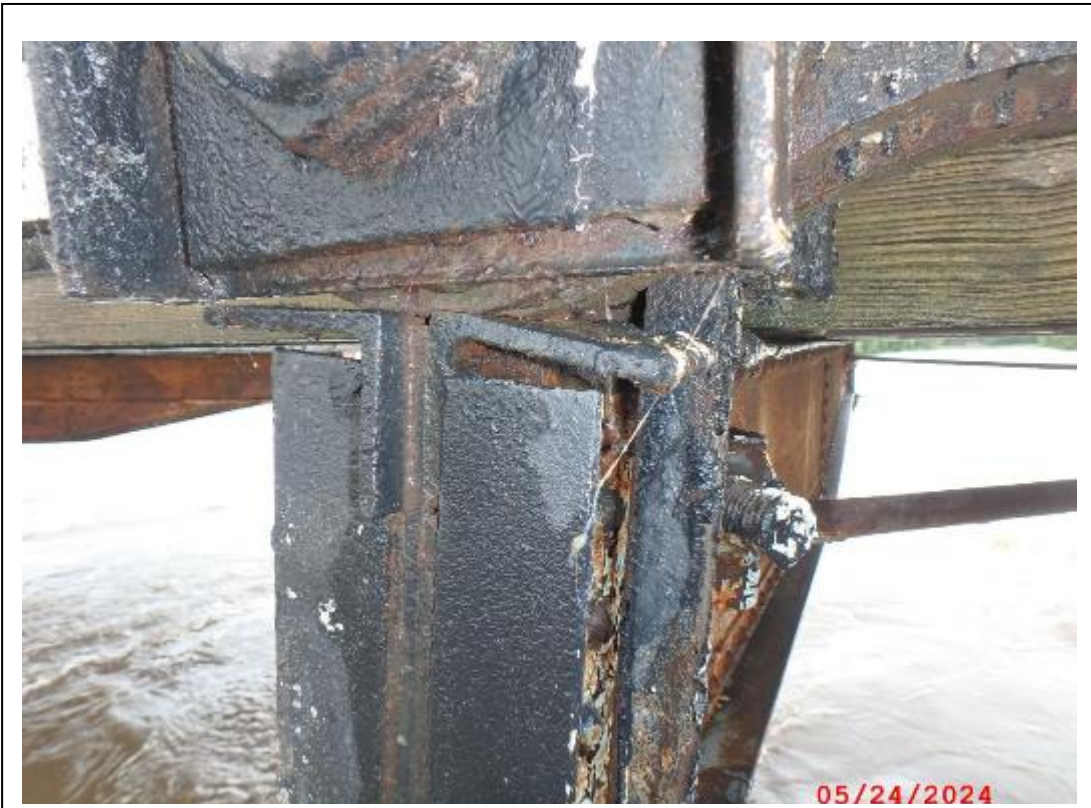
PHOTO 25      L2W – FLOORBEAM SOUTHWEST, TOP FLANGE

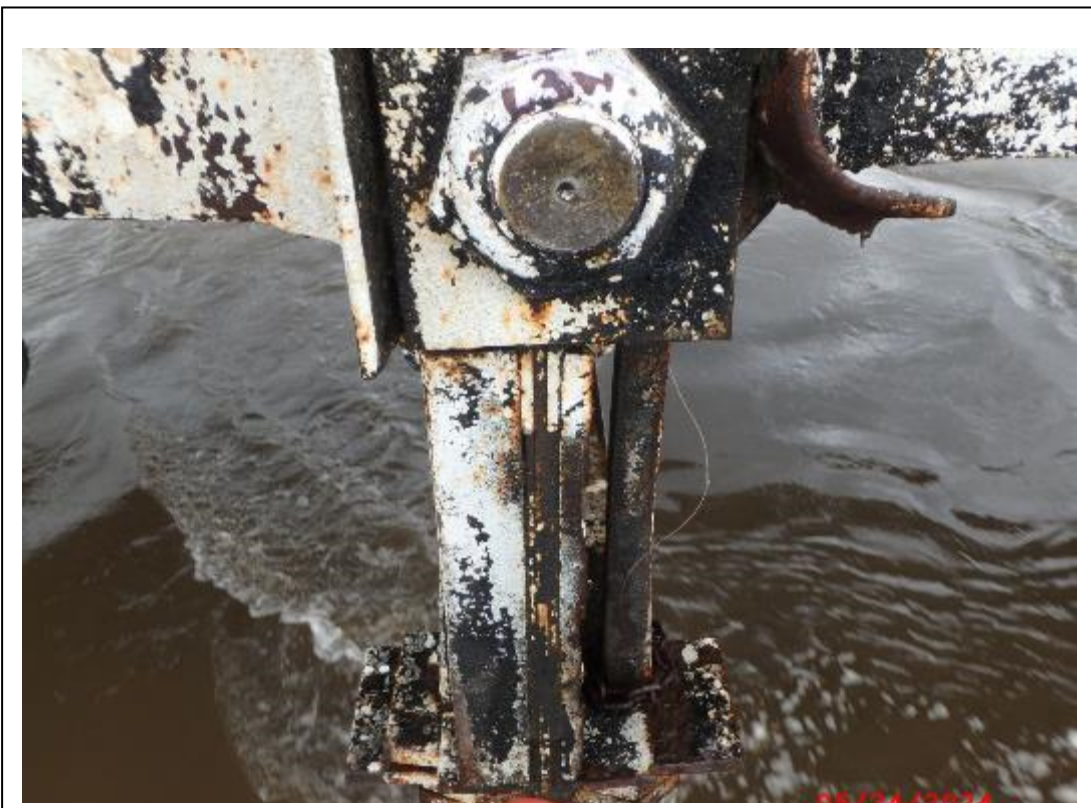
PHOTO 26      L3W – FLOORBEAM, SOUTHWEST FLANGE

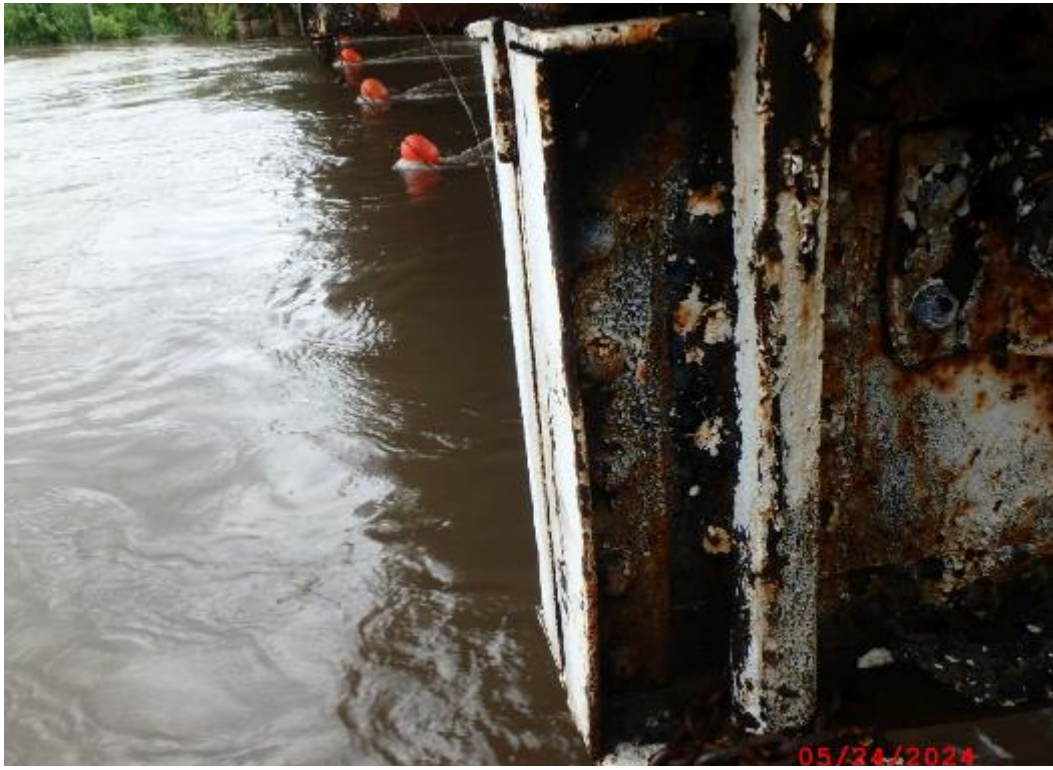
PHOTO 27

L4W – FLOORBEAM, SOUTHWEST FLANGE

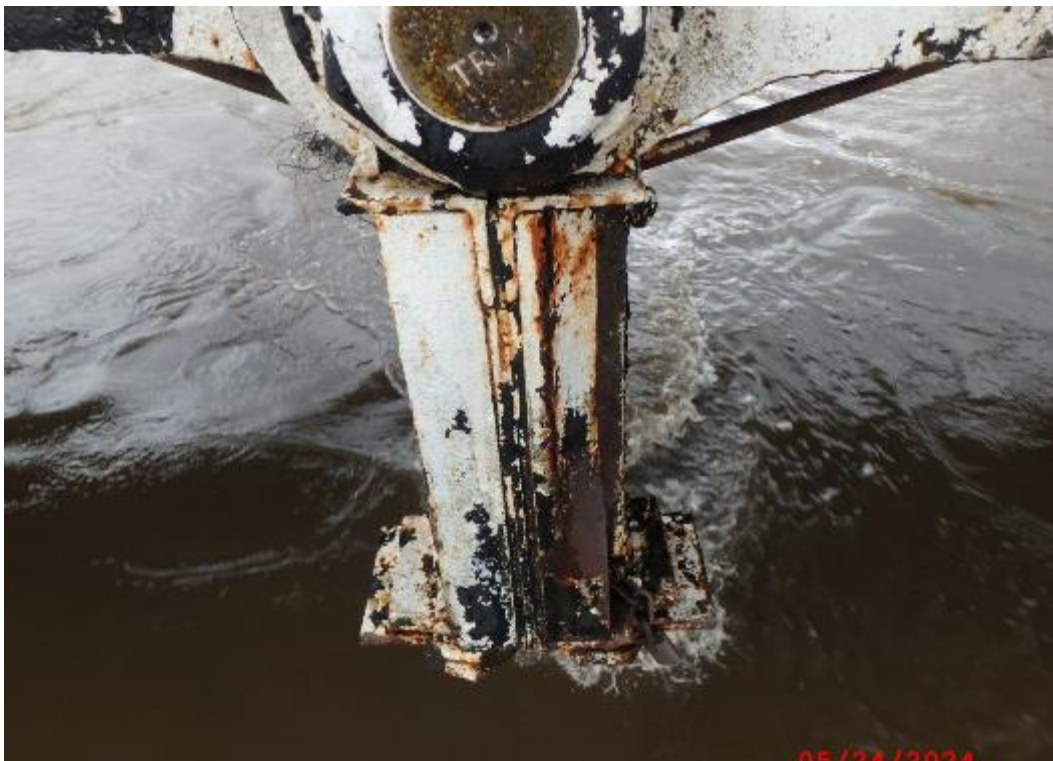
PHOTO 28

L5W – FLOORBEAM, SOUTHWEST FLANGE

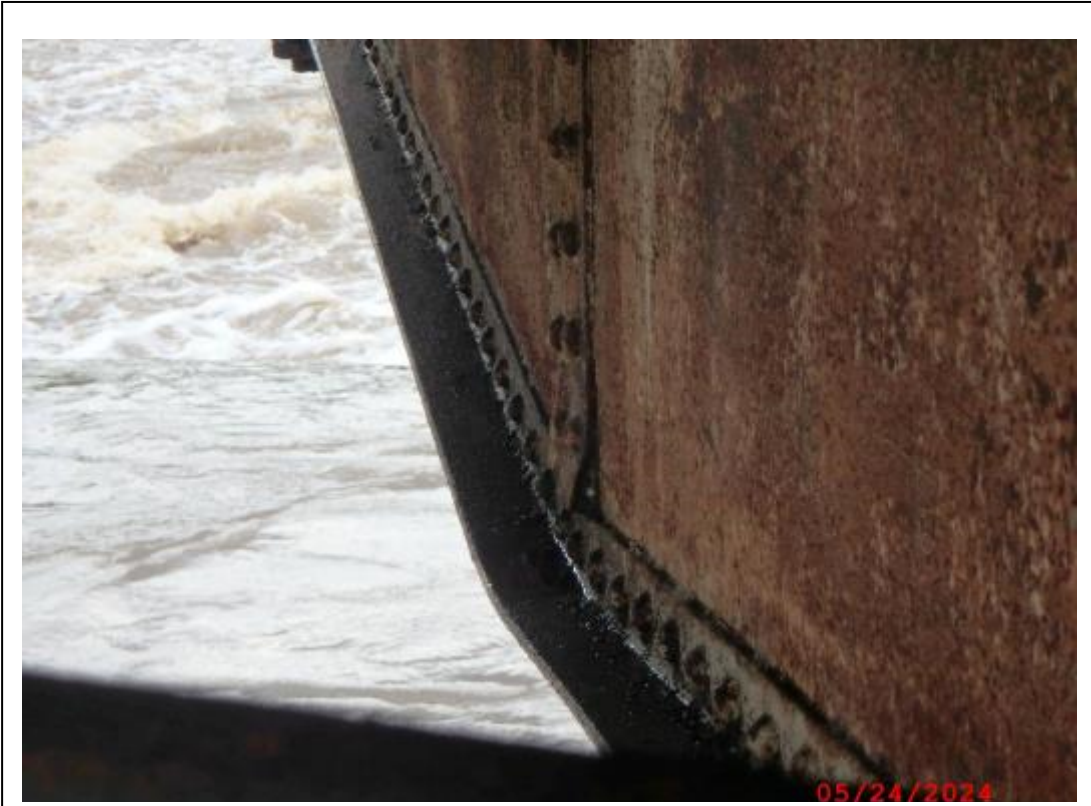
PHOTO 29 4W, PANEL 5 – FLOORBEAM, WEB CONNECTION PLATE

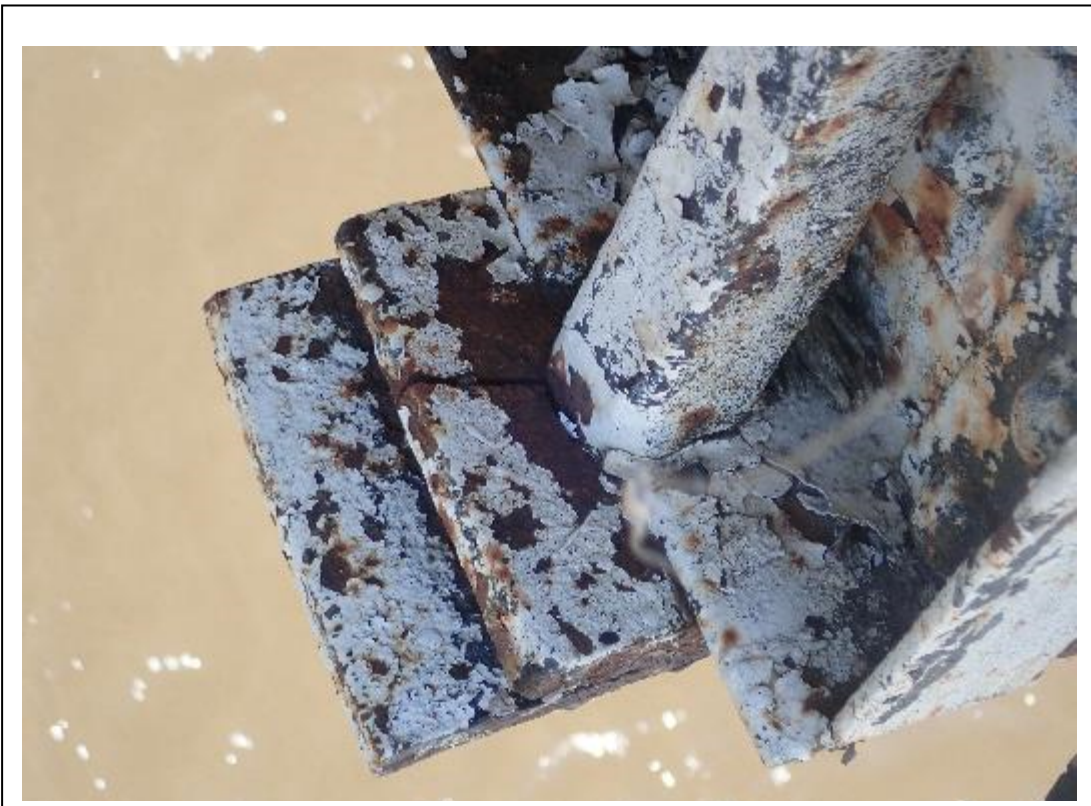
PHOTO 30 L4E – FLOORBEAM, EAST U-BOLT SPACER PLATE

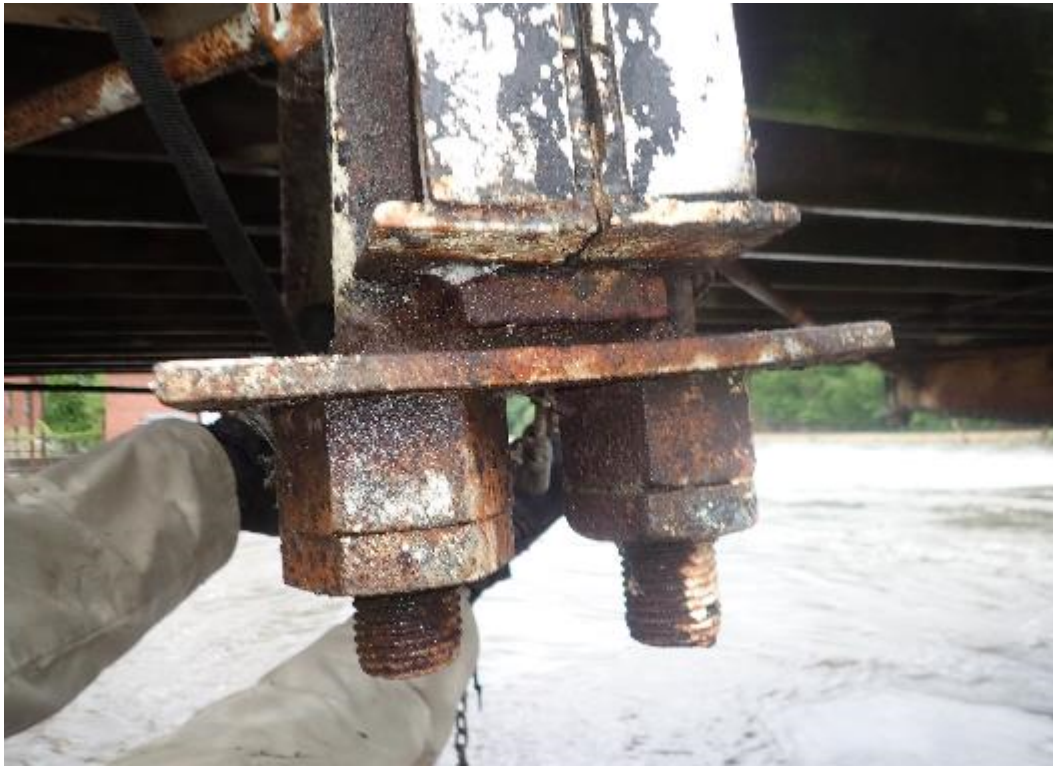
PHOTO 31 L8W – FLOORBEAM, WEST U-BOLT SPACER PLATE

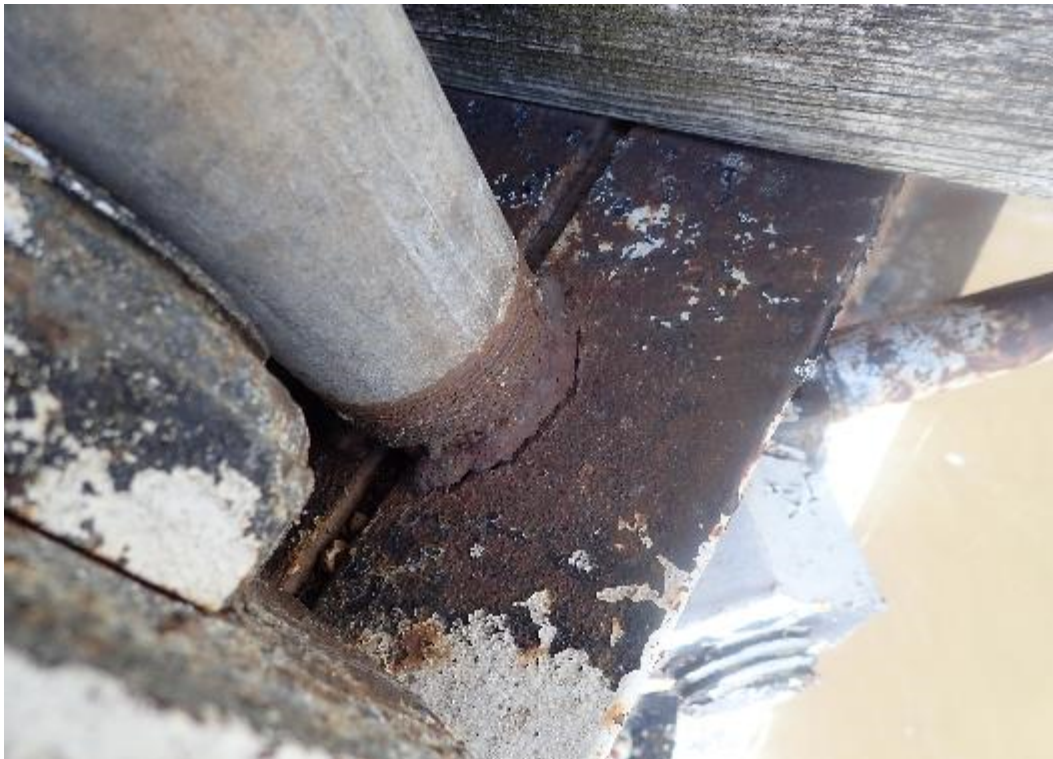
PHOTO 32 1E – FLOORBEAM, RAILING POST

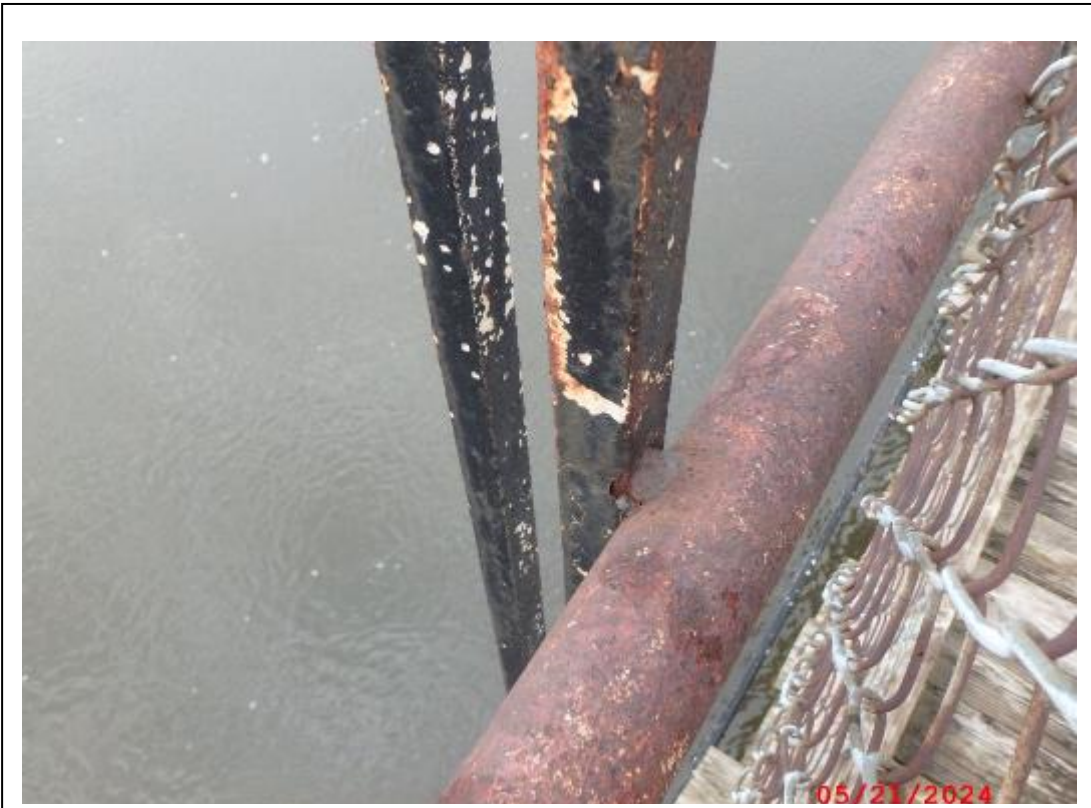
PHOTO 33

1W – FENCE RAILING

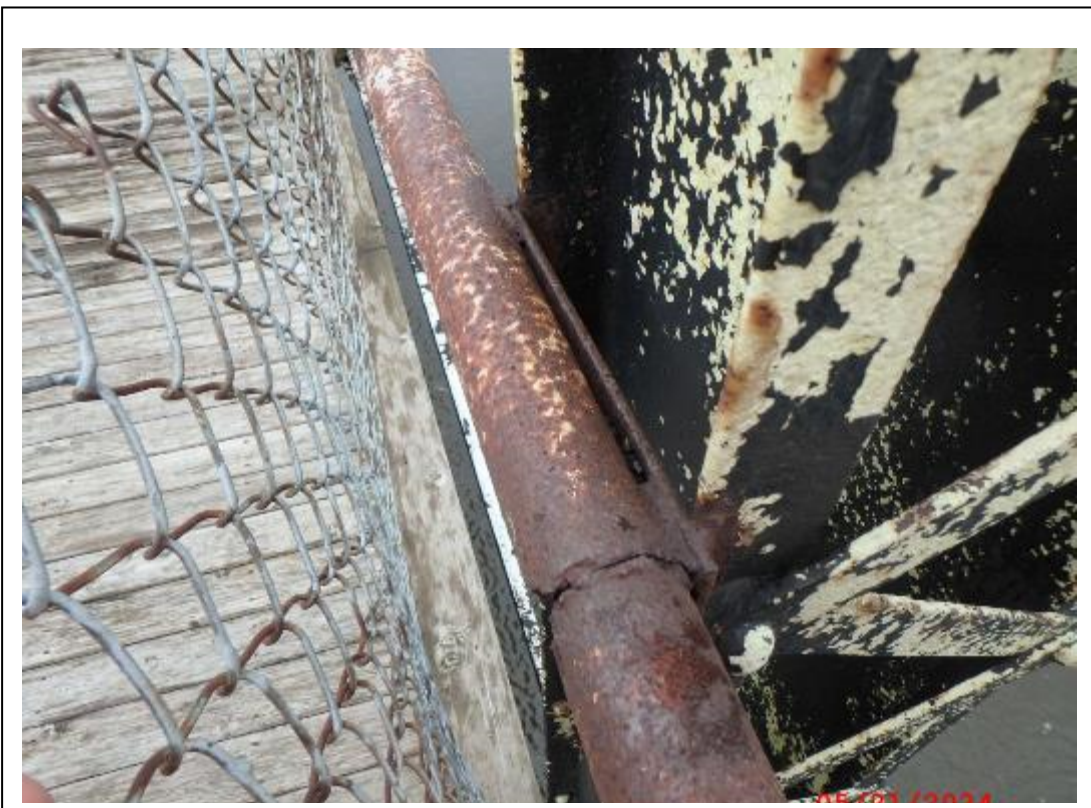
PHOTO 34

3E – FENCE RAILING
