# Anamosa Dillion Military (Cemetery) Road Bridge Anamosa, Iowa

## 2024 Bridge Inspection Report

Bridge Inspection By: Modjeski and Masters, Inc.

June 30, 2024

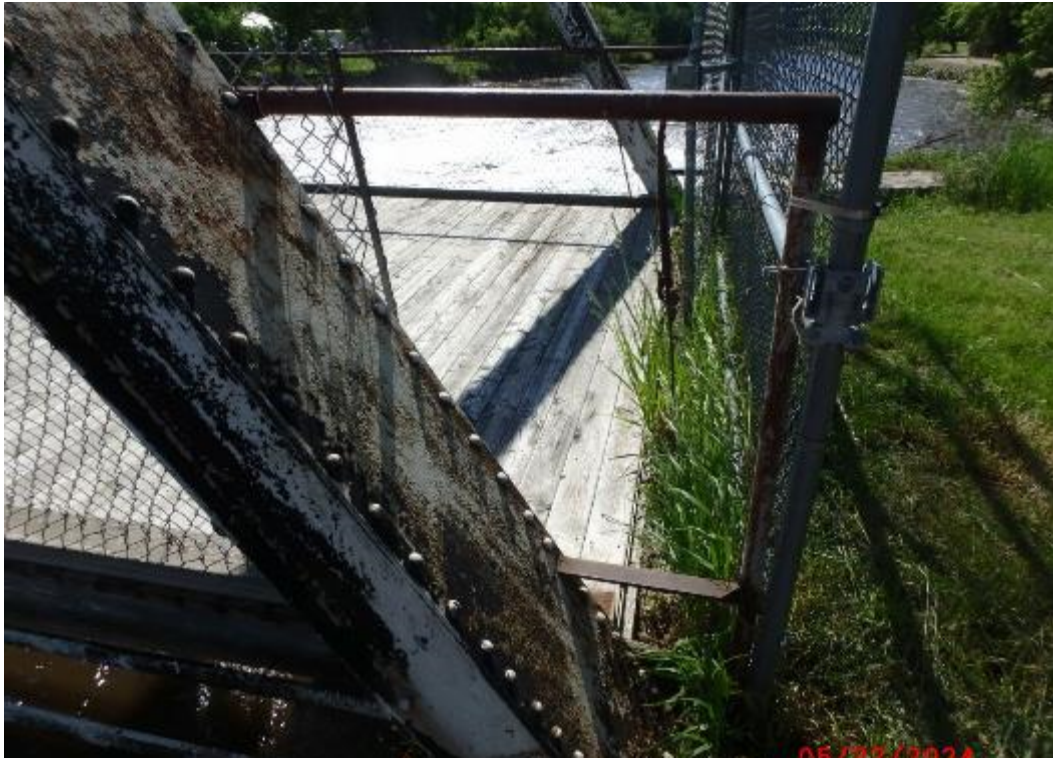
PHOTO 35

OW – FENCE RAILING

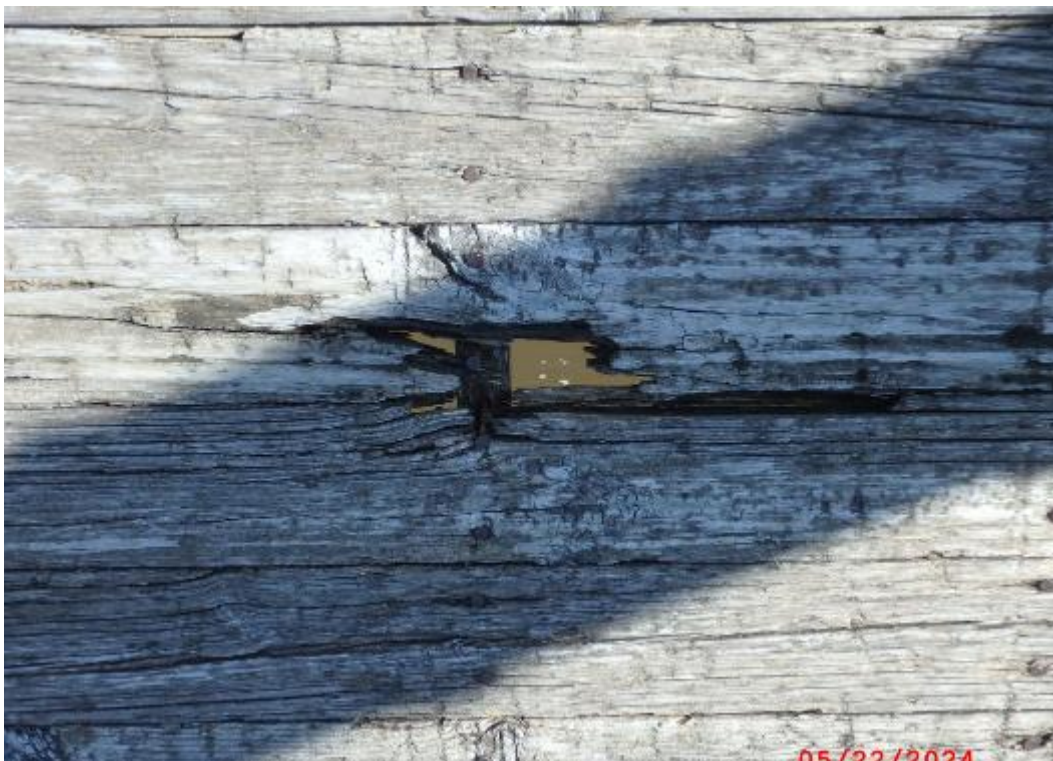
PHOTO 36

PANEL 2 - DECK

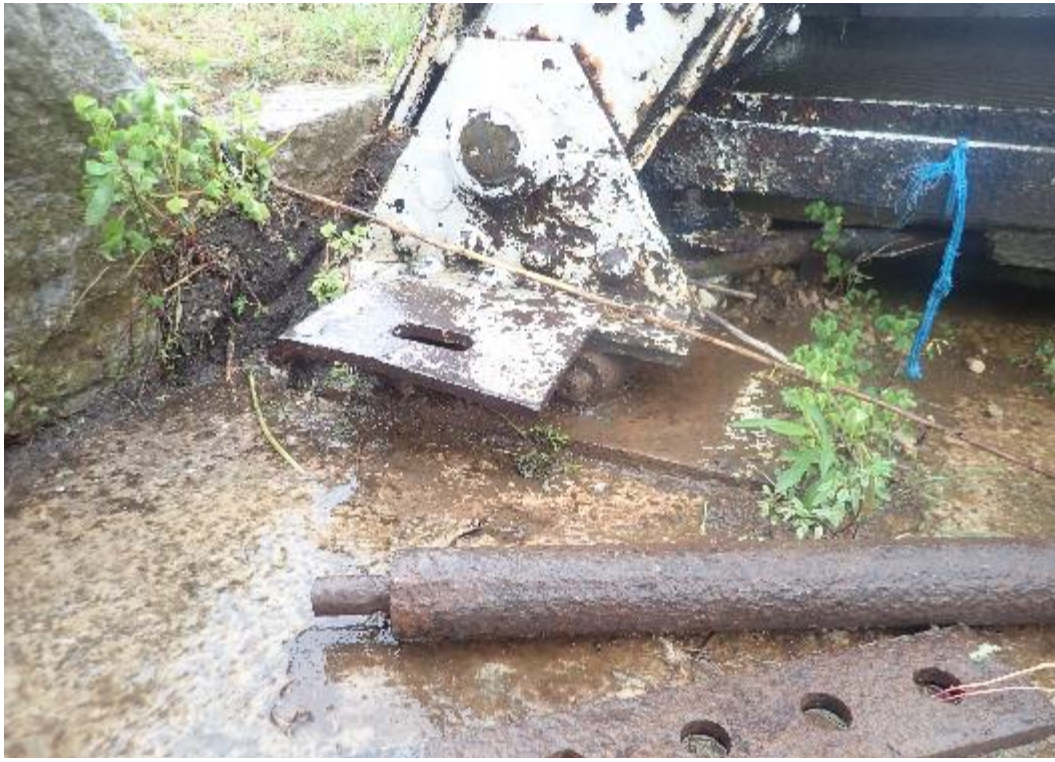
The east roller retainer bar of the southeast roller bearing is displaced at the inboard and outboard ends allowing one roller to be completely displaced from the assembly and the remaining rollers to be misaligned. At the southwest roller bearing, the north roller is completely exposed and not bearing any load. The South Abutment bearings both have dirt and debris washed into the bearings.

PHOTO 37 SOUTH ABUTMENT – EAST ROLLER BEARING

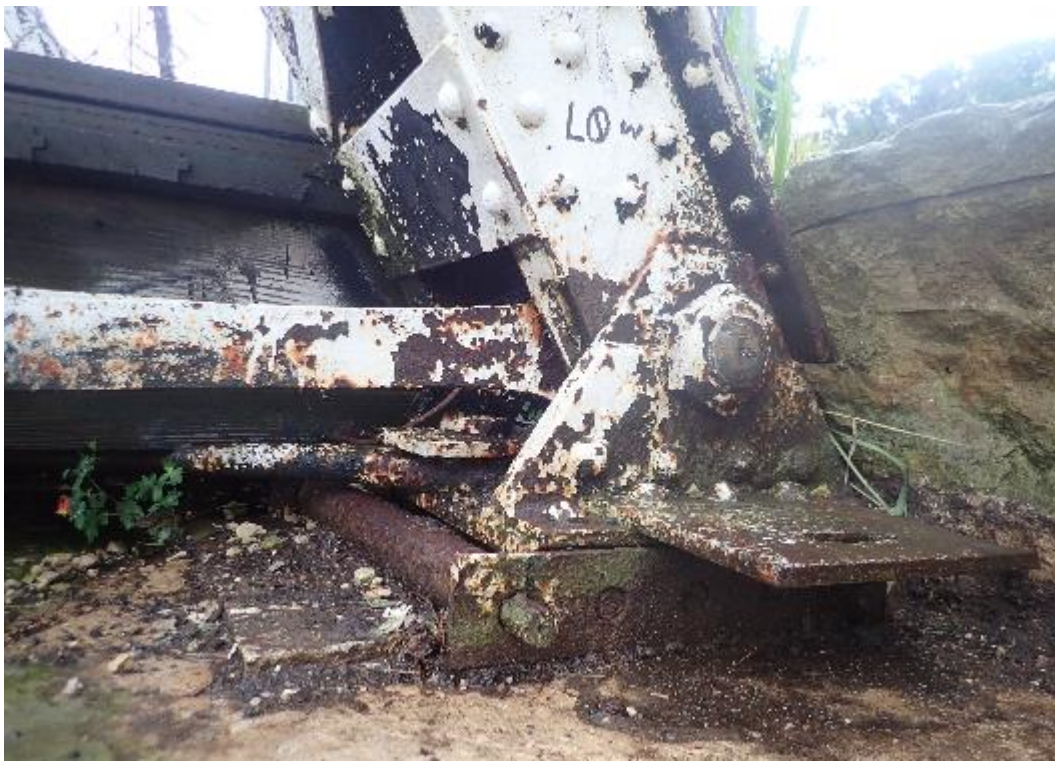
PHOTO 38 SOUTH ABUTMENT – WEST ROLLER BEARING

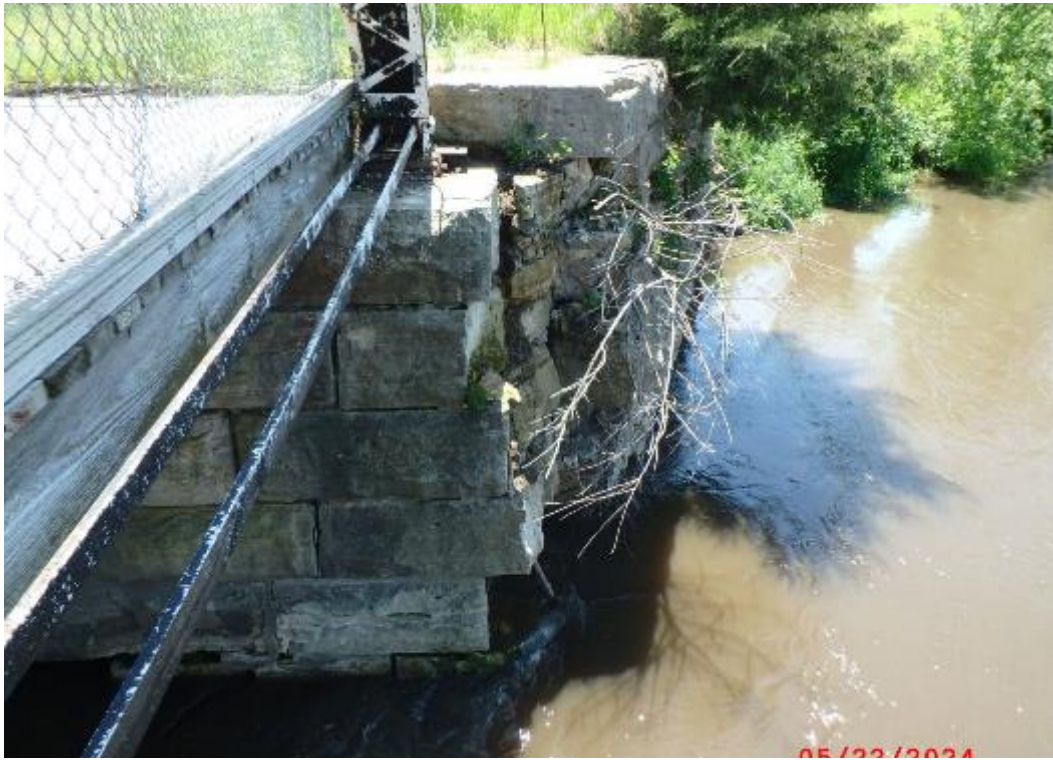
PHOTO 39

South Abutment is also missing mortar between all of the masonry stones. At the interface between the west end of the South Abutment and the South Abutment's west wingwall, most of the masonry stones are partially displaced and a few large stones are missing. The South Abutment also exhibits minor vegetation growth, as well as evidence of previous plant debris and root systems throughout the abutment. Finally, the South Abutment may be susceptible to scour due to the flow of water and angle of attack being focused in this area; the presence of scour conditions could not be assessed during the inspection due to high flow of the river.

SOUTH ABUTMENT – WEST WINGWALL

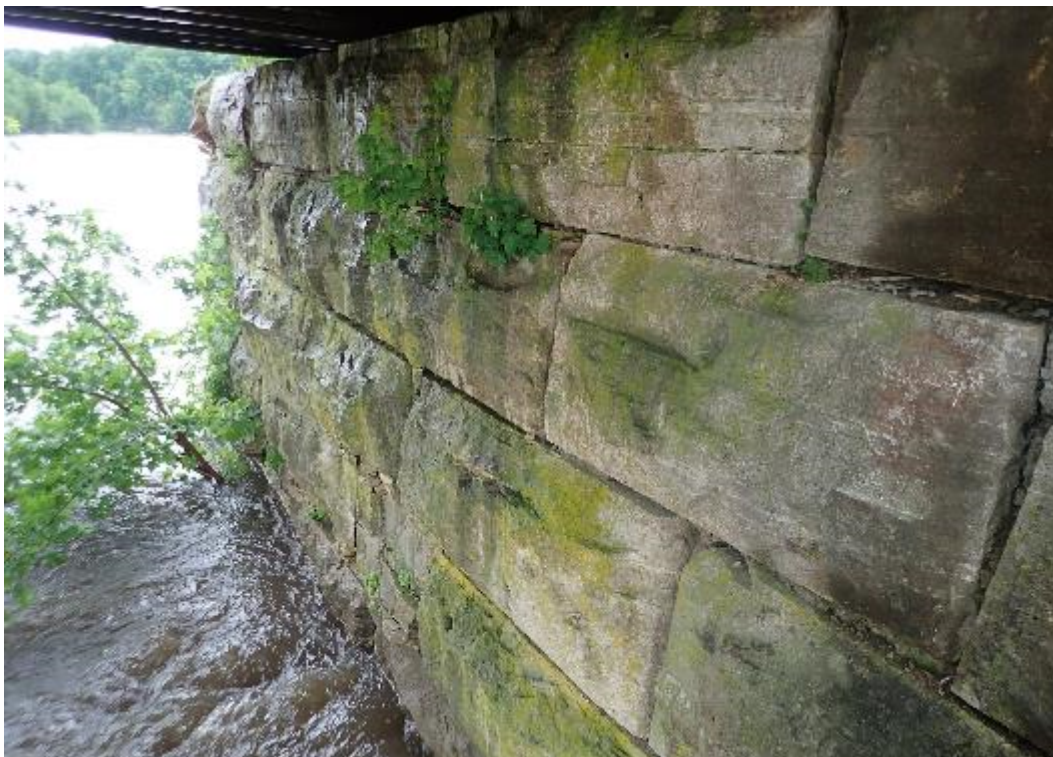
PHOTO 40

SOUTH ABUTMENT

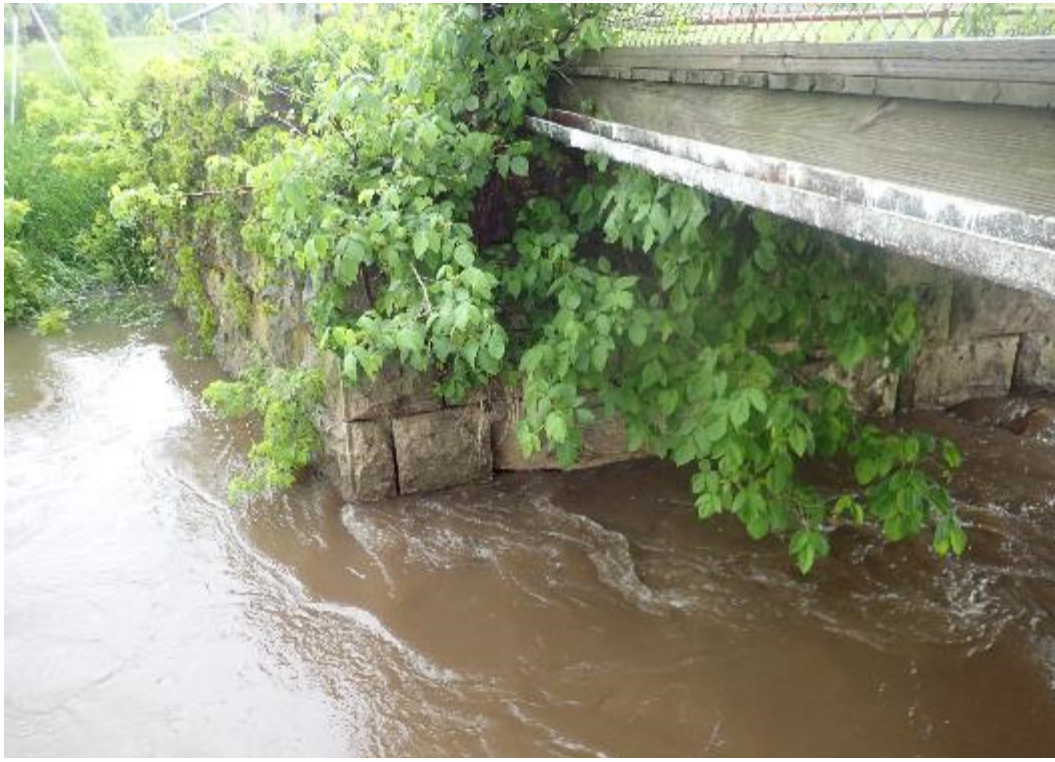
PHOTO 41

NORTH ABUTMENT – WEST WINGWALL

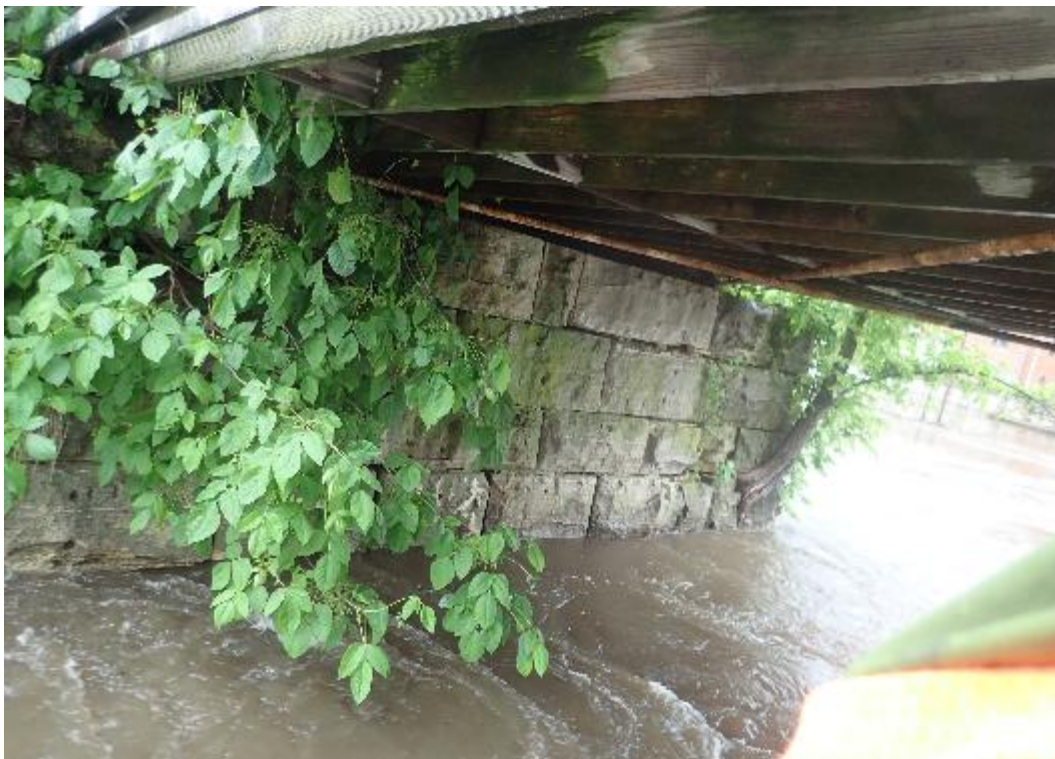
PHOTO 42

The north and south abutments are constructed with stone masonry and are in overall poor condition. At the North Abutment, there is excessive vegetation and trees that prevented complete access. The North Abutment is missing mortar between all the masonry stones and there is one small 3" diameter tree growing from the mortar joint below the east truss line. The

NORTH ABUTMENT

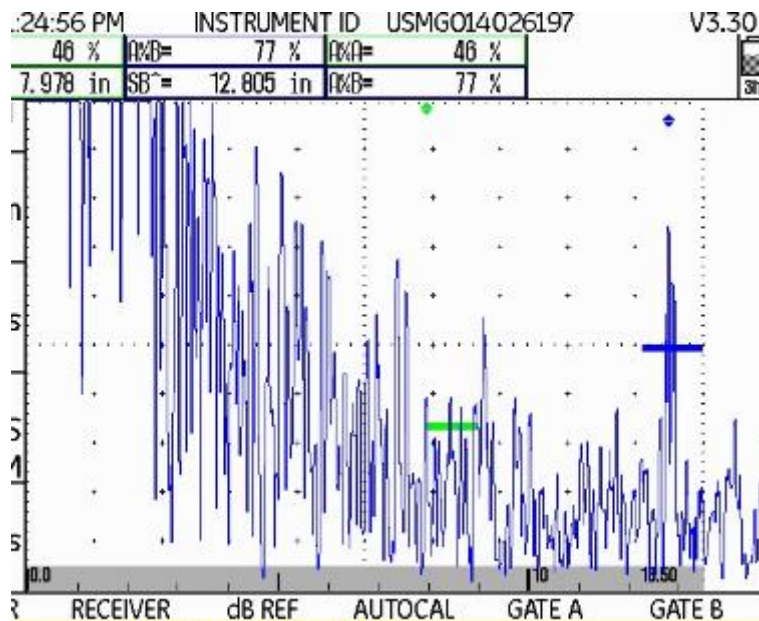
- There is an extreme amount of attenuation (dampening and scattering of sound due to a coarse grain microstructure and/or improper heat treatment processes employed during the formation of the bridge pins). The extreme amount of attenuation and the likely existence of numerous internal defects makes it impossible to ultrasonically "view" the entire volume of the various pins.
- Backwall measurements (pin lengths) could be identified for 21 of the 22 bridge pins examined with UT. Typically, backwall measurements could not be made throughout the

**Figure B2:** Typical A-scan of Cemetery Road Bridge Pins (excessive attenuation blocking a thorough UT investigation of the volume of the pin).
