PHYSICAL NEEDS ASSESSMENT AND ENERGY AUDIT

HOUSING AUTHORITY OF BERGEN COUNTY

BROOKSIDE GARDENS

293 Murray Hill Terrace
Bergenfield, New Jersey 07621

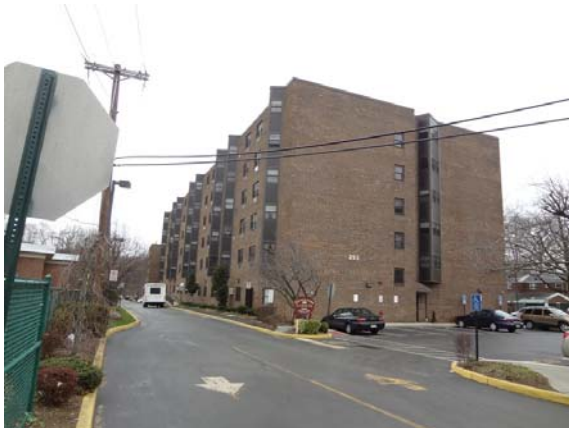
Photo #1: Front, western elevation

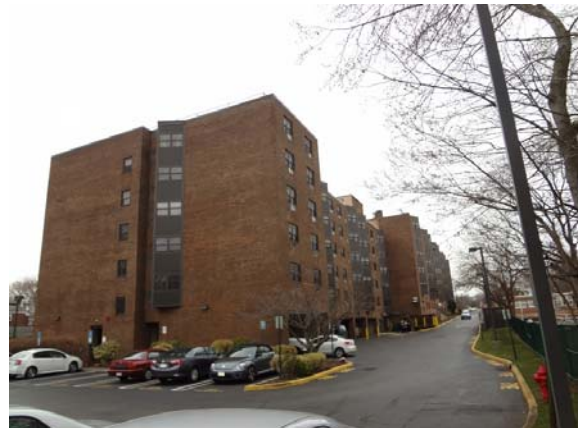
Photo #2: Left side, northern elevation

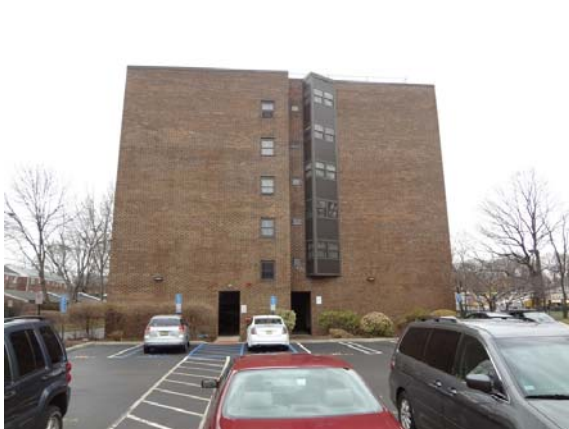
Photo #3: Rear, eastern elevation

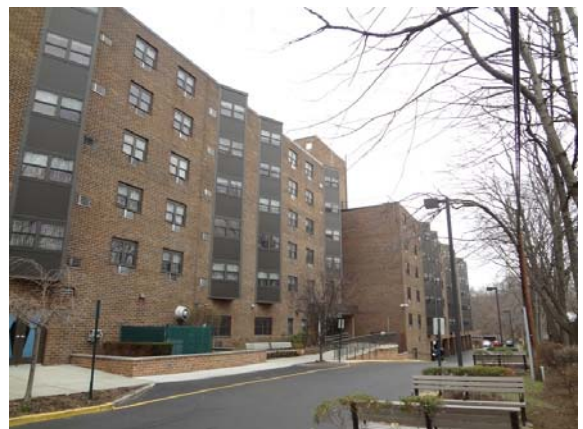
Photo #4: Right side, southern elevation

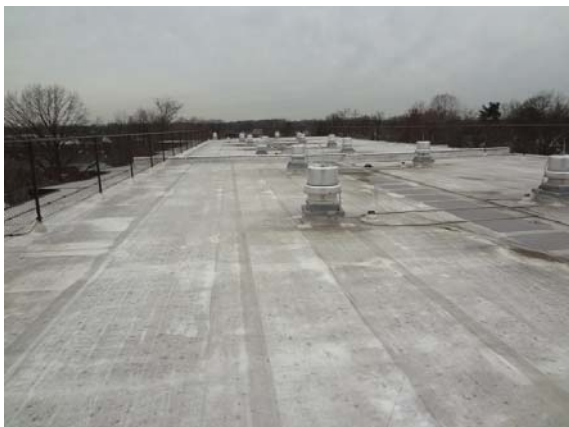
Photo #5: Roof overview

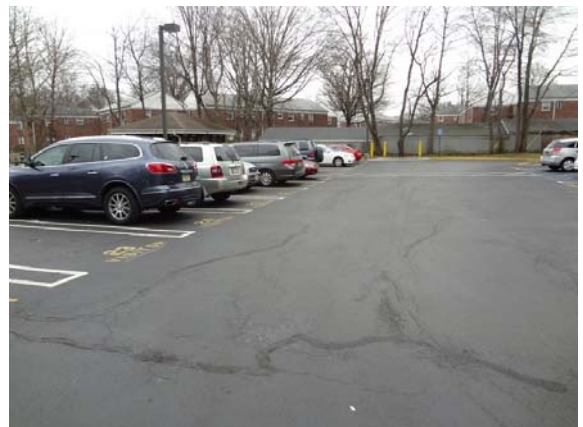
- The asphalt pavement is in fair condition. There are isolated areas of failure and deterioration, such as alligator cracking and localized depressions are found throughout the site. All of the paving must be overlaid with new asphalt paving in order to maintain the integrity of the overall pavement system. The cost of this work is included in the Replacement Reserves Report.

Photo #6: Parking overview

- In addition to aforementioned overlay, seal coating and striping will be required during the assessment period. The cost of this work is included in the Replacement Reserves Report.
- The concrete pavement is in good condition. There are no significant signs of cracks or surface deterioration. Epoxy sealing of minor cracks will be required over the assessment period as part of the property management's routine maintenance program.
- The concrete curbs, gutters, and sidewalks throughout the property are in good condition. Routine cleaning and maintenance will be required over the assessment period.

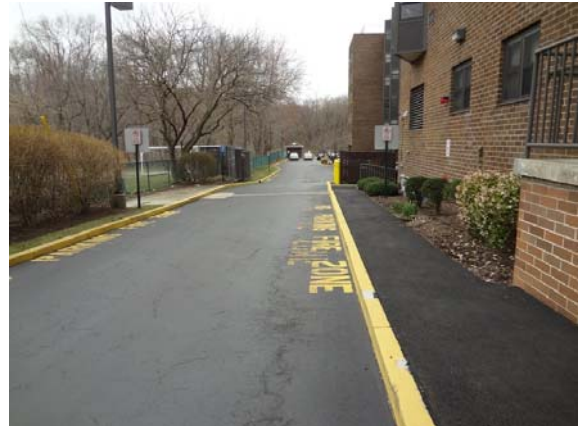
Photo #8:	Drive lane on north side of building
-----------	--------------------------------------

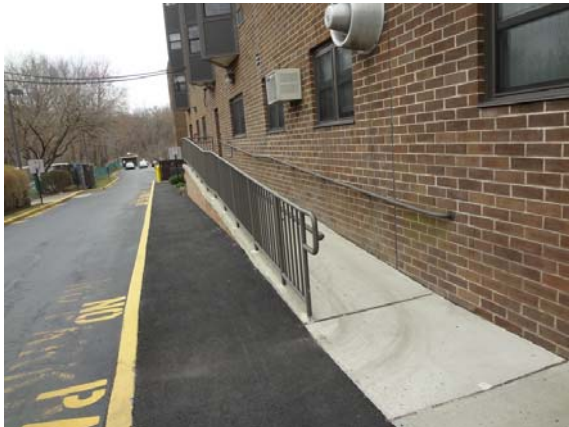
Photo #9:	ADA ramp at north side of building
-----------	------------------------------------

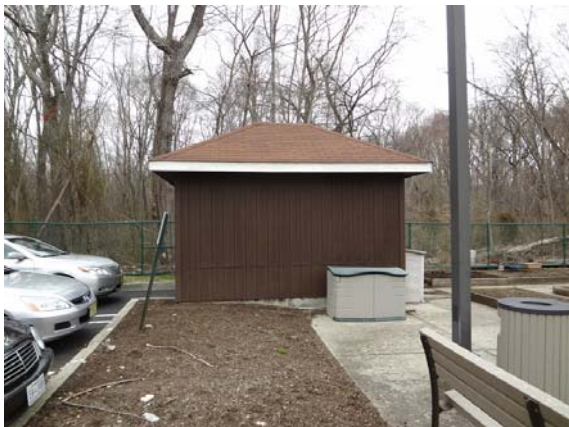
Photo #15: Small storage shed on eastern side of property

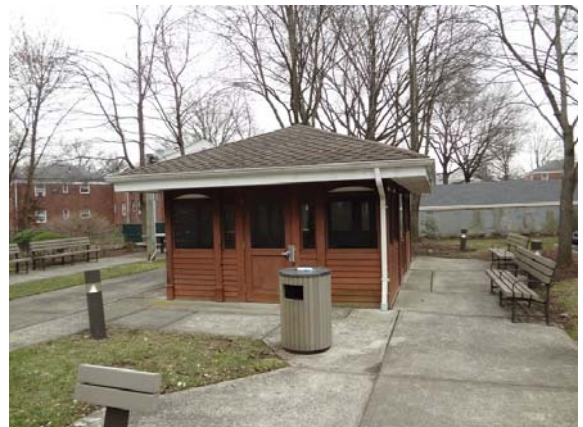
Photo #16: Screened gazebo at east side of property

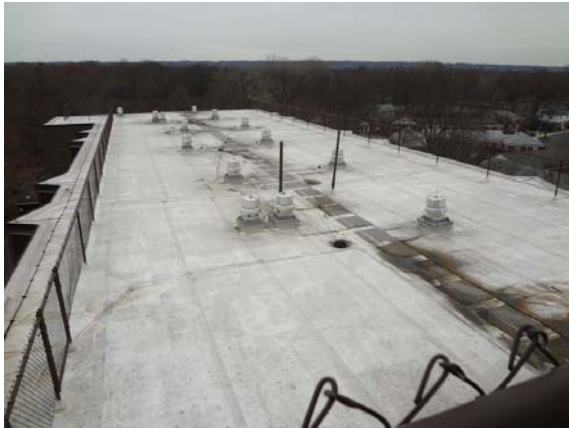
Photo #19: Roof of eastern wing

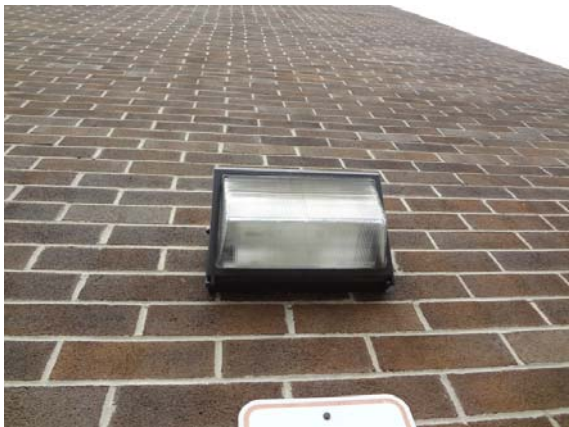
Photo #21: Brick veneer recently repointed and coated, surface mounted lighting

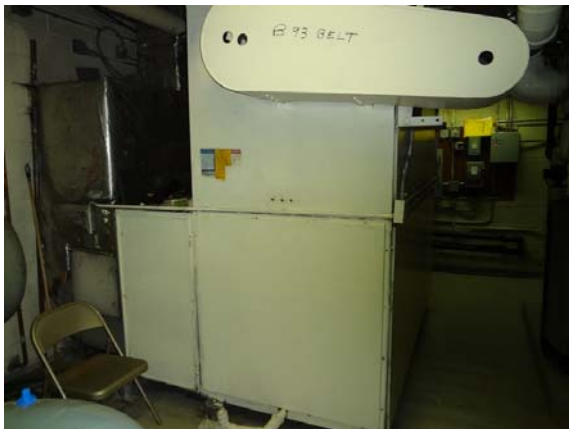
Photo #33: Main air handler

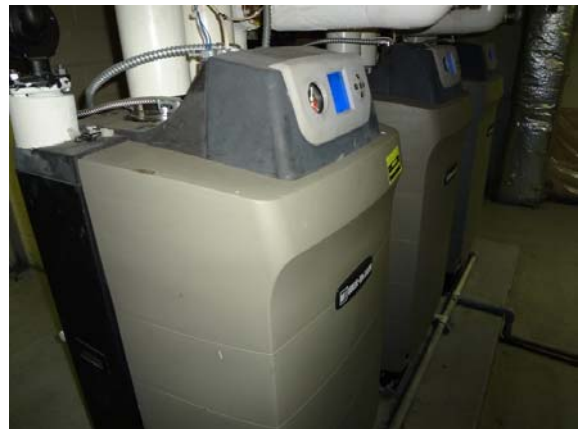
Photo #34: Domestic water boilers

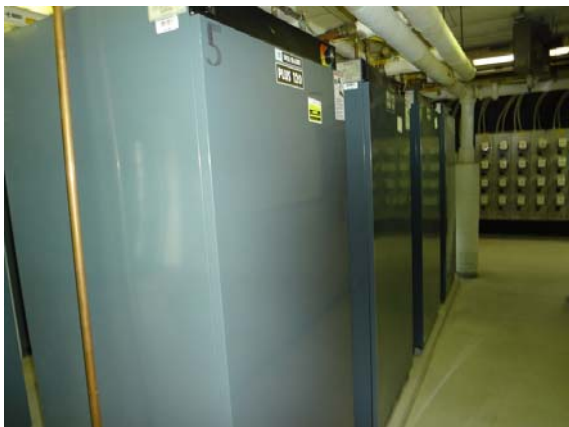
Photo #35: Water heaters connected to domestic boilers

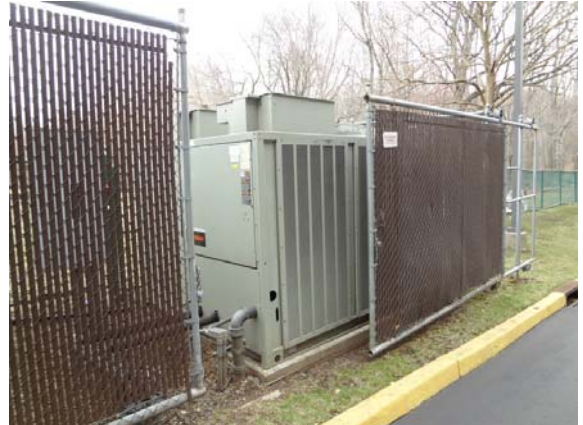
Photo #38: Large condenser at north side of property
