# RAD GREEN PCA REPORT

## RAD PROGRAM PHYSICAL CONDITION ASSESSMENT of DAVID F. ROCHE APARTMENTS 2 Aladdin Avenue Dumont, New Jersey 07628

EMG Project #: 107534.13R-003.306

Date of Report: September 8, 2014

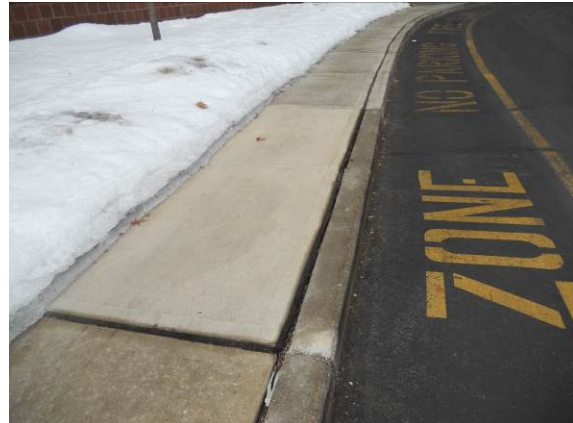
| Photo #8: | Shifted concrete walkway |

| Critical Repair Description | PCA Contractor Estimate | Actual Cost | Included in Rehab or To Be Completed Prior To Closing? |
|---|---|---|---|
| Sidewalk with differential settlement causing potential trip hazard, 25 SF @ \$7/SF | \$175 | | Included in Rehab |

| WORK | | | | | | |
|---|---|---|---|---|---|---|
| 3.2.4.02 | Parking and Driveways Other #2 | Replace heaved concrete | 25 | \$7.00 | \$175 | |

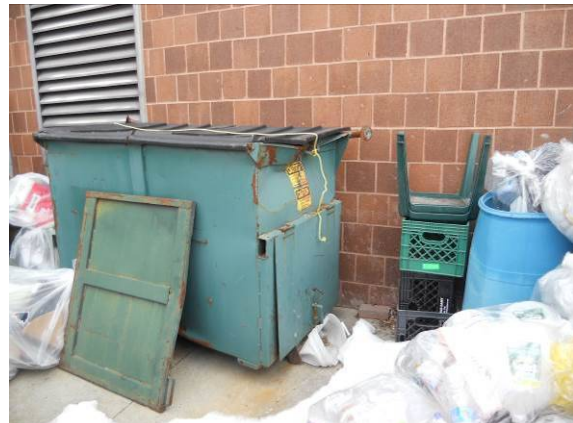
| Photo #10: | Damaged Dumpster |

| WORK | | | | | | |
|---|---|---|---|---|---|---|
| 3.8.06 | Dumpsters - Property Owned | Replace dumpsters | 6 | \$437.50 | \$2,625 | |

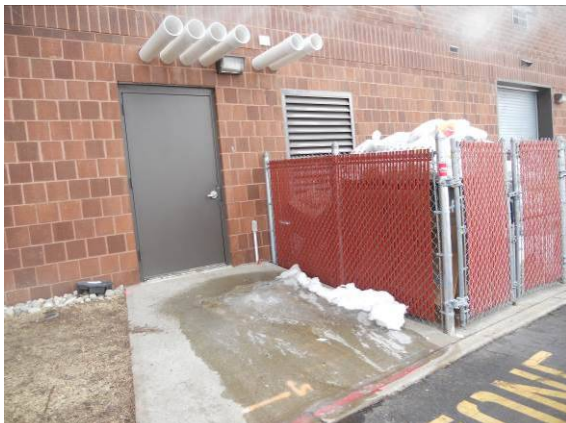
| Photo #11: | Condensation exhaust causing ice to form at exit from main mechanical room |

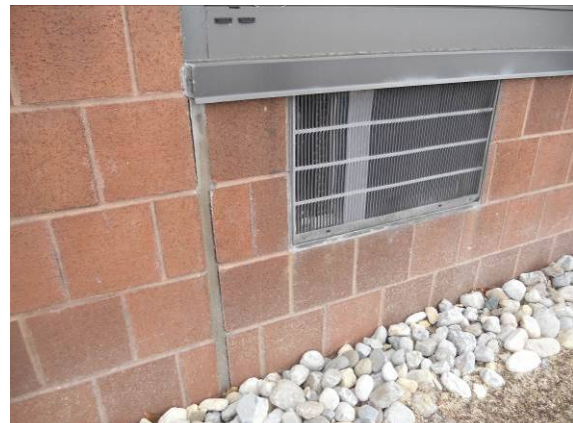
| Photo #12: | Separating construction joint |

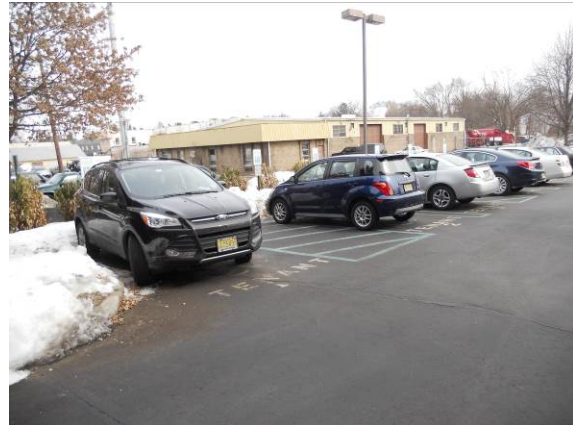
Photo #14: ADA parking with post signage at non-compliant heights

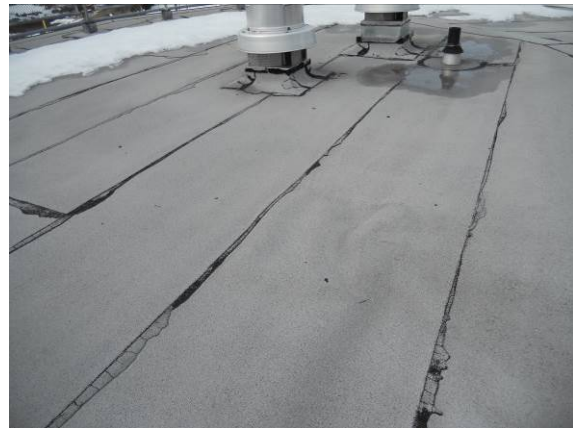
Photo #16: Roof close up showing bulges in membrane

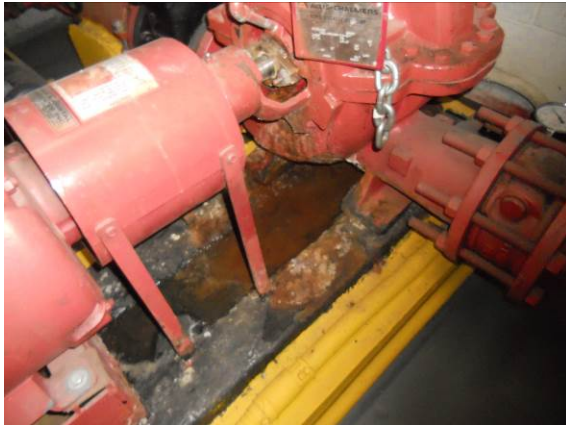
Photo #25: Fire pump with excessive corrosion at pan

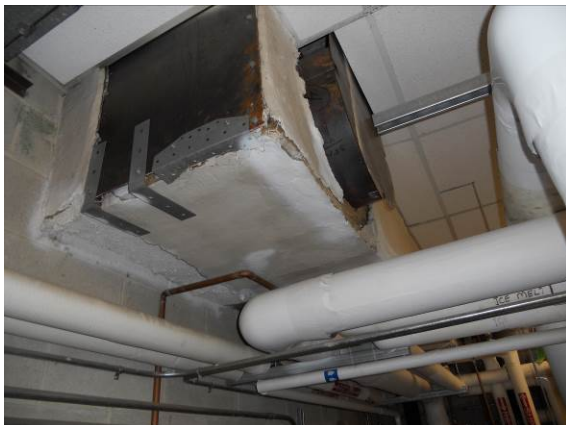
- No smoke detectors located within bedrooms
- No carbon monoxide detector in natural gas fired generator room
- Sidewalk with differential settlement causing potential trip hazard.
- An isolated area of insulation potentially containing asbestos in the boiler was observed as damaged, brittle and exposed. As such, EMG recommends that an Asbestos Survey be conducted.

Photo #29: Suspect asbestos at duct

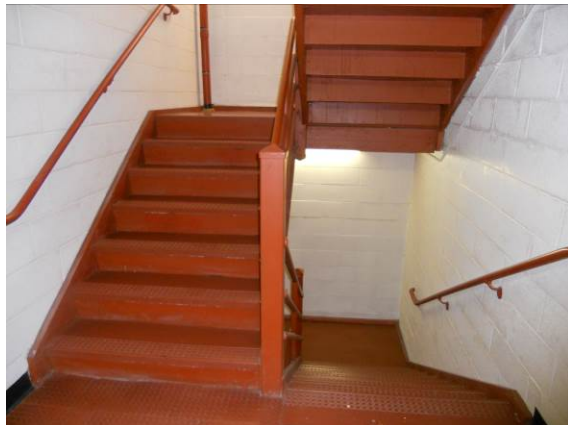
Photo #33: Fire stair without continuous inner railing but extensions on outer railing

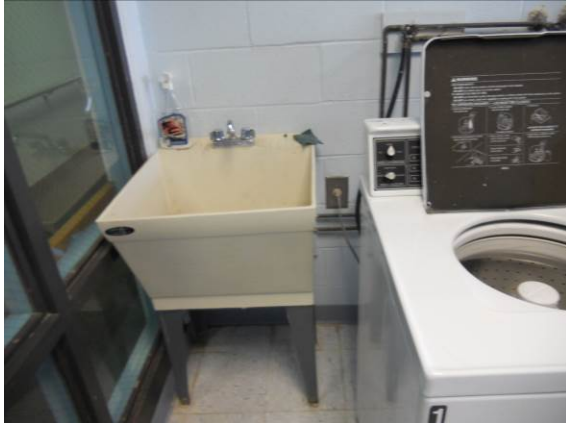
Photo #37: Laundry sink with non-GFCI

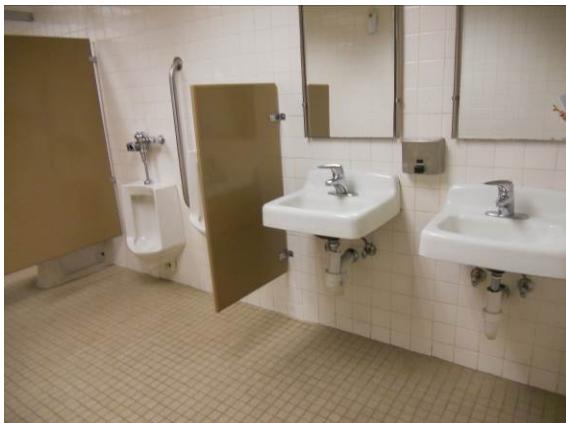
Photo #41: Common area men's restroom with loose drain pipe insulation

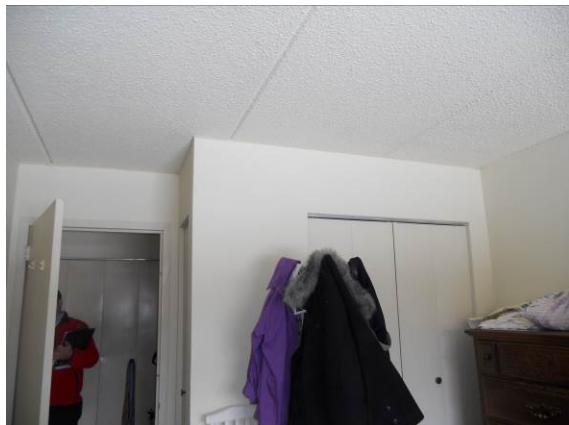
Photo #47: Apartment unit bedroom with no smoke detector

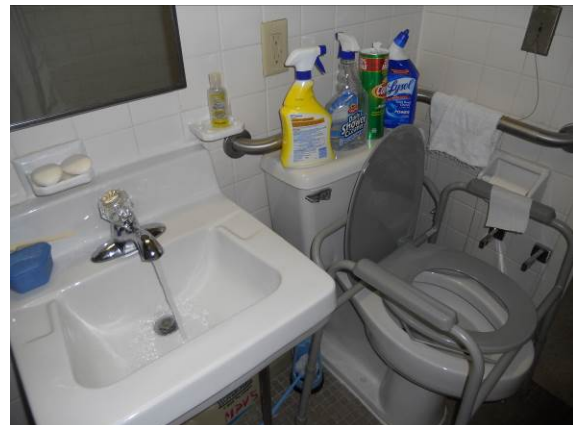
Photo #54: Apartment ADA unit with non-compliant faucet handle and grab bar lengths

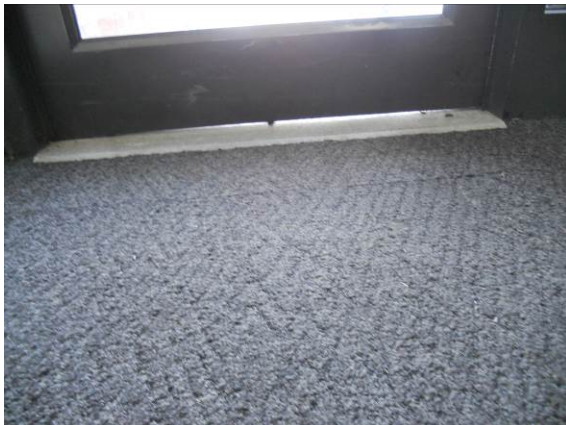
Photo #57: Secondary entrance with daylight seen under door frame

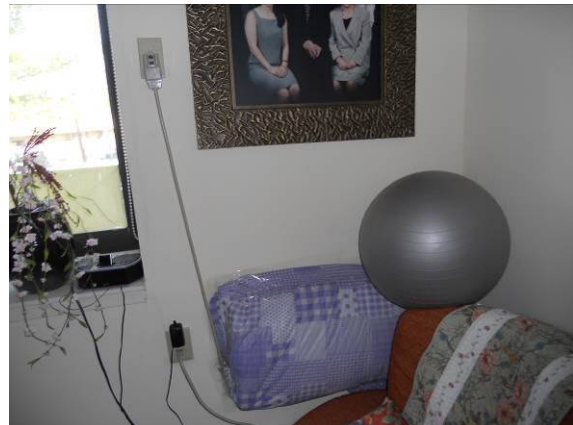
Photo #58: Apartment unit with dedicated receptacle location too far from air conditioning unit
