RAD PHYSICAL CONDITION ASSESSMENT

RAD PROGRAM PHYSICAL CONDITION ASSESSMENT of CARUCCI APARTMENTS

281 Stuyvesant Avenue

EMG Project #: 107534.13R-002.306

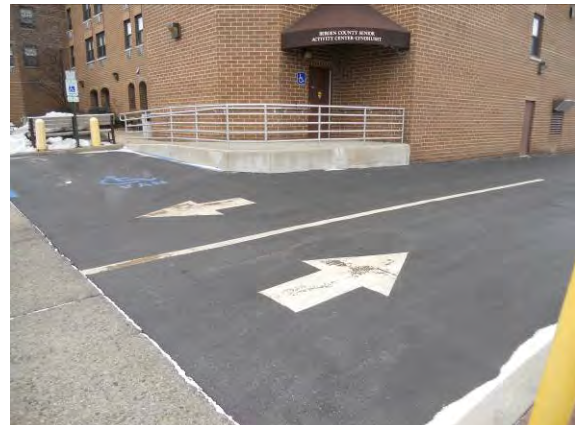
Photo #4: Driveway entrance and front ADA stall with no access aisle markings

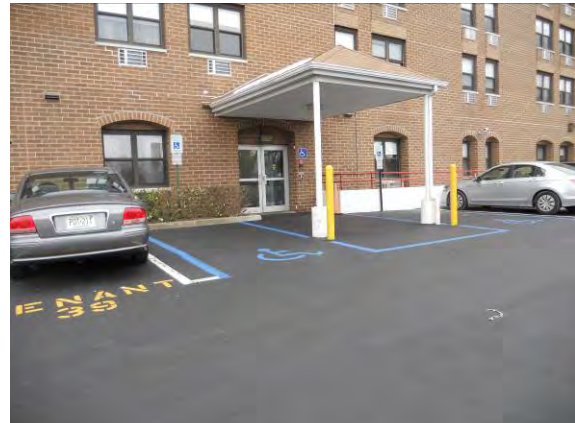
Photo #6: Rear entrance with additional ADA stalls and no access aisle markings

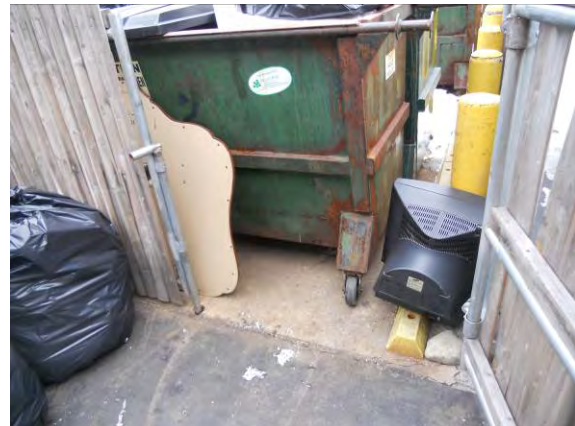
Photo #8: Dumpster, enclosure and bollards with concrete fill pushing up and out of tops

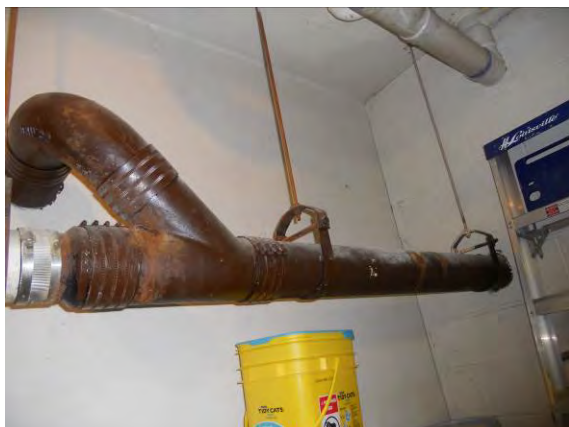
Photo #21: Waste line with corrosion in basement

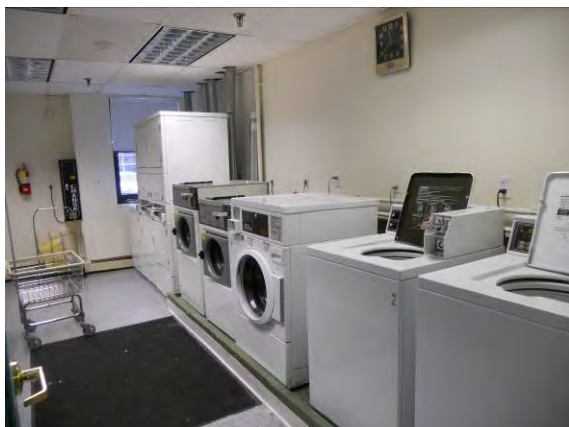
Photo #27: Laundry room with disconnected dryer vent in distance

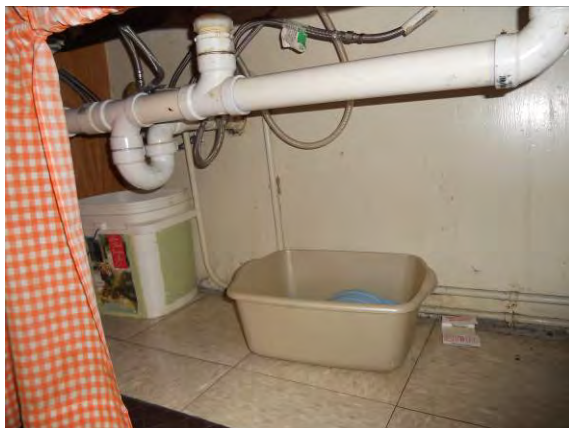
Photo #31: Non-insulated drainage piping under community room kitchen sink

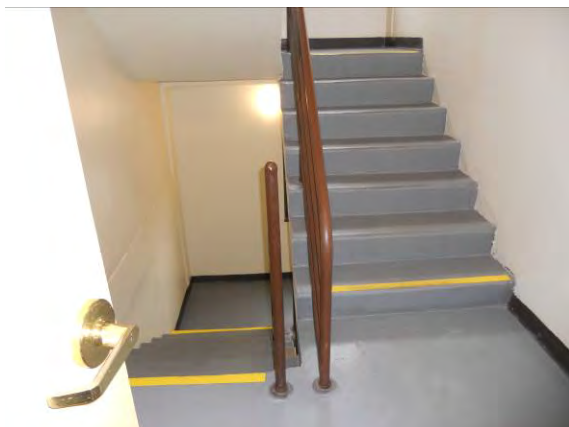
Photo #33: Fire stair with non-continuous railings

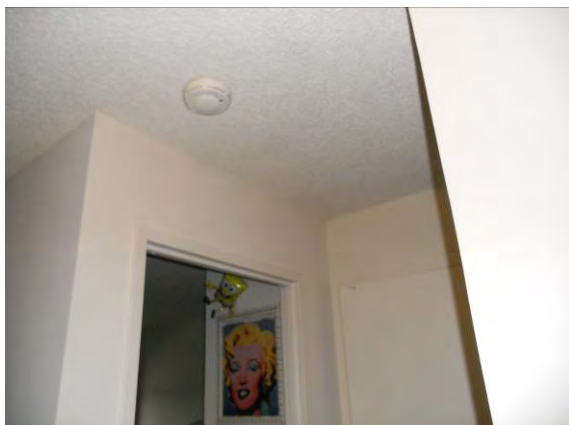
Photo #39: Apartment unit smoke detector outside of bedroom only

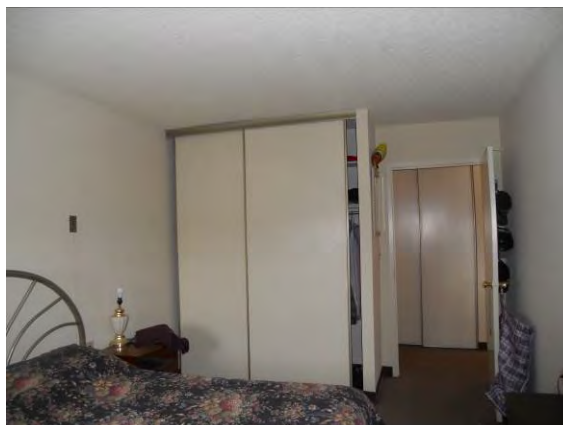
Photo #40: Bedroom with no smoke detector

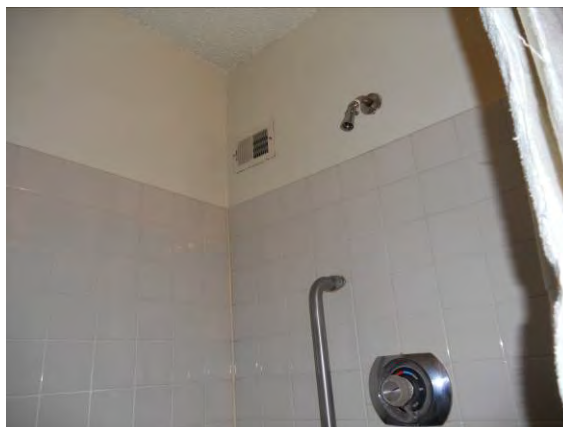
Photo #52: ADA unit with roll-in shower but no hand-held shower head

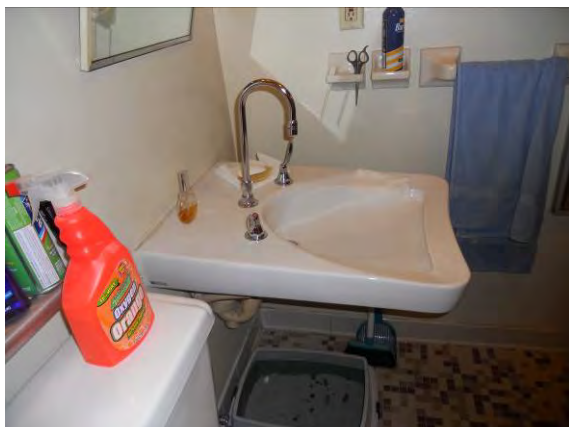
Photo #53: ADA unit sink sloping/not set level

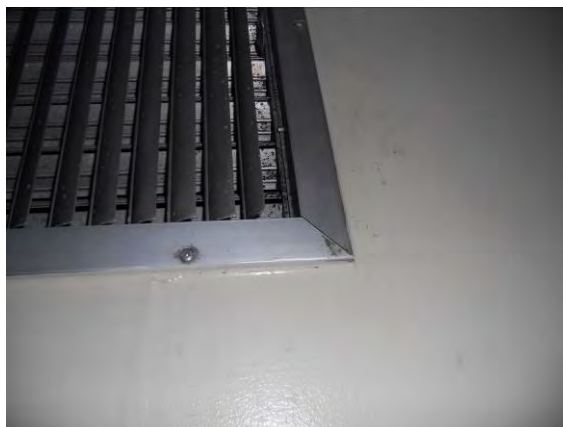
Photo #54: Suspect mold in supply vent in corridor

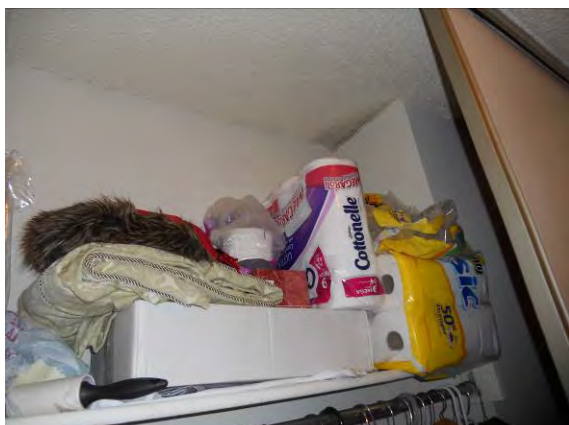
Photo #55: Suspect mold in apartment unit closet – 5N

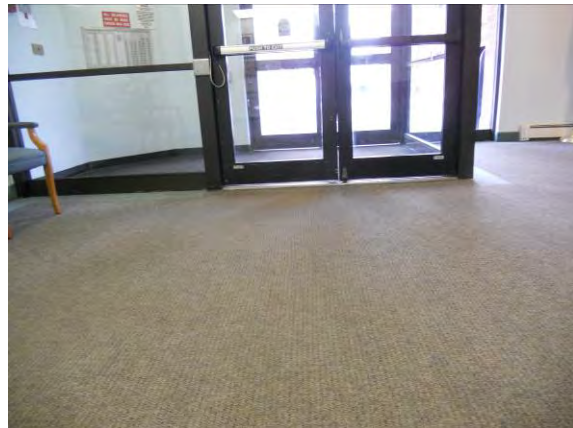
Photo #62: Main lobby entrance seeing daylight under door frame at both sets

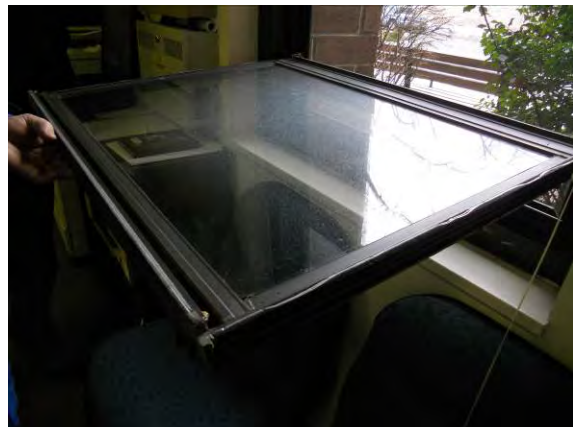
Photo #64: Window pane showing issue with air infiltration

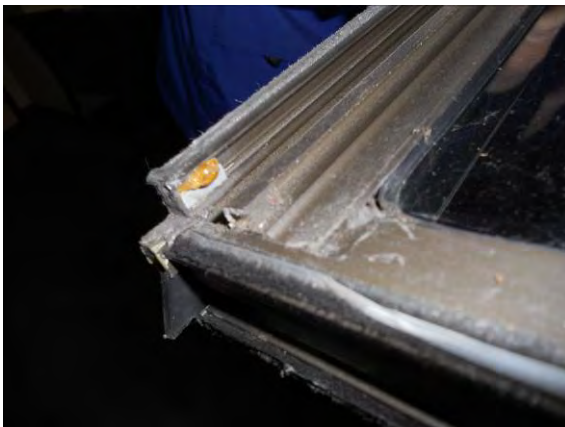
Photo #65: Showing attempts to fill possible air infiltration areas at window frame

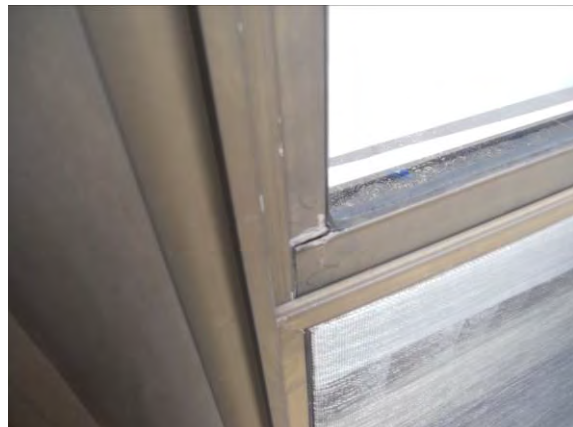
Photo #66: Exterior of window frame showing cracked window frame sealant at joint
