RAD GREEN PCA REPORT

RAD PROGRAM GREEN PHYSICAL CONDITION ASSESSMENT of MAHWAH PUBLIC HOUSING

1600 Ramapo Brae Lane
Mahwah, New Jersey 07430

EMG Project #: 107534.13R-005.306
Date of Report: August 7, 2014
On site Date: March 5, 2014

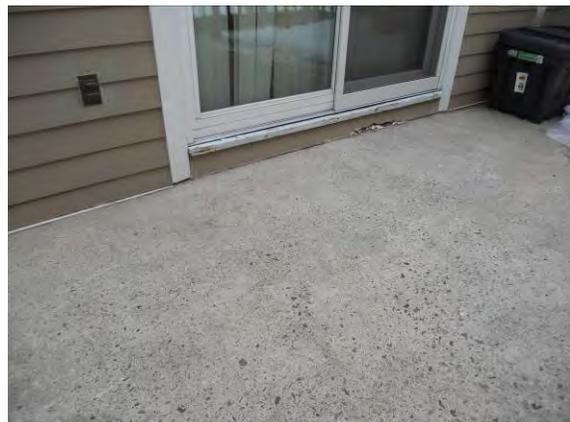
Photo #6:	Damaged siding under sliding door
-----------	-----------------------------------

3.3.2.5.01	Exterior Doors	0	\$0.00	\$0		
3.3.2.5.02	Storm Doors	0	\$0.00	\$0		
3.3.2.9.01	Exterior Siding - Repair	Repair exterior siding damage	3,500	\$7.27	\$25,445

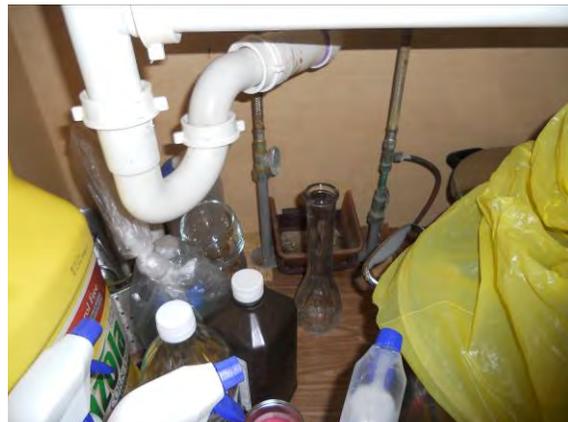
- No smoke detectors in the bedrooms
- Polybutylene supply piping from storage tank to fixtures – it was reported that approximately 70% of it has issues
- Active leak in crawl space under unit 605

Photo #12: Polybutylene supply piping at kitchen sink

3.4.1.2.01	Polybutylene Supply Piping -	Replace polybutylene piping in tenant units	35	\$1,650.00	\$57,750	
3.4.1.2.02	Indirect Fired Hot Water Storage	0	\$0.00	\$0

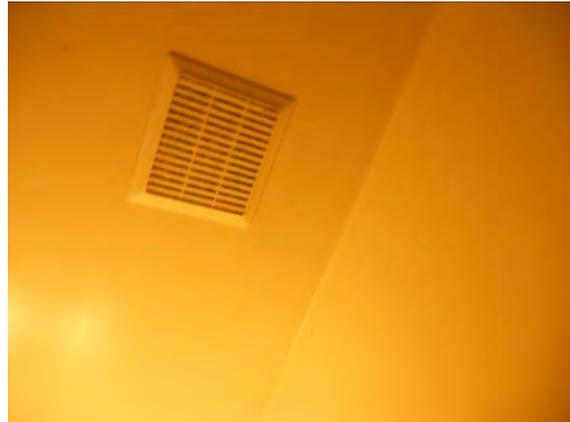
Photo #14: Dust filled exhaust fan in bathroom

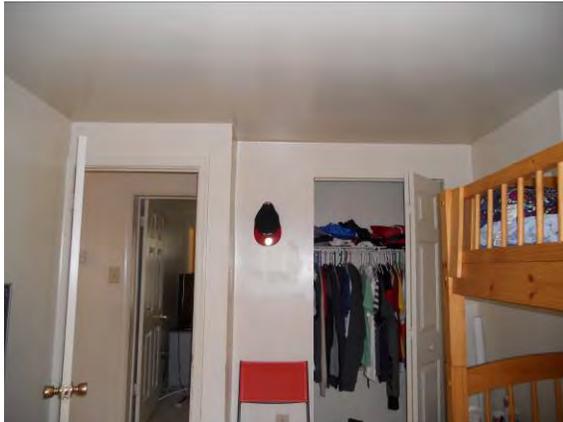
Photo #19: Bedroom with no smoke detector

Critical Repair Description	PCA Contractor Estimate	Actual Cost	Included in Rehab or To Be Completed Prior To Closing?
Install smoke detectors in all tenant bedrooms	\$26,265	\$26,265	Included in Rehab
Replace polybutylene piping	\$57,750	\$57,750	Included in Rehab

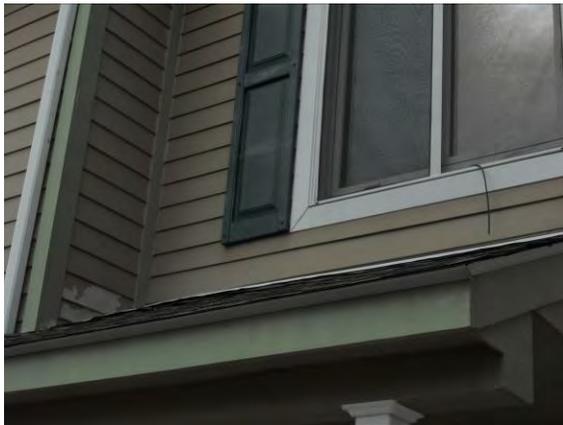
Photo #21: Damaged siding and loose window gasket

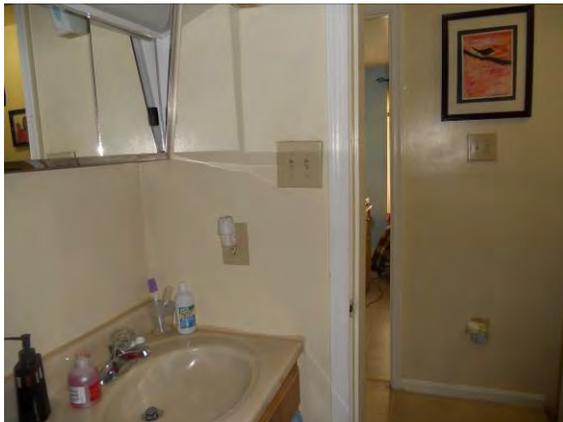
Photo #27: Unit bathroom with non-GFCI test type receptacle

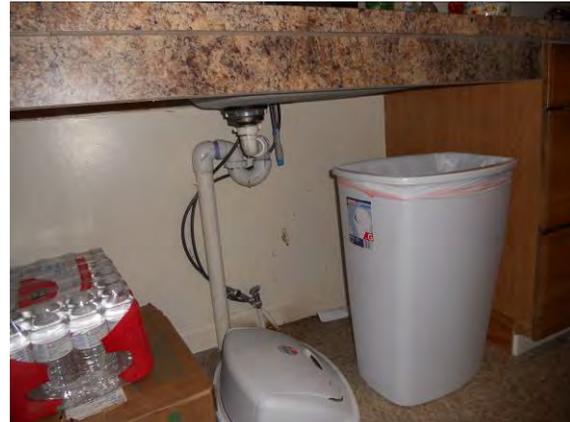
Photo #32: Non-insulated drain pipe in kitchen of ADA unit

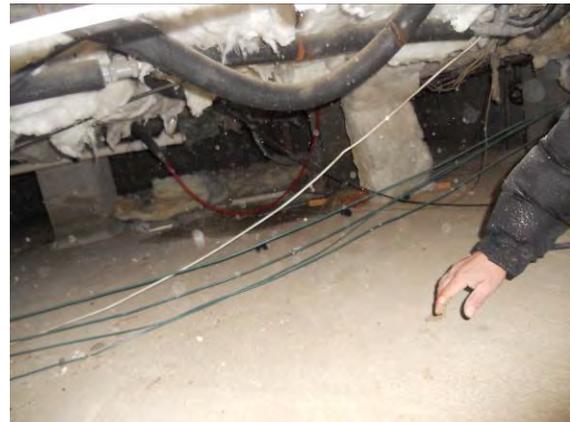
Photo #34: Crawl space with active leak under unit 605

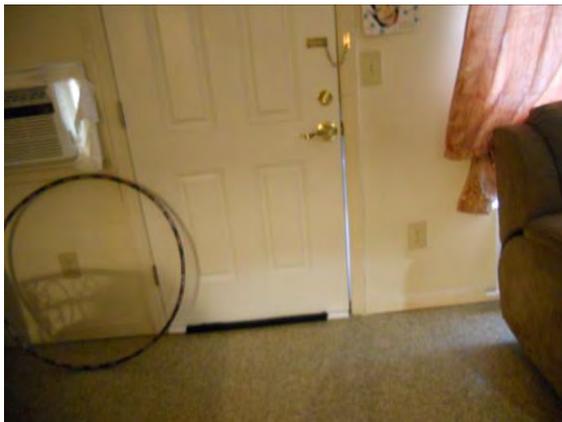
Photo #35: Daylight seen at perimeter of entry door

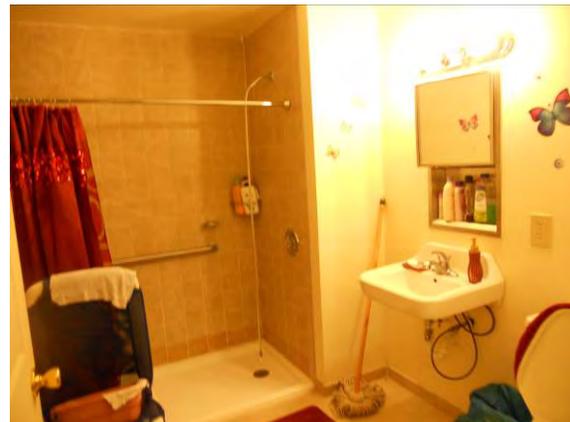
Photo #36: ADA unit bathroom with no drain pipe insulation or hand-held shower mount

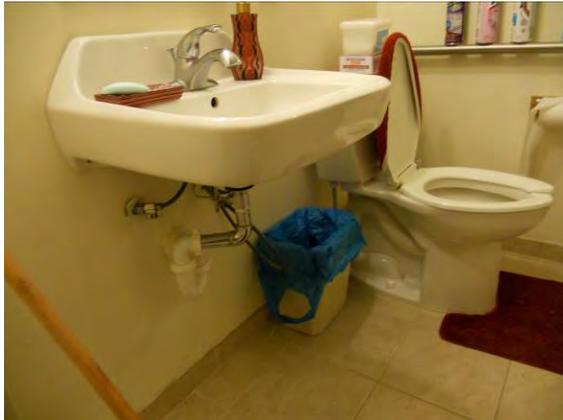
Photo #37: No drain pipe insulation or rear grab bar at toilet in ADA unit

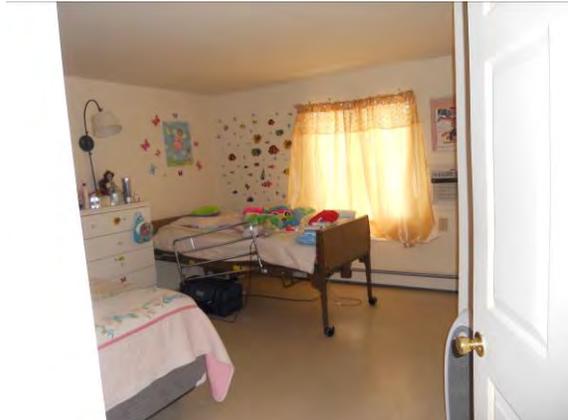
Photo #38: Bedroom in ADA unit without lever handle

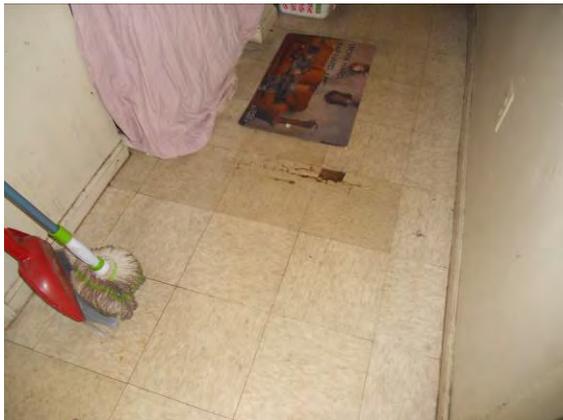
Photo #39: Damaged flooring near tenant installed washing machine

3.7.2.3.02	Interior Doors	0	\$0.00	\$0		
3.7.2.3.03	Interior Painting	0	\$0.00	\$0		
3.7.2.39.01	Interior Unit Flooring	0	\$0.00	\$0		
3.7.2.39.02	Subfloor - replace particle board	Replace damaged subfloor	10	\$1,500.00	\$15,000

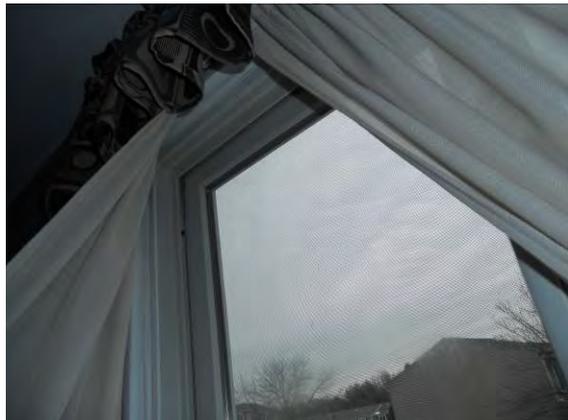
Photo #40: Window sash not sitting flush in frame

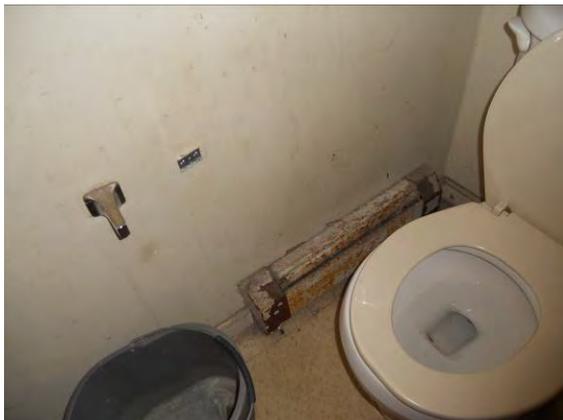
Photo #41: Rusted and corroded hydronic baseboard heater

3.4.9.02	Baseboard Hydronic Heaters	Replace hydronic water heaters	24	\$500.00	\$12,000	
3.4.9.03	M&E Other #2	0	\$0.00	\$0		
3.4.9.04	M&E Other #3	0	\$0.00	\$0

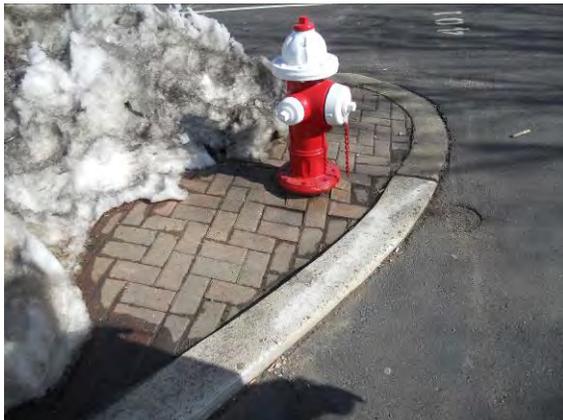
Photo #57: Fire hydrant and sunken brick pavers

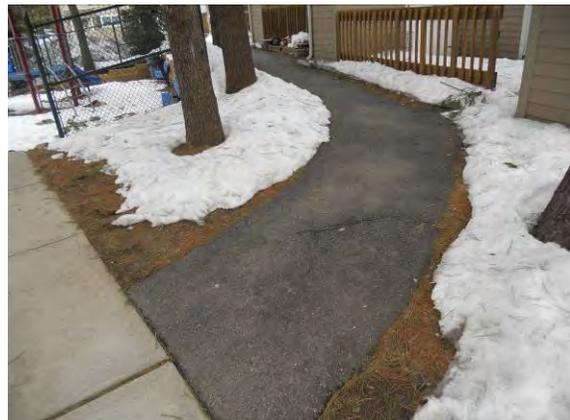
Photo #60: Asphalt sidewalk with isolated heaving from tree roots
