RAD GREEN PCA REPORT

RAD PROGRAM GREEN PHYSICAL CONDITION ASSESSMENT of HIGHLAND VIEW APARTMENTS

300 Highland Avenue
Palisades Park, New Jersey 07650

EMG Project #: 107534.13R-004.306
Date of Report: October 7, 2014
On site Date: March 6, 2014

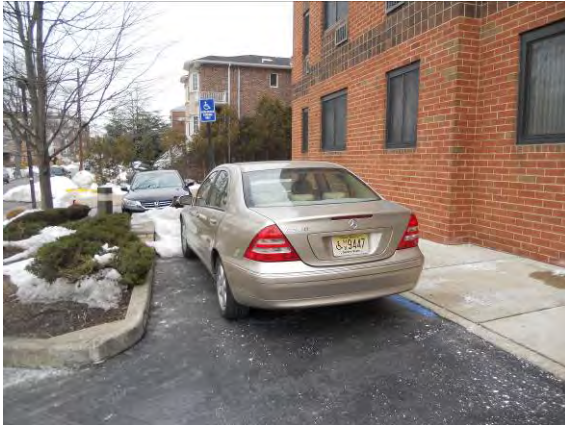
Photo #7:	ADA parking without access aisle
-----------	----------------------------------

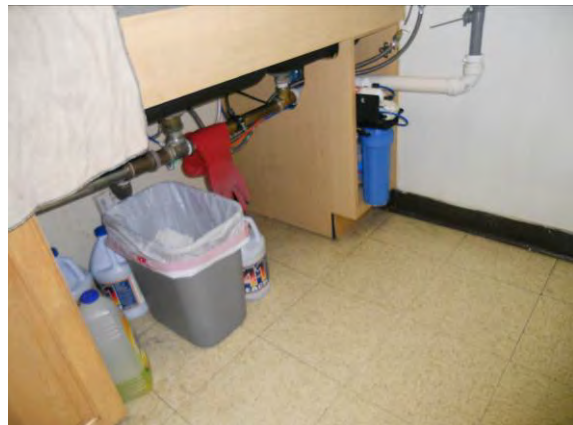
Photo #16: Non insulated drain lines under sink in community room kitchen

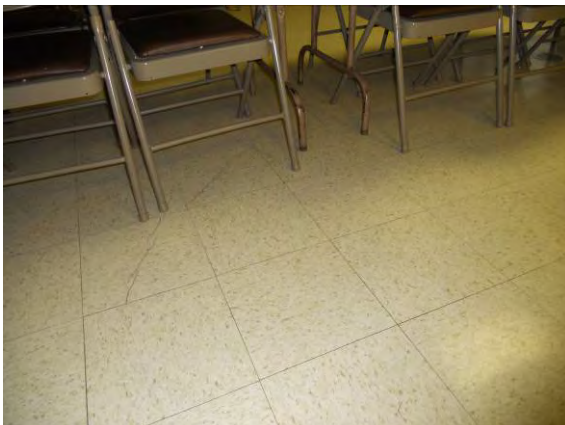
Photo #17: Crack in flooring in community room

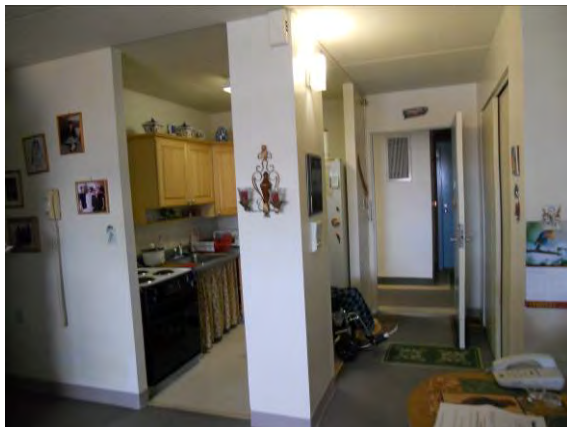
Photo #29: ADA apartment kitchen and entrance with no pull side clearance

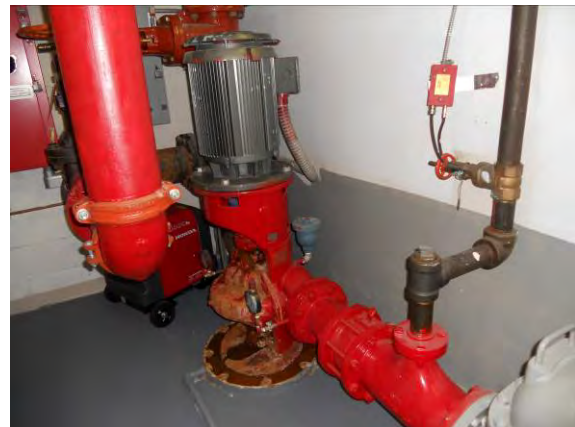
Photo #34: Rusty fire pump

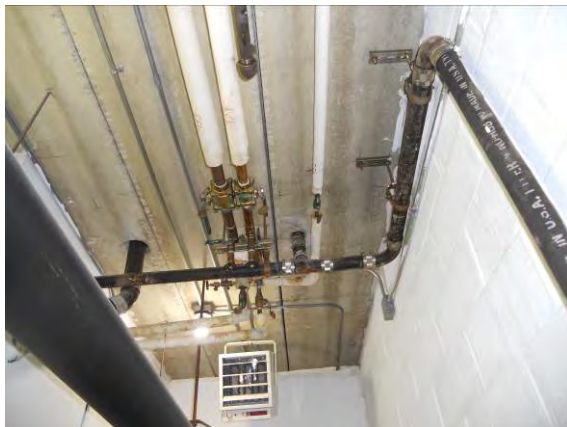
Photo #35: Uninsulated sections of piping
