# PHYSICAL NEEDS ASSESSMENT AND ENERGY AUDIT

## LEHMANN GARDENS

12-14 Sulak Lane  
Park Ridge, New Jersey 07656

**EMG Project #:** 107534.13R -008.308  
**Date of Report:** July 25, 2014  
**On site Date:** April 8, 2014

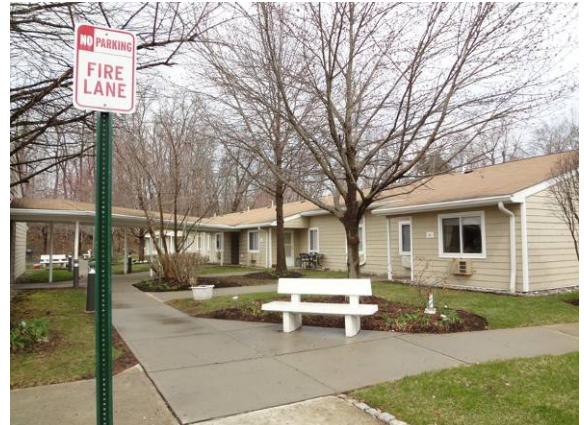
Photo #6: Twenty year, three tab shingles throughout property

| Report<br>Section | ID | Cost Description | Lifespan<br>(EUL) | E | Age | RUL | Quantity | Unit | Unit Cost | Subtotal | 2014 | 2015 | 2016 | 2017 | 2018 | 2019 | 2020 | 2021 | 2022 | 2023 | 2024 | 2025 | 2026 | 2027 | 2028 | 2029 | 2030 | 2031 | 2032 | 2033 | Deficiency<br>Repair<br>Estimate |
|---|---|---|---|---|---|---|---|---|---|---|---|---|---|---|---|---|---|---|---|---|---|---|---|---|---|---|---|---|---|---|---|
| 6.3 | 244129 | B3011 Asphalt shingles, removal and replacement with premium grade | 30 | 19 | 11 | 468 | SQ | | \$430.00 | \$201,240 | | | | | | | | | | | | \$201,240 | | | | | | | | | \$201,240 |

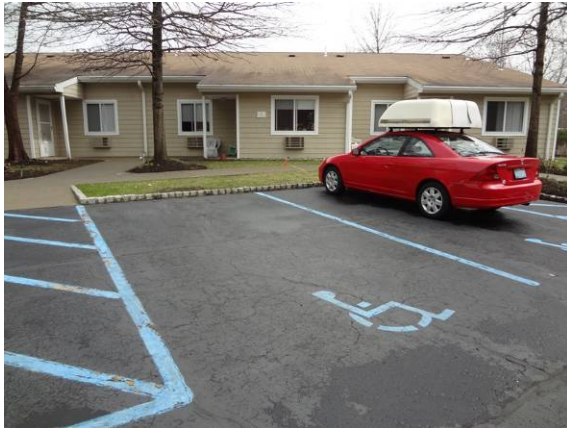
Photo #7: ADA parking throughout site does not have signage

| Report<br>Section | ID | Cost Description | Lifespan<br>(EUL) | E | Age | RUL | Quantity | Unit | Unit Cost | Subtotal | 2014 | 2015 | 2016 | 2017 | 2018 | 2019 | 2020 | 2021 | 2022 | 2023 | 2024 | 2025 | 2026 | 2027 | 2028 | 2029 | 2030 | 2031 | 2032 | 2033 | Deficiency<br>Repair<br>Estimate |
|---|---|---|---|---|---|---|---|---|---|---|---|---|---|---|---|---|---|---|---|---|---|---|---|---|---|---|---|---|---|---|---|
| 3.2 | 240600 | G2025A ADA - Install signage indicating Van Accessible Parking, pole mounted | 0 | 0 | 0 | 1 | Sign | | \$280.00 | \$280 | \$280 | | | | | | | | | | | | | | | | | | | | \$280 |
| 3.2 | 240599 | G2025A ADA - Install signage indicating Accessible Parking, pole mounted | 0 | 0 | 0 | 19 | Each | | \$280.00 | \$5,320 | \$5,320 | | | | | | | | | | | | | | | | | | | | \$5,320 |

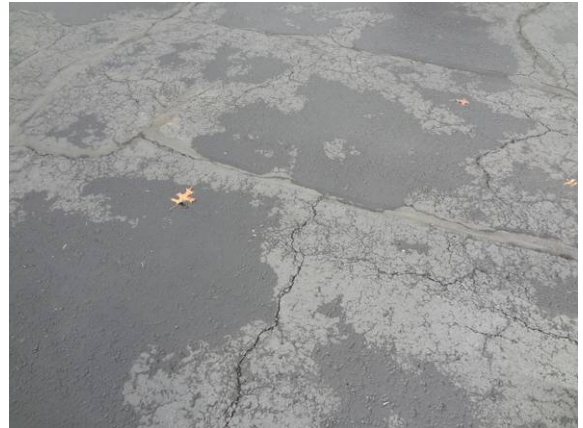
- The asphalt pavement is in fair condition. There are notable areas of failure and deterioration, such as alligator cracking and localized depressions throughout the property. All of the paving must be overlaid with new asphalt paving in order to maintain the integrity of the overall pavement system. The estimated cost of this work is included in the Replacement Reserves Report.
- The concrete sidewalks throughout the property are in good condition. There are no significant signs of cracks or surface deterioration. Epoxy sealing of minor cracks will be required over the assessment period as part of the property management's routine maintenance program.
- The stone curbs throughout the property are in good condition. Routine cleaning and maintenance will be required over the assessment period.

Photo #8: Asphalt paving shows signs of cracking throughout site

| Report<br>Section | ID | Cost Description | Lifespan<br>(EUL) | E | Age | RUL | Quantity | Unit | Unit Cost | Subtotal | 2014 | 2015 | 2016 | 2017 | 2018 | 2019 | 2020 | 2021 | 2022 | 2023 | 2024 | 2025 | 2026 | 2027 | 2028 | 2029 | 2030 | 2031 | 2032 | 2033 | Deficiency<br>Repair<br>Estimate |
|---|---|---|---|---|---|---|---|---|---|---|---|---|---|---|---|---|---|---|---|---|---|---|---|---|---|---|---|---|---|---|---|
| 5.2 | 240601 | G2012 Asphalt- overlay 1" | 25 | 17 | 8 | 62695 | SF | | \$0.92 | \$57,679 | | | | | | | | | \$57,679 | | | | | | | | | | | | \$57,679 |

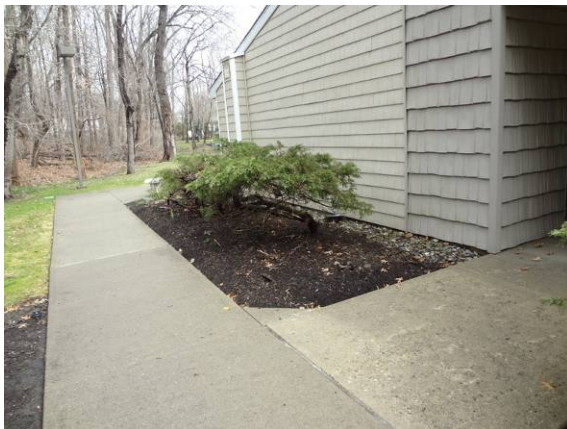
Photo #9: Concrete throughout site is in good condition

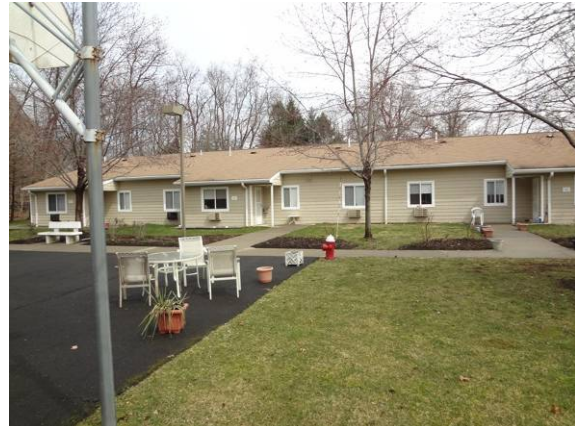
Photo #14: Roofs are in fair condition

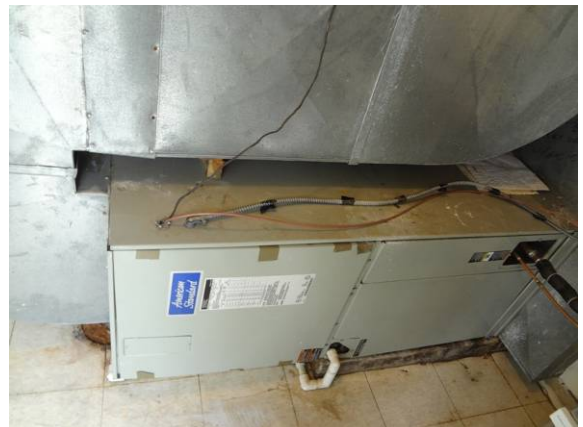
Photo #22: Air handler provides air conditioning for community room

| Report<br>Section | ID | Cost Description | Lifespan<br>(EUL) | E | Age | RUL | Quantity | Unit | Unit Cost | Subtotal | 2014 | 2015 | 2016 | 2017 | 2018 | 2019 | 2020 | 2021 | 2022 | 2023 | 2024 | 2025 | 2026 | 2027 | 2028 | 2029 | 2030 | 2031 | 2032 | 2033 | Deficiency<br>Repair<br>Estimate |
|---|---|---|---|---|---|---|---|---|---|---|---|---|---|---|---|---|---|---|---|---|---|---|---|---|---|---|---|---|---|---|---|
| 7.1 | 240641 | D3041 Replace air handler 2500-3000 CFM | 15 | 12 | 3 | 1 | EA | | \$7,400.00 | \$7,400 | | | | \$7,400 | | | | | | | | | | | | | | | \$7,400 | | \$14,800 |

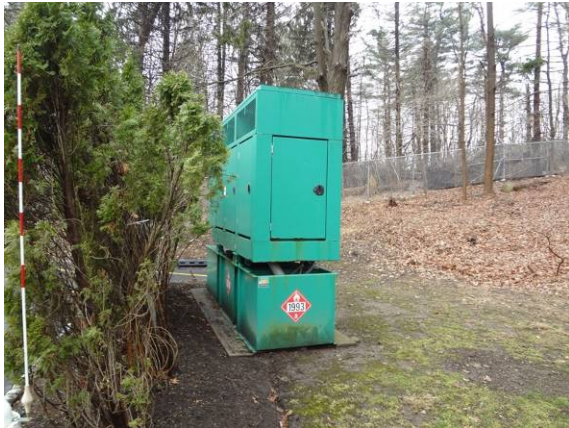
Photo #25: Backup generator

| Report<br>Section | ID | Cost Description | Lifespan<br>(EUL) | E | Age | RUL | Quantity | Unit | Unit Cost | Subtotal | 2014 | 2015 | 2016 | 2017 | 2018 | 2019 | 2020 | 2021 | 2022 | 2023 | 2024 | 2025 | 2026 | 2027 | 2028 | 2029 | 2030 | 2031 | 2032 | 2033 | Deficiency<br>Repair<br>Estimate |
|---|---|---|---|---|---|---|---|---|---|---|---|---|---|---|---|---|---|---|---|---|---|---|---|---|---|---|---|---|---|---|---|
| 7.4 | 241562 | D5092 Replace Diesel Generator 75kW to 90 kW | 25 | 13 | 12 | 1 | Each | | \$36,595.00 | \$36,595 | | | | | | | | | | | | | \$36,595 | | | | | | | | \$36,595 |

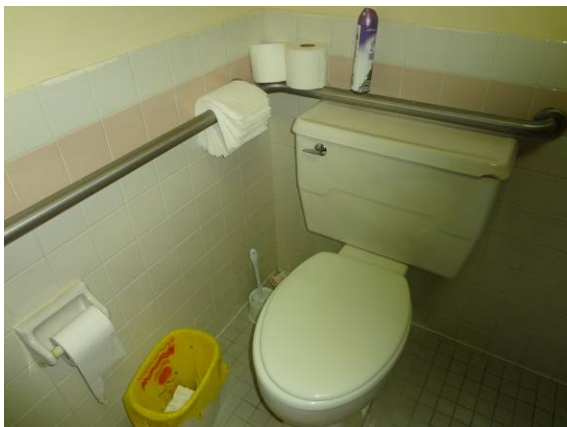
Photo #35: Water closet in tenant unit

| Report<br>Section | ID | Cost Description | Lifespan<br>(EUL) | E | Age | RUL | Quantity | Unit | Unit Cost | Subtotal | 2014 | 2015 | 2016 | 2017 | 2018 | 2019 | 2020 | 2021 | 2022 | 2023 | 2024 | 2025 | 2026 | 2027 | 2028 | 2029 | 2030 | 2031 | 2032 | 2033 | Deficiency<br>Repair<br>Estimate |
|---|---|---|---|---|---|---|---|---|---|---|---|---|---|---|---|---|---|---|---|---|---|---|---|---|---|---|---|---|---|---|---|
| 8.4 | 240651 | D2011 Replace Commercial Grade water closet with 1.6 GPF unit | 25 | 24 | 1 | 136 | EA | | \$606.00 | \$82,416 | | \$82,416 | | | | | | | | | | | | | | | | | | | \$82,416 |
