RAD GREEN PCA REPORT

HOUSING AUTHORITY OF BERGEN COUNTY

RAD PROGRAM GREEN PHYSICAL CONDITION ASSESSMENT of RAMSEY PUBLIC HOUSING

EMG Project #: 107534.13R-006.306
Date of Report: October 7, 2014
On-Site Date: March 5, 2014

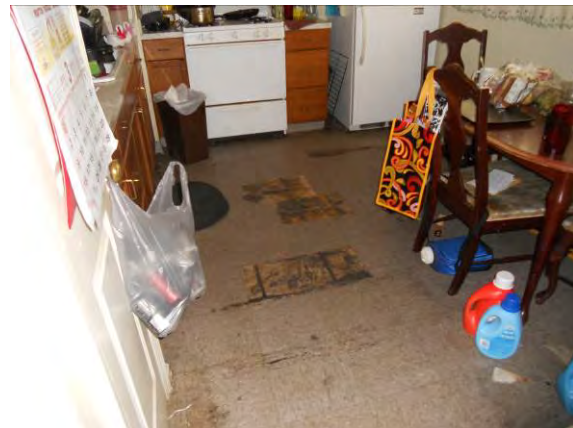
Photo #4: Flooring condition – within Mahwah section

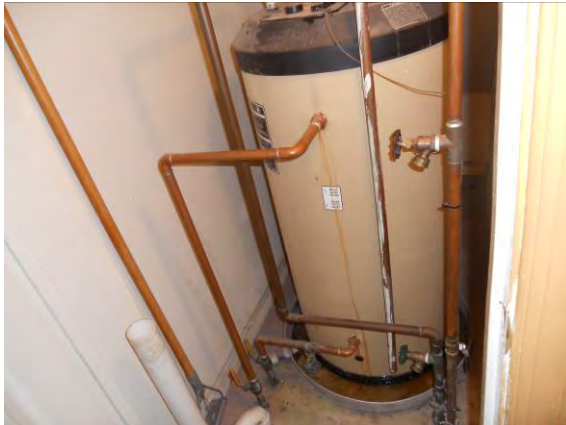
Photo #13: Domestic water heater storage tank with pan filled with water

3.4.1.2.02	Indirect Fired Hot Water Storage	Replace domestic HW tanks	31	\$3,197.00	\$99,107	
3.4.1.2.03	DHW #3		0	\$0.00	\$0	
3.4.1.2.04	DHW #4		0	\$0.00	\$0

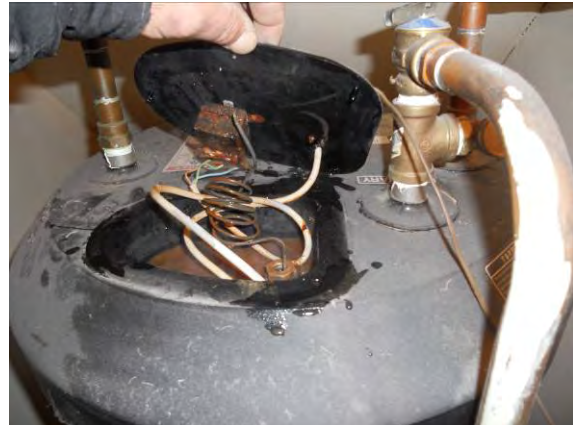
Photo #14: Rusted thermostat at top of domestic water heater storage tank

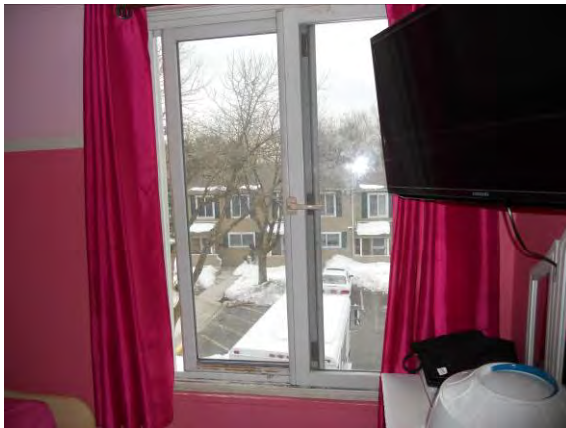
Photo #15: Sliding window with peeling paint

3.3.2.3	Insulation		0	\$0.00	\$0	
3.3.2.4.01	Sliding Glass Doors		0	\$0.00	\$0	
3.3.2.4.02	Windows	Replace windows	66	\$405.00	\$26,730	
3.3.2.5.01	Exterior Doors		0	\$0.00	\$0

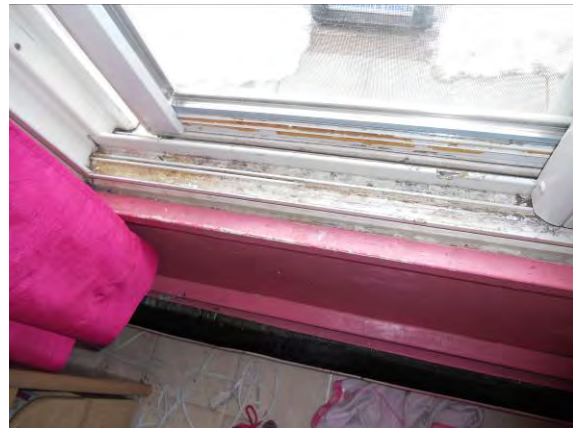
Photo #16: Close up of peeling paint at window frame

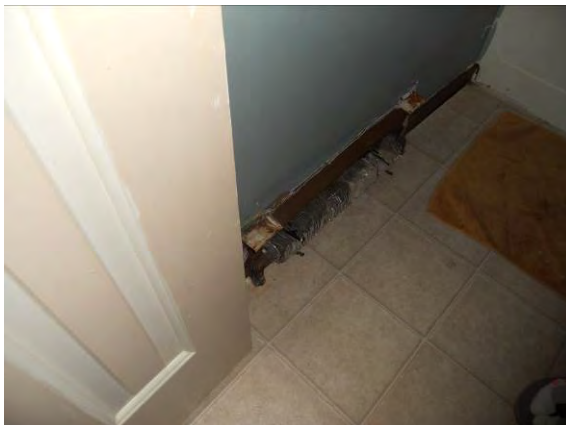
Photo #17: Missing cover and damaged fins at baseboard radiator

3.4.3.1.03	HVAC In-Unit Cooling		0	\$0.00	\$0	
3.4.9.01	Programmable Thermostats		0	\$0.00	\$0	
3.4.9.02	Baseboard Hydronic Heaters	Replace hydronic baseboard heaters	93	\$500.00	\$46,500

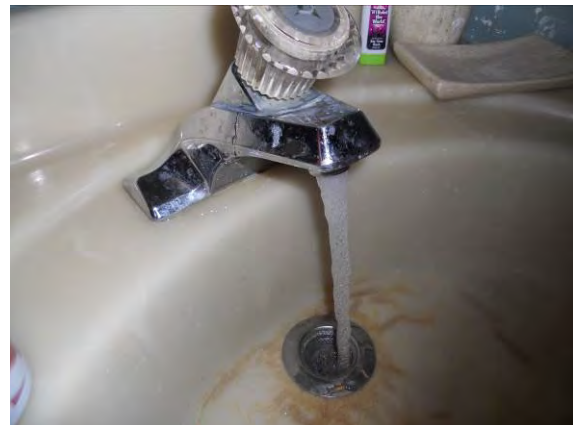
Photo #18: Cracking at lavatory basin

3.7.2.2.02	Bath Floor Covering		0	\$0.00	\$0	
3.7.2.2.03	Bath Vanities	Replace bathroom vanities	62	\$1,140.00	\$70,680	
3.7.2.29.01	Bathtub and surround	Replace bathtub and surrounds	31	\$1,660.00	\$51,460

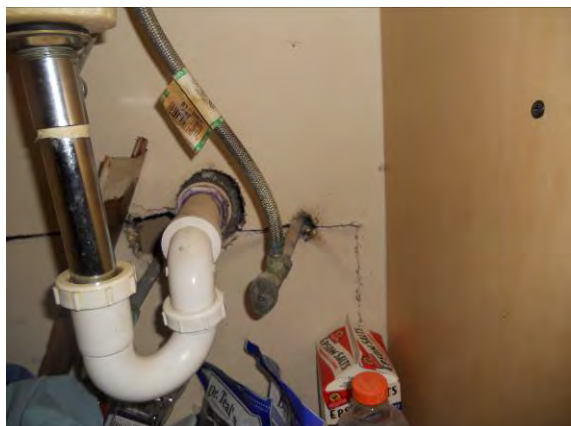
Photo #19: Polybutylene piping from through wall to shut-off

3.3.2.9.03	Bldg Envelope Other #3		0	\$0.00	\$0	
3.3.2.9.04	Bldg Envelope Other #4		0	\$0.00	\$0	
3.3.4	Roofs		0	\$0.00	\$0	
3.4.1.2.01	Polybutylene Supply Piping -	Replace domestic water supply piping	31	\$1,650.00	\$51,150

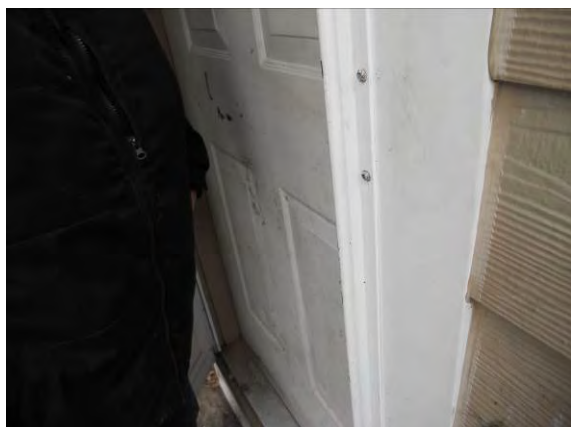
Photo #21: Damaged front door

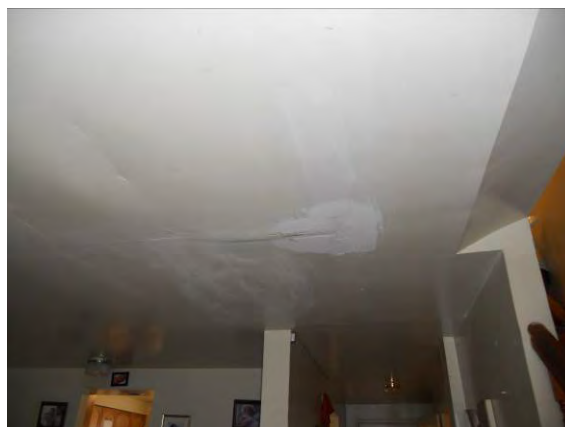
Photo #22: Patched ceiling from prior leak over living room

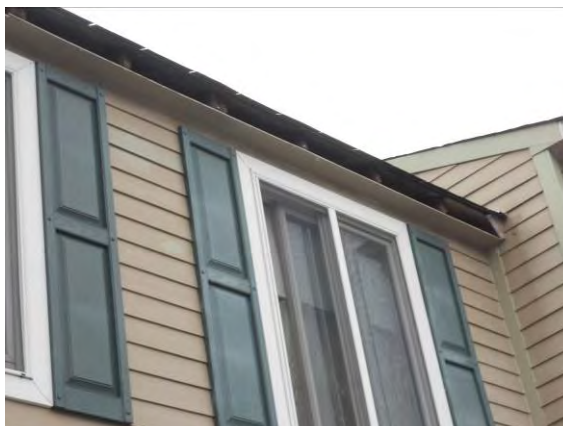
- Electrical receptacle replacements due to plugs not staying in place in the De Simone Court units
- Fascia installation due to pieces missing from previous snow storm which exposed nails that were too short during original construction of the De Simone Court units
- Flooring and sub-flooring replacement due to water damage and heaving in approximately 30% of the De Simone Court units

Photo #26: Missing fascia board at DeSimone Court

3.3.2.5.02	Storm Doors		0	\$0.00	\$0	
3.3.2.9.01	Exterior Siding - Repair	Repair areas of damaged siding	3,100	\$7.27	\$22,537	
3.3.2.9.02	Roofing Fascia	Repair/replace damaged fascia board	480	\$15.00	\$7,200

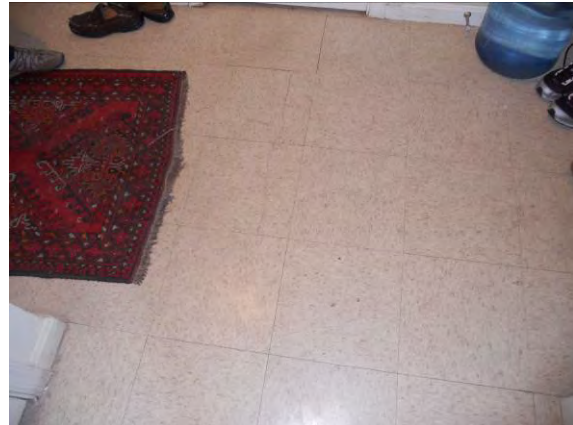
Photo #32: Cracked flooring due to water damaged subfloors ~ 30% units of DeSimone Court

3.7.2.3.03	Interior Painting		0	\$0.00	\$0	
3.7.2.39.01	Interior Unit Flooring	Replace unit flooring	17,650	\$2.05	\$36,183	
3.7.2.39.02	Subfloor - replace particle board	Replace unit sub-floor	31	\$1,500.00	\$46,500

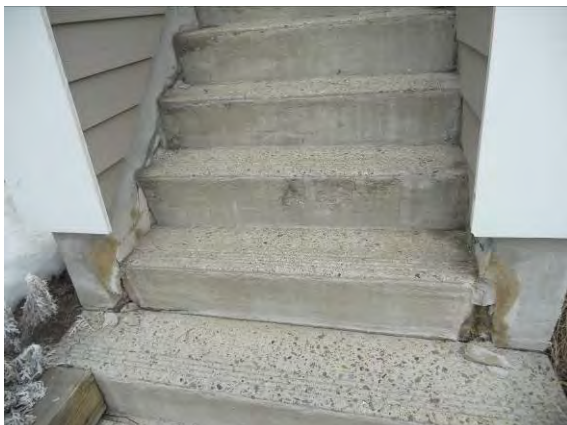
Photo #35: Spalling concrete steps at DeSimone Court
