PHYSICAL NEEDS ASSESSMENT AND ENERGY AUDIT

PHYSICAL NEEDS ASSESSMENT AND ENERGY AUDIT of RIDGECREST APARTMENTS

7-11 Ridge Road
Ridgewood, New Jersey 07450

EMG Project #: 107534.13R-009.308
Date of Report: August 7, 2014
On site Date: April 9, 2014

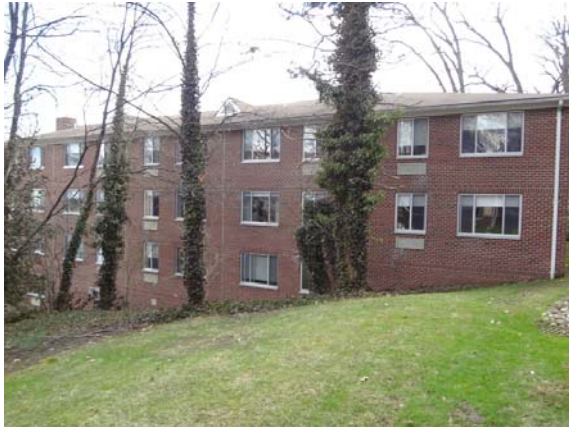
Photo #1: Exterior building elevation, partial roof overview

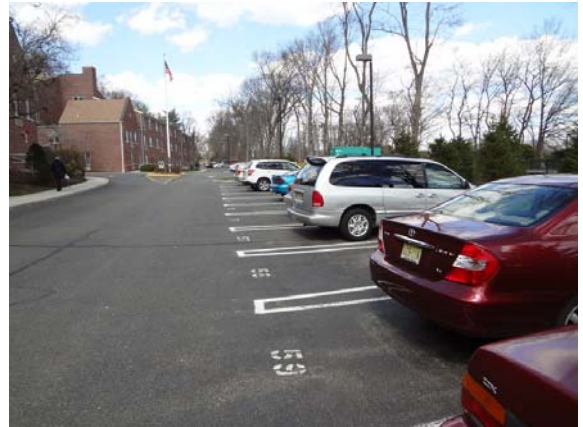
Photo #2: Parking provided adjacent to building

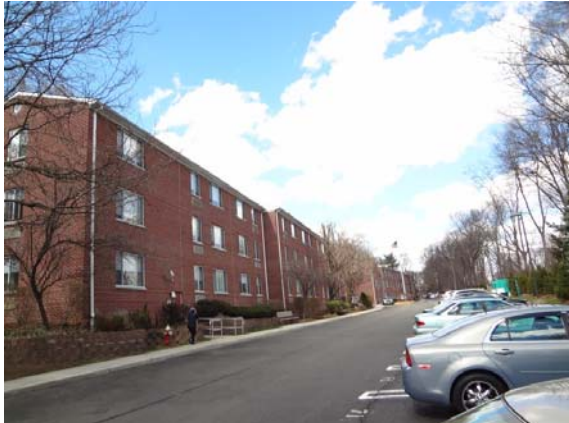
- The asphalt pavement is in fair condition. There are no significant signs of cracks or surface deterioration. In order to maximize the pavement life, pothole patching, crack sealing, seal coating, and re-striping of the asphalt paving will be required over the assessment period. The cost of this work is included in the Replacement Reserves Report.
- The concrete pavement is in good condition. There are no significant signs of cracks or surface deterioration. Epoxy sealing of minor cracks will be required over the assessment period as part of the property management's routine maintenance program.
- The concrete curbs, gutters, and sidewalks throughout the property are in good condition. Routine cleaning and maintenance will be required over the assessment period.

Photo #7: Parking stalls and drive aisle

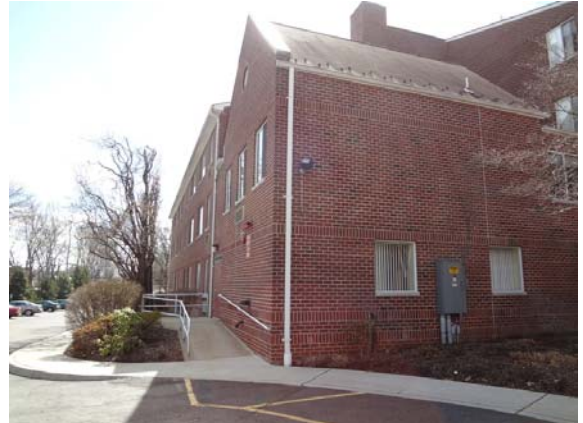
Photo #8: Concrete sidewalk throughout property

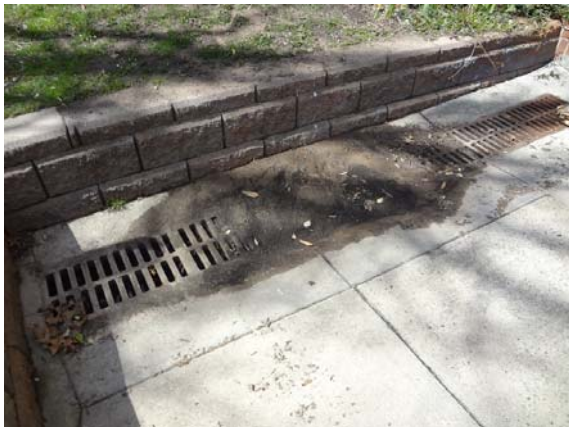
- There is no evidence of storm water runoff from adjacent properties. The storm water system appears to provide adequate runoff capacity. There is no evidence of major ponding or erosion.
- The retention pond appears to be in good condition and adequately sized for the property.

Photo #9: Drainage

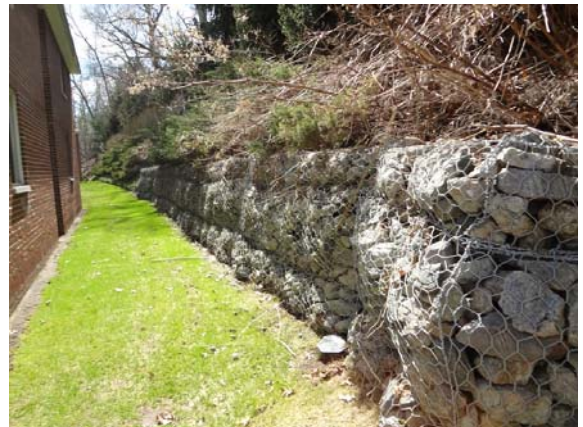
Photo #10: Retention wall on west side of property

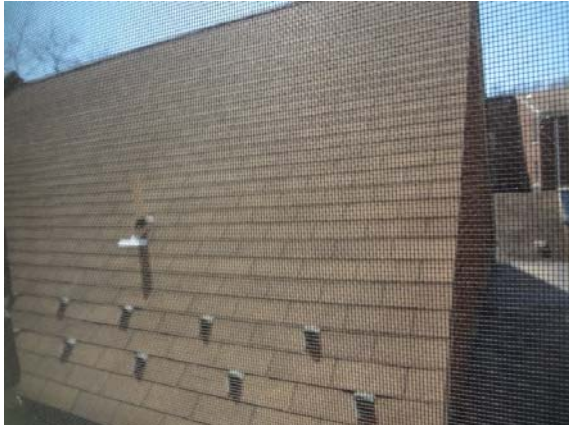
- The fields of the roofs are in good condition. Based on the estimated Remaining Useful Life (RUL), the shingles will require replacement over the assessment period. The cost of this work is included in the Replacement Reserves Report.

Photo #13: Majority of roof is 20 year 3-tab shingles

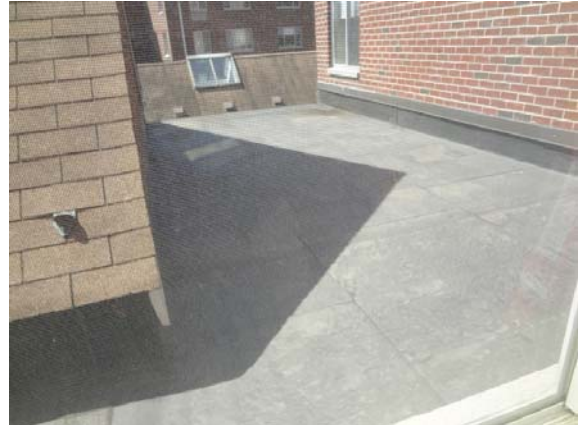
- The fields of the roofs are in good condition. Based on the estimated Remaining Useful Life (RUL), the roof membranes will require replacement over the assessment period. The cost of this work is included in the Replacement Reserves Report.

Photo #14: Small sections of roof have rubber roofing

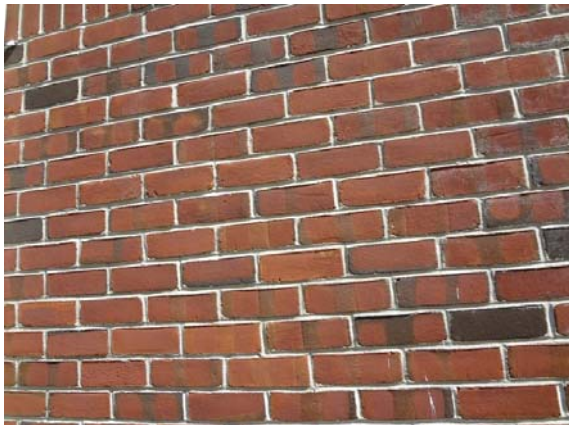
Photo #15: Exterior wall brick veneer

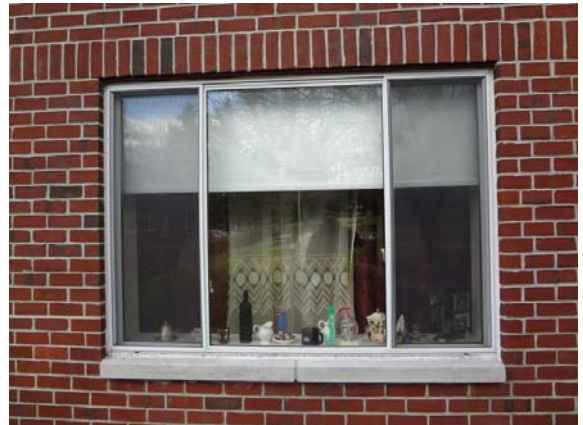
Photo #18: Sliding windows throughout building

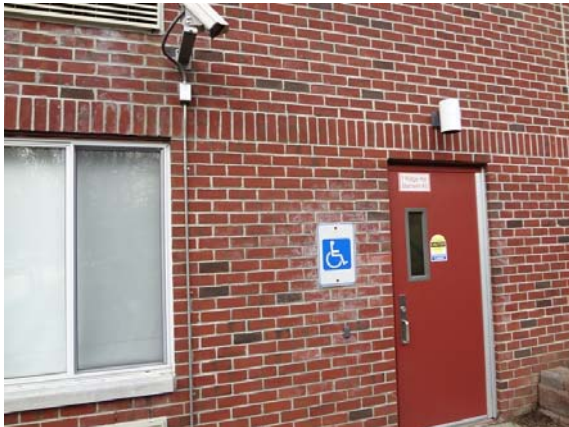
Photo #19: Metal exit doors with lever handles

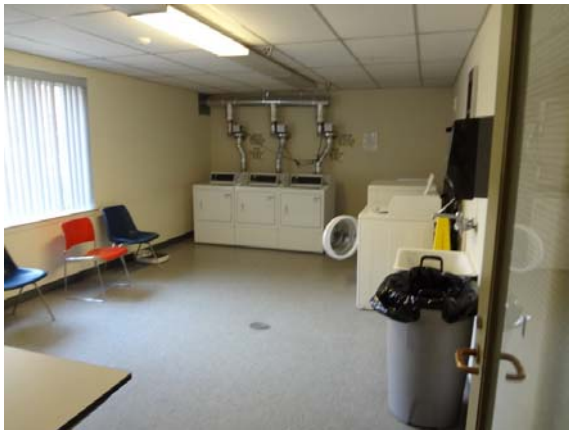
Photo #21: One of two laundry rooms

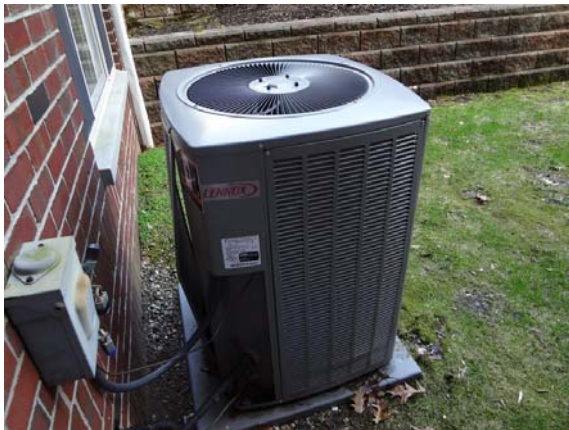
Photo #27: Condenser for community room

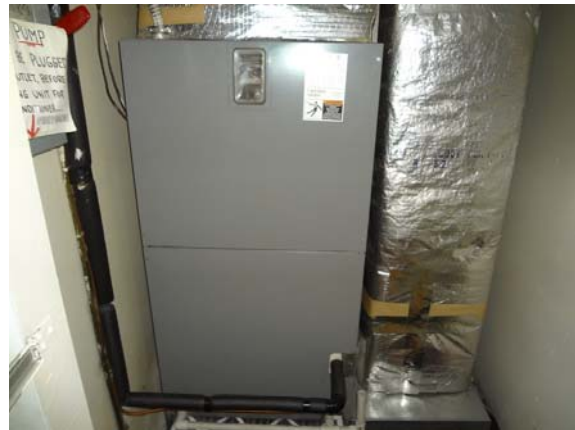
Photo #28: Air handler for community room

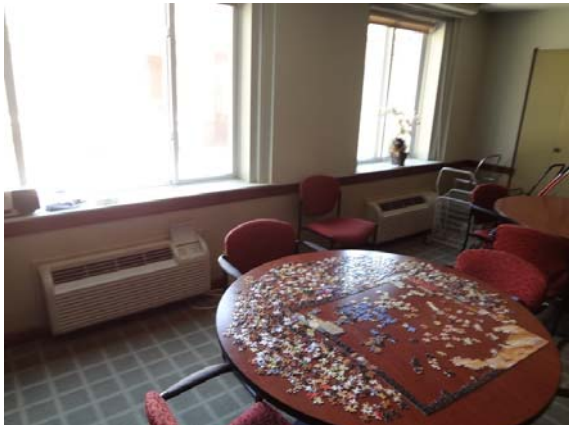
Photo #29: PTAC units throughout common areas

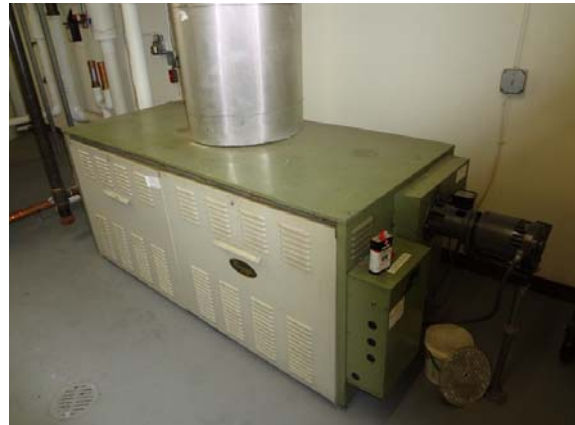
Photo #30: Domestic hot water boiler

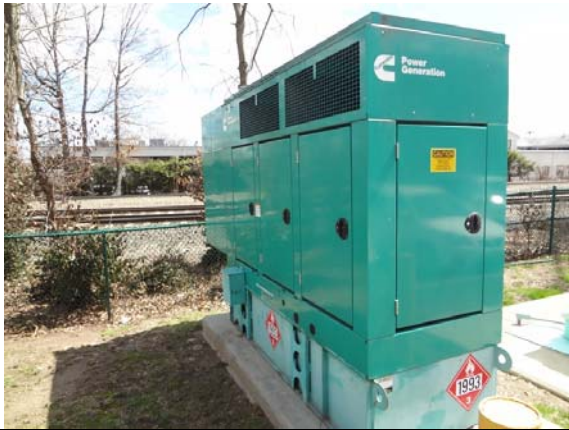
Photo #31: Emergency generator

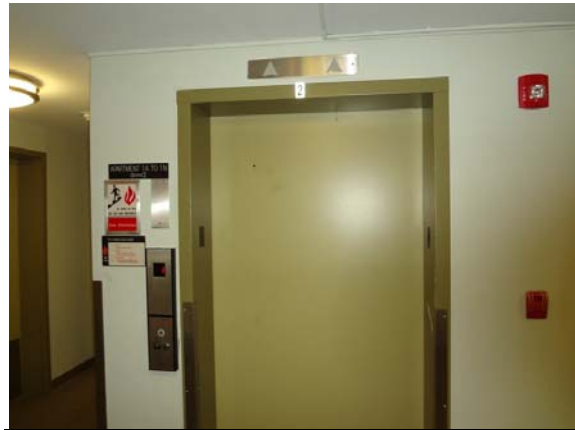
Photo #32: Elevator (one of two)

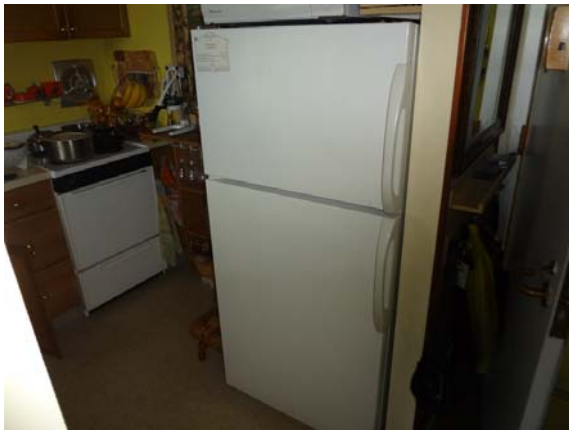
Photo #39: Electric range and refrigerator in every unit kitchen

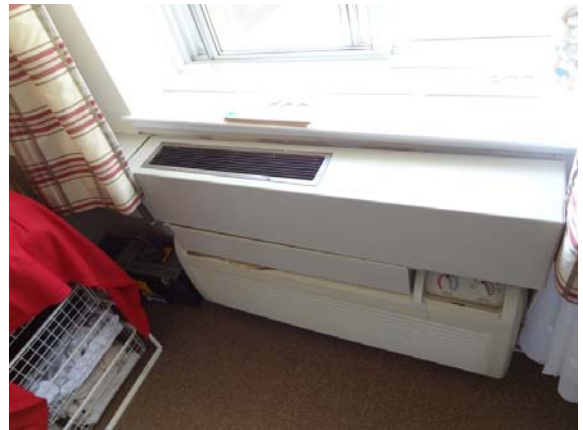
Photo #40: PTAC unit in every tenant apartment

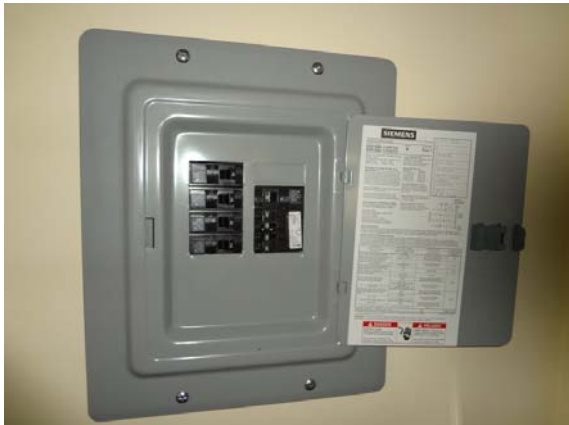
Photo #41: Electric panel in each unit
