**Agenda Item 3**  
**335 Robinson Drive**  
**Revisions to Previously Approved Plans**

## STAFF REPORT AND RECOMMENDATION

| SUBJECT: | <b>335 Robinson Drive</b> – Revisions to Previously Approved Plans |

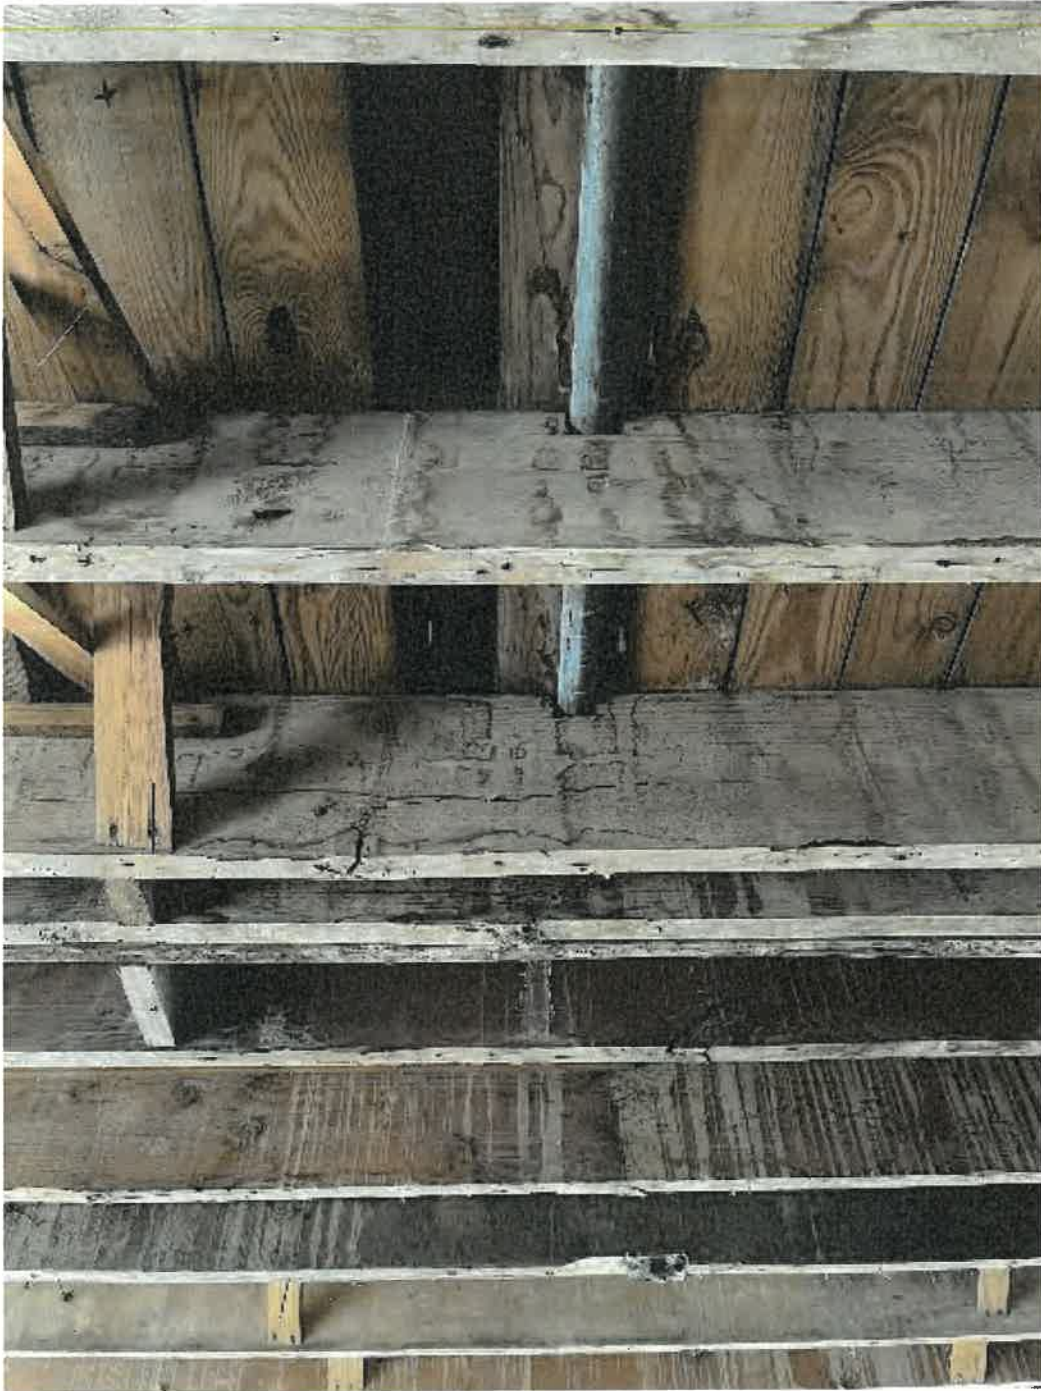
Photo 2: South Wing (First Floor) - Second floor joists discolored and stained showing possible evidence of moisture damage. Floor framing bouncy at both first and second floors. Note structural failures of some joists.

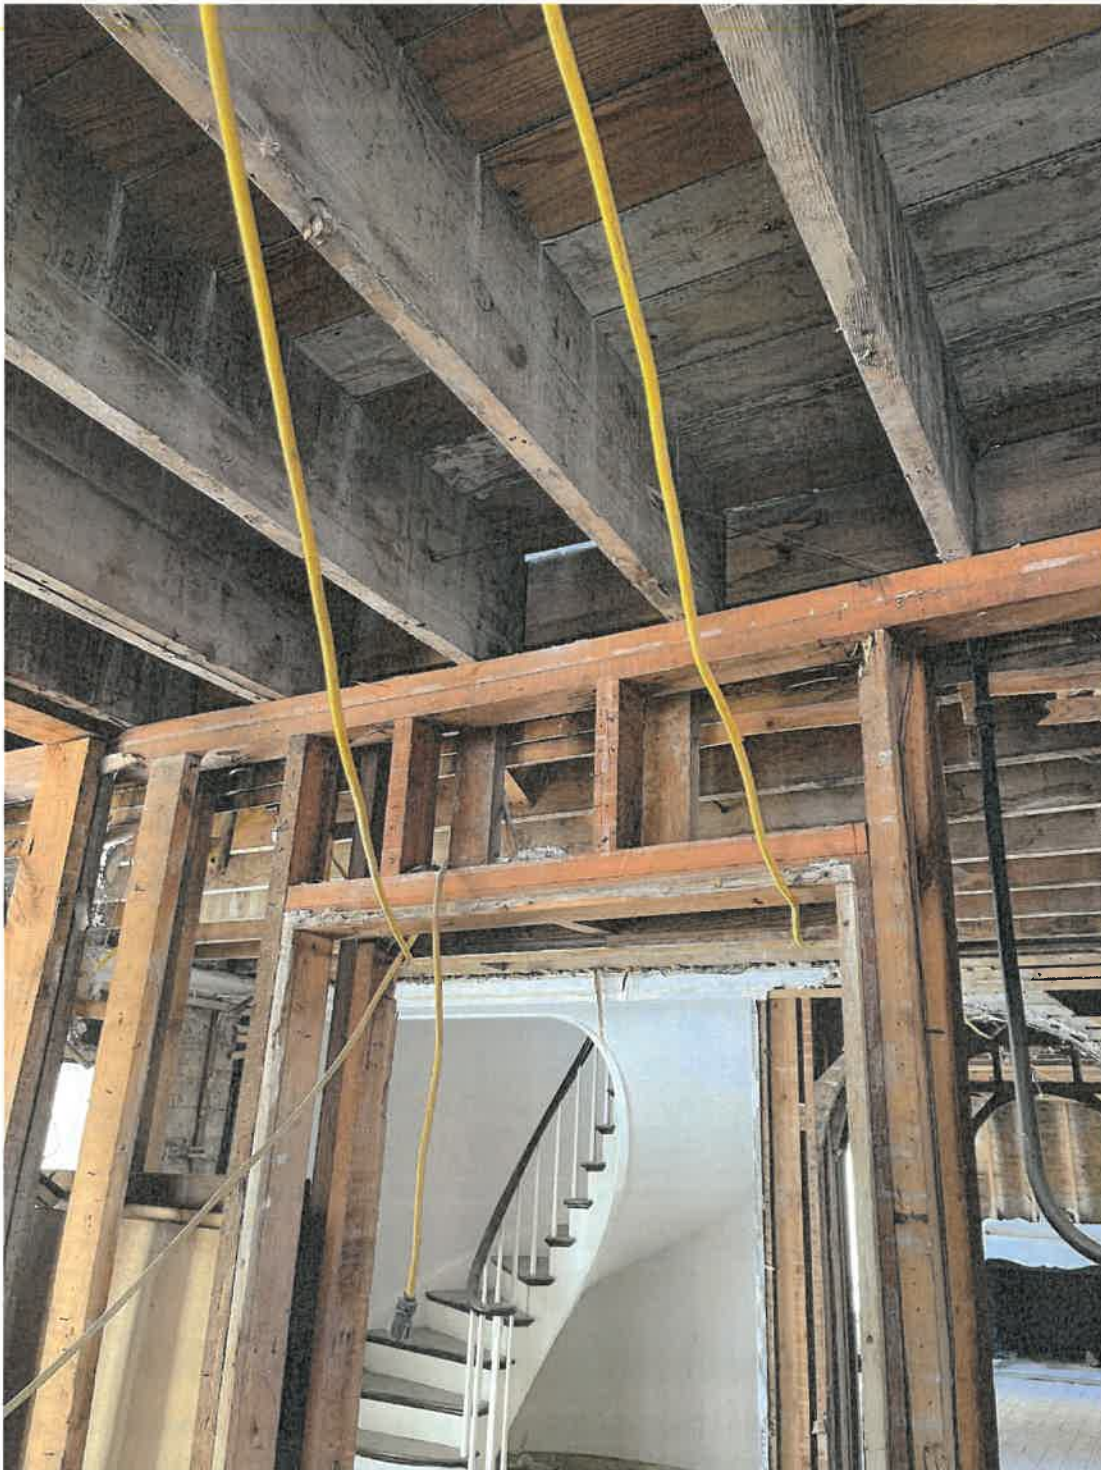
Photo 3: South Wing (First Floor) – Interior bearing wall with no structural header at door opening

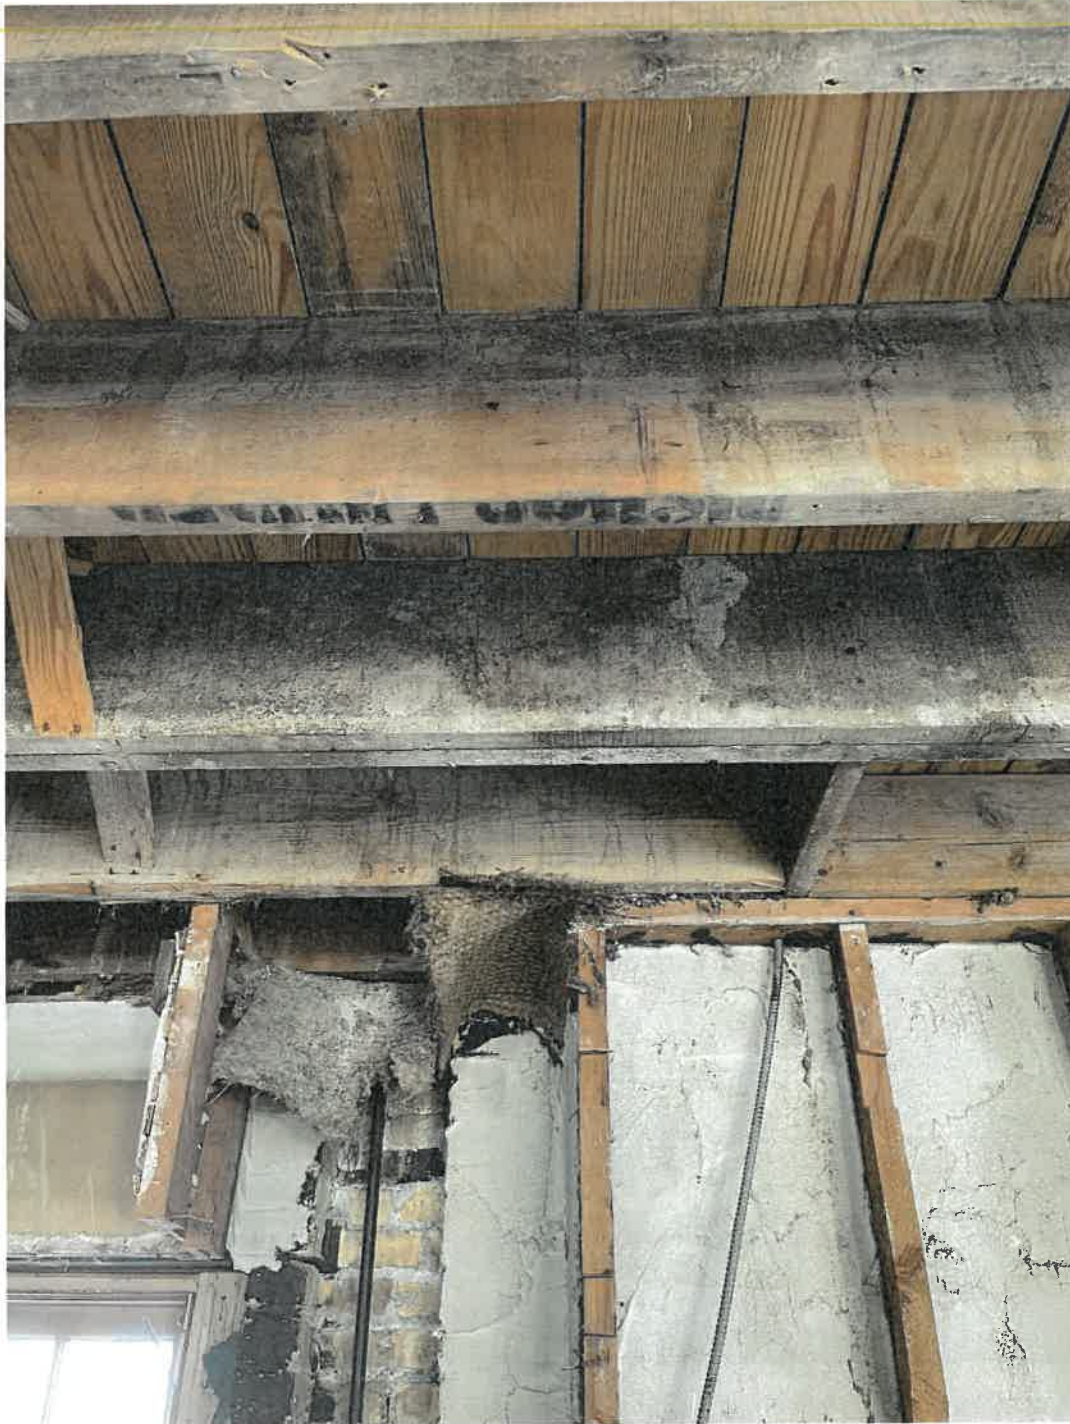
Photo 4: South Wing (First Floor) – Second floor wood joists and floor boards showing stain from moisture and possible mold

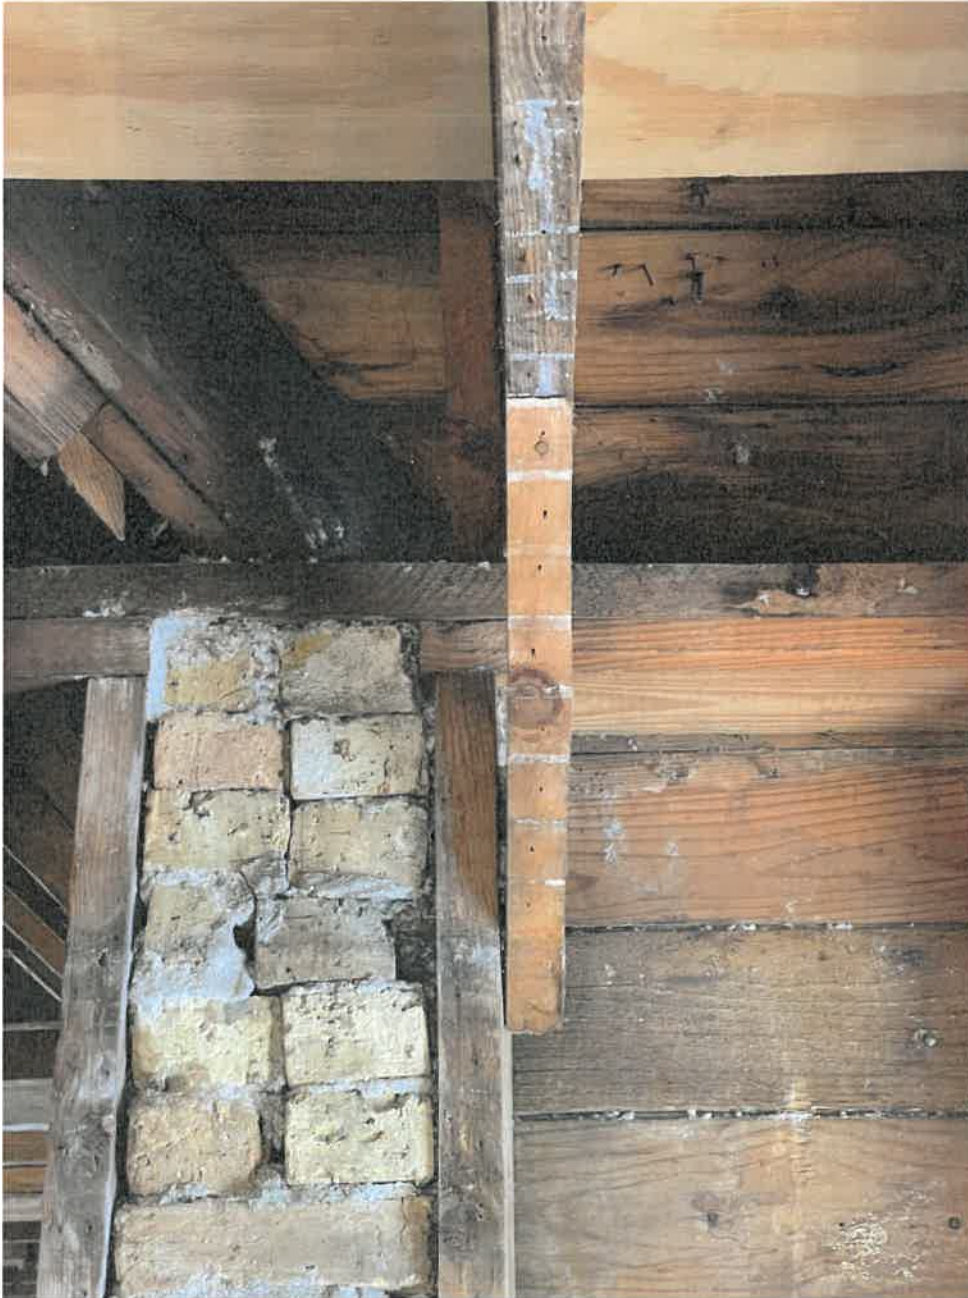
Photo 5: South Wing (Second Floor) – Intersection of Central (2-wythe brick masonry) Wing with South (wood framed) Wing at roof valley. Indeterminate bearing point for valley framing, evidence of charred valley rafter from prior fire, efflorescence at brick wall and evidence of moisture damage at wood framing members

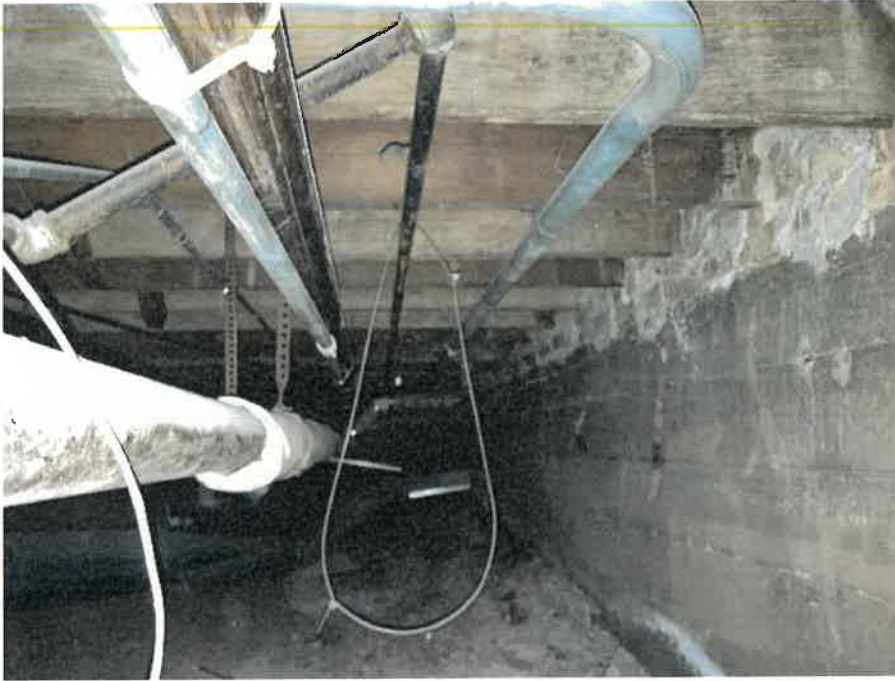
Photo 6: South Wing (Crawlspace) - First floor wood joists pocketed into 3-wythe brick masonry bearing wall at grade and top of foundation, Environmental Reports indicate high presence of mold

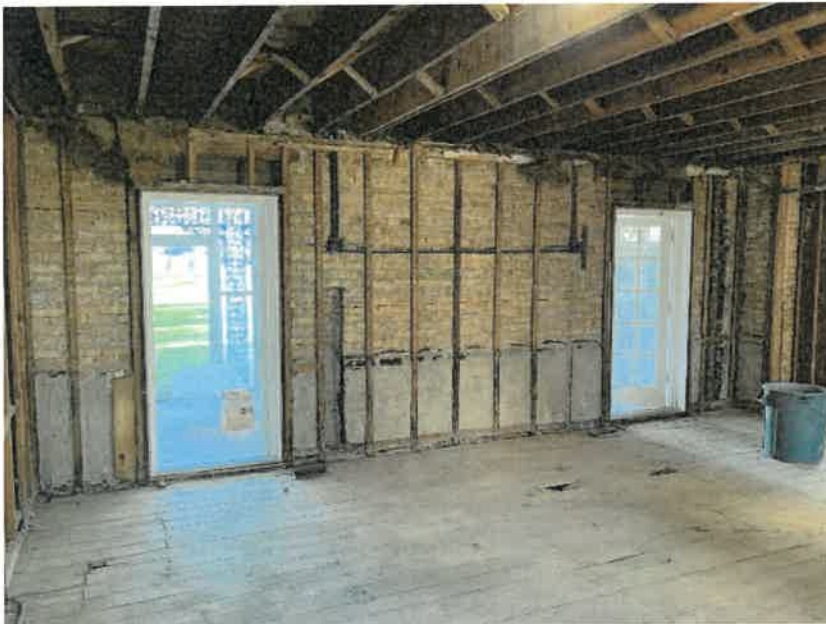
Photo 7: Central Wing (First Floor) – second floor wood joists fixed solid with masonry bearing on 3-wythe brick masonry wall.

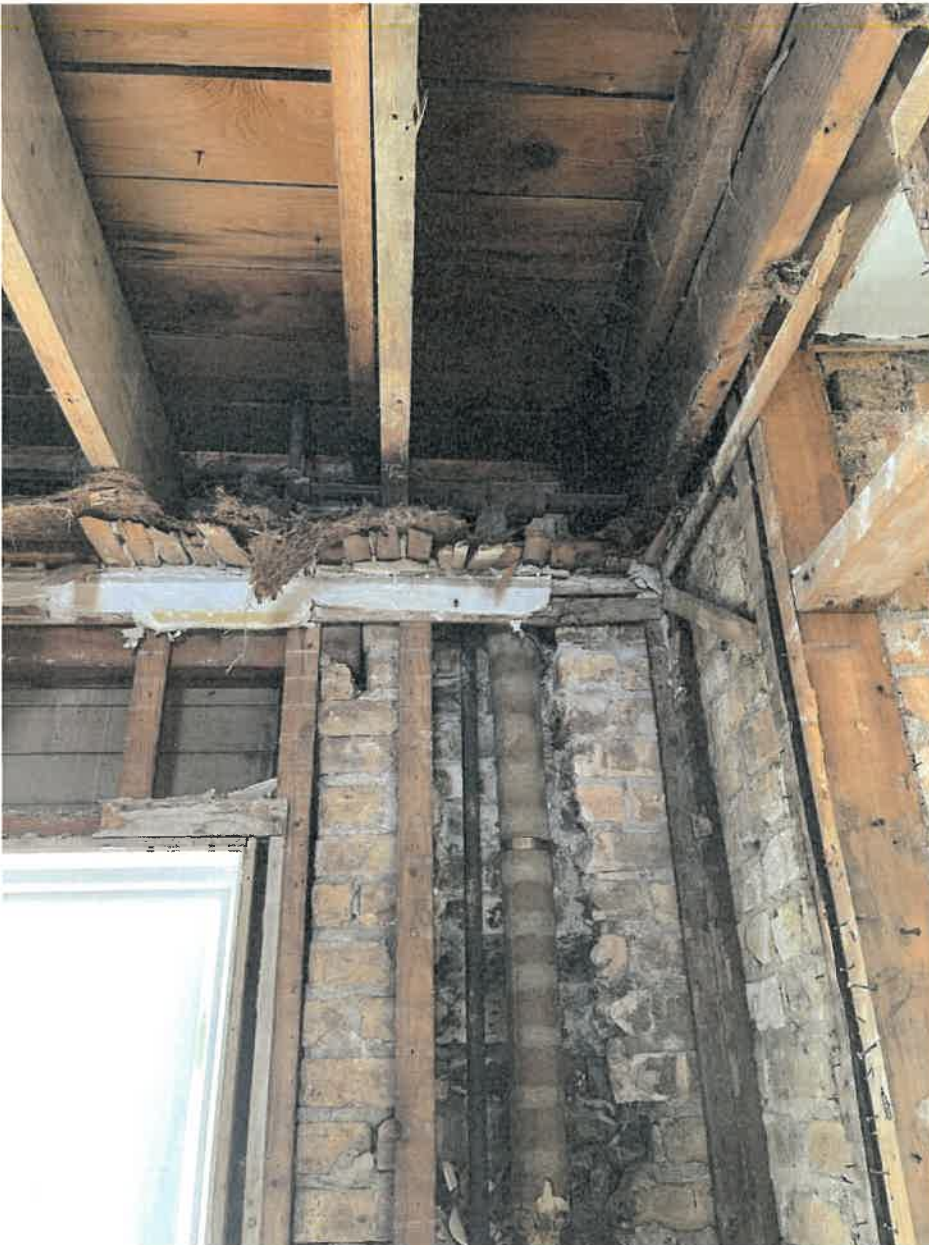
Photo 7A: Central Wing (First Floor) – Detail second floor wood joists & timber window header bearing on 3-wythe brick masonry wall. Efflorescence & water damage at brick wall and corner wood framing. Typical condition at masonry window openings, wood infill between top of window and underside of timber header, with 1-wythe brick masonry jack arch exterior side. Masonry cracking evident from exterior over windows. Masonry chopped out for piping

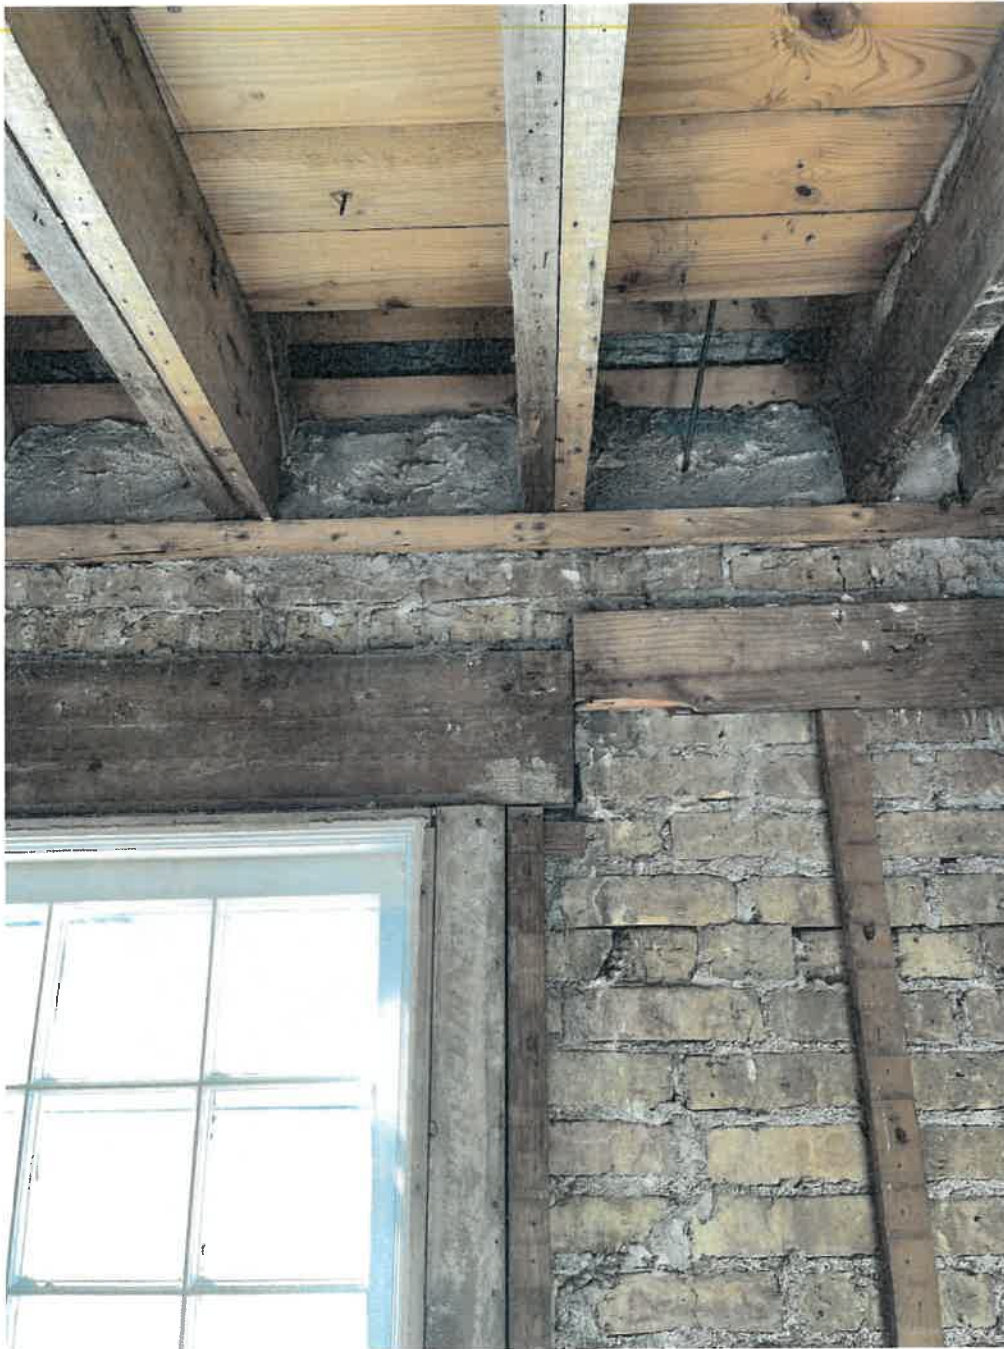
Photo 8: Central Wing (Second Floor) – Timber header showing evidence of moisture damage from masonry above. Masonry failure in various locations. Second floor ceiling joists are solidly set in masonry wall and show moisture damage and possible mold growth.

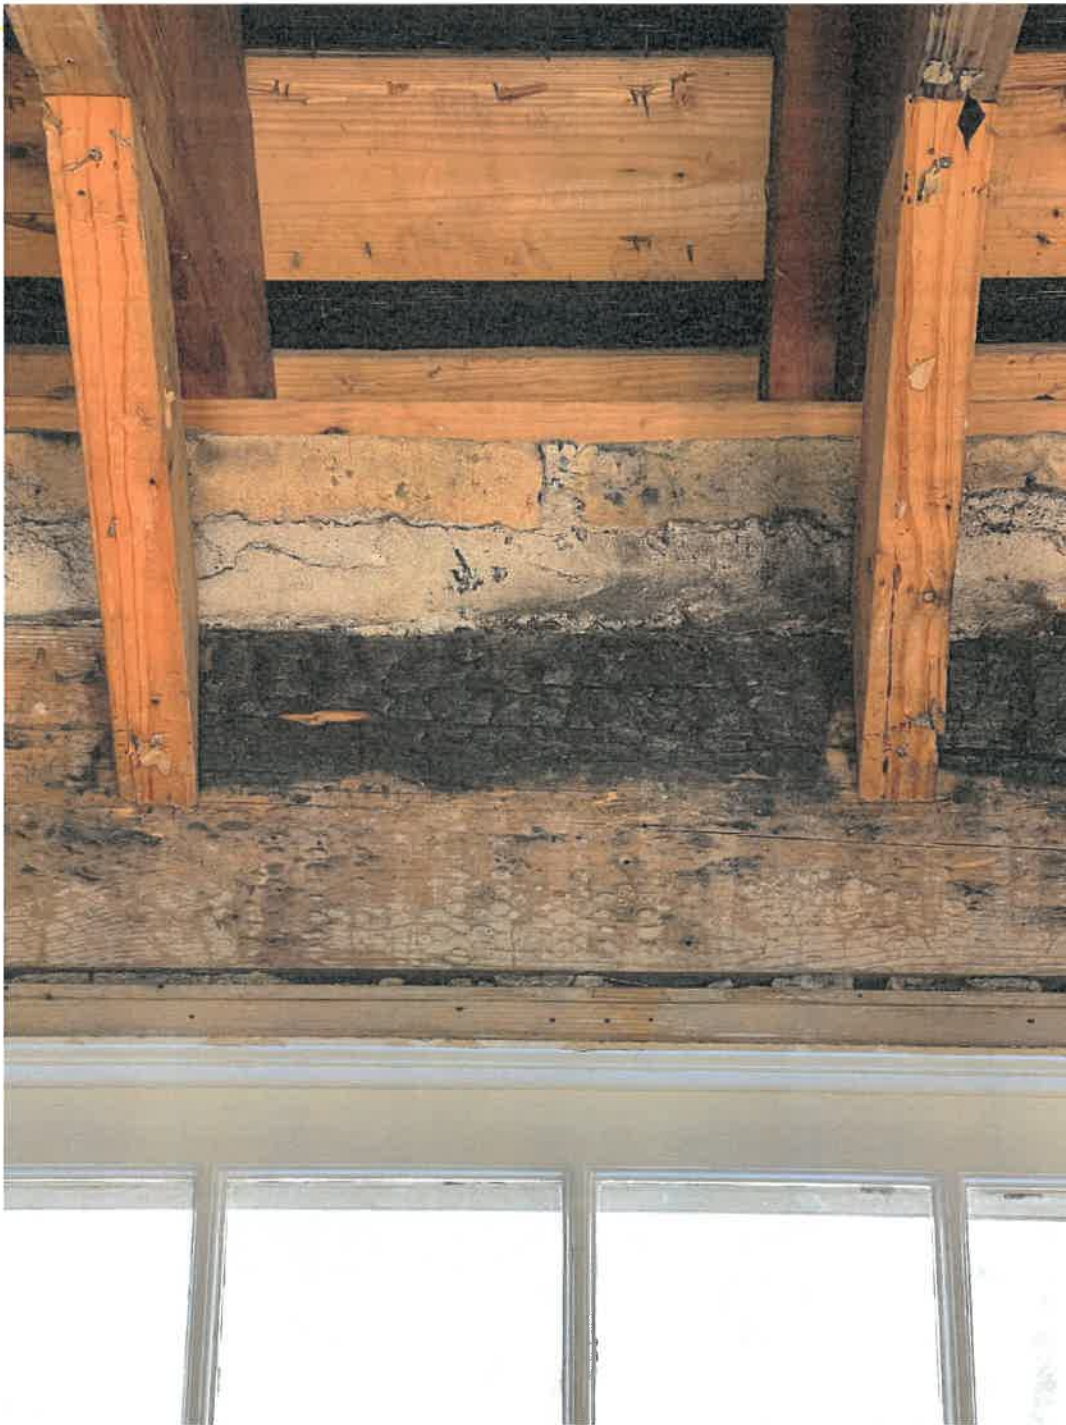
Photo 9: Central Wing (Second Floor) – Charred timber header

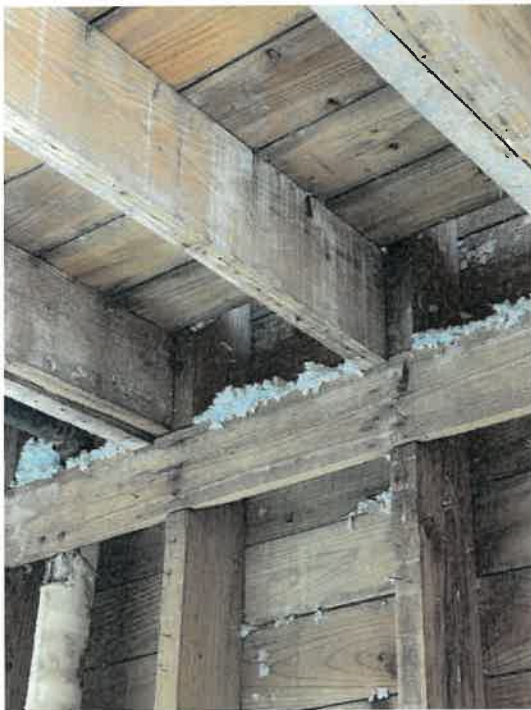
Photo 10A: North Wing (First Floor) – Balloon framing detail at west wall, no fire blocking between first and second floors. Staining of floor boards and framing members may indicate impregnated mold condition.

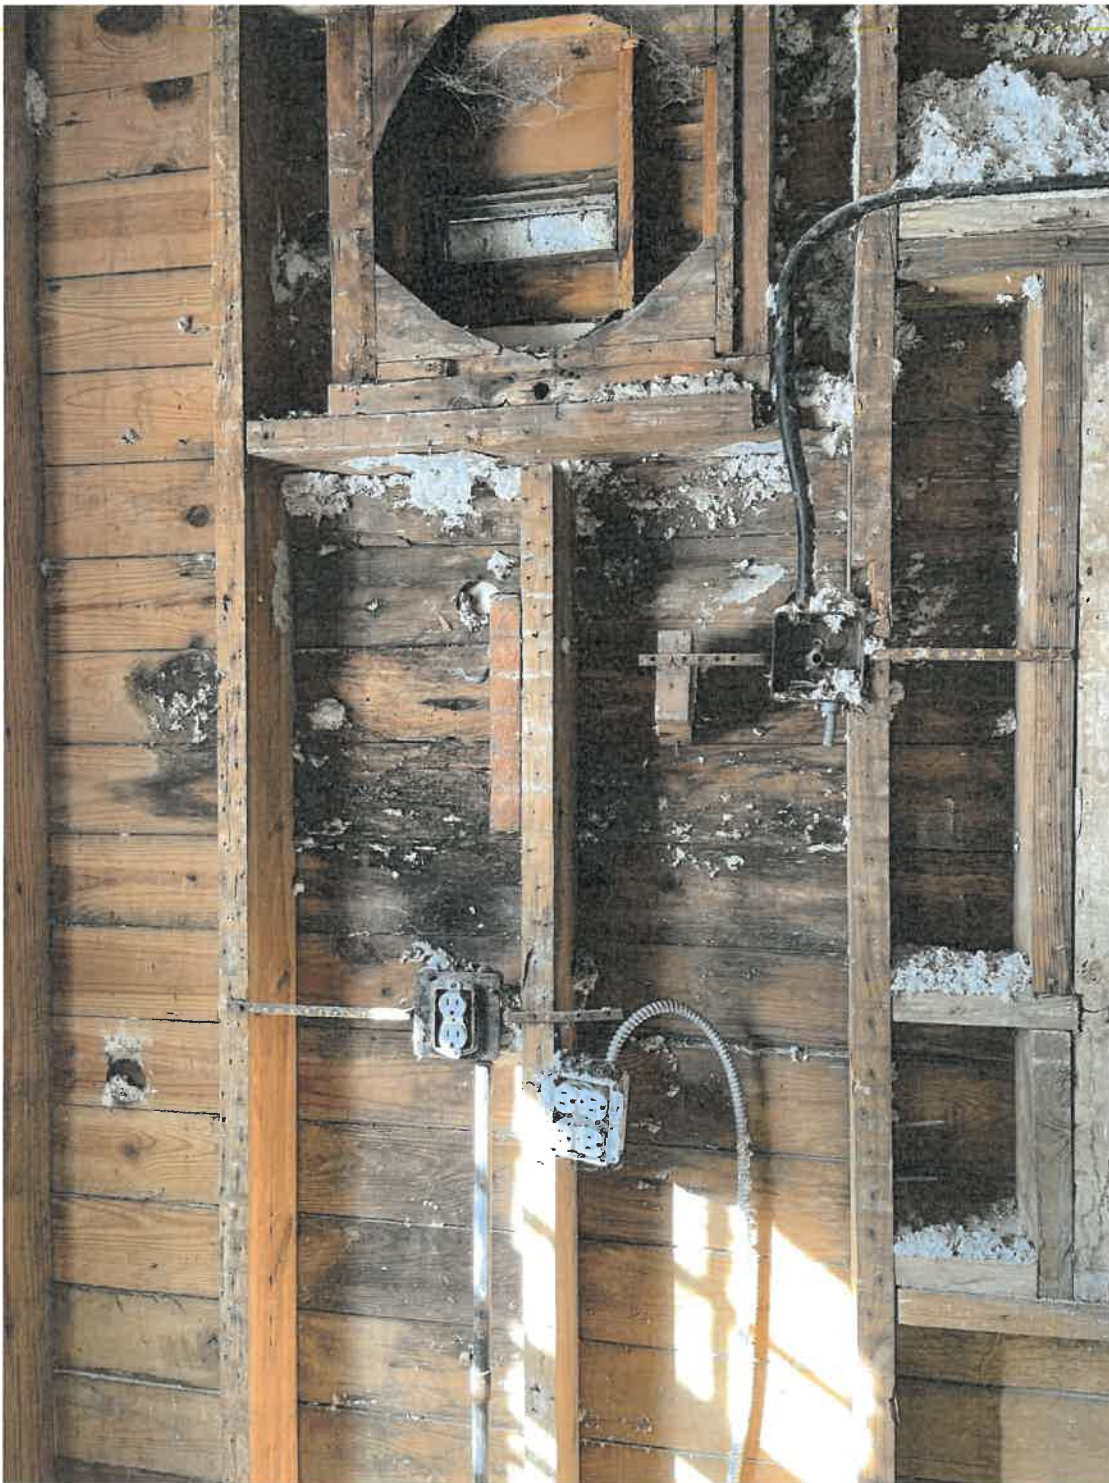
Photo 11: North Wing (First Floor) – Balloon framing at north wall, mold inside face of cladding

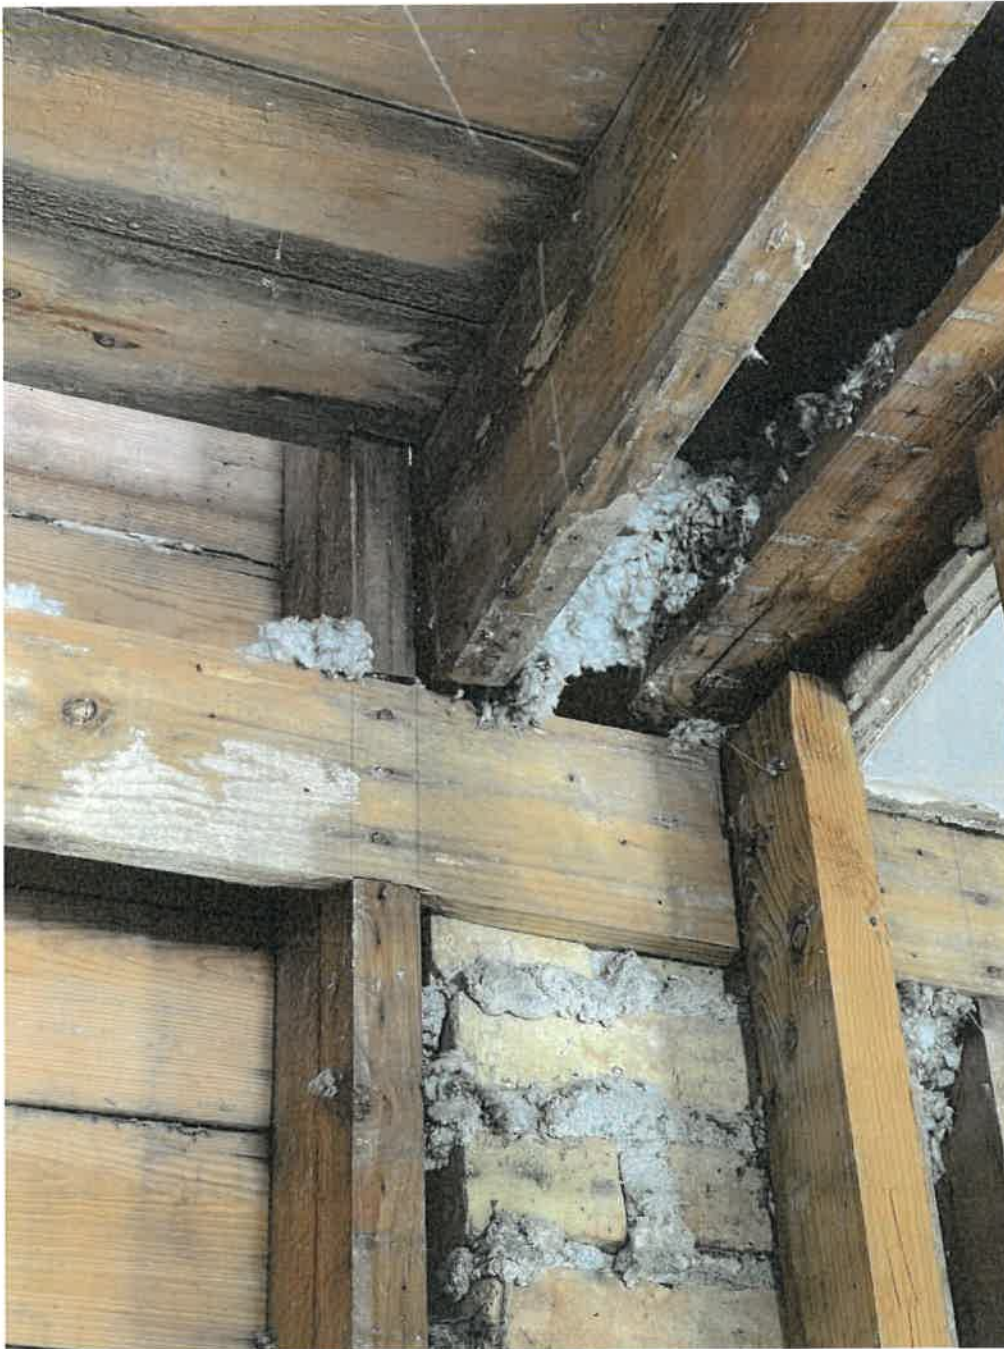
Photo 12: North Wing (First Floor) – Intersection balloon framing at east wall & brick masonry bearing wall, with floor joists pocketed into masonry. Staining of floor boards and framing members may indicate impregnated mold condition. Air gaps at intersection of wood framing and irregular masonry surfaces pose constructability problems for air sealing building envelope.

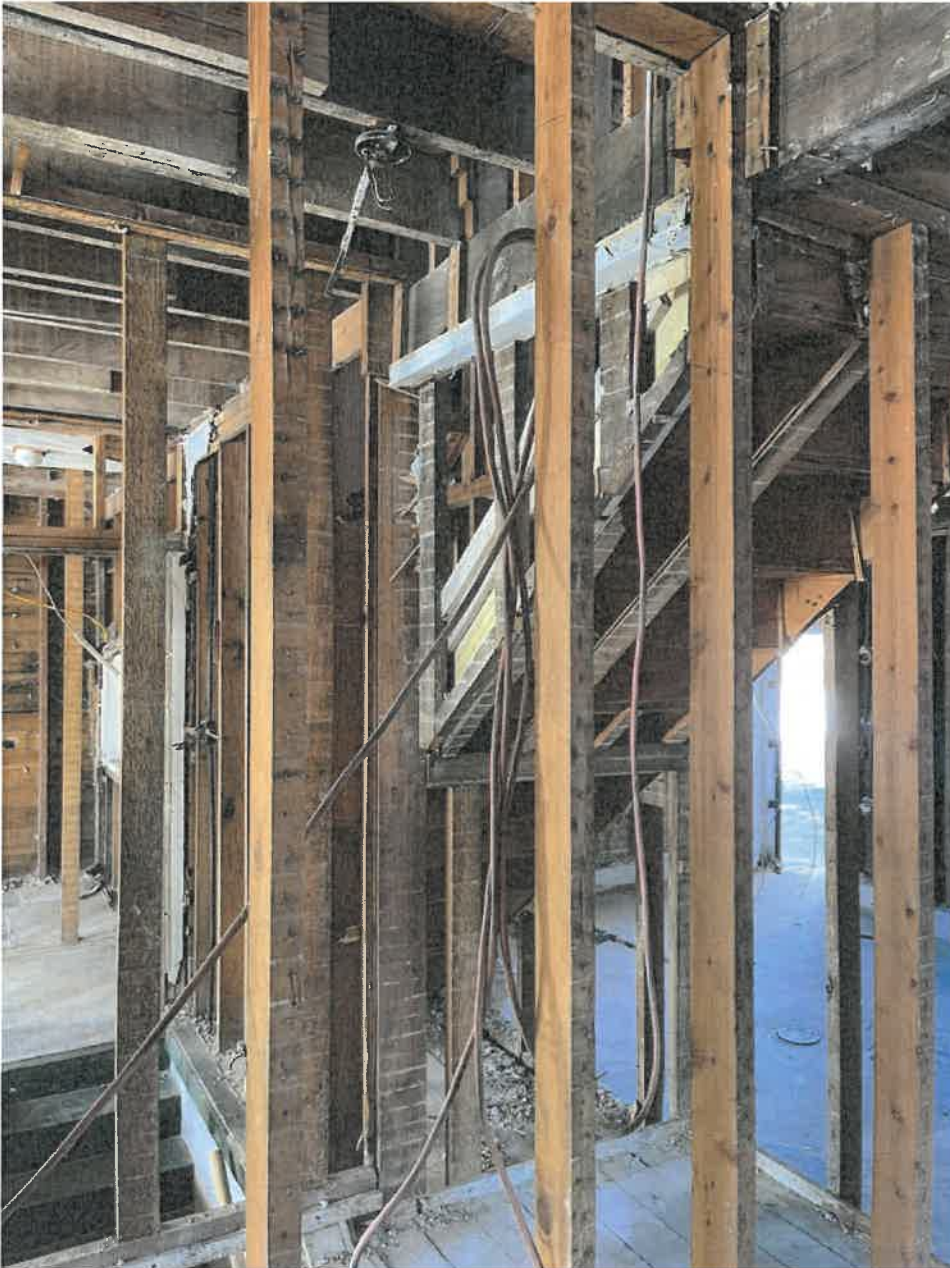
Photo 13: North Wing (First Floor) – Wood framing at east wall. Floor framing unsupported and timber beam has no apparent vertical support.

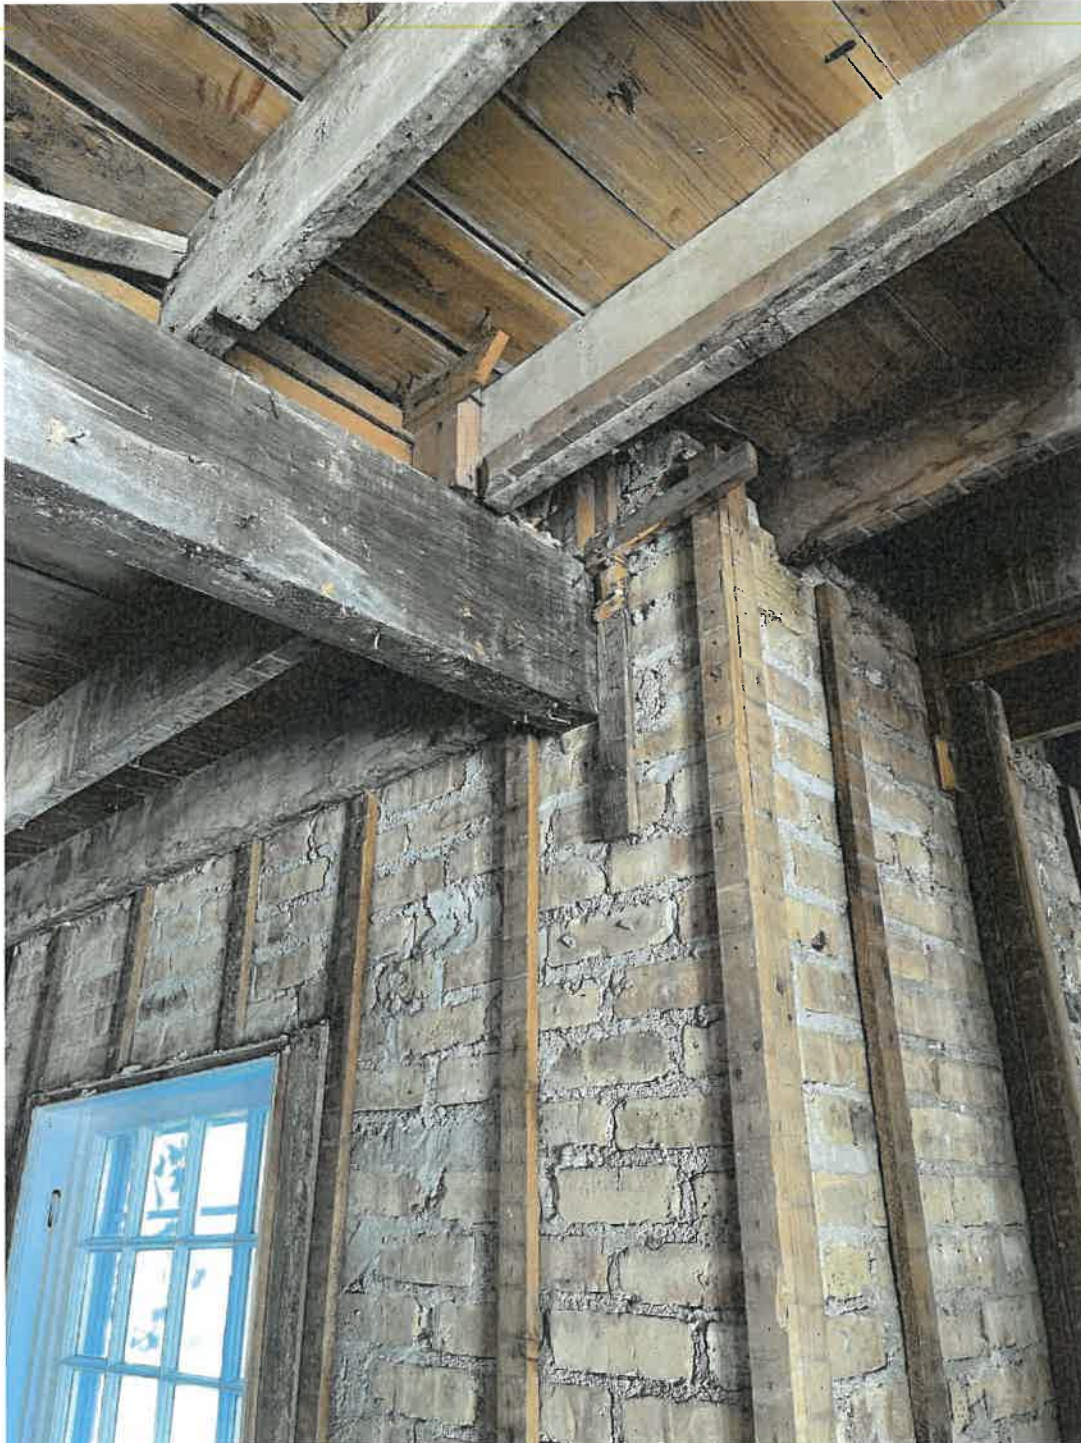
Photo 13A: North Wing (First Floor) – Wood framing at east wall. South end of timber beam pocketed into 3-wythe brick masonry bearing wall with evidence of water damage and possible mold.

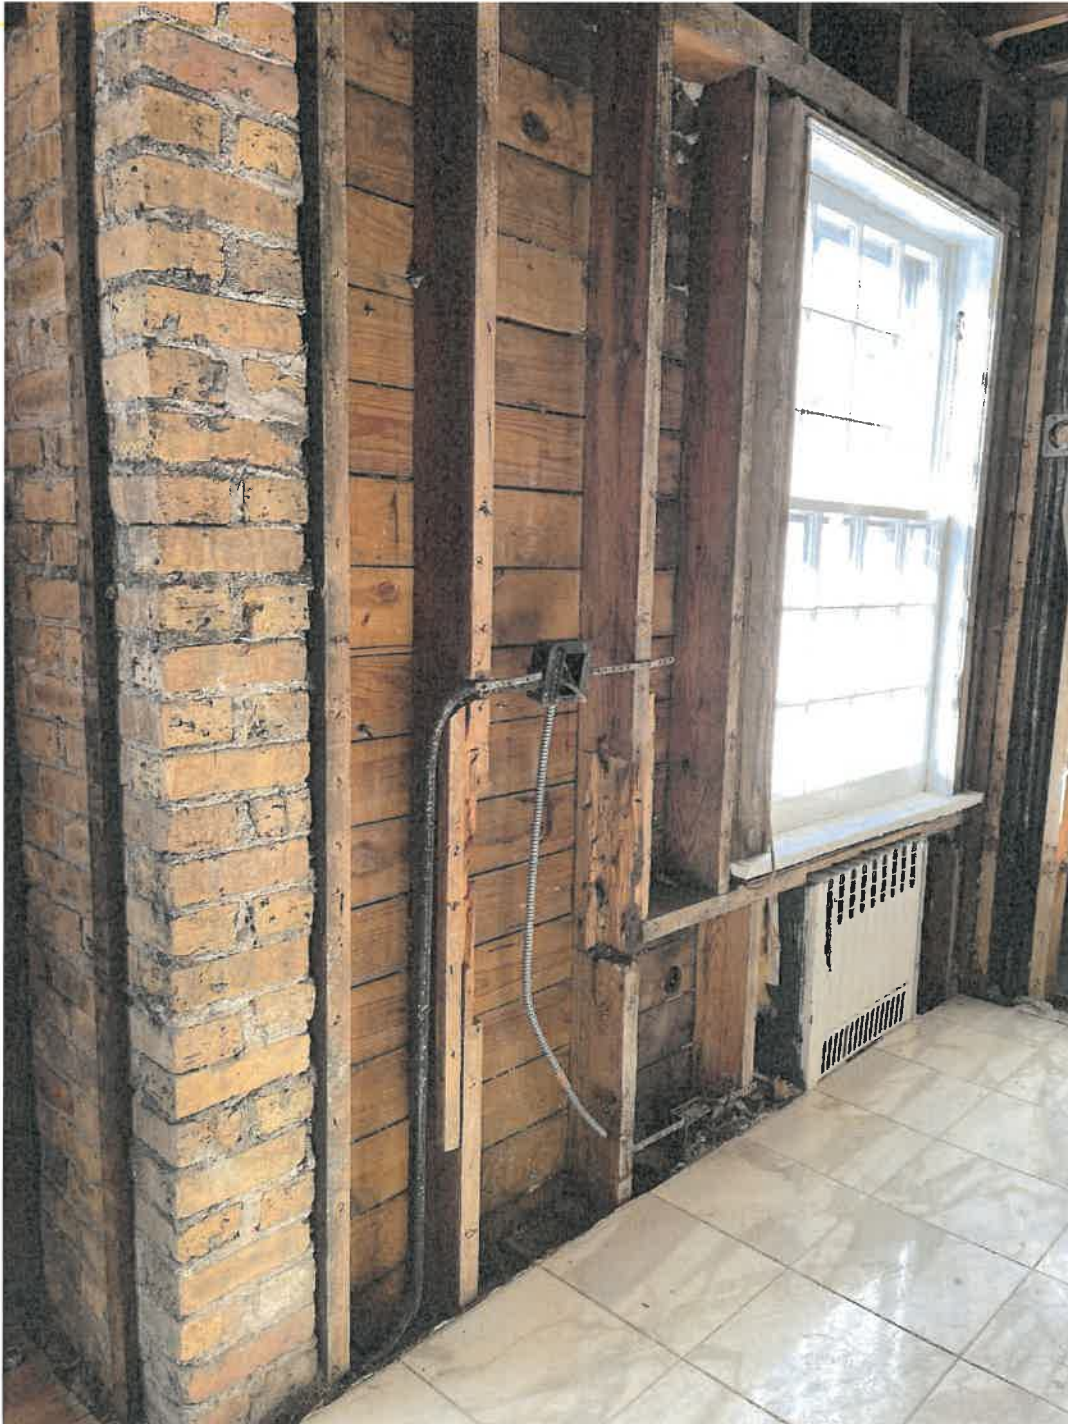
Photo 14: North Wing (Second Floor) – Balloon framing at west wall. Framing hacked out and spliced. No header at window opening. Indication of moisture penetration at masonry.

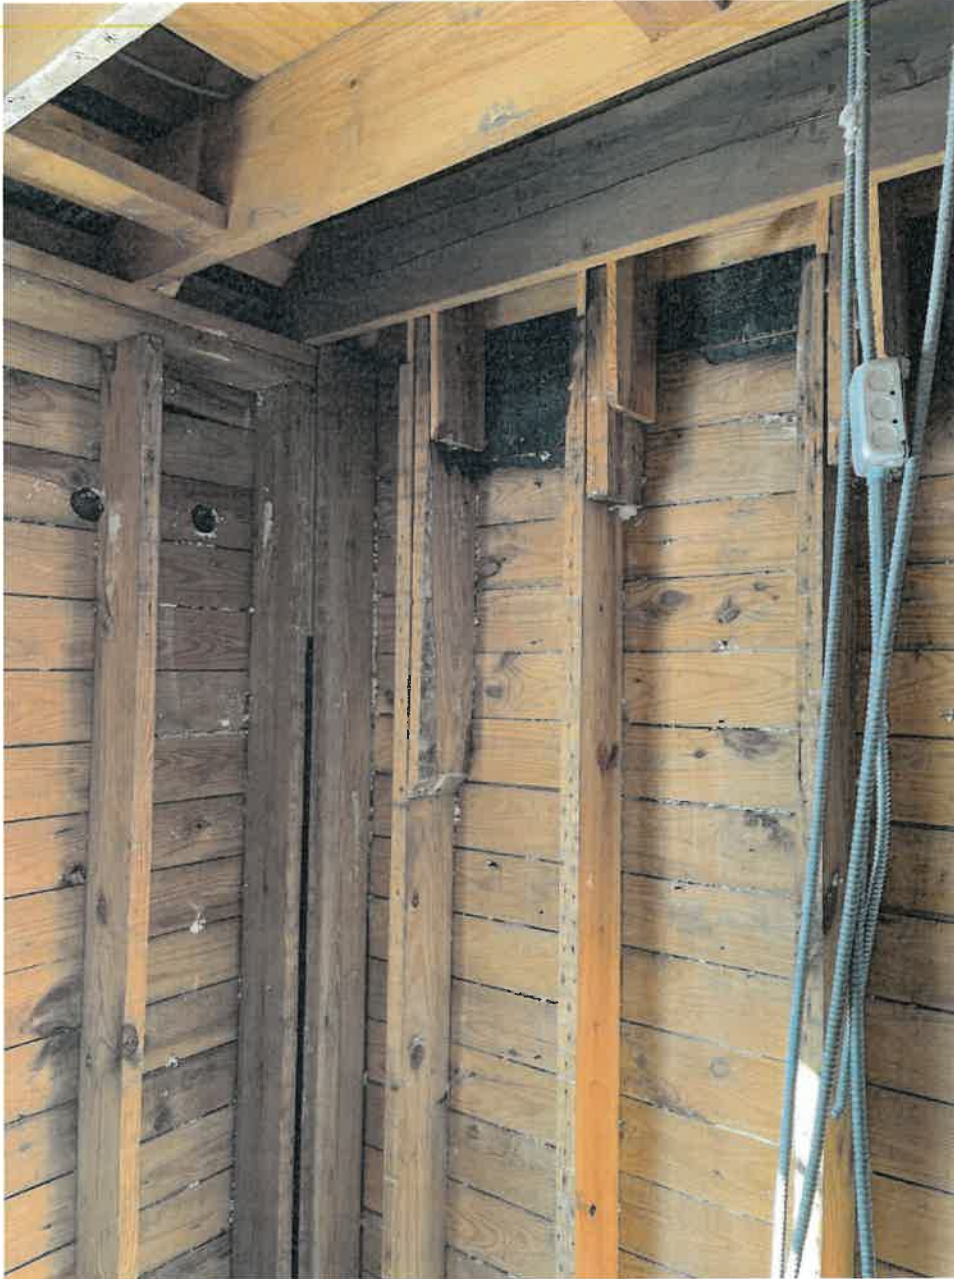
Photo 15: North Wing (Second Floor) – Balloon framing at north wall. Vertical framing scabbed and spliced, should be continuous vertical members. Charred remains indicate evidence of prior fire. Structural failure on ceiling framing. No fire blocking between second floor and attic. Water damage evident on backside of sheathing boards. Consistent air gaps in wall sheathing pose constructability problems for air sealing building envelope.

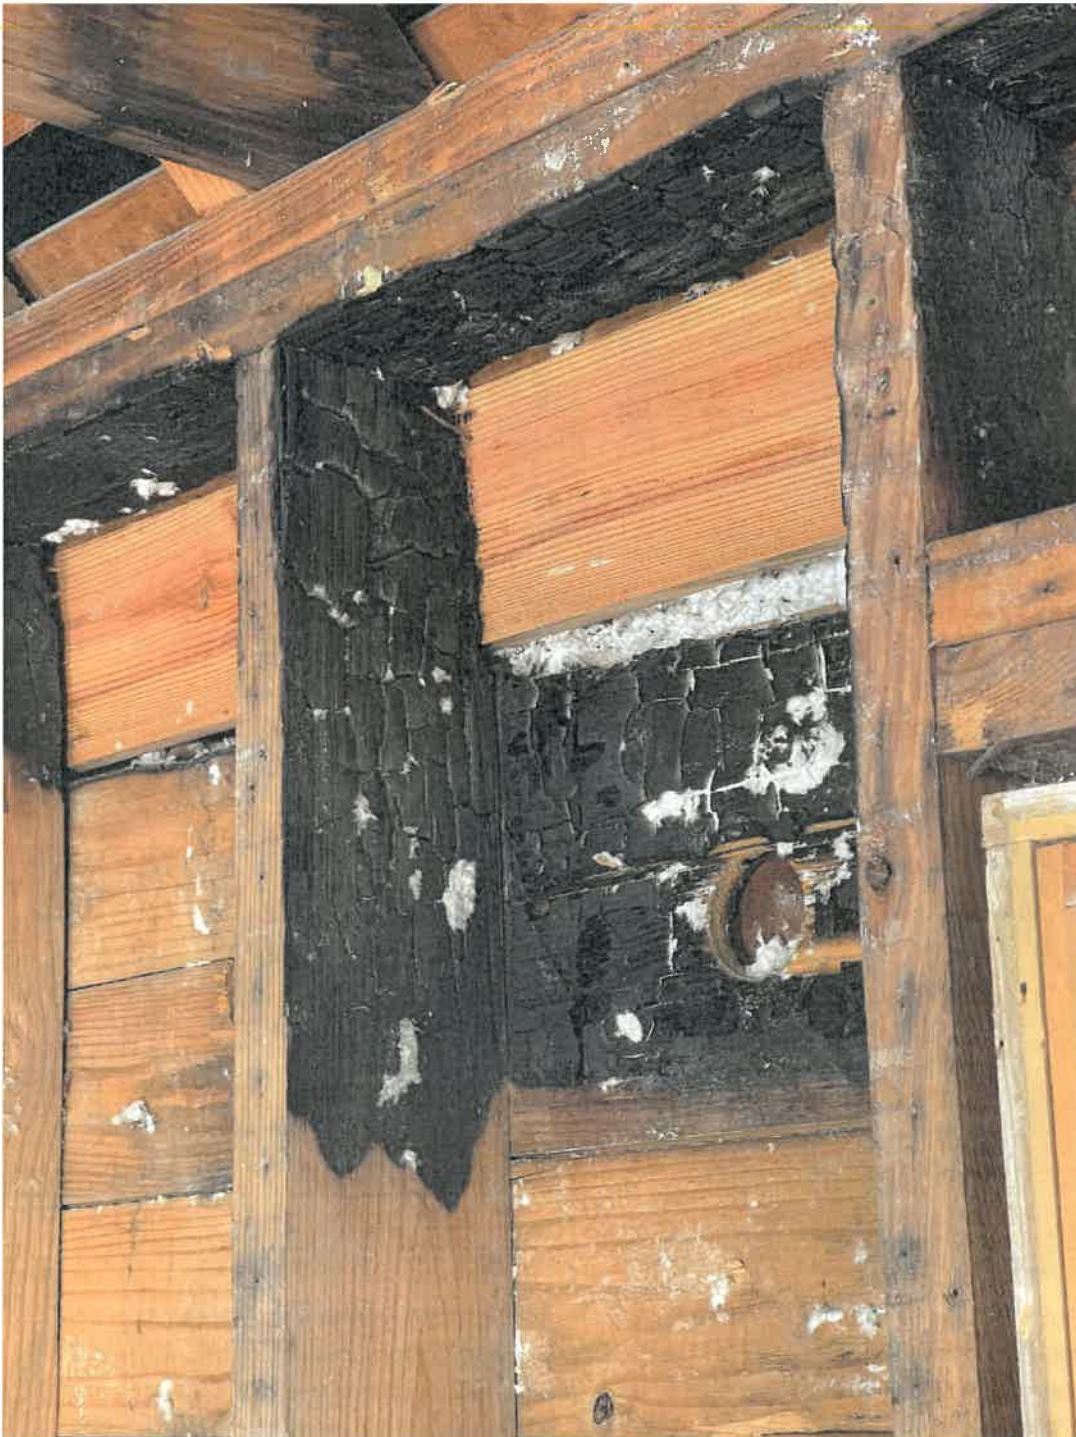
Photo 16: North Wing (Second Floor) –Wood framing at east wall. Charred remains indicate evidence of prior fire
