**Agenda Item 3**  
**335 Robinson Drive**  
**Revisions to Previously Approved Plans**

## STAFF REPORT AND RECOMMENDATION

| SUBJECT: | <b>335 Robinson Drive</b> – Revisions to Previously Approved Plans |

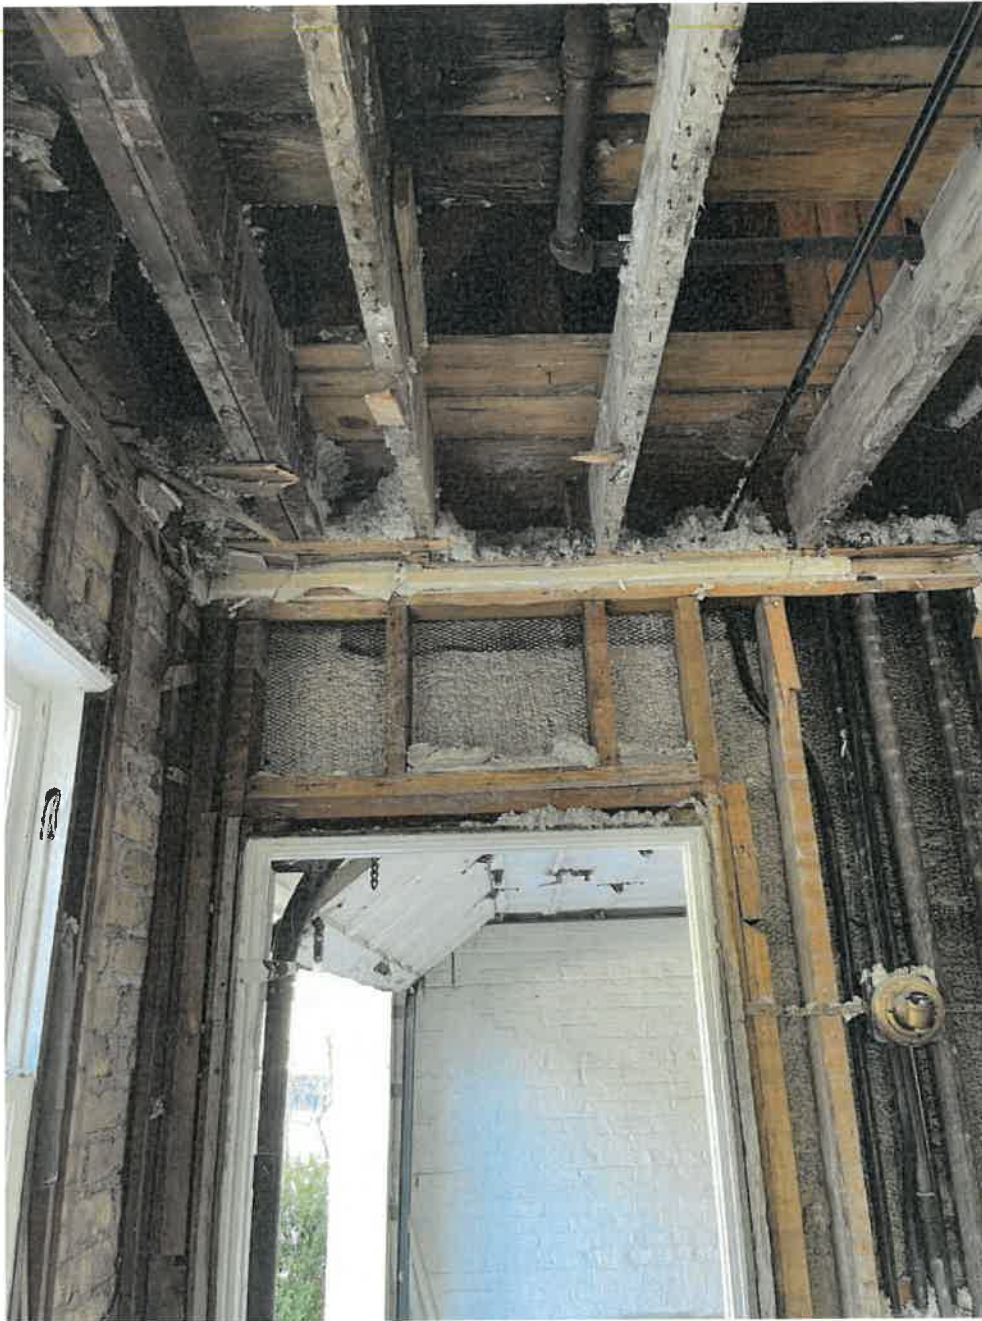
Photo 17: East Wing Garage (First Floor) – Wood floor/ceiling joists bouncy & not level. Wood framed bearing wall lacking header at door opening. Plumbing lines cut into floor framing members and second floor sheathing. Evidence of water damage and possible mold. Garage wall painted on both exterior and interior faces, not allowing masonry wall to breathe. Condition of masonry, under paint, unknown.

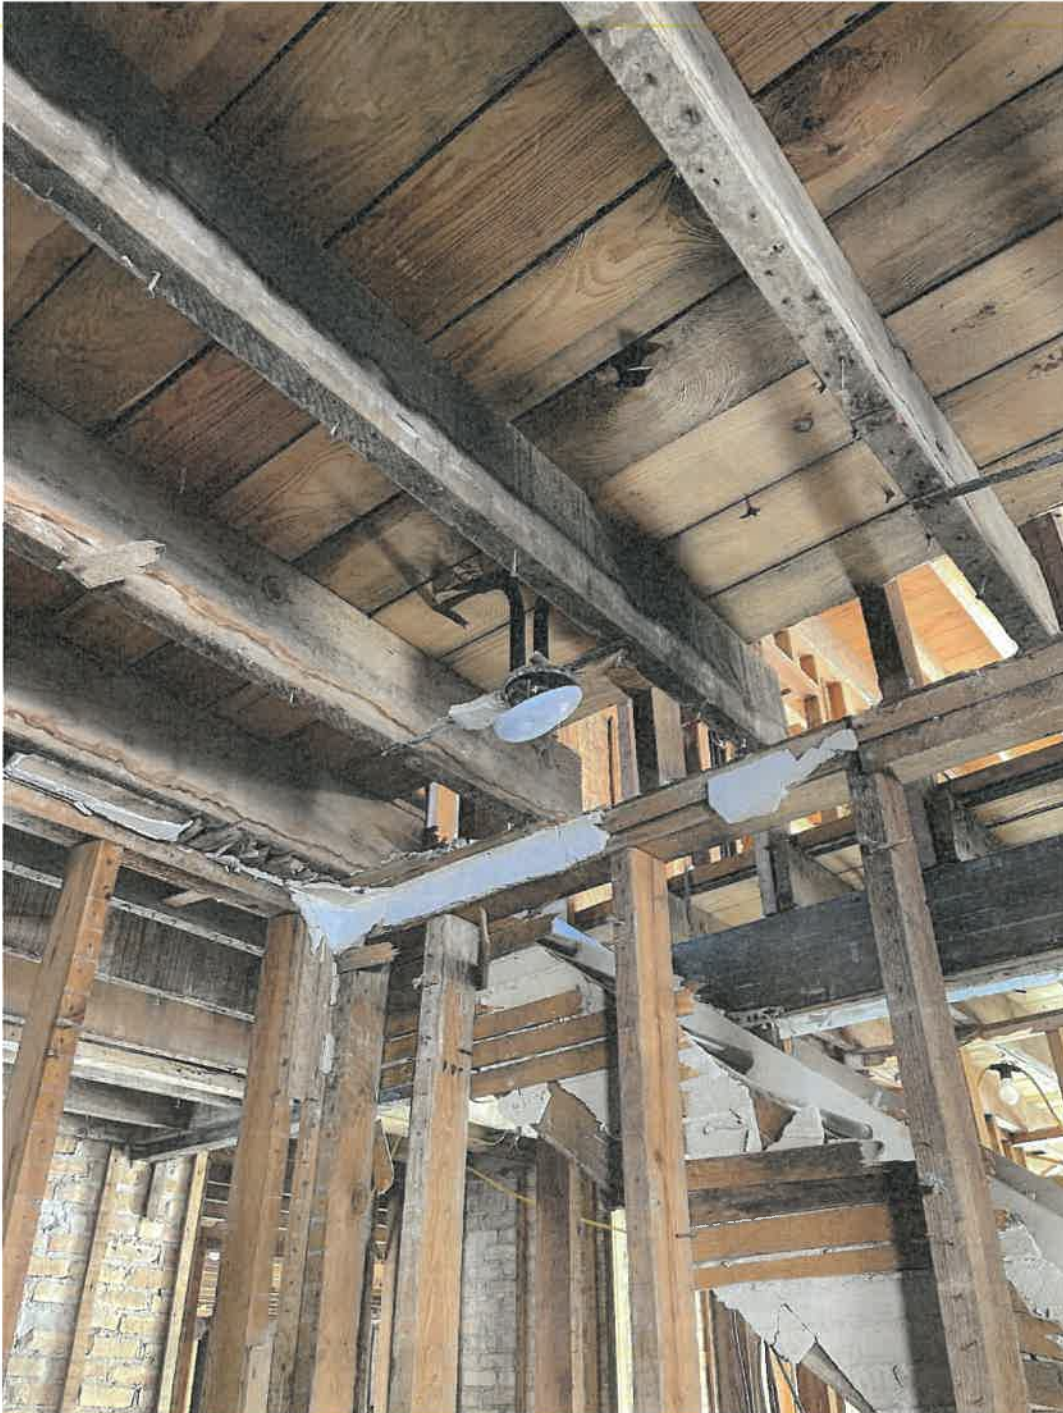
Photo 18: North & East Wing (First Floor) – Wood floor/ceiling joists bouncy & not level. Wood framing members stained indicating moisture damage and possible mold. Timber beam vertically unsupported.

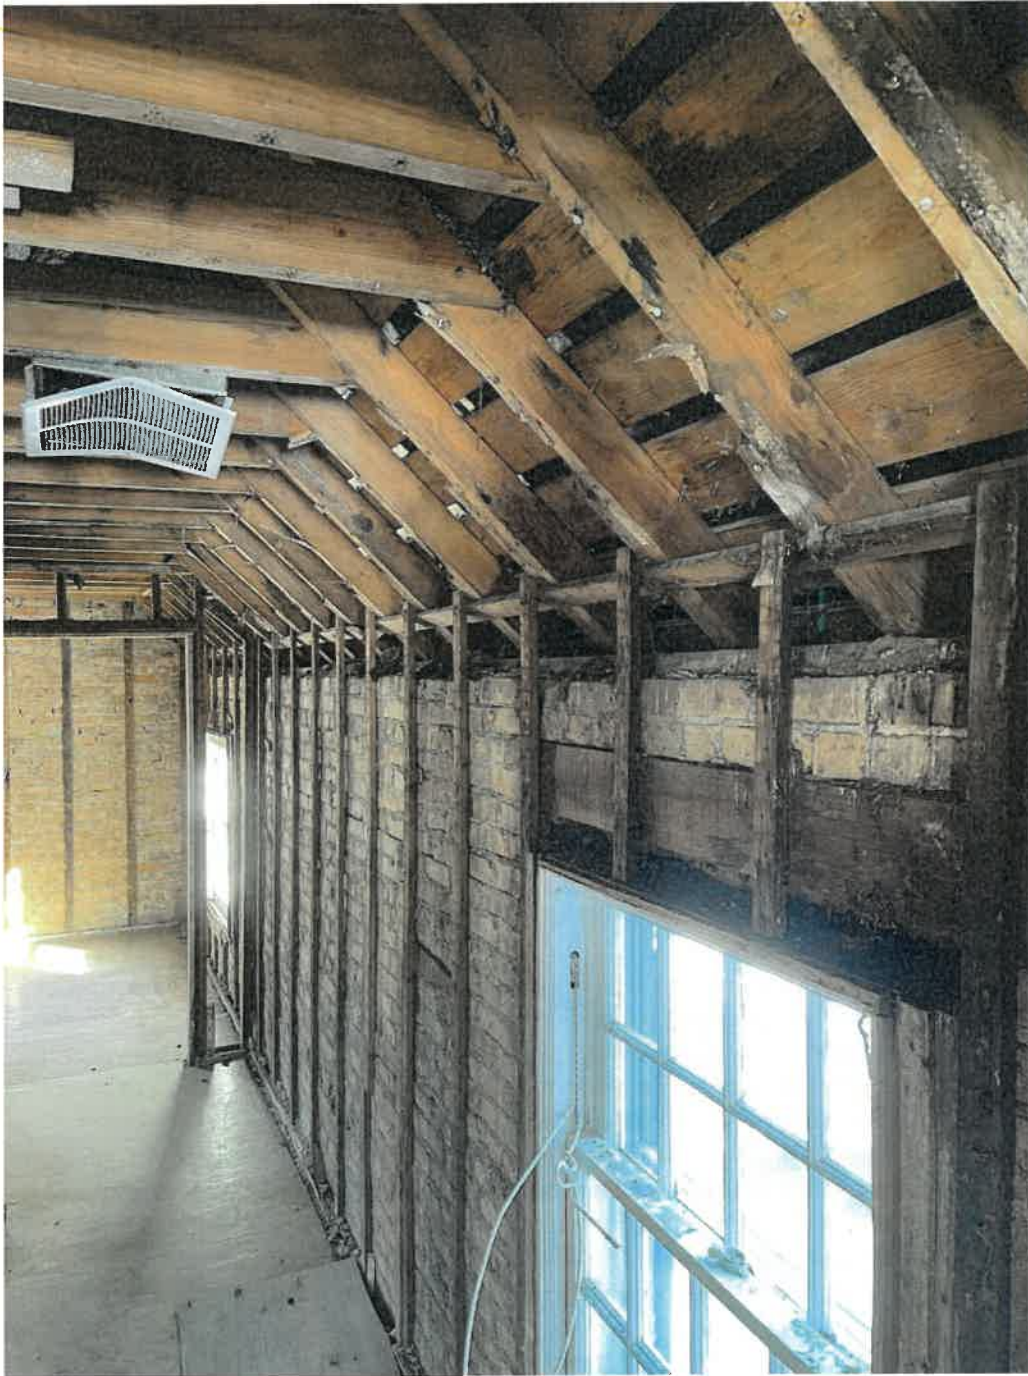
Photo 19: East Wing (Second Floor) – Roof framing undersized for spans. Evidence of moisture damage and possible mold at intersection of roof framing, wood plate and masonry.

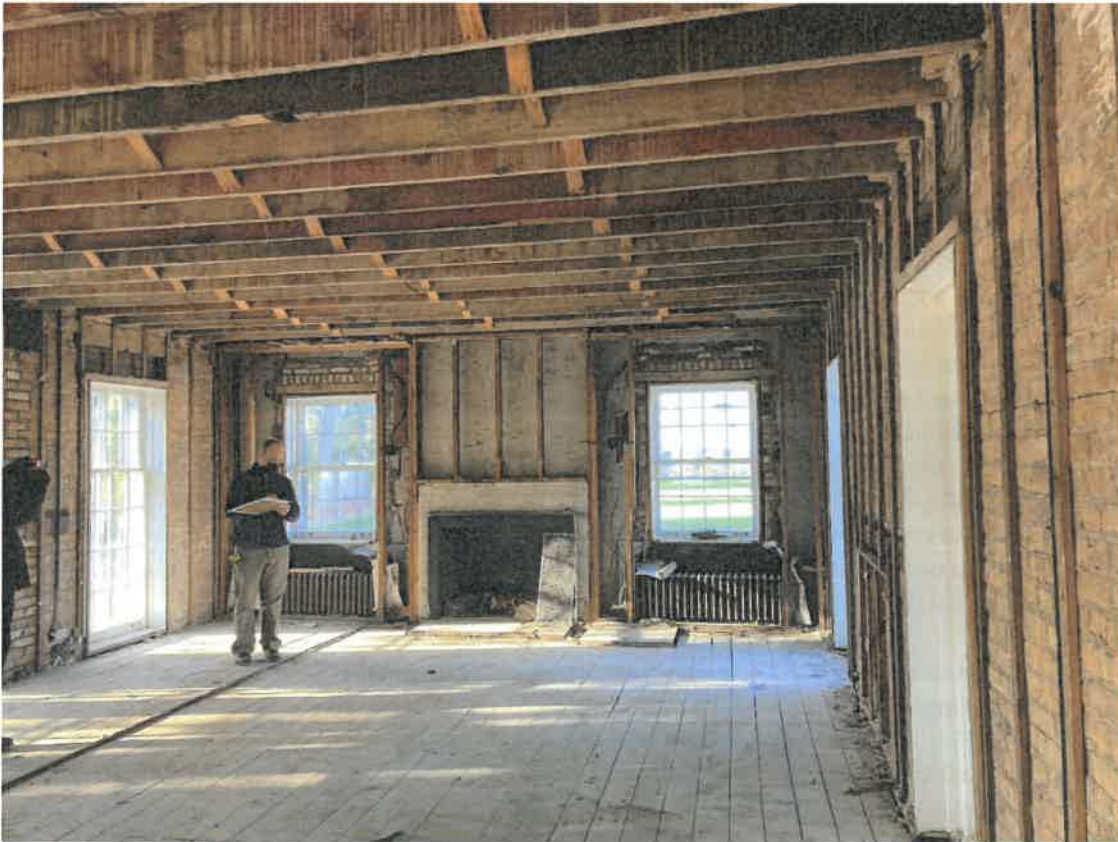
Photo 20: South Wing (First Floor) – Floor framing at both first and second floors bouncy with too much deflection. Structural reinforcement of floor and ceiling framing required. The environmental report indicated that there was an extremely high concentration of mold in the south wing crawlspace.

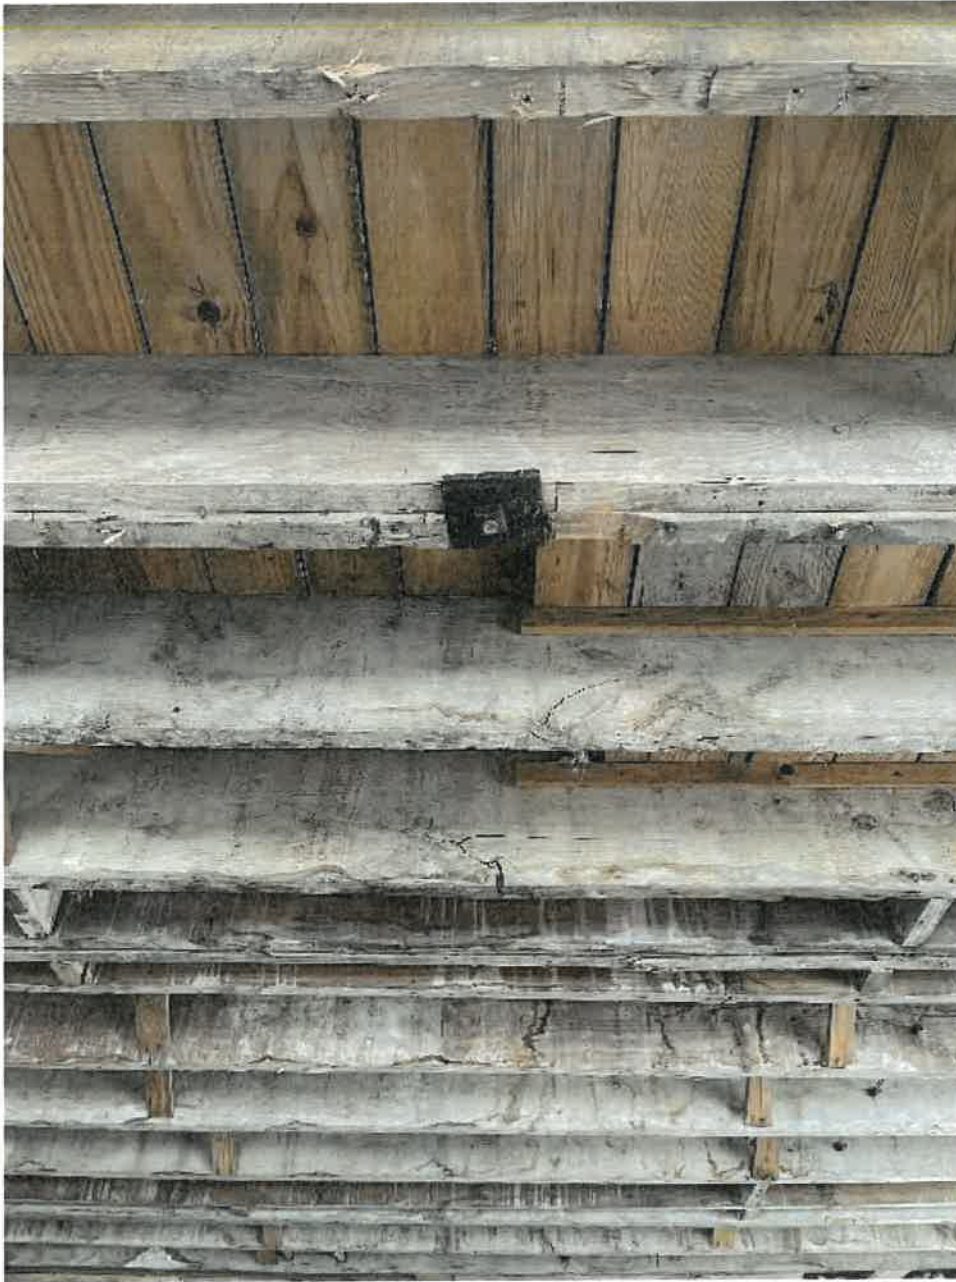
Photo 21: South Wing (First Floor) – 1of 2 tie rod connectors at ceiling framing connected through second floor to roof framing. Floor/ceiling joists bouncy. Evidence of structural failure in some of the framing members. Joists stained by possible moisture damage. Structural reinforcement of floor, ceiling and roof required.

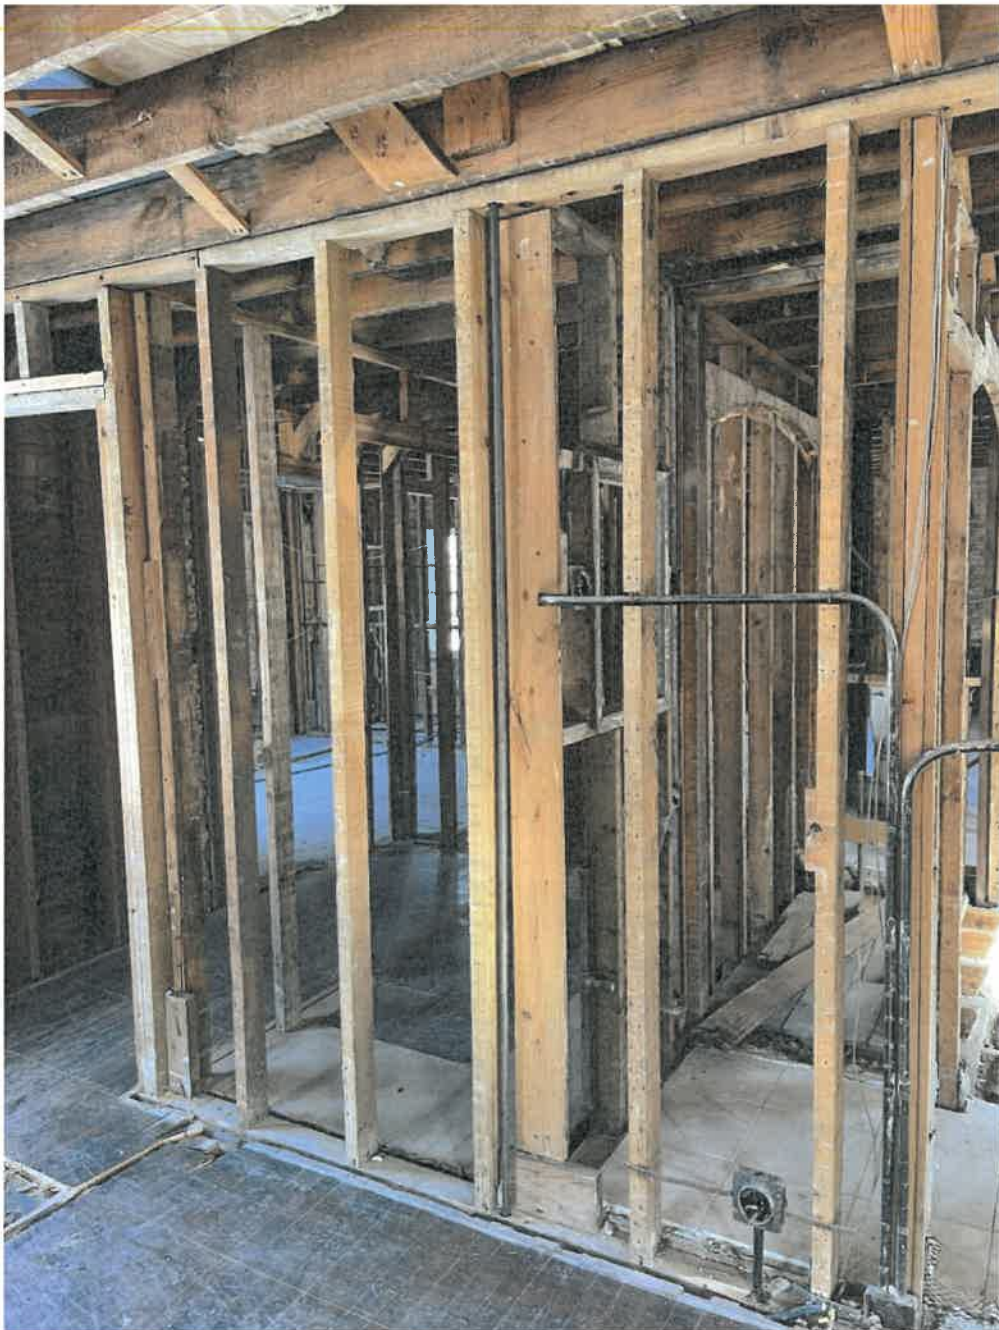
Photo 22: South Wing (Second Floor) – 1 of 2 tie rods through wall framing connected through to roof framing with carpenter built timber truss/beam at ceiling framing. Tie rods and truss/beam do not have any apparent structural purpose and probably distribute roof loads to undersized ceiling and floor framing members, contributing to structural failures and bouncy floors. Structural reinforcement of floor, ceiling and roof framing required.

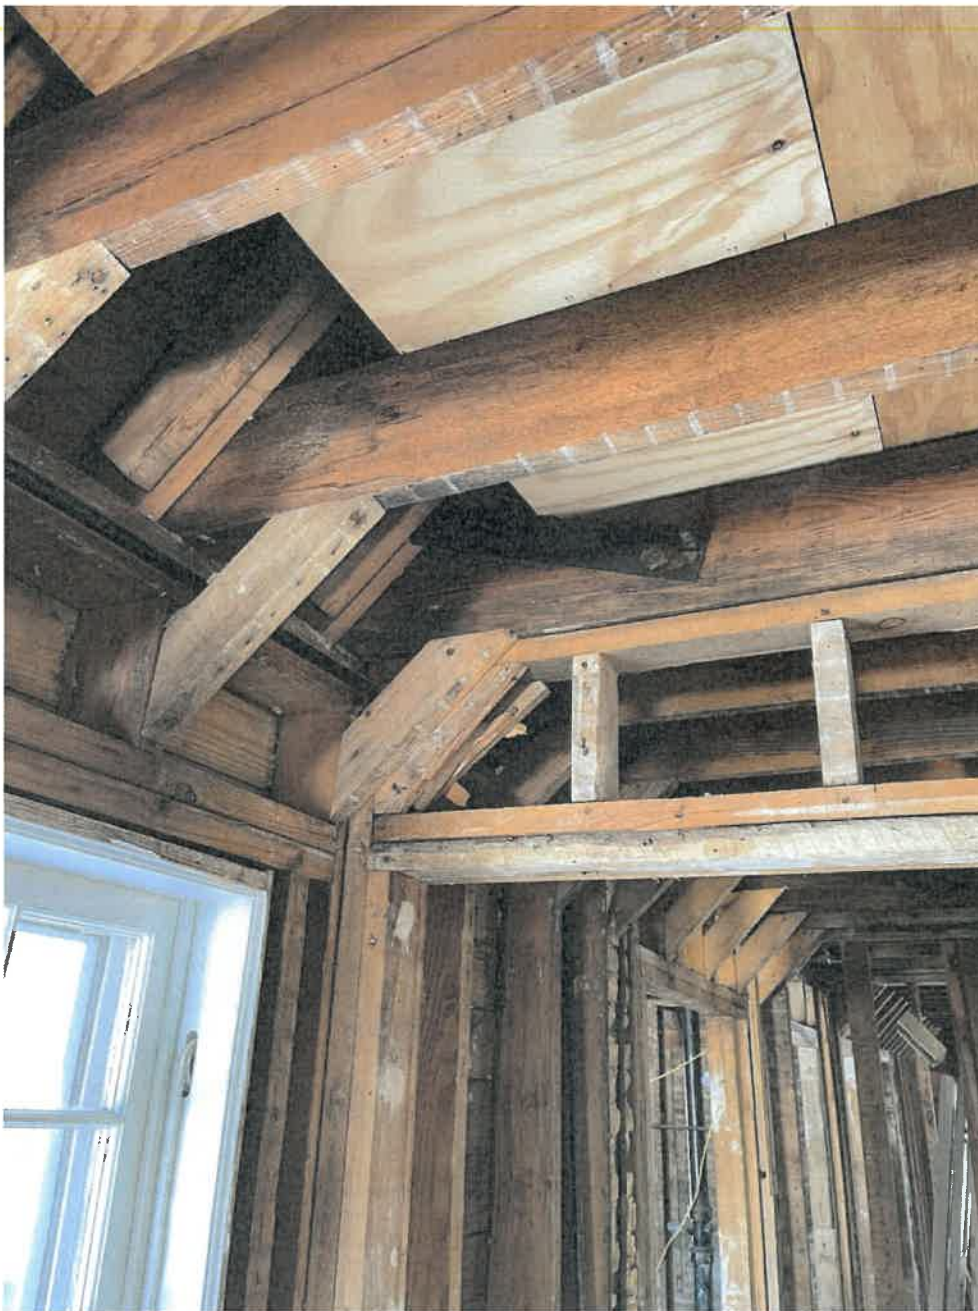
Photo 22B: South Wing (Second Floor) – Black strap end connection detail that appears part carpenter built timber truss/beam at wall and ceiling framing. Roof framing not totally connected to wall plates. Water damage evident and possible mold. Structural reinforcement of floor, ceiling and roof framing required.

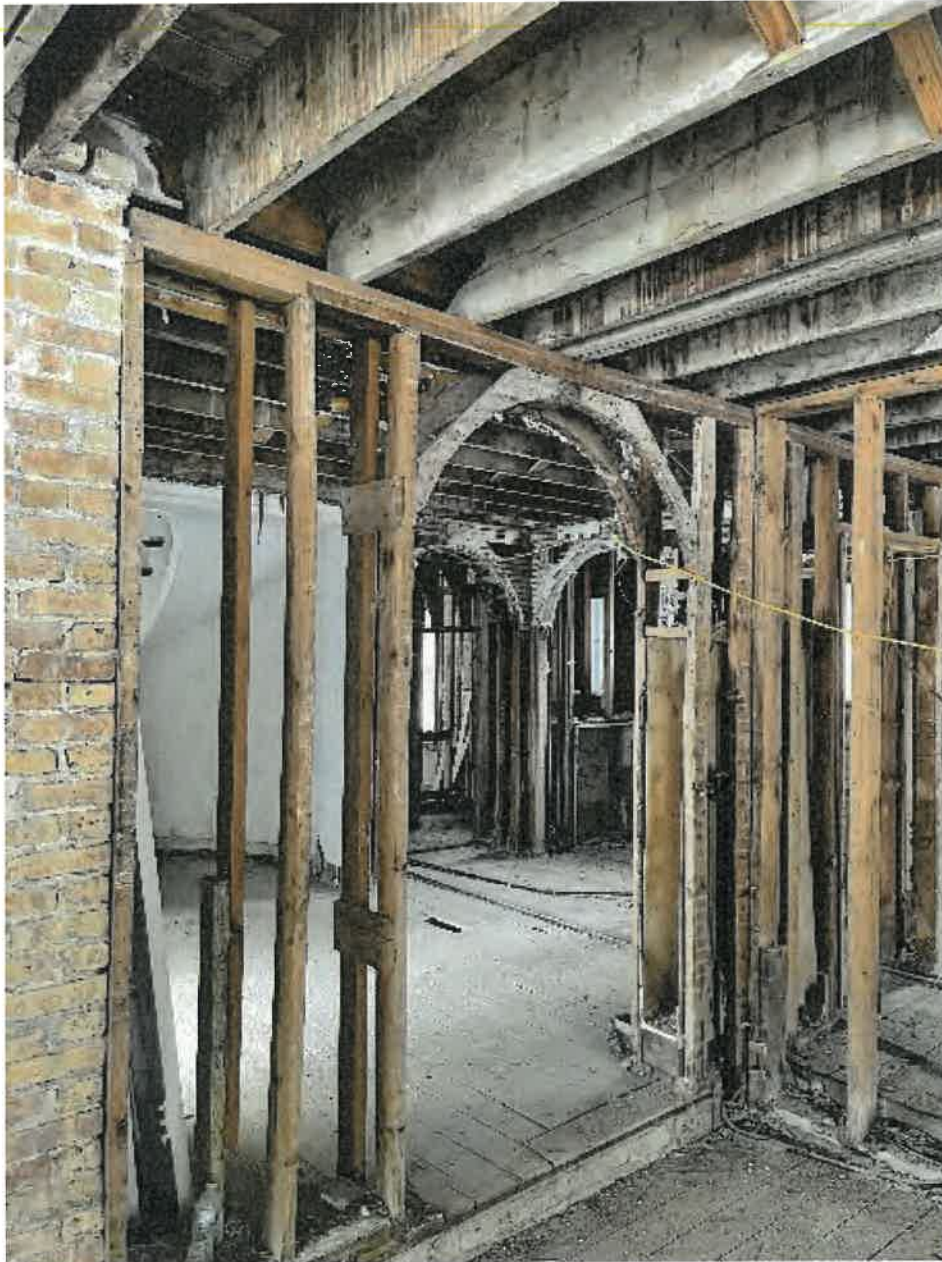
Photo 23: South Wing (First Floor) – Floor framing second floor bouncy with too much deflection. Wood framed bearing wall lacking header at door opening and joist ends. Structural reinforcement required. Efflorescence at brick wall and evidence of moisture damage at wood framing members bearing on masonry. In the upper left corner of the photo, the wood framing member that is typically pocketed into the masonry is exposed and illustrates the concern about susceptibility of wood decay where wood framing is pocketed into masonry.

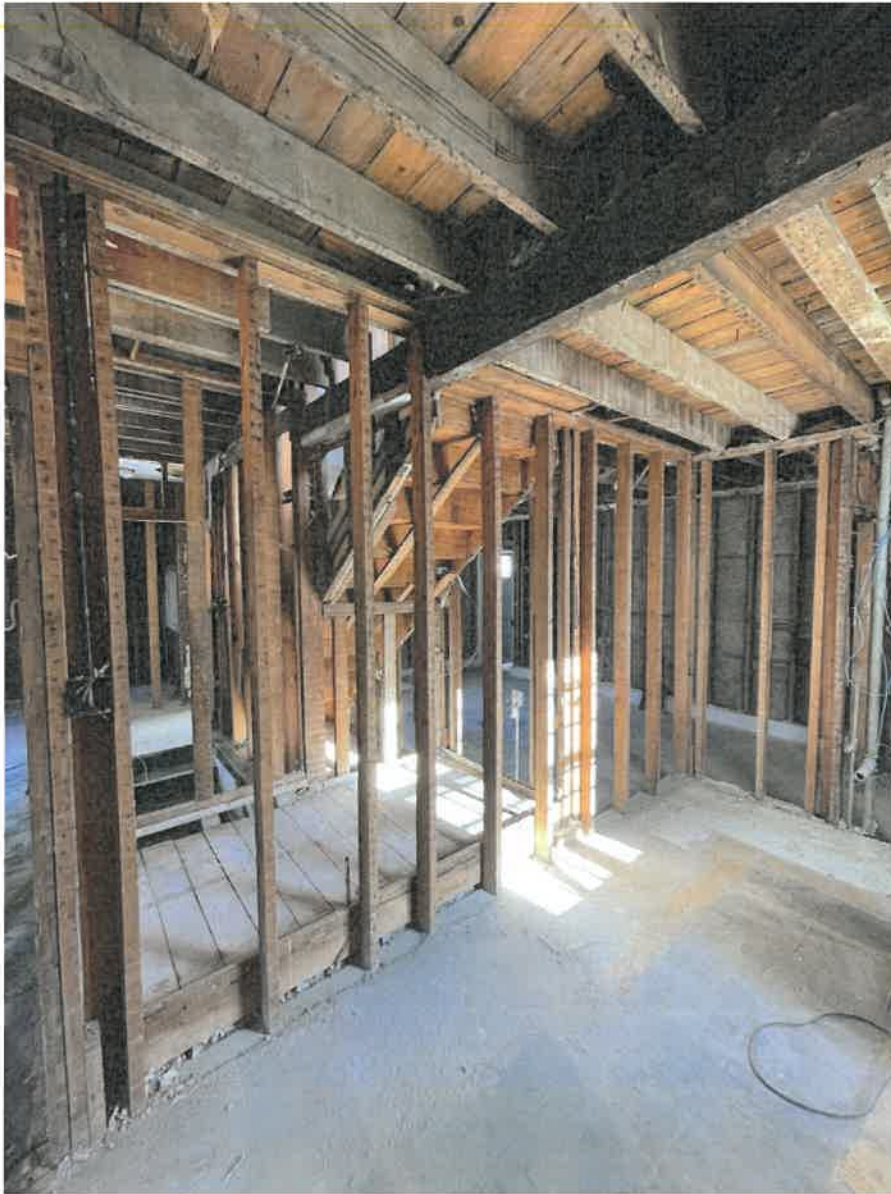
Photo 24: North/East Wing (First Floor) – Interior wood framing. Second floor framing bouncy and significantly not level with 3" +/- dip in floor. Vertical support of north beam end at stair indeterminate. Structural reinforcement of floor framing required.

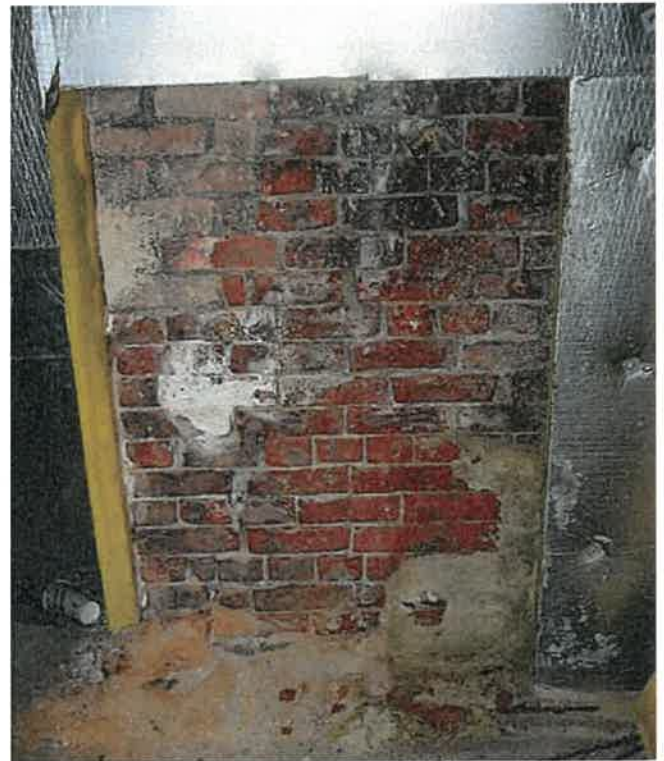
Fig. 21. The interior face of a brick masonry wall shows damage that resulted from the installation of a vapor retardant (foil facing) and thermal insulation. Photo: Simpson Gumpertz & Heger.

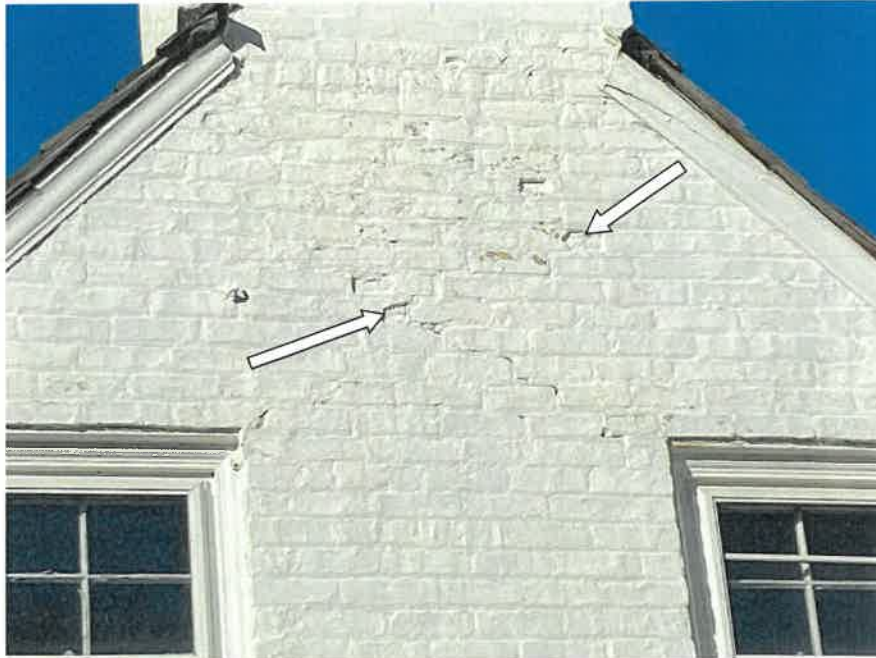
Photo One – Deteriorated masonry on the veneer of the detached garage.

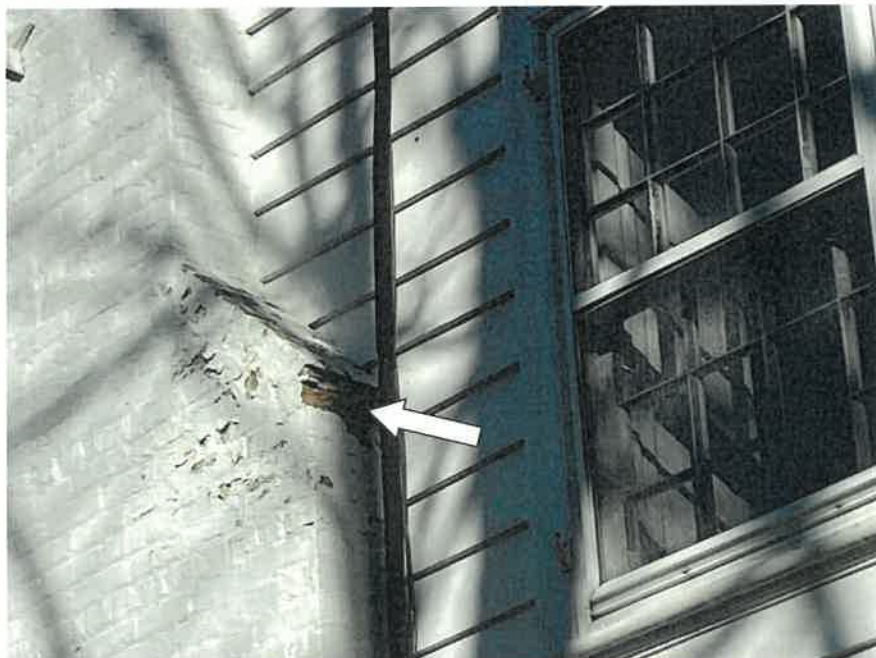
Photo Two – Deteriorated masonry on a chimney on the main house.

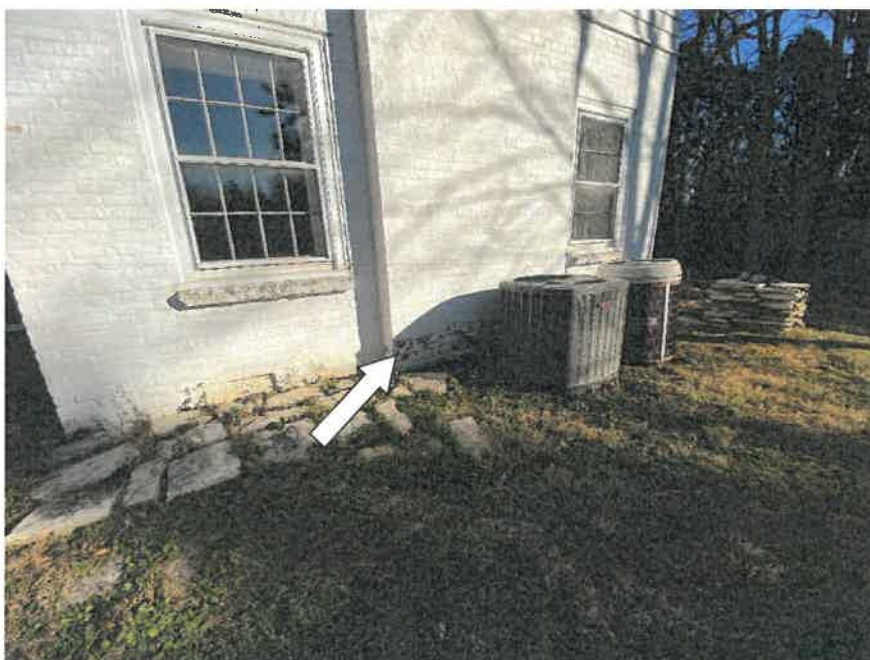
Photo Three – Deteriorated masonry at the base on a chimney on the main house.

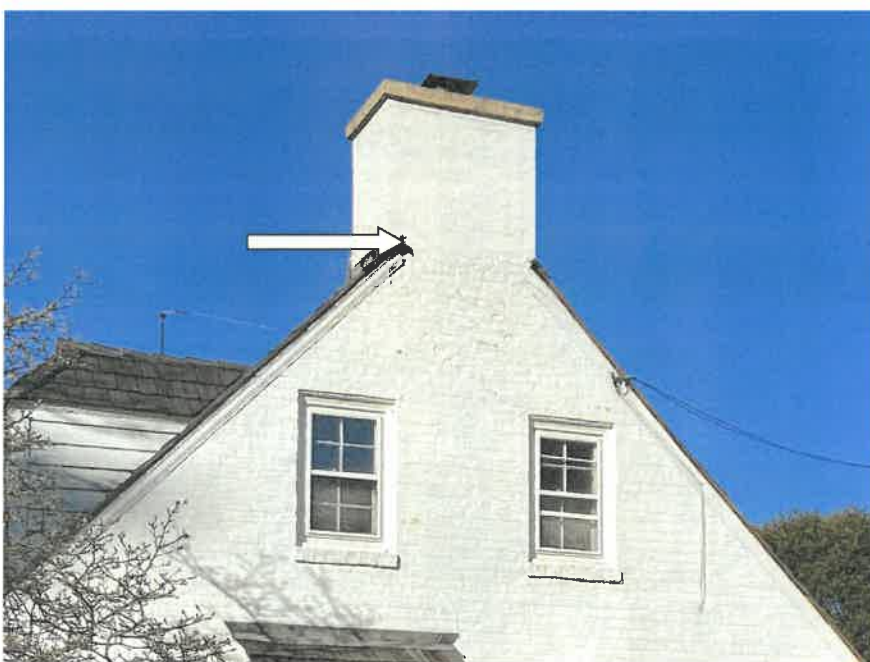
Photo Four – The upper portion of this chimney had been replaced. Additional deterioration appears to be present in the brick below the repaired section of masonry.

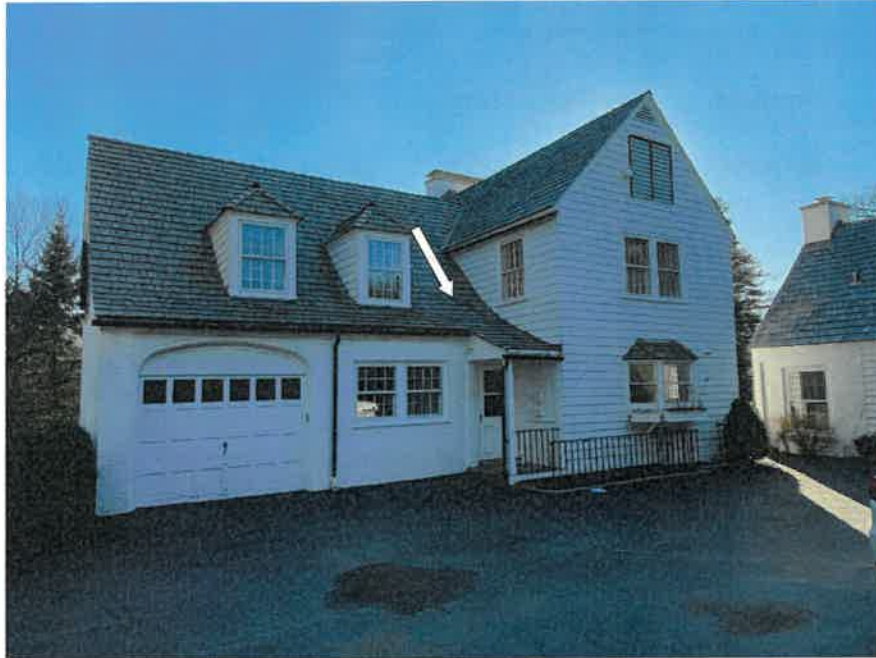
Photo Five – A sag in the roof plane above the garage is evidence of similar sagging in the second-floor joists within.
