# Neighborhood Condition Survey:

## Housing and Infrastructure Conditions Analysis

Neighborhoods: East Lake Park, Habitat &  
Mickens Harper - Dade City, FL

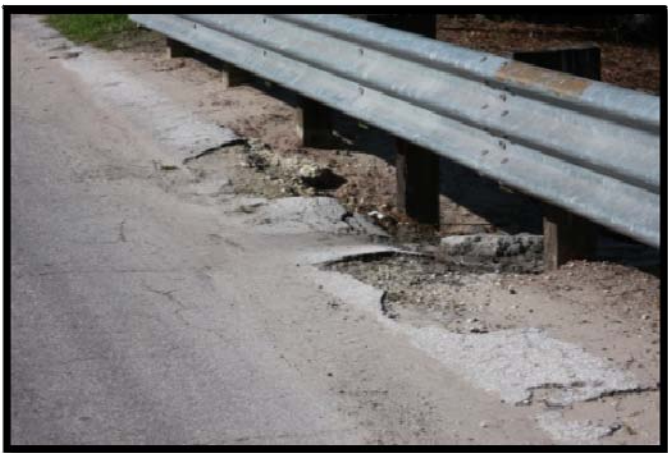
Wilson St.  
Pavement Failure at canals.

- Repave Wilson St., Pave Railroad Ave. & Taylor Ave. round-about,
- Install Sidewalks along Wilson St., Canal St., Taylor St. & Delmar St.,
- Assess the need for Speed Control Devices along MLK, Wilson St., Canal St., & Taylor St.,
- Reassess street and canal intersections for possible road failure.
- Install railing on Summer Lake Rd where it intersects the Shadow Lake canal.

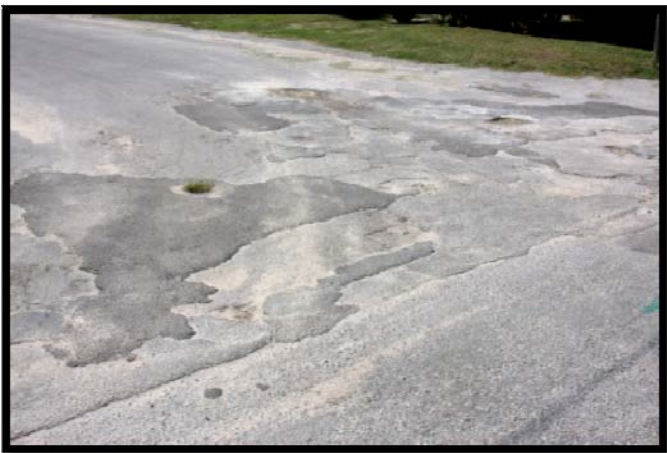
Wilson St. & Ferguson Ave.  
Pot Holes & Failing Patches

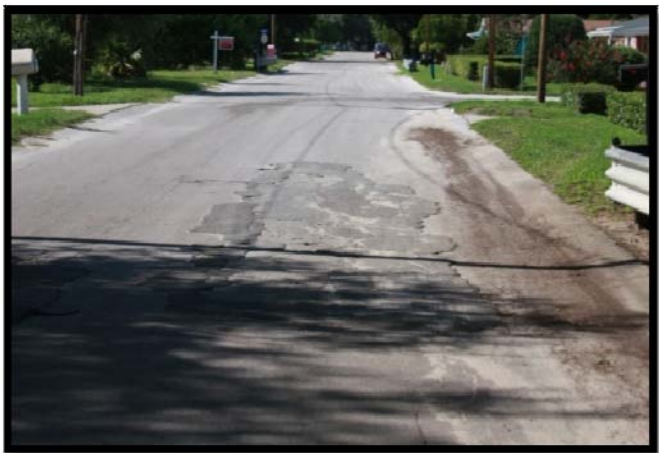
Wilson St. by canal  
Drainage Issue & Pot Holes

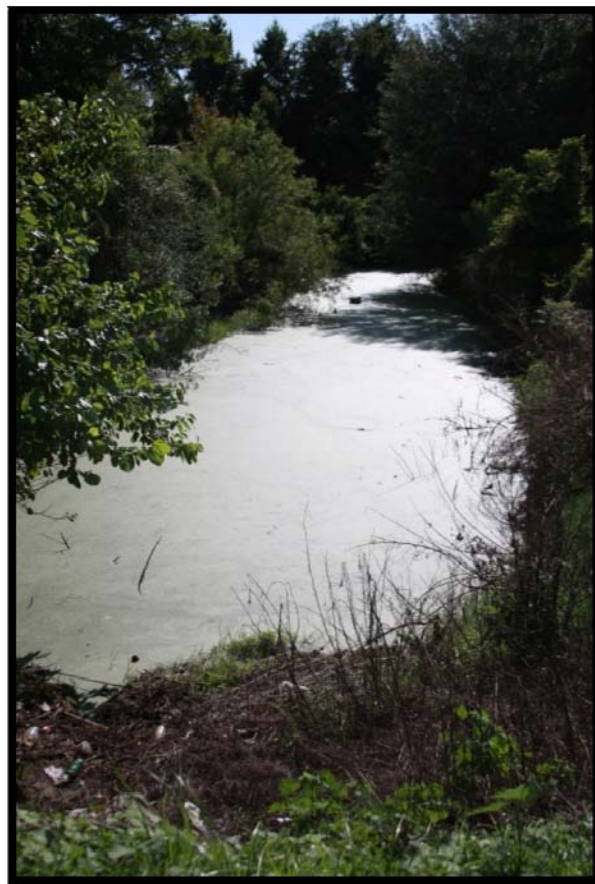
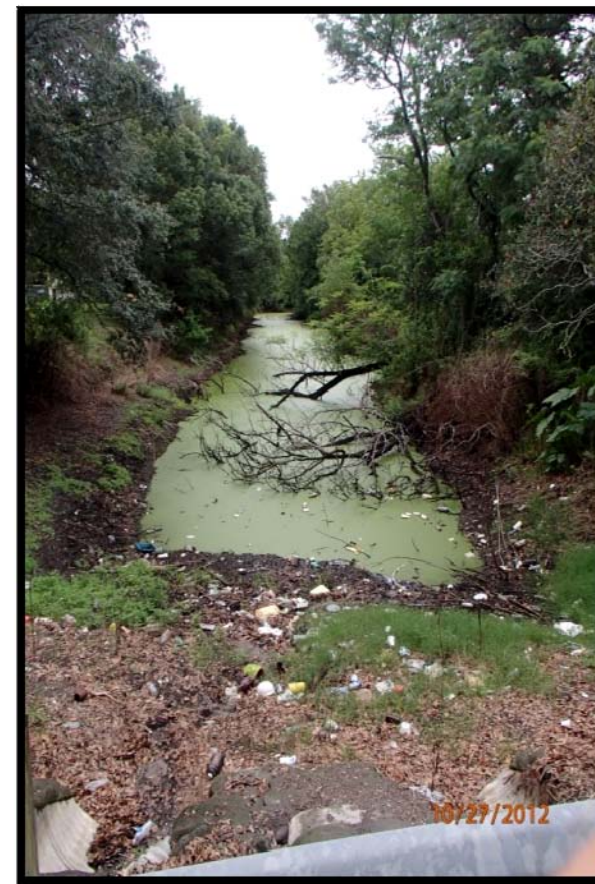
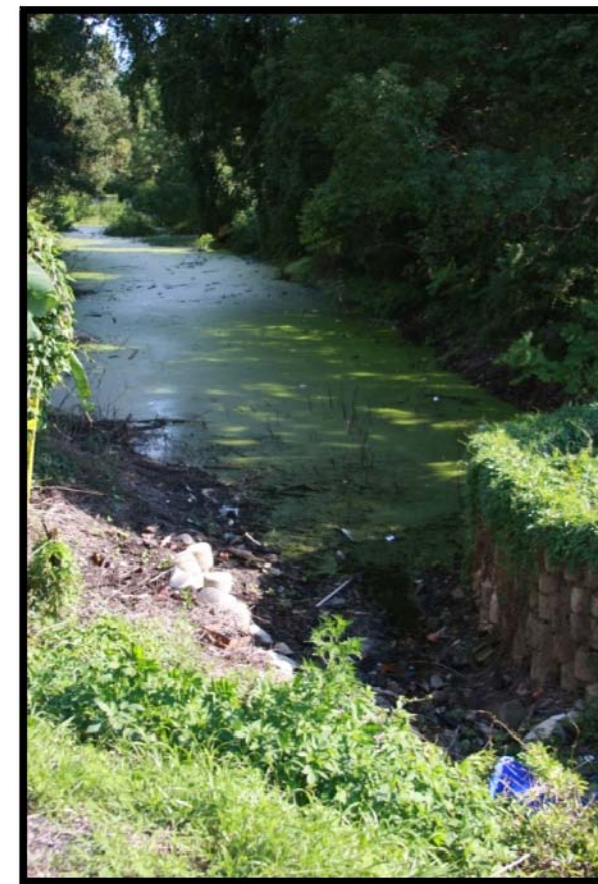
*Dumping was prevalent in the canals, and the areas depicted here represent the worst observed cases of dumping in the West canals.  
Debris includes a couch, chairs, cinder blocks, tires, toys and a pallet.*

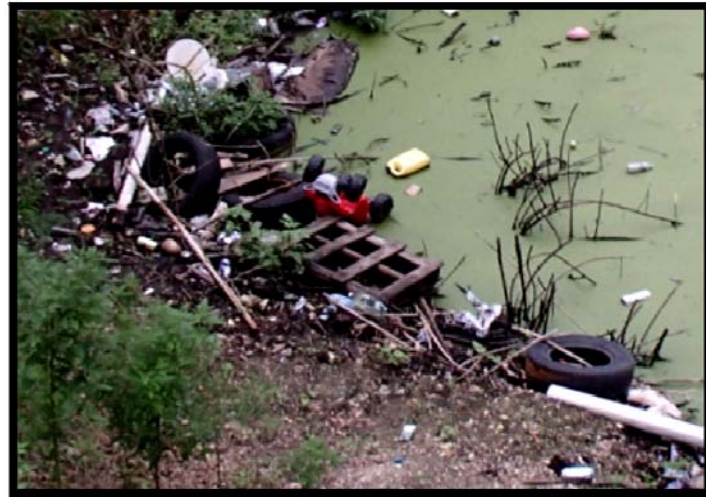
*Ferguson Ave. between  
Blake & Morgan St.*

The areas depicted below are the worst dumping areas observed in the West canals. Each of the photographs below were taken in the East Lake Park subdivision. The photos below display such disregard for the community's health and safety. Residents that dump waste and garbage within their neighborhood are putting themselves and their children at risk of injury and water related health issues.

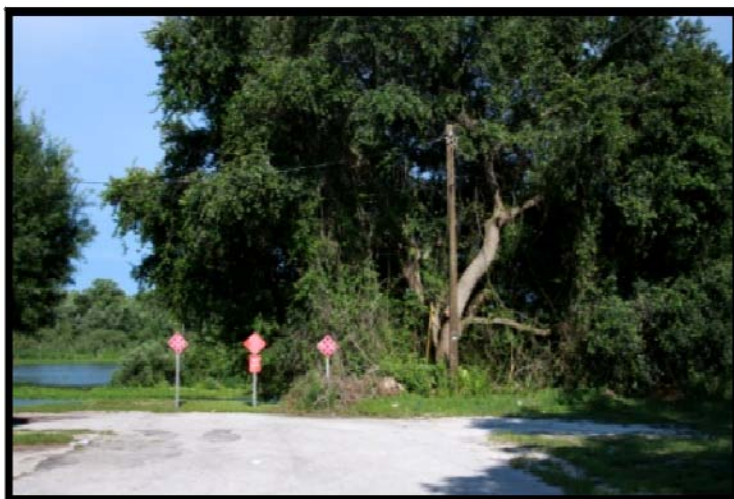
*Lake Ave. East  
Toward Shadow Lake*

The dead end roads adjacent to Shadow Lake provide no incentive to venture down due to the current obstructions from overgrown vegetation. Shadow Lake is an opportunity for the community to enhance its appeal and amenities. If these areas were trimmed and water access was granted potential recreational spaces such as docks, gazebos or small boat launching uses can be realized. Multiple properties off of Shadow Lake are available for such potential land uses mentioned above. The photos below are the East end of Cedar St., Lake Ave. and Pine Ave. and provide engaging lake views if the vegetation was trimmed.

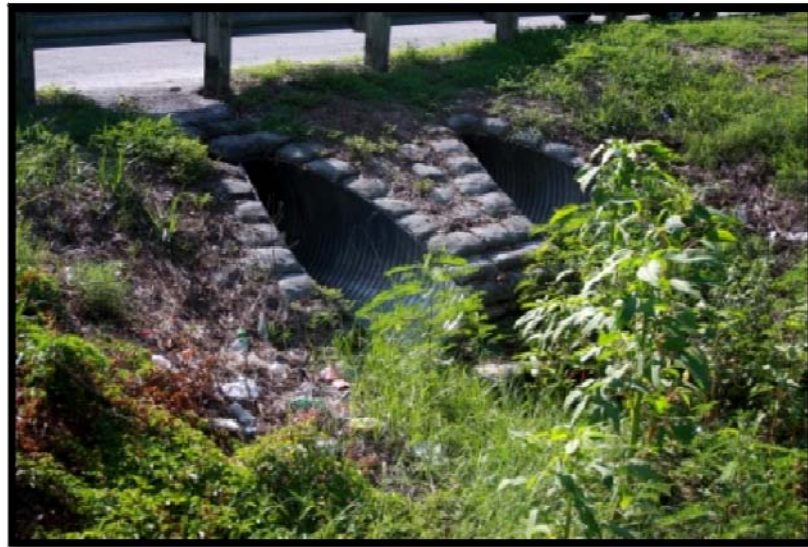
*Excessive Vegetation Around Culverts  
Water Level Remain Low.*

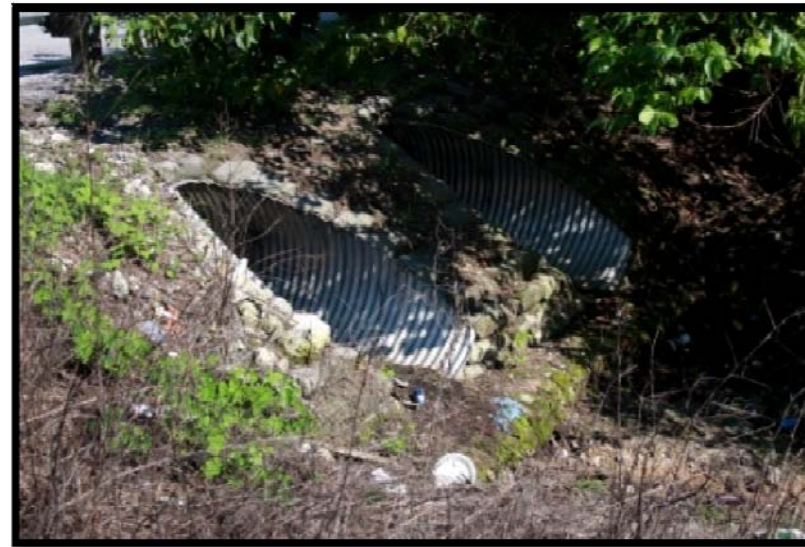
*Culverts Openings are  
Large and Not Secured.*

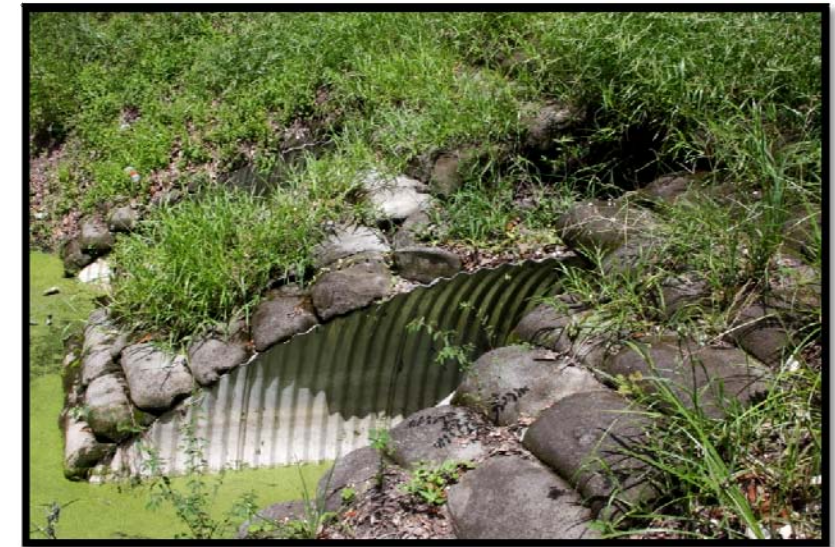
Some of the structures around the culverts are failing and in return effecting road conditions above.

*Failing Structure Around Culvert  
Watch for Possible Pavement Failure Above.*

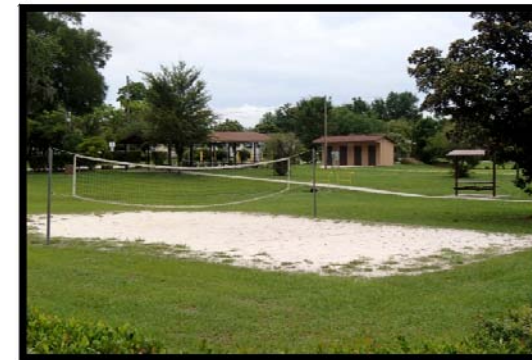
#### Volleyball Court

Needs regular maintenance from edging, net repair & tightening and leveling the sand.

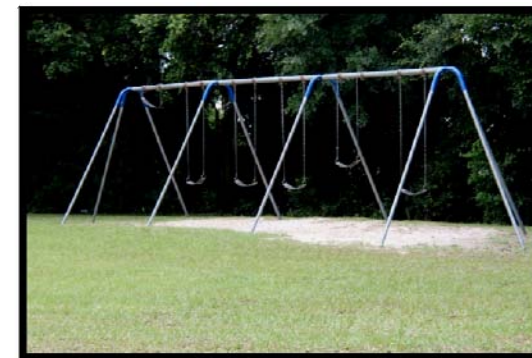
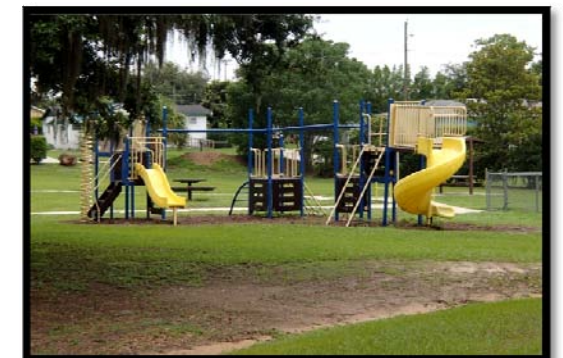
#### Swing Set and Playground

Both the swing set and playground were in good repair. To enhance the safety of these two park amenities rubber mulch may benefit both the user from falls and the city from increasing insurance rates.

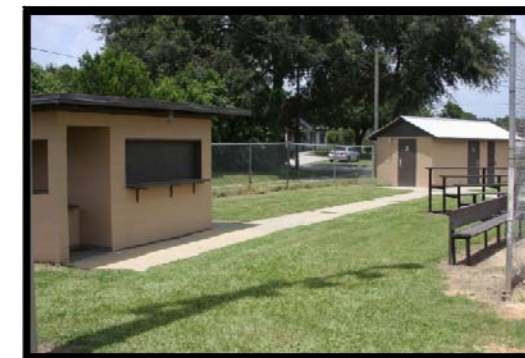
**Walkways & Sidewalks**  
In need of edging
