# Building and Site Assessment

Charter Township of Delta

April 23, 2020

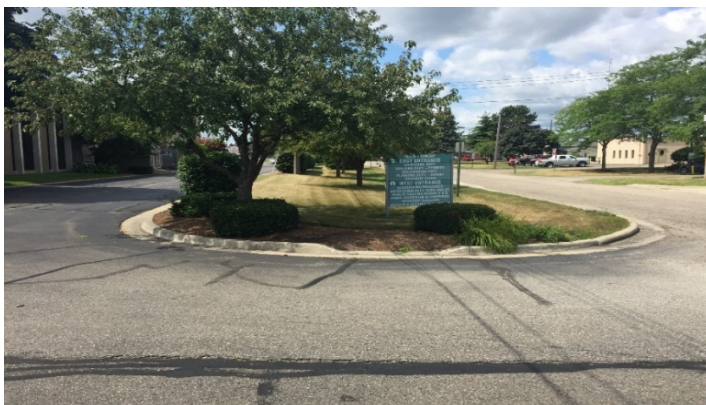
- No sidewalk connectivity from administration building to fire station, sheriff sub-station or parks maintenance sites.

- East parking lot has many cracks.
- Site signage outdated.
- North building entrance not ADA accessible, but leads directly to staircase.
- A storage building added on north side of site. This creates an undesirable aesthetic.

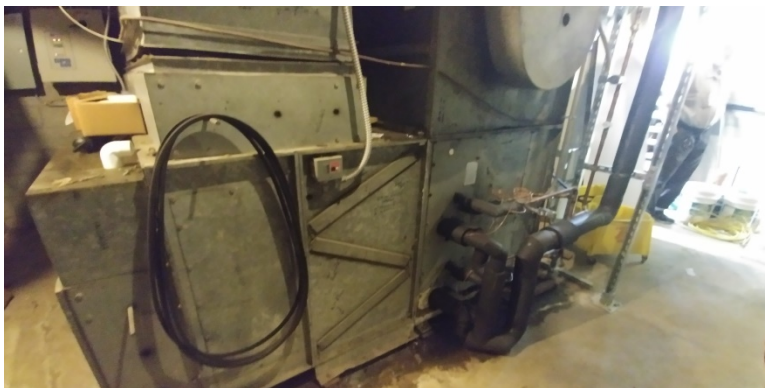
- Natural gas piping on roof rusting and should be painted.
- Drain waste vent piping on old side of building is original cast iron and past expected service life. This piping replacement throughout the building should be in next five years. In particular, a section of under floor drain piping was reported as plugged/collapsed on new building side and should be repaired as soon as possible.
- Air handling units serving original building area are dated and should be replaced with new more energy efficient natural gas fired heating and direct expansion refrigerant cooling forced air units.

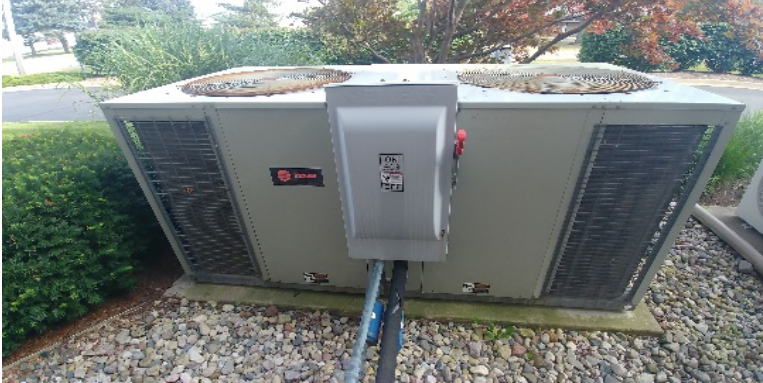
- Condensing units on grade are in poor shape and should be replaced except for the condensing unit on the old side of building which was replaced in 2018.

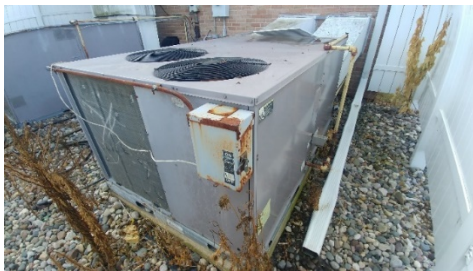
- Two natural gas fired heating and direct expansion refrigerant cooling air handling units are in poor shape and at end of their expected service life and should be replaced.

| Item # | Description of Work | Budget Amount | Category 1 - | Category 2 - | Category 3 - |
|---|---|---|---|---|---|
| <u>28</u> | Replace AHU's (NG w/DX) | \$173,866 | 0 | \$173,866 | 0 |

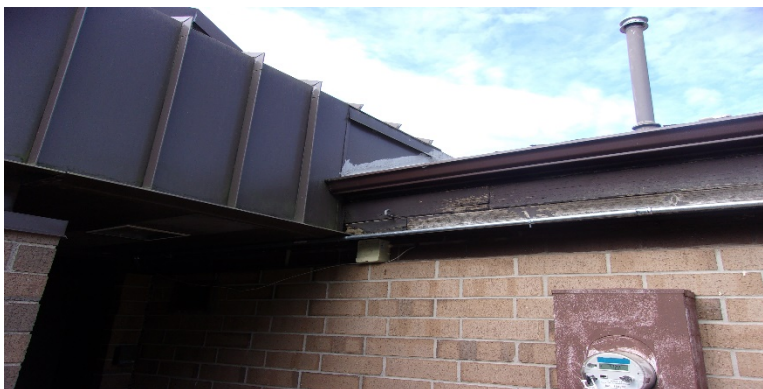
- Asphalt shingles on the original 1982 building are near end of expected life.
- Standing seam metal roof and fascia on the 1991 addition is in good condition.
- Exterior finish on windows is fading and thinning.
- Moisture is getting thru some masonry walls. Consider sealing brick if moisture is wicking through open mortar joints.
- Exterior slab near 1991 canopy addition is getting wash out below it.
- Wood planter, wood trim on original 1982 building and deteriorating.
- The roof gutter system is inadequate and is not properly draining water off roof and away from building.

- Wood soffits and vent on the original 1982 building are damaged and deteriorating and should be repaired/replaced.
- The coating on the wood gable end is failing, should be cleaned, repainted and/or restained.

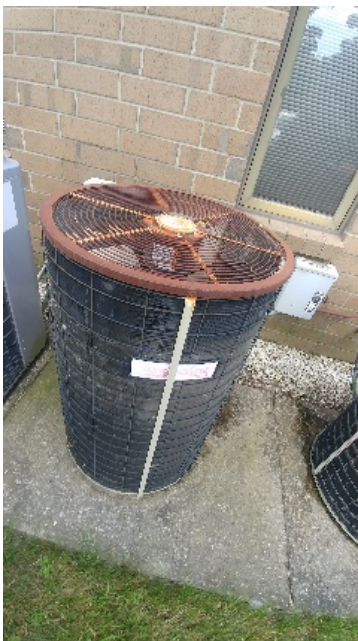
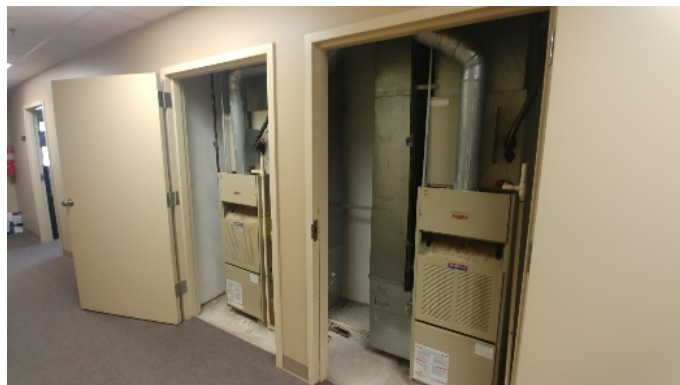
- Six natural gas fired, forced air furnaces serve the building with condensing units mounted outside on grade. Condensing units are in poor shape and should be replaced. All furnaces are original and approaching end of expected service life. They should be replaced with new in kind units or a single air handling unit with ductwork to serve each space independently. New thermostats should be installed when replacing the units. Installation of a single unit will require significant interior renovations to run new ductwork.
- Plumbing fixtures in all rest rooms, locker and shower rooms are original and dated and should be replaced in the next five years.
- All DWV piping below slab piping has reported issues, with some sections failing and should be entirely replaced if building is renovated.

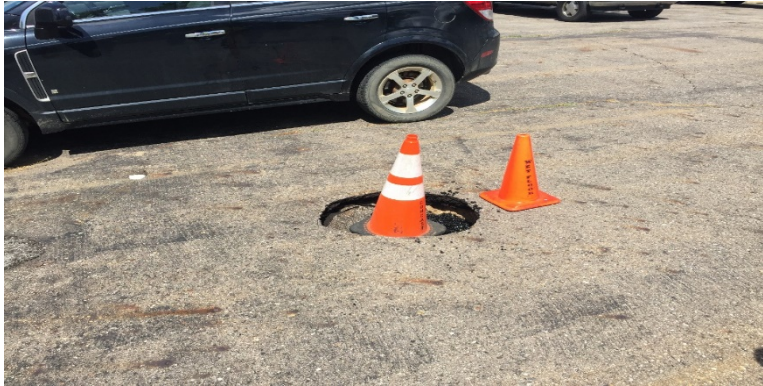
- Parking lot pavement in poor condition and should be reconstructed rather than overlaid.
- Sink holes in parking lot, perhaps due to compacted fill around old building foundations.
- Parking lot reconstruction should include over excavation of existing soils, mass grading, curb and gutter, and storm water control including both green infrastructure and catch basins/storm sewer.

- Ponding in road east of building
- Remove asphalt parking area on east side of building
- Dumpster in bad location directly adjacent to sidewalk, which is not desirable.

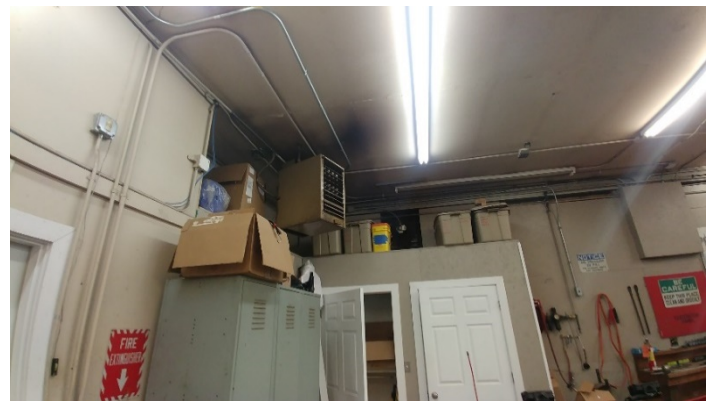
- Wall insulation is minimal and does not meet current standards.
- Existing lighting is not efficient. There are no lighting controls. There are occupancy/motion sensors in some areas now.
- No HVAC controls other than thermostats are present, if building to be brought back into occupied use; programmable controls should be installed to operate HVAC systems at best efficiency.
- A comparison of energy usage at a typical storage building in the same climate zone as published by the U.S. Department of Energy (DOE) versus this building was not performed, as there was not an equivalent building type in the DOE database to use for comparison.

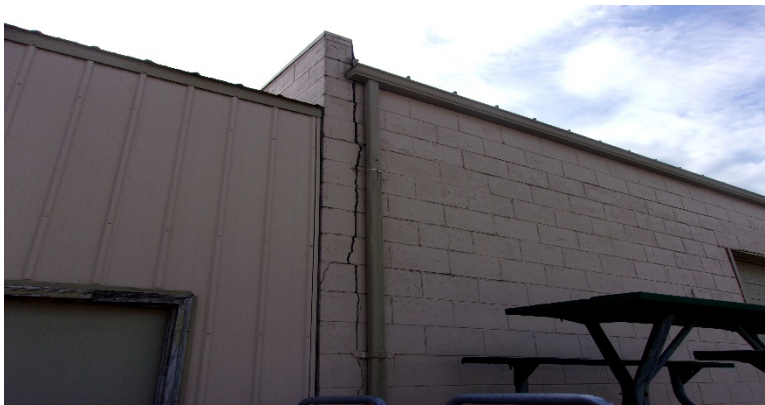
- There are multiple instances of cracking in the exterior wall, which allows moisture to penetrate the envelope.
- The paint on masonry severely worn and does not provide adequate resistance to moisture infiltration.

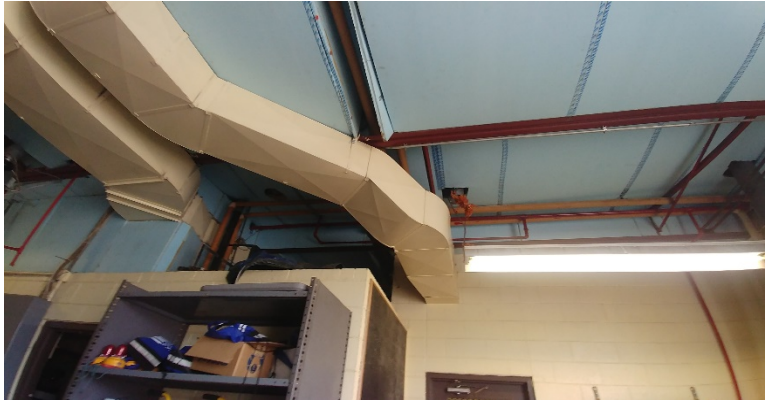
- Mechanical and plumbing systems currently shut off and abandoned. Natural gas fired unit heaters in vehicle bays are utilized for freeze protection only. If building is to be occupied replace existing natural gas heating and direct expansion refrigerant cooling forced air furnaces and unit heaters with new units serving each area independently.
