- > Downtown/Flats Area Sewer System Evaluation Survey (I&I Study) was initiated in 2023
 - Project study area north of IL 72 and west of Van Buren Street
- > This study is particularly important for the Flats neighborhood and downtown area due to:
 - Close proximity to the Fox River
 - Elevated groundwater table
 - Aging/aged sanitary sewer system
- ➤ History of sewer backups in those areas
- Increased wastewater flow into the wastewater treatment plant that would otherwise be conveyed to natural waterways via storm sewers
- ➤ Hill Street Lift Station pump improvements that were completed in 2022 were made to address additional stormwater/groundwater flow coming into and through the lift station during rainy periods

03/04/24

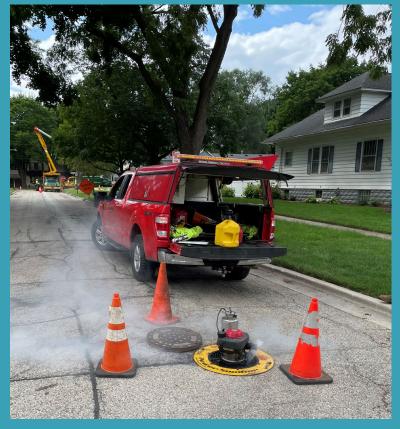
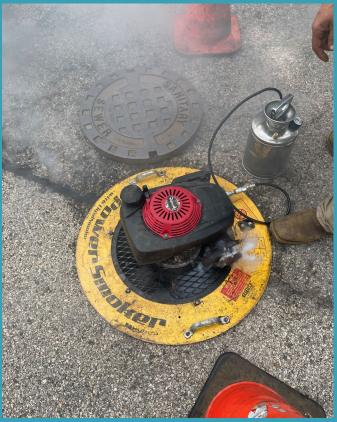
12 Hill St Manhole 1-59

- Total of 60 sanitary sewer manholes were inspected of which defects were identified in 22
 - Recommendation to replace 12 manhole covers (11 have since been replaced by Public Works)

- Smoke would not be observed in a completely tight sanitary sewer system
 - Smoke was observed exiting 10 storm sewer inlets/structures indicating some level of cross-connect

- Remaining manholes (approx. 15) to be repaired contractually
 - <u>Smoke Testing</u> –injected a supply of smoke into the sanitary sewer.
 - Smoke visible outside of the injection point indicated leaks in the sanitary sewer system that were located/logged.
