POTTER COMMUNITY CENTER MASTER PLAN REPORT

PREPARED FOR
VILLAGE OF FAIRPORT

Dec. 8, 2011

LOMONACO ASSOCIATES

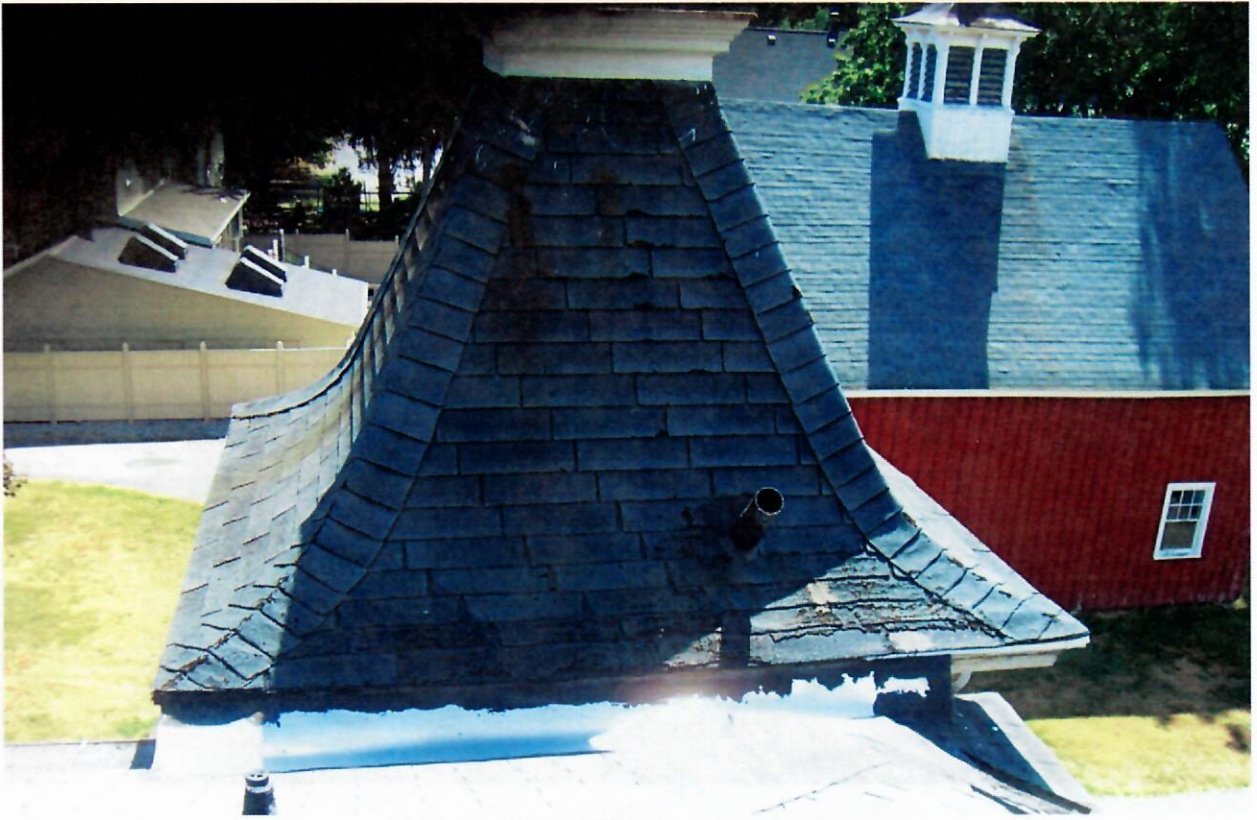
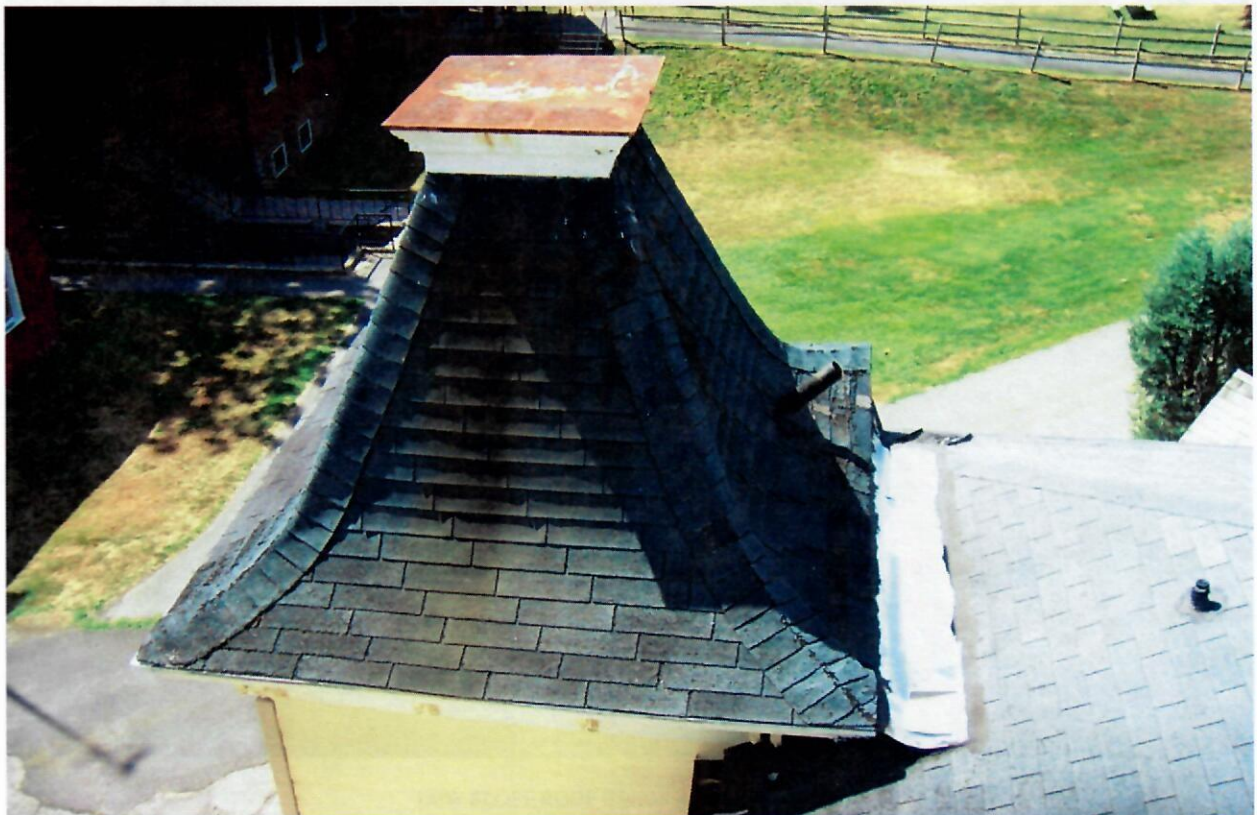
SHINGLES HAVE OUTLIVED THEIR USEFUL LIFE

- All of the roofs except the two low roofs replaced in 2010 have outlived their useful life and immediate plans should be made to replace them.
- The north, east and west steep slope roofs drain toward a center low sloped roof portion. This center roof is a failed metal roof (which has a failed built up roof on top of it) that drains onto the asphalt shingles on the south side of the building. This is a tremendous amount of water to drain onto asphalt shingles and a lack of proper detailing at all the roofs exacerbate the water infiltration issues.

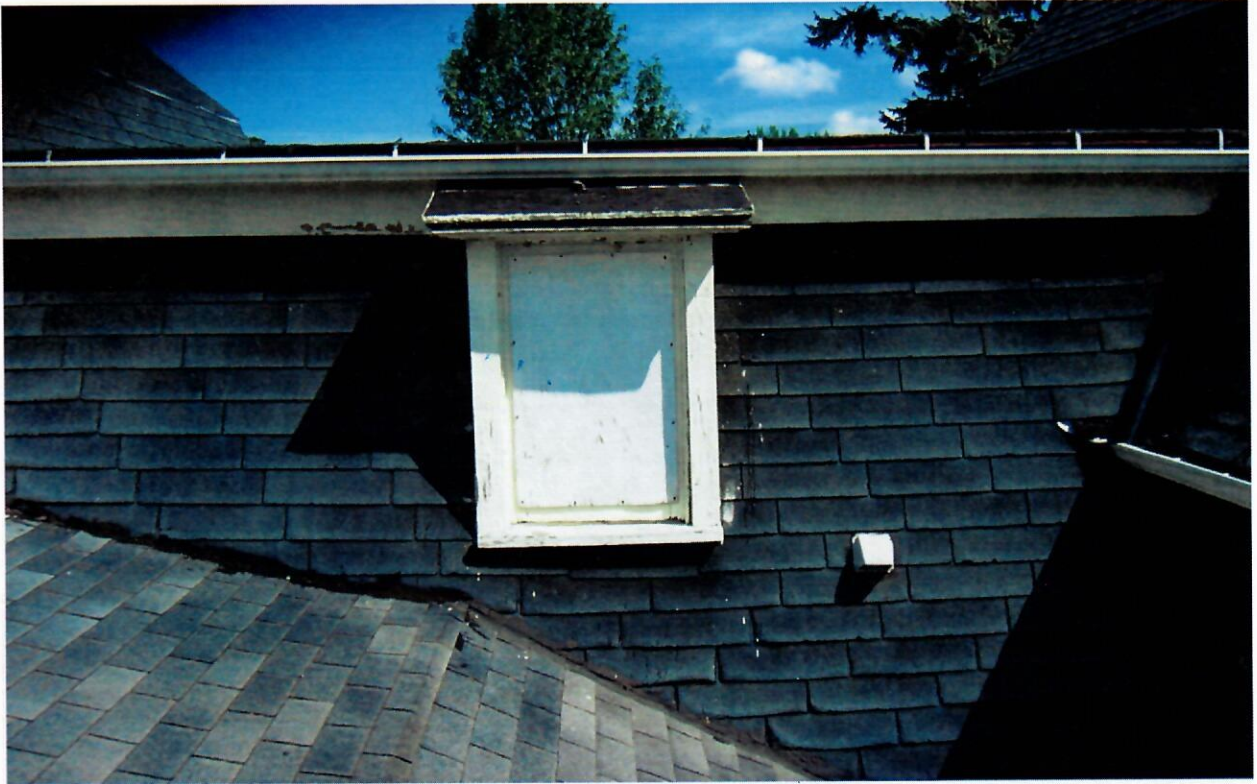
AGED SHINGLES & CAP NEEDS REPLACEMENT

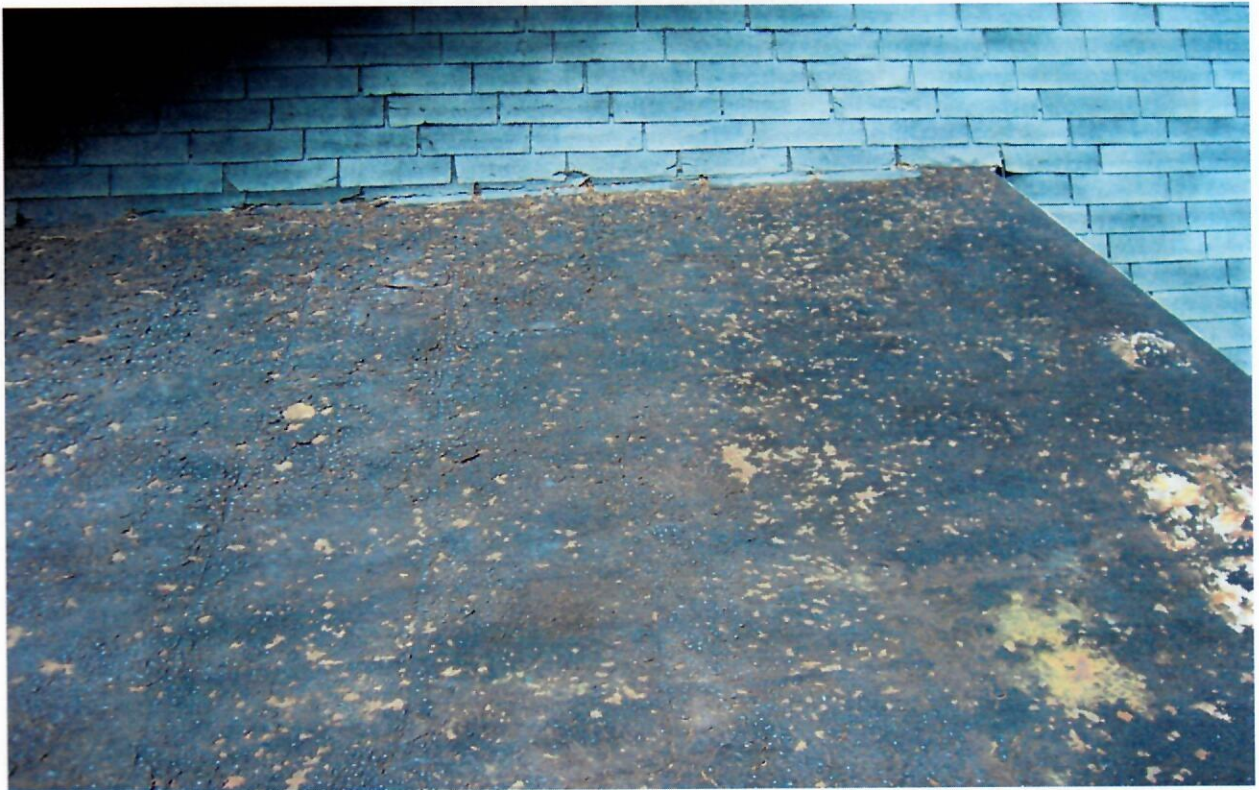
LOW SLOPE ROOF NEEDS REPLACEMENT

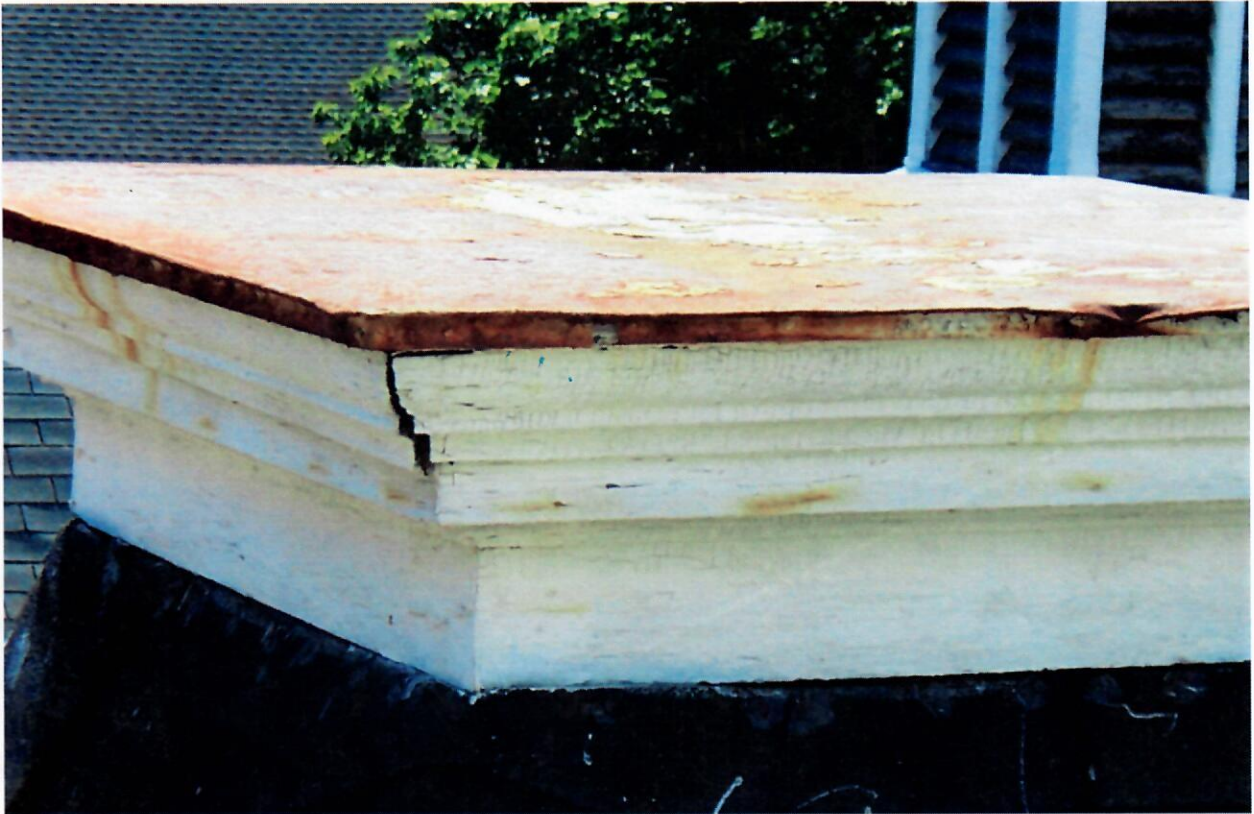
METAL ROOF CAP NEEDS REPLACEMENT

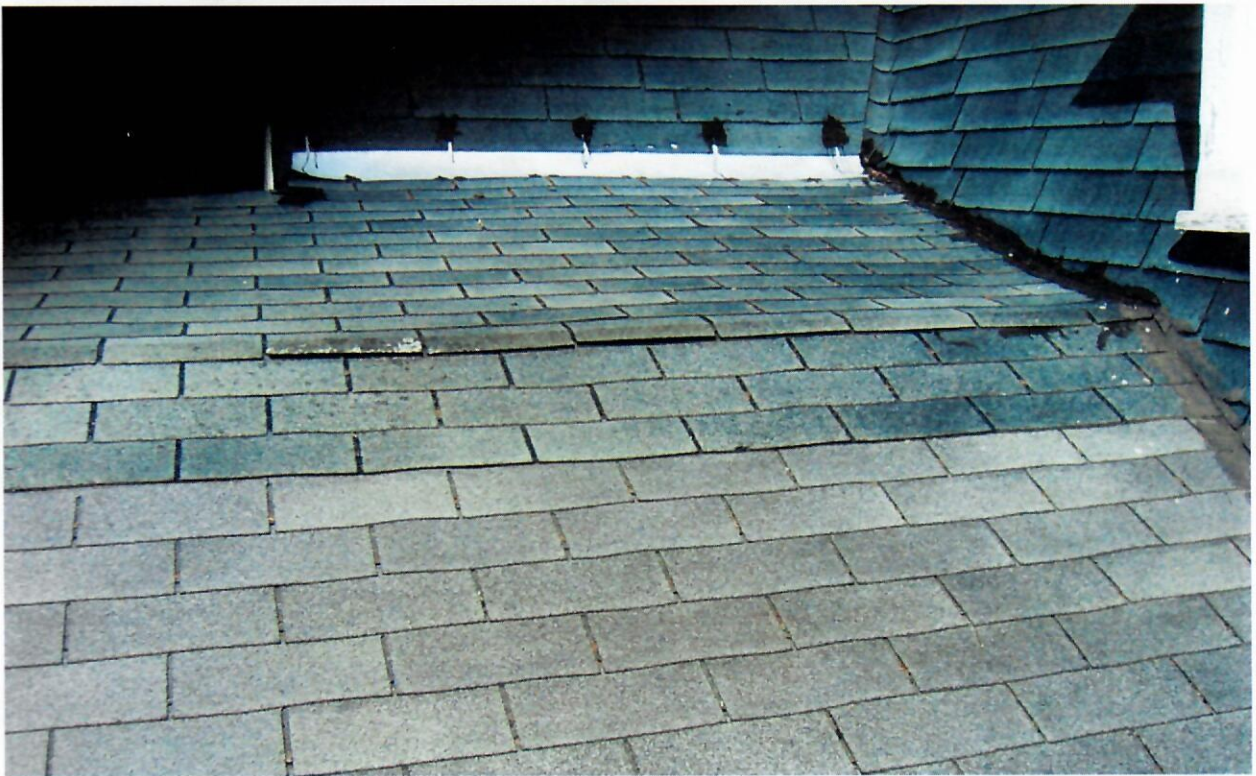
AGED SHINGLES & PAST ATTEMPTS TO STOP LEAKS

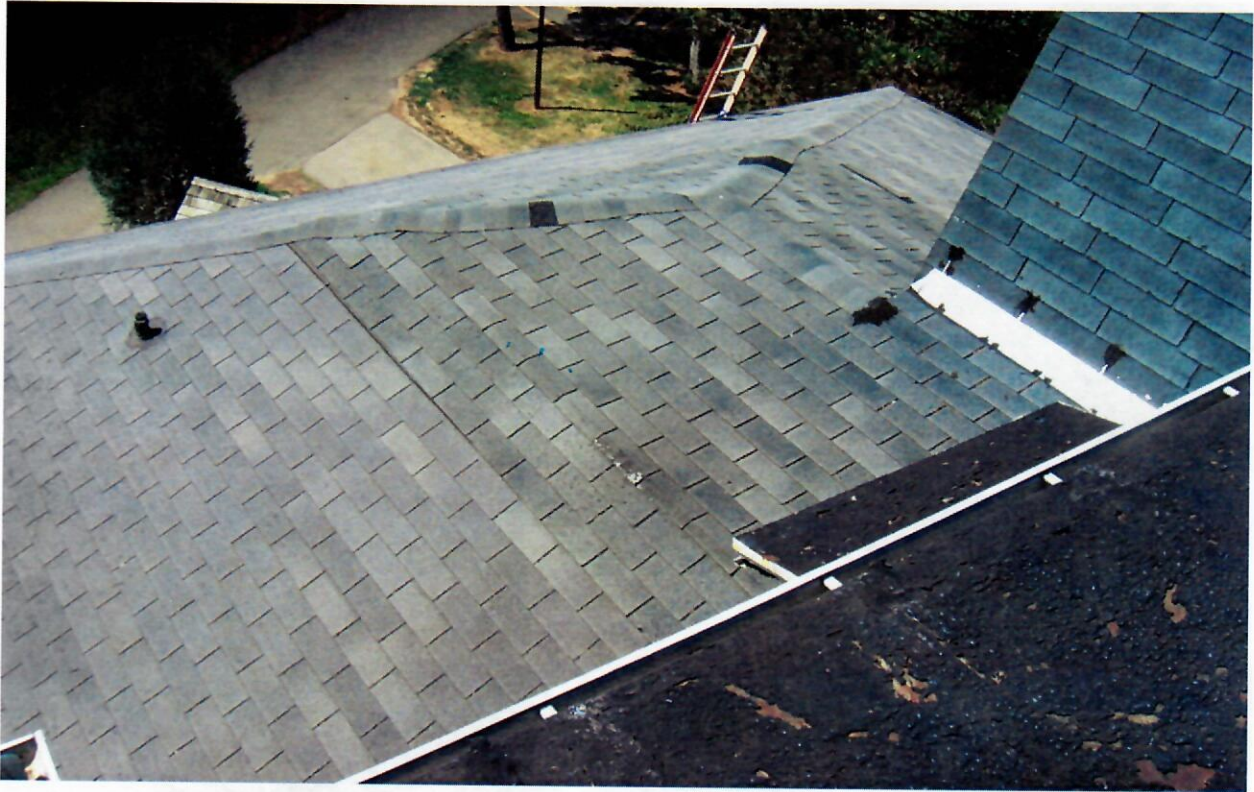
MISSING SHINGLES & CONFIGURATION OF ROOFS LEADS TO PREMATURE AGING

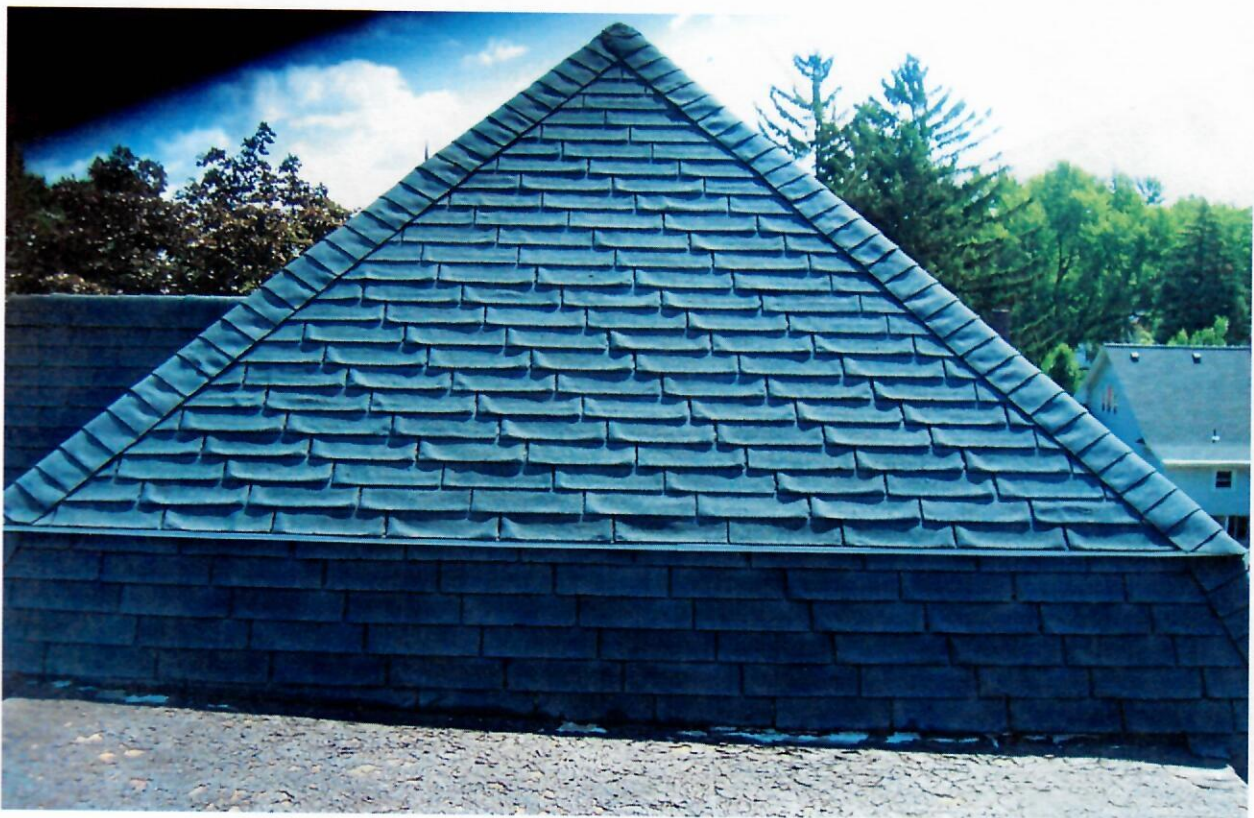
AGED SHINGLES

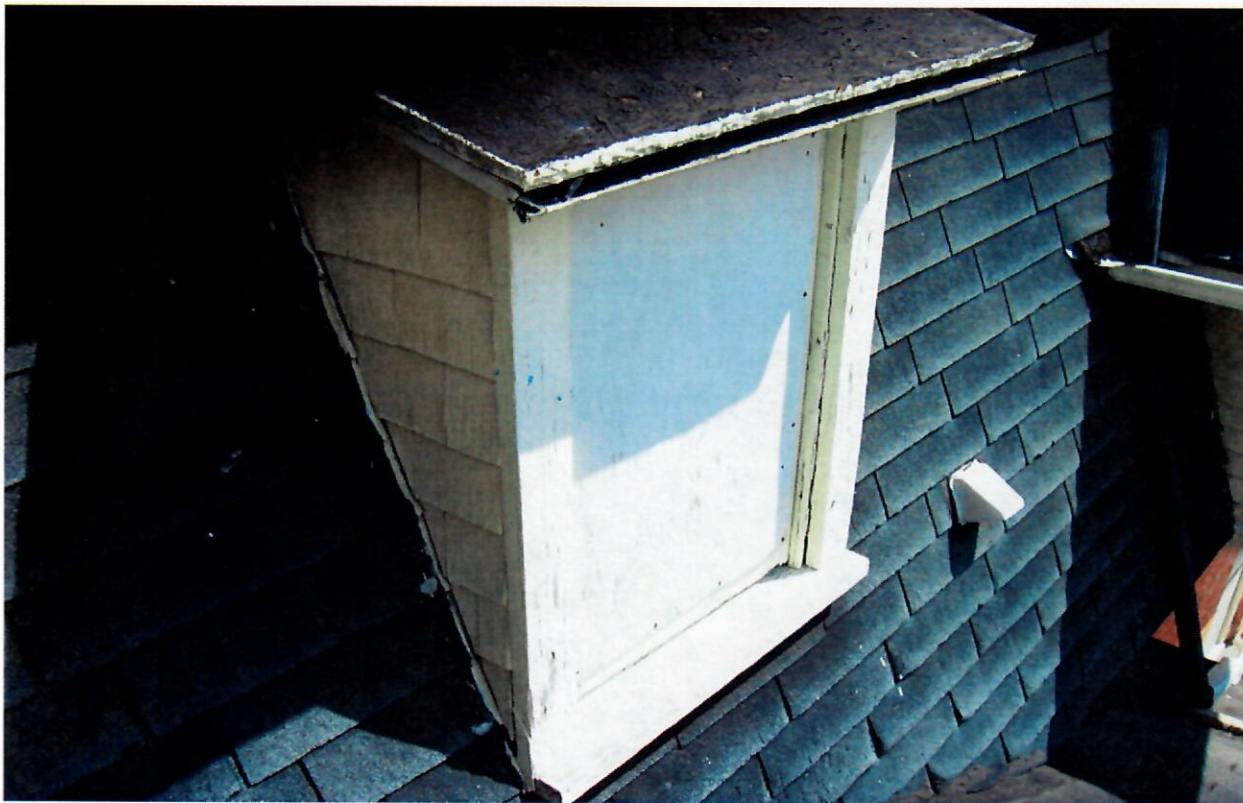
DORMER SHOULD BE RENOVATED OR REMOVED

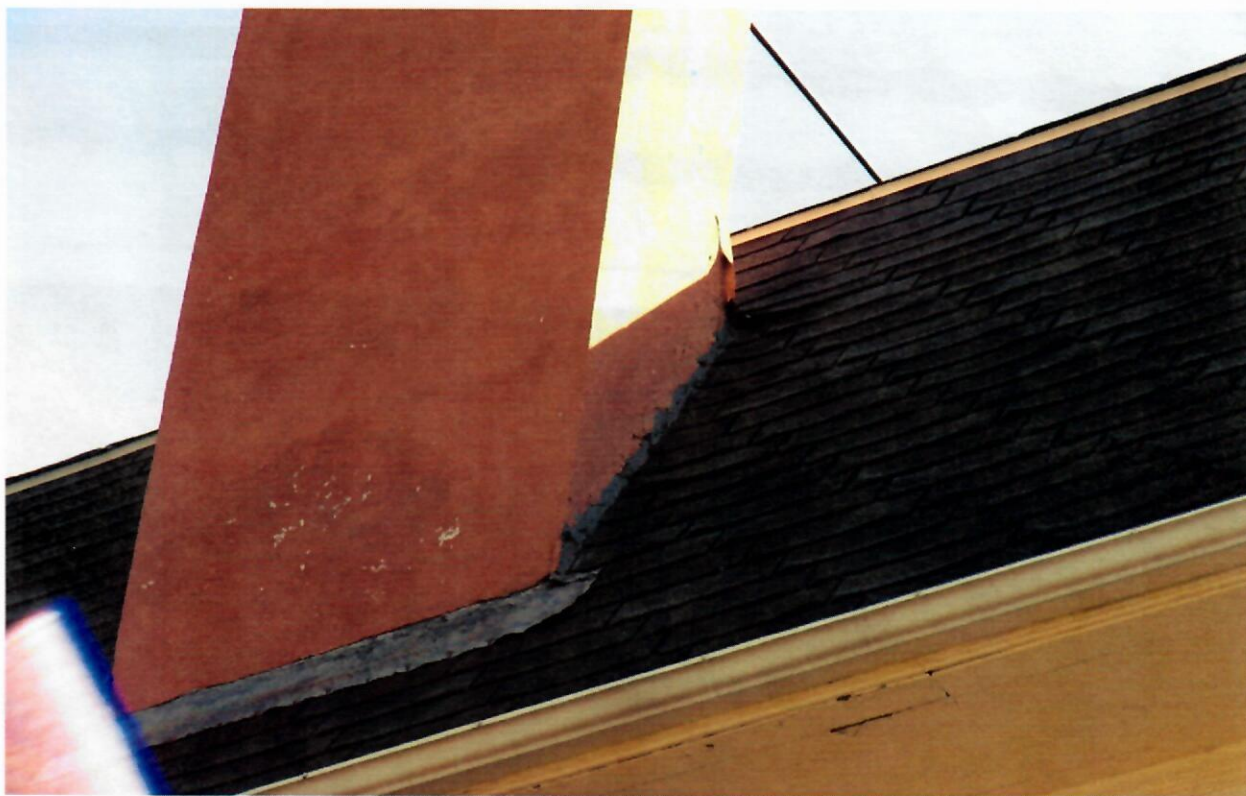
CHIMNEY NEEDS SADDLE & NEW FLASHING

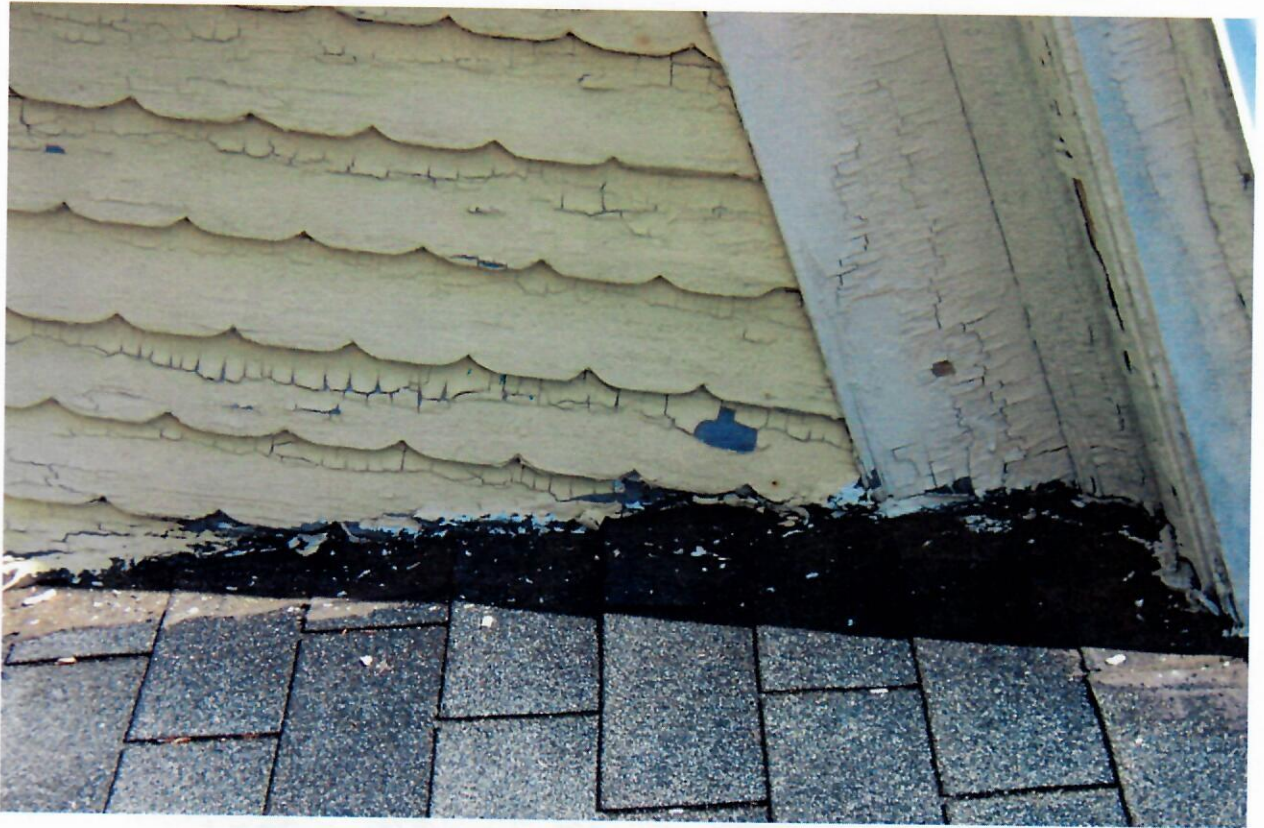
WOOD SIDING SHOULD BE CUT BACK & METAL STEP FLASHING PROVIDED WITH COUNTER FLASHING

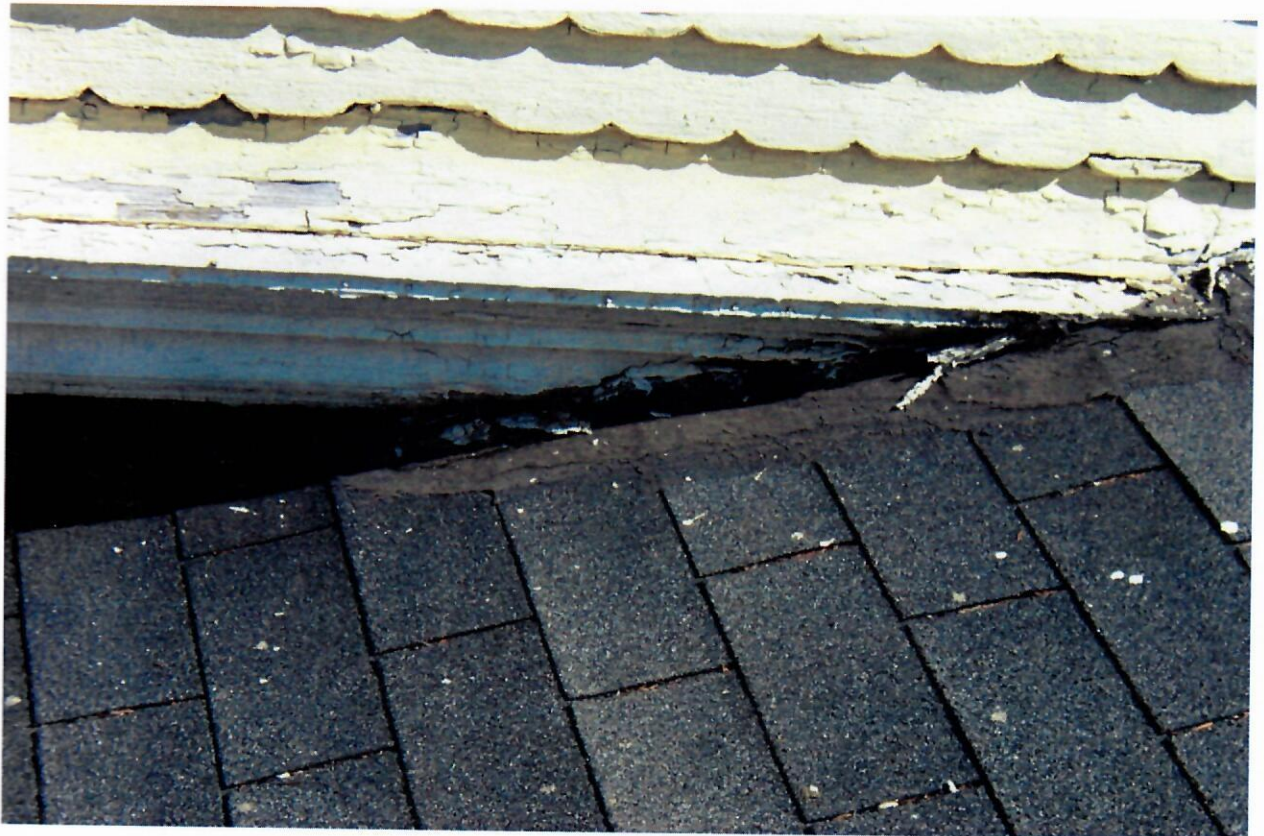
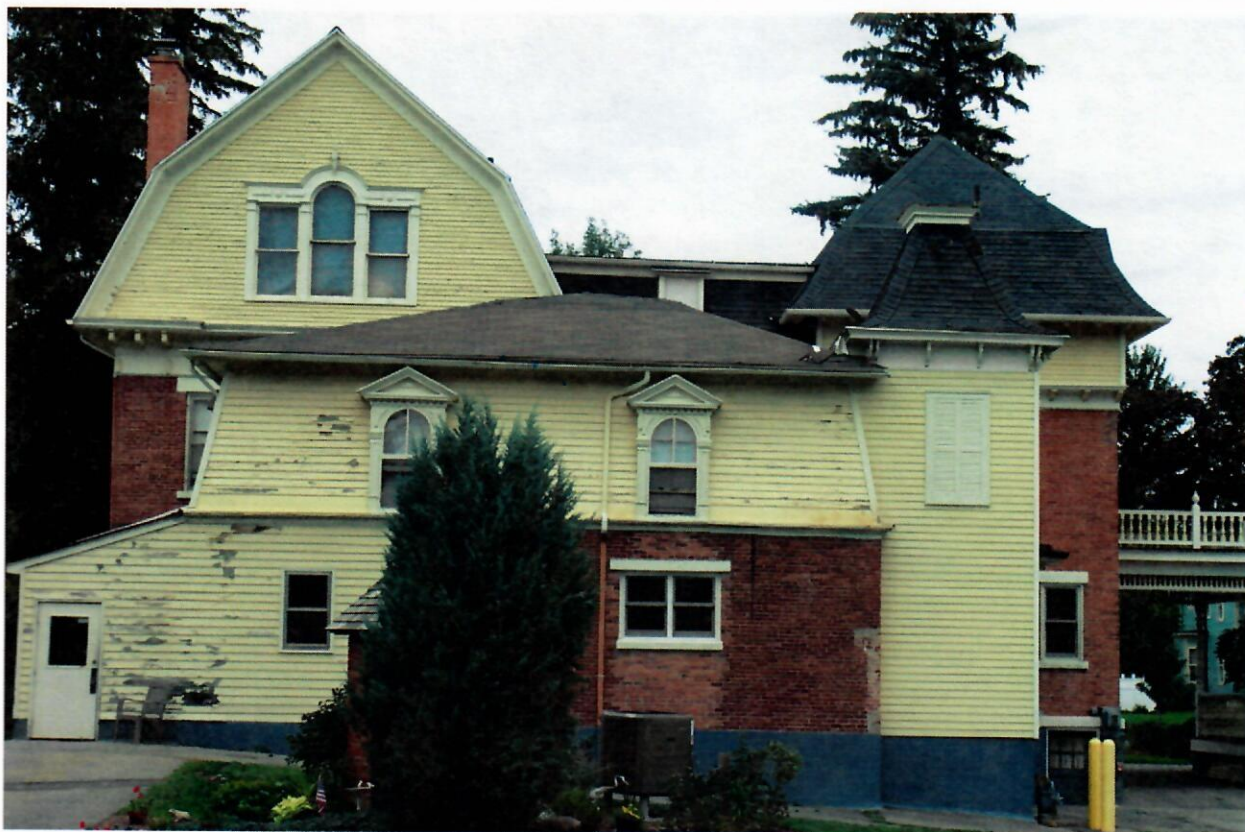
WOOD SIDING & TRIM NEEDS PAINTING EXCEPT AT TOWER - SOUTH SIDE IN WORST CONDITION

- Exterior wood siding and trim needs painting except at southeast tower which has new siding.
- Masonry window sills need scraping and painting.

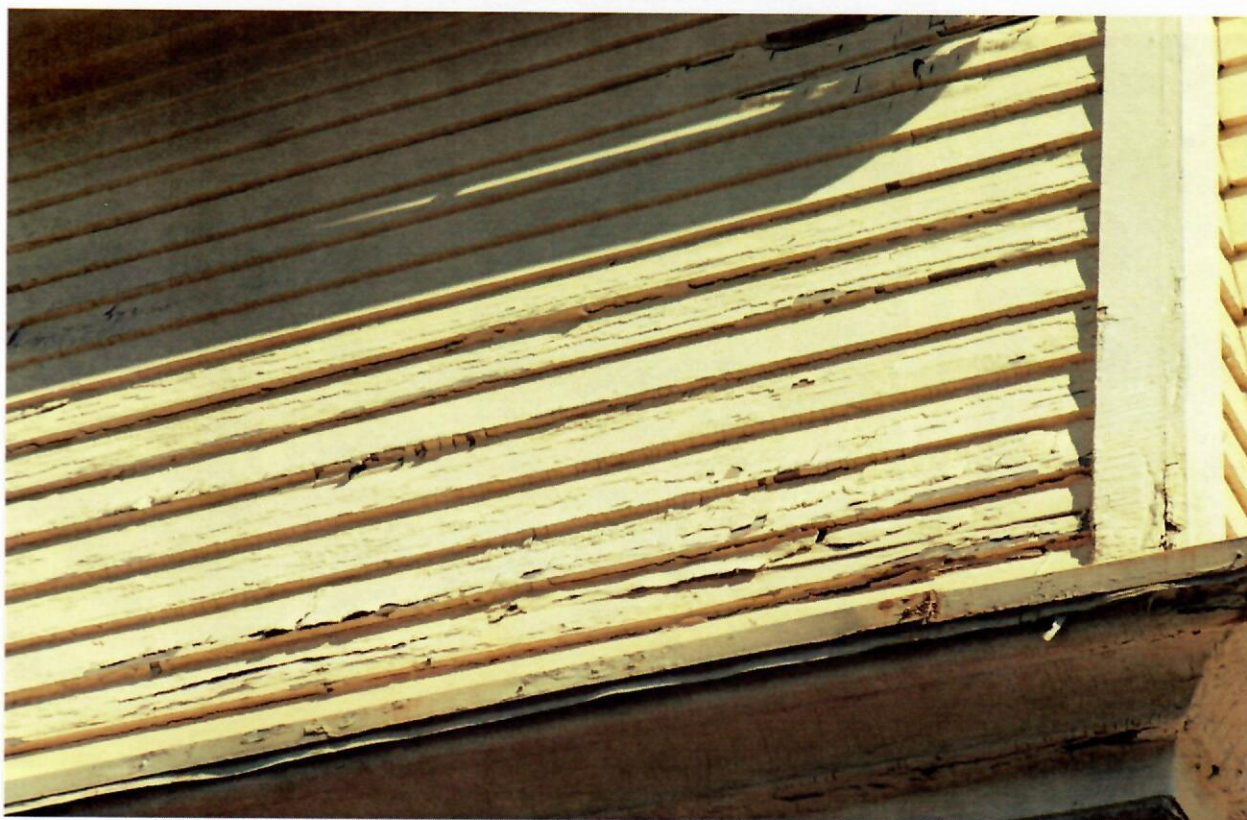
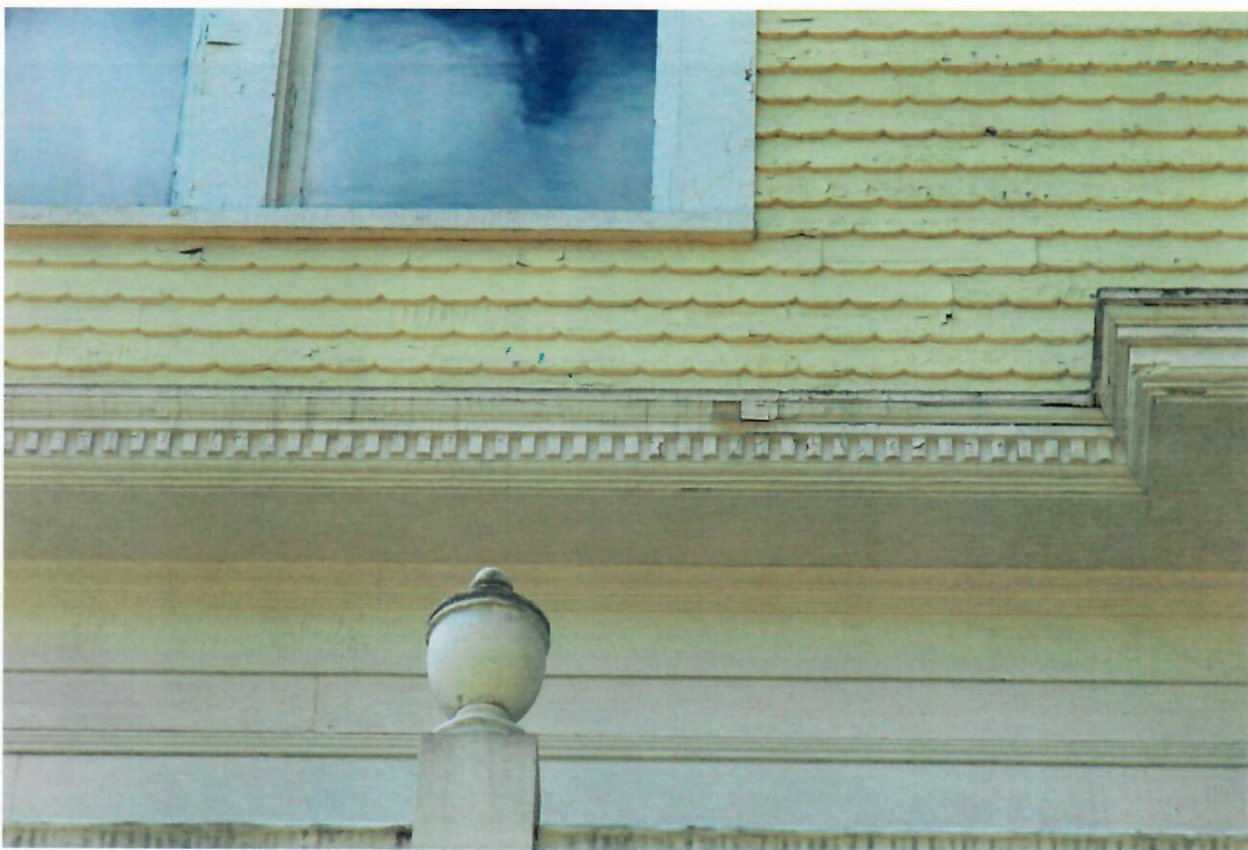
ALL WOOD TYPES NEED PAINTING

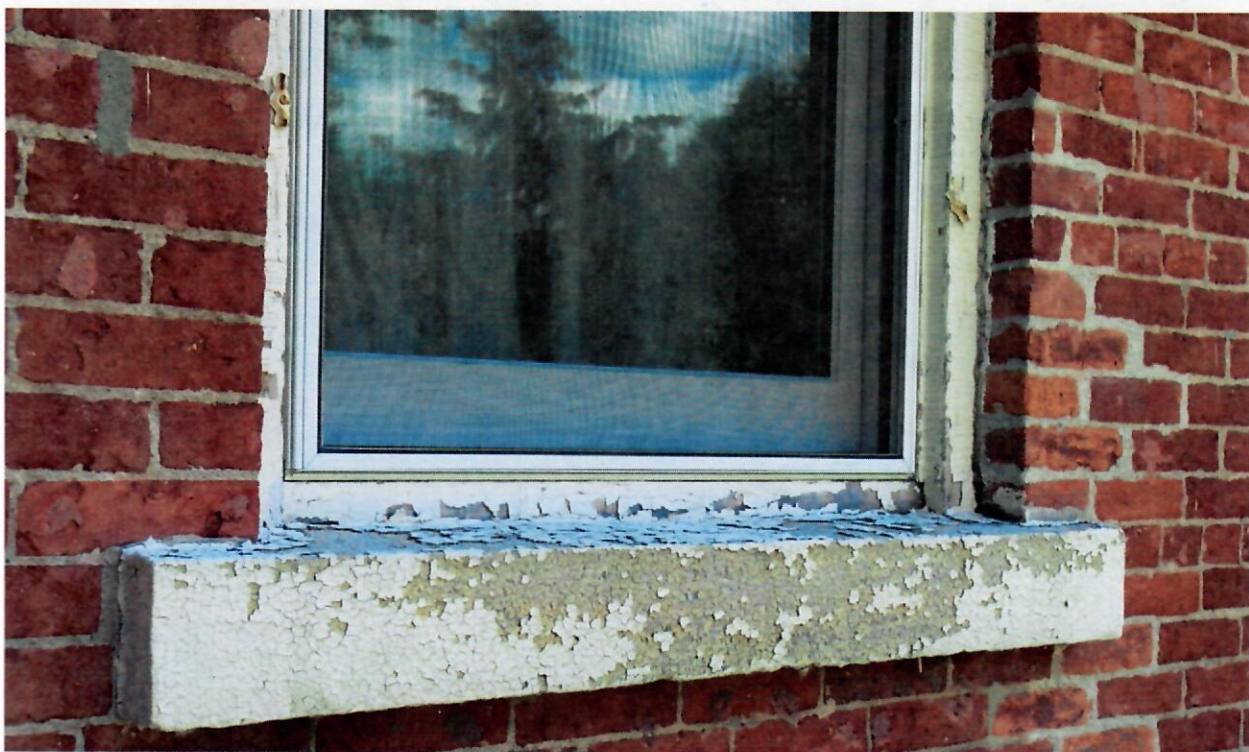
MASONRY SILLS NEED ELASTOMERIC PAINTING

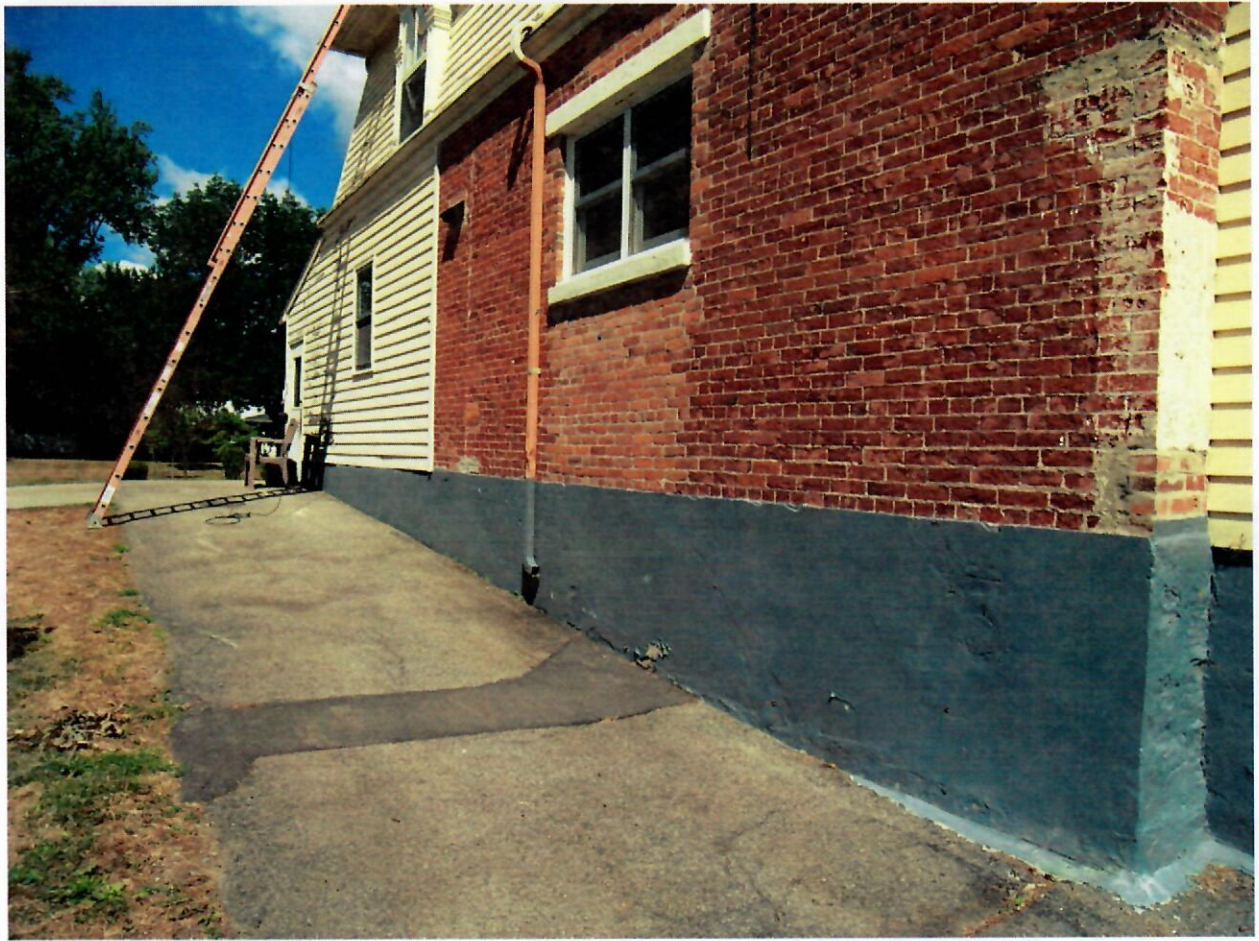
LOWER BLOCK & MASONRY SHOULD BE PAINTED & PATCHED

- Portion of masonry chimney on west side above the roof needs the parging removed, replace damaged brick as needed, repoint and check status of cap. Work should be done concurrent or prior to roof work.
- Lower portion of building below the water table should be parged as needed and painted.

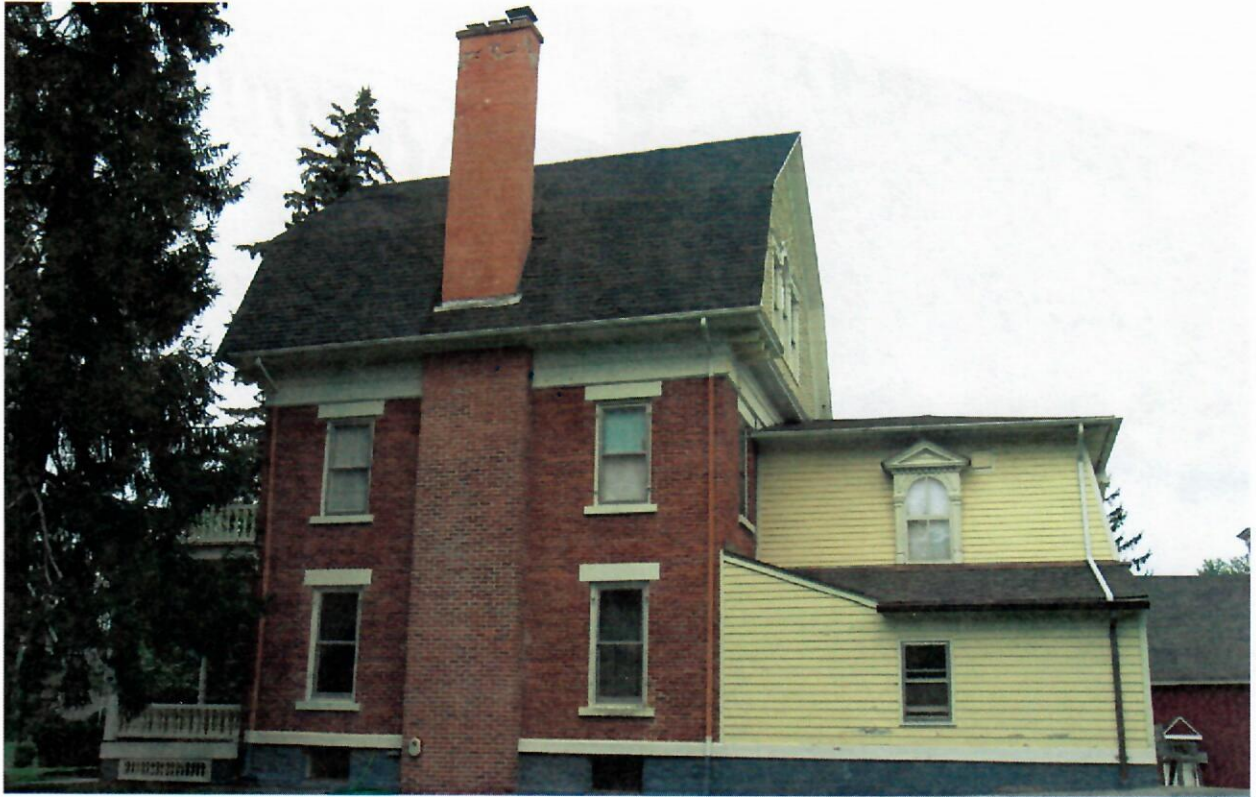
UPPER PORTION NEEDS PAINT REMOVED & REPAIR/REPOINTING

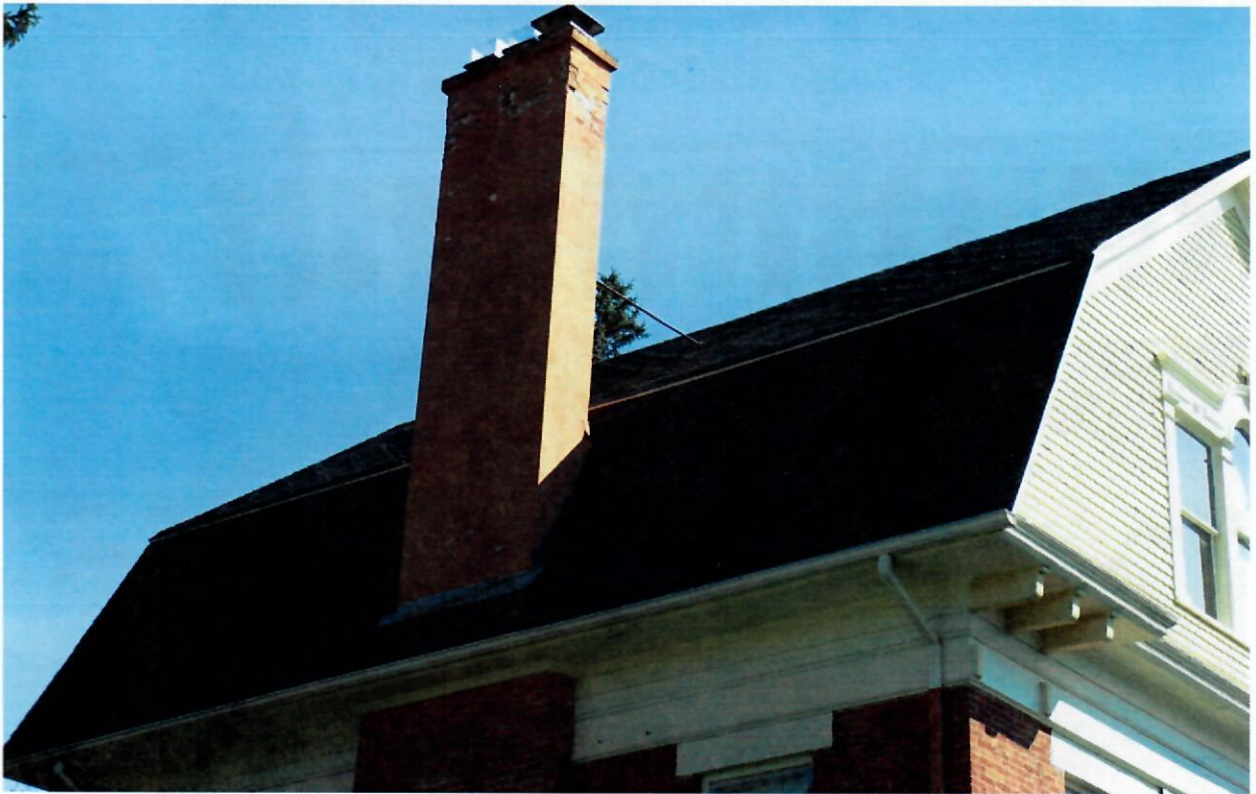
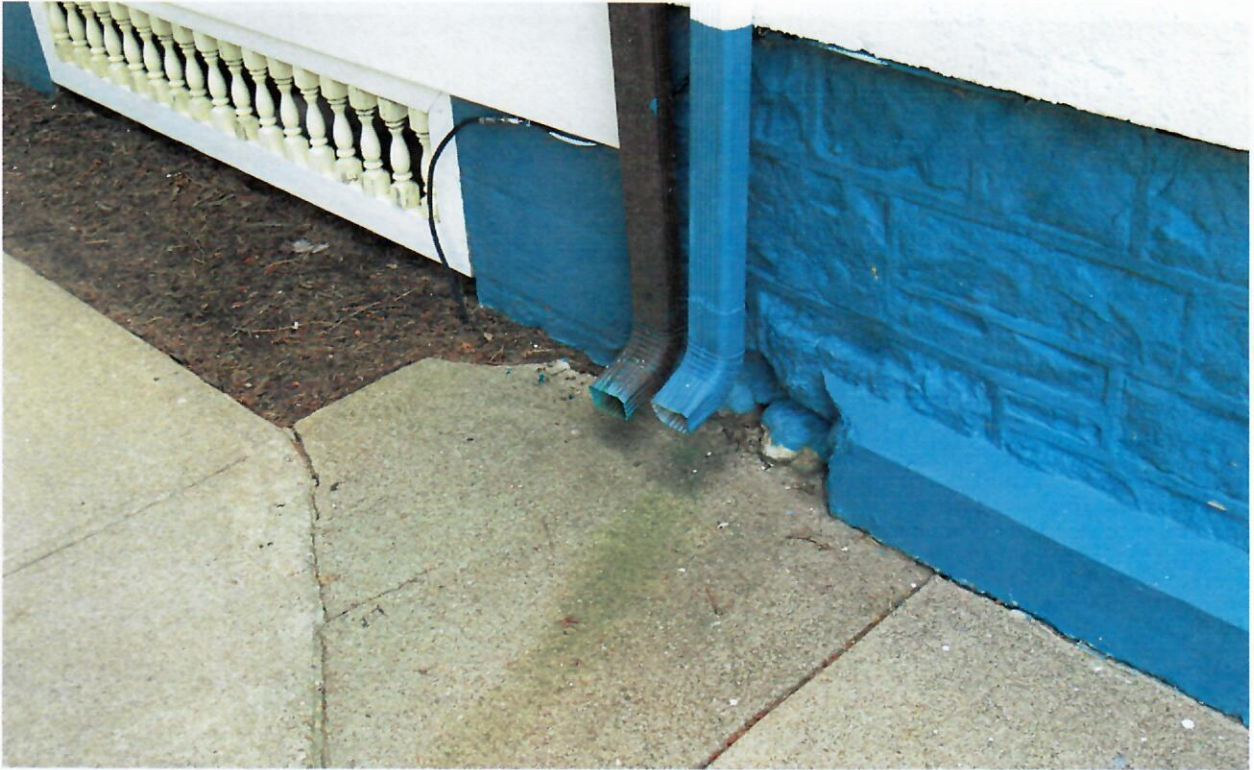
DOWNSPOUTS DRAINING AT GRADE DETERIORATING MASONRY AND WALK / DRAIN FROM BASEMENT

- Majority of downspouts from gutters are not tied into storm drains and drain on sidewalks or asphalt. Existing and any new downspouts should be tied into storm drains.

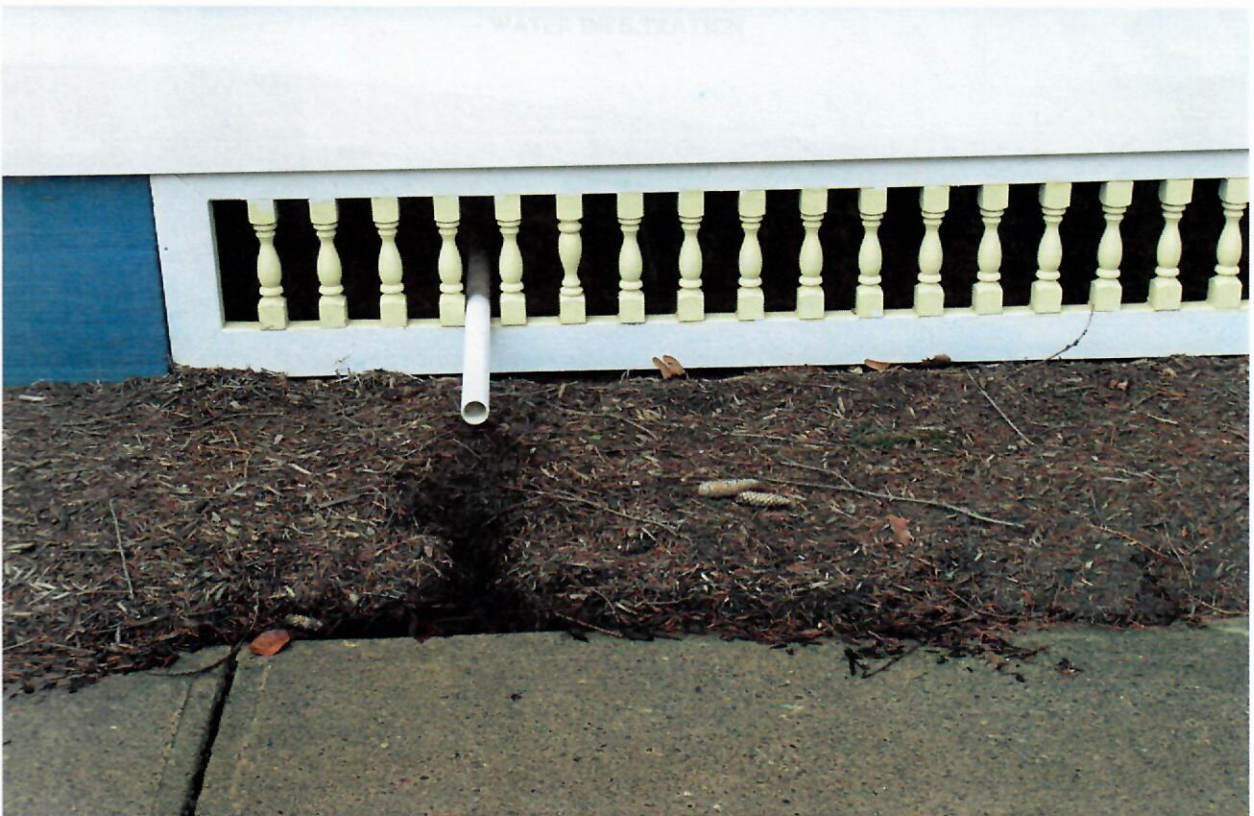
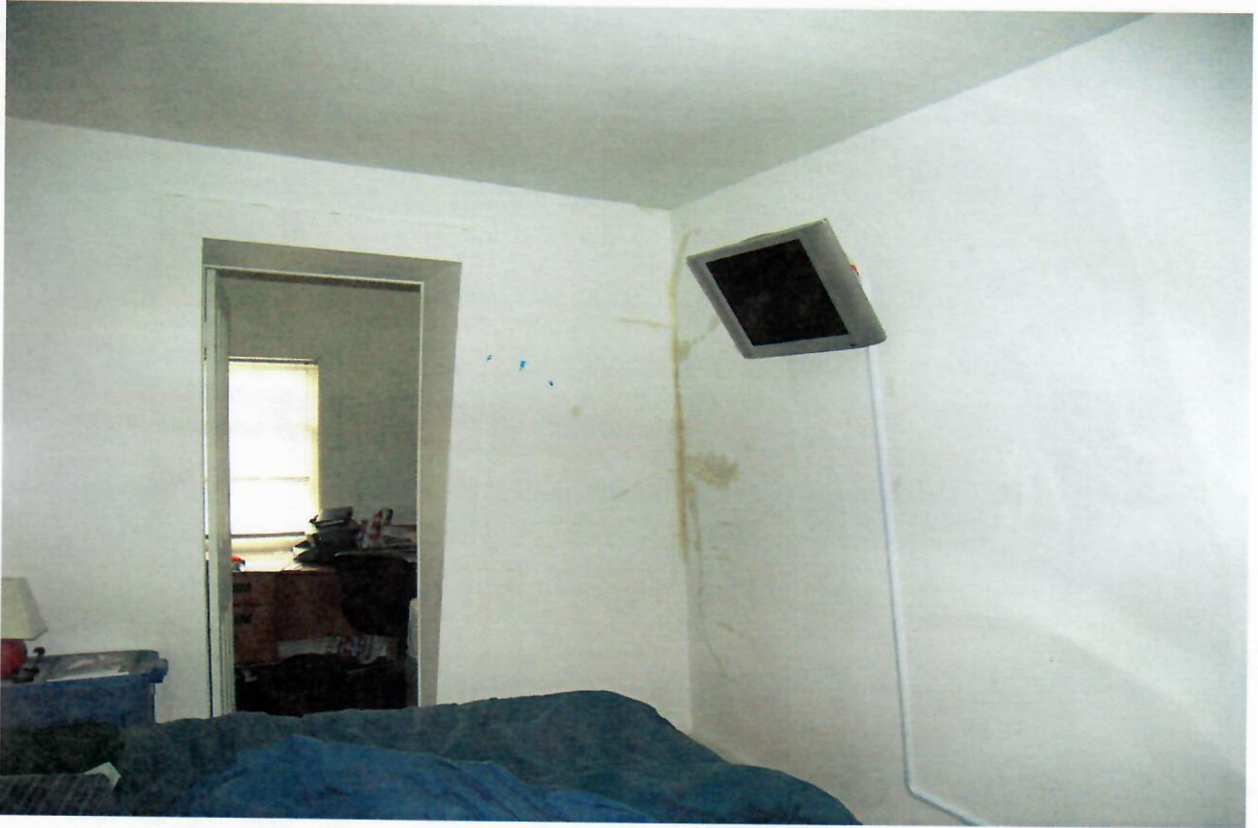
WATER INFILTRATION
