POTTER COMMUNITY CENTER MASTER PLAN REPORT

PREPARED FOR
VILLAGE OF FAIRPORT

Dec. 8, 2011

LOMONACO ASSOCIATES

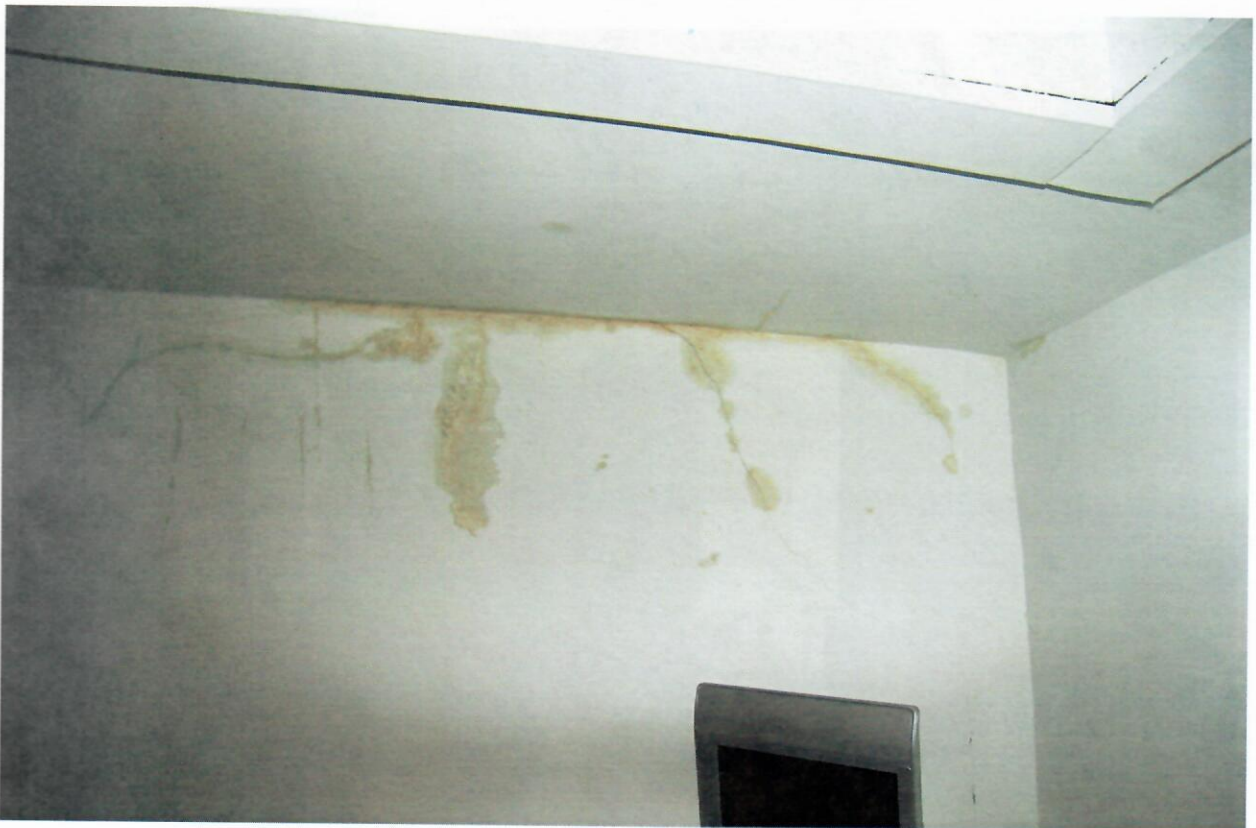
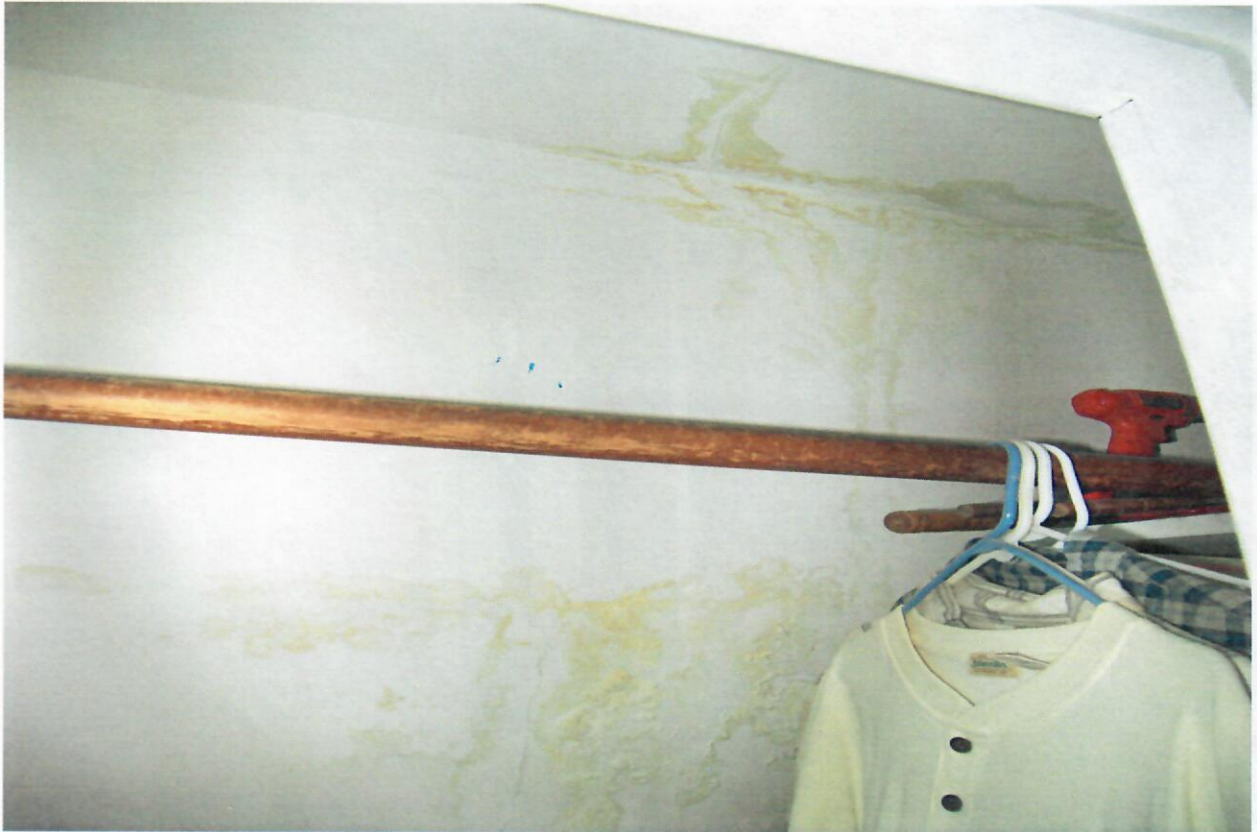
PRIOR WALL DAMAGE AT ENTRYWAY BELOW

- Rest rooms should be updated with tile wainscot, new flooring and more handicap amenities.
- Address damaged drywall at beam and paint due to water infiltration.
- Reduce ceiling tile area and replace tiles that remain.
- Address wood floor which is aged and does not hold up to this kind of traffic and wear.
- Provide new finishes at damaged entryway due to water infiltration.
- Provide upgrade at kitchen floor.

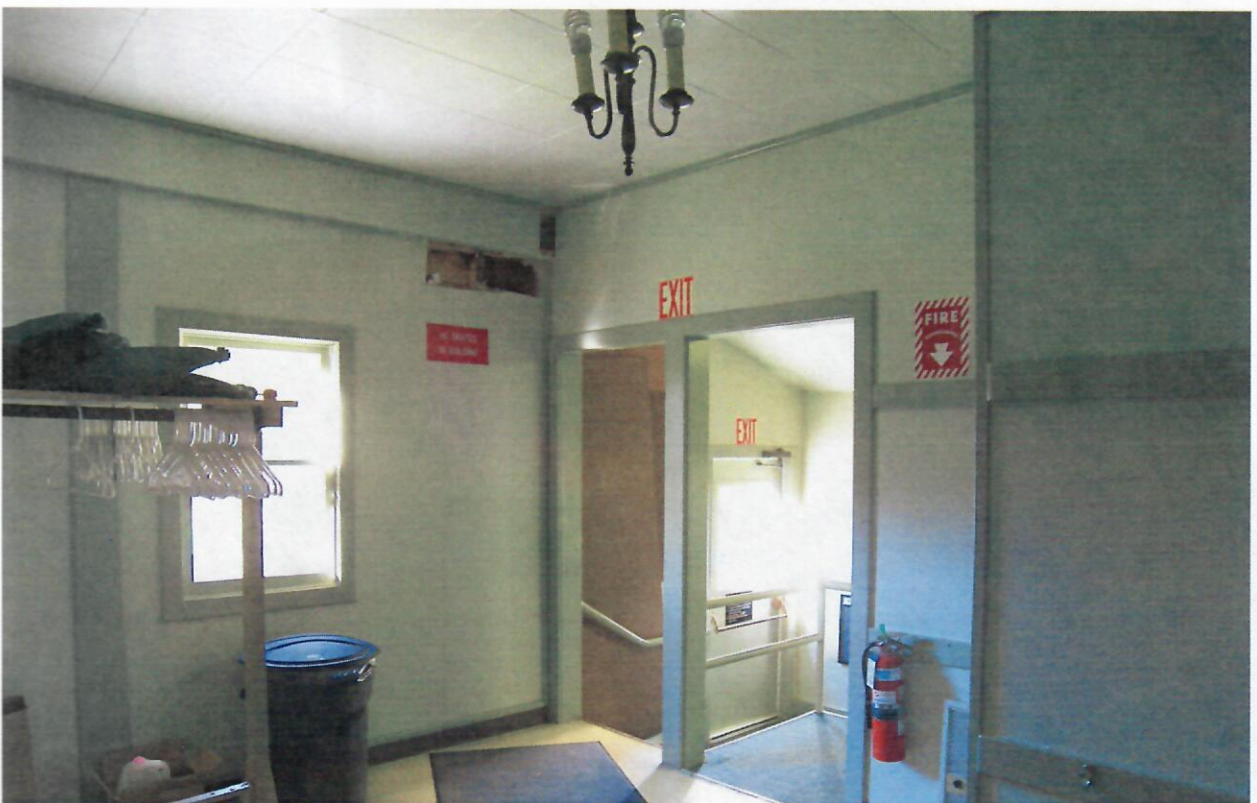
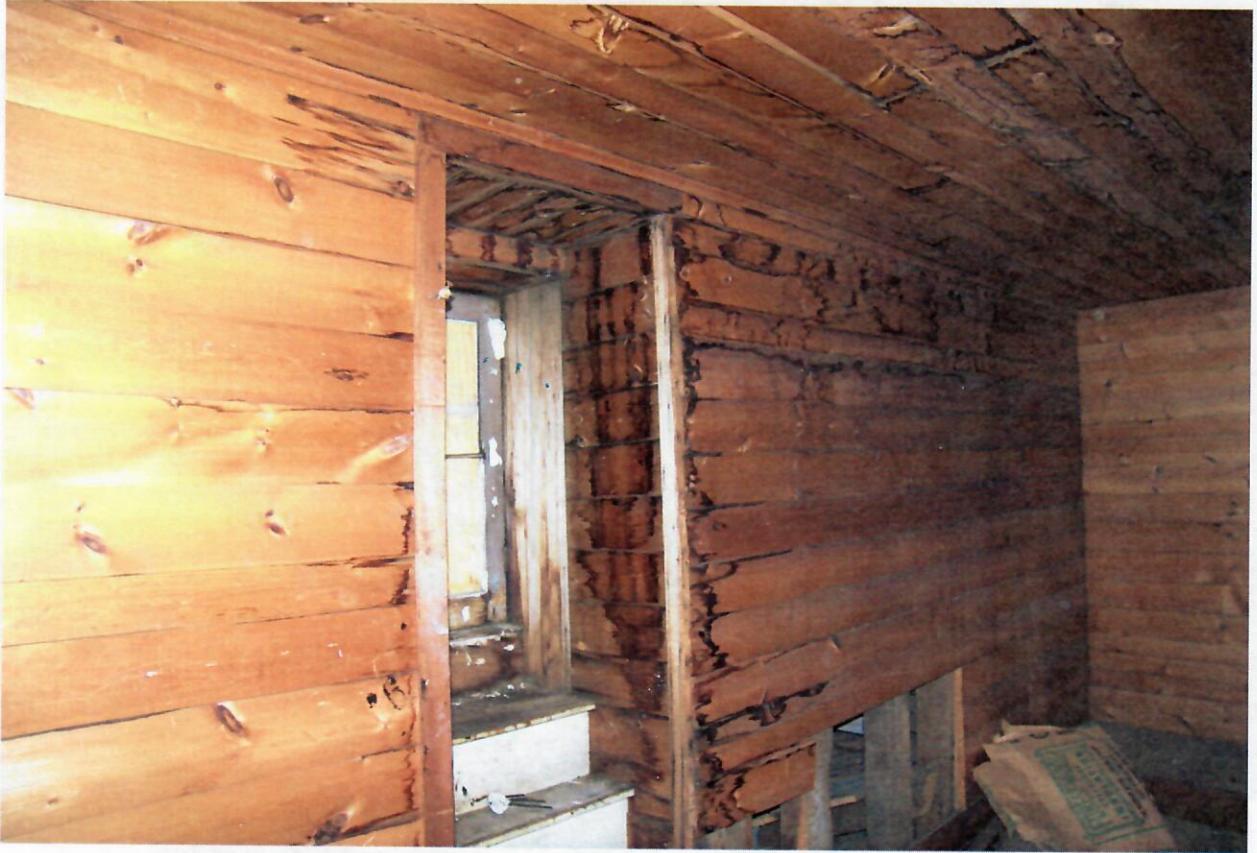
ATTIC WATER DAMAGE ABOVE / OUTDATED REST ROOMS BELOW
