BRANFORD MANOR MOISTURE CONDITIONS INVESTIGATION

TO	Lauryn Tacoronte Related Affordable 60 Columbus Circle New York, NY 10023 (347) 880-5643 Mobile ltacoronte@related.com	William Zoeller, RA 22 July 2022 RELA101A_Branford Manor 13 July 2022 9:30 AM – 12:00PM	REPORT BY REPORT DATE SWA PROJECT DATE OF VISIT TIME
----	---	---	--

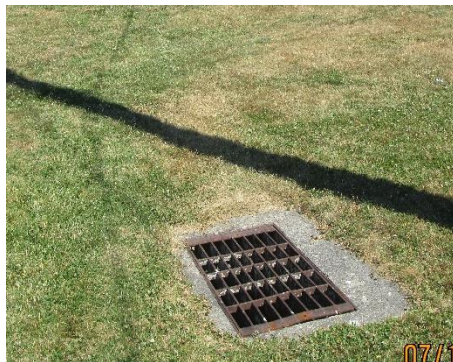
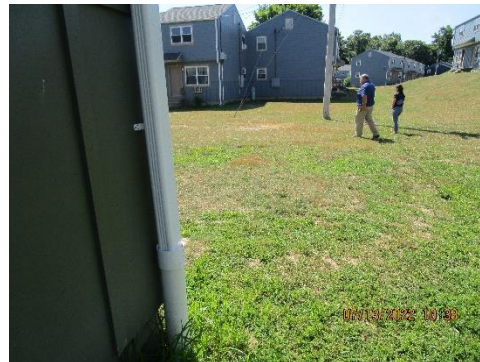
12. Most of the reported high levels of moisture and relative humidity are specific to the basements and crawlspaces of the buildings. Although the site drainage for the most part appears adequate, there were some noted typical practices occurring throughout the property which will tend to exacerbate below grade moisture conditions.
13. As is shown in image 1 above, rainwater collected from the roofs of the building via the gutter system collect and deposit the rainwater directly adjacent to the foundation. This has the effect of concentrating storm water directly at foundation potentially overwhelming whatever foundation damp-proofing may exist.
14. The site does have a storm drainage system in place, but only a few rain leaders are directly tied into it.

Images 3, 4: Typical storm area drain; rain leader terminating below grade.

50. Improve positive surface drainage away from downslope buildings where presently deficient. Swales should direct surface runoff around buildings or to area drains.
51. Roof water storm water management is highly deficient and must be improved. Ideally the vertical rain leaders should terminate in below grade drains feeding into the present area drains. If this is not practical, alternate means to produce a similar result should be employed. Discharging the rainwater at the foundation is highly problematic for moisture loading.

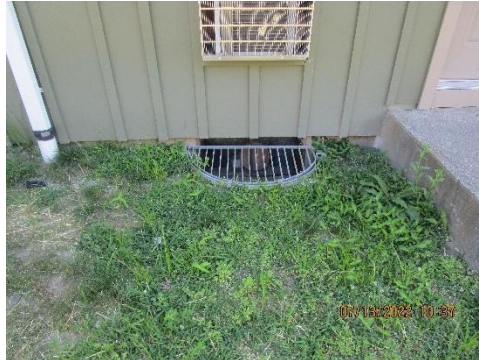
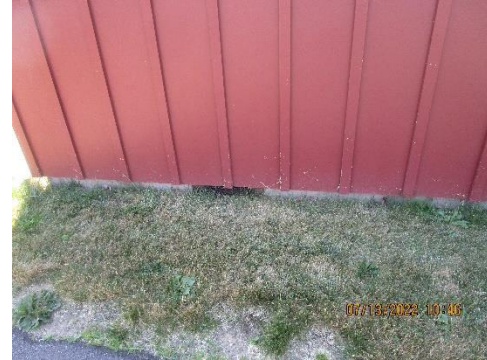
15. The general topography is rolling / lightly sloped with the major drainage direction to the northeast. Appropriate surface swales for drainage management exist, but there are a few instances where basement window wells and crawlspace vents are close to grade and are potentially breached during substantial rainfall events.

Images 5, 6: Basement window well and crawlspace vent level with existing grade and subject to water infiltration.

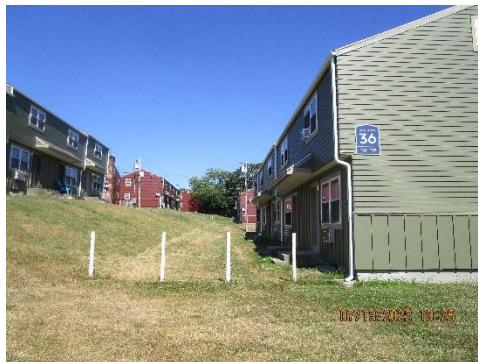
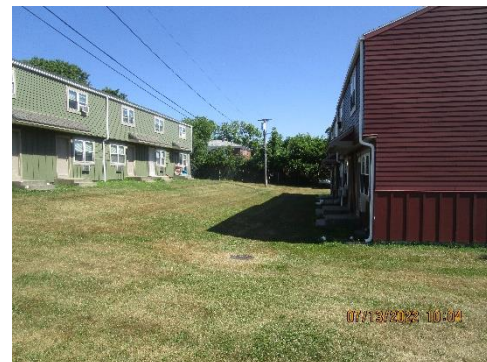
Images 7, 8: Grades slope to the northeast generally. Drainage swales exist between buildings but are marginal in some cases. Positive drainage away from foundations should ideally extend for 10' minimum away from each building.

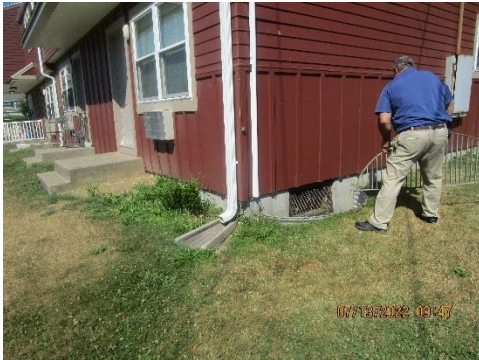
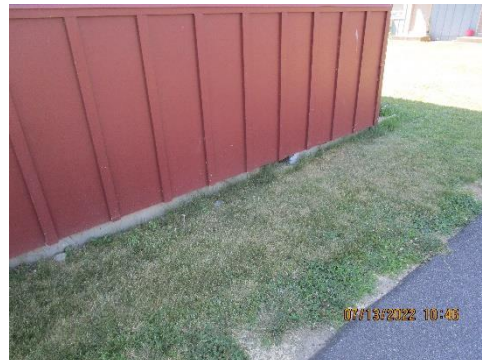
Images 9, 10: Typical crawlspace access; typical crawlspace vent

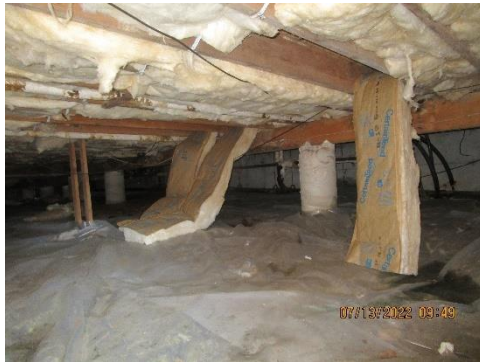
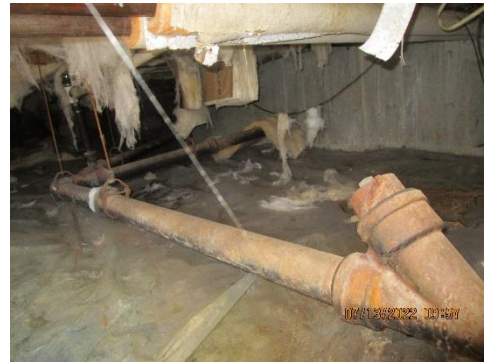
18. Multiple crawlspaces were accessed and viewed. Observed conditions were consistent across buildings. Interior headroom is approximately 4' in height between floor and floor framing above.
19. Floors are unimproved soil with an unreinforced polyethylene vapor barrier covering. The vapor barrier is not secured in place and displaced and non-continuous at areas. Seams are not taped/sealed, etc.
20. Fiberglass insulation batts are in place above within the floor joist cavities. The 2017 renovation drawings call out as new unfaced R-30 batts. The insulation observed is kraft-faced R-19 batts and in overall poor condition. The material is not secured, falling out of position and only marginally effective.

Images 12, 13: Crawlspaces with dislodged insulation, and unsealed poly vapor barrier

56. The crawlspaces represent fewer simple options to attain the same level of effectiveness as the basements. The crawlspaces are vented, and to get high-level moisture control, they would need to be converted to non-vented. (more below).
57. Primary action at the basements is to improve the vapor barrier covering the soil floor. The exist 6 mil poly VR should be removed, and be replaced with a reinforced 12 mil or greater VR.

58. The insulation at the crawlspace ceiling should be replaced. There are multiple options with varying attributes. The least costly highly effective solution would be to install new unfaced fiberglass batts in the joist cavities supported in strung wire (not wire clips) such that the fiberglass remains flush with the bottom of the joists. A 1" layer of foil faced polyisocyanurate is installed to cover the fiberglass and joists with all seams taped with foil tape. All penetrations and edges at the perimeter are sealed with close cell foam. This would effectively separate the crawlspace from the living space above.

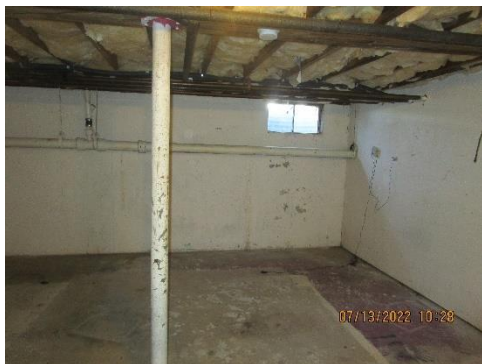
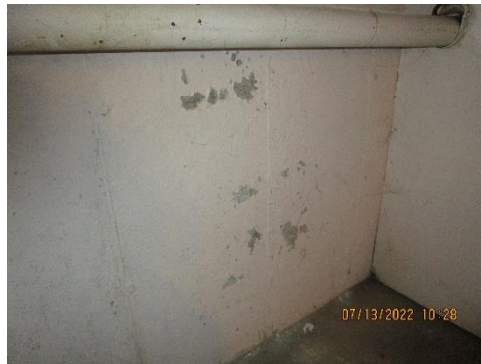
Images 14, 15: Typical basement space with framed partition to right of image; spalling coating indicating presence of moisture in concrete wall.

26. Like the crawlspaces, levels of elevated atmospheric moisture were evident within the basements. Evidence of moisture vapor migration through the concrete walls and slabs were observed. Image 15 above shows the interior surface coating spalling off exposing the concrete below. The most typical cause of this is high levels of soil moisture, permeating the concrete, and seeking to dry to the (relatively) dryer interior space. The coating is not highly permeable, so as the moisture exists the wall, it forces the coating off the surface causing the coating to spall.

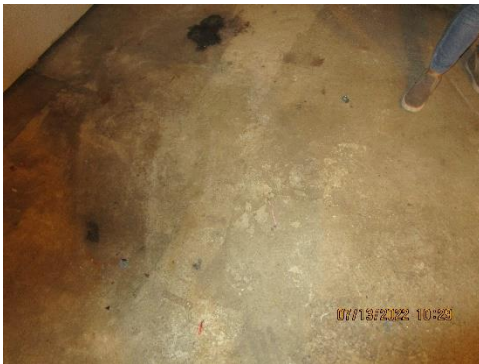
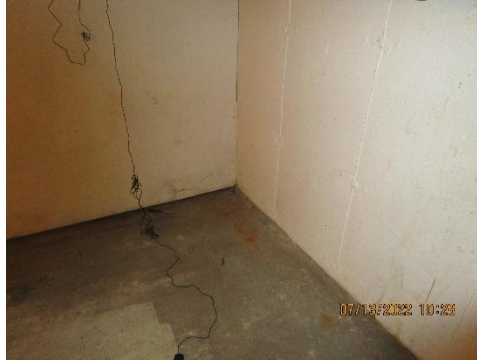
29. The concrete floor slabs similarly exhibit signs of vertical moisture migration through the concrete into the basement space. Standard practice at the time of original construction was to basement slabs onto a sand drainage layer without the use of a vapor retarder membrane. That is likely the case here but was not confirmed with a probe.

Images 16, 17: Surface spalling on concrete basement slab; staining and potential mold growth at base of concrete foundation wall.

30. Areas of rough slab surfaces (image 16) are indications of moisture drive through the slab. Relative high levels of moisture in sub-slab soils will cause the moisture to migrate upwards into the (relatively) drier basement. Surface spalling of the concrete is a result of this action.
31. Property management reports that except for rare occasions of basement window wells and crawlspaces vents being water-infiltrated by extreme surface run-of events, the basements are not subjected to chronic flooding, or active water penetration. The main problem is one of elevated interior humidity, and a lack of drying capability creating unconformable interior environmental conditions.
32. The townhomes have a very limited capability for moisture removal. Passive drying is through natural infiltration and through the vented attics

53. The concrete slabs likely do not possess a vapor retarder between the slab and the soil. A core probe could be conducted to confirm. If no VR is found, a fluid applied product can be used to coat the top surface of the slab. One product is <https://laticrete.com/en/resinous-and-decorative-finishes/vapor-reduction-coatings/vapor-ban-er>. This is not a product recommendation which would need to include a more exhaustive scope of work consideration, and compatibility testing. Similar coatings may also be appropriate for walls.

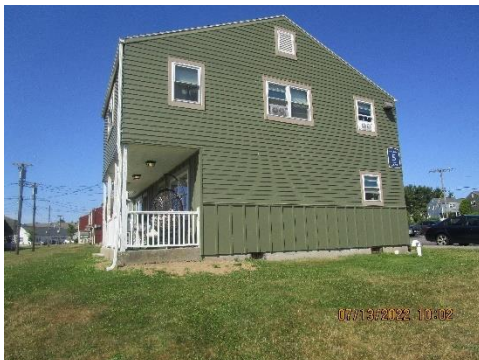
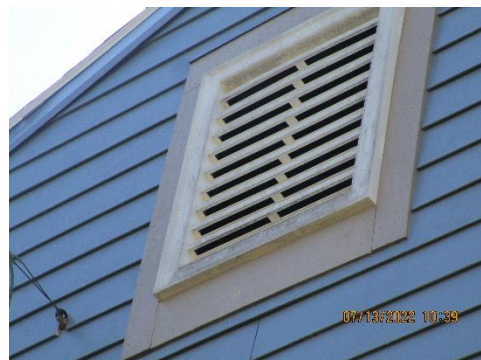
Images 18, 19: Attic ventilation is limited to gable vents at the gable end of each building "block", and shingle-over ridge vents.

33. Attic ventilation is very limited. A gable vent exists at the gable end of each townhouse block and a shingle-over ridge vent is in place. There is no soffit and therefore, no room to place soffit vents.

34. Attic access was not available at the time of the site visit, so representative attic spaces were not accessed. SWA was not able to determine if the gable vents are operable/open, or if the roof decking was cut back from the ridge beam as needed for the ridge vents to be functional. Even if these vents are functional, the clear vent area is marginal, and the passive ventilation will be limited. It should be noted that the purpose of attic venting is moisture removal, not heat removal, so inadequate attic ventilation will contribute to inadequate moisture removal.

60. As noted above, access to the attics was not provided at the time of the site visit. The apparent lack of attic ventilation likely has a minimal effect on the interior moisture level, but it still should be confirmed to be functional by direct observation.
