2022

Canyon Road Tree Evaluation

Mark Malmstrom
Arbor Care, LLC
5/20/2022

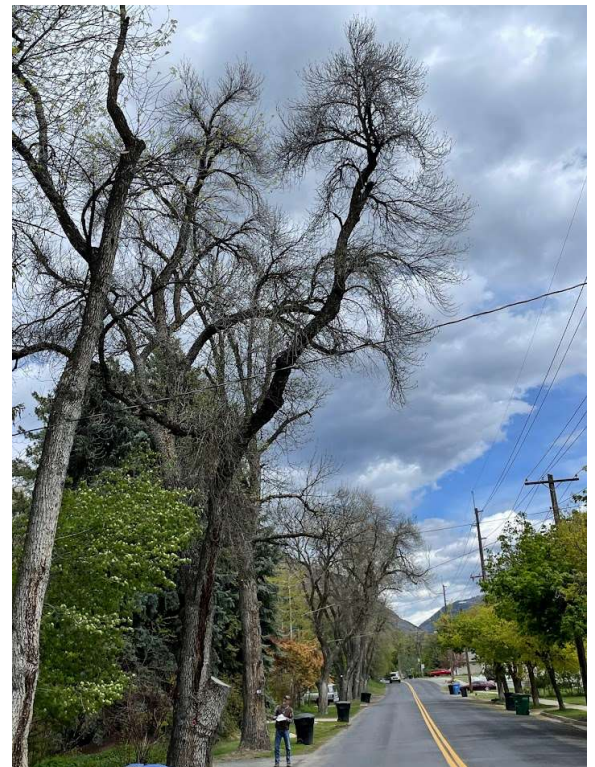
Figure 1 Canyon Road looking east

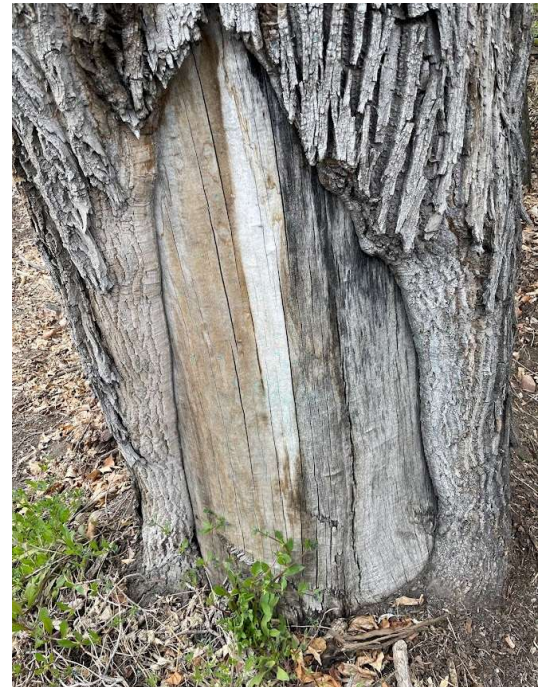
The location of the trees is on the north side of Canyon Road in Logan, Utah between approximately 623 East and 717 East. All of the trees are relatively close to the asphalt on the road and between .71 feet and 7.16 feet from the limits of construction. The trees border residential properties and driveways. There are no sidewalks or curb and gutter. Many of the trees have wounds on the trunks, some presumably by vehicle collisions.

Figure 2 Old wounds on lower trunk

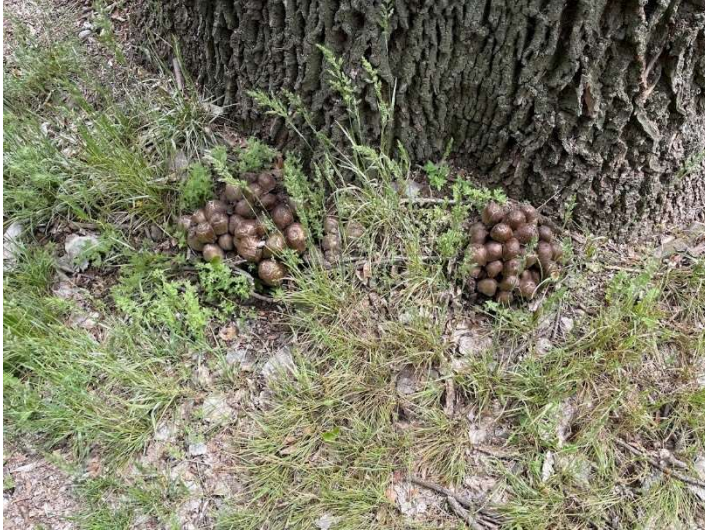
20	35"	.71	Major lead over road. Serious decline in tree. Tree condition is poor. A lot of deadwood and branch stubs. Major trunk wound and <i>Armillaria</i> at base of tree.

Figure 3 Armillaria at base of tree

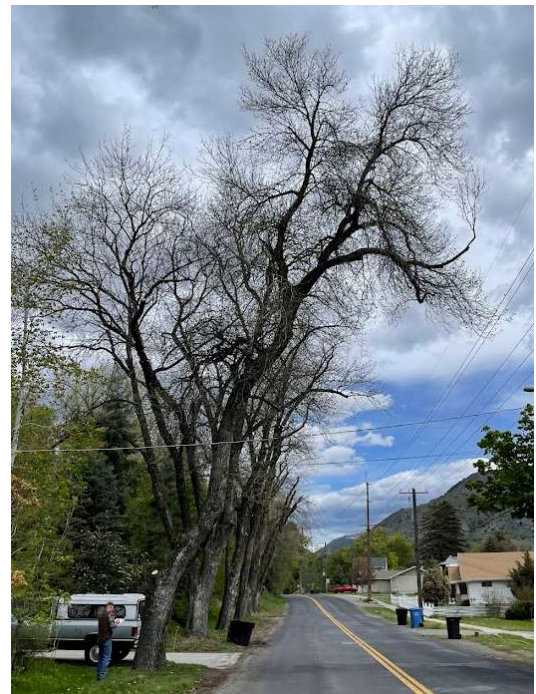
All of the ash trees have been lions tailed and over raised. Lions tailing is the inappropriate pruning practice of removing lateral branches along the lower and middle sections of major leaders or the trunk and concentrating growth at the tips of the branches. Lions tailing is problematic because it removes live branches that make food for the trees when leaves photosynthesize sunlight. This deprives the trees of energy needed for optimal health and vigor. It also creates wounds that the tree needs to

Figure 4 Lions tailing and over raising

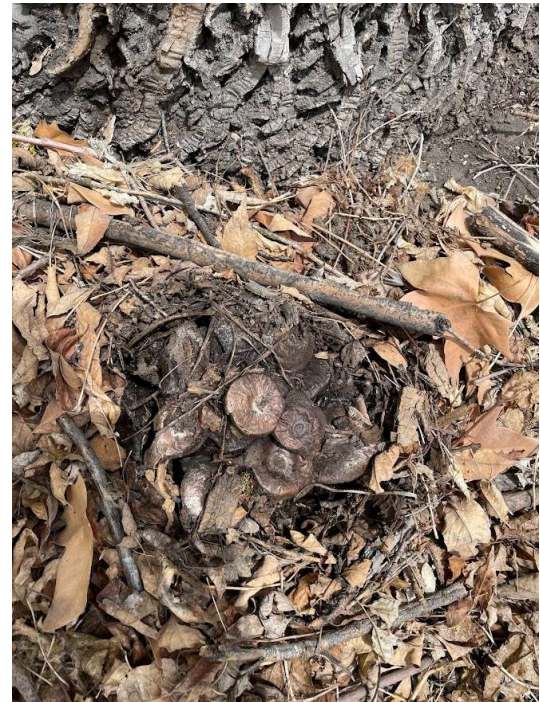
Some of the trees have *Armillaria* at their base. In addition to already being present on the site *Armillaria* can enter into large diameter roots that have been damaged by excavation. This decay fungi can continue to grow into the heartwood at the base of the tree. (Dunster 2017)

Figure 5 Armillaria at base of tree

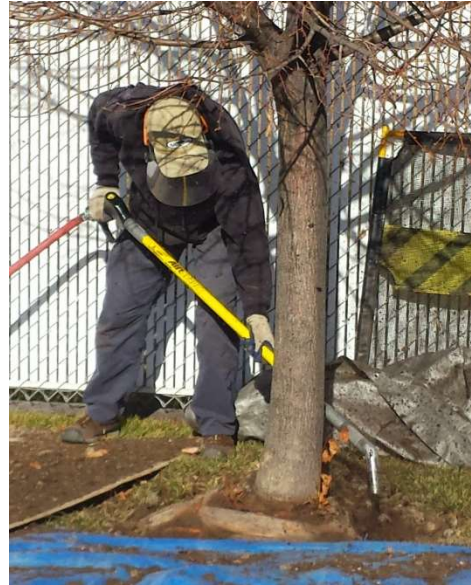
Figure 6 Root excavation with air tool

Since only three trees are listed for preservation supersonic air tools such as an Air-Spade (<https://www.airspade.com/collections/all/#/>) or Hydro Vac should be used to expose the roots for cutting. Once the roots have been exposed, they can be cut cleanly with a chainsaw or a diamond concrete blade. If a chainsaw is used it is important to clean soil from the roots as much as possible to avoid rapid dulling of the chainsaw chain.

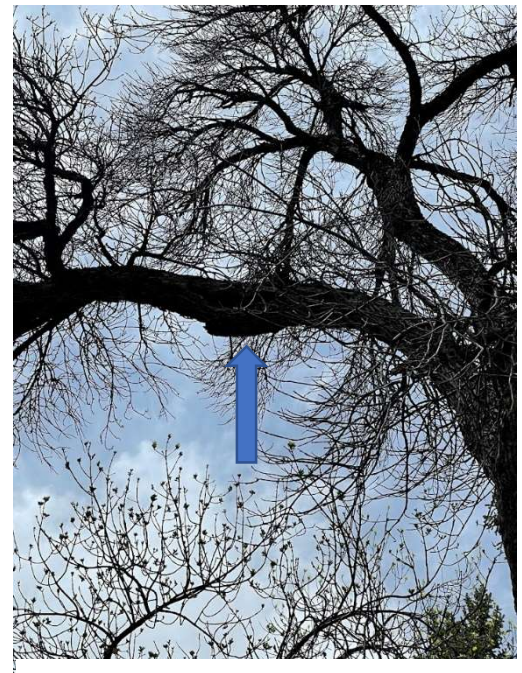
Figure 7 Transverse fracture tree # 10

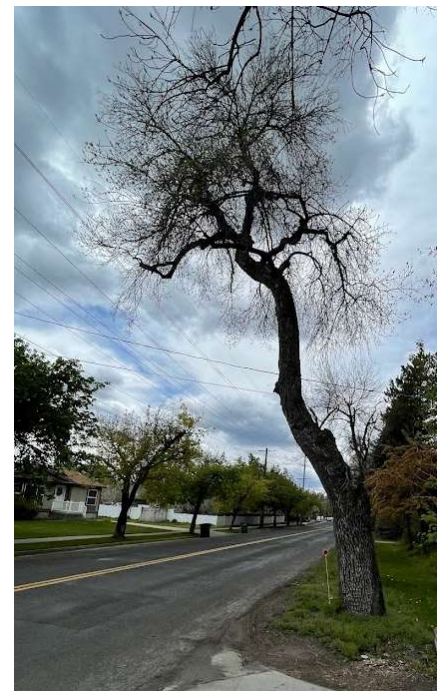
Figure 8 Tree #15 leaning over road

To minimize this impact, fencing should be placed at the limits of excavation so that the trench does not extend further than absolutely necessary and so that construction equipment does not compact soil or disturb the trees or root system beyond the fencing. Posts should be placed in the ground to support fencing so that it is not easily moved and it should remain in place until construction is complete. Fencing should extend for at least 20' and preferably more to reduce impacts to roots.
