# City of Manassas Engineering Department Inspection Report

Project Name: Didlake Site Plan 2021-0014

Inspection Type: Inspection  
and Stage: Erosion\_Sediment\_Controls

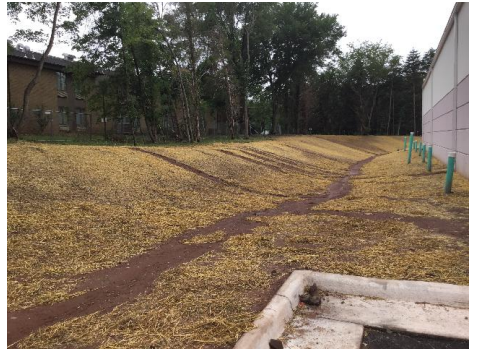
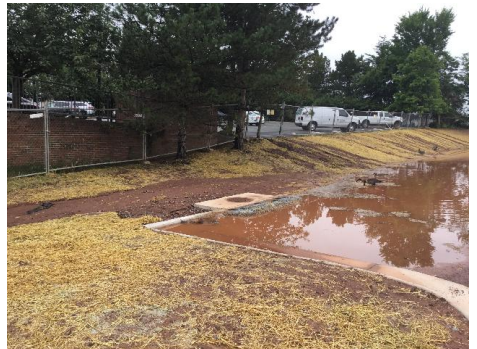
Deficiency #1 Temporary slope stabilization was not matted

ES Deficiency #1      3.36 Soil Stabilization Blankets and Matting   111-356

Additional Comments: Unexpected overnight heavy rain storm of 1&3/4" inches of rain in a small amount of time overwhelming the temporary stabilization measures. Slopes did not have matting and neighboring properties added to drainage to the site.

Corrective Action #1 Sod or installation of jute mesh on slopes of parking lot must be installed. Contractor is working on cleaning up and is actively making restoration repairs prior to my leaving the site.

Corrective Action Comments:      Contractor is actively making repairs and restoration while I was on site. Clean up is being performed.

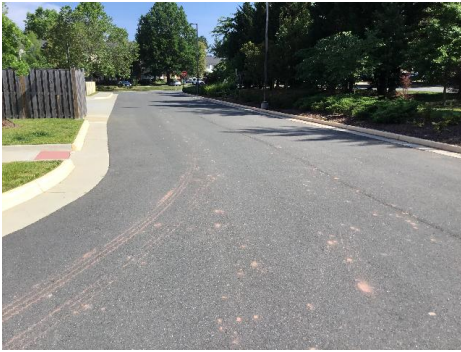
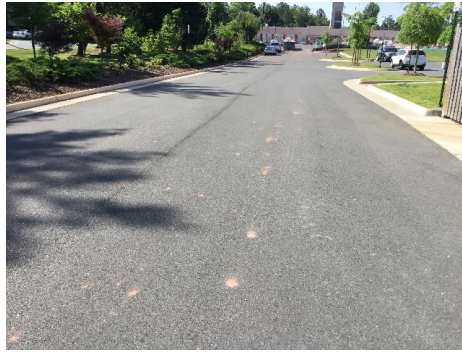
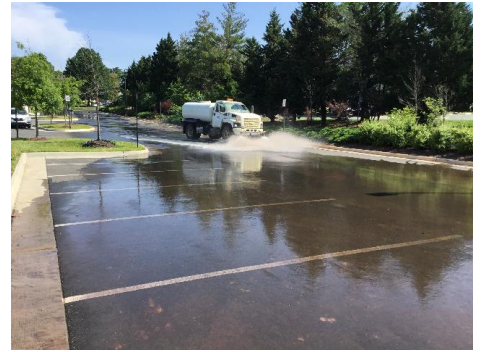
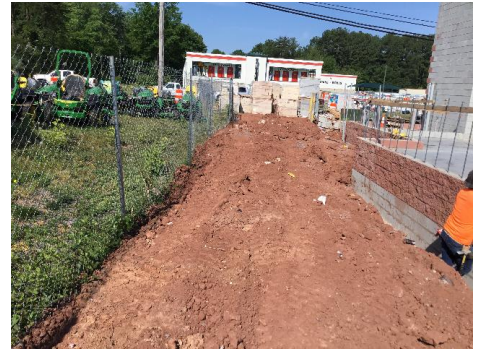
Deficiency #1 Mud tracking onto the road and Goddard School parking lot

The construction roads within the site around the building is not stabilized and dust control measures haven't been taken as previously instructed on 06/01/2023.

- ES Deficiency #1 3.02 Construction Entrance 111-6
- ES Deficiency #2 3.39 Dust Control 111-414

Additional Comments: I noticed concrete being washed out on the adjacent property (Virginia Tractors Company) in addition of sediment leaving the site towards that property. In instructed the contractor to install silt fence to have the sediment contained within the site. The contractor was previously instructed to have a specified concrete wash out on sit.

Corrective Action #1 Refreshing the construction entrance as needed and construct it according to the specs (STND & SPECS 3.02 Virginia ESC handbook) and drawings, remove all materials tracked from vehicles immediately on regular basis and not to use water trucks for achieving this.

Corrective Action #2 To follow STDS & SPEC 3.39 in Virginia ESC handbook to control dust being generated from the site as previously instructed on 06/01/2023.

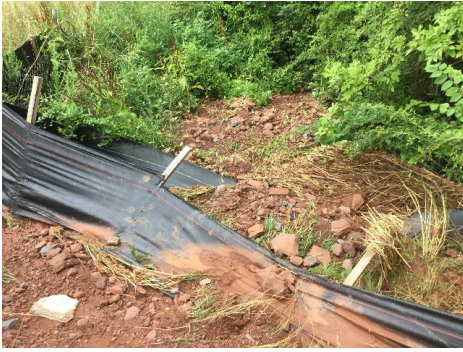
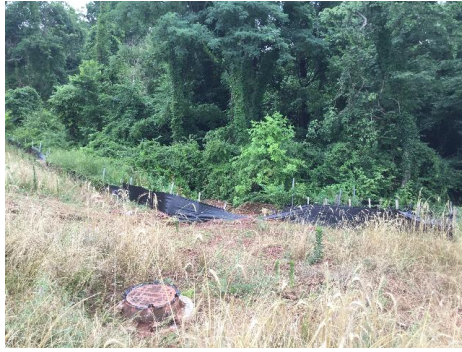
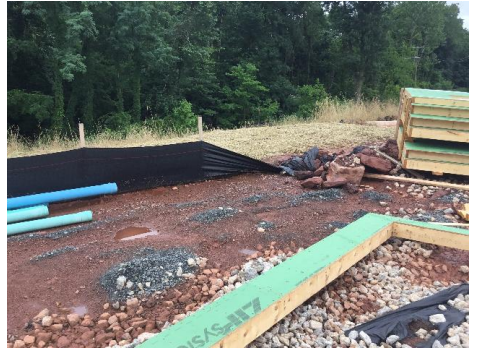
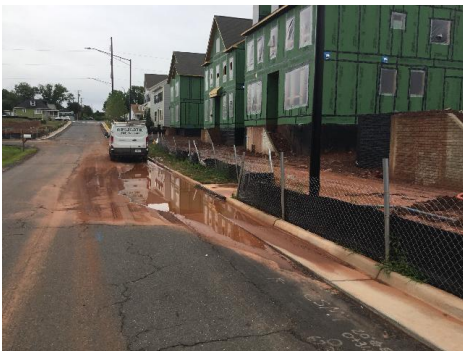
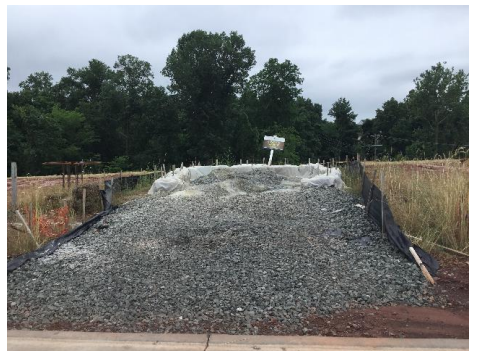
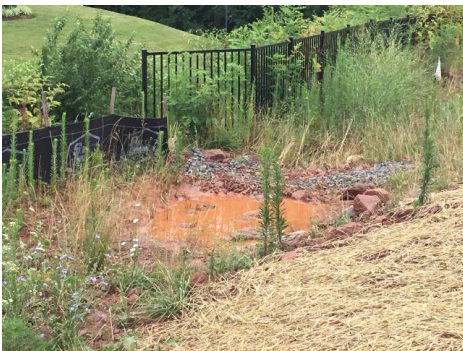
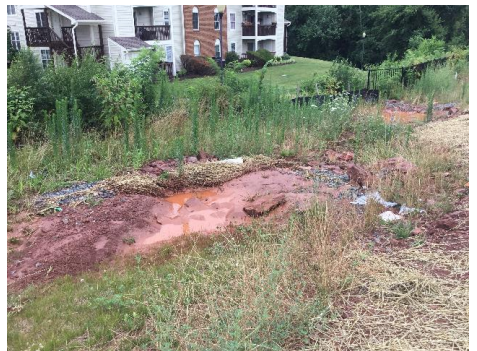
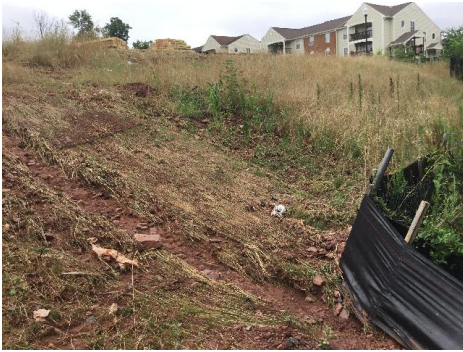
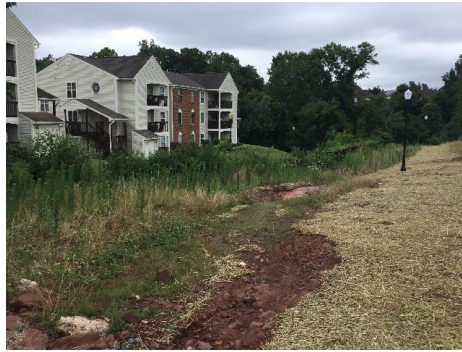
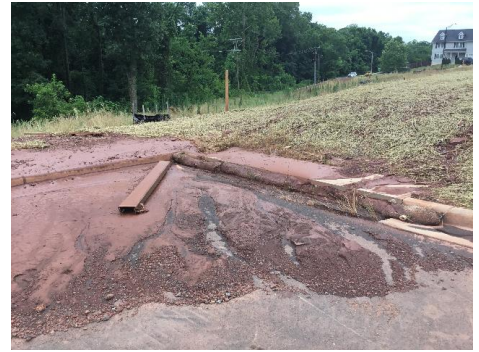
- Deficiency #1 Silt fence is down or blown out in multiple locations on site. Rear of project has blowouts that have breached next the stream.
- Corrective Action #1 Clean up silt in roadway on Jefferson St and on interior road of Barnes Loop. Replace or repair all silt fence and super silt fence that is down or blown out on the entire project.  
Concrete Washout is overflowing and in need of maintenance and repairs

- ES Deficiency #1 3.05 Silt Fence 111-19
- ES Deficiency #2 other
- ES Deficiency #2 Concrete Washout
- Other
- ES Deficiency #3 3.31 Temporary Seeding 111-284
- ES Deficiency #4 3.07 Storm Drain Inlet Protection 111-3 1

Additional Comments: RLD reports have not been reflected accurately as conditions on the project are evident that issues have been overlooked as part of RLD inspections.

- Corrective Action #2 Have Concrete Washout cleaned out and restored.
- Corrective Action #3 Multiple locations onsite where temporary stabilization has failed  
Have all areas on the project perimeter where temporary stabilization has failed and washed out repaired and restored to positive drainage and re-apply temporary stabilization  
Inlet protection on the project are in need of replacement or repair.

- Corrective Action #4 Replace or repair all inlet protection measures onsite as needed

Corrective Action Comments: Repairs and restorations must be completed by close of business 3pm July 13, 2022  
 Correct these deficiencies by: 7/13/2022 11:00:00 AM

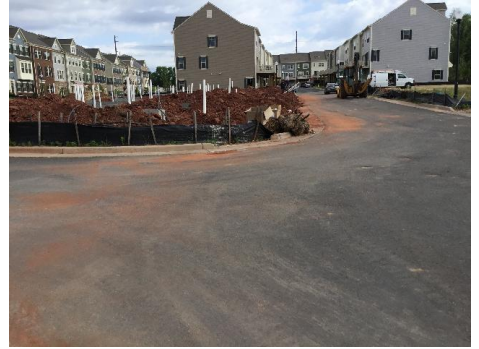
Deficiency #1 Parameter control (silt fence) has been removed, part of the dirt stock piles (resulted from building excavation activities) are placed beyond the limit of disturbance (on the gutter pan) and not stabilized.

ES Deficiency #1      3.05 Silt Fence 111-19

Corrective Action Comments:      The removal of the parameter control (silt fence) and having the dirt stock piles placed beyond the limit of disturbance caused the dirt (sediment) to leave the site during yesterday's storm event to the storm drainage structures in operation. I instructed the contractor yesterday and today to take all the necessary arrangements to have the dirt stock piles contained within the site and replace the parameter control as specified. I met the contractor on site and explained to him the deficiencies and corrective actions needed.

Corrective Action #1 All the parameter control (silt fence) should be restored, dirt stock piles are to be contained within the site and stabilized, according to the specs and drawings.

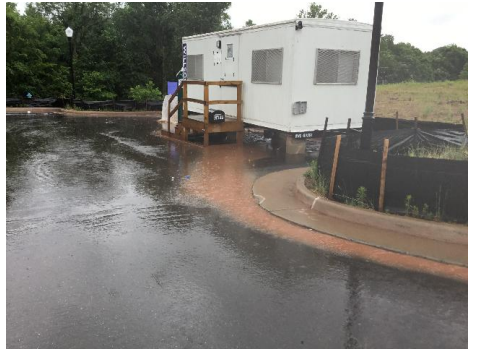
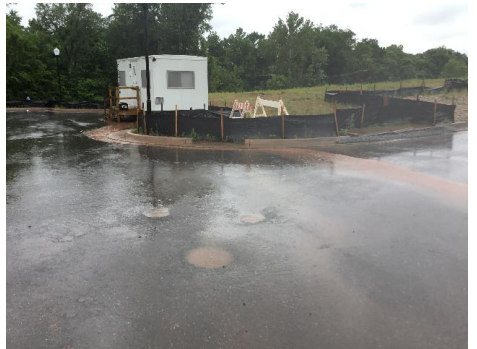
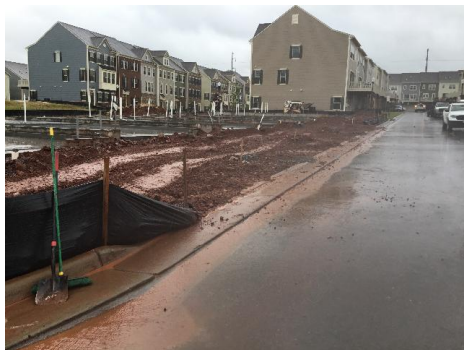
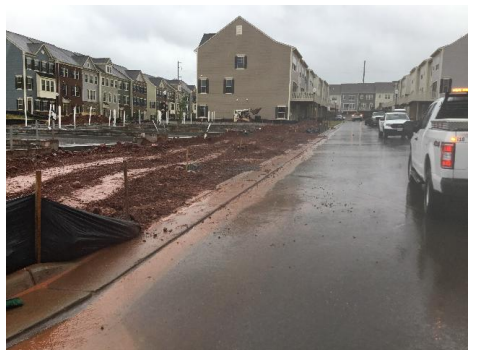
Deficiency #1 Silt fence has been removed from the limit of disturbance for lots #79-#85 while the drainage area is not stabilized.

ES Deficiency #1      3.05 Silt Fence 111-19

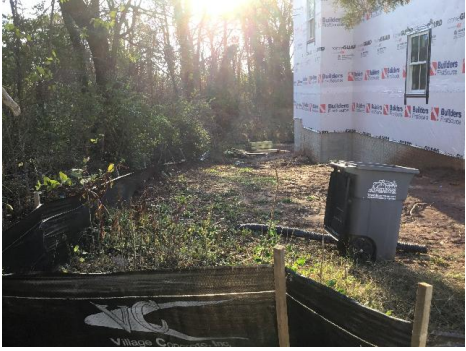
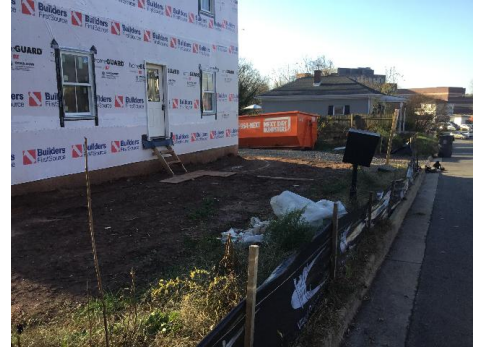
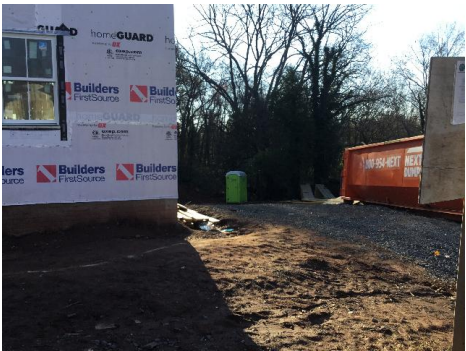
Deficiency #1 Silt fence has been damaged by contractor and is down in several locations.

ES Deficiency #1      3.05 Silt Fence 111-19

Corrective Action #1 Restore or replace silt fence that has been damaged or downed

Corrective Action Comments:      Restore or replace silt fence that has been damaged or downed on the site

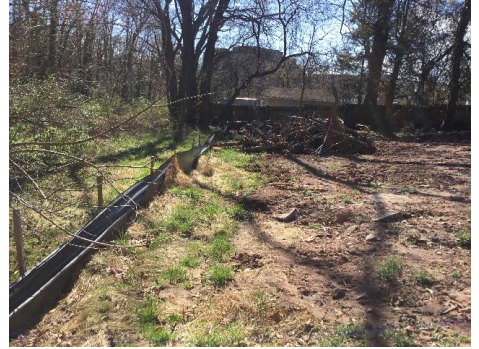
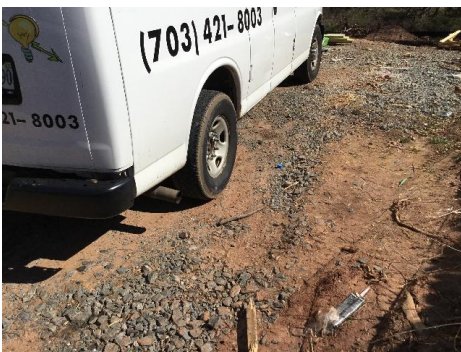
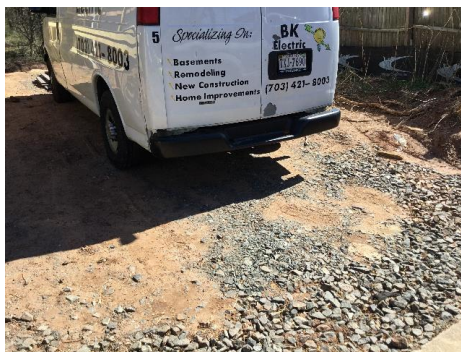
| Deficiency #1 | Silt fence is buried and broken in some locations around the site parameter in addition of having some Construction debris alongside the silt fence |

- ES Deficiency #1      3.05 Silt Fence   111-19  
ES Deficiency #2      3.02 Construction Entrance   111-6

| Corrective Action #2 | The contractor was instructed to have the construction area restored as specified in the drawing |

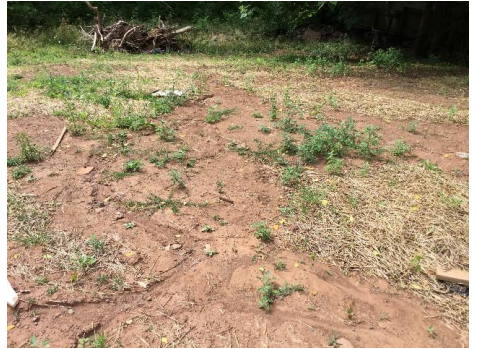
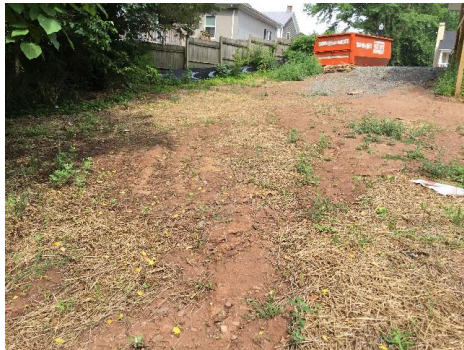
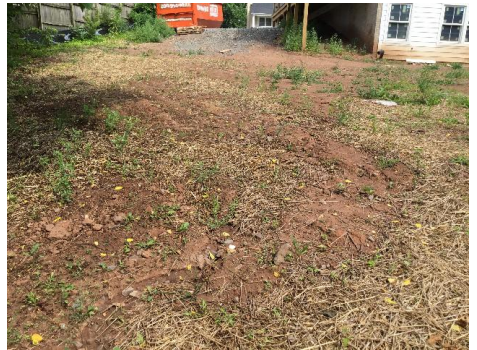
Deficiency #1 Silt fence is down at different locations within the site limit of disturbance.

ES Deficiency #1      3.05 Silt Fence 111-19

Additional Comments: The back yard needs to be stabilized as I observed signs of rill erosion and with having the silt fence down, the dirt will not be contained within the site.

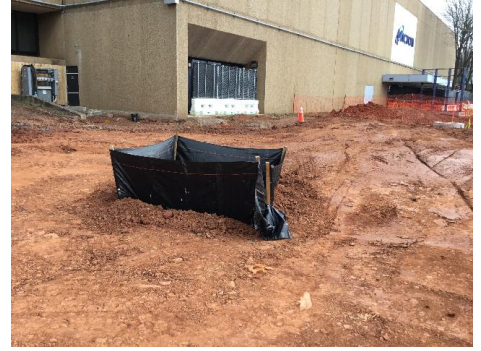
Deficiency #1 The silt fence has been relocated and is not entrenched as required.

- ES Deficiency #1      3.05 Silt Fence 111-19  
ES Deficiency #2      3.07 Storm Drain Inlet Protection 111-3 1

Corrective Action #2 Inlet protection should be installed as specified on approved E&S plans

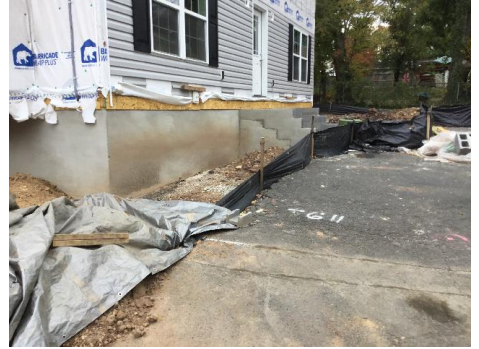
Deficiency #1 Silt fence has been removed and damaged in some locations around the perimeter of the building pad

ES Deficiency #1      3.05 Silt Fence 111-19

Corrective Action #1 Repair or replace the the downed or damaged silt fence

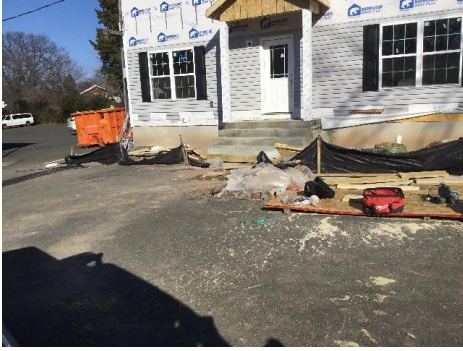
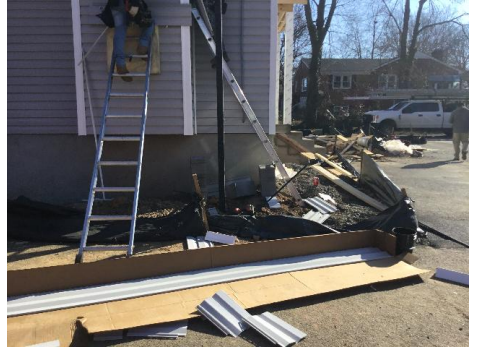
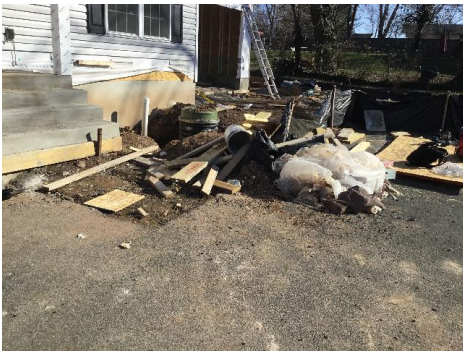
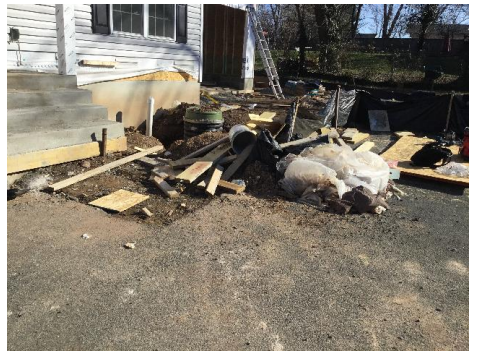
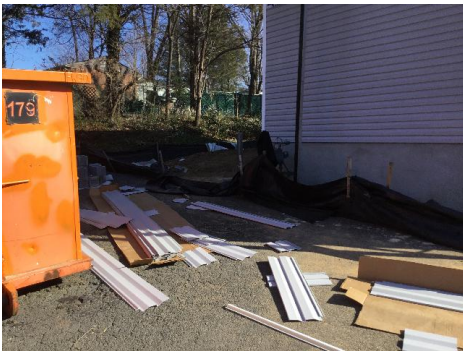
Deficiency #1 Silt fence has been removed or damaged

ES Deficiency #1      3.05 Silt Fence 111-19

Corrective Action #1 Repair or replace downed or damaged silt fence around perimeter of construction area

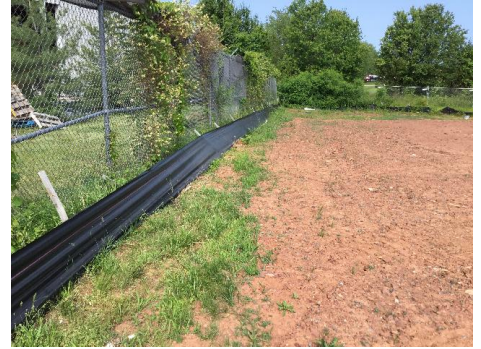
Deficiency #1 Silt fence is down at certain locations within the site especially between the site and the adjacent land (TM 101-01-00-45).

- ES Deficiency #1      3.05 Silt Fence   111-19  
ES Deficiency #2      3.31 Temporary Seeding   111-284

Corrective Action #2 To be stabilized according to the drawings sheets 6&4, and the specs.

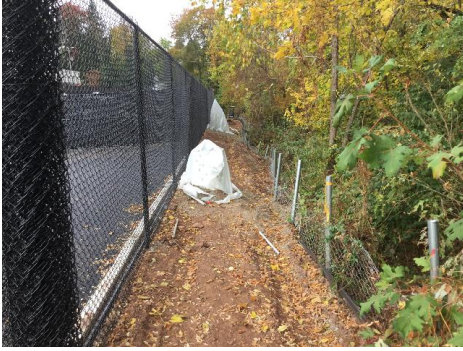
Deficiency #1	Super Silt Fence at rear LOD has been compromised and buried or damaged with excess spoils from excavation of underground storm facility
Corrective Action #1	Install temporary silt fence along rear perimeter LOD next to compromised super silt fence until final grading can be completed.

ES Deficiency #1      3.05 Silt Fence 111-19

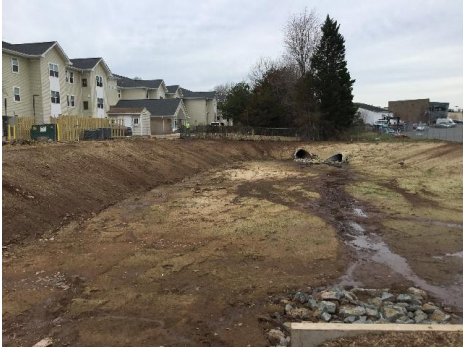
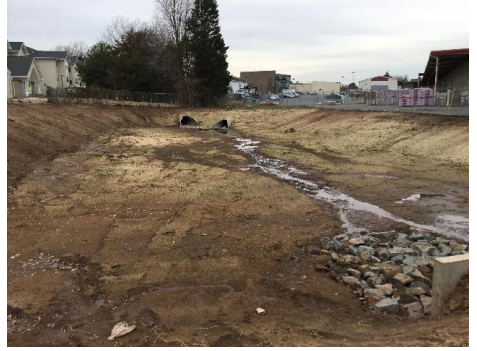
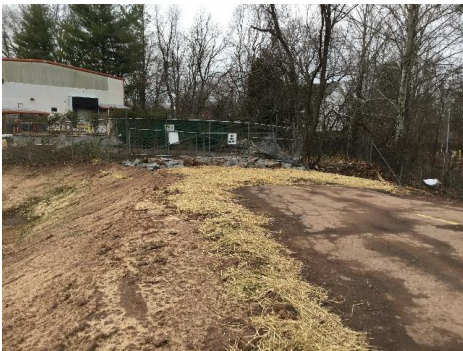
Deficiency #1 Slopes are not properly seeded and stabilized

ES Deficiency #1      3.32 Permanent Seeding      111-289

Corrective Action #1 Repaired all erosion to slopes, apply stabilization matting and seeding

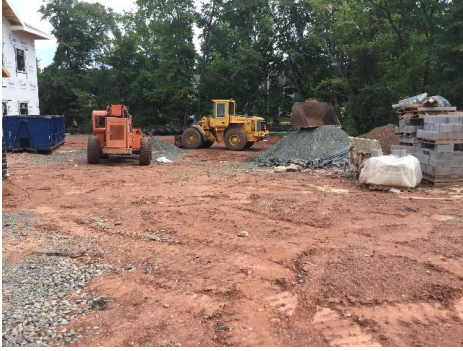
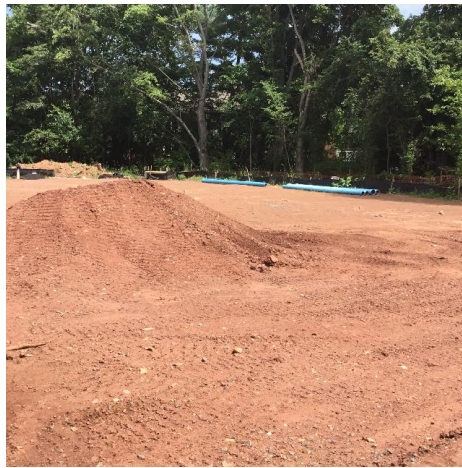
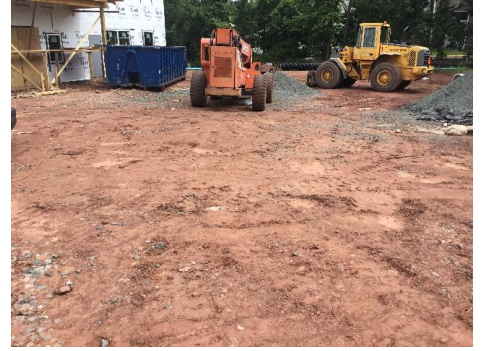
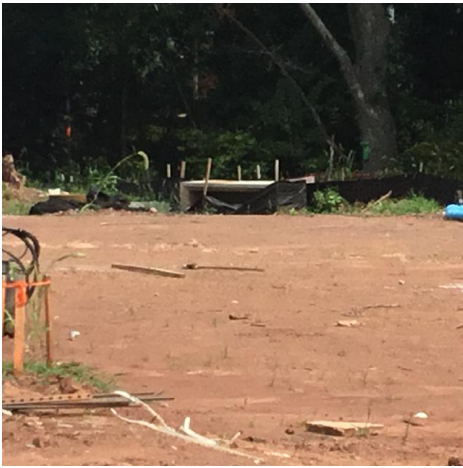
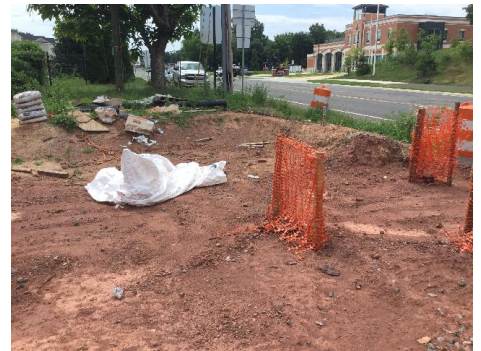
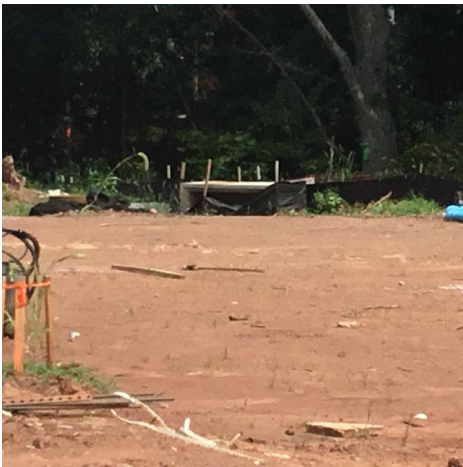
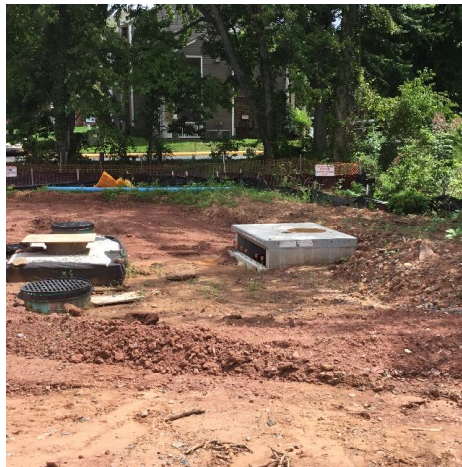
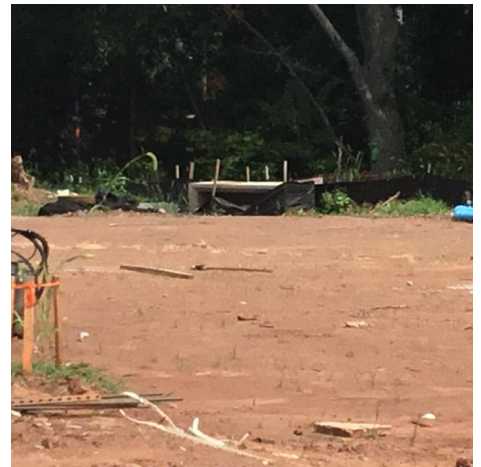
Deficiency #1 Construction Entrance and wash rack has been removed without approval

ES Deficiency #1     3.02 Construction Entrance   111-6  
ES Deficiency #2     3.31 Temporary Seeding   111-284  
ES Deficiency #3     other  
ES Deficiency #3     Trash and Construction Debris  
Other  
ES Deficiency #4     3.07 Storm Drain Inlet Protection   111-3 1

Corrective Action #4 Repair or replace inlet protection on all inlets on site

Corrective Action Comments:     Corrections to E&S must be addressed by close of business Friday August 5th at 3pm  
Correct these deficiencies by:     8/5/2022 11:00:00 AM

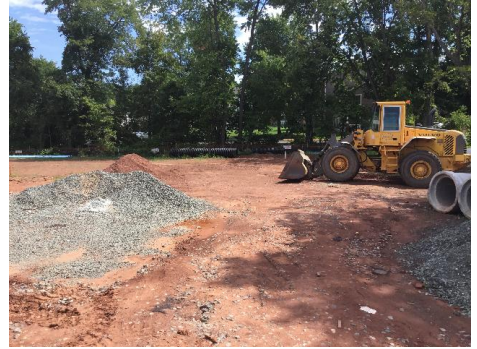
Deficiency #1 Temporary stabilization seeding and stabilization has not been completed as directed in last two Non-Compliance reports issued.

ES Deficiency #1      3.31 Temporary Seeding    111-284

Corrective Action #1 Have Temporary Seeding and or Stabilization completed on all denuded areas of the entire project site to avoid issuance of Stop Work Order.

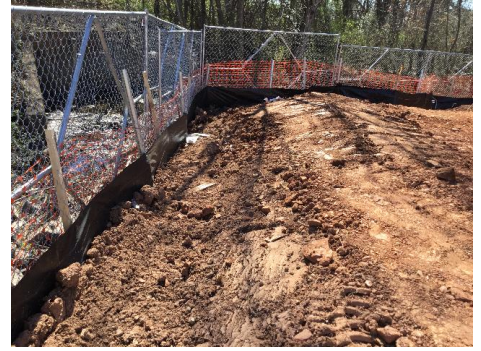
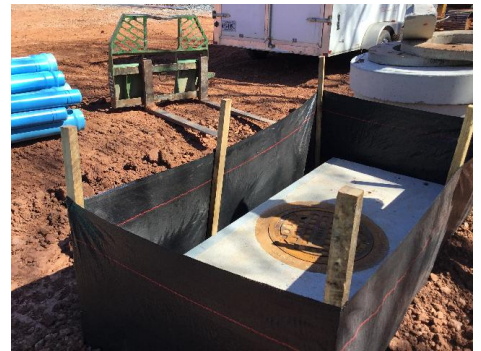
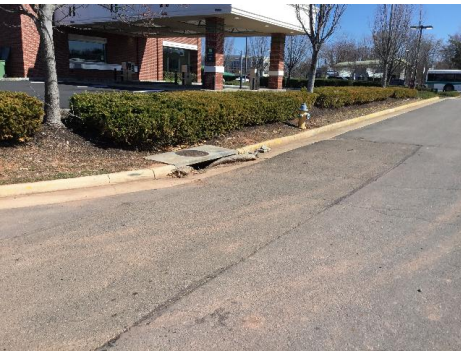
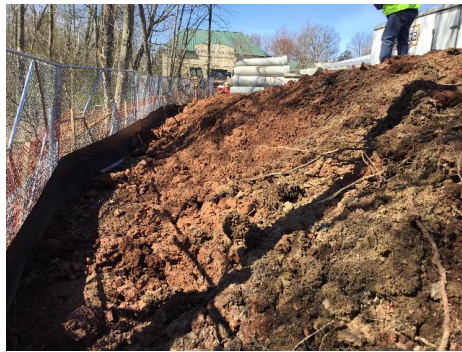
Deficiency #1 Missing silt fence in some spots, the sit fence is buried in other locations, the existence of construction debris alongside the silt fence

| ES Deficiency #1 | 3.01 Safety Fence III-1 |
| ES Deficiency #2 | 3.08 Culvert Inlet Protection 111-46 |
| ES Deficiency #3 | 3.36 Soil Stabilization Blankets and Matting 111-356 |

Corrective Action #3 The stock piles should be stabilized as specified

Corrective Action Comments: The contractor was instructed to have all the above mentioned deficiencies corrected as specified in the drawings and the specs

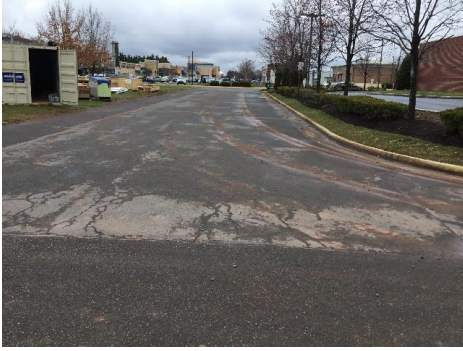
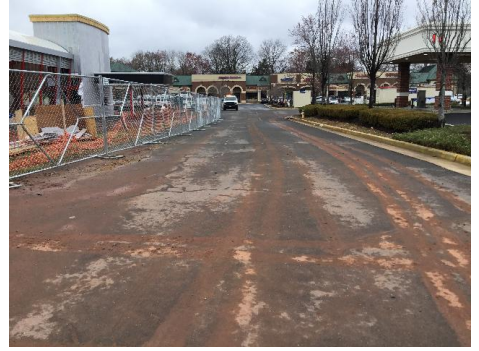
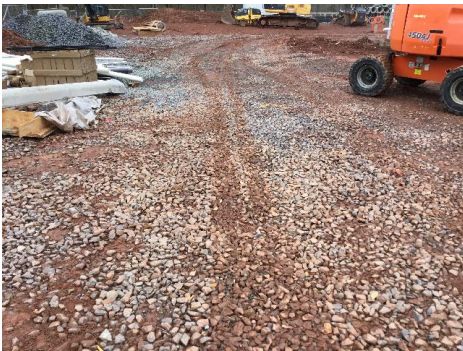
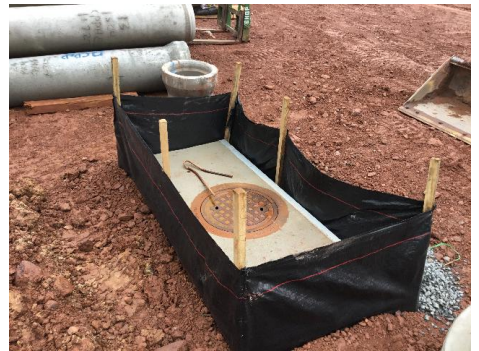
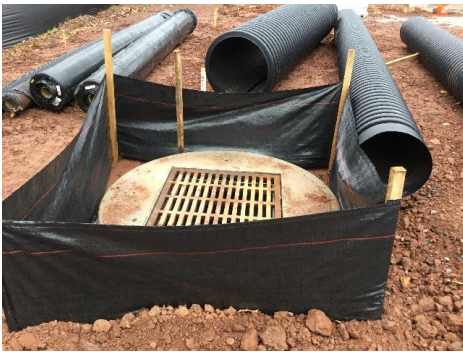
Deficiency #1 Sings of sediment leaving the site on the adjacent roads

- ES Deficiency #1      3.02 Construction Entrance   111-6  
ES Deficiency #2      3.07 Storm Drain Inlet Protection   111-3 1

Corrective Action #2 To make the corrective measures to fix the inlet protection as specified in the drawings and specs.

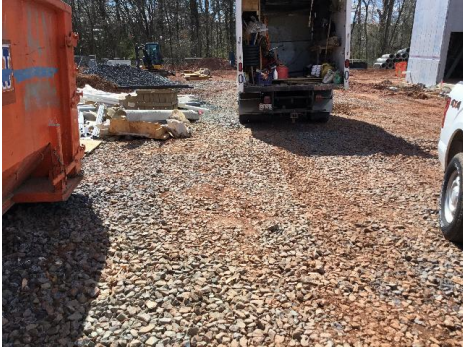
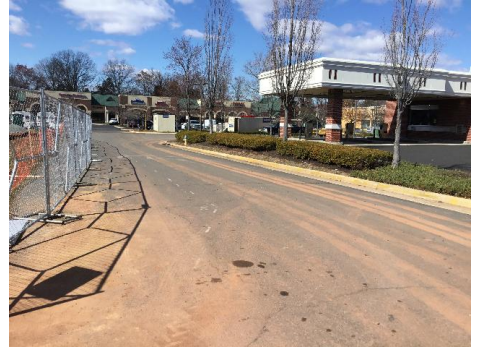
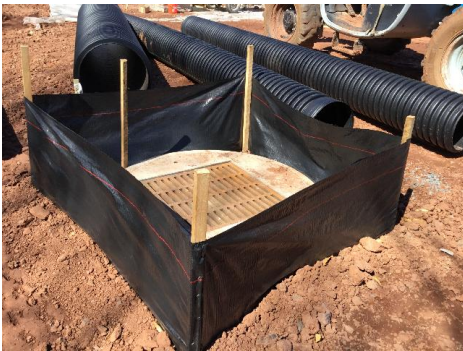
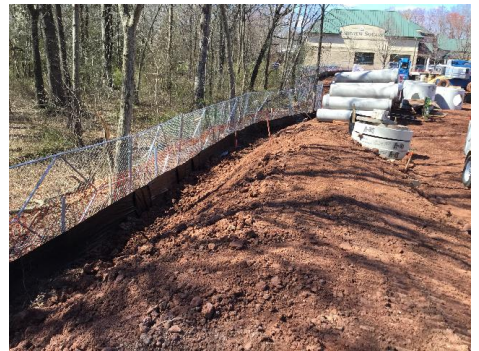
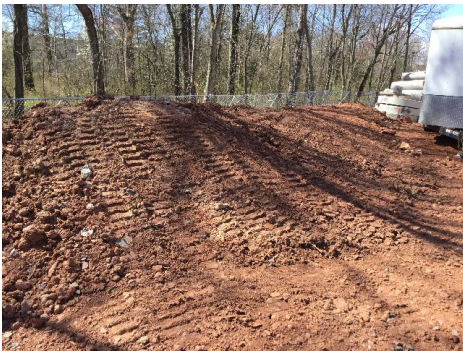
Deficiency #1 Construction entrance is not as specified and signs of sediment leaving the site were noticed on adjacent roads

- ES Deficiency #1 3.02 Construction Entrance 111-6  
ES Deficiency #2 3.08 Culvert Inlet Protection 111-46

Corrective Action #2 The inlet protection should be installed as specified in the drawings and specs

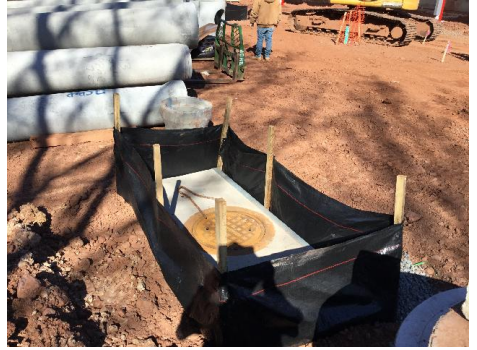
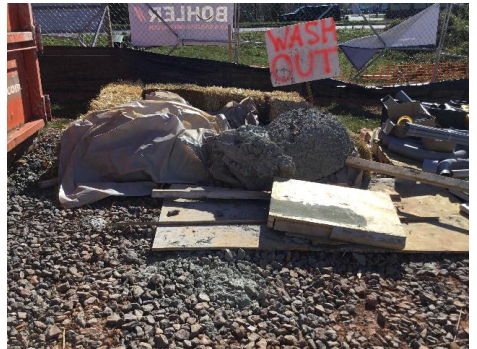
Deficiency #1 The construction entrance shows aggregate dissipation into the underlying soil and signs of trucks tracking were observed on the adjacent road

- ES Deficiency #1 3.02 Construction Entrance 111-6
- ES Deficiency #2 3.07 Storm Drain Inlet Protection 111-3 1
