Underground Facility Inspection Report					
Facility Name	Manassas Station Redev	Facility ID	STMF0091651	Type of Inspection: Initial Inspection	
Location	Lat: 38.908792 Long: -77.474171	Watershed	Rocky Branch-Broad Run	Previous 48 Hour Precipitation Total	0.35"
Materials available for inspection	N/A	Owner Notification Date		Owners/ Owner's Representative	Prince Properties, LLC
Inspectors	gky_mfreeman	Date of Inspection	6/29/2023	Date of Last Inspection	N/A
Overall Condition Score					
	1	Adequate	No deficiencies identified.		
	2	Monitor	No maintenance may be needed at the time, but might become an issue in the future. Will revisit next inspection. Examples include minor erosion, small sediment accumulation, or small structural issues of facility components.		
3	3	Routine Maintenance Needed	Facility is functional but preventative maintenance is required. Examples includes minor structural damage, minor erosion, or trash/debris removal.

Facility ID: STMF0091651
Facility Name: Manassas Station Redevelopment

Inspection Date: 06/27/2023

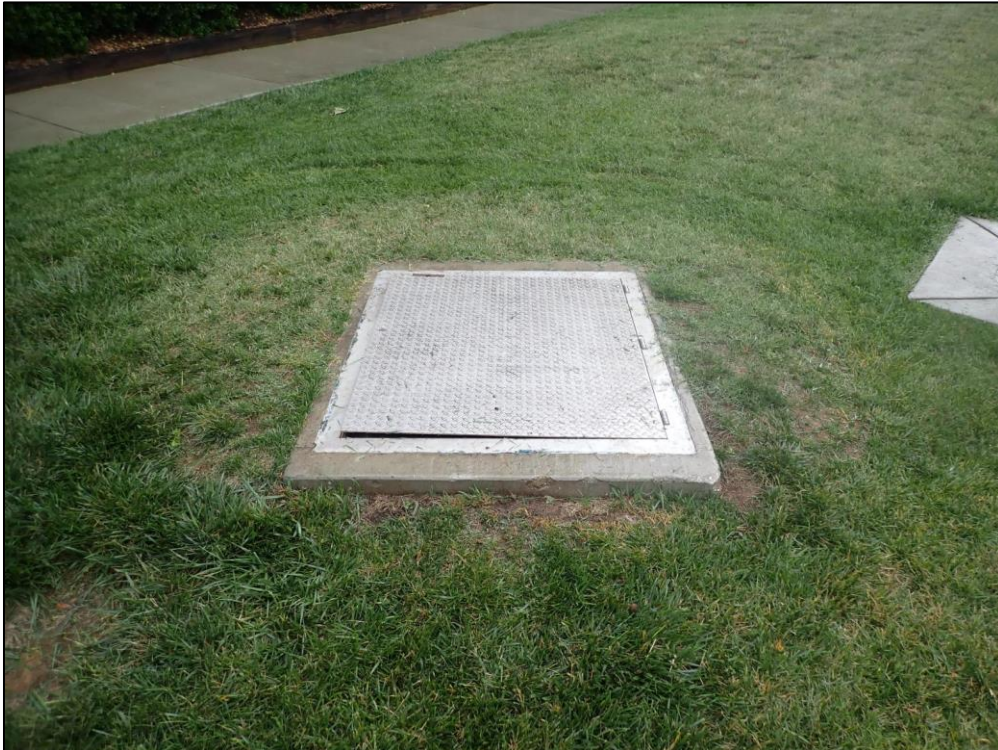
4524: Top of the Cartridge Bay. Damage to inlet pipe or structure, Broken Bilco door lock (Immediate Repair Needed).

4	Immediate Repair Needed	Facility is close to or currently not carrying out intended function. Examples include significant sediment accumulation , or structural component failure. Repair Immediately		
	N/A	Not Applicable	Does not pertain to this facility.		
Remarks					
Inspection Items					
Score	Description		Comment(s) / Corrective Action(s)	Reference Image	
Overall					
1	Inadequate access to complete thorough inspection				
1	Hazardous fumes present				
1	Surrounding drainage area trash/debris/unauthorized substances that might affect facility				
1	Surrounding drainage area erosion that might affect facility				
Inlets					
1	Buildup of trash, debris, and sediment				
1	Evidence of erosion or undermining around inlet				
1	Vegetation or other obstruction blocking inflow				
4	Damage to inlet pipe or structure		The lock and latch on the Bilco access door is broken. Repair the lock and latch so that the door can be closed and secured.	4525

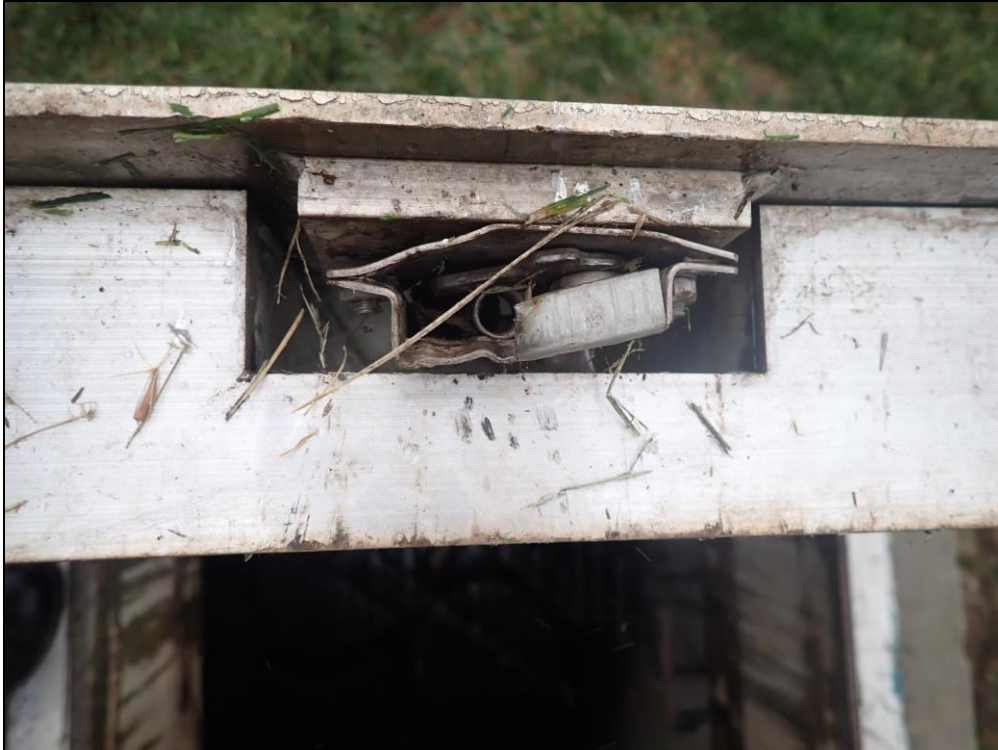
4525: Close-up of the Cartridge Bay access door. Damage to inlet pipe or structure, Broken Bilco door lock (Immediate Repair Needed).

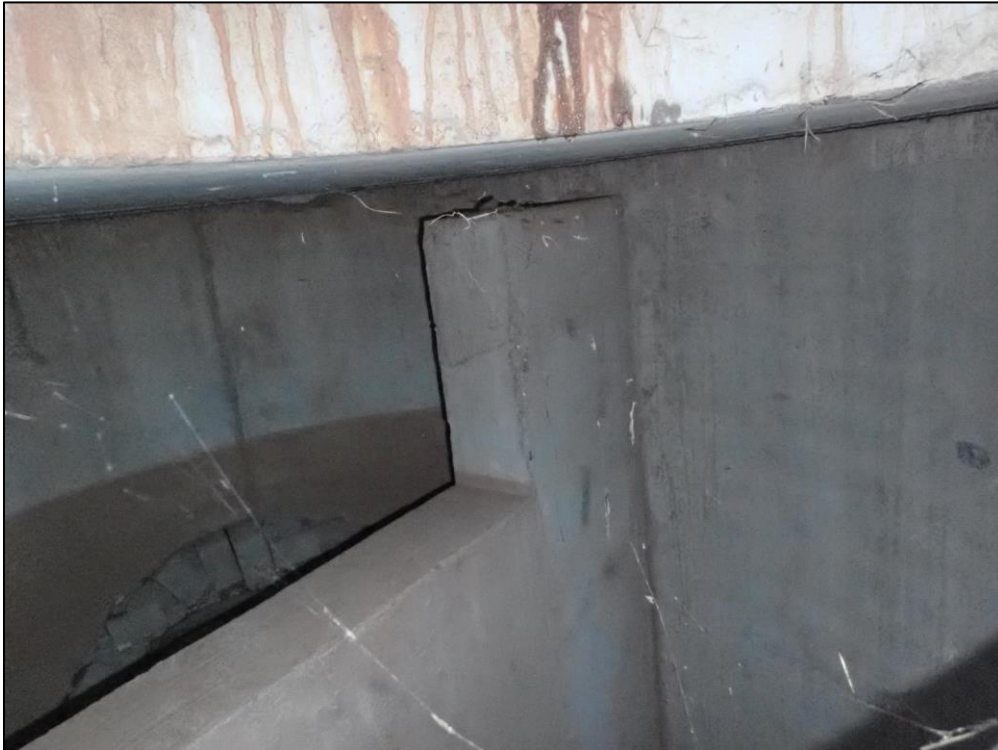
4538: Inside Control Structure 3, looking towards the weir. Damage to outlet pipe or structure, pipe connections are not sealed (Routine Maintenance Needed).

Score	Description	Comment(s) / Corrective Action(s)	Reference Image
Outlet			
1	Buildup of trash, debris, and sediment		
3	Damage to outlet pipe or structure	The walls around the upstream pipes in the structure are not sealed and filled with loose stone. These areas need to be parged with concrete to seal the connections.	4538, 4540, 4543
1	Signs of erosion around outlet		
1	Orifice is clogged		
1	Leaking or failing joints		
1	Control Value is functional

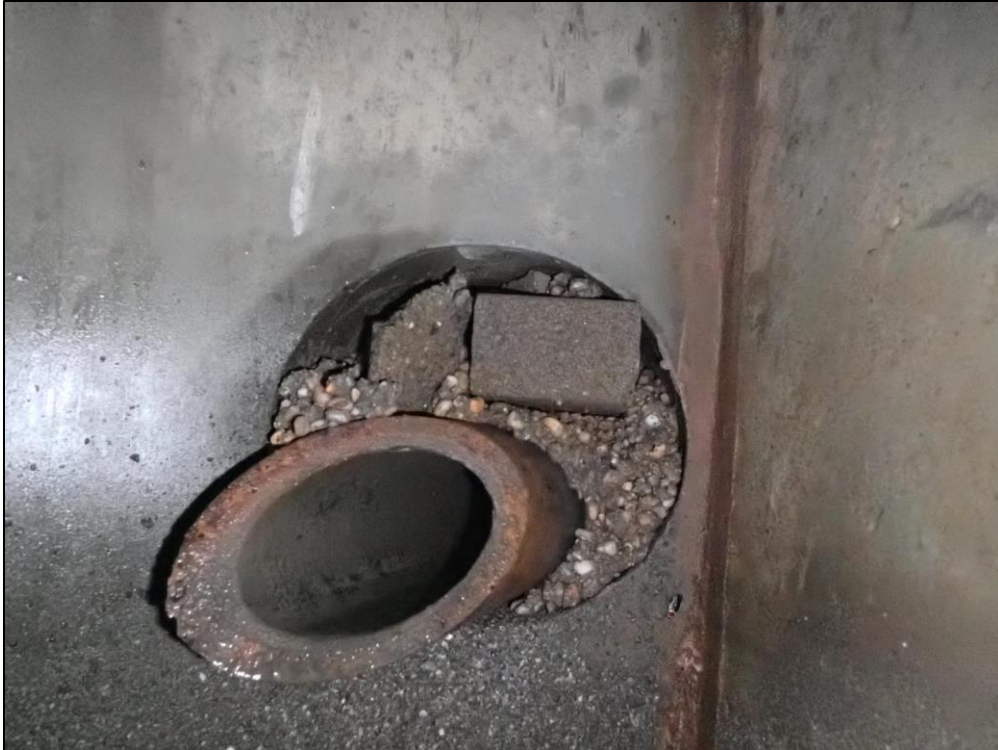
4540: Inside Control Structure 3, looking upstream toward the Cartridge Bay. Damage to outlet pipe or structure, pipe connections are not sealed (Routine Maintenance Needed).

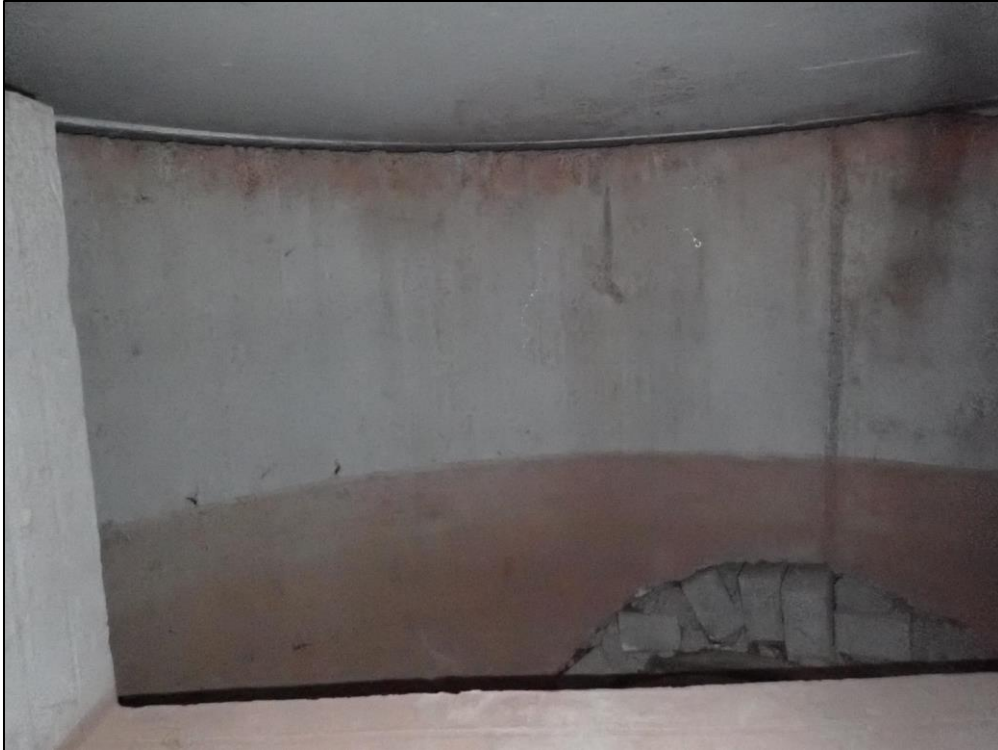
4543: Inside Control Structure 3, looking toward detention. Damage to outlet pipe or structure, pipe connections are not sealed (Routine Maintenance Needed).

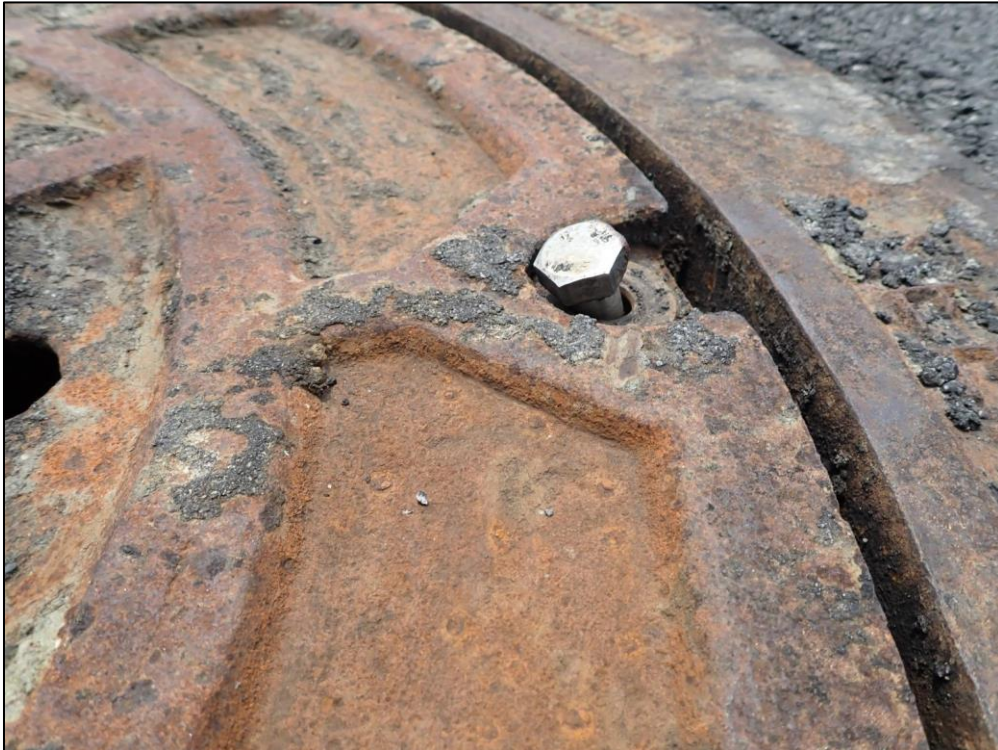
5099: Close-up of Manhole 6. Inadequate access to complete a thorough inspection, bent bolt (Routine Maintenance Needed).

1	Trash/Debris accumulation				
1	Damage to chamber structure				
1	Damage to baffle/weir structure				
3	Damage to access hatch and/or ladder		Bolts locking the access structure were bent and unable to be removed. Remove and replace these bolts.	5099, 5100, 5102, 5103	
1	Chambers are draining properly				
1	Filter media is in good condition				
1	Orifice is clogged

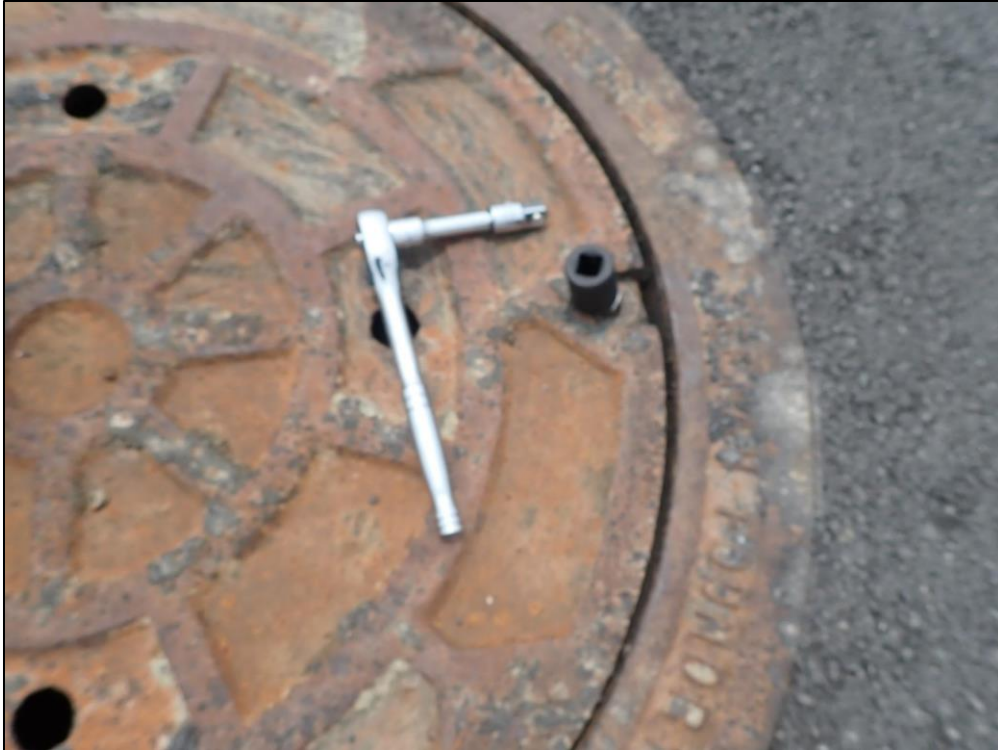
5100: Close-up of Manhole 6. Inadequate access to complete a thorough inspection, bent bolt (Routine Maintenance Needed).

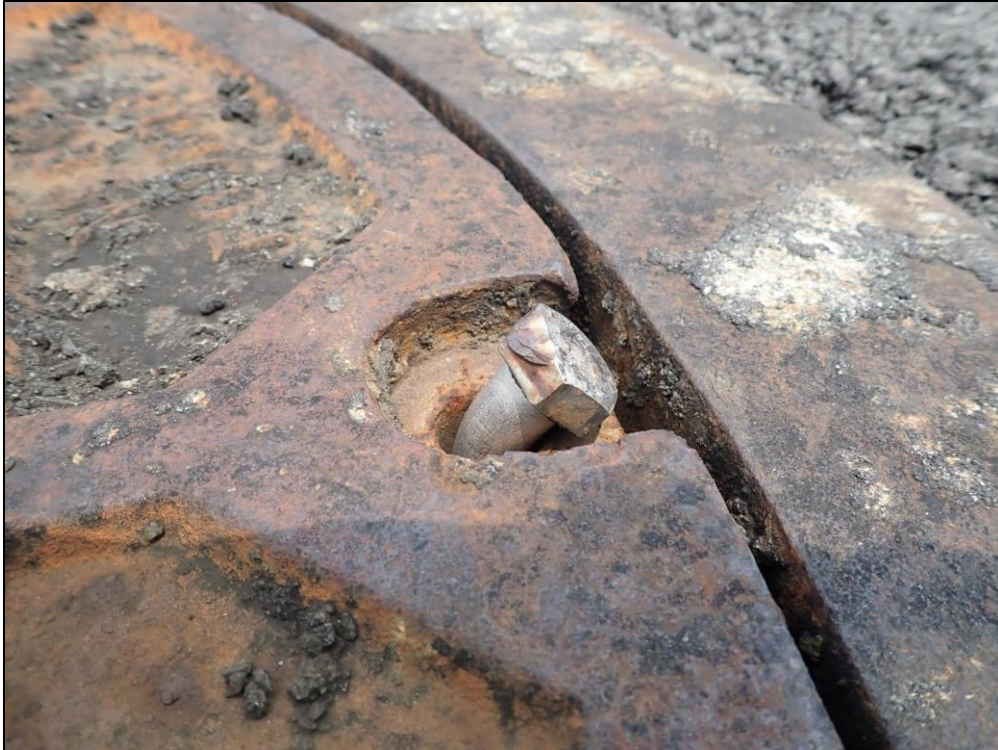
5102: Close-up of Manhole 7. Inadequate access to complete a thorough inspection, bent bolt (Routine Maintenance Needed).

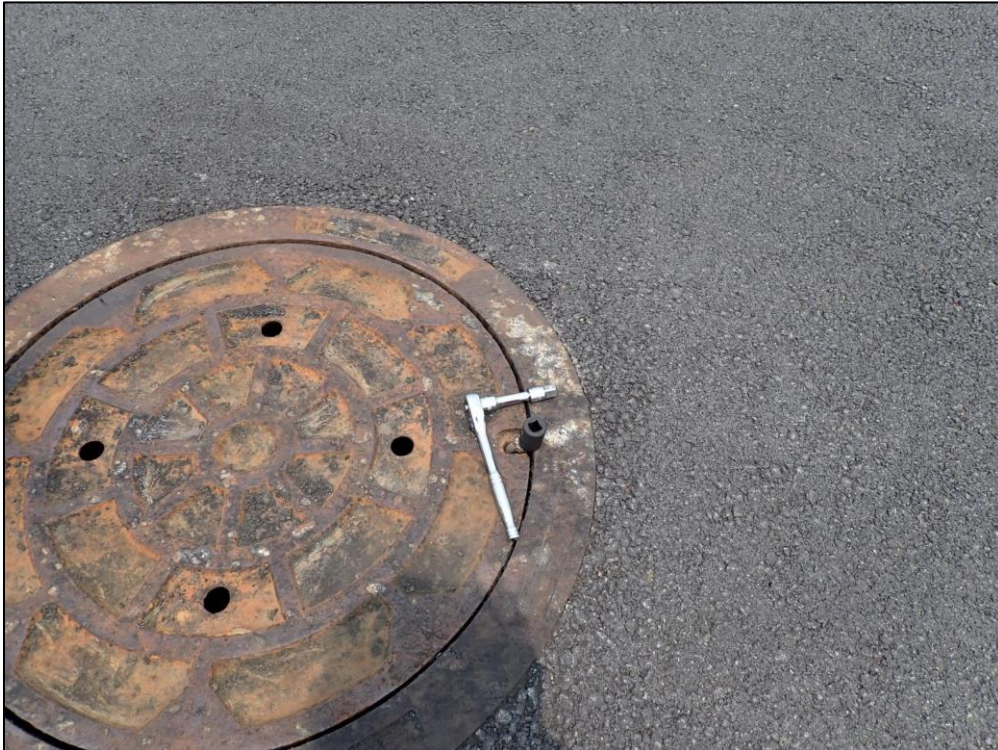
5103: Close-up of Manhole 7. Inadequate access to complete a thorough inspection, bent bolt (Routine Maintenance Needed).

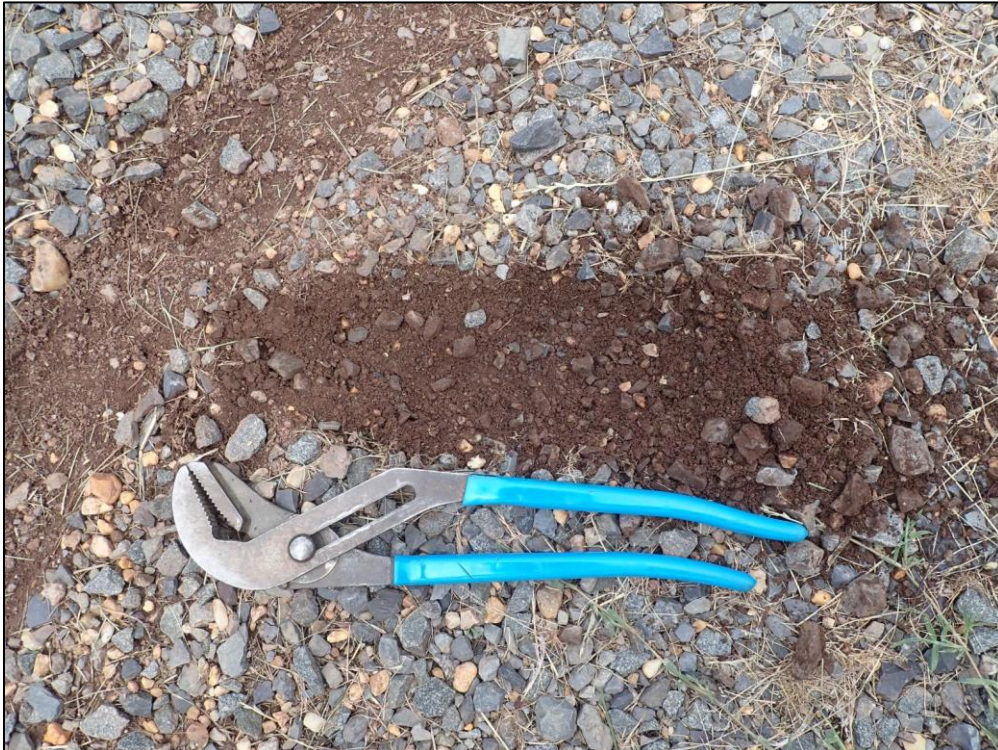
4757: Close-up showing the Gravel Detail. Evidence of clogging (Immediate Repair Needed).

4	Evidence of clogging		Sediment accumulation was observed in the facility's gravel layer. Remove this material to ensure continued function.	4757, 4758	
1	Filter Fabric Needs Repair				
Observation Well/ Cleanout (s)					
1	Missing/ Not Found				
1	Cap Missing/ Stuck				
1	Water/ Sediment Observed in Well

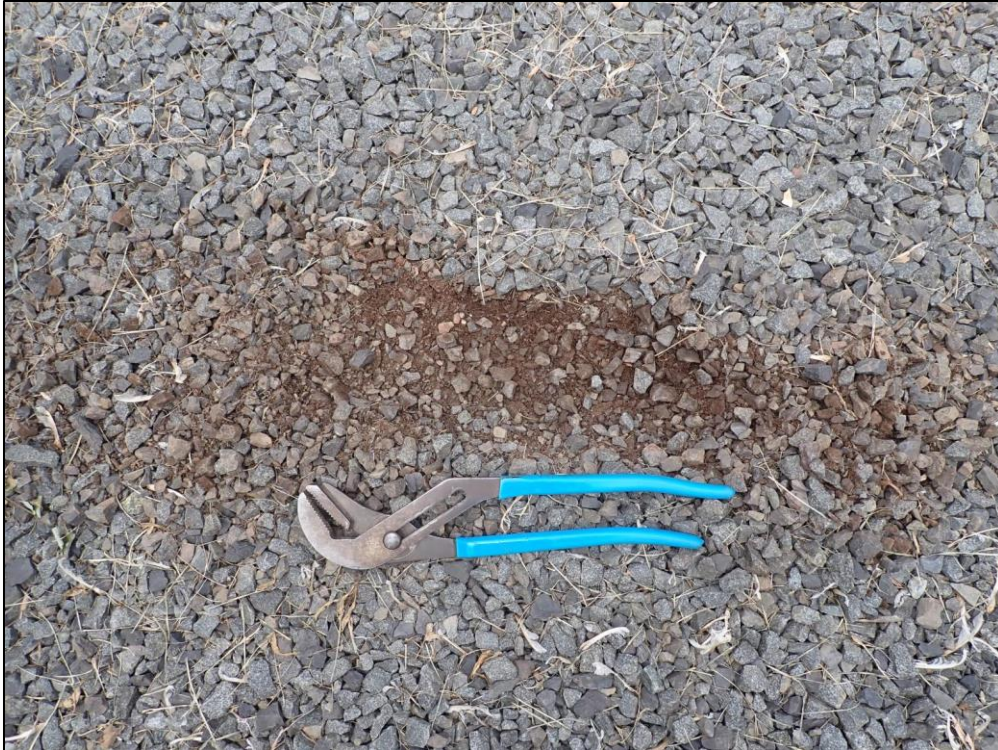
4758: Close-up showing the Gravel Detail. Evidence of clogging (Immediate Repair Needed).

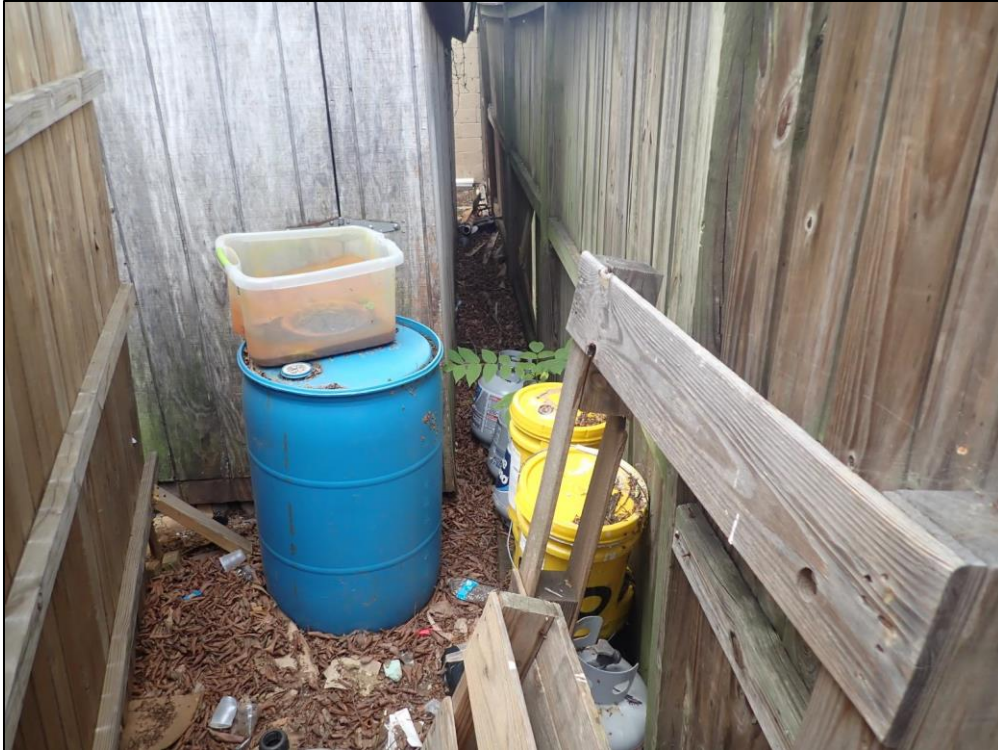
4494: Facility overall, looking West. Surrounding drainage area trash/debris/Unauthorized substances that might affect the facility. (Immediate Repair Needed).

4	4	Immediate Repair Needed	Facility is close to or currently not carrying out intended function. Examples include major erosion, significant sediment accumulation , or structural component failure. <u>Repair Immediately</u>		
	N/A	Not Applicable	Does not pertain to this facility.		
Remarks					
The facility was not found. In the area specified in the plans, a shed was observed with adjacent outside storage. It appears that this facility has either been removed or altered to the point where it can no longer function as designed.					
Inspection Items					
Score	Description	Comment(s) / Corrective Action(s)	Reference Image		
Overall					
1	Inadequate access to complete thorough inspection				
1	Fences are damaged or have vegetation growing on them				
1	Missing or damaged safety signage				
4	Surrounding drainage area trash/debris/unauthorized substances that might affect facility	The area of and adjacent to the trench and the sidewalk drain were covered in trash, debris, and other unauthorized substances. This material needs to be removed.	4494, 4495, 4497, 4502

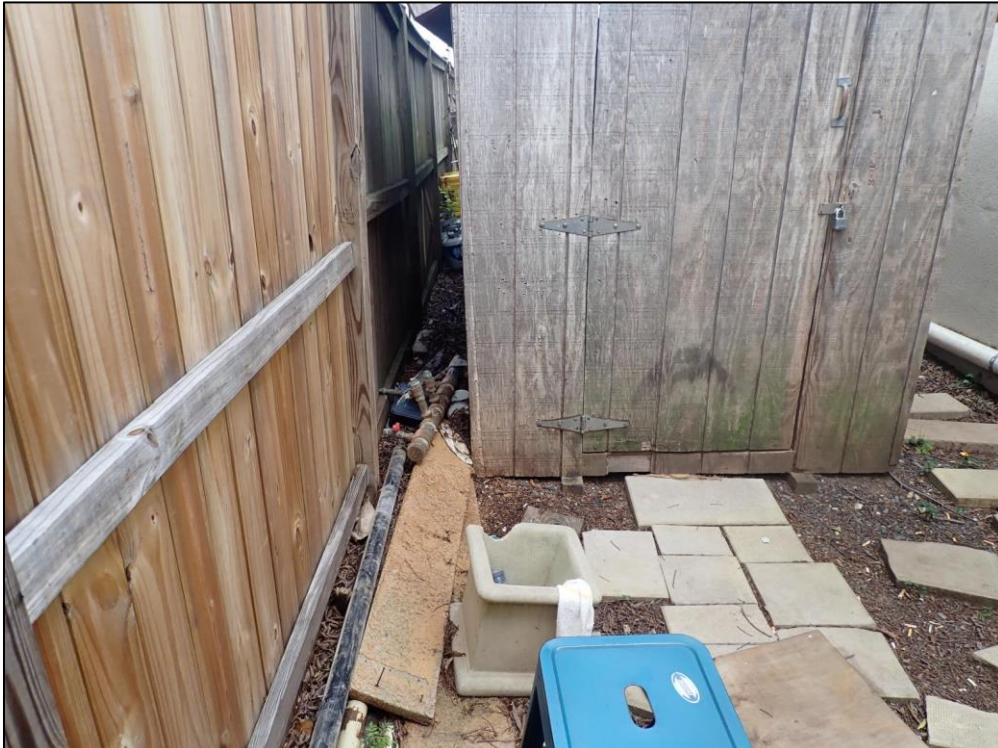
4495: Facility overall, looking East. Surrounding drainage area trash/debris/Unauthorized substances that might affect the facility. (Immediate Repair Needed).

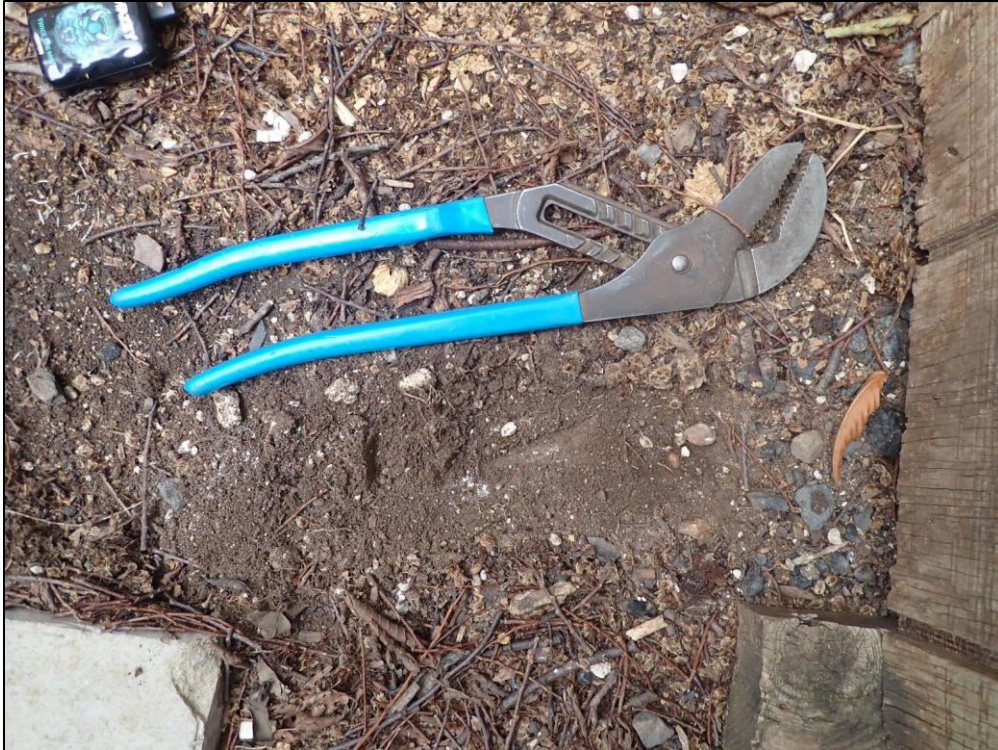
4496: Close-up showing the Gravel Detail. The trench appears to have been eliminated or severely altered. (Immediate Repair Needed).

1	Surrounding drainage area erosion that might be related to facility				
Surface Trench Components					
Gravel Bed Surface					
4	Trench Eliminated	The area of the trench in the plans has been severely altered, and the trench appears to have been eliminated.	4496, 4498		
1	Gravel Not Found Under Turf				
1	Gravel Footprint				
1	Condition of Grass or Fabric				
1	Signs of erosion or exposed soil				
1	Evidence of clogging				
1	Filter Fabric Needs Repair				
Observation Well/ Cleanout (s)					
1	Missing/ Not Found				
1	Cap Missing/ Stuck				
1	Water/ Sediment Observed in Well

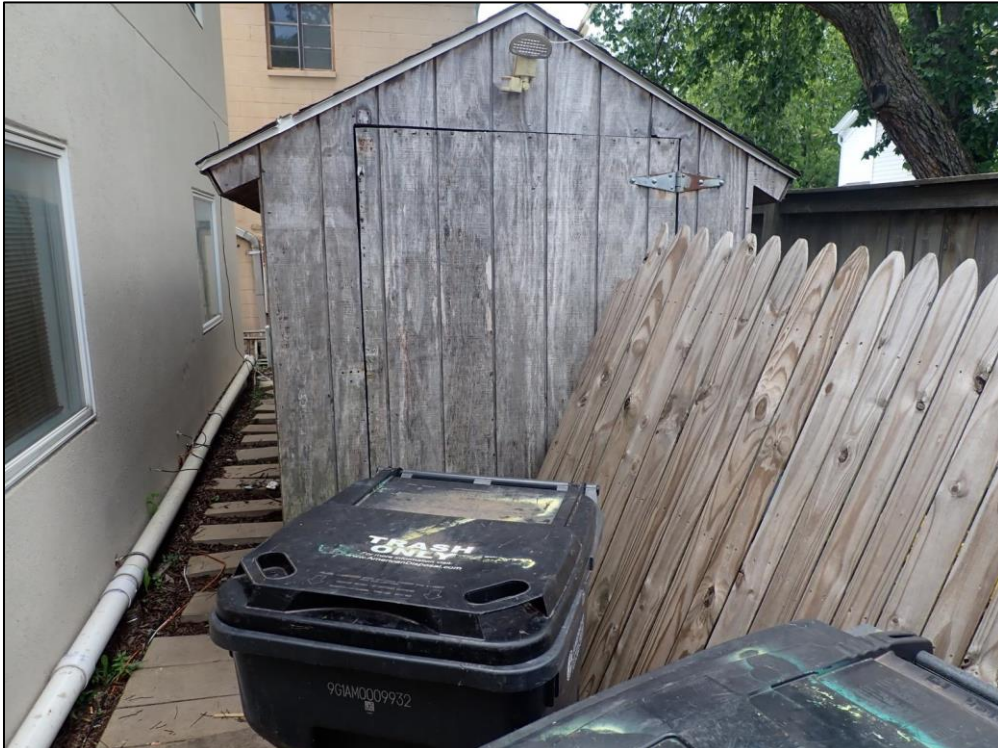
4497: Facility overall, looking West. Surrounding drainage area trash/debris/unauthorized substances that might affect the facility. (Immediate Repair Needed).

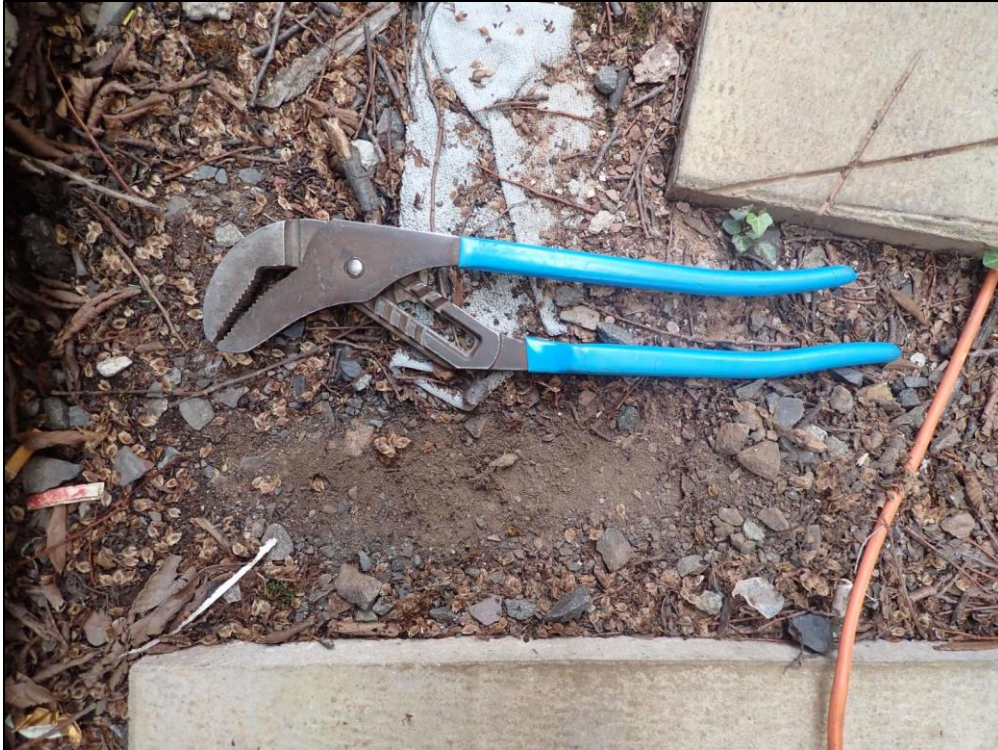
4498: Another close-up showing the Gravel Detail. The trench appears to have been eliminated or severely altered. (Immediate Repair Needed).

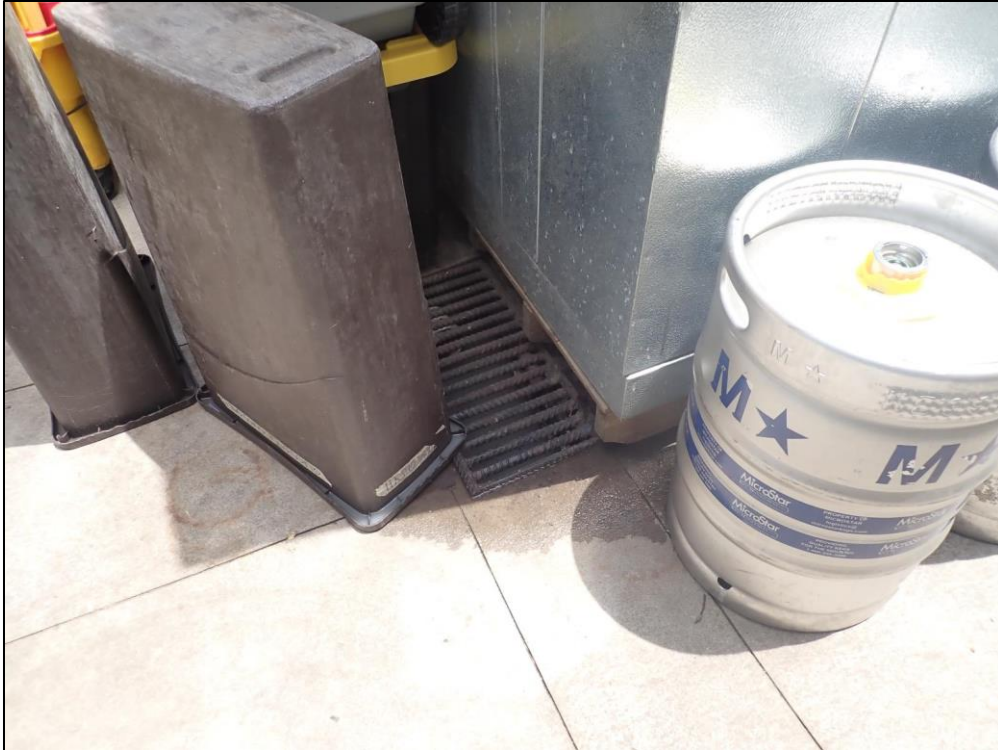
4502: Top of Sidewalk Drain. Surrounding drainage area trash/debris/Unauthorized substances that might affect the facility. (Immediate Repair Needed).

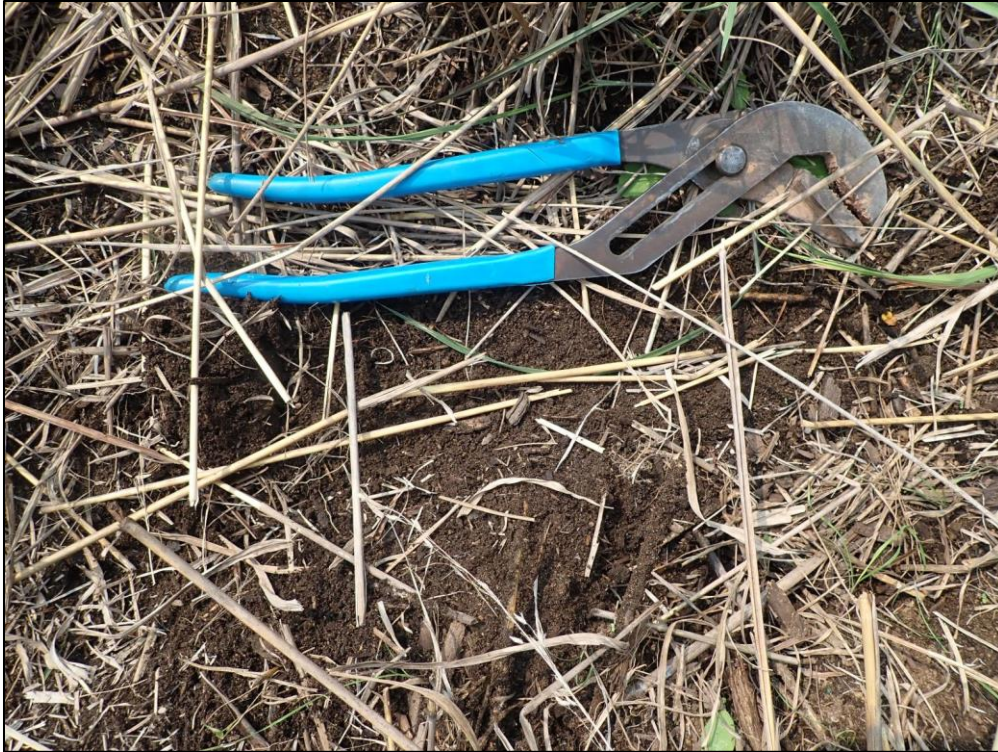
5006: Close-up of the ponding area showing 0" of mulch. Mulch layer is less than 2" deep or is otherwise in poor condition (Routine Maintenance Needed).

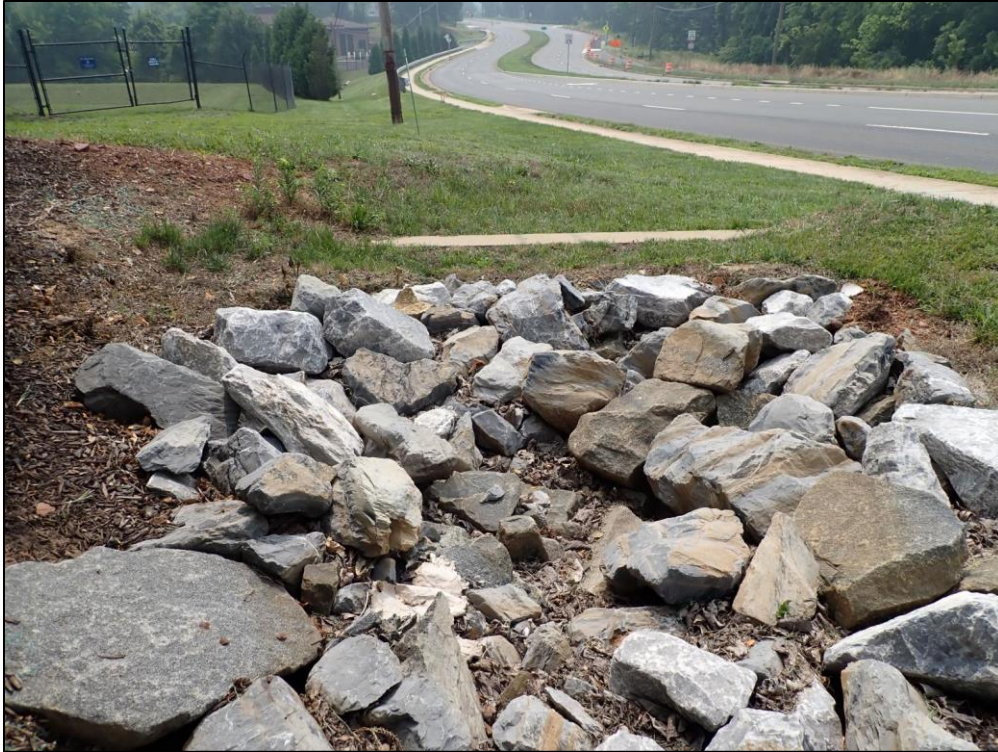
5048: Looking downstream from Outfall Structure 1. Erosion observed on the adjacent slope (Routine Maintenance Needed).

1	Invasive species or weeds make up at least 10% of the facility's vegetation		
1	Grass is too high and needs to be mowed		
Filter Media			
1	Filter media is too low, too compacted, or the composition is inconsistent with design specifications		
3	Mulch layer is less than 2" deep or is otherwise in poor condition	No mulch was observed throughout the filter bed. Add the 2-3" of mulch specified by the approved facility plan.	5006
1	Excessive trash, debris, or sediment and/or evidence of chemicals, fertilizers, or oil/grease		
1	Concentrated flows, erosion or exposed soil		
1	Filter bed is clogged and/or filled inappropriately / signs of standing water		
Underdrain/Observation Well (Proper Drainage)			
1	Perforated pipe is not conveying water as designed		
1	Observation well cap missing or damaged		
Outlet/ Overflow Spillway			
1	Outlets are obstructed		
3	Erosion and soil exposure is evident below the outlet	Erosion was observed adjacent to the level spreader. Repair the erosion and stabilize the area with seed and mulch.	5048, 5049

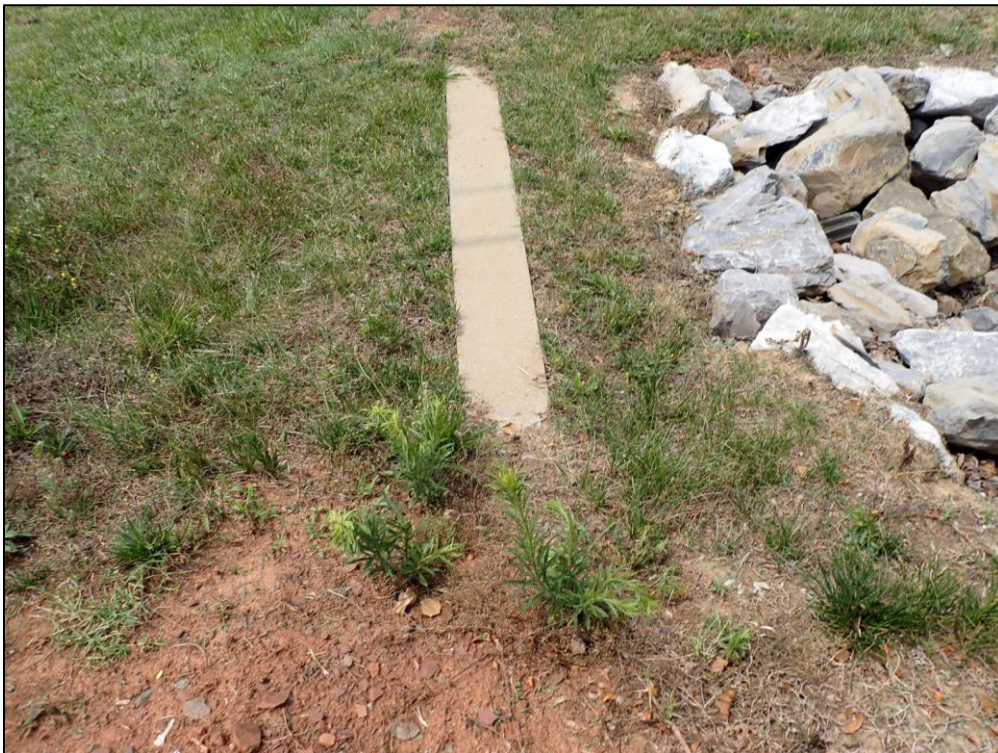
5049: Overall view of the Level Spreader. Erosion observed on the adjacent slope (Routine Maintenance Needed).

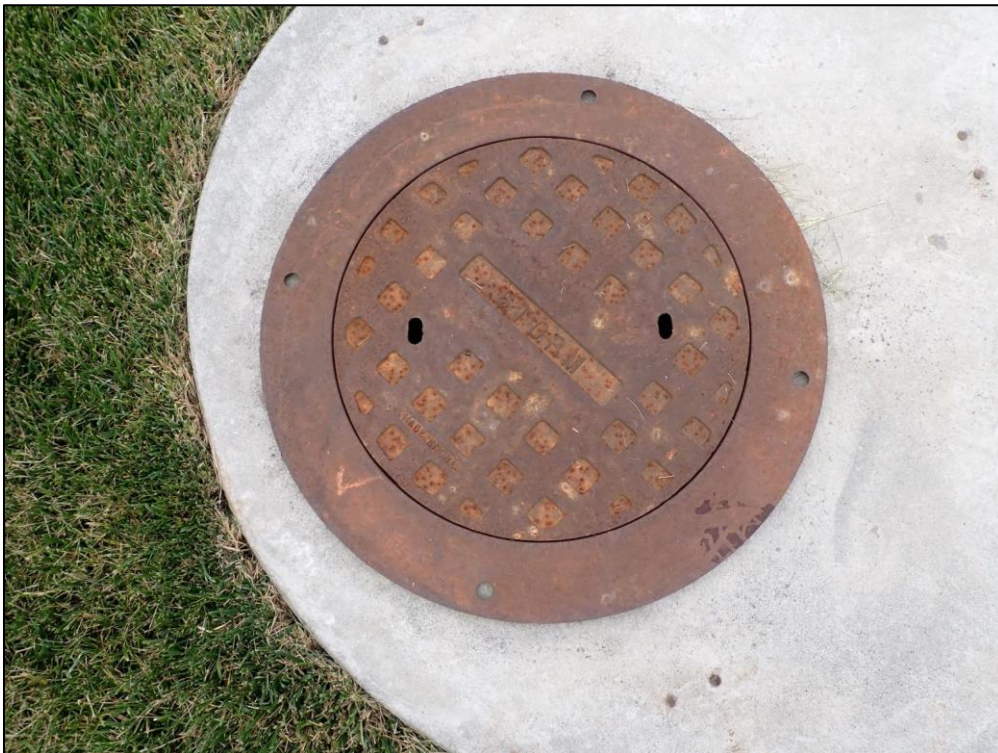
4556: Close-up of Manhole 2. Damage to the access hatch and/or ladder; the collar is not bolted down (Immediate Repair Needed).

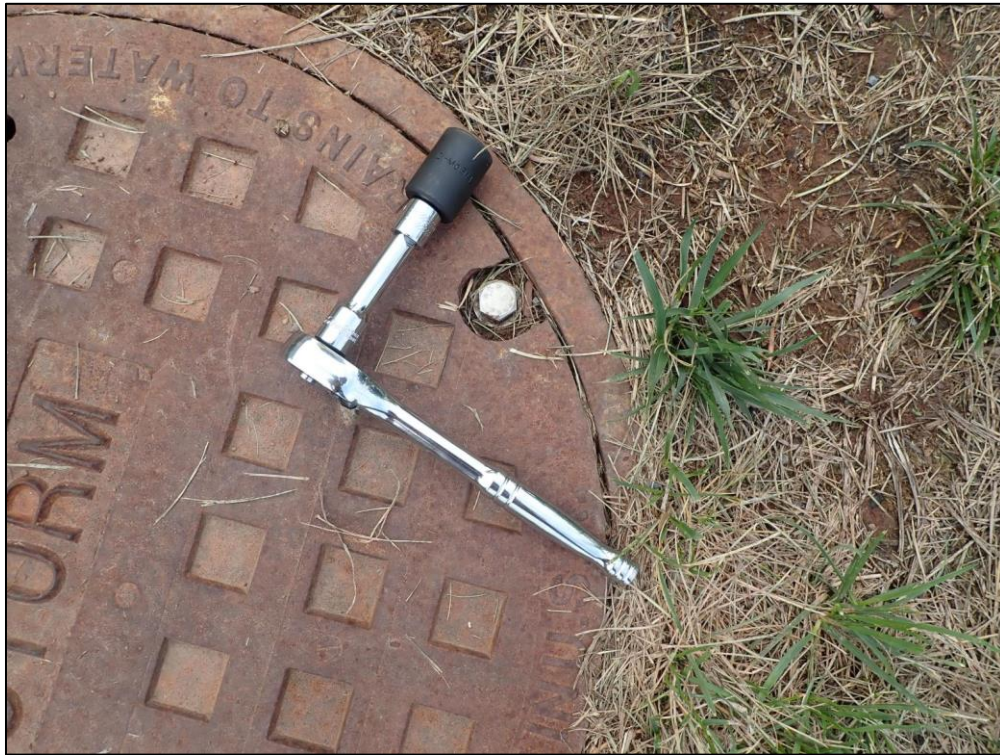
4569: Close-up of the downstream end of Control Structure 12. Inadequate access to complete a thorough inspection; one of the two bolts was stuck (Routine Maintenance Needed).

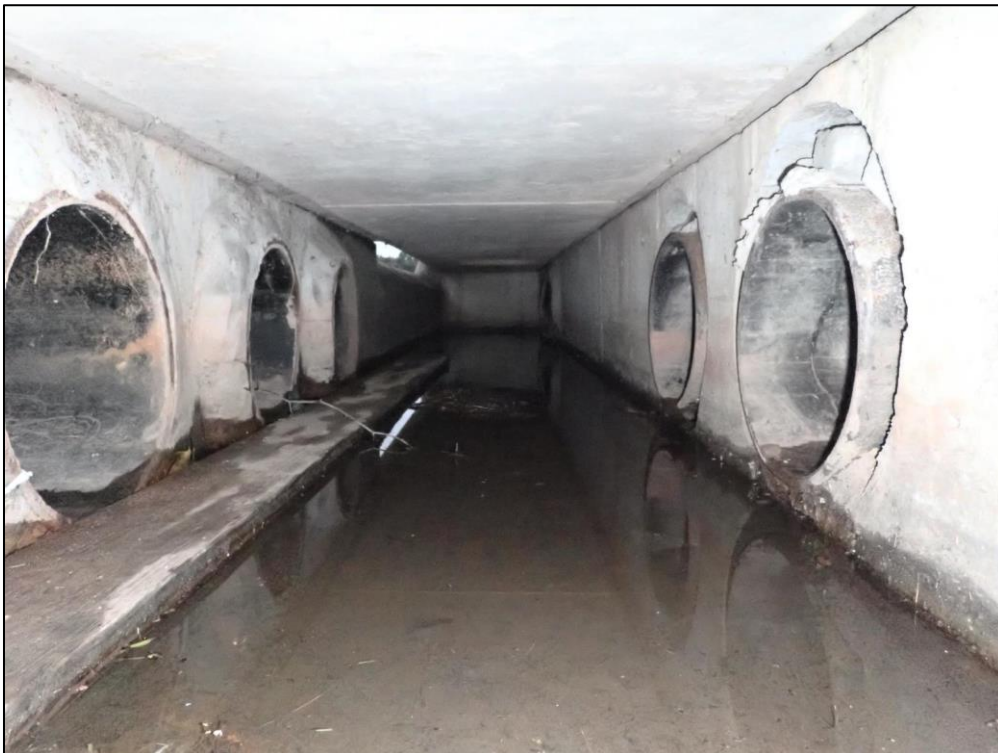
4572: Inside Outfall Structure 11, looking South. Damage to outlet pipe or structure, pipe connections are not sealed (Routine Maintenance Needed).

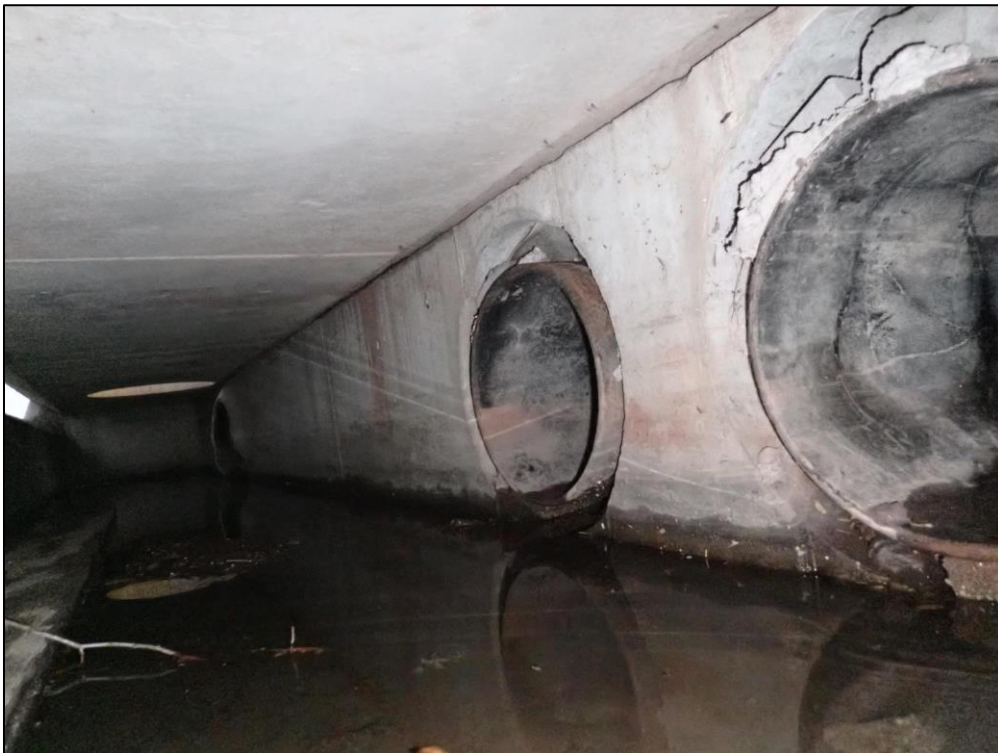
4576: Inside Outfall Structure 11, looking upstream along the Western principal spillway pipe. Damage to outlet pipe or structure, pipe connections are not sealed (Routine Maintenance Needed).
