Wet Pond Inspection Report									
Facility Name	Sumner Pond		Facility ID	STMF0090056	Type of Inspection: Initial Inspection				
Location	Lat: 38.774472 Long: -77.477521		Watershed	Middle Bull Run	Previous 48 Hour Precipitation Total	0.00"			
Materials available for inspection	N/A		Owner Notification Date	N/A	Owners/Owner's Representative	City of Manassas			
Inspector	gky_n	nfreeman	Date of Inspection	6/27/2023	Date of Last Inspection	5/19/2022			
	Overall Condition Score								
	1	Adequate		No deficiencies identified.					
	2	Monitor		No maintenance may be needed at the time, but might become an issue in the future. Will revisit next inspection. Examples include minor erosion, small sediment accumulation, or small structural issues of facility components.					
3	3	Routine Maintenance Needed		Facility is functional but preventative maintenance is required. Examples includes vegetation management, minor erosion, or trash/debris removal.

Facility ID: STMF0090056 Inspection Date: 06/27/2023

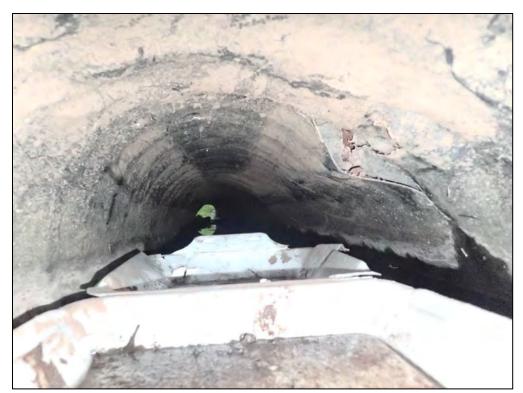
4384: Inflow 3, front. Buildup of trash, debris, and sediment (Routine Maintenance Needed).

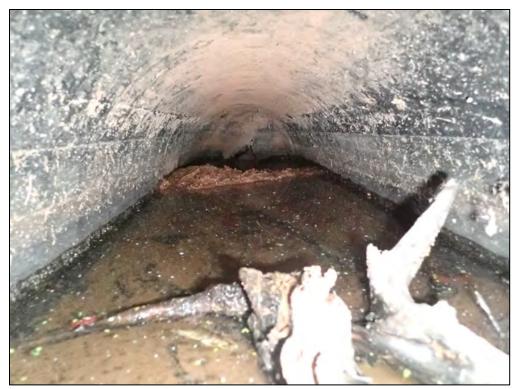
Inflow 7, the pipe appears to be at least partially collapsed and obstructing flow. Immediate repair is needed at this location.

4411: Inside Inflow 7. Buildup of trash, debris, and sediment. Pipe appears to be collapsed (Immediate Repair Needed).

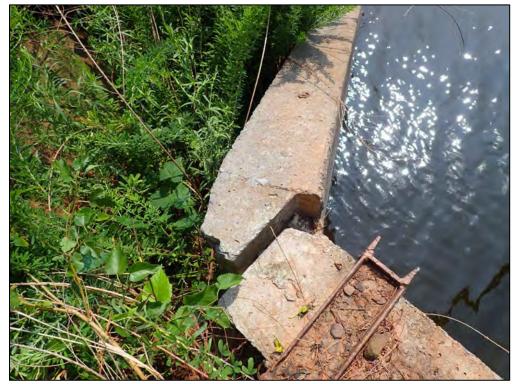
1	Evidence of nuisance animals								
3	Damage to inlet pipe or structure	Spalling/deterioration at Inflow 2 and Inflow 6.	4827, 4828, 4875

4827: Inflow 2, closeup. Damage to inlet pipe or structure (Routine Maintenance Needed).

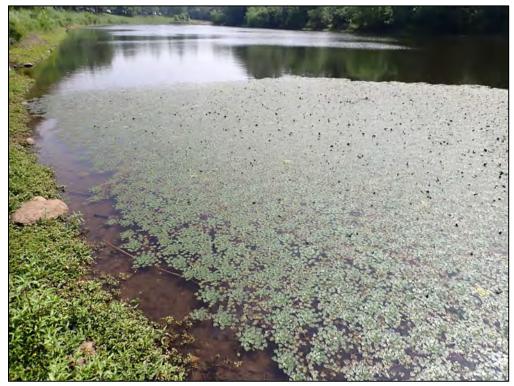
4833: Impoundment area, overall. Ponding area is showing signs of poor health (i.e., nutrient overload, excess aquatic vegetation, or turbidity), Invasive species Trapa sp. (Immediate Repair Needed).

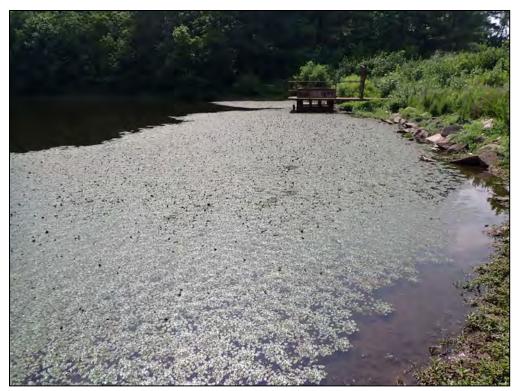
4834: Impoundment area, overall. Ponding area is showing signs of poor health (i.e., nutrient overload, excess aquatic vegetation, or turbidity), Invasive species Trapa sp. (Immediate Repair Needed).

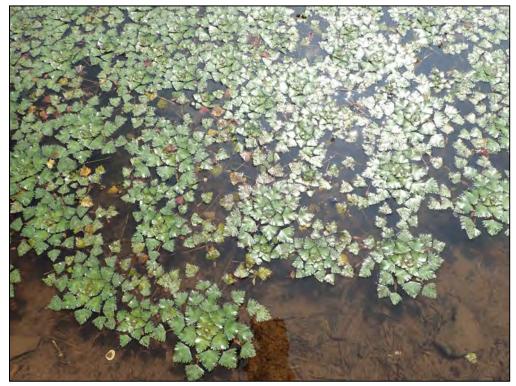
4835: Impoundment area, closeup. Ponding area is showing signs of poor health (i.e., nutrient overload, excess aquatic vegetation, or turbidity), Invasive species Trapa sp. (Immediate Repair Needed).

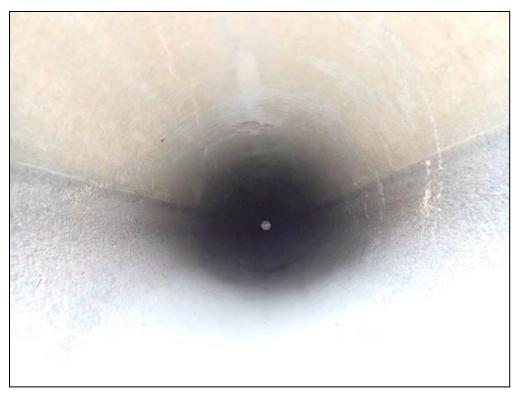
4875: Inflow 6, closeup. Damage to inlet pipe or structure (Routine Maintenance Needed).

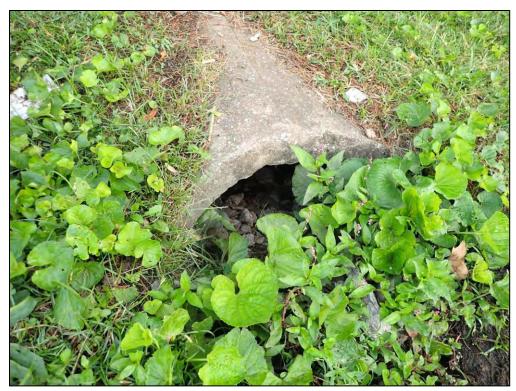
4890: Inflow 1, closeup. Buildup of trash, debris, and sediment (Immediate Repair Needed).

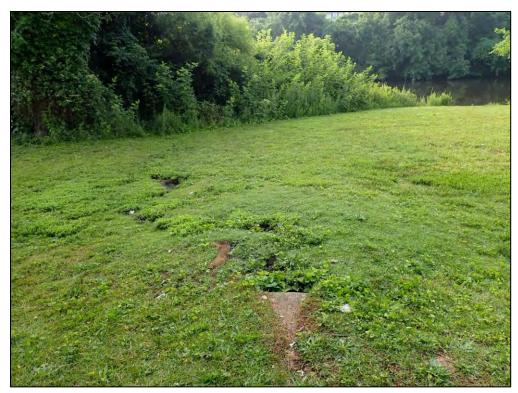
4892: From Inflow 1, looking downstream. Buildup of trash, debris, and sediment (Immediate Repair Needed).

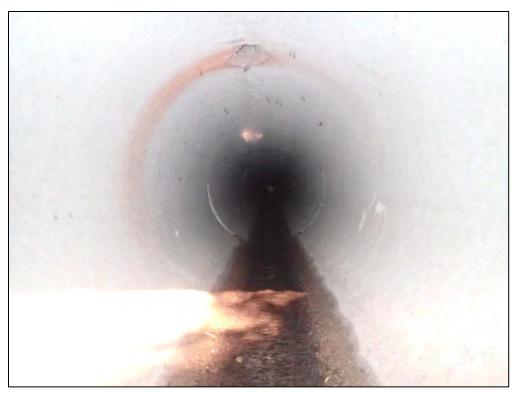
4901: Inflow Structure EX. EW-1, closeup. Damage to inlet pipe or structure, Spalling (Routine Maintenance Needed).

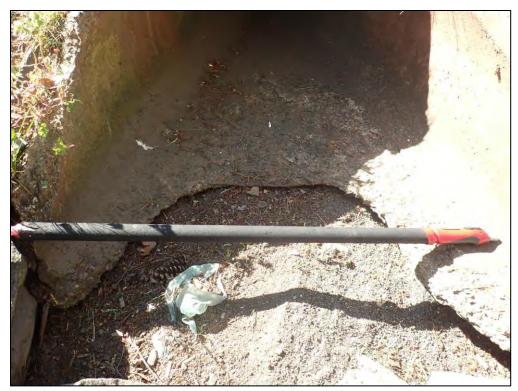
inlet	Cubic Feet).	3333		
1	Woody growth around inlet structure				
1	Evidence of nuisance animals				
		Inflow 4, spalling (2 bags of concrete) and			
		joint separation (6.28 Linear Feet), Inflow 6,	9593, 9594, 9600, 962 9632		
3	Damage to inlet pipe or structure	joint separation (6.28 Linear Feet), Inflow			
		Structure 9, joint separation (7.85 Linear			
		Feet).

9593: Inflow 4, closeup. Damage to inlet pipe or structure (Routine Maintenance Needed).

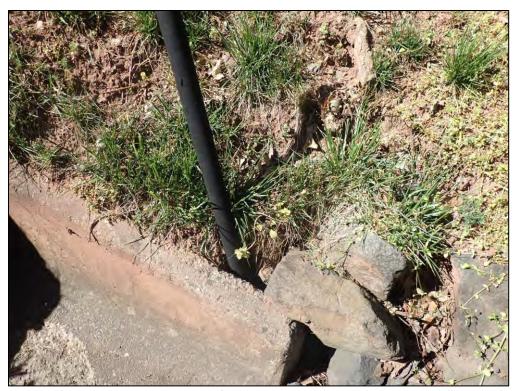
In	spection Items			
Score	Description	Comment(s) / Corrective Action(s)	Reference Image		
		Overall			
1	Inadequate access to complete thorough				
	inspection				
1	Fences are damaged or have vegetation				
	growing on them				
1	Missing or damaged safety signage				
1	Mosquitos				
	Surrounding drainage area				
1	trash/debris/unauthorized substances that				
	might affect facility				
1	Surrounding drainage area erosion that might				
т.	be related to facility				
	P	re-Treatment			
1	Buildup of trash or debris				
1	Signs of erosion or exposed soil				
4	Sediment in forebay has reached 50% or				
1	more of capacity				
1	Evidence of clogging				
1	Vegetation does not match original design				
		Inlet			
		Inflow Structure EX. 19 (7 Cubic Feet), Inflow			
3	Buildup of trash, debris, and sediment	4 (4 Cubic Feet), Inflow 5 (4 Cubic Feet),	9573, 9596, 9602, 9631,9		
		Inflow Structure 9 (8 Cubic Feet).			
2	Evidence of erosion or undermining around	Erosion observed adjacent to Inflow 4 (0.5	9595

9595: Inflow 4, closeup. Evidence of erosion or undermining around inlet (Monitor).

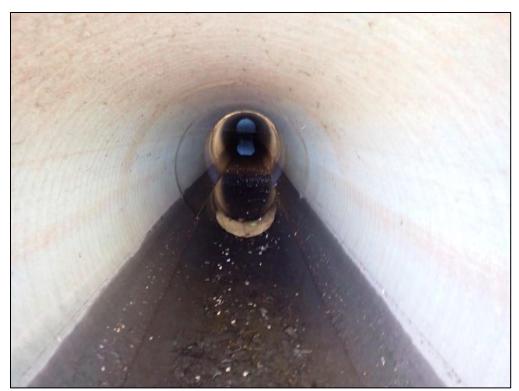
9600: Inflow 5, closeup. Damage to inlet pipe or structure (Monitor).

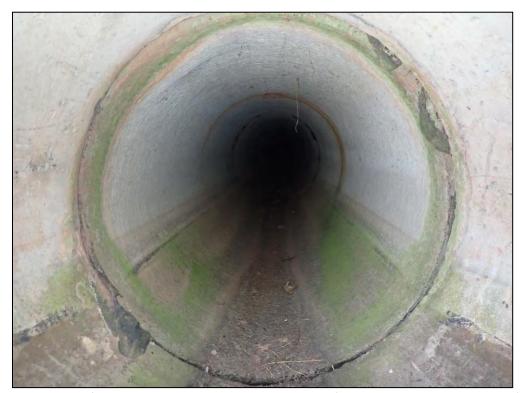
9624: Inside Inflow 6. Damage to inlet pipe or structure (Routine Maintenance Needed).

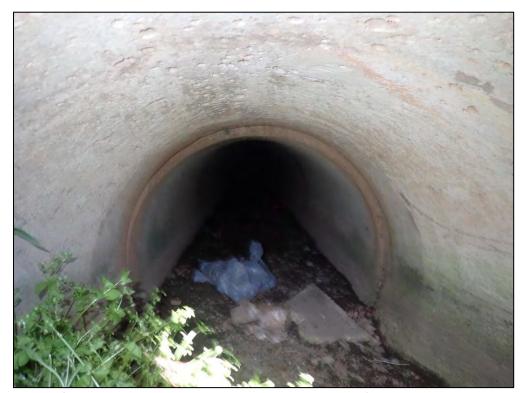
9631: Inflow Structure 9, front. Buildup of trash, debris, and sediment (Immediate Repair Needed).

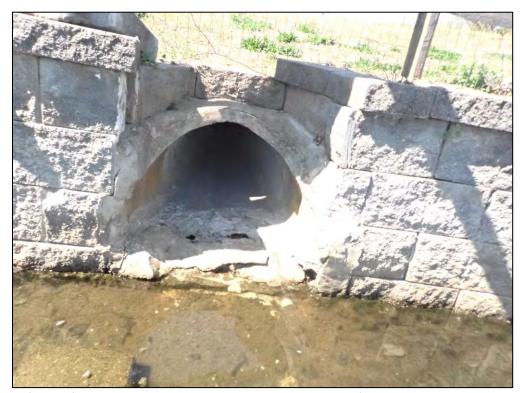
3	Damage to inlet pipe or structure	Spalling observed at Inflow 3 (1 bag of concrete).	9520, 9522

9520: Inflow 3, front. Damage to inlet pipe or structure, Spalling(Routine Maintenance Needed).

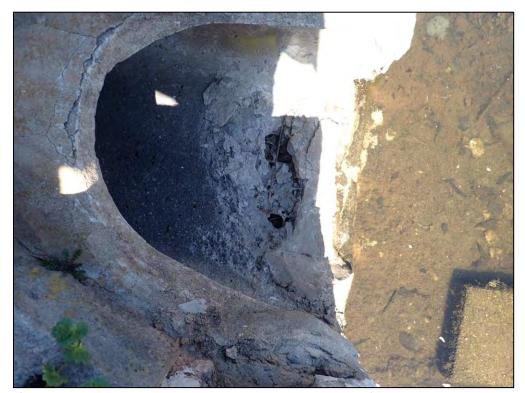
9522: Inflow 3, closeup. Damage to inlet pipe or structure, Spalling (Routine Maintenance Needed).

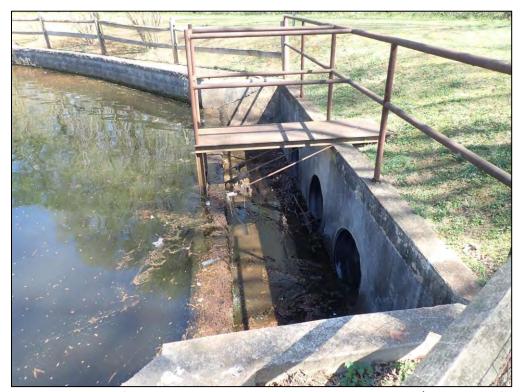
-	BMP device is deteriorated, misaligned,	Dewatering valve control missing and not	
4	and/or damaged	fully closed.	9543, 9544, 9546, 9547
1	BMP device is missing	runy ciosea.	
	Low-level gate drain is accessible and		
1	operational. Drain has been exercised in last		
1	three years.		
1	Trash, debris, or other material in BMP device		
1			
	Princi	pal Spillway Pipe	
1	Spillway is blocked by debris or sediment		
1	Evidence of leaking joints		
1	- -		
1	One or more sections of the pipe have settled to the point that it threatens the integrity of		
_	the dam		
		nt Area and Side Slopes	
1	Buildup of trash and debris	•	
	· ·		
1	Silt and sedimentation buildup		
	Ponding area is showing signs of poor health		
1	(i.e. nutrient overload, excess aquatic vegetation, or turbidity)		
4	Signs of erosion along shoreline		
1	Signs of erosion along shoreline		
1	Sparse vegetation or erosion		
1	Evidence of nuisance animals		
	Outfall St	ructure and Channel

9544: Control Structure 11, front. BMP device is deteriorated, misaligned, and/or damaged (Immediate Repair Needed).

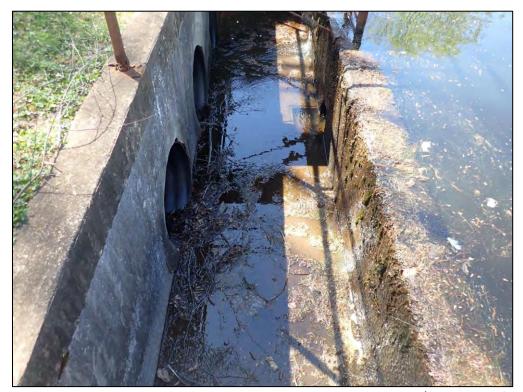
9546: Inside Control Structure 11. BMP device is deteriorated, misaligned, and/or damaged (Immediate Repair Needed).

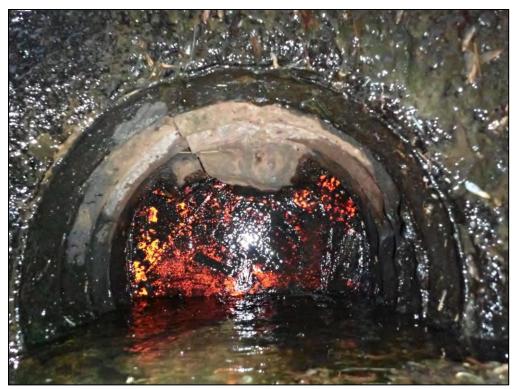
The dewatering valve orifice was not entirely closed, and no control apparatus for it was found.

9547: Inside Control Structure 11, looking upstream toward the dewatering valve orifice. BMP device is deteriorated, misaligned, and/or damaged (Immediate Repair Needed).

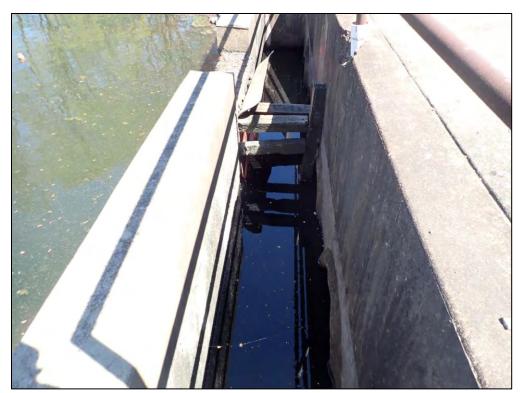
9465: Inside Control Structure 13. Trash, debris, or other material in BMP device (Immediate Repair Needed). BMP device is deteriorated, misaligned, and/or damaged (Immediate Repair Needed).

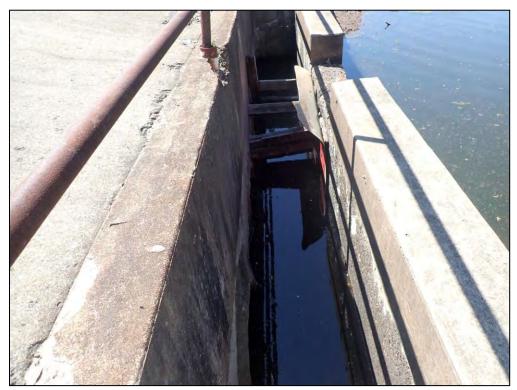
9466: Inside Control Structure 13. Trash, debris, or other material in BMP device (Immediate Repair Needed). BMP device is deteriorated, misaligned, and/or damaged (Immediate Repair Needed).

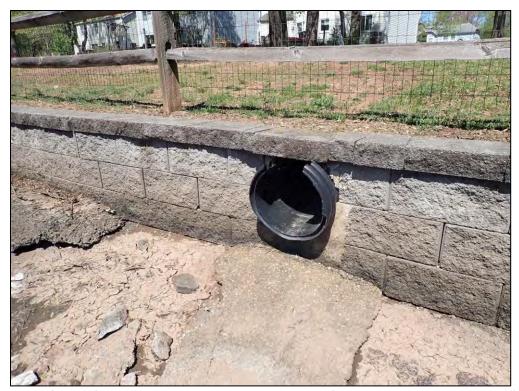
9475: Inflow 1, front. Damage to inlet pipe or structure (Routine Maintenance Needed).

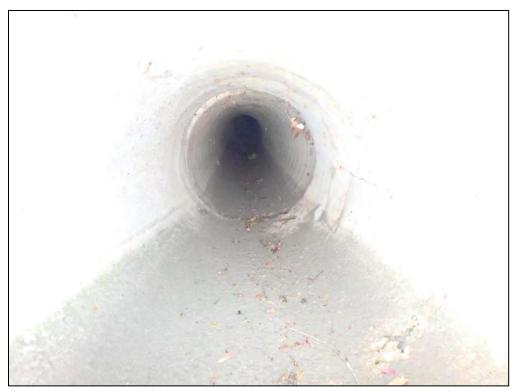
9481: Inside Inflow 3. Damage to inlet pipe or structure (Monitor).

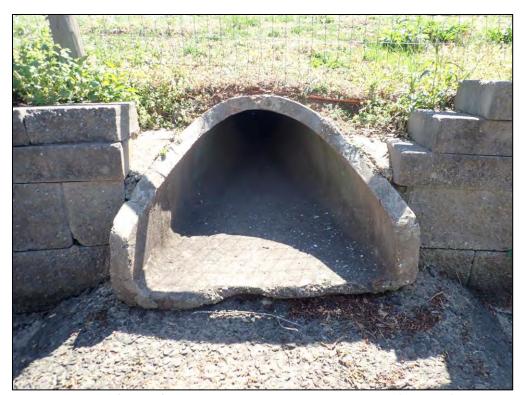
9485: Inflow 4, front. Damage to inlet pipe or structure (Monitor).

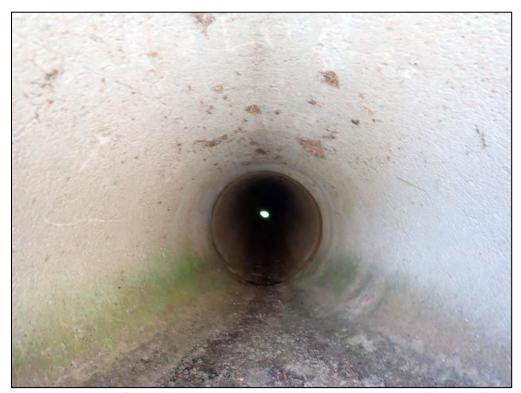
9498: Inside Inflow Structure 3. Damage to inlet pipe or structure (Monitor).

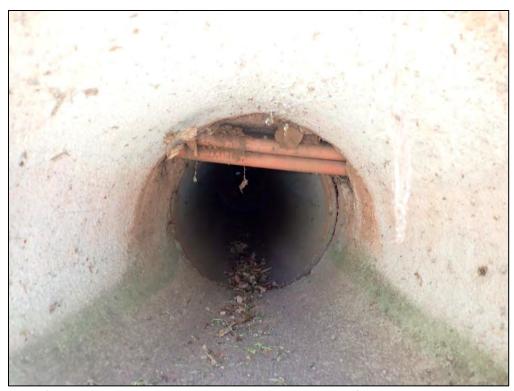
9404: Inflow Structure 15. Damage to inlet pipe or structure (Immediate Repair Needed).

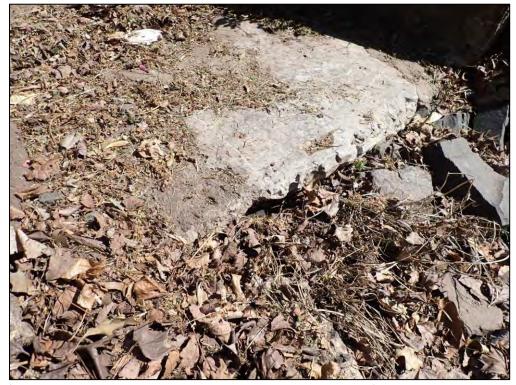
9405: Inflow Structure 15, closeup. Damage to inlet pipe or structure (Routine Maintenance Needed).

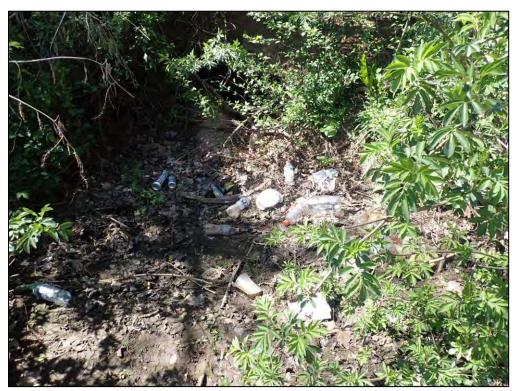
9419: Control Structure 1A, front. Trash, debris, or other material in BMP device (Immediate Repair Needed).

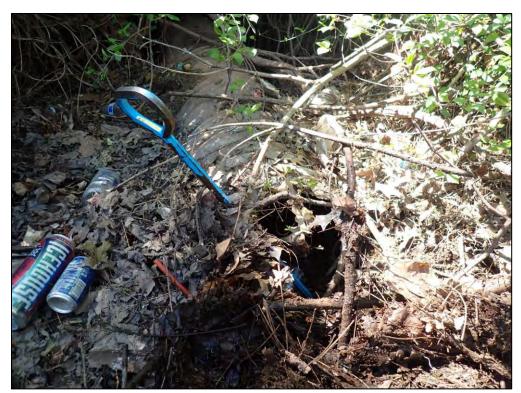
9420: Control Structure 1A, closeup. Trash, debris, or other material in BMP device (Immediate Repair Needed).

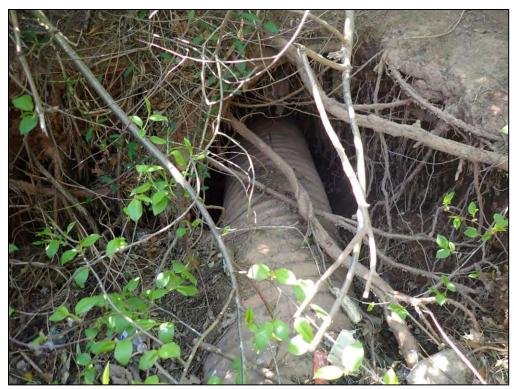
9422: Control Structure 1A, closeup. Signs of erosion, settlement, piping, or slope slippage (Immediate Repair Needed).

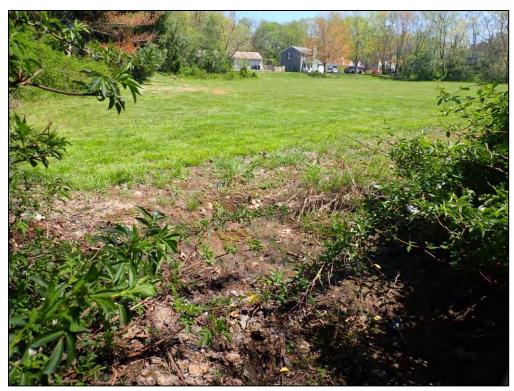
9423: Control Structure 1A, closeup. Signs of erosion, settlement, piping, or slope slippage (Immediate Repair Needed).

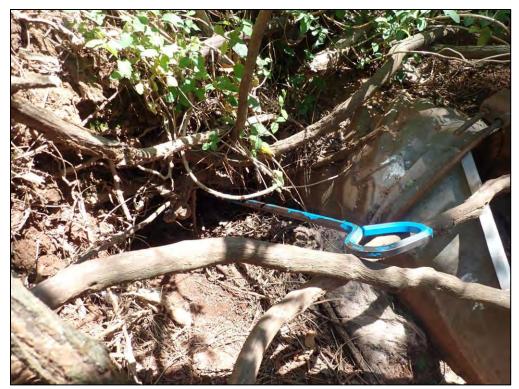
9432: Outfall Structure 1B, closeup. Signs of erosion, settlement, piping, or slope slippage (Immediate Repair Needed).

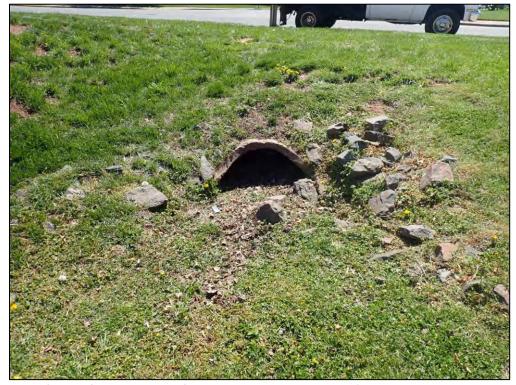
9435: Inflow 1, front. Buildup of trash, debris, and sediment (Immediate Repair Needed).

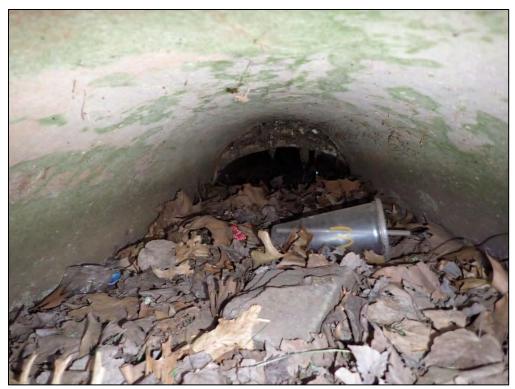
9436: Inside Inflow 1. Joint Separation (Immediate Repair Needed). Buildup of trash, debris, and sediment (Immediate Repair Needed).

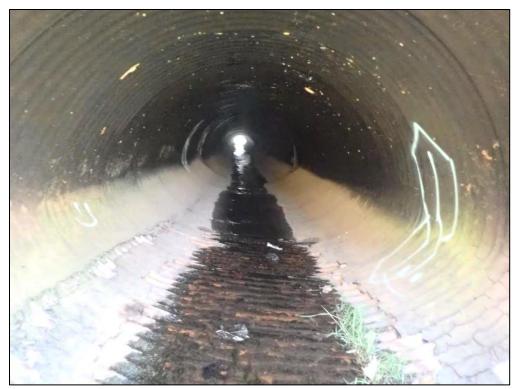
2865: Inside Control Structure E-2. BMP device is deteriorated, misaligned, and/or damaged (Routine Maintenance Needed).

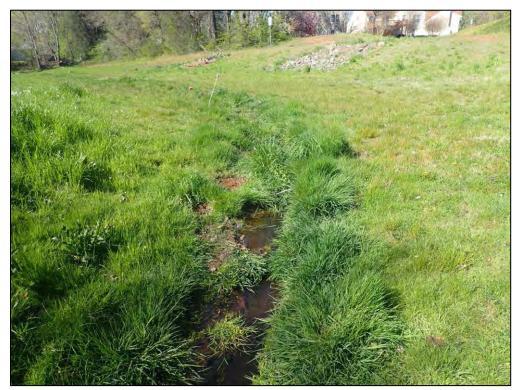
2866: From Control Structure E-2, looking upstream. Low-flow ditch is clogged with sediment/debris (Routine Maintenance Needed).

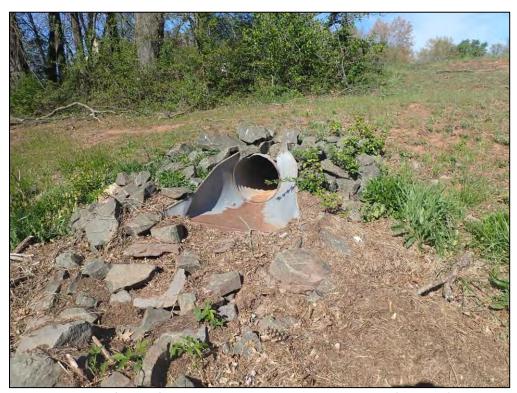
2872: Inflow 2, front. Damage to inlet pipe or structure (Monitor).

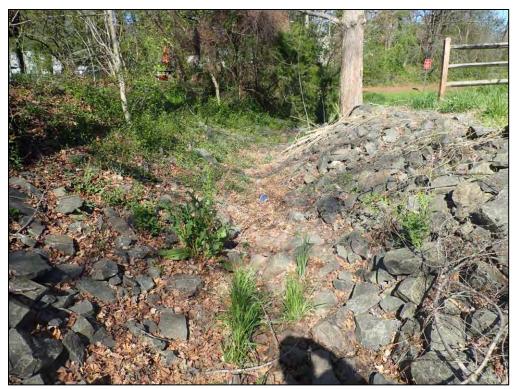
2887: From Inflow E-3, looking downstream. Buildup of trash, debris, and sediment (Routine Maintenance Needed).

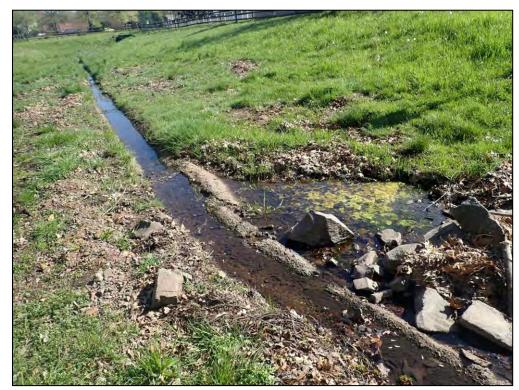
2888: Trickle Ditch, closeup. Sections of the low-flow dich are cracked or showing signs of undercutting (Routine Maintenance Needed).

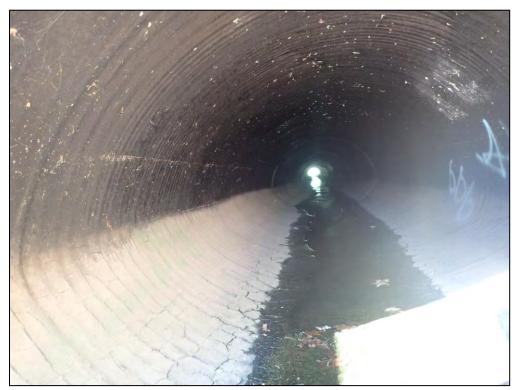
2890: Outfall Structure E-1, inside. Outfall structure is damaged or rusting (Routine Maintenance Needed).

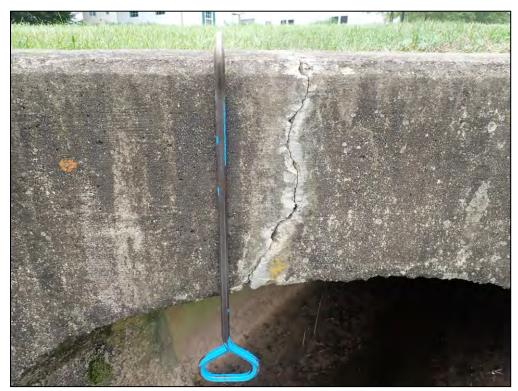
4684: Inflow Structure 1, closeup of the Middle Southern pipe. Damage to inlet pipe or structure, Cracking (Routine Maintenance Needed).

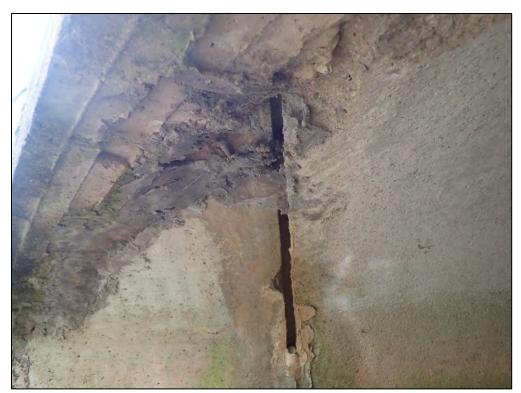
4687: Inflow Structure 1, closeup of the Middle Southern pipe. Damage to inlet pipe or structure, Spalling (Routine Maintenance Needed).

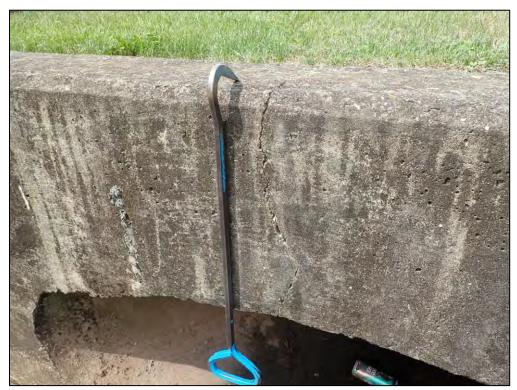
4688: Inflow Structure 1, closeup of the middle Northern pipe. Damage to inlet pipe or structure, Spalling (Routine Maintenance Needed).

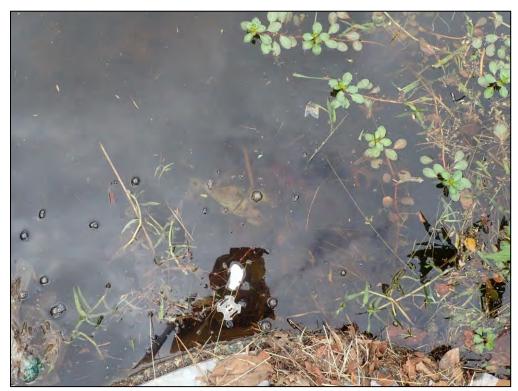
4708: Control Structure 23, closeup of the low-flow orifice. The low-flow orifice is blocked (Immediate Repair Needed).
