Infiltration Trench Inspection Report					
Facility Name	Fairview Riverdale	Facility ID	STMF0090080	Type of Inspection: Initial Inspection	
Location	Lat: 38.747968 Long: -77.460524	Watershed	Lower Bull Run	Previous 48 Hour Precipitation Total	0.35"
Materials available for inspection	N/A	Owner Notification Date	N/A	Owners/ Owner's Representative	City of Manassas
Inspectors	gky_mfreeman	Date of Inspection	6/28/2023	Date of Last Inspection	3/29/2022
Overall Condition Score					
	1	Adequate	No deficiencies identified.		
	2	Monitor	No maintenance may be needed at the time, but might become an issue in the future. Will revisit next inspection. Examples include minor erosion, small sediment accumulation, or small structural issues of facility components.		
	3	Routine Maintenance Needed	Facility is functional but preventative maintenance is required. Examples includes vegetation management, minor erosion, or trash/debris removal.

Facility ID: STMF0090080
Facility Name: Fairview Riverdale

Inspection Date: 06/28/2023

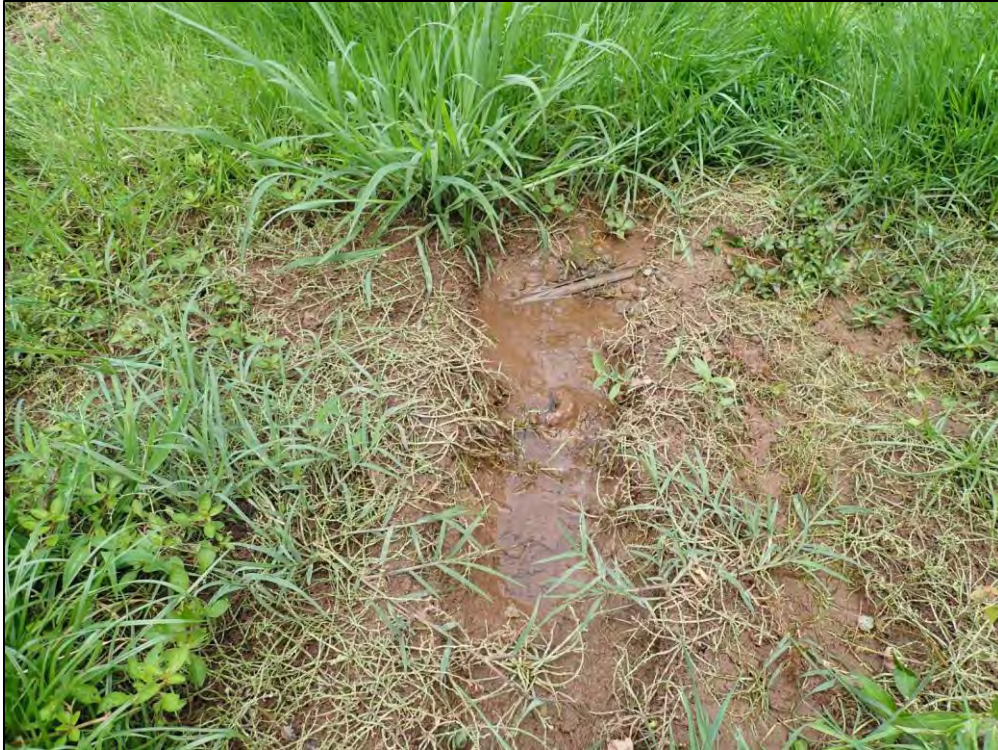
4801: Close-up showing the Gravel Detail. Evidence of clogging (Immediate Repair Needed).

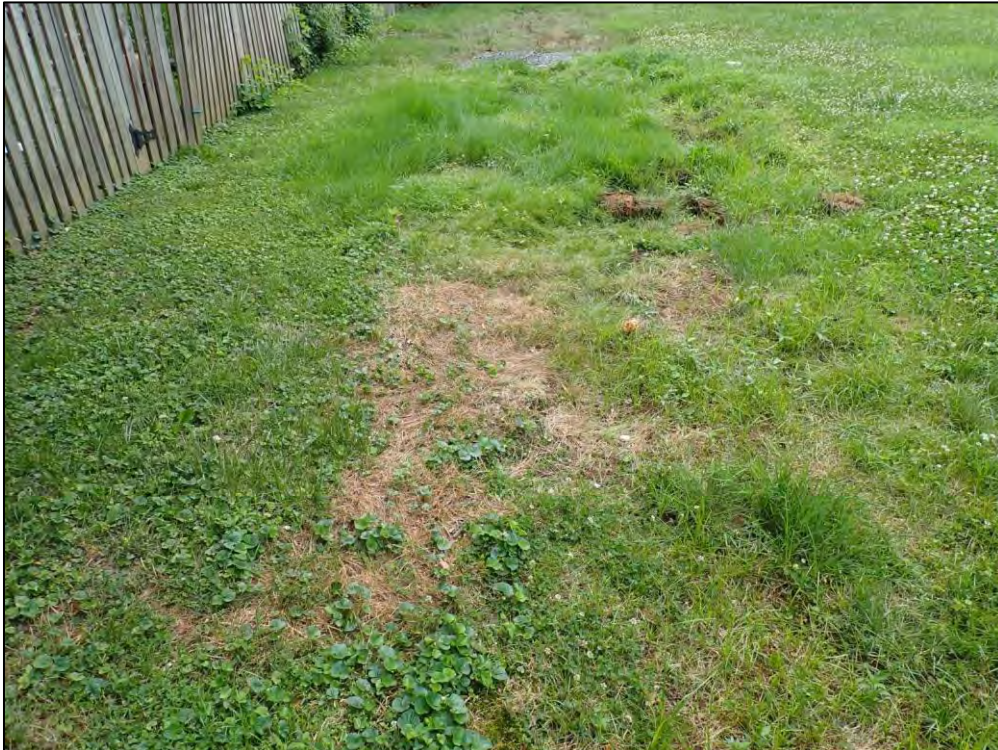
4802: Closeup of the Gravel Bed. Evidence of clogging (Immediate Repair Needed).

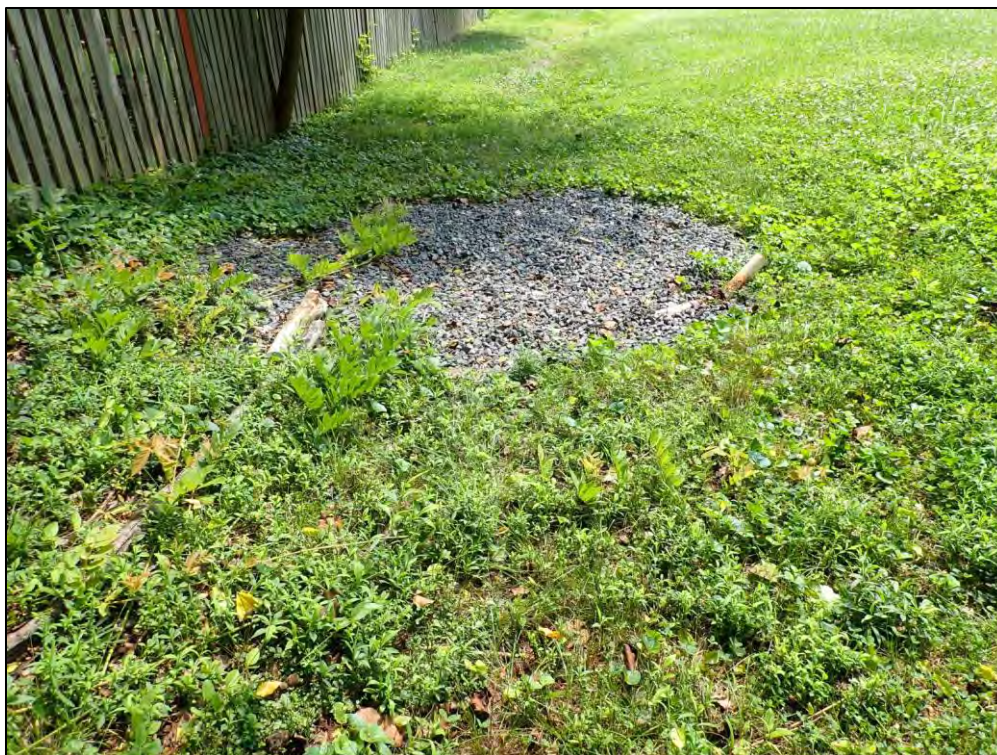
4805: Another close-up showing the Gravel detail. Evidence of clogging (Immediate Repair Needed).

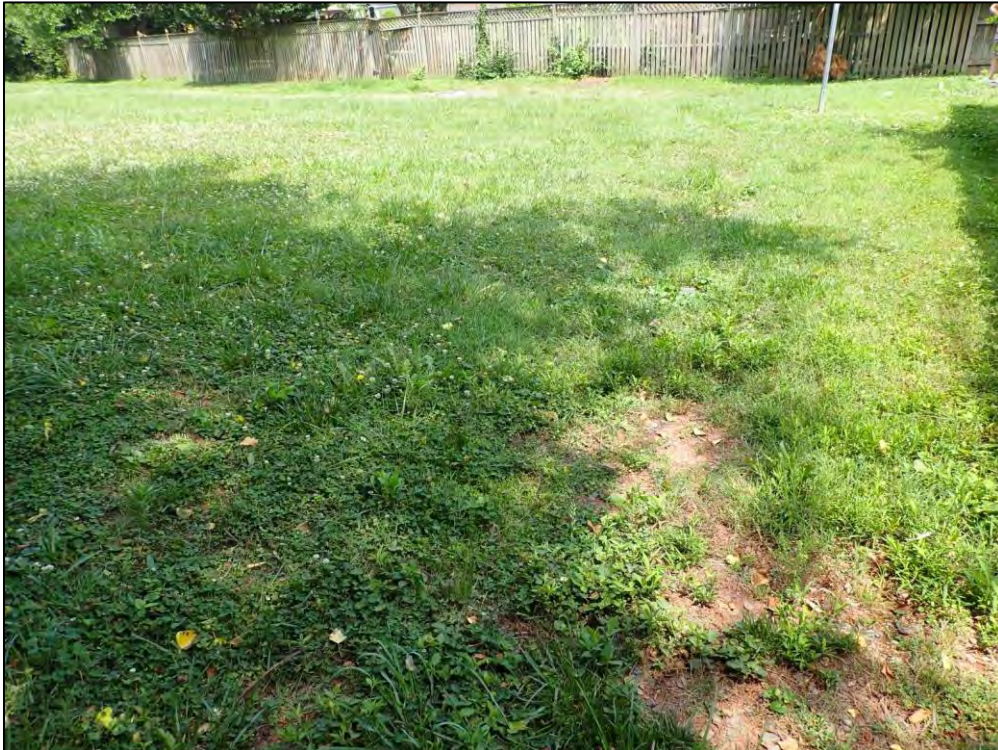
4811: Gravel detected approximately 3" beneath the surface. Evidence of clogging (Immediate Repair Needed).

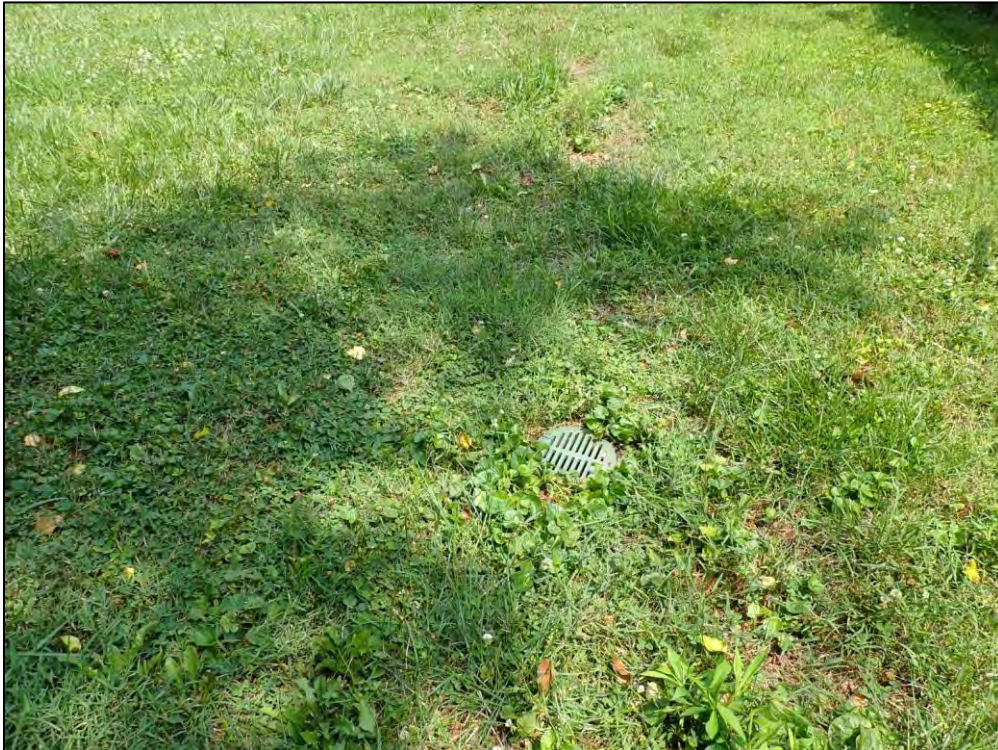
4813: Another close-up showing the Gravel Detail. Evidence of clogging (Immediate Repair Needed).

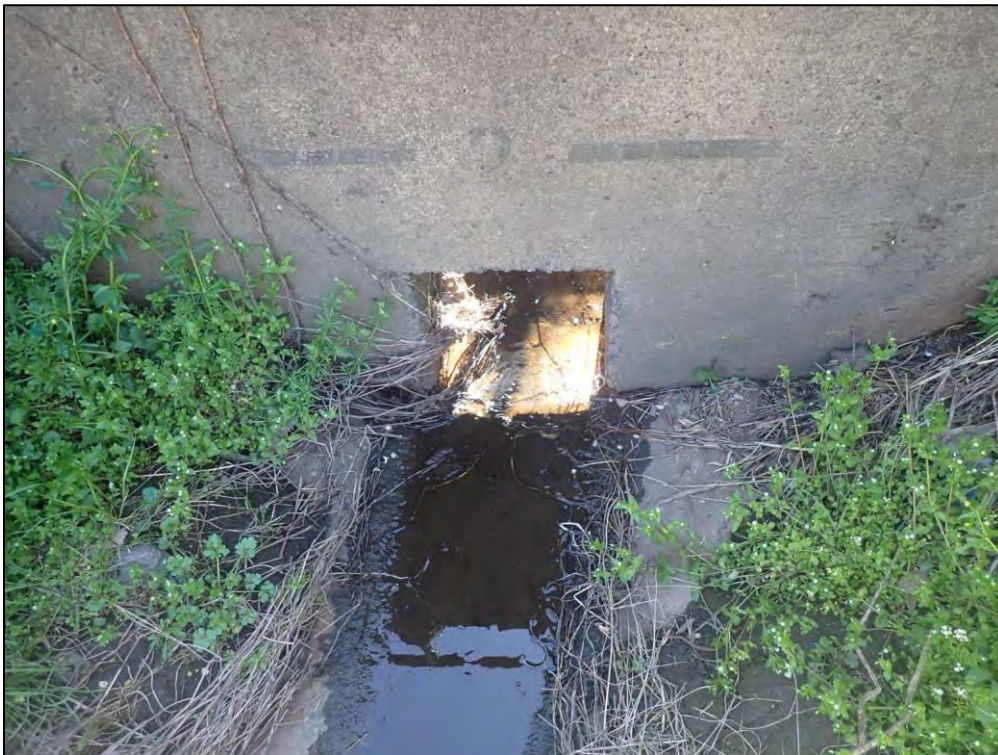
3	Trash, debris, or other material in BMP device	Trash and debris observed in and adjacent to Control Structure 3 (12 Cubic Feet)	2836
Principal Spillway Pipe			
1	Spillway is blocked by debris or sediment		
1	Evidence of leaking joints		
1	One or more sections of the pipe have settled to the point that it threatens the integrity of the dam		
Impoundment Area and Side Slopes			
1	Buildup of trash and debris		
3	Silt and sedimentation buildup	Sediment observed covering the trickle ditch. Remove sediment in the trickle ditch (180 Linear Feet)	2849
3	Ponding area is showing signs of poor health (i.e. nutrient overload, excess aquatic vegetation, or turbidity)	Cattails observed growing within the facility (8,250 Square Feet).	2859, 2861
1	Signs of erosion along shoreline		
1	Low-flow ditch is clogged with sediment/debris		
1	Sections of low-flow ditch are cracked or showing signs of undercutting		
1	Sparse vegetation or erosion

2836: Control Structure 3, front. Trash, debris, or other material in BMP device (Routine Maintenance Needed).

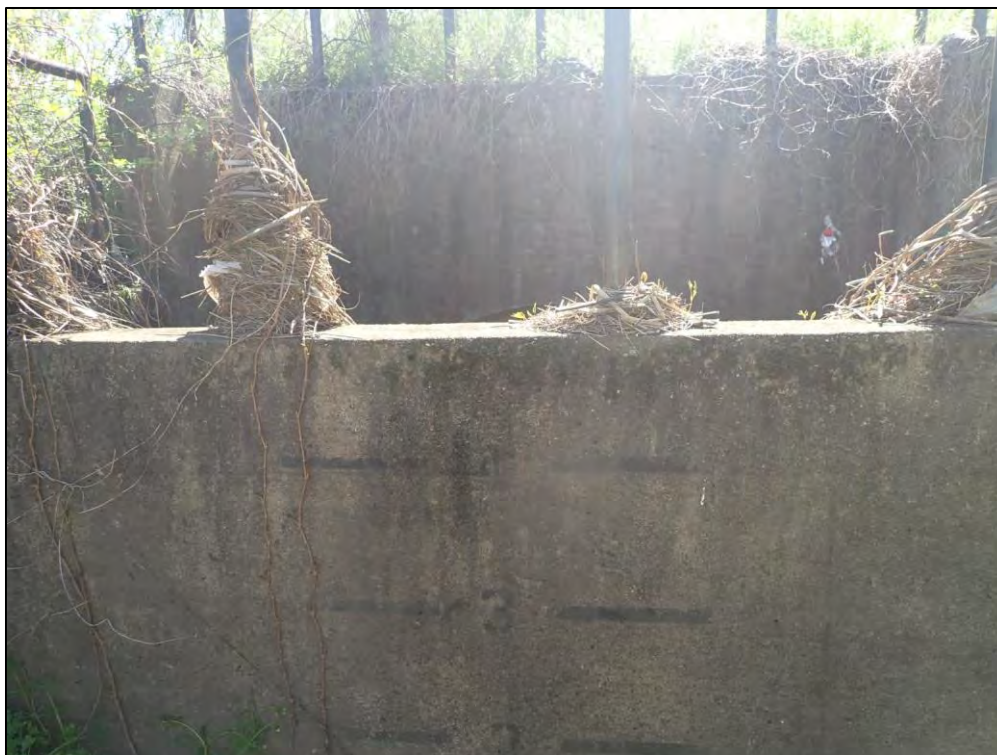
2837: Control Structure 3, low-flow orifice close-up. BMP Orifice Plate is missing (Immediate Repair Needed).

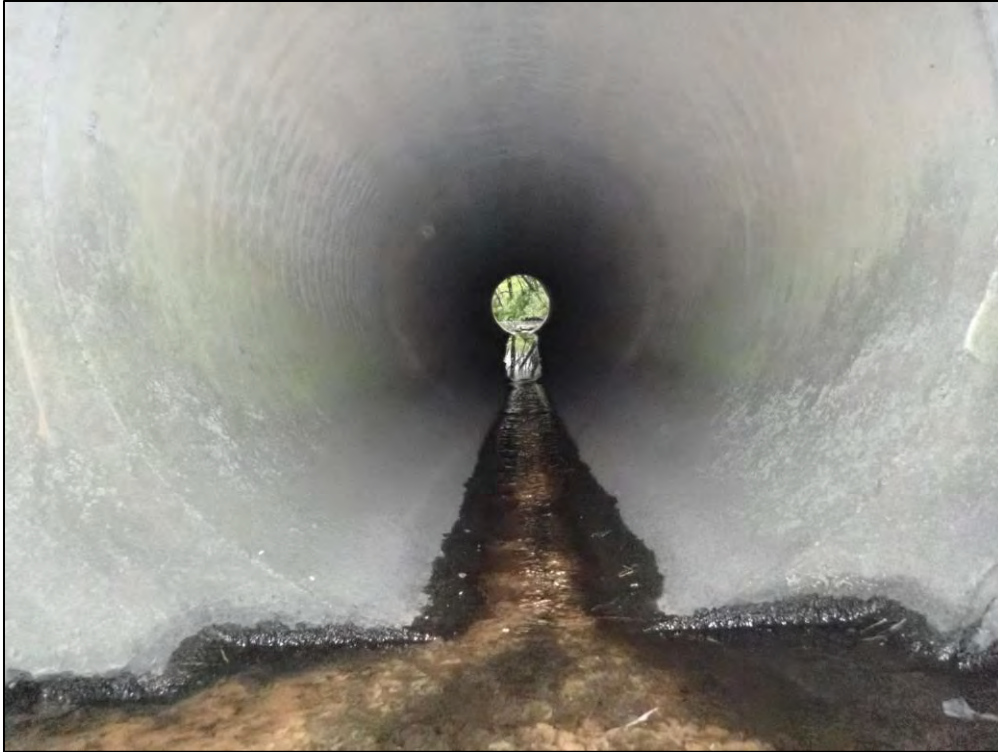
2841: Inside Control Structure 3, looking upstream toward the low-flow orifice. Orifice Plate is missing (Immediate Repair Needed).

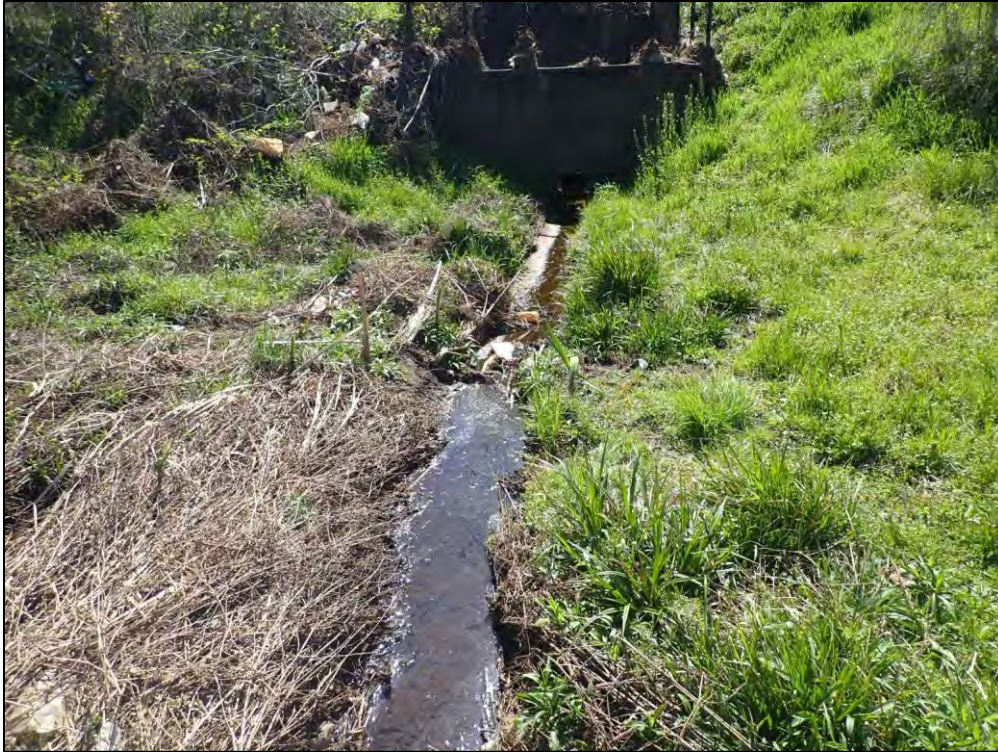
2849: Looking upstream along the Trickle Ditch toward Inflow Structure 2. Sediment observed within the trickle ditch. (Routine Maintenance Needed).

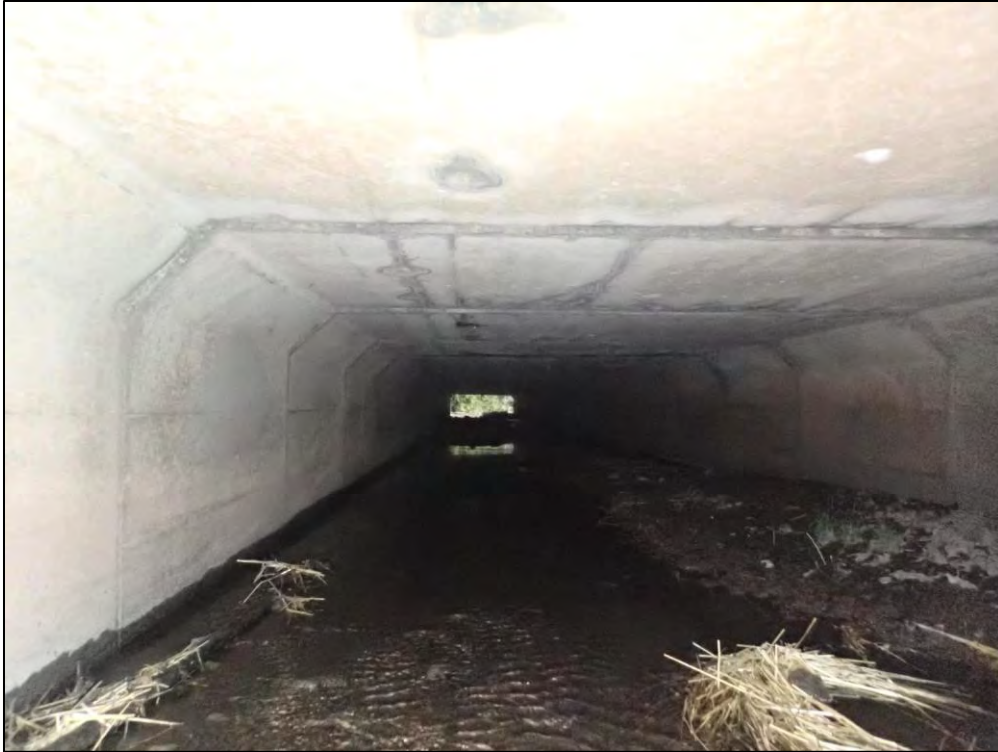
2782: Inside Inflow 4, looking along the Middle pipe. Buildup of trash, debris, and sediment (Routine Maintenance Needed).

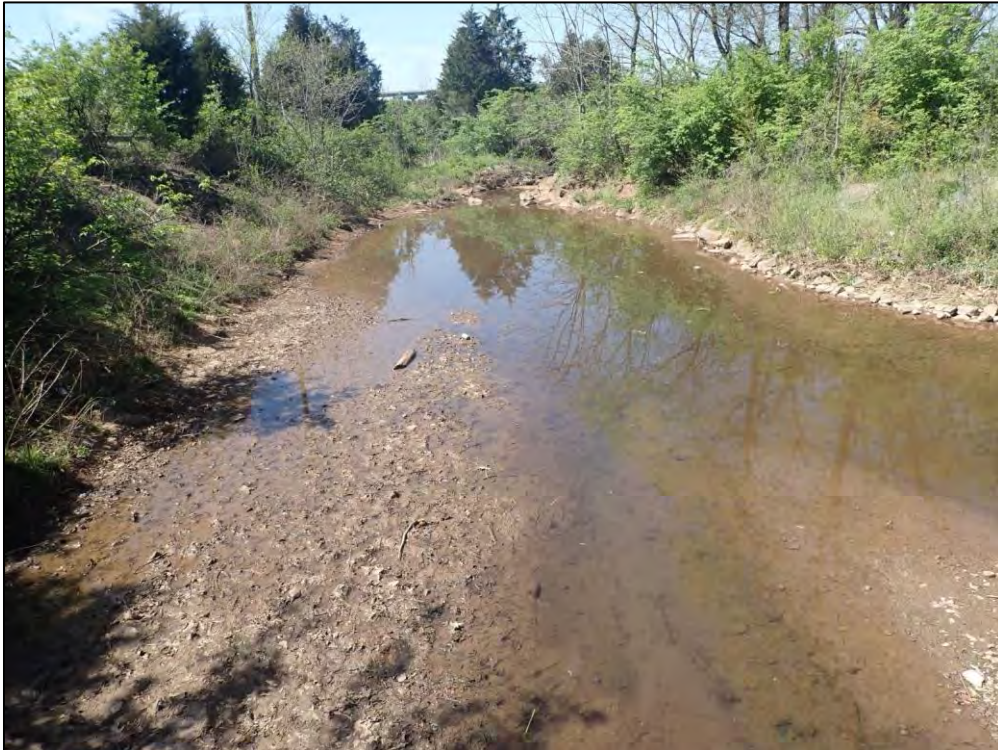
2783: Inside Inflow 4, looking along the Southern pipe. Buildup of trash, debris, and sediment (Immediate Repair Needed).

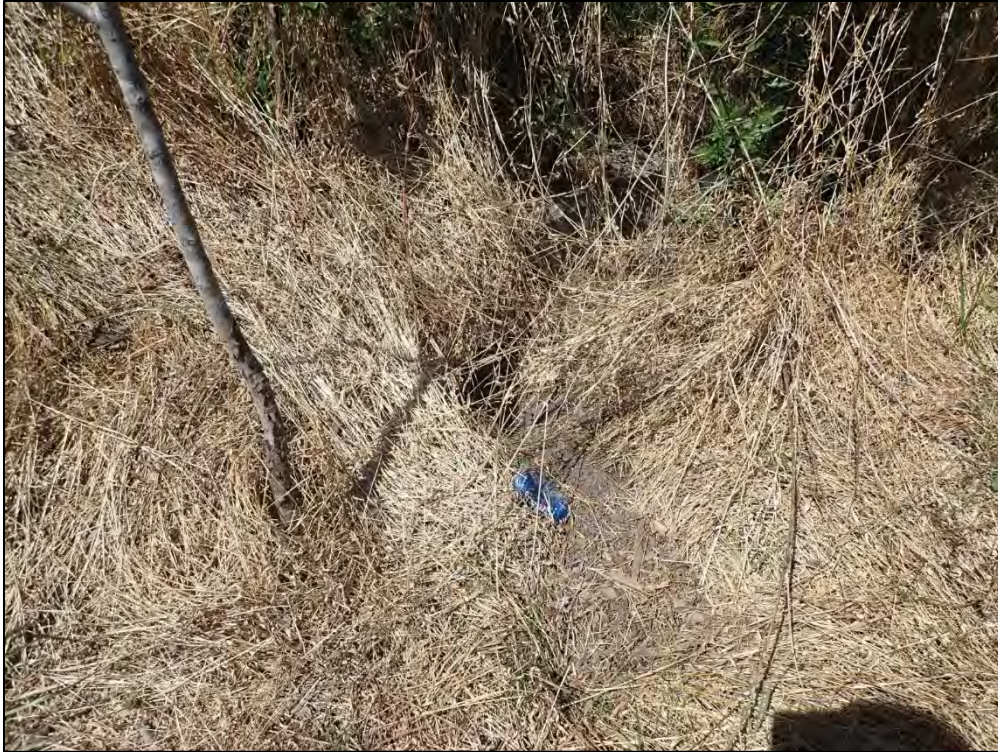
2804: From Inflow 7, looking downstream. Buildup of trash, debris, and sediment (Monitor).

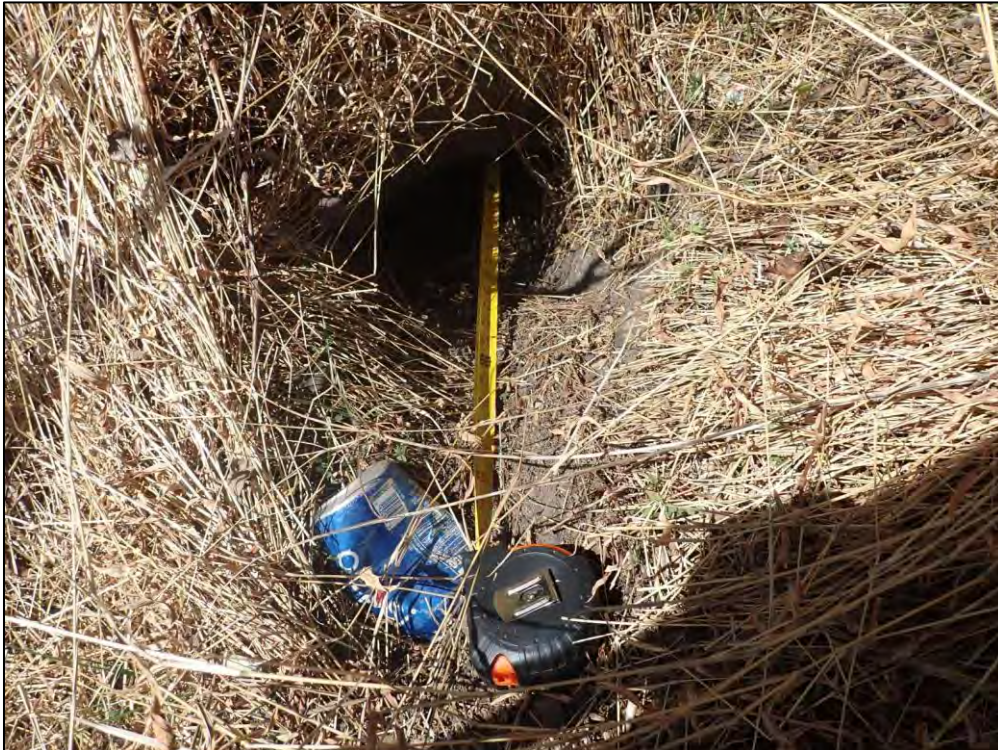
2805: Inflow 8, overall. Buildup of trash, debris, and sediment (Immediate Repair Needed).

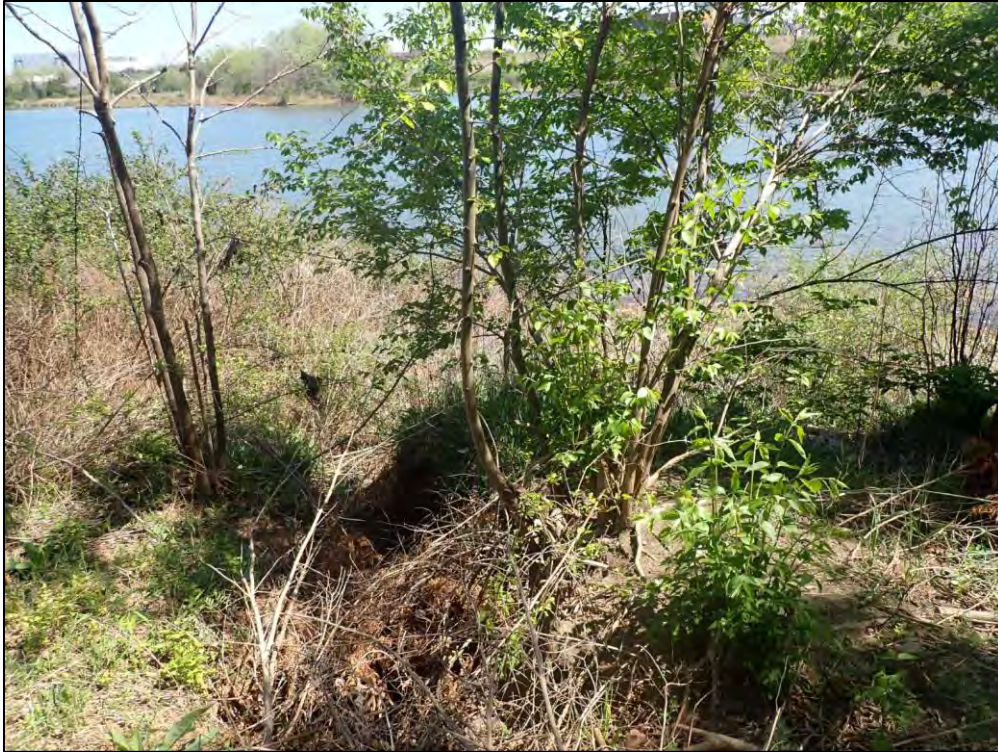
2810: Inside Inflow 9. Damage to inlet pipe or structure (Routine Maintenance Needed).

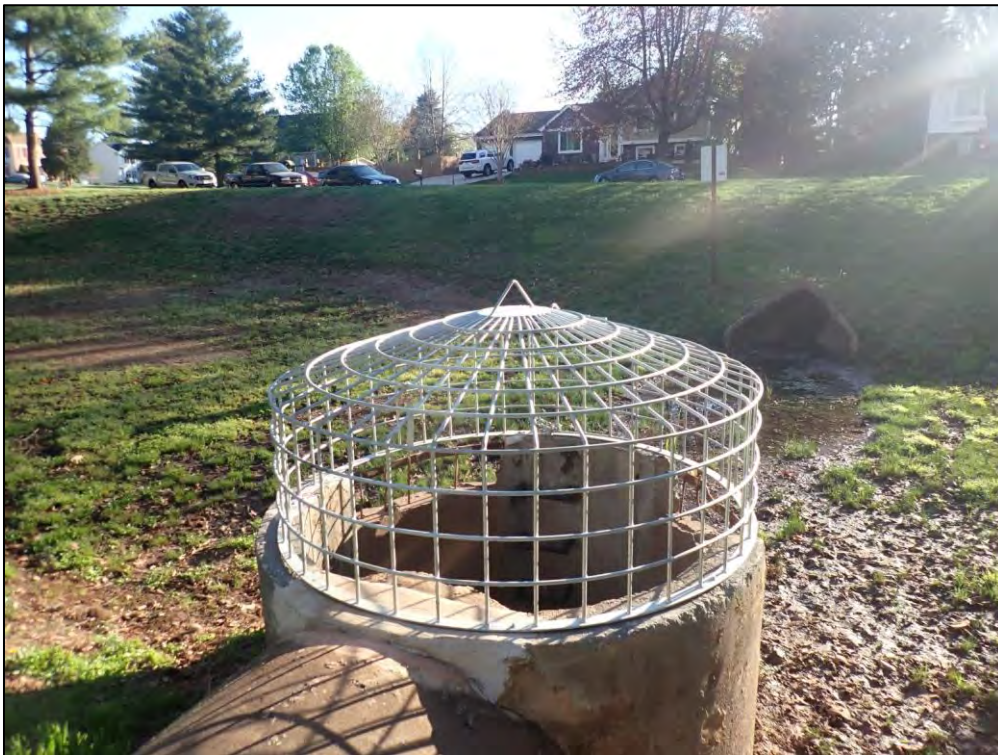
9265: Control Structure B2, Southern upper orifice close-up. Damage to trash rack. (Routine Maintenance Needed).

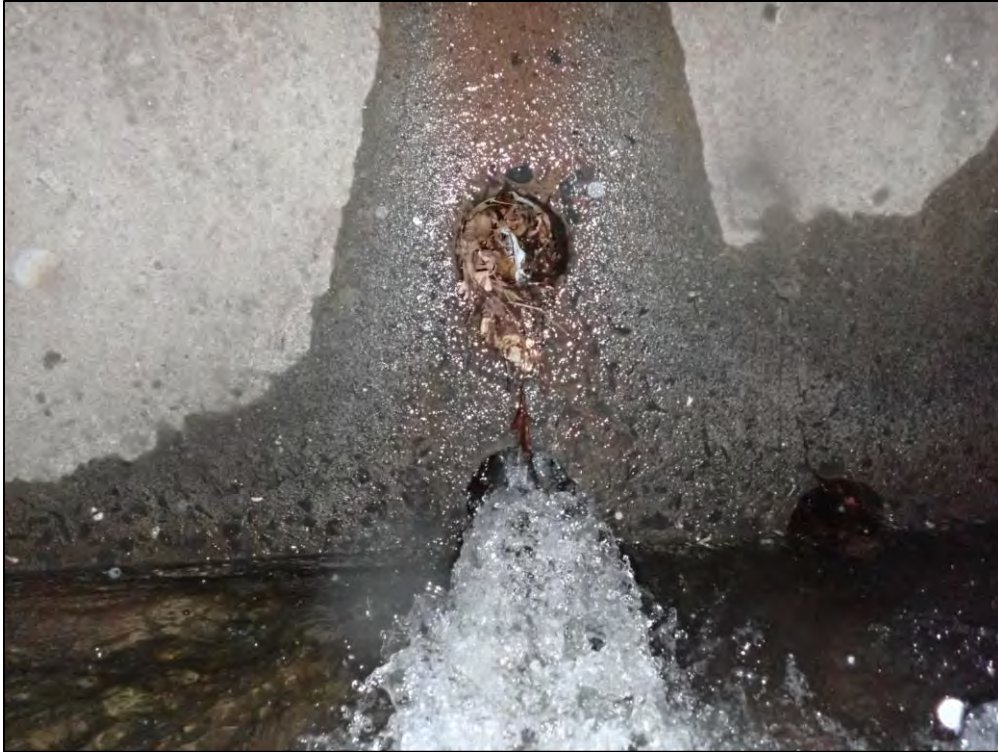
9294: Inside Control Structure D4, looking upstream toward the low-flow orifices. The low-flow orifices are blocked (Immediate Repair Needed).

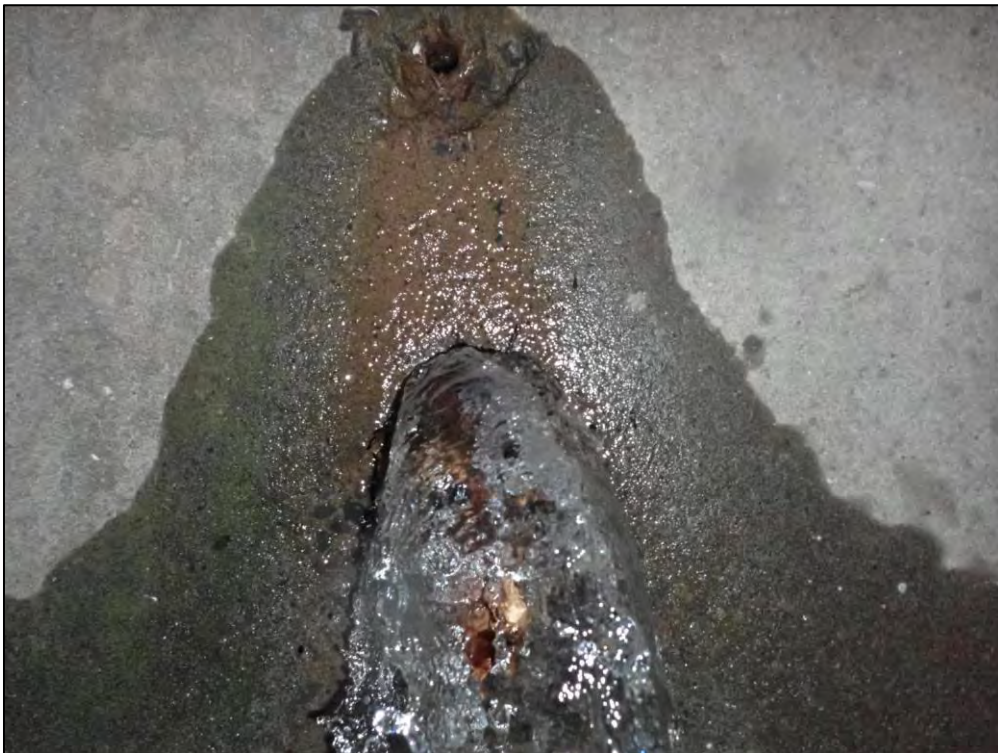
9295: Inside Control Structure D4, looking upstream toward the low-flow orifices. The low-flow orifices are blocked (Immediate Repair Needed).

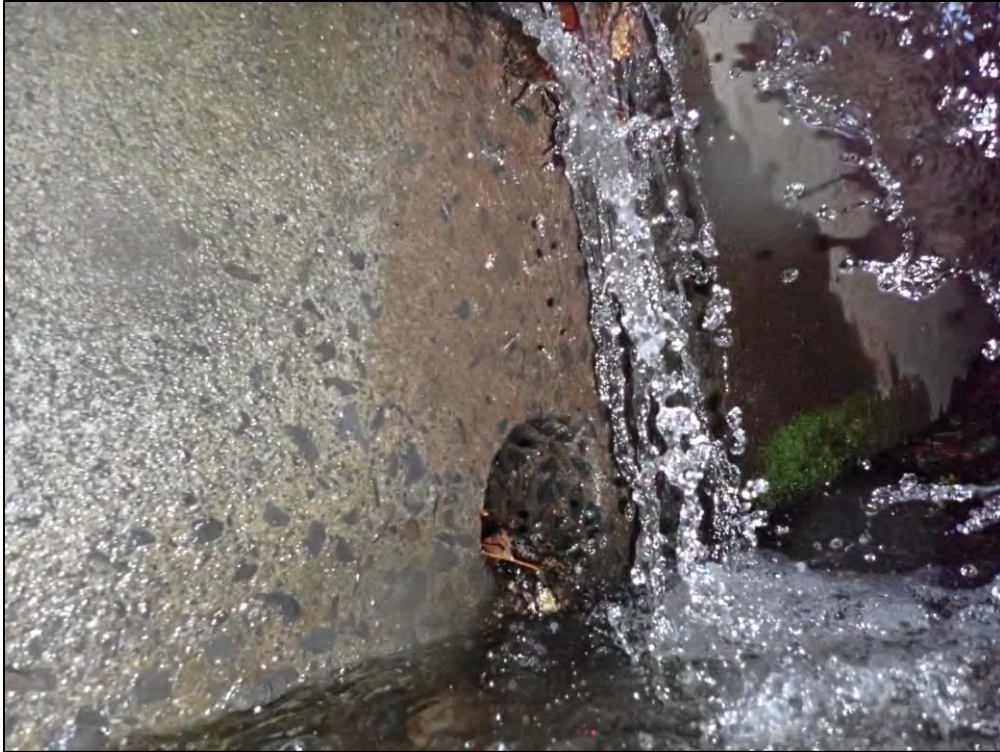
9296: Inside Control Structure D4, looking upstream toward the low-flow orifices. The low-flow orifices are blocked (Immediate Repair Needed).

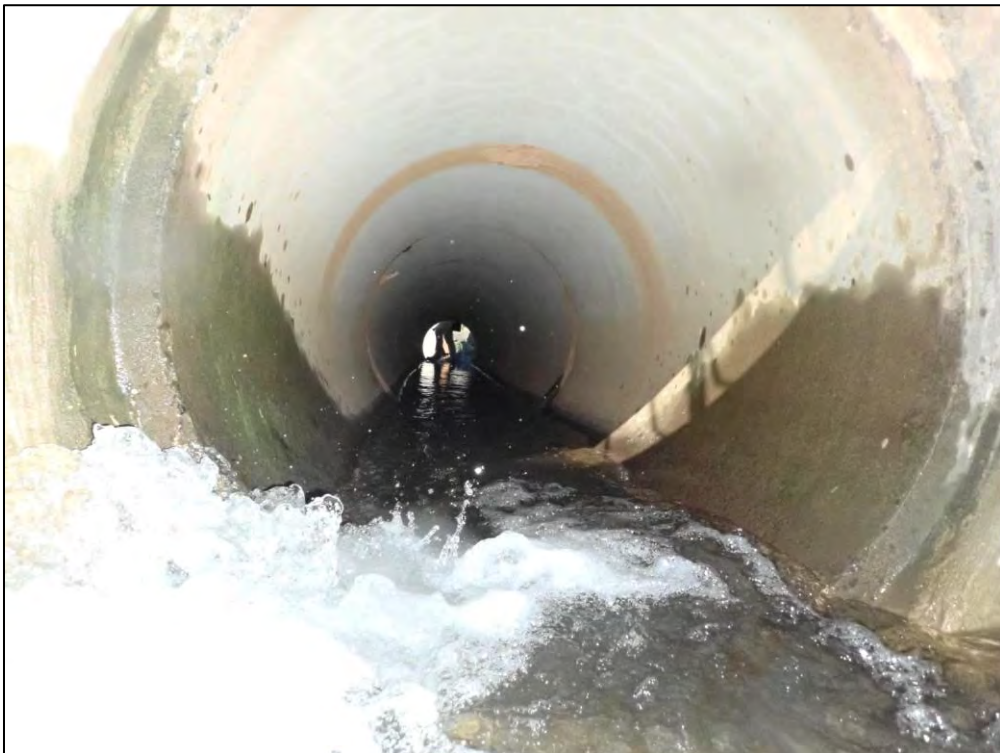
9297: Inside Control Structure D4, looking upstream toward the low-flow orifices. The low-flow orifices are blocked (Immediate Repair Needed).

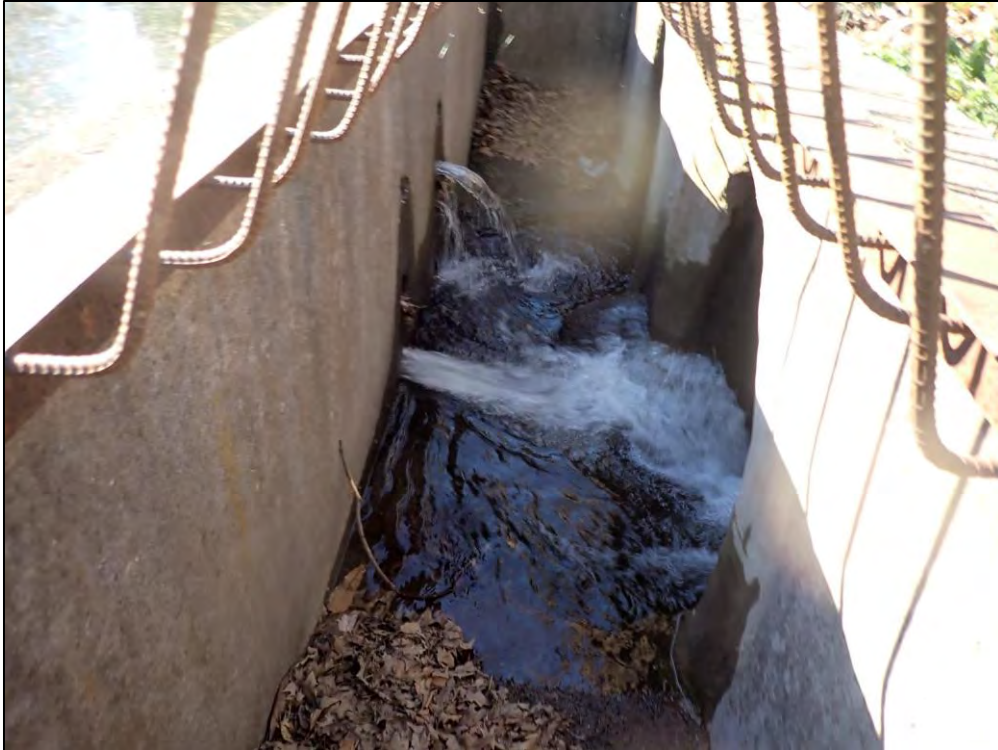
9300: Inside Control Structure D4. The low-flow orifices are blocked (Immediate Repair Needed).

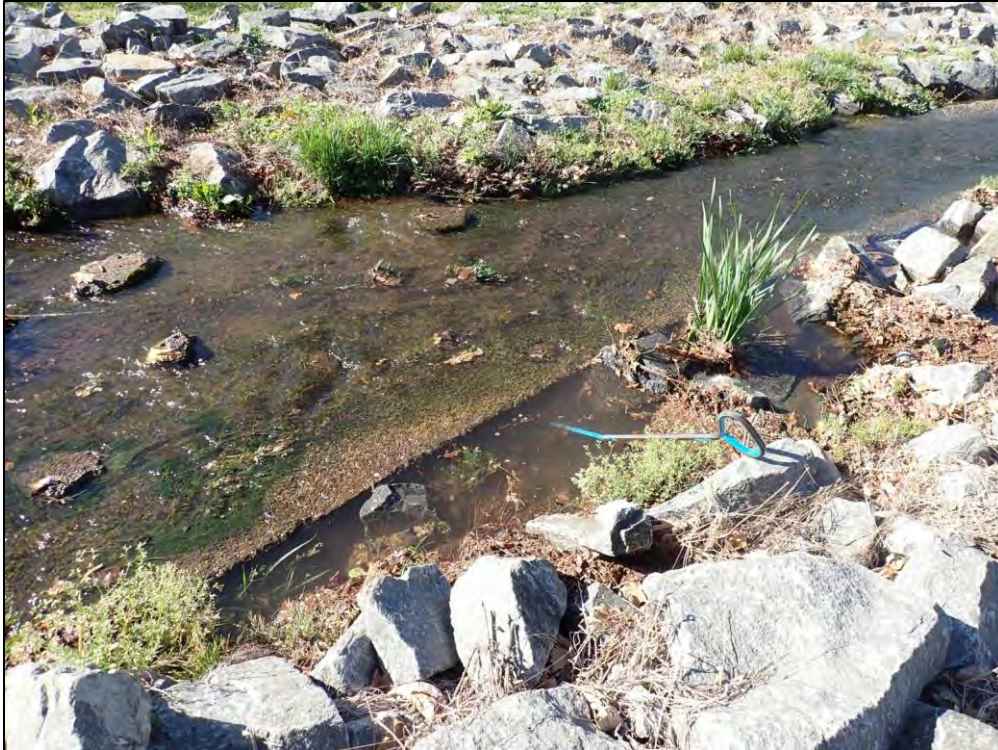
9327: Looking downstream along the Trickle Ditch. The low-flow ditch is clogged with sediment/debris (Monitor).

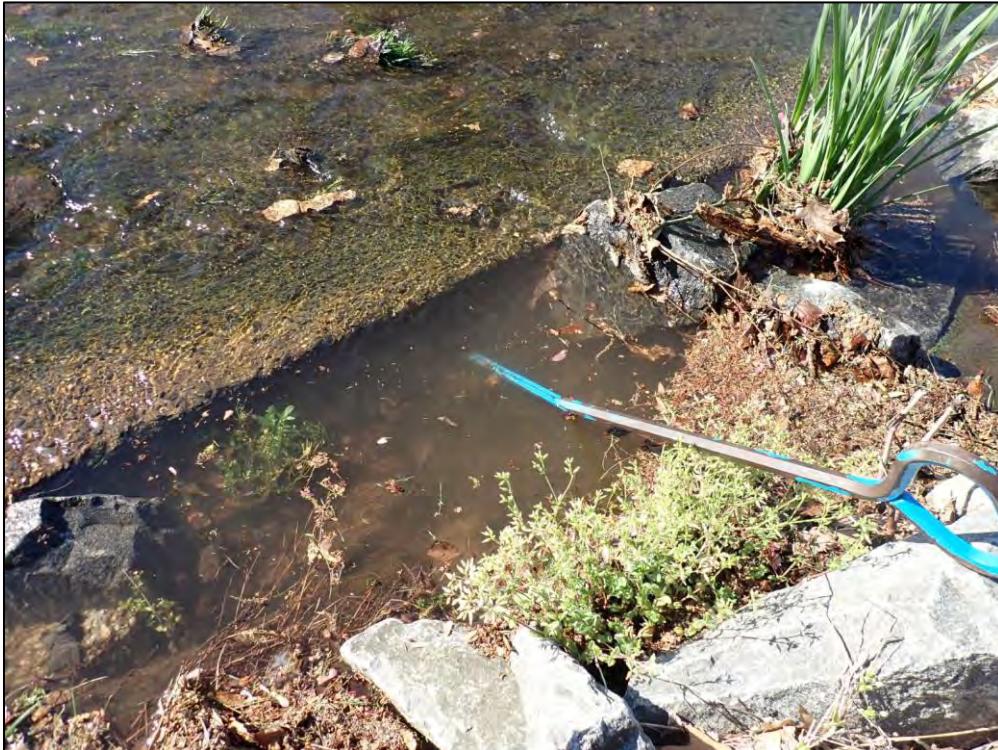
1	Low-level gate drain is accessible and operational. Drain has been exercised in last three years.		
1	Trash, debris, or other material in BMP device		
Principal Spillway Pipe			
1	Spillway is blocked by debris or sediment		
1	Evidence of leaking joints		
1	One or more sections of the pipe have settled to the point that it threatens the integrity of the dam		
Impoundment Area and Side Slopes			
1	Buildup of trash and debris		
1	Silt and sedimentation buildup		
1	Ponding area is showing signs of poor health (i.e. nutrient overload, excess aquatic vegetation, or turbidity)		
1	Signs of erosion along shoreline		
2	Low-flow ditch is clogged with sediment/debris	Sediment and debris beginning to accumulate in and adjacent to the Trickle Ditch (4 Cubic Feet).	9326, 9327
3	Sections of low-flow ditch are cracked or showing signs of undercutting	Erosion was observed adjacent to the Trickle Ditch (10 Cubic Feet). Apply topsoil to the eroded areas and stabilize.	9330, 9331

9330: Trickle Ditch, overall. Sections of the low-flow ditch are cracked or showing signs of undercutting (Routine Maintenance Needed).

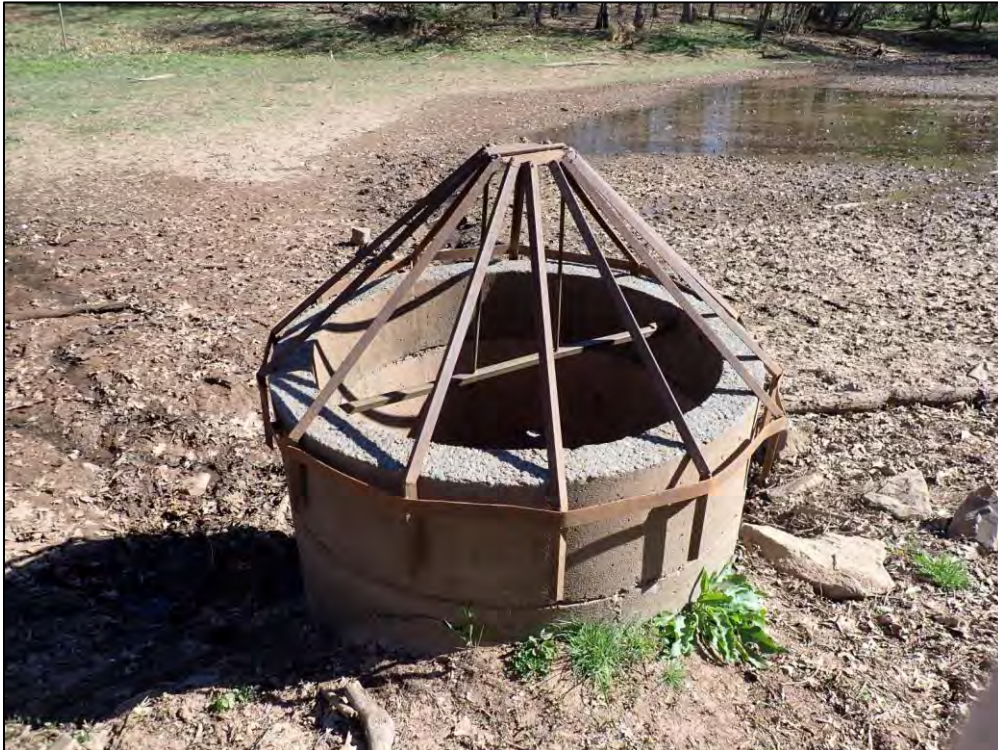
Score	Description	Comment(s) / Corrective Action(s)	Reference Image
Dam Embankment (Includes emergency spillway if applicable)			
3	Woody vegetation on embankment	Trees were observed growing on the dam (35, 2-6"; 15, 7-12"; and 2, 13-24" trees), and on the emergency spillway (14, 2-6" and 3, 7-12" trees).	9351, 9353, 9355, 9356, 9357, 9358, 9359, 9360
1	Shrubby, low growing vegetation, and/or vine material growing on embankment		
2	Sparse vegetative coverage	Bare spots were observed along the top of the dam (150 Square Feet).	9350, 9352
1	Signs of erosion, settlement, piping, or slope slippage		
1	Signs of seepage, soft spots, and sinkhole formation		
1	Evidence of nuisance animals		
1	Buildup of trash or debris on embankment		
1	Trash, debris, or obstructions in emergency spillway		
Outlet/Riser Structure			
4	Low-flow orifice is blocked	The low-flow orifices were observed to be partially blocked (0.22 Cubic Yards).	9337, 9341, 9342, 9343

9337: Control Structure, low-flow orifice close-up. The low-flow orifices are blocked (Immediate Repair Needed).

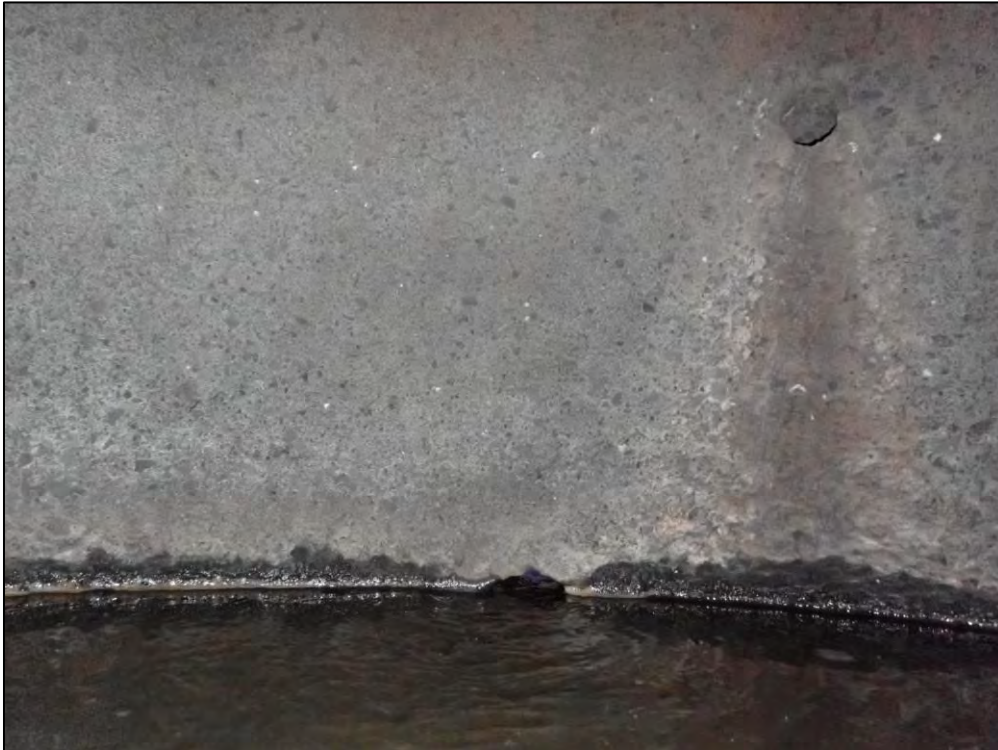
9341: Inside the Control Structure, looking upstream toward the Eastern low-flow orifice. The low-flow orifices are blocked (Immediate Repair Needed).

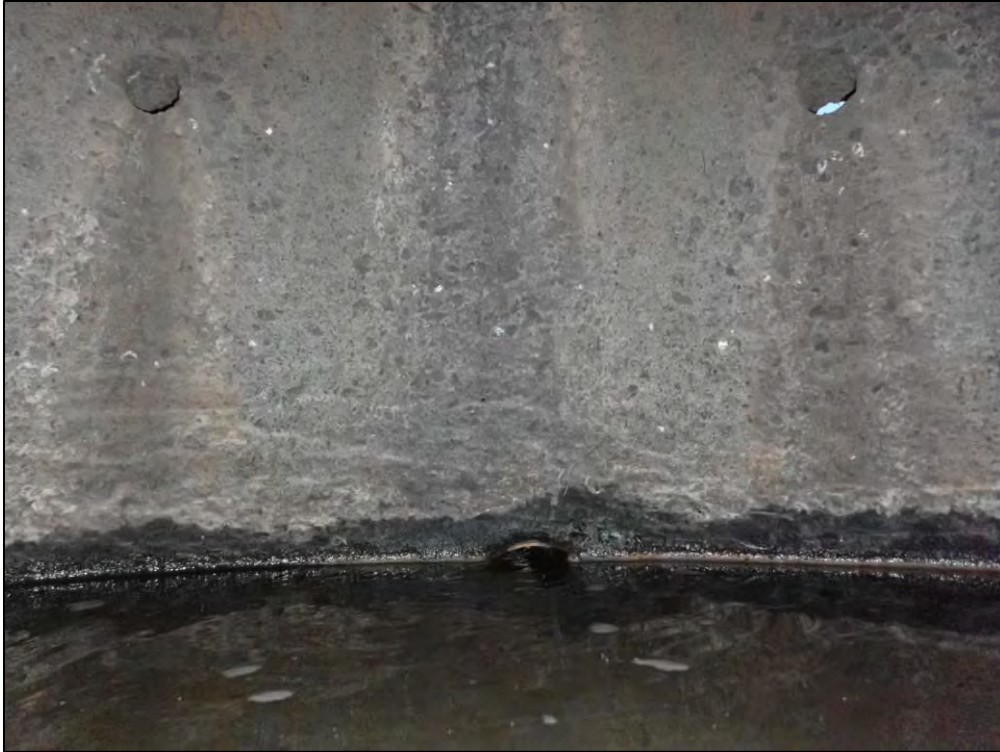
9342: Inside Control Structure, looking upstream toward the Northern low-flow orifice. The low-flow orifice is blocked (Immediate Repair Needed).

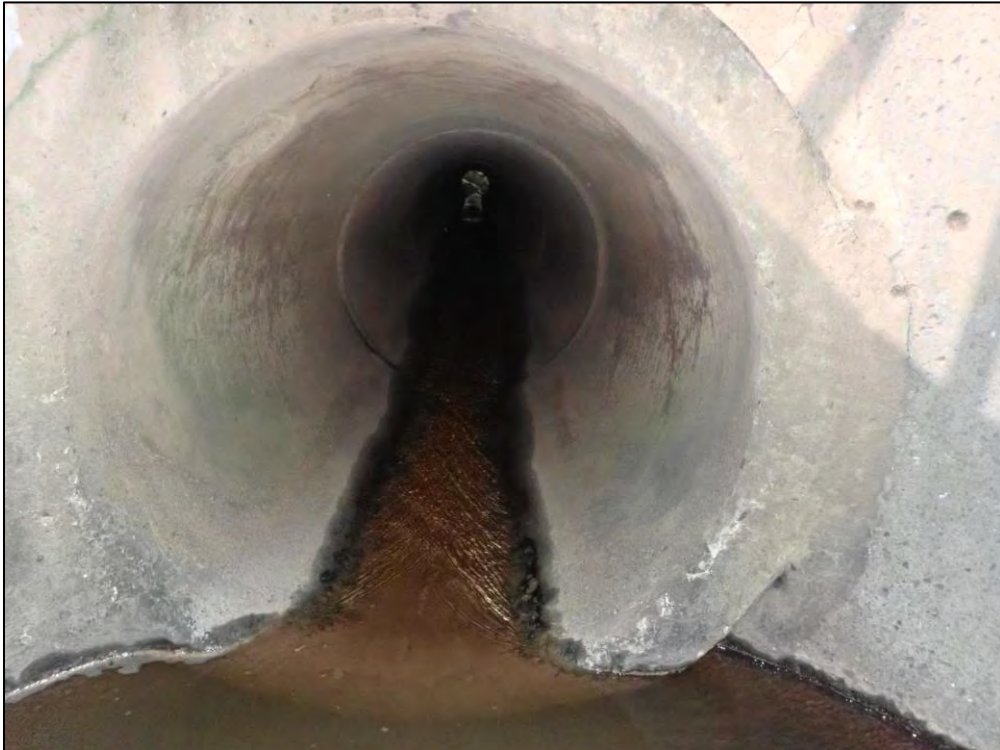
9343: Inside the Control Structure, looking upstream toward the Northeastern low-flow orifice. The low-flow orifices are blocked (Immediate Repair Needed).

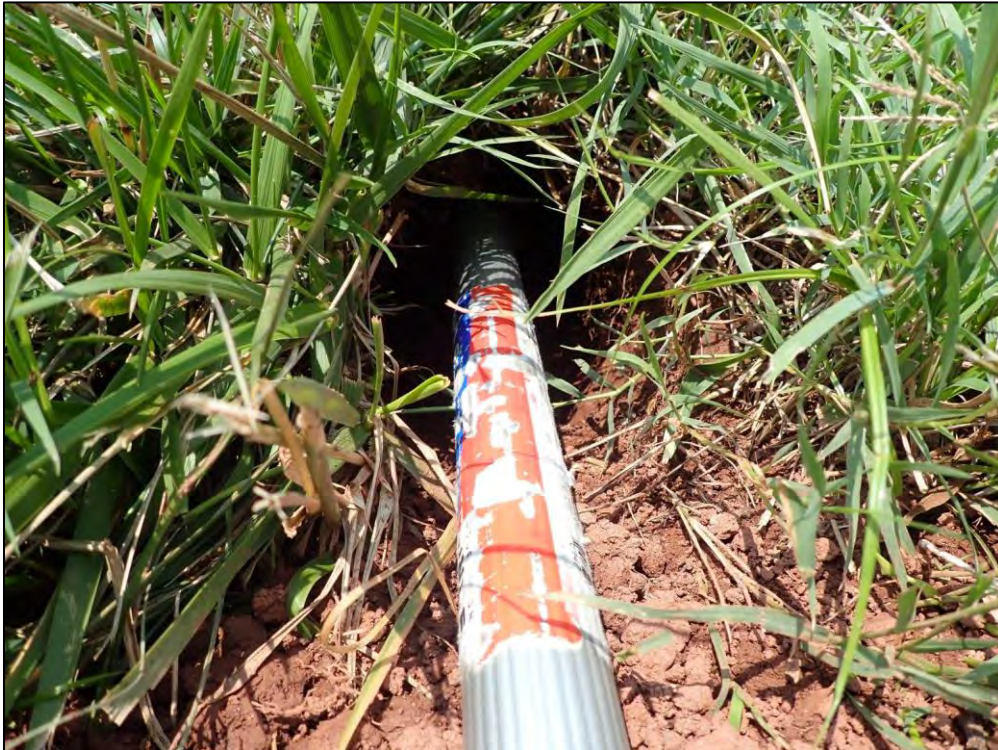
4788: Animal hole, overall. Evidence of nuisance animals (Immediate Repair Needed).

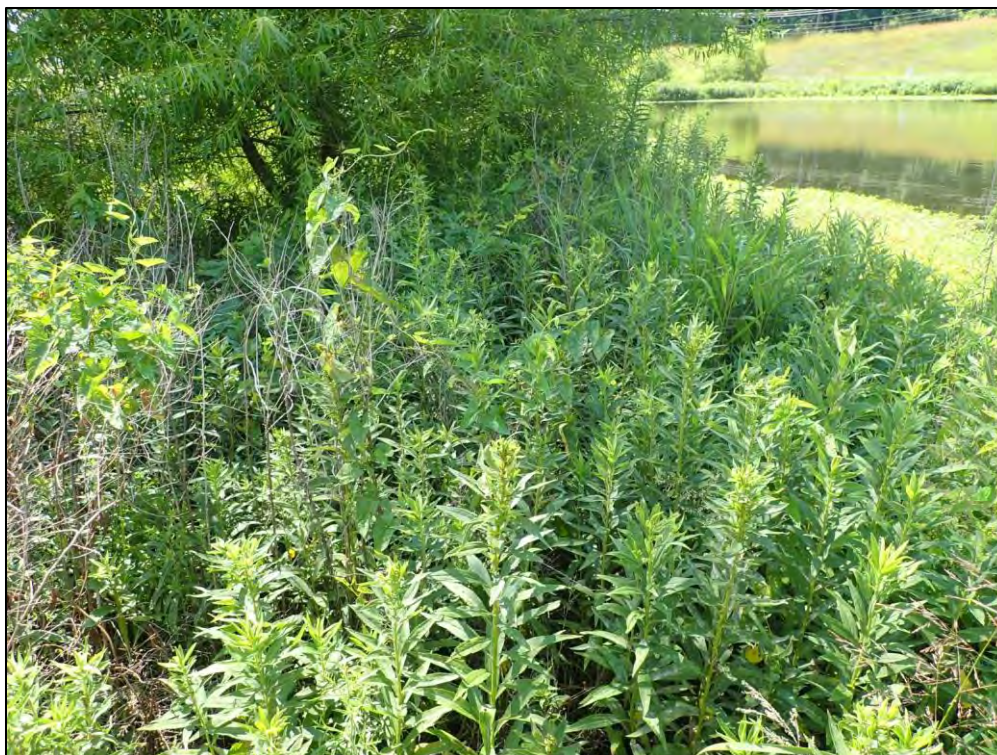
4448: Inflow 1, Overall. Woody growth around inflow structure (Immediate Repair Needed).
