Infiltration Trench Inspection Report					
Facility Name	Fairview Riverdale	Facility ID	STMF0090080	Type of Inspection: Initial Inspection	
Location	Lat: 38.747968 Long: -77.460524	Watershed	Lower Bull Run	Previous 48 Hour Precipitation Total	0.35"
Materials available for inspection	N/A	Owner Notification Date	N/A	Owners/ Owner's Representative	City of Manassas
Inspectors	gky_mfreeman	Date of Inspection	6/28/2023	Date of Last Inspection	3/29/2022
Overall Condition Score					
	1	Adequate	No deficiencies identified.		
	2	Monitor	No maintenance may be needed at the time, but might become an issue in the future. Will revisit next inspection. Examples include minor erosion, small sediment accumulation, or small structural issues of facility components.		
	3	Routine Maintenance Needed	Facility is functional but preventative maintenance is required. Examples includes vegetation management, minor erosion, or trash/debris removal.

Facility ID: STMF0090080
Facility Name: Fairview Riverdale

Inspection Date: 06/28/2023

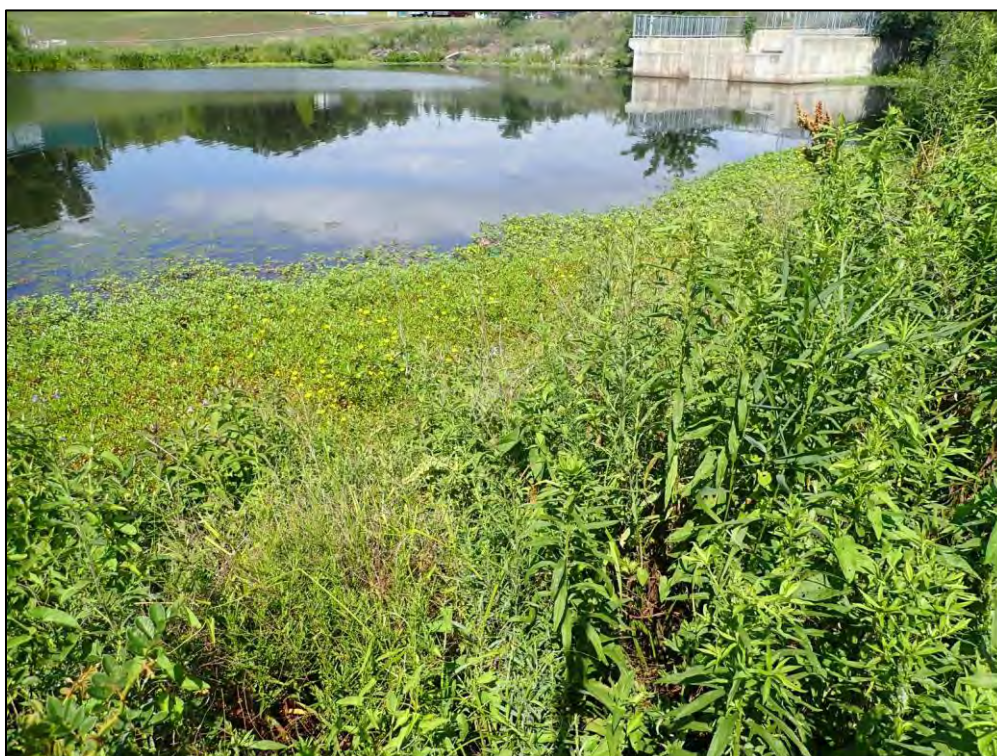
4449: Inflow 1, Overall. Woody growth around inflow structure (Immediate Repair Needed).

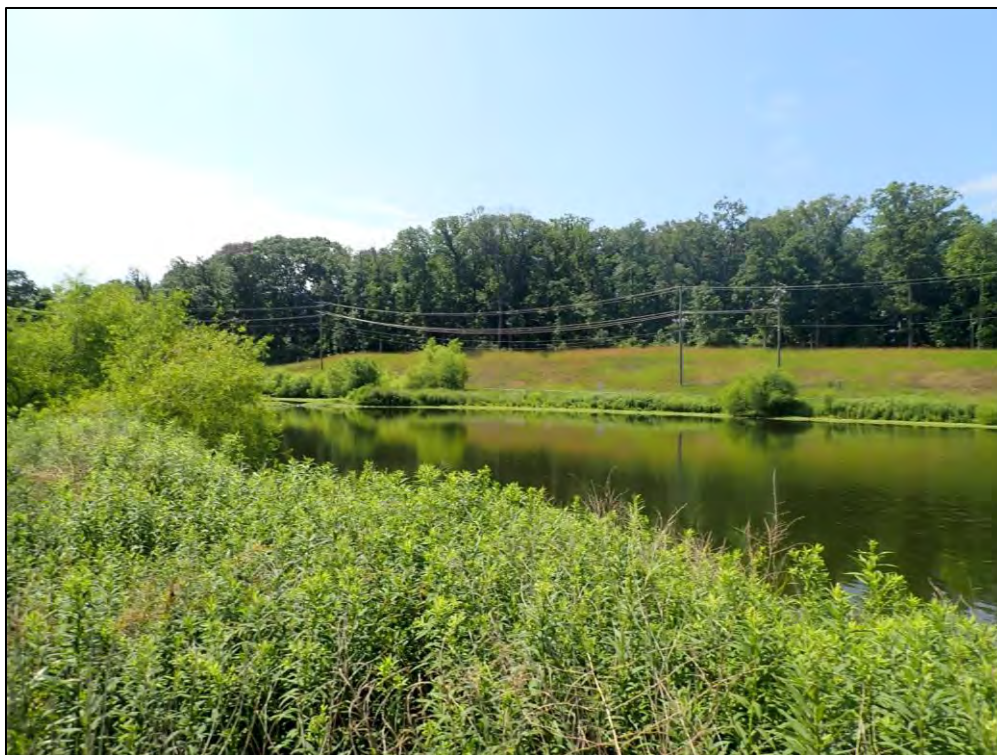
4452: Inflow 2, Overall. Woody growth around inflow structure (Immediate Repair Needed).

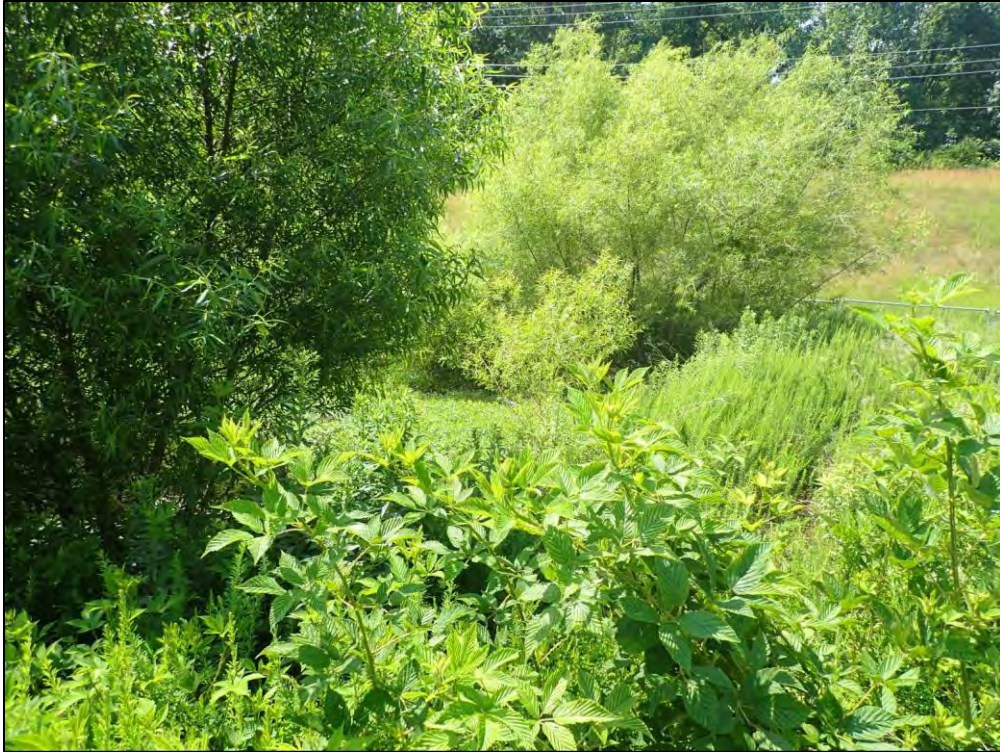
4480: Inflow Structure 6, Overall. Woody growth around inlet structure (Immediate Repair Needed).

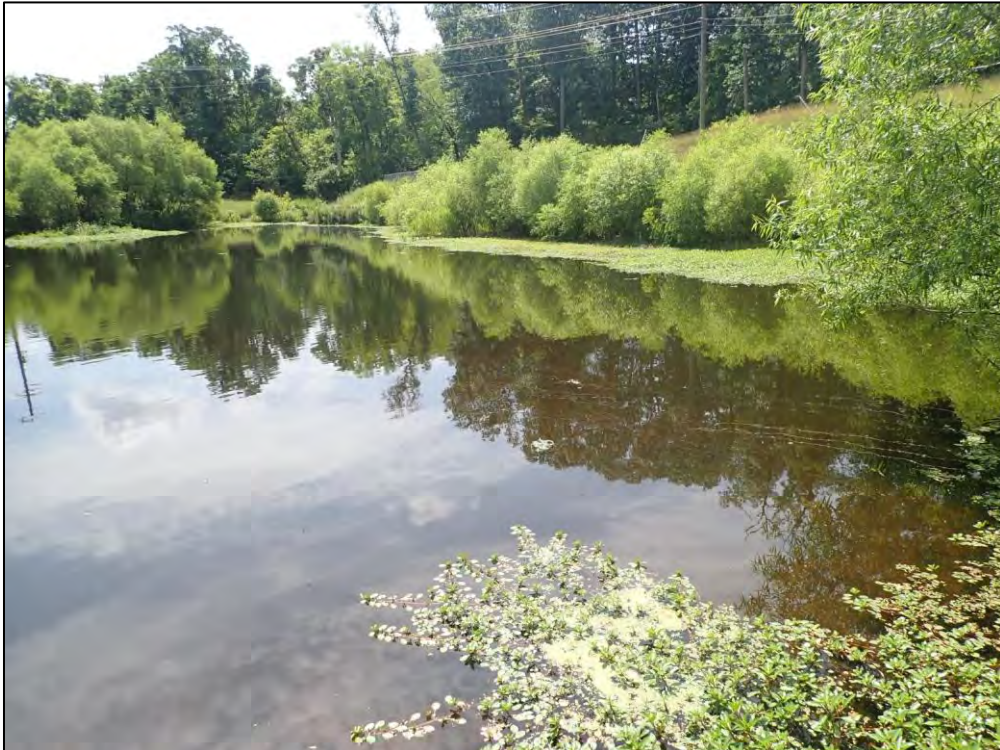
4481: Inflow Structure 6, Overall. Woody growth around inlet structure (Immediate Repair Needed).

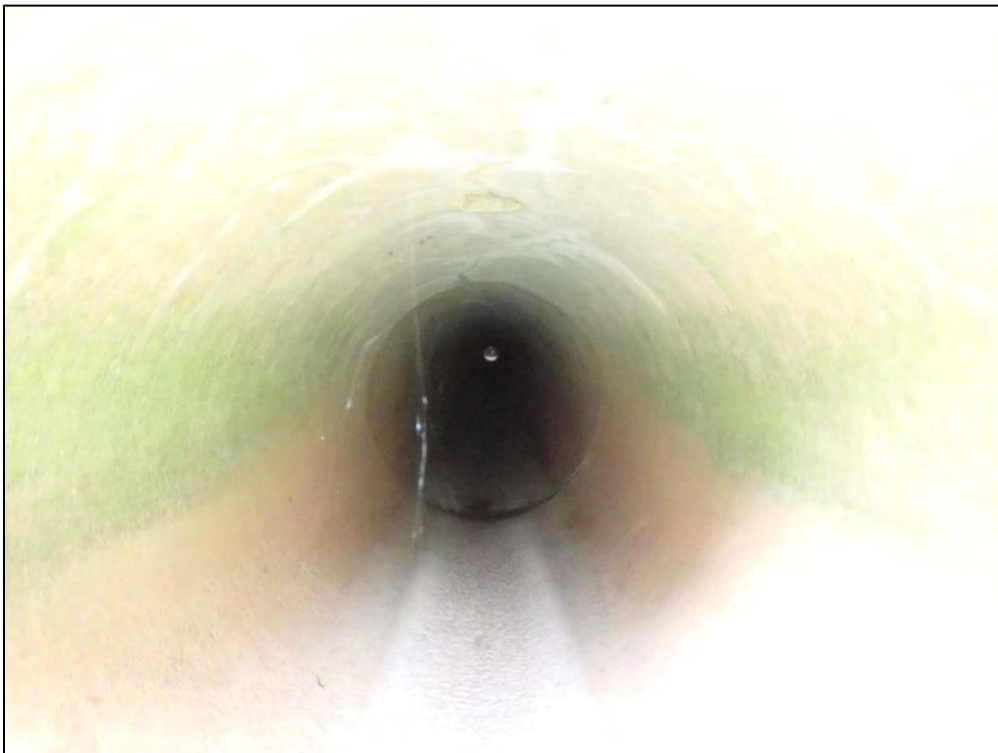
4744: Inflow Structure B1, closeup. Damage to inlet pipe or structure (Routine Maintenance Needed).

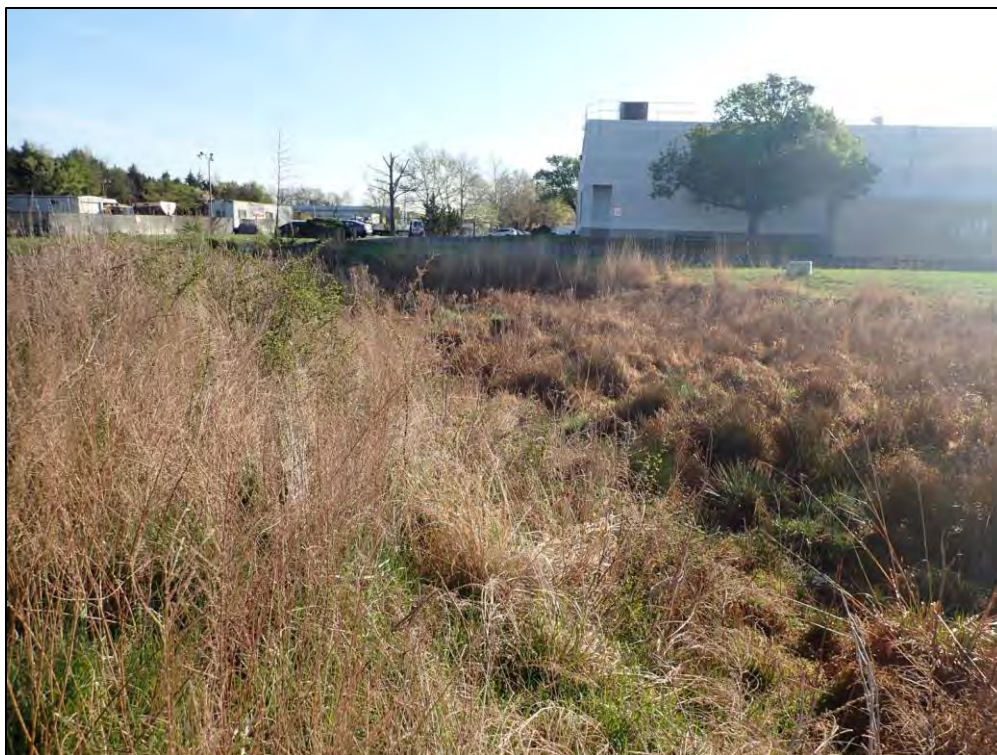
2691: Facility Overall. Overgrown vegetation was observed on the pond floor (Routine Maintenance Needed).

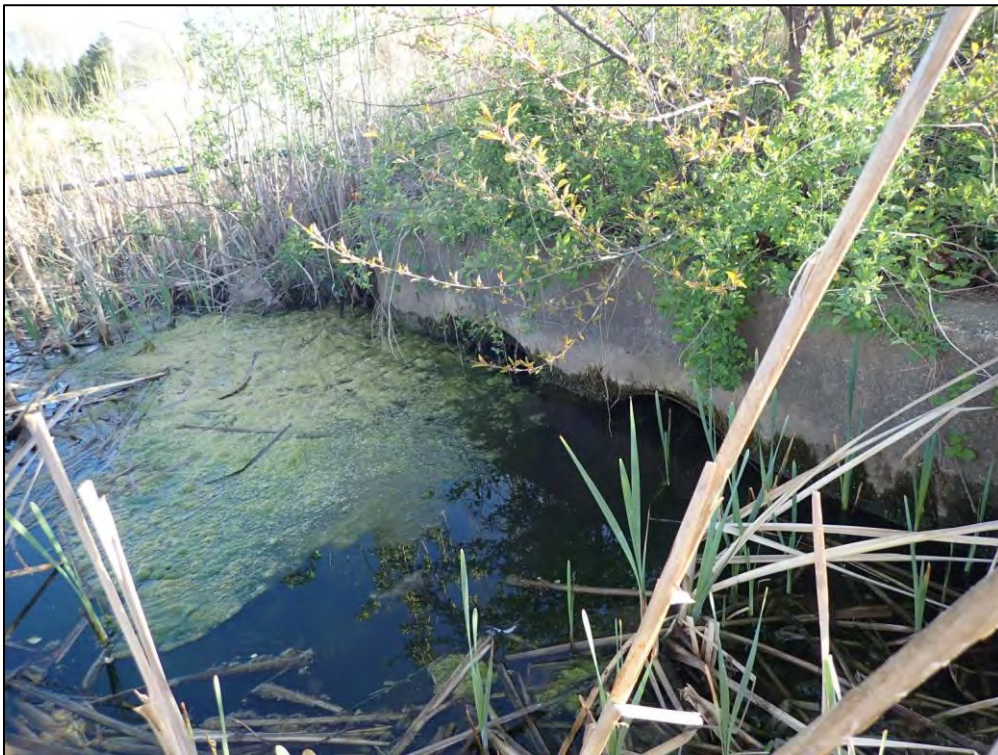
2698: Outfall, Overall. Woody vegetation growing within 5' of outlet and barrel (Immediate Repair Needed).

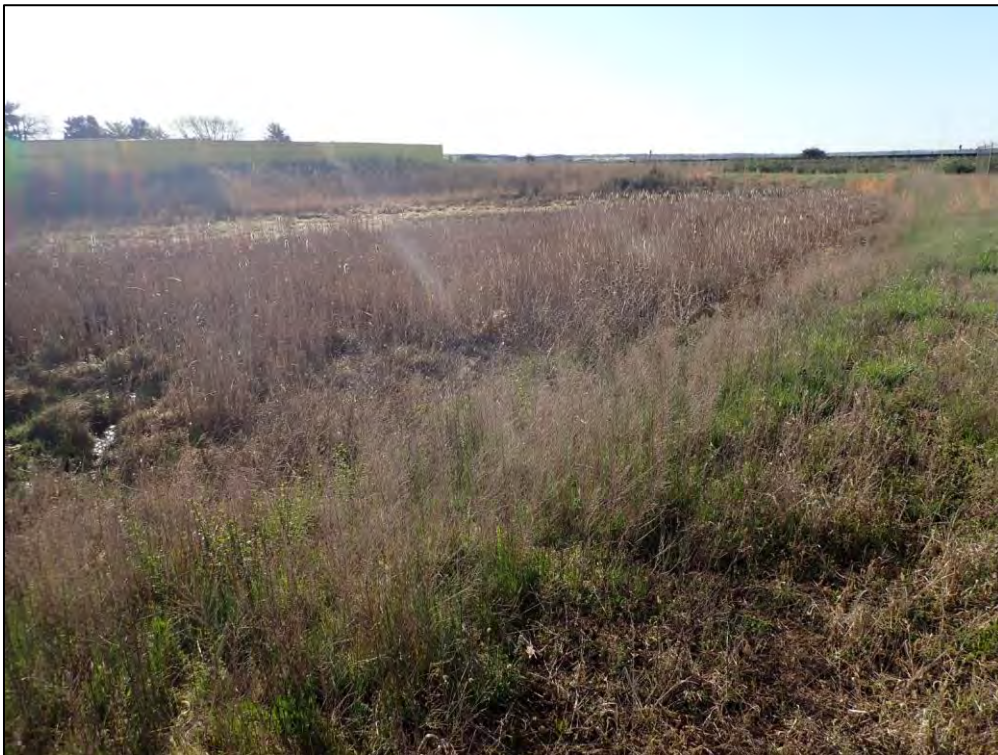
2700: From the Outfall, looking downstream. Overgrown vegetation was observed on the pond floor (Routine Maintenance Needed).

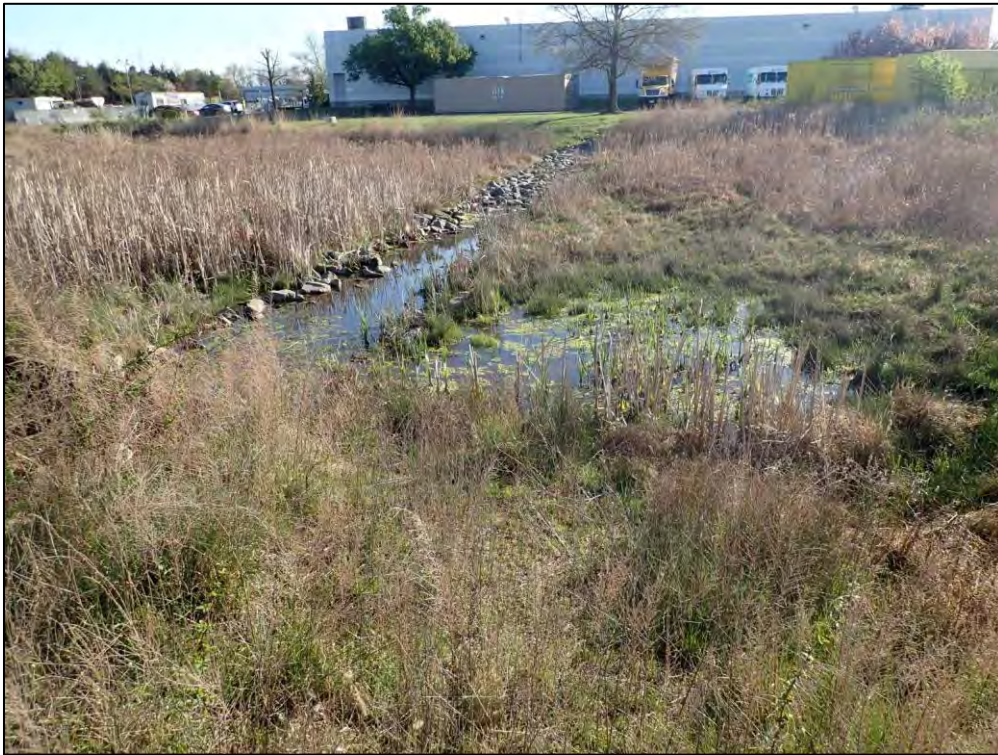
2701: Facility Overall. Overgrown vegetation was observed on the pond floor (Routine Maintenance Needed).

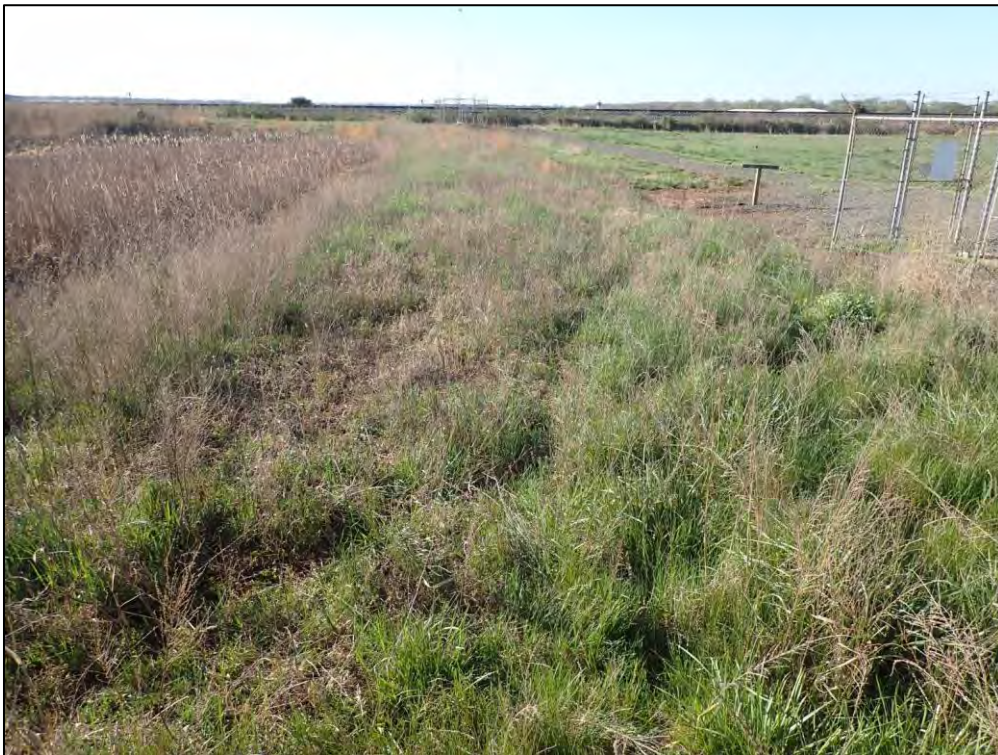
2702: Facility Overall. Overgrown vegetation was observed on the pond floor (Routine Maintenance Needed).

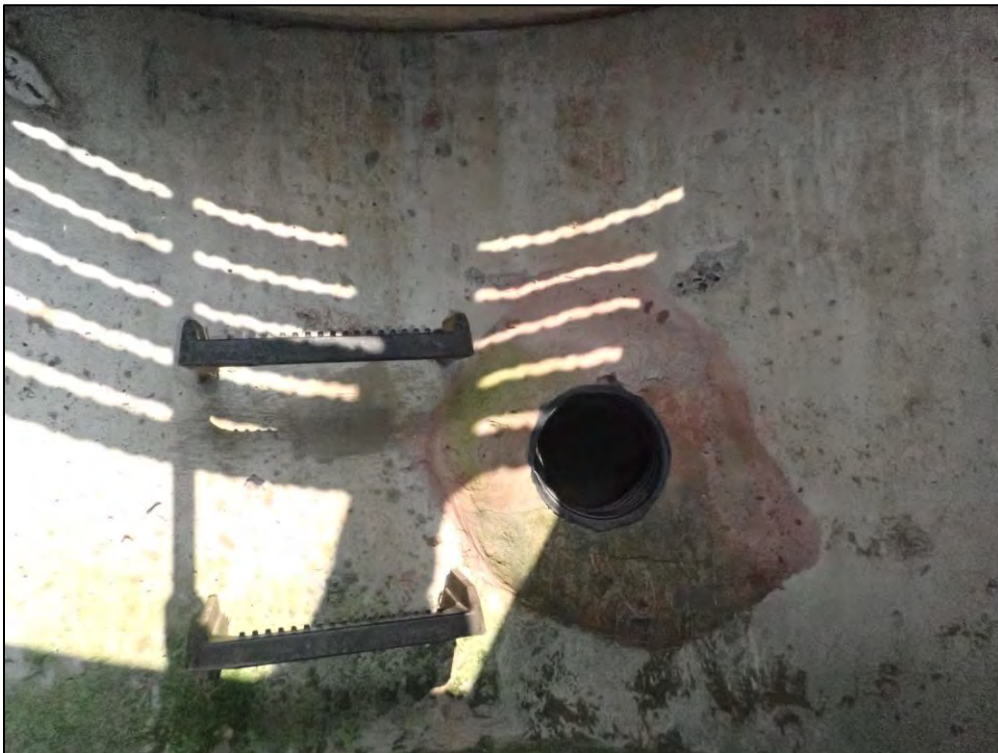
4600: Inside Control Structure I-29-017, looking upstream along the Northern underdrain. Debris observed within the underdrain (Immediate Repair Needed).
