MARTIN COUNTY COURTHOUSE

DOME AND ROOF REPAIR UPDATE

March 2021

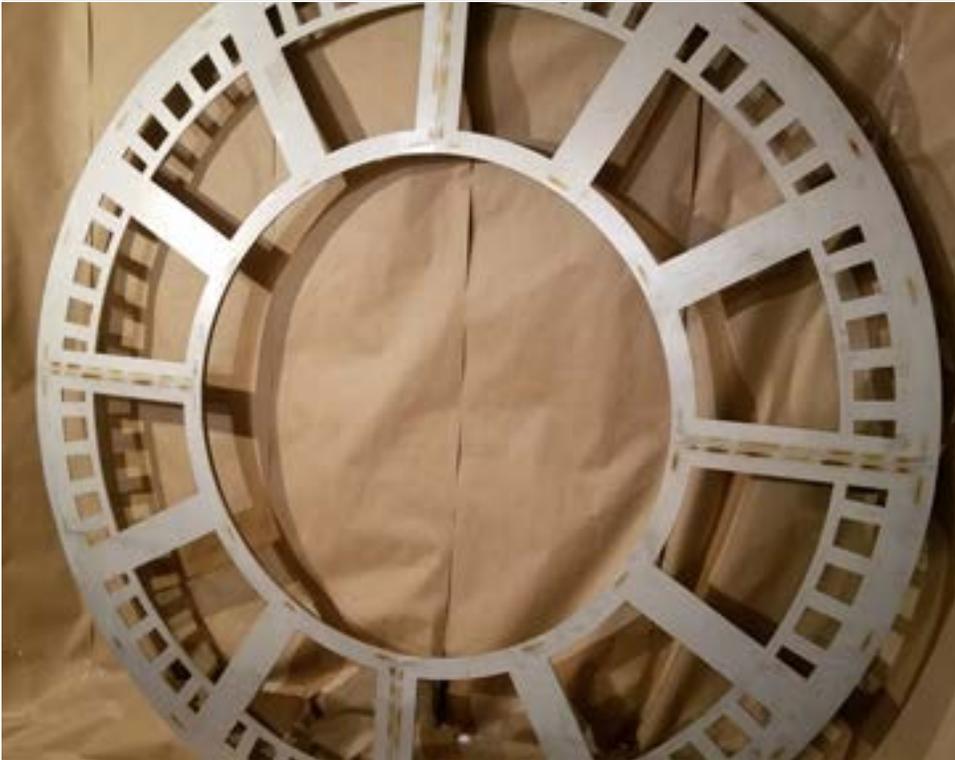
Below: Fully assembled replacement clock dial. Right: Sections of clock dial before assembly.

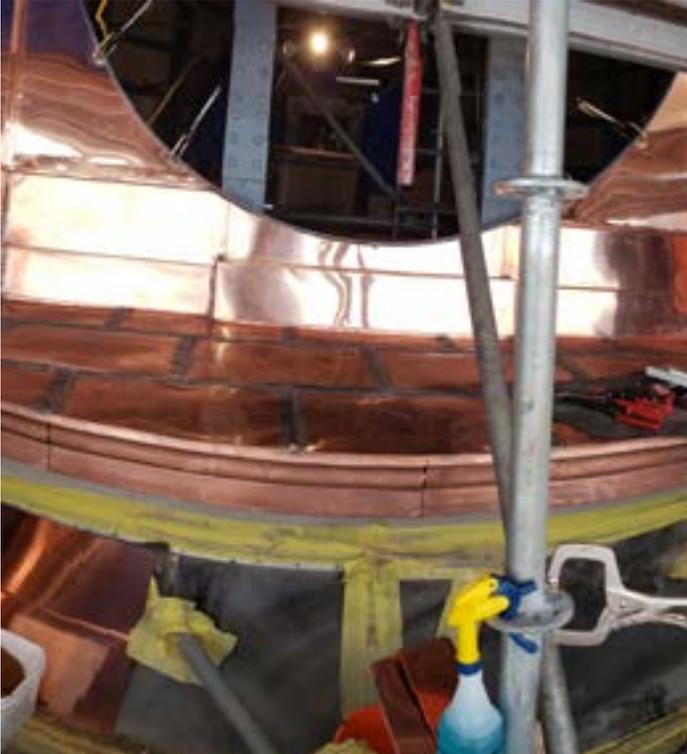
Copper work at the base of the clock dial.

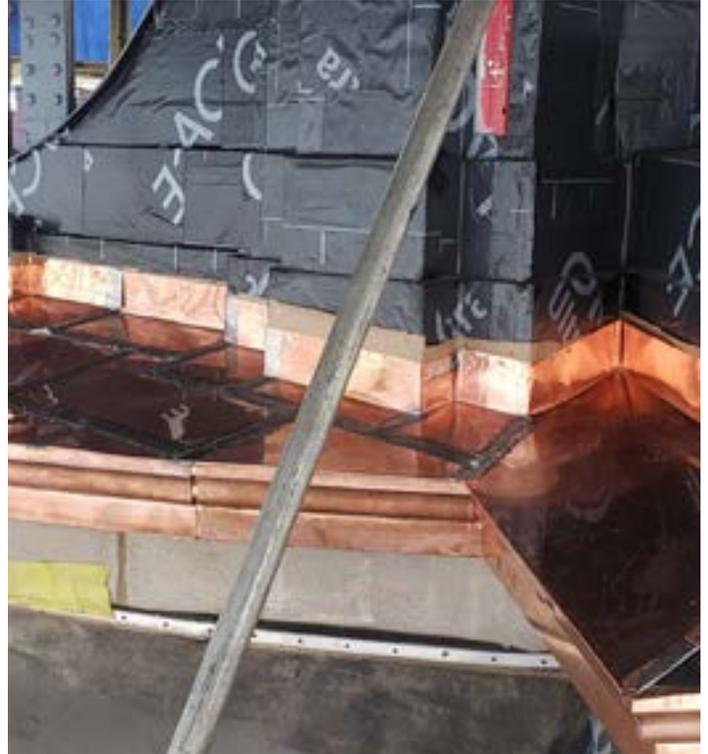
Vertical copper work installation.

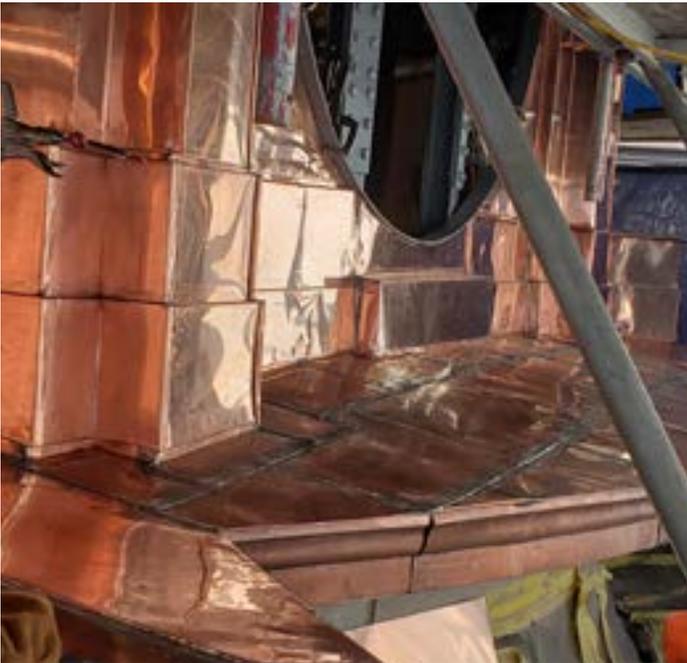
Copper work at the clock dial base. There are four similar areas like this to repeat the work on. Due to the original construction, each one is slightly different in size.

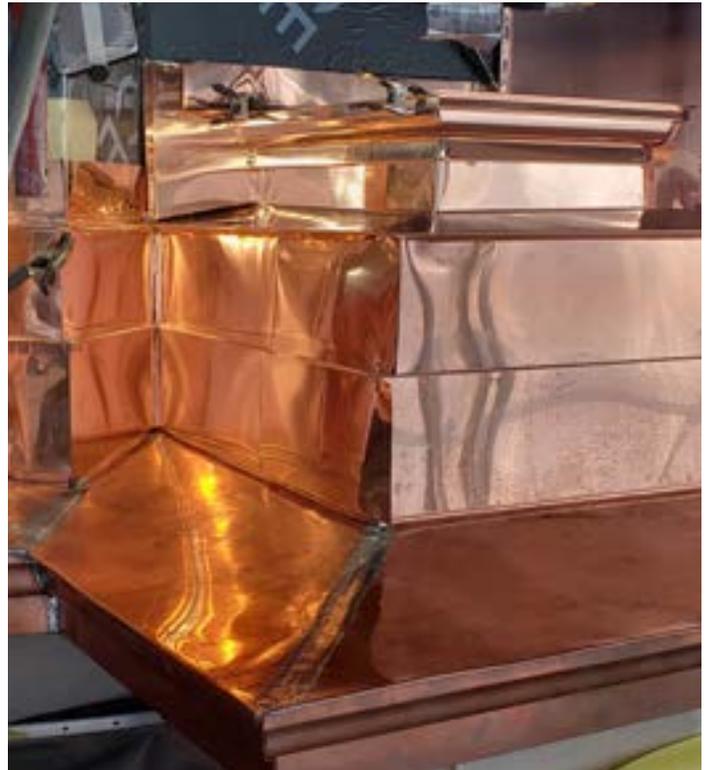
Copper work at the base of an eagle perch.
