**The Charter Township of Orion**  
**Space Allocation Study**  
October 2018

Orion Twp. Hall Facility  
Assessment  
Lake Orion, Michigan

# Mechanical & Electrical Condition Assessment

## REPORT ON BUILDING CONDITION SURVEY

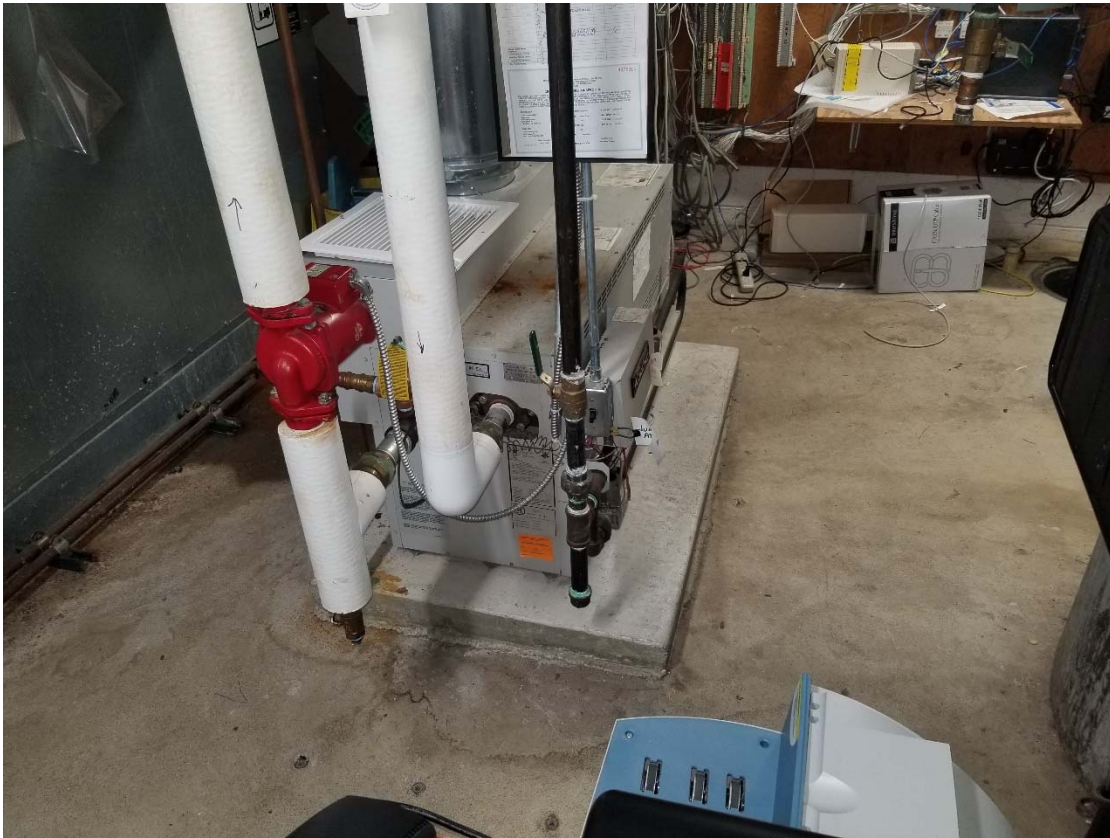
One natural gas fired atmospheric boilers, (Lochinvar model CBN399), provides heating hot water for the building. (Refer to photo M1) The boiler is rated for 399 MBH input and 328 MBH output, (82% efficient when first put into operation). The boiler is approximately 16 years old, appear to be in good condition and should have approximately 8 more years of useful life, (24-year useful life per ASHRAE). The boiler has its own individual pump and air separator, (Refer to photo M2), which are 16 years old as well.

M1 Gas Fired Boiler

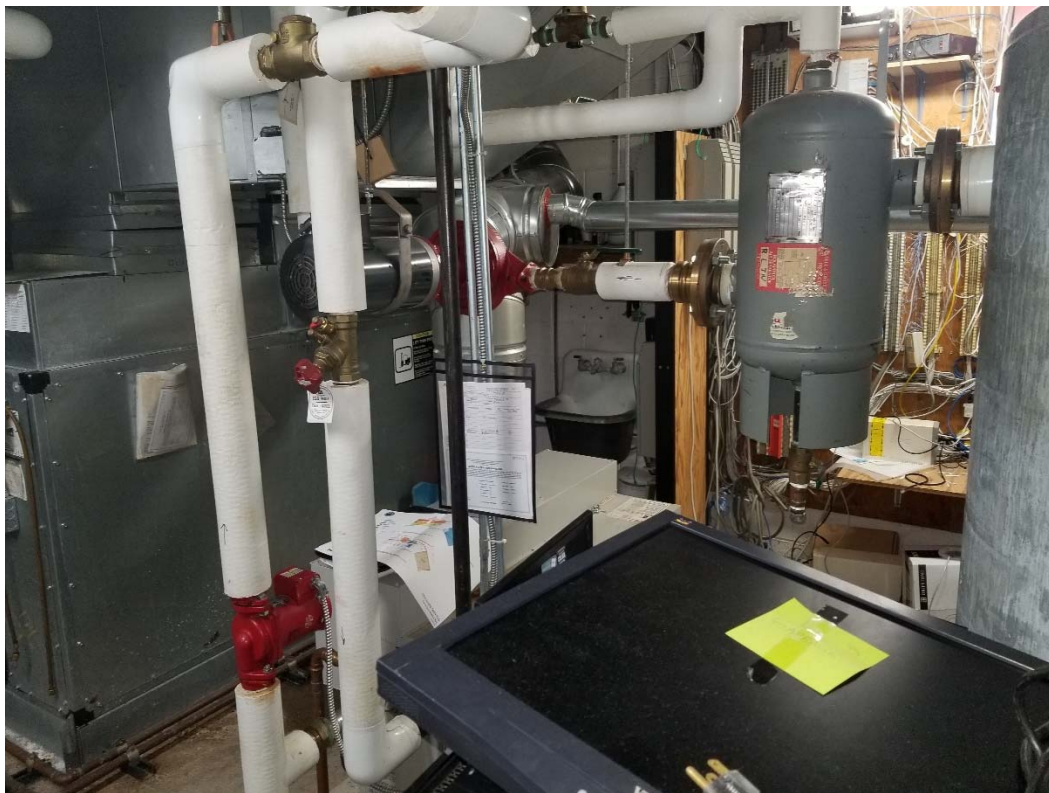
M2 Heating system pump and air separator

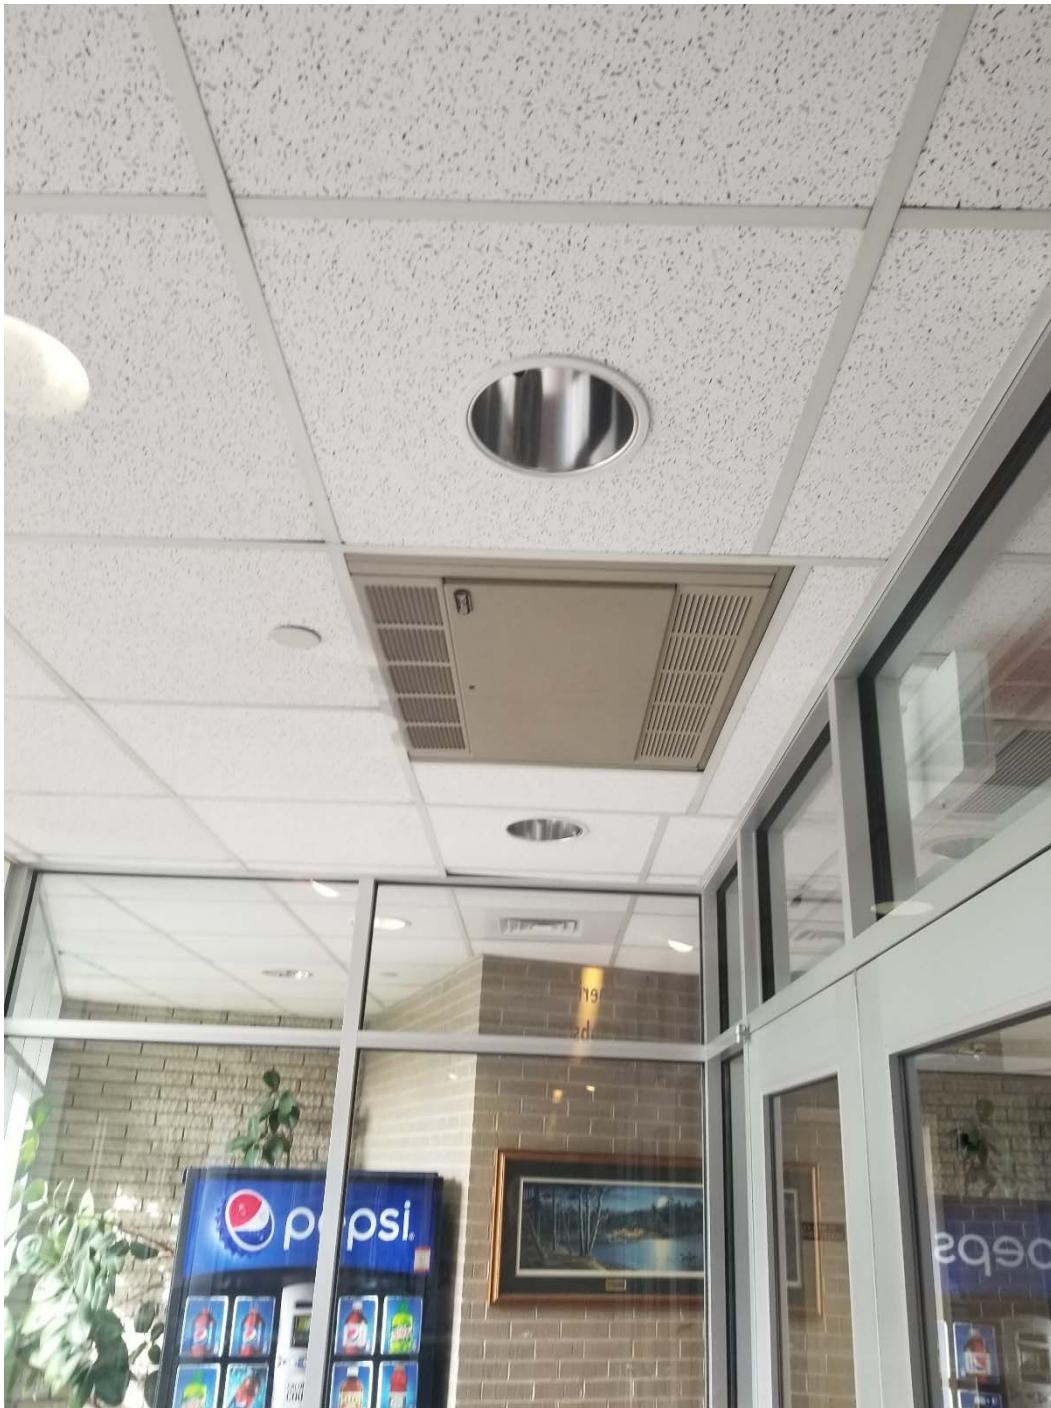
Heating hot water supply and return piping is routed throughout the building to baseboard fin tube radiation and a ceiling mounted cabinet unit heater. (Refer to photo M6) There is also at least one electric cabinet unit heater serving an entrance. (Refer to photo M5) Some of the baseboard's cover is in fair to poor condition. (Refer to photos M3 & M4) Heating hot water is also supplied to a central heating and ventilation unit located in the same room as the boiler, Trane model MCCA017, manufactured in 2002, 16 years old. (Refer to photo M12) This unit appears to be in fair condition, though it is approaching the end of its useful life. (Coils 20-year useful life, and centrifugal fans 25-year useful life, per ASHRAE).

M6 Hydronic Cabinet Unit Heater

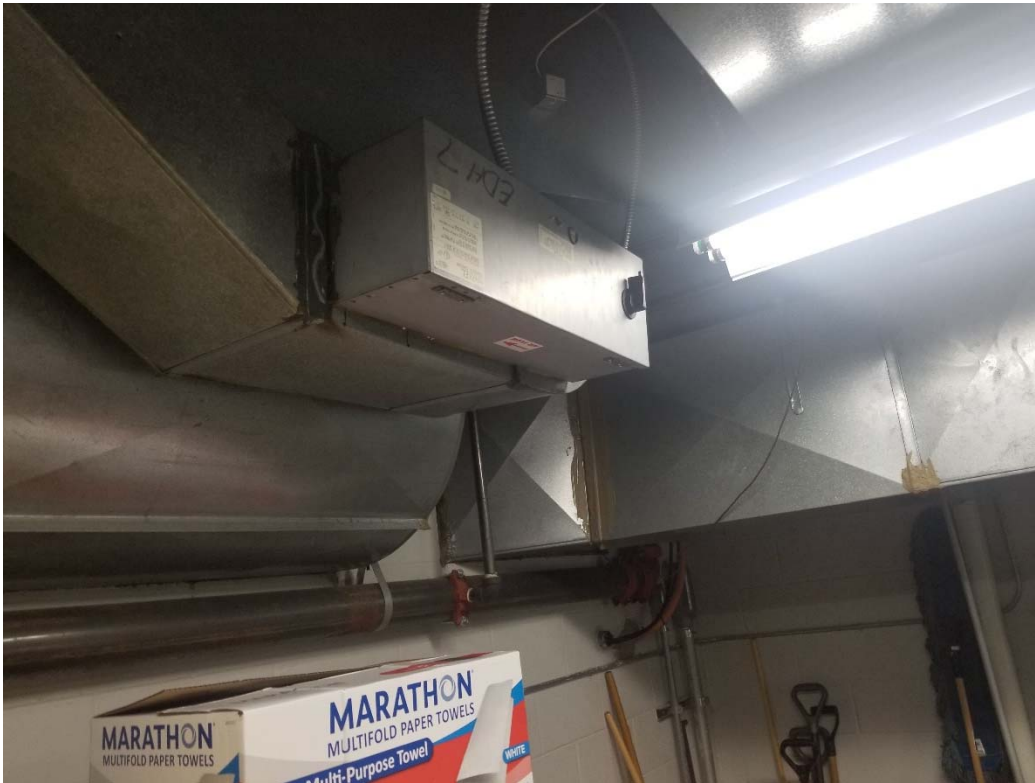
Ducts coming off one or both of the grade mounted rooftop units incorporate electric duct heaters to provide individual zone temperature control, Markel models. (Refer to photo M7)

M7 Electric Duct Coil

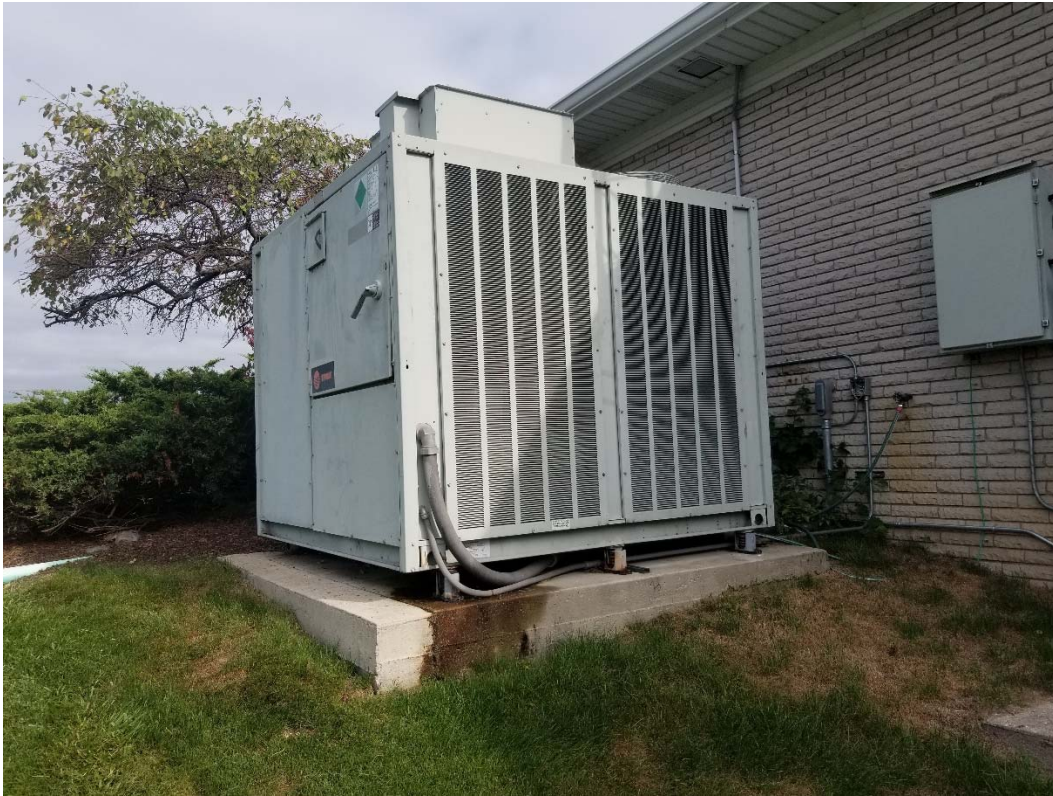
One 30-ton air cooled chiller, Trane model CGAFC30EFA1000DF, manufactured in 2002, serves the indoor air handling unit. (Refer to photo M9) This chiller is 16 years old and approaching the end of its useful life, (20-year useful life per ASHRAE). A chilled water circulating pump located in a small closet at the northwest corner of the building on the lower level, (Refer to photo M8), circulates chilled water to the indoor air handling unit. This pump appears to be in good condition.

M9 Air Cooled Chiller

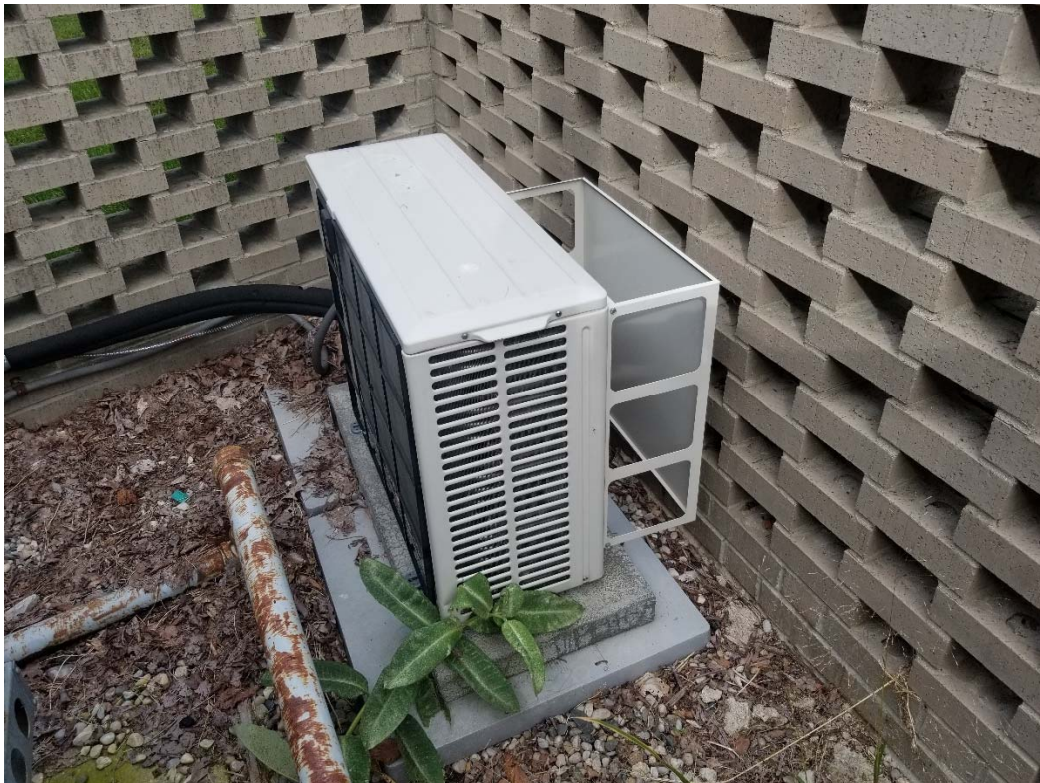
There is an outdoor grade mounted 1.5-ton condensing unit, Mitsubishi model PUY-A18NHA4, that appears to be in fair condition. This is split system cooling associated with an indoor fan coil unit. (Refer to photo M10)

M10 Condensing Unit

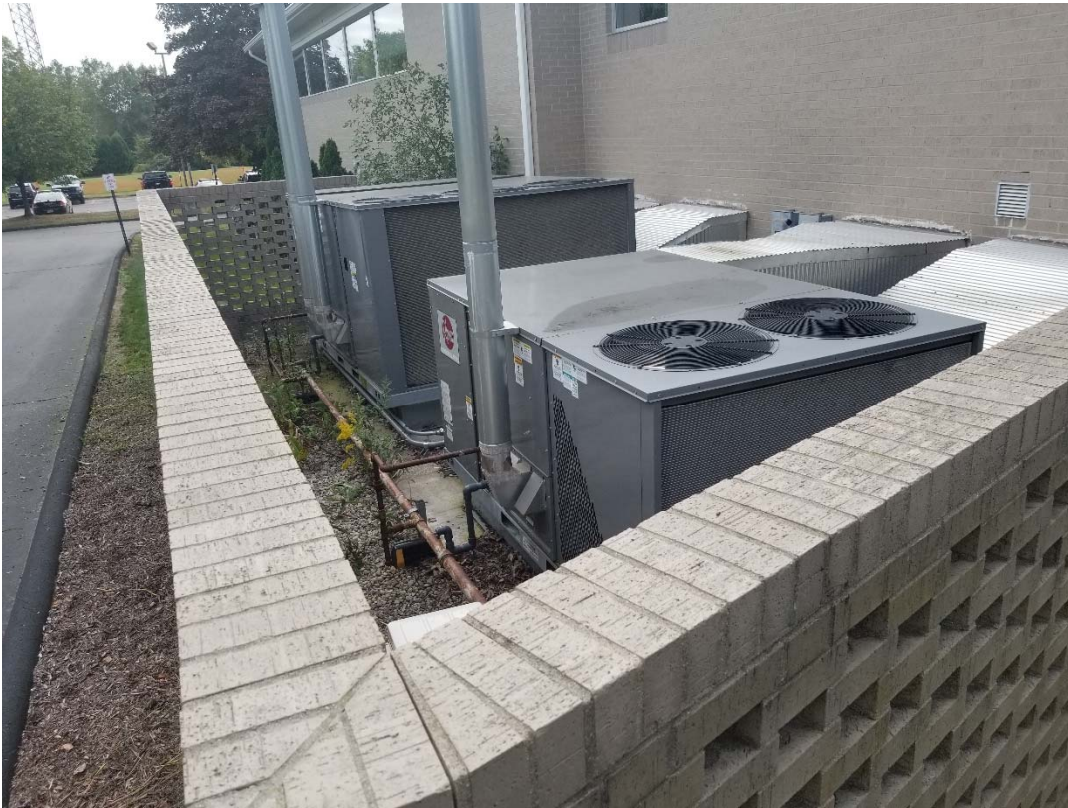
Two packaged grade-mounted, gas fired rooftop units appear to serve the 1996 addition. (Refer to photo M11) One is a 15-ton Rheem model RKKL-B180CL35E manufactured in 2014 and the other is a 12.5 ton Rheem model RKKL-B151CL25E, manufactured in 2015. Both are only approximately 3-1/2 years old and in good condition. The wrapped supply and return air ductwork from these should be provided with positive water drainage to prevent cladding deterioration and rusting. (Refer to photo M13)

M11 Gas Fired Roof top units on grade

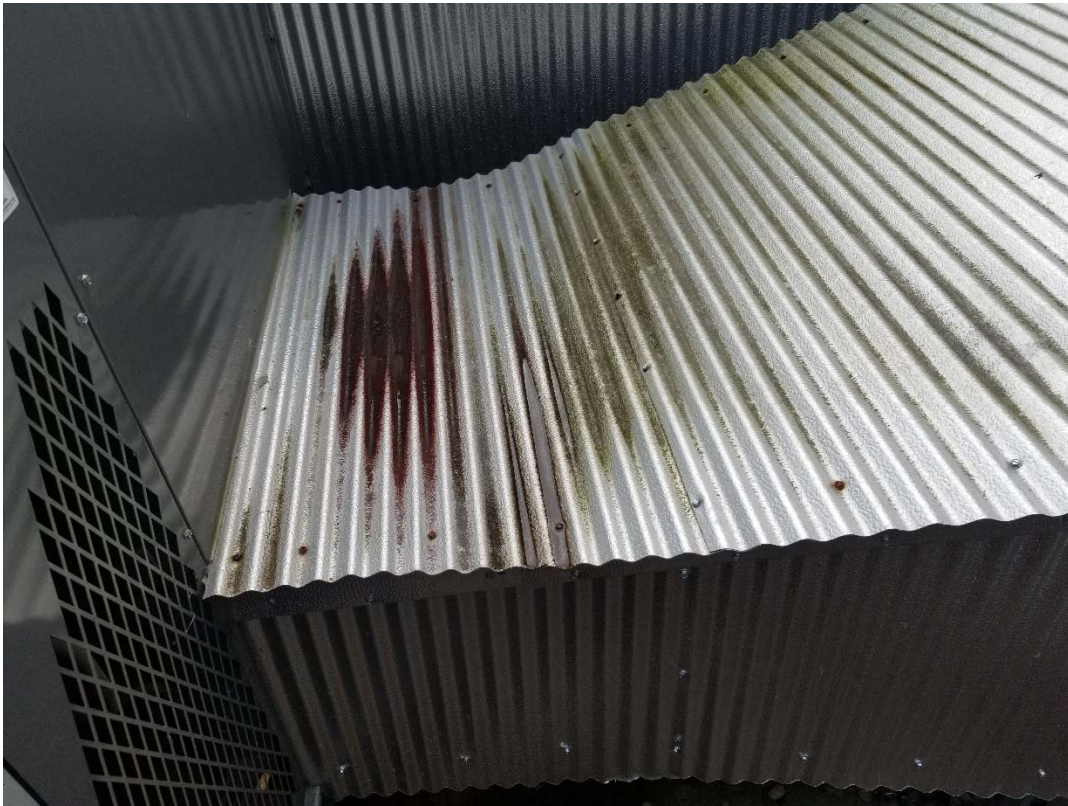
M13 Rusty Duct Covering

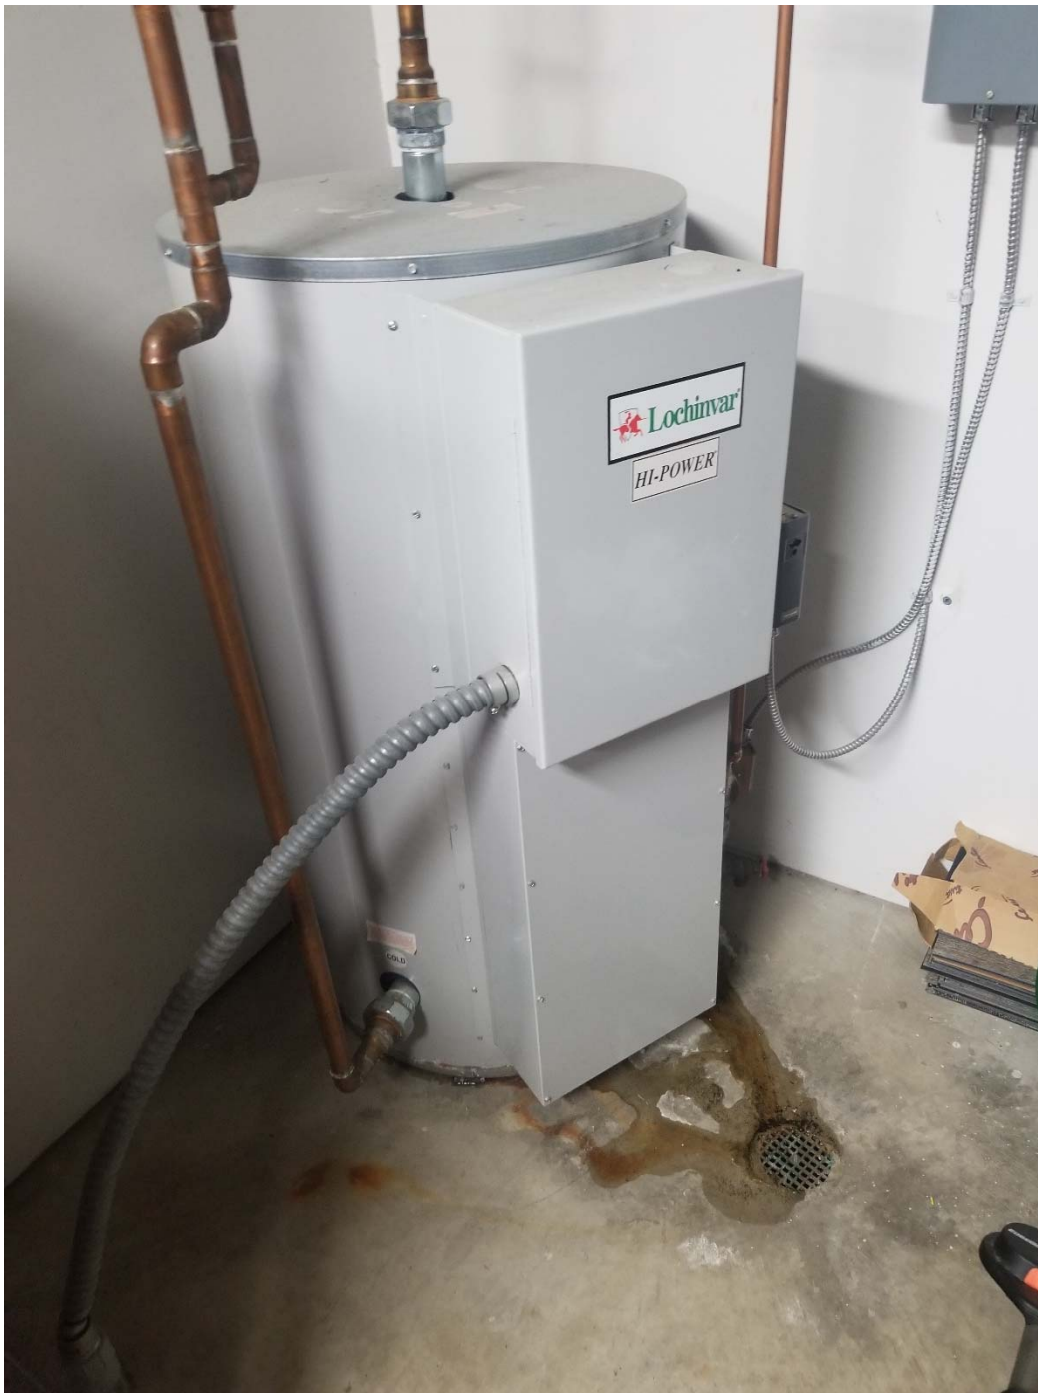
One 11-year-old 18 KW, 52-gallon electric domestic water heater, Lochinvar model HST18-052 located in the 1996 addition serves that portion of the building. (Refer to photo P6) There appears to be continuous leak, either from the tank, relief valve or circulating pump. (Refer to photo P7). This water heater is in fair to poor condition and should be replaced. (12-year average useful life per ASHRAE)

P6 Electric Domestic Water Heater

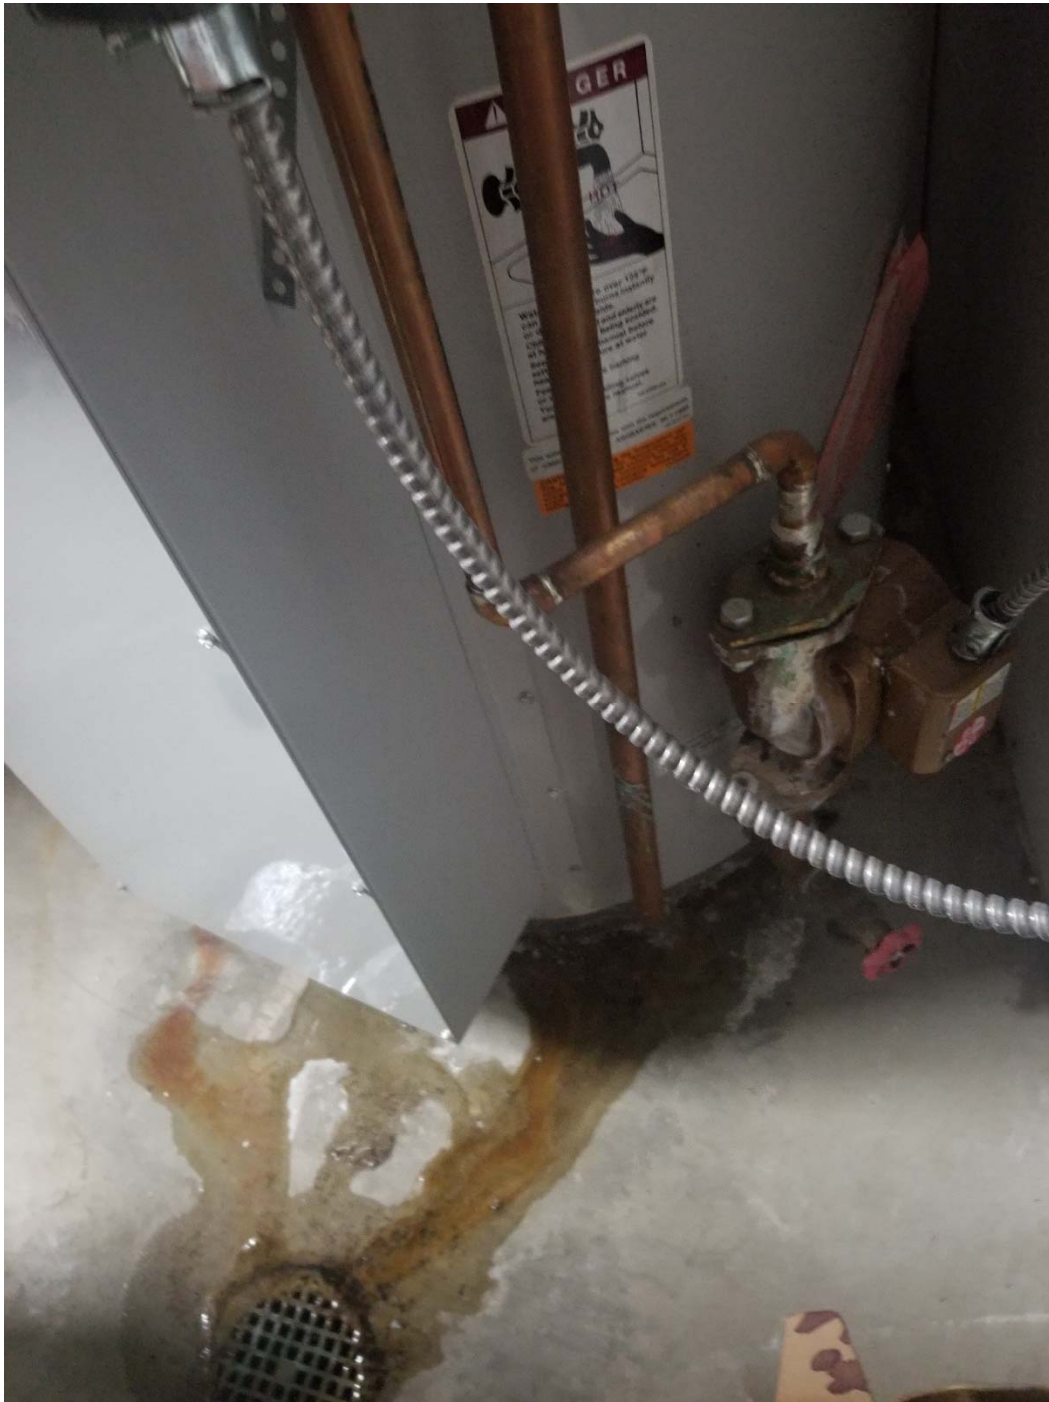
P7 Leak at domestic water heater

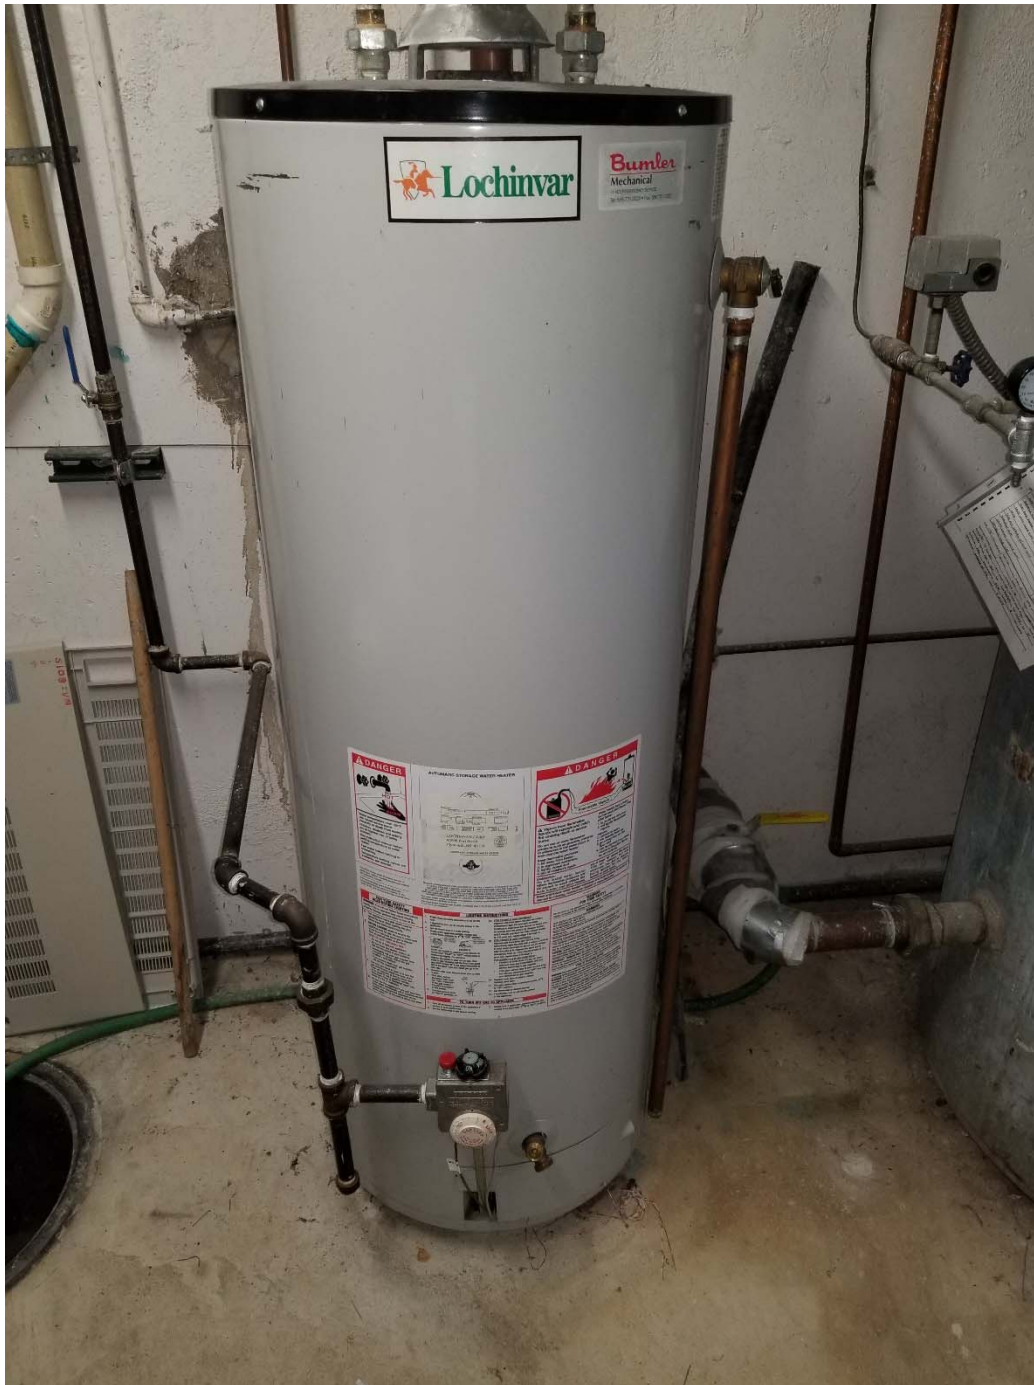
One 16-year-old 50 MBH gas fired domestic water heater, Lochinvar model STN050-4, serves the original portion of the building. (Refer to photo P8) It is in fair to poor condition and beyond the end of its useful life.

P8 Gas Fired Domestic Water Heater

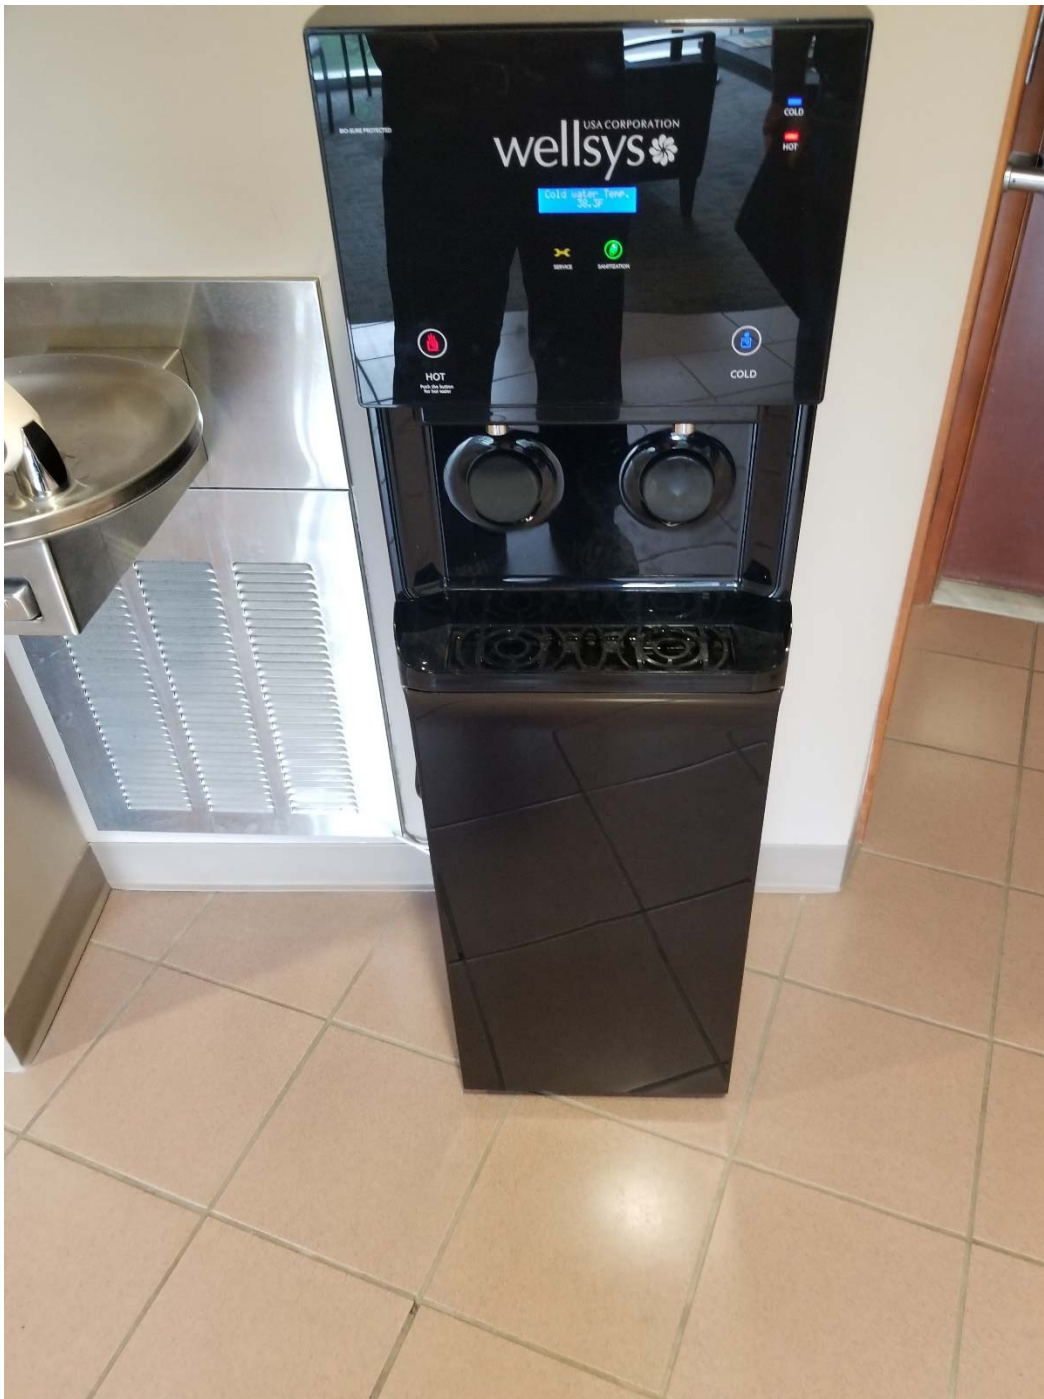
The plumbing fixtures appear to be original and in good condition. (Refer to photos P9, P13, P14 & P15) The lavs did not have the code required thermostatic mixing valve to prevent scalding. There was also a standalone hot and cold-water dispenser. (Refer to photo P10)

P10 Portable Hot and Cold-Water Dispenser

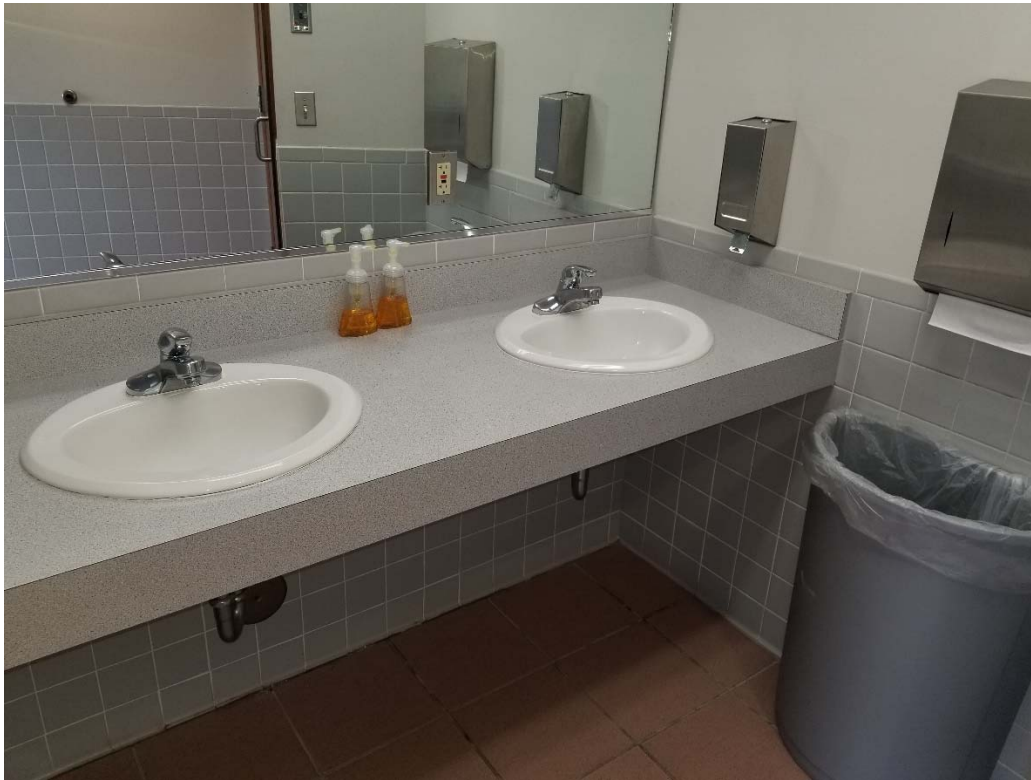
P13 Typical Lavs

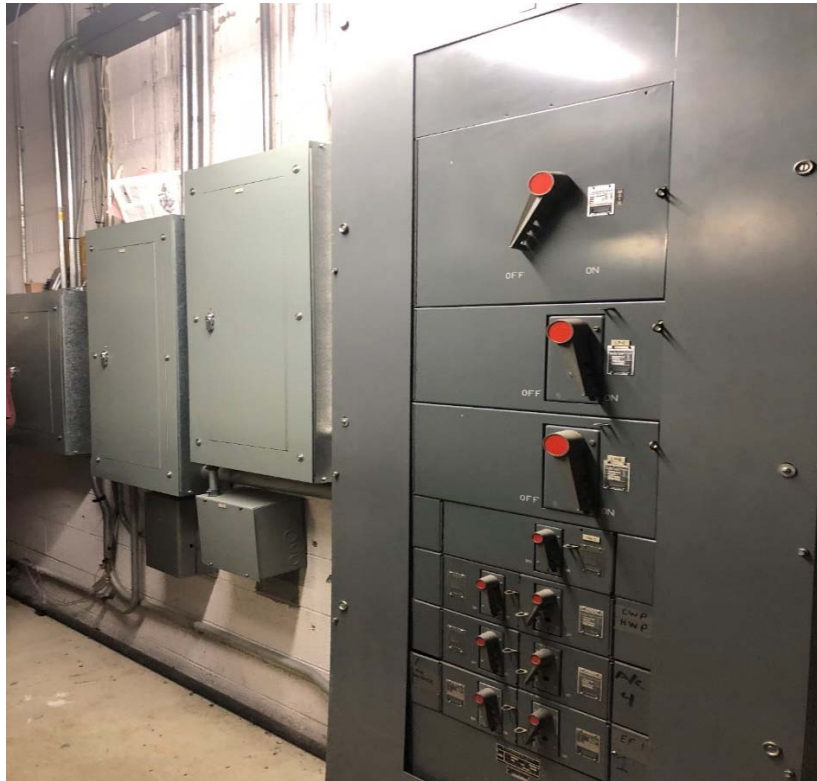
Distribution Panel DP-1 is 400A 208Y/120V 3 phase 4 wire, manufactured by “Federal Pacific”. This company is no longer in business and replacement parts are hard to come by. DP-1 is approximately 50 years old and it certainly exceeded its life expectancy. **(See Picture E3)**.

The original building and the addition in 1996 have two sets of electrical distribution equipment that vary in age and life expectancy. The 1996 branch panelboards are over 20 years old but appear to be in good condition. As for the original building electrical panelboards, they appear to have been replaced in 1996. The only original building panel is DP-1. This distribution panel is over 50 years old and in need of upgrade due to age and lack of replacement parts. **(See picture E3)**.

Picture E3 – DP-1 Original Building

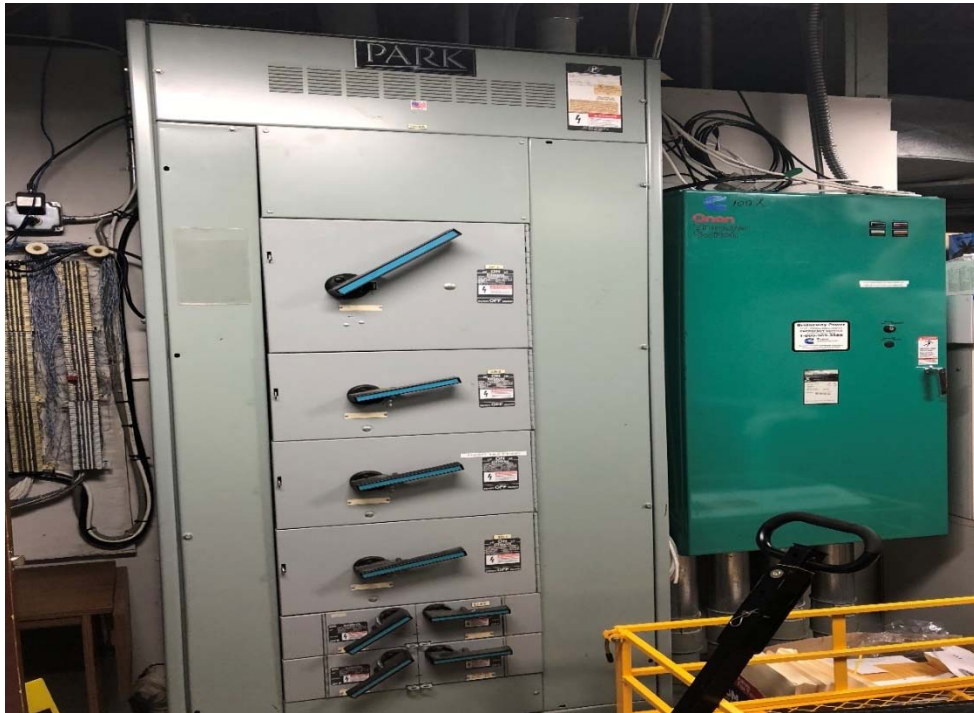
The building is currently equipped with a 100Kva 208/120v 3 phase 4 wire Natural Gas generator. The generator is located on the North side of the building, house in a sound attenuating enclosure, and is manufactured by “Onan/Cummins”. The generator was installed in 1996 with the new addition. It appears to be in good shape and in good working condition according to building owner **(See picture E4)**. The feeders from the generator enter the building underground to a 400A 3P automatic Transfer Switch (ATS) located in the main electrical room. The generator and the ATS are connected on the load side to distribution panel DP-SB (600A-208Y/120V 3 phase 4wire) which in turn feeds the entire original building distribution panel DP-2 (400A-208Y/120V 3 phase 4wire) along with the elevator and other HVAC units. The generator appears to be overloaded. **(See picture E5)**.

Picture E5 – Existing ATS and Emergency Load panel DP-SB

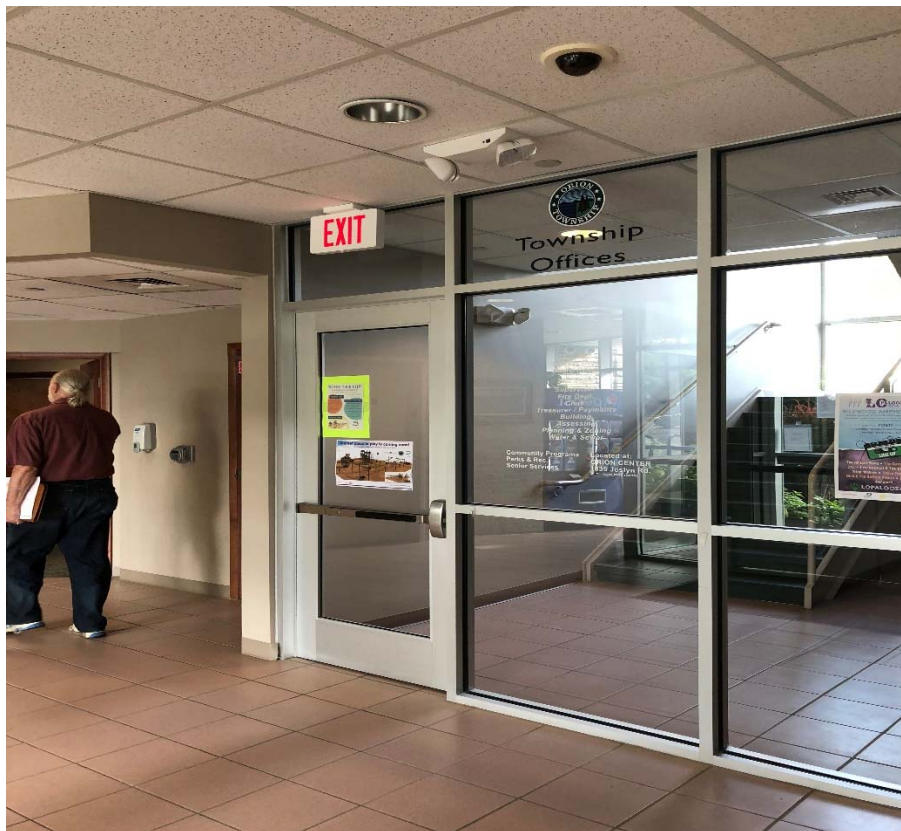
The emergency lighting system consist of Emergency Battery Units (EBU) scattered throughout the building and battery-operated exit signs. The Egress pathway needs to have sufficient spacing to provide the 1 foot-candle average and a 0.1 minimum. The exit signs and the EBU appears to be in good condition. We need to review maintenance schedule with the owner to verify working conditions. No exterior egress lighting was observed which is a current code requirement. **(See picture E6)**.

Picture E6 – Existing Emergency Lighting

The emergency lighting system is battery operated, may not meet code in certain areas, and will need to be maintained in good condition by replacing batteries every 5 years.

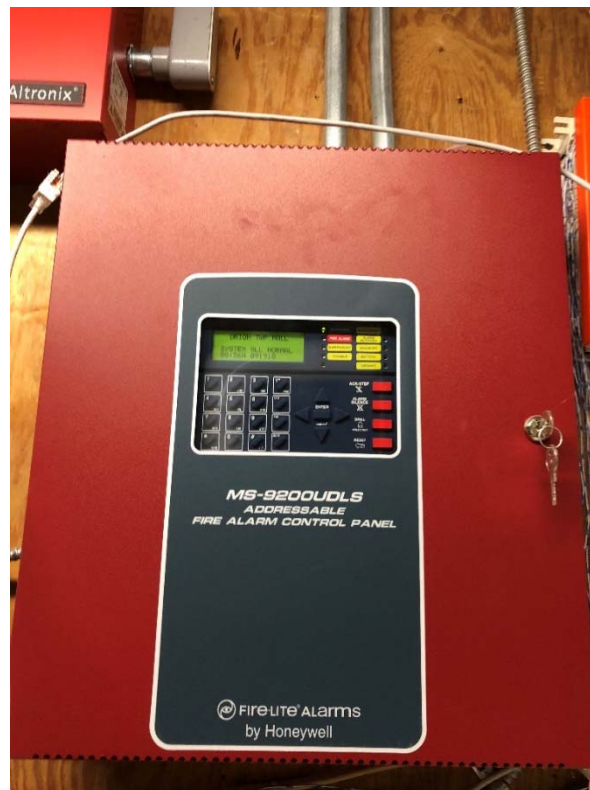
The building fire alarm system is an electronic addressable system consisting pull stations, Horns and Horn/strobes located throughout the building as required by current codes. The Fire Alarm control panel is located in the original building mechanical room. For any building addition, this panel will need to be replace with a new control panel due to age and the lack of support regarding older models. **(See picture E8).**

Picture E8 – Existing Fire Alarm Control Panel
