ALDRICH PUBLIC LIBRARY

FEASIBILITY STUDY

Issued: October 21, 2021

CROSSKEY ARCHITECTS, LLC
750 Main Street, Suite 150
Hartford, CT 06103

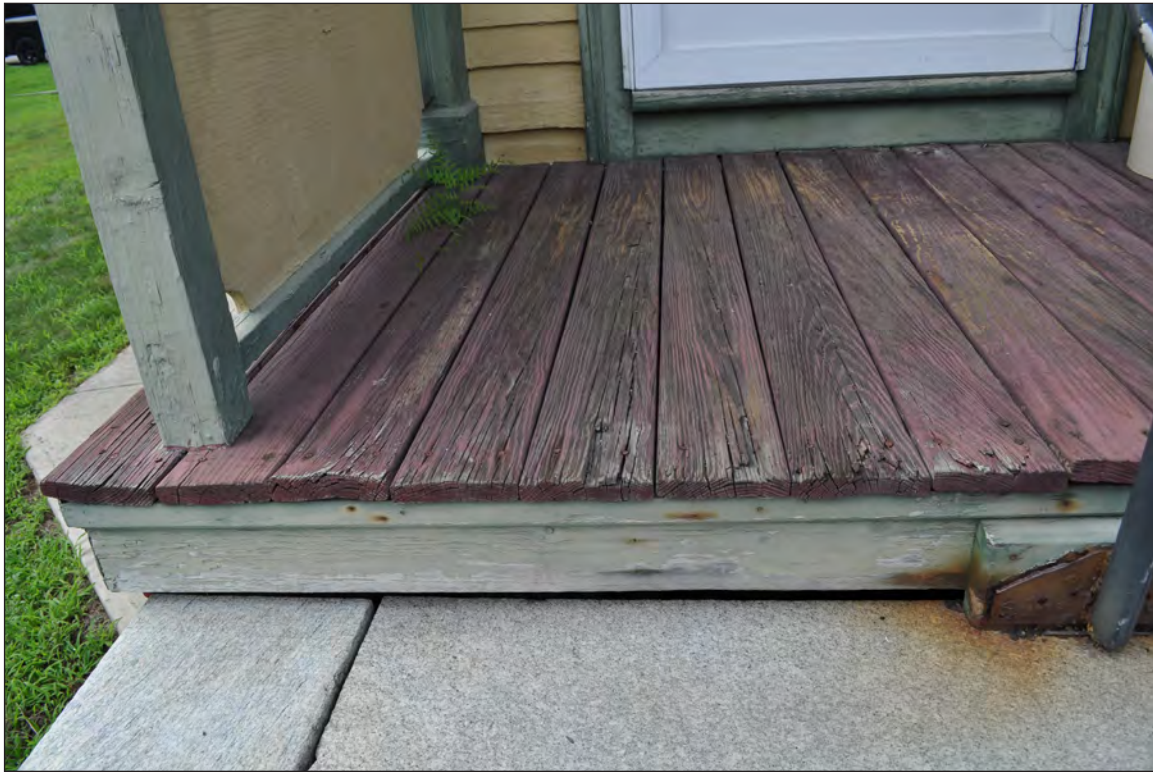
6. South elevation, deteriorated porch boards, camera facing down and north.

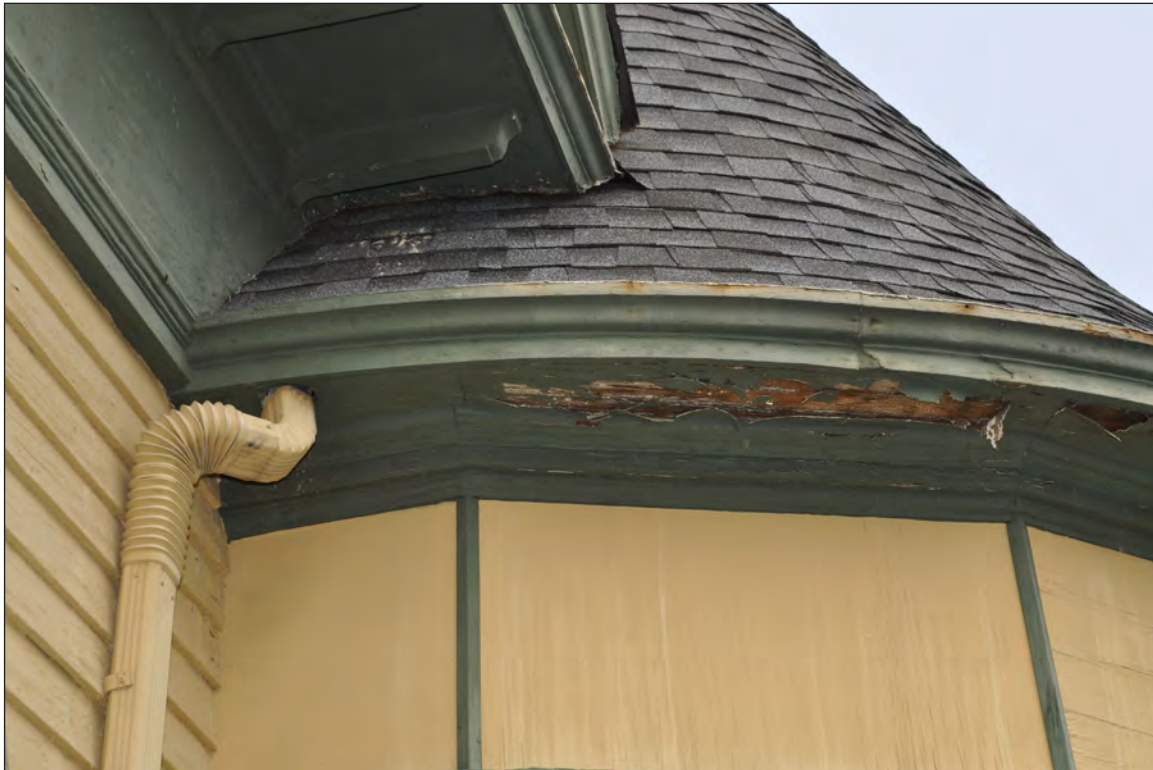
9. South elevation, west elevation of tower, camera facing up and northeast. Note deterioration of soffit boards.

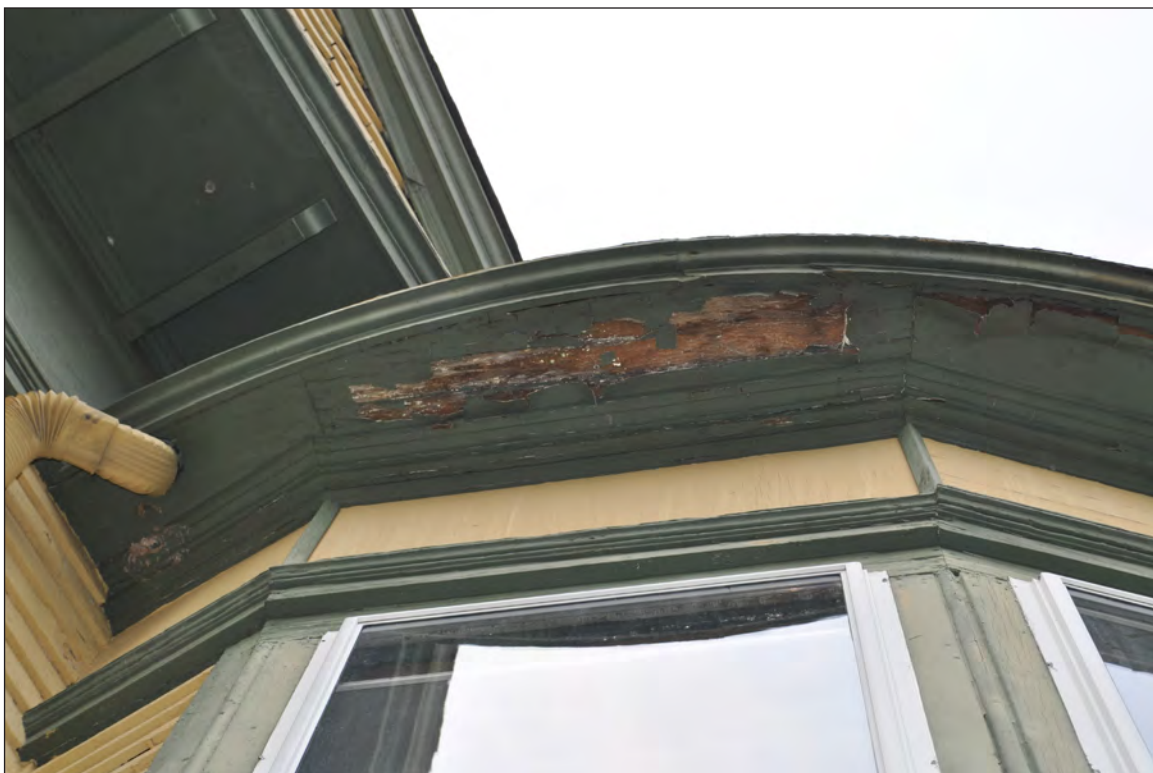
10. South elevation, west elevation of tower, camera facing up and northeast. Note deterioration of soffit boards.

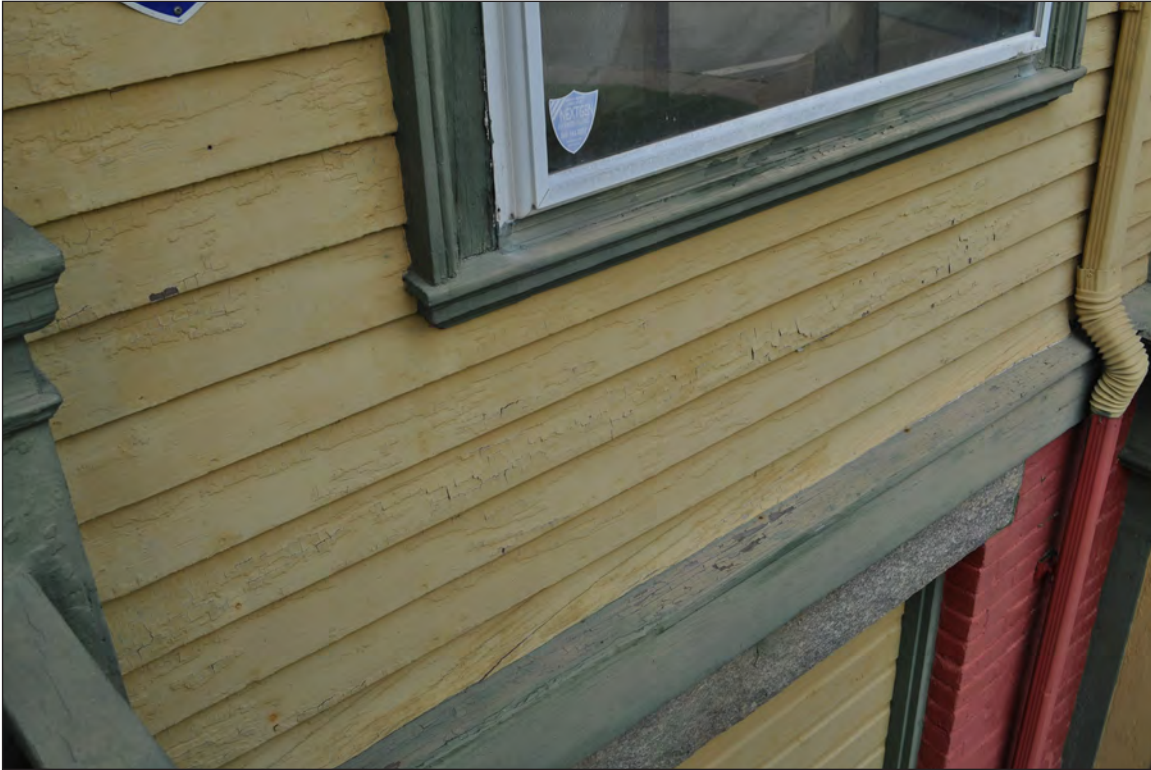
12. South elevation, camera facing down and northeast. Note deterioration of water table boards.

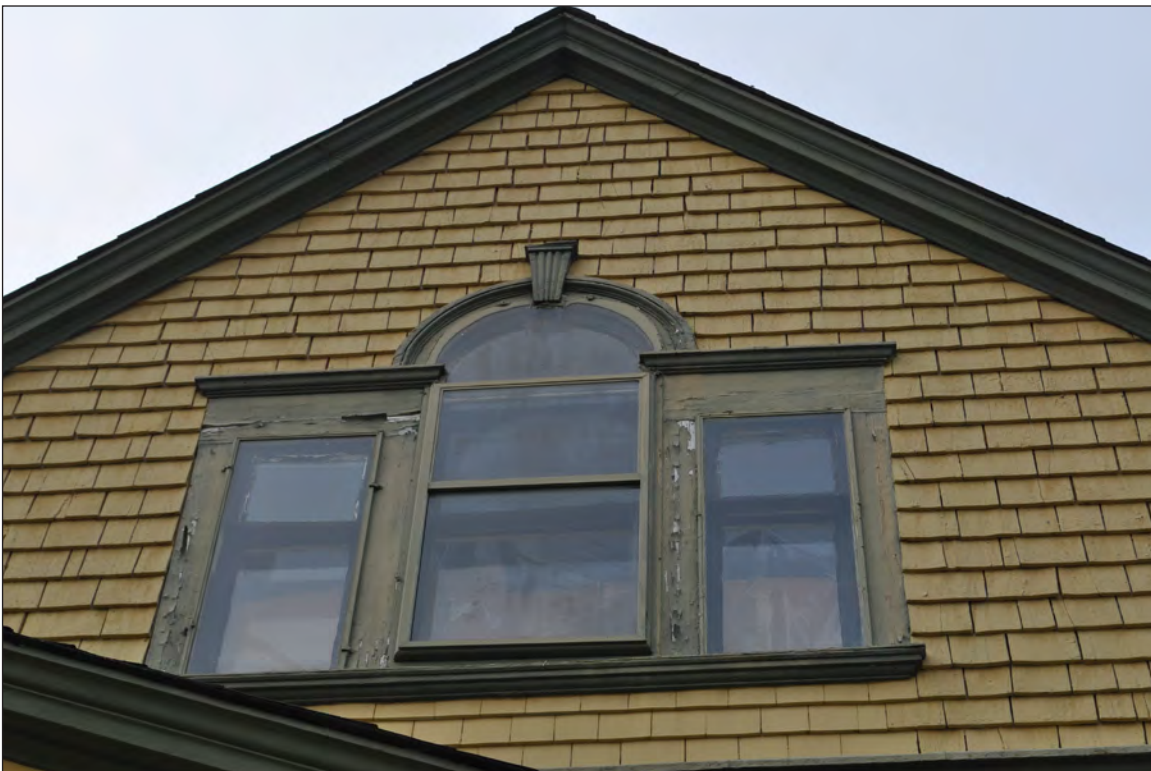
13. South elevation, camera facing up and north. Note missing trim on window surround.

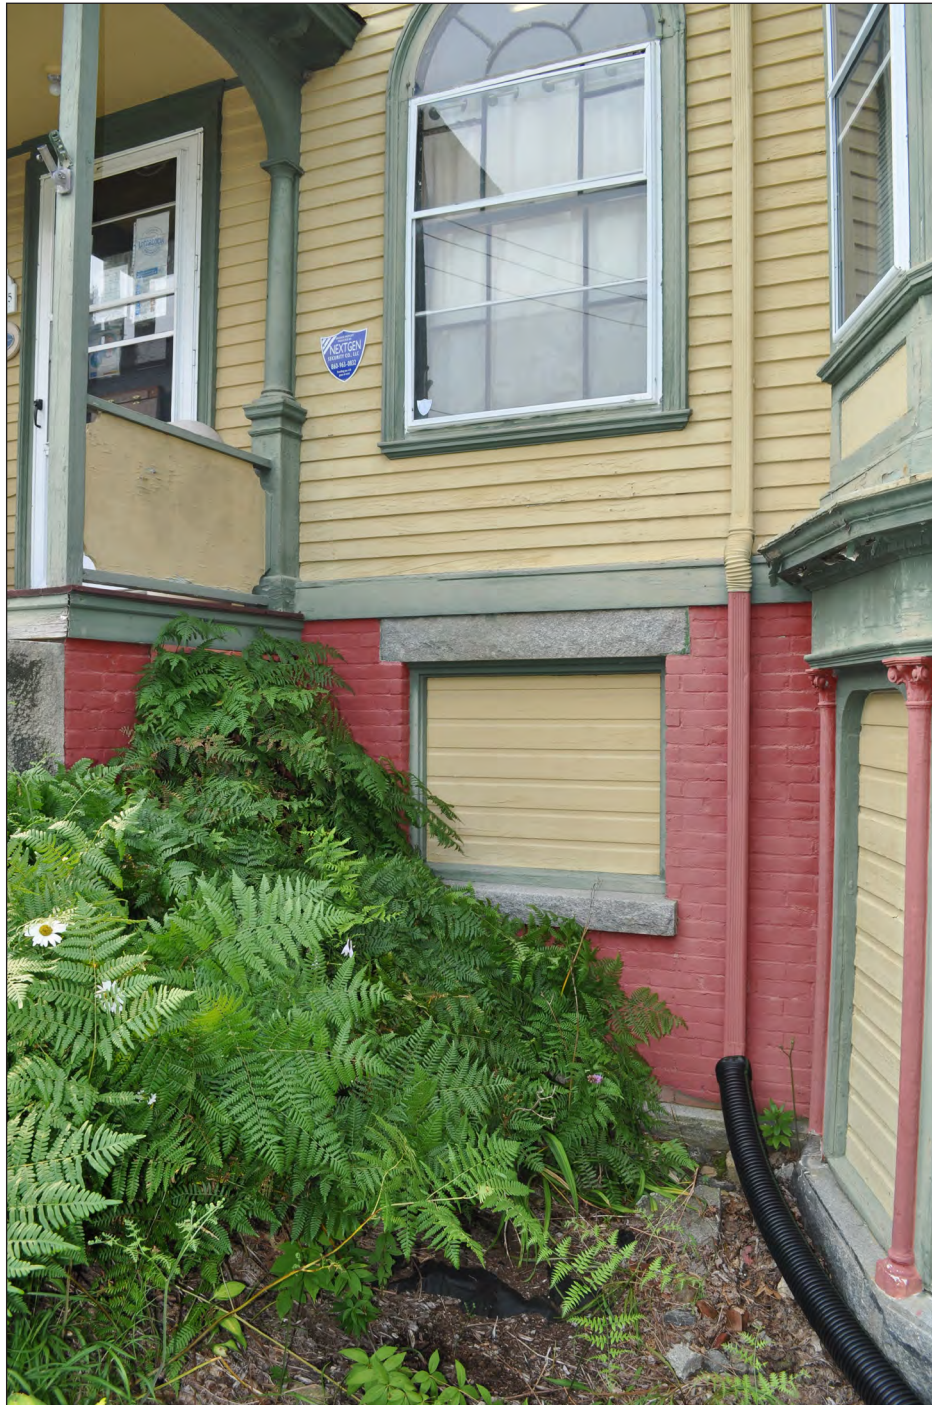
14. South elevation, vegetation growing against east elevation of stair.

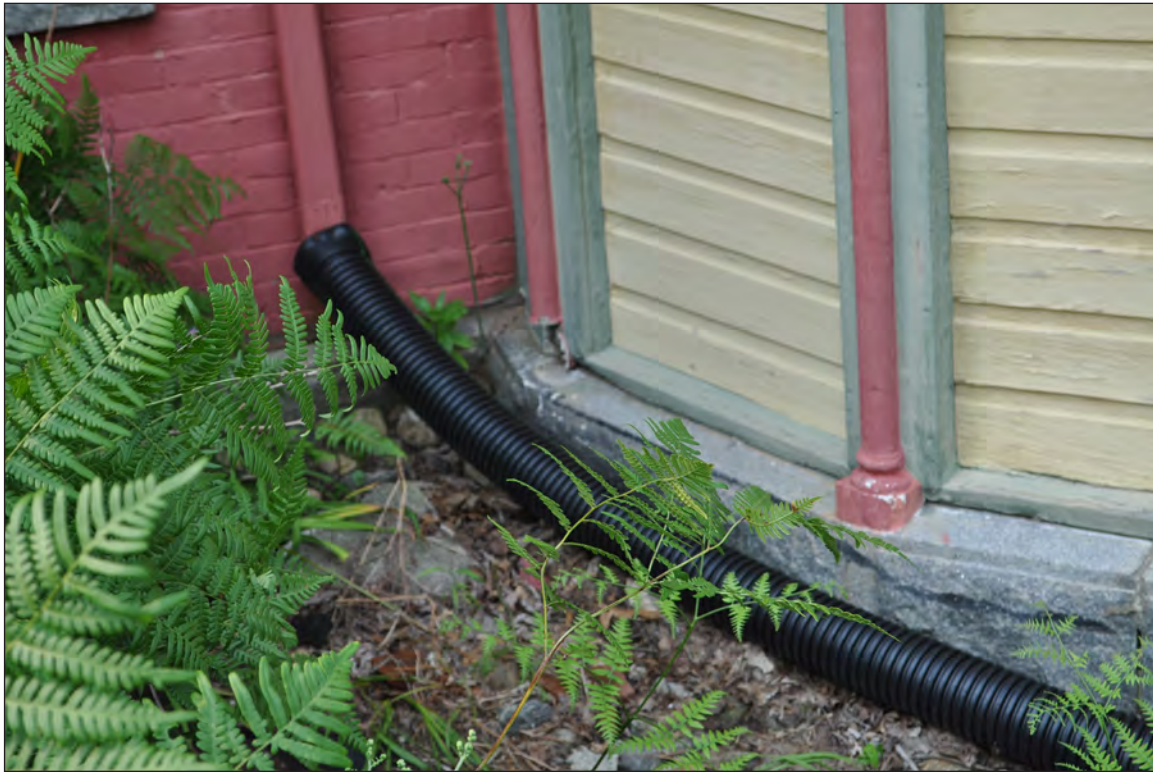
15. South elevation, west elevation of tower, camera facing down and northeast. Note missing column base.

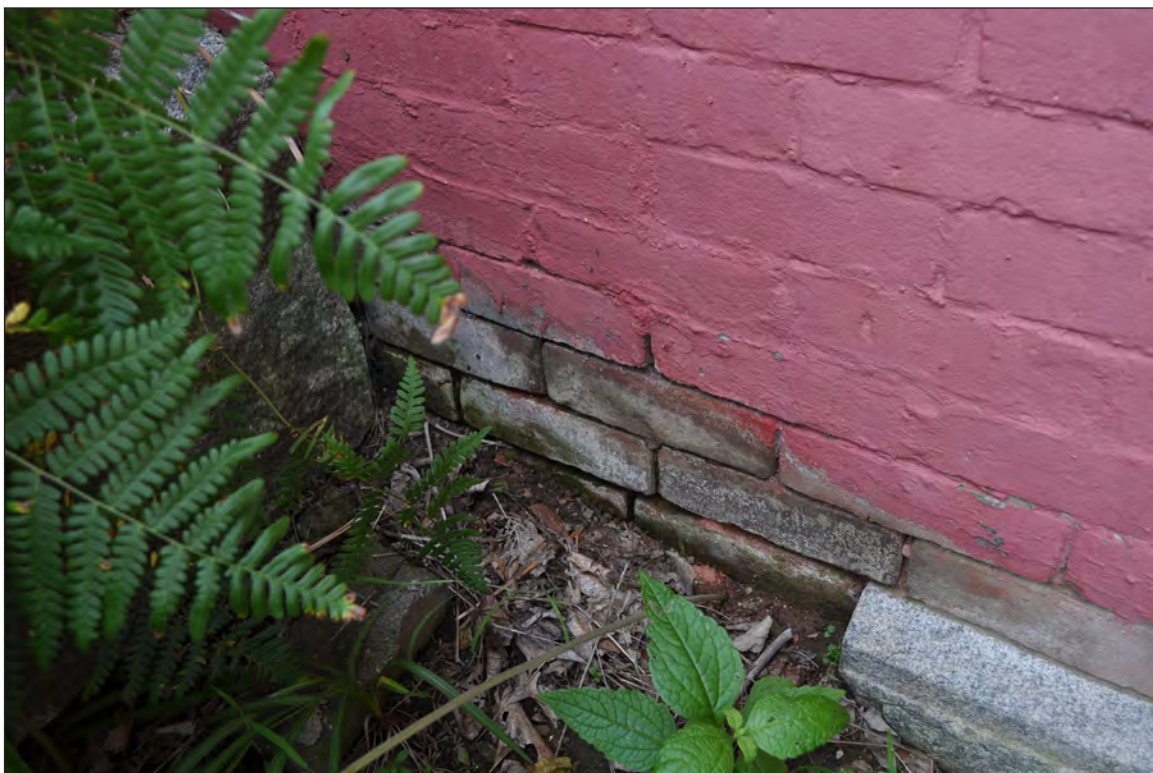
16. South elevation, vegetation growing against east elevation of stair. Note paint deterioration and missing mortar.

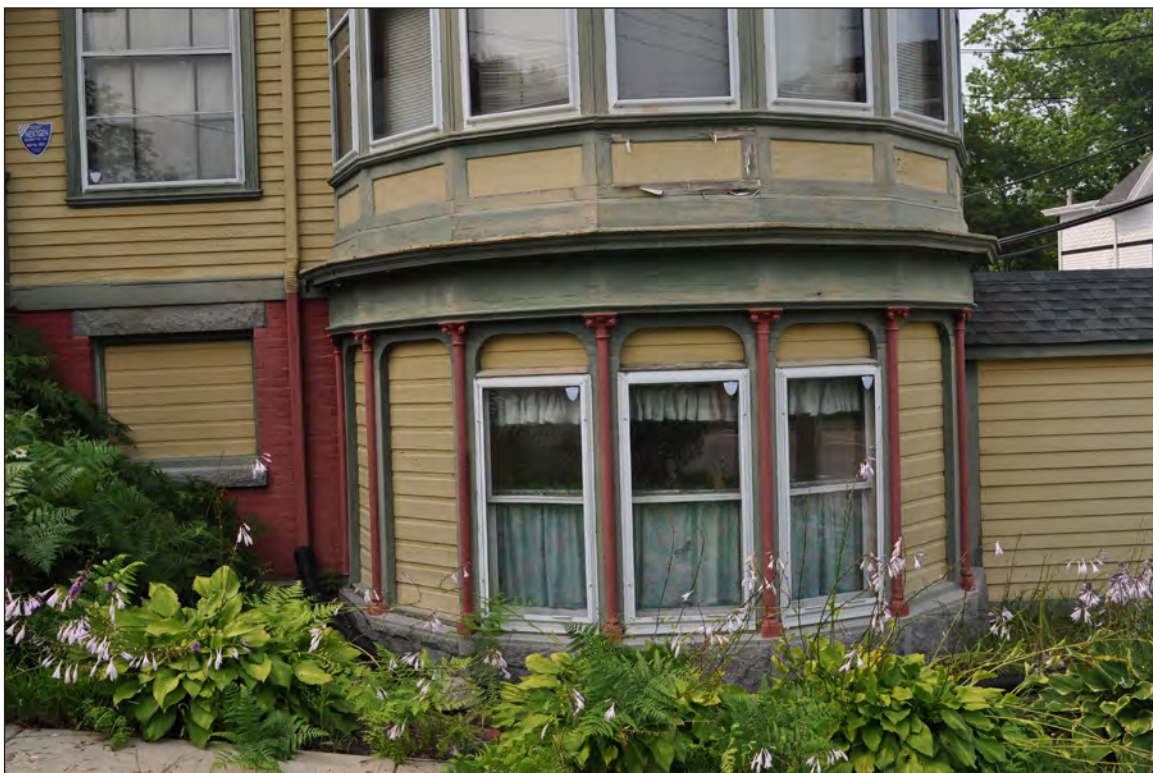
20. South elevation, tower, camera facing north. Note deteriorated of bulkheads below first-floor windows.

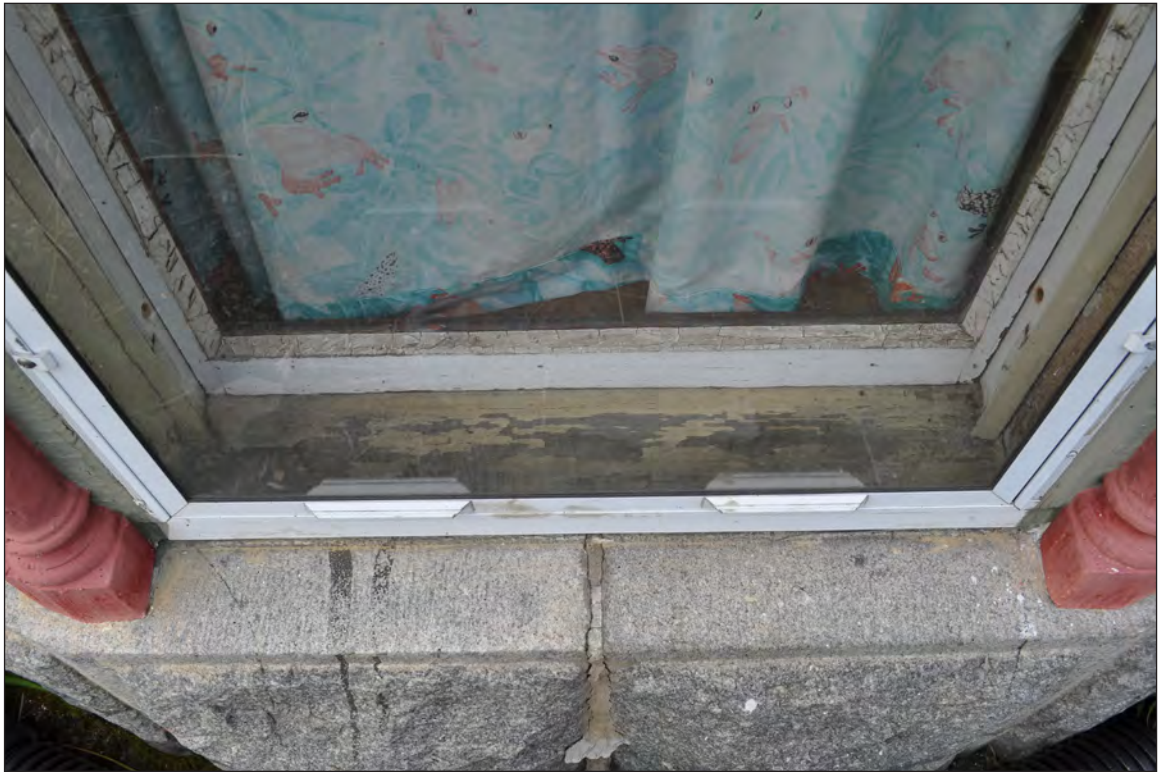
21. South elevation, tower, camera facing down and north. Note deteriorated window sash and sill.

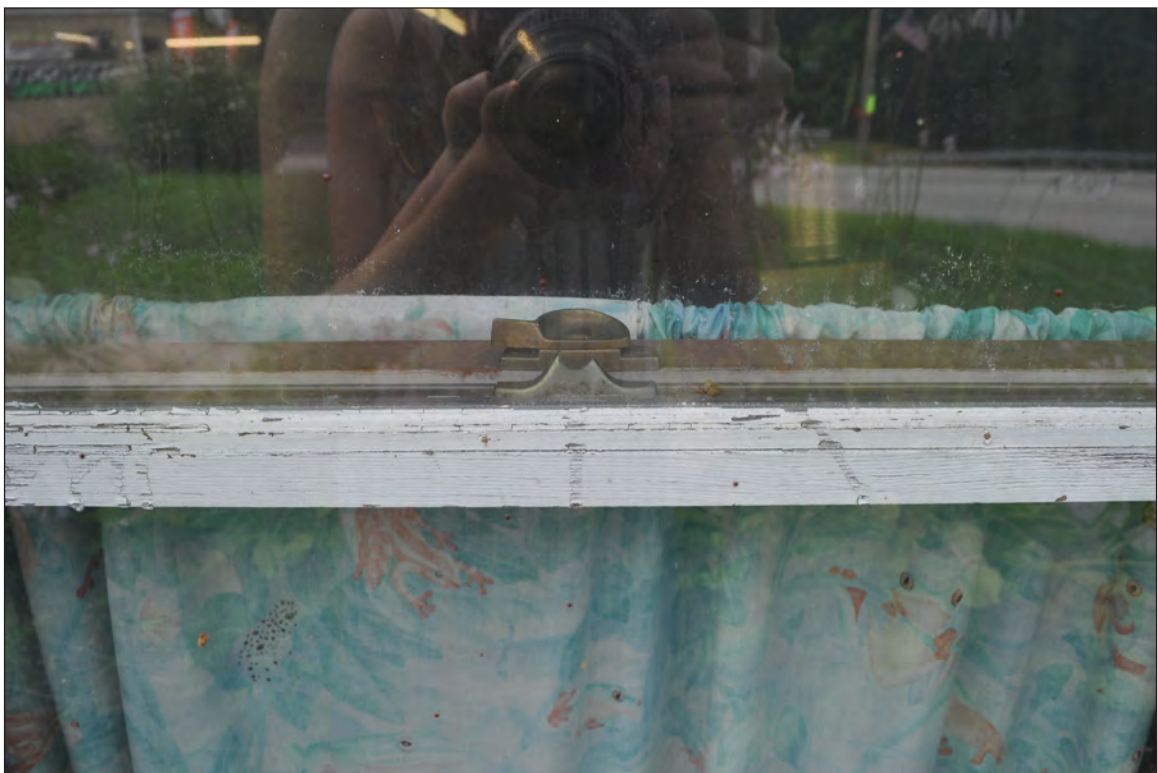
22. South elevation, tower, camera facing north. Note broken hardware.

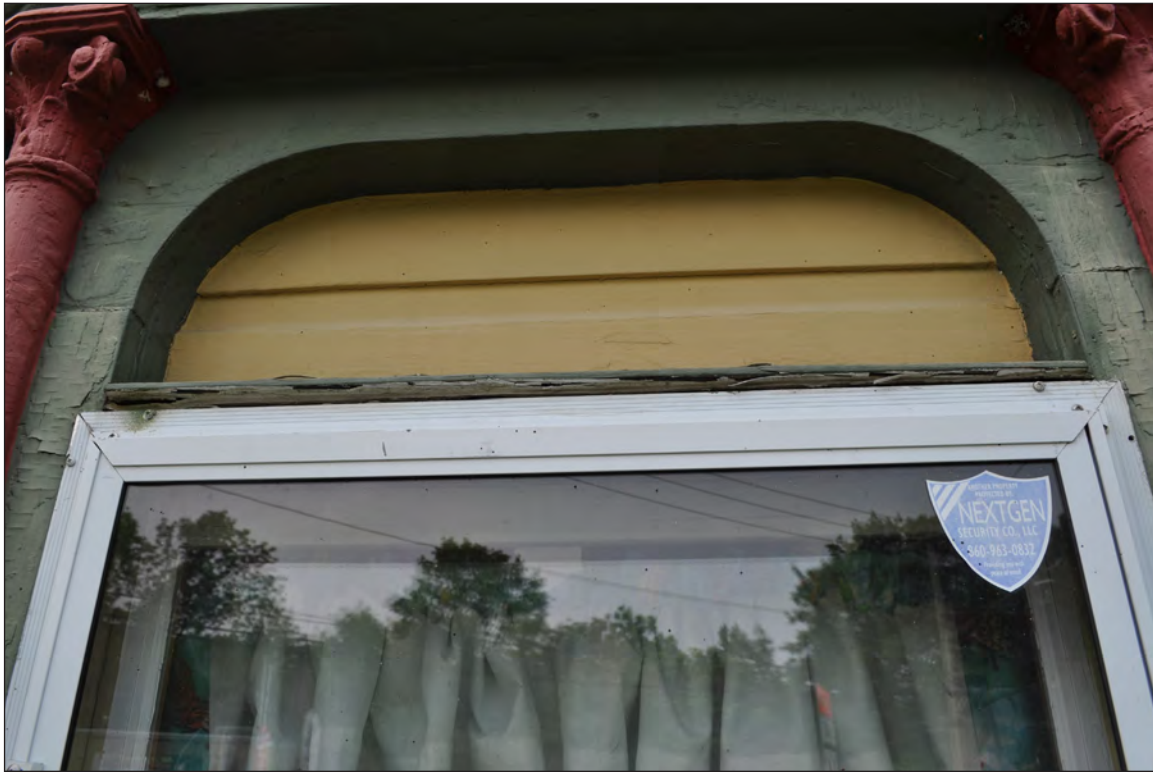
23. South elevation, tower, camera facing up and north. Note deteriorated flashing at top of storm window and infilled transom above.

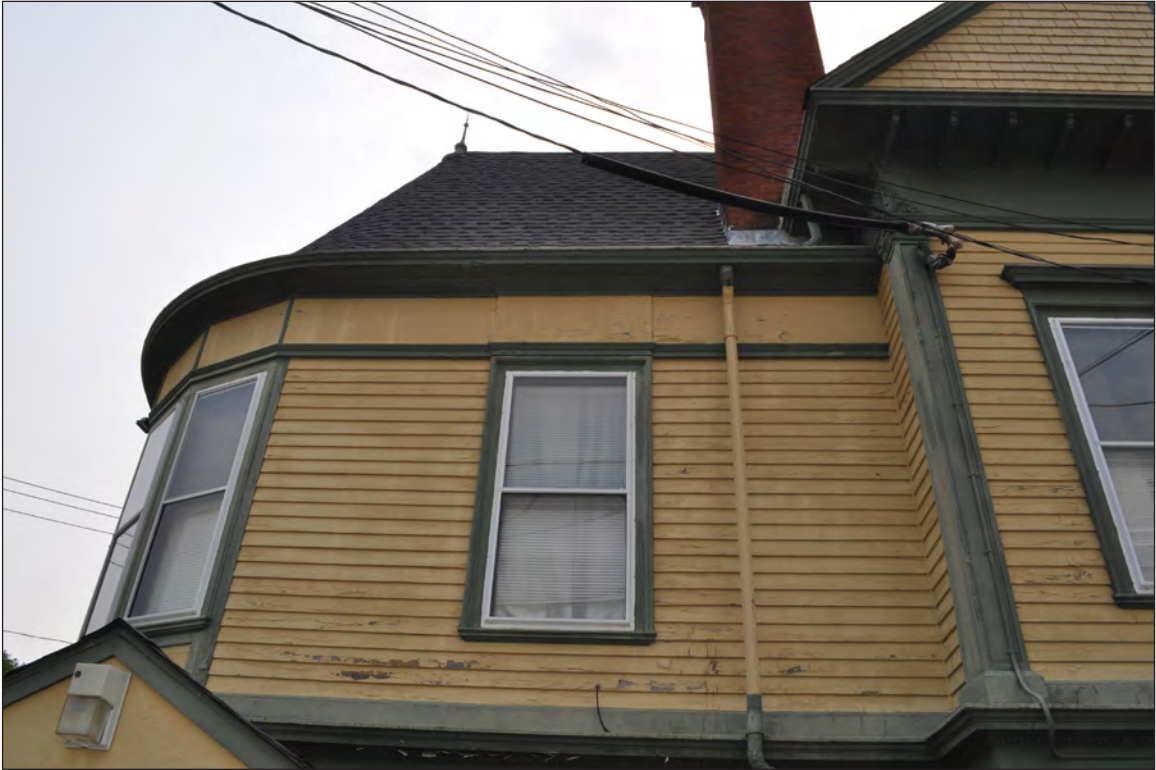
34. East elevation, camera facing up and west. Note condition of clapboards.

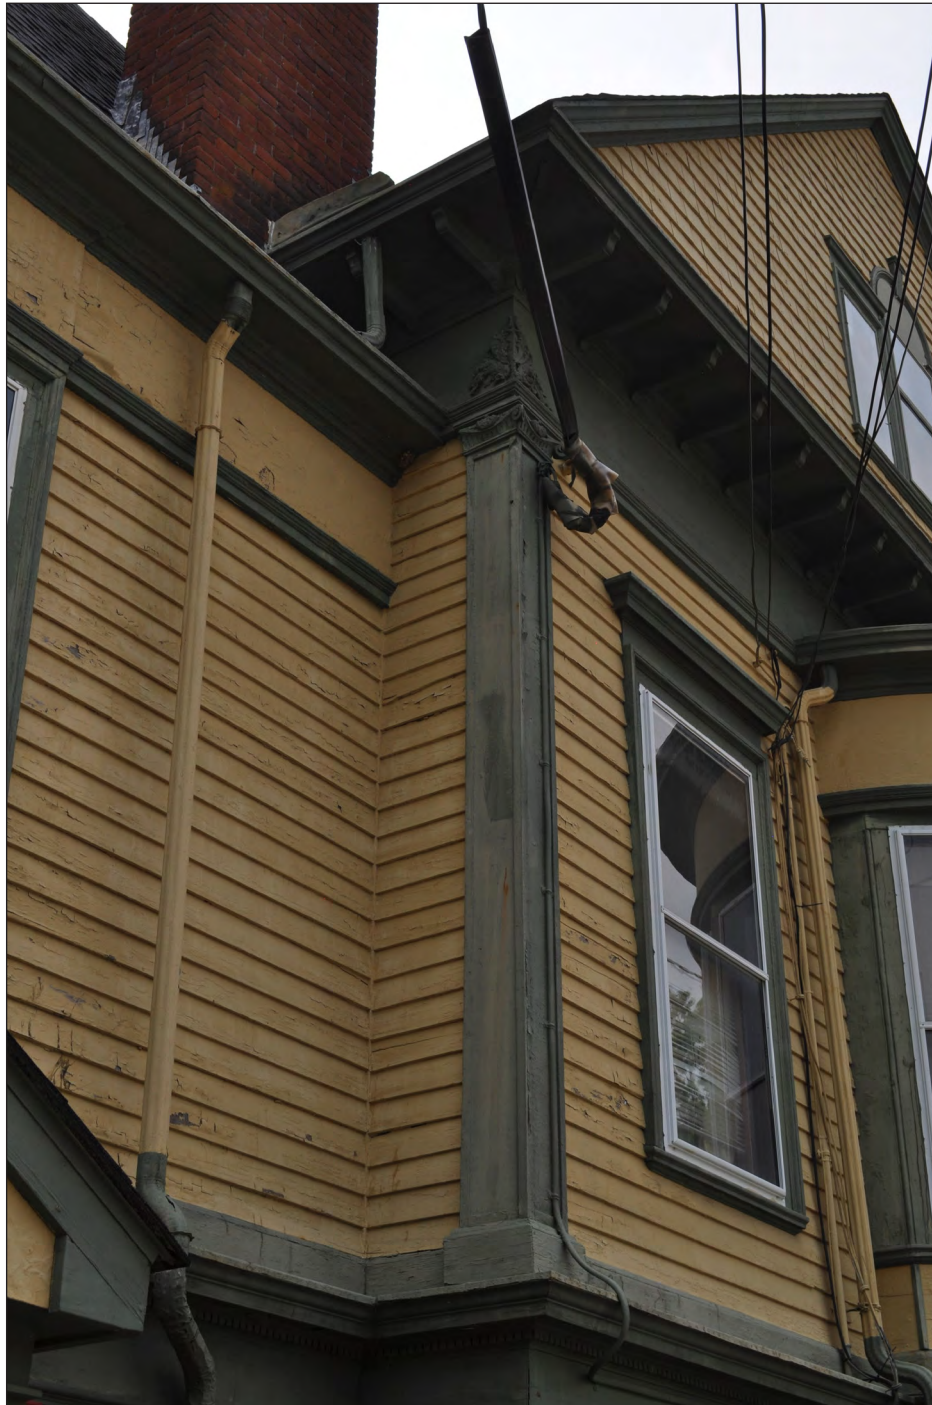
36. East elevation, camera facing northwest. Note condition of clapboards and corner pilasters.

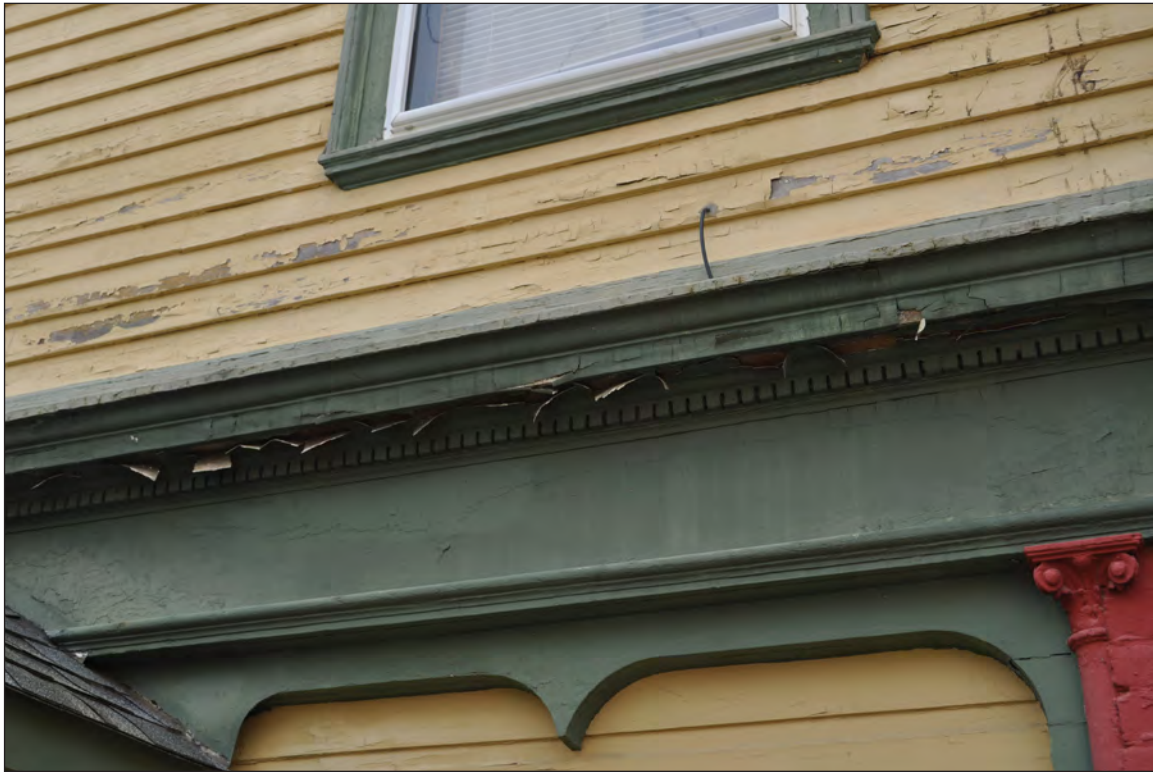
37. East elevation, camera facing southwest. Note conditions of clapboards and cornice components.

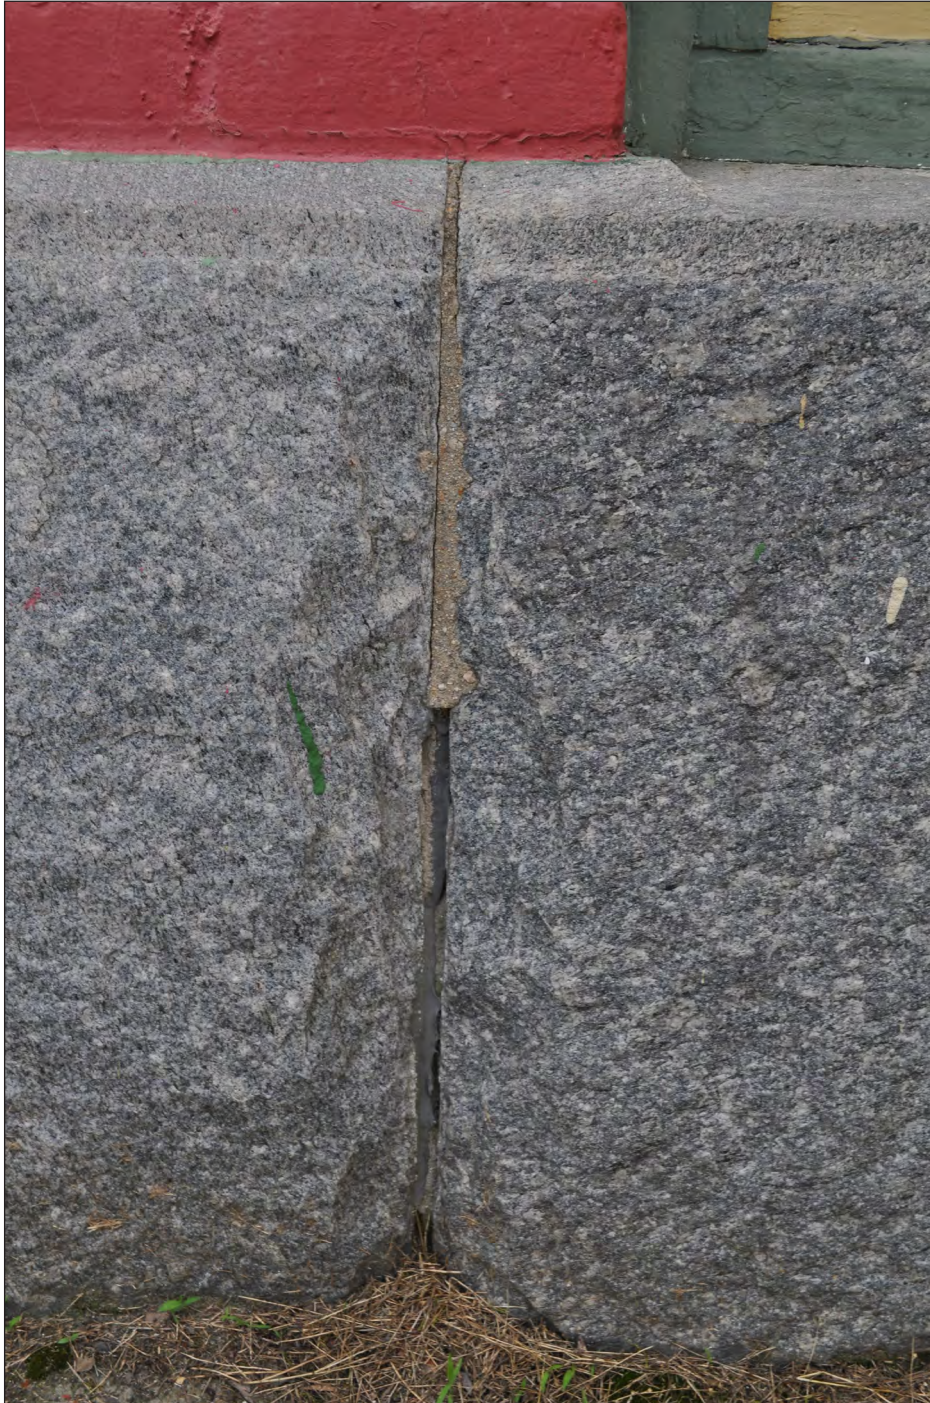
43. East elevation, missing mortar joint, camera facing down and west.

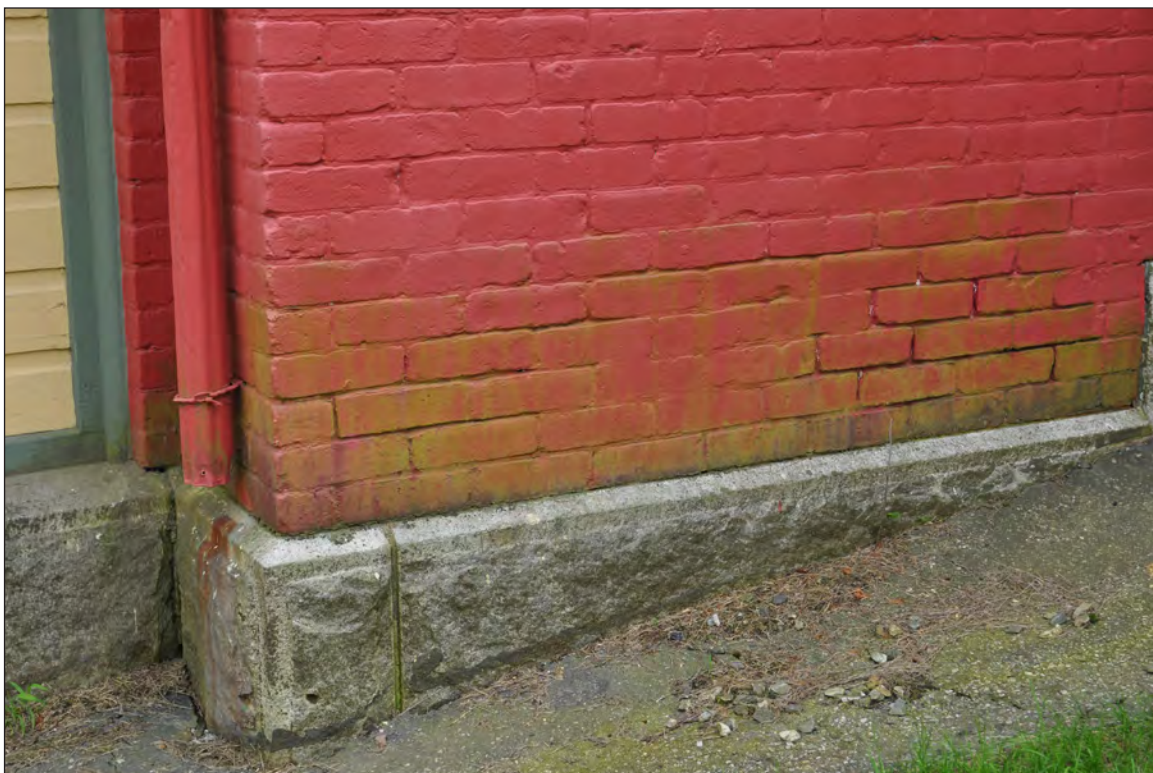
48. North elevation, camera facing down and southwest. Note bio growth and missing mortar.

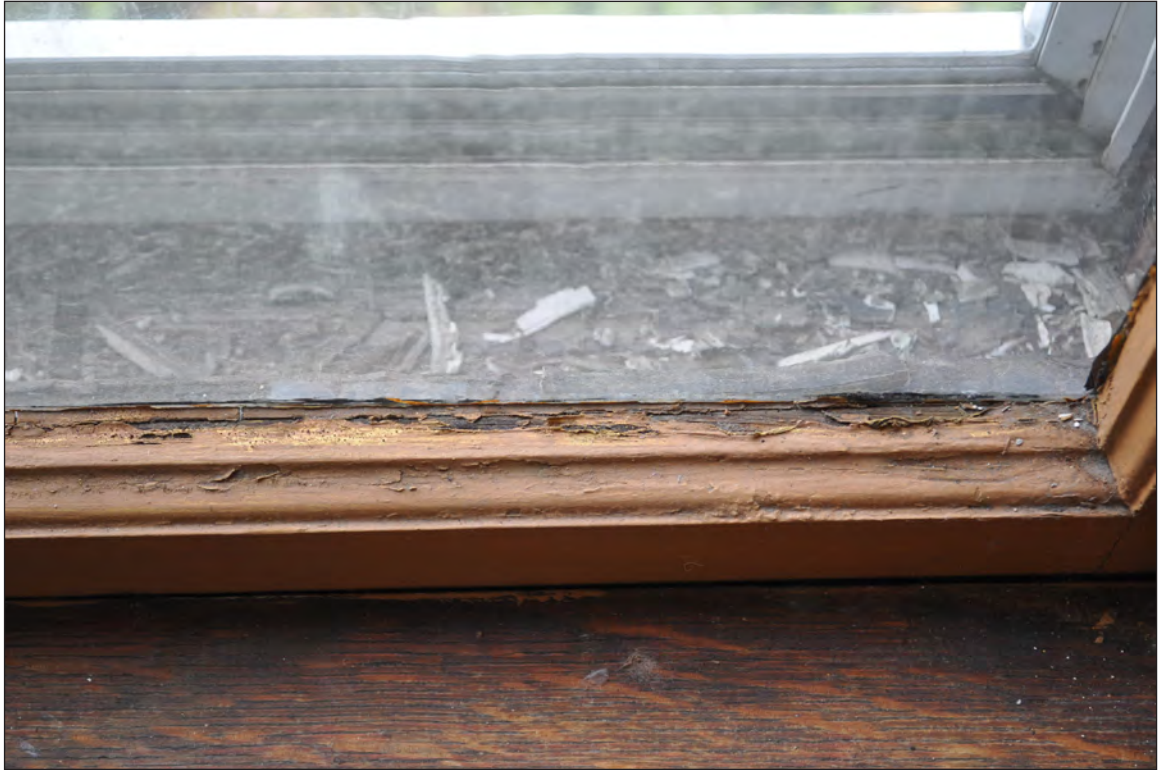
97. First-floor, computer room (201), example condition of bottom rail of window, camera facing south.

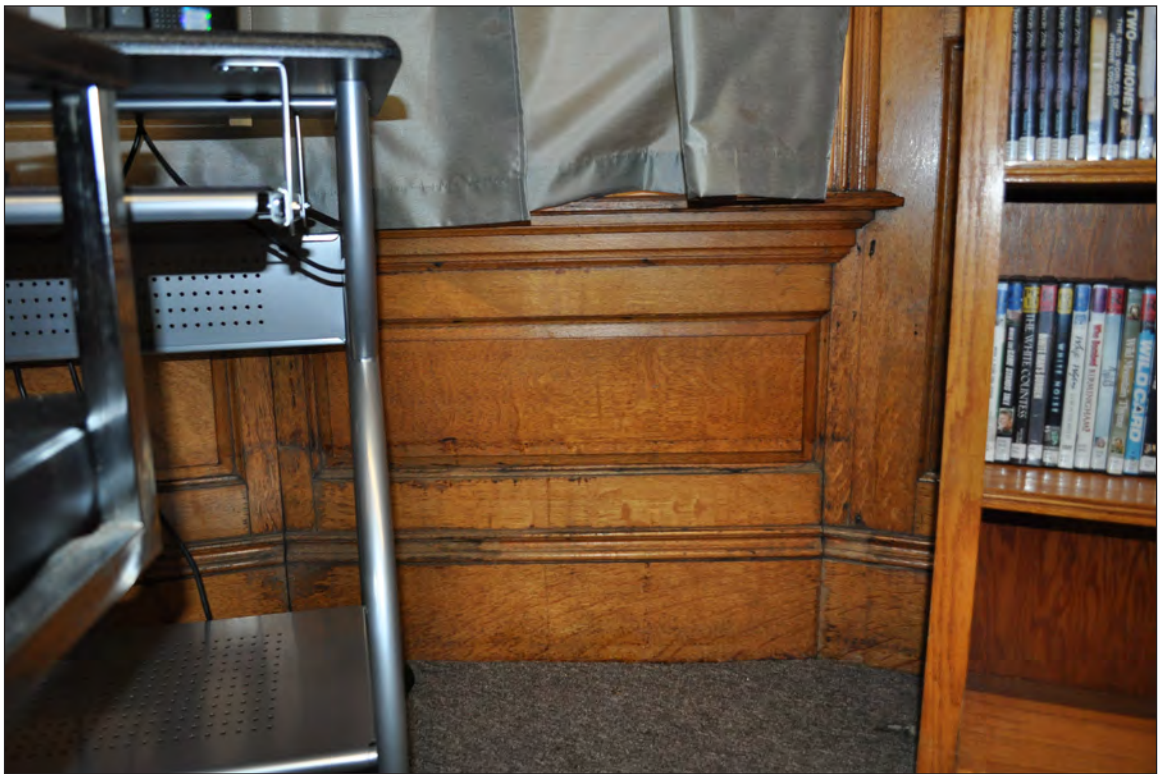
98. First-floor, computer room (201), camera facing southwest. Note staining on panel below window.

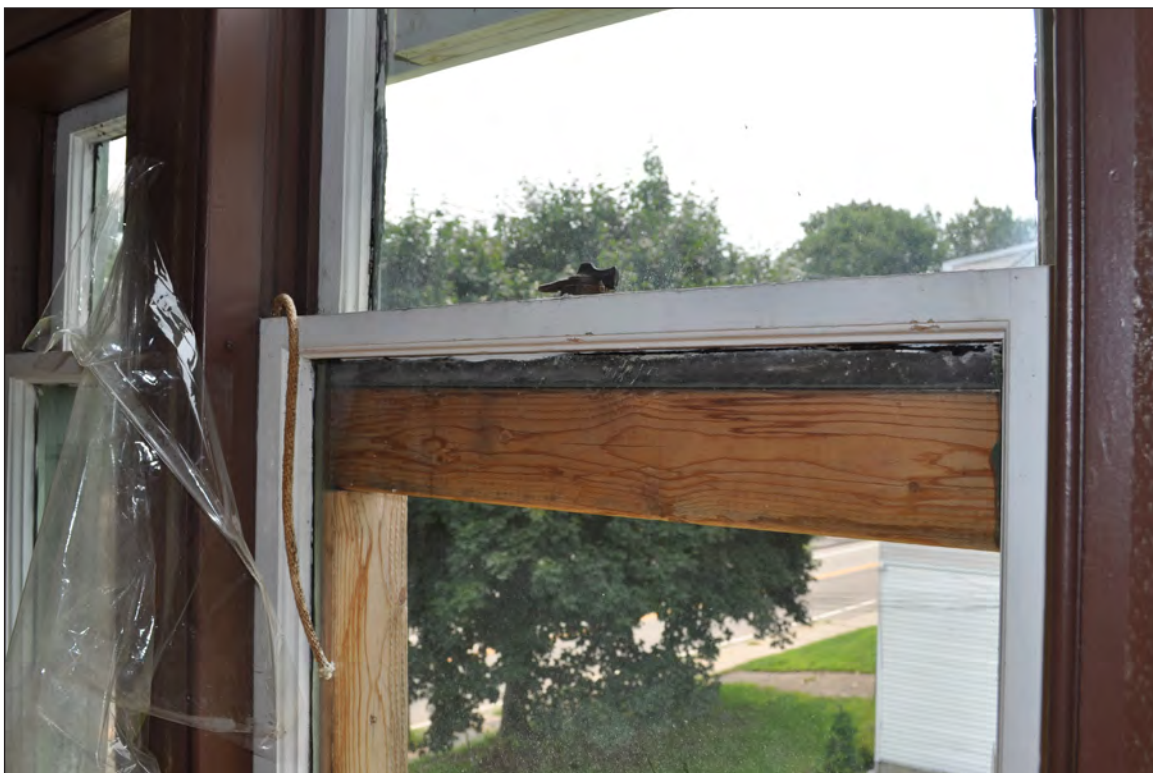
140. Second-floor, window in stair, camera facing southwest. Note broken sash and sash cord.

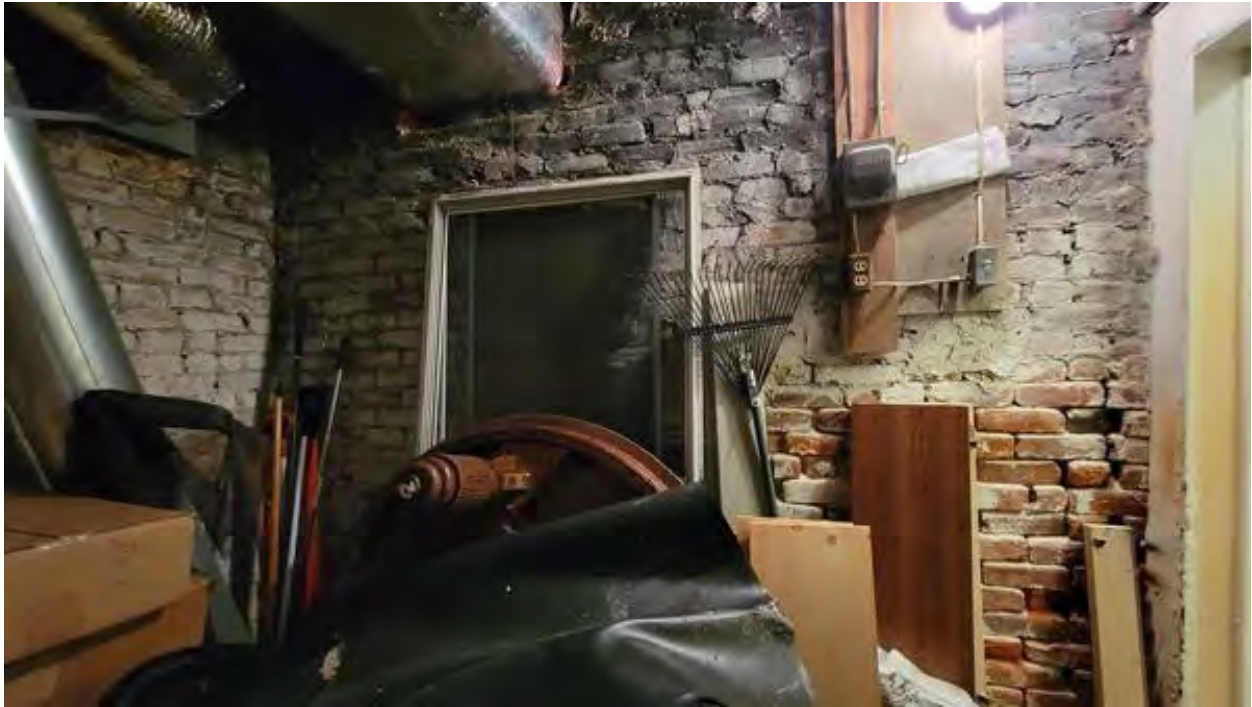
1. South wall of Furnace Room showing irregular brickwork and deterioration due to rising damp. Treatment is required to arrest the damp. Replacement of damaged brick units and repointing of mortar joints is also needed.

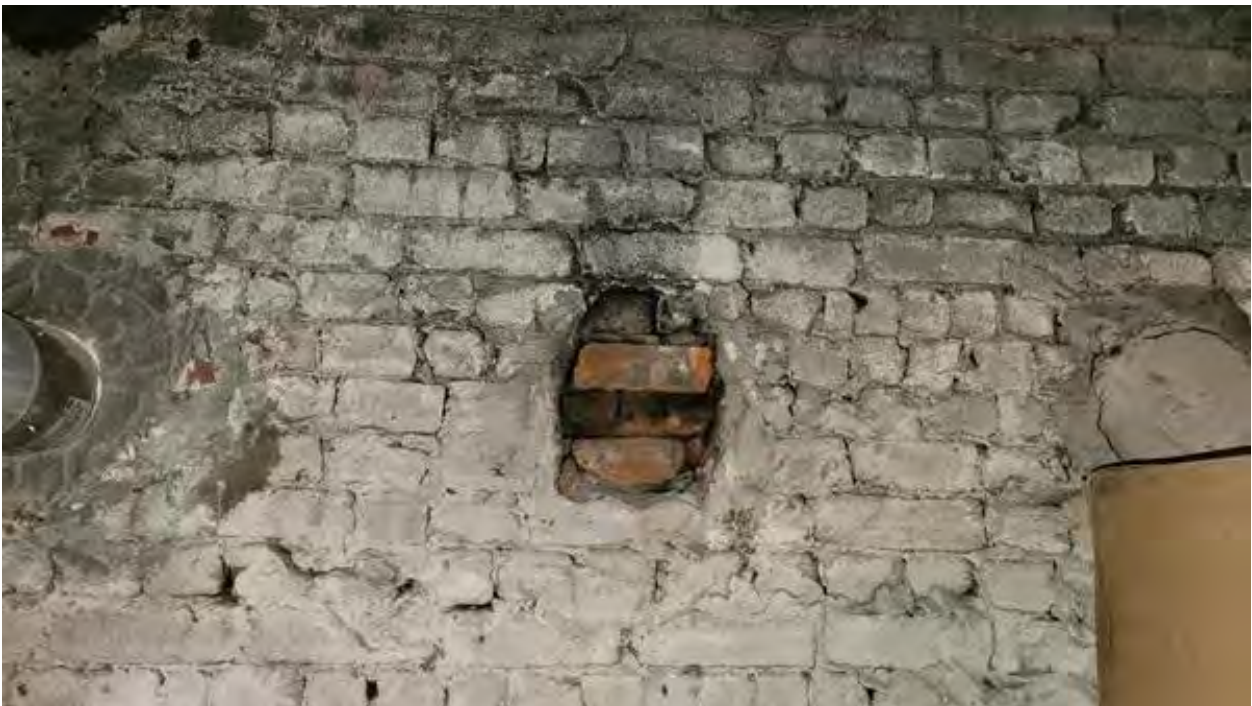
2. East wall of Furnace Room. Hole into inactive chimney should be properly sealed with brick.

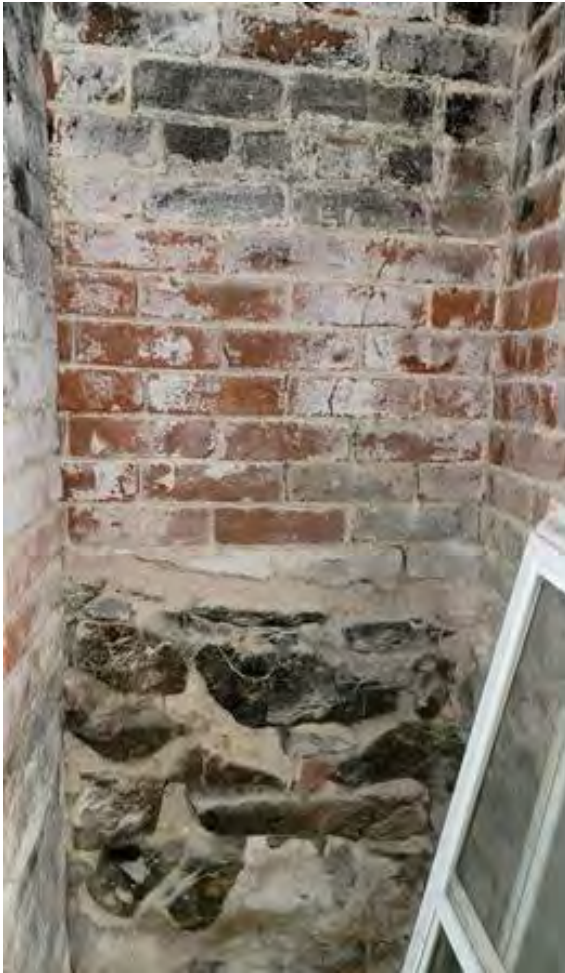
3. Interior face of north foundation wall with hairline crack in brick wall.

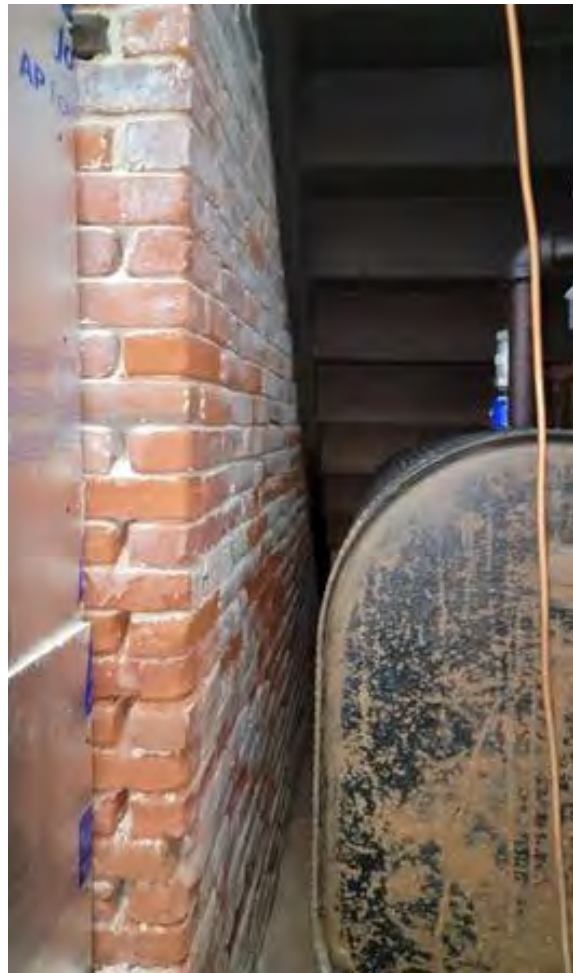
4. Brick wall next to fuel oil tank showing effects of rising damp. Inaccessible for treatment from this side but could be treated from corridor side if conditions worsen.

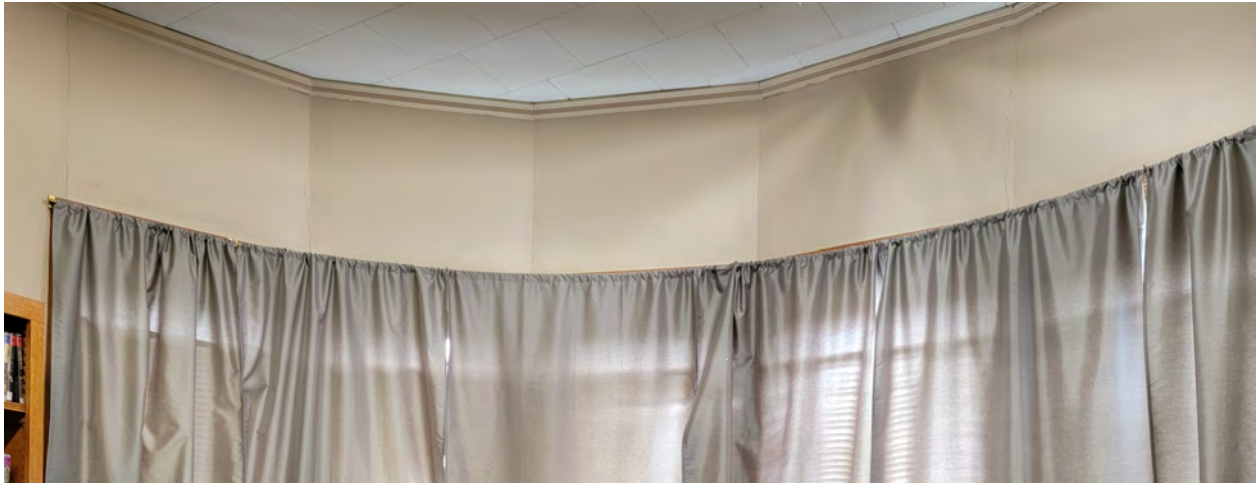
5. Slight cracking in corners of the south wall of the Computer Room. Not of structural concern.
