ALDRICH PUBLIC LIBRARY

FEASIBILITY STUDY

Issued: October 21, 2021

CROSSKEY ARCHITECTS, LLC
750 Main Street, Suite 150
Hartford, CT 06103

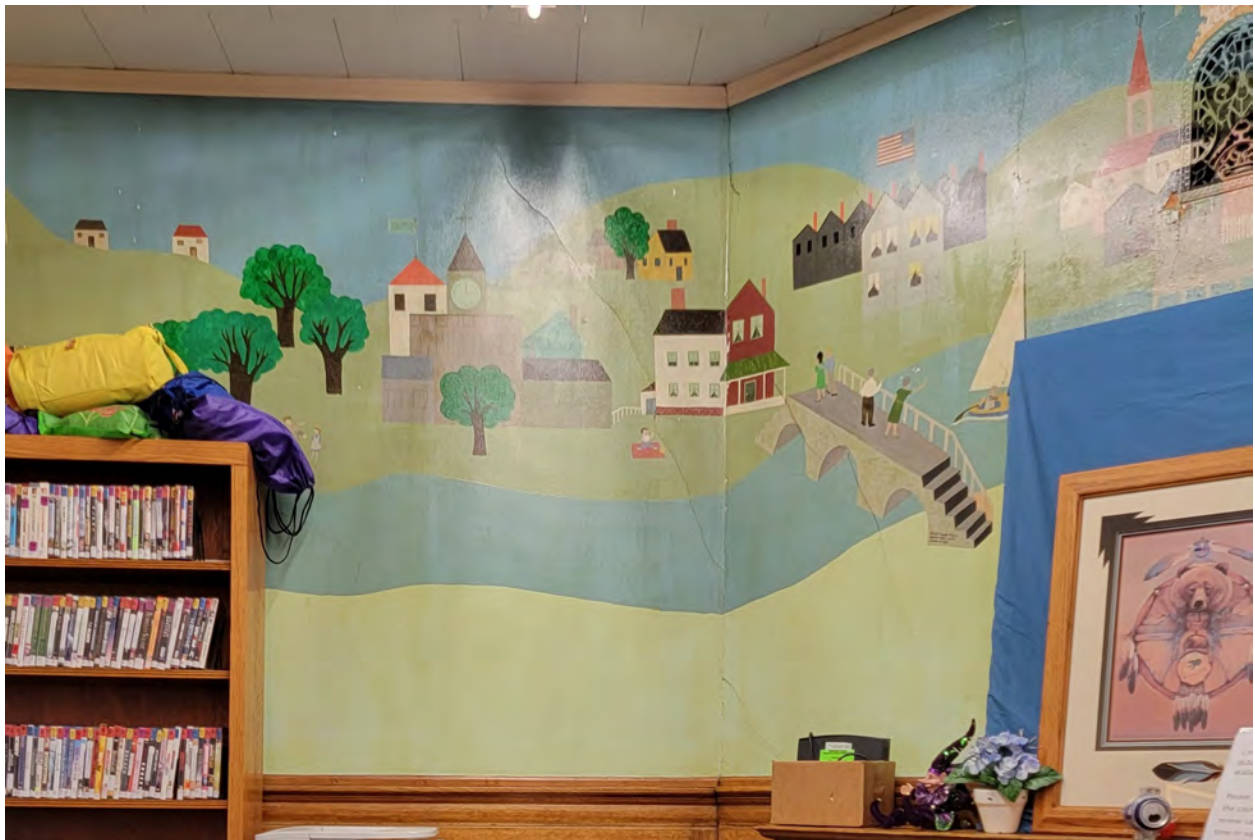
6. Diagonal cracking in north wall of Computer Room. Probable cause is slight deflection of the floor supporting the wall. Not a structural concern.

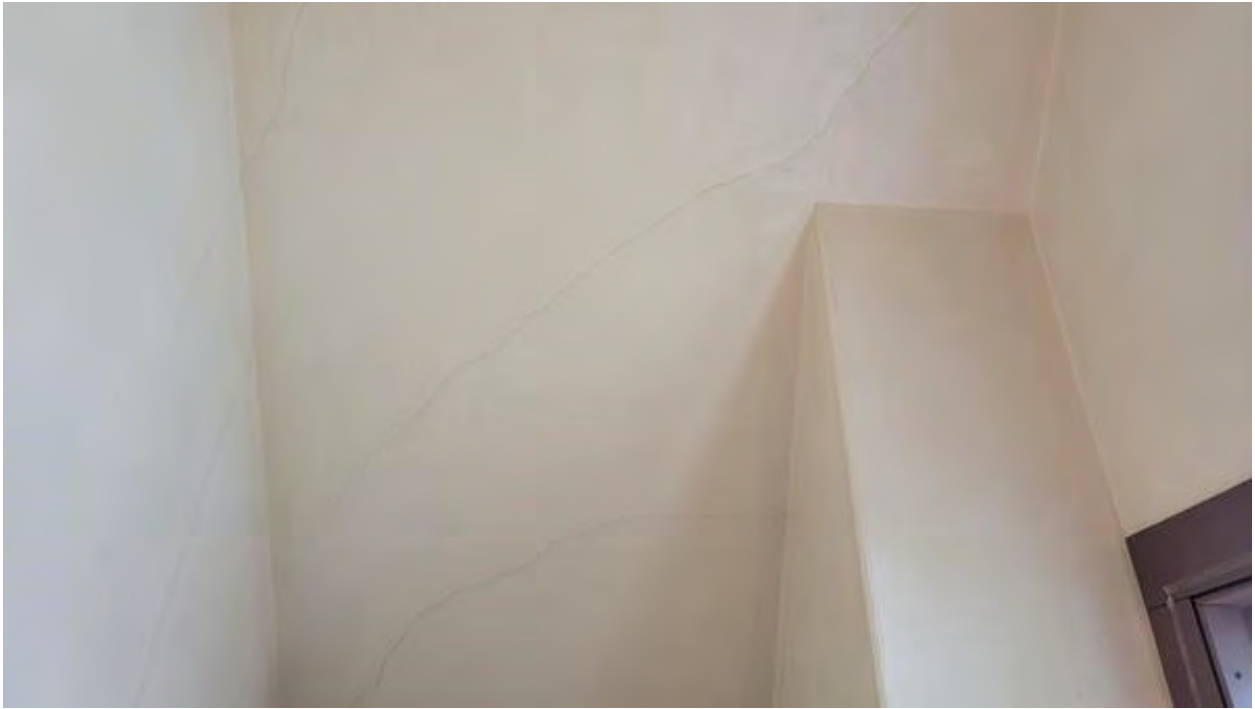
7. Ceiling cracks in stairwell to second floor. Probable cause is change in temperature and humidity during seasonal cycles but could also be slight settlements. Not a structural concern.

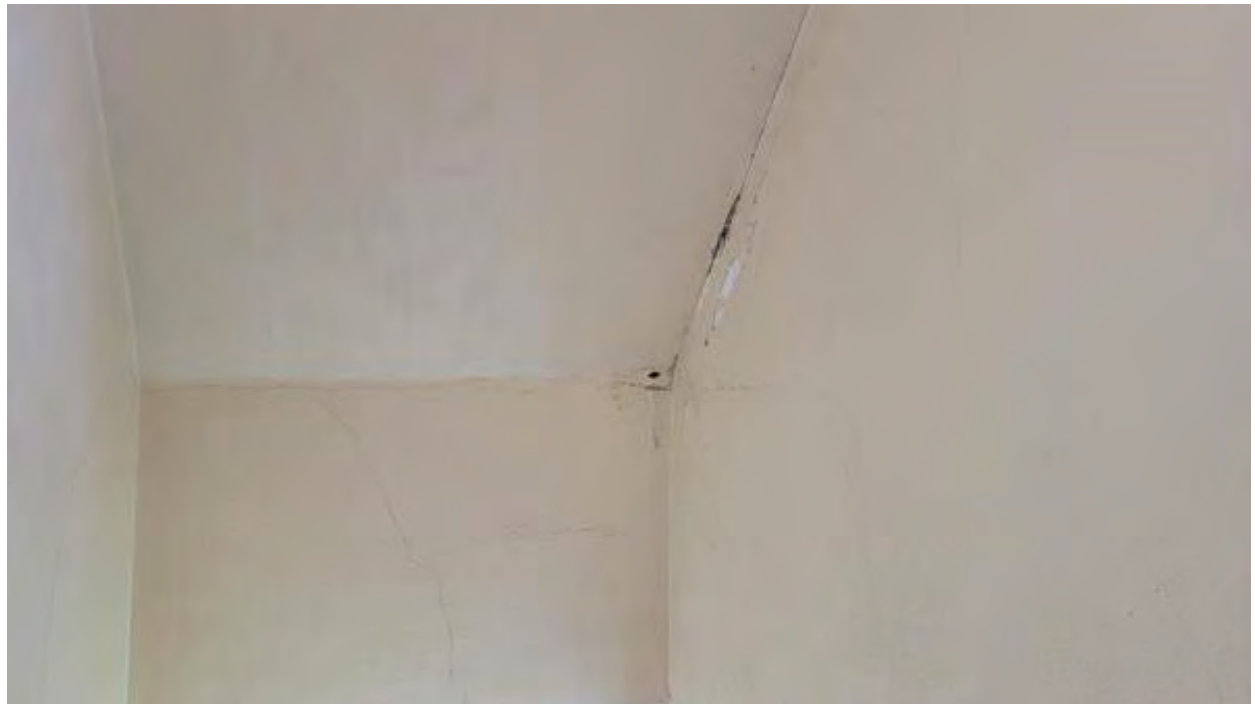
8. Additional stairwell ceiling and wall cracks and localized damage from leak. Not a structural concern.

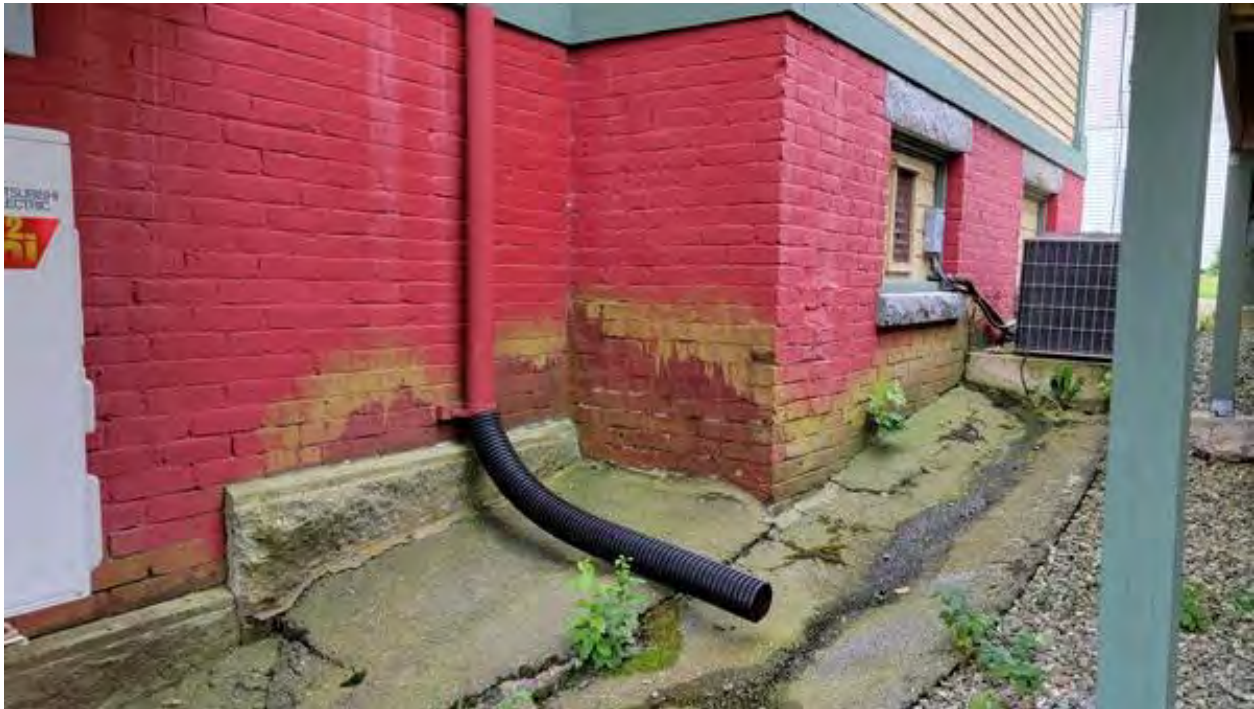
At the north elevation, the concrete walkway terminates before the concrete pad for the condensing unit. A pipe is embedded into the concrete which directs runoff from the sidewalk through the pad to a bituminous paved swale that abuts the foundation wall and expels water onto the sidewalk. The paved swale is cracked and the joint between the brick and stone is open. Sections of the joint have been patched with mortar but those patches are deteriorated, and there is a significant amount of bio growth and staining on the brick wall above. The areas of brick with bio growth have brick deterioration and mortar loss. The mortar joint between the brick and granite is also deteriorated, and the vertical joints between the granite blocks are missing mortar. Furthermore, the layer(s) of paint on the brick surface are likely trapping moisture. Refer to the Structural Assessment for more information.

9. Conditions along the north wall. Signs of excessive moisture in the brick wall, brick spalling and mortar loss. The bituminous swale should be replaced and repairs made to the hidden brick wall as needed.

Rising damp treatment of brick walls in basement:	\$5000.
Repointing of mortar joints in basement walls:	\$7000.
Repointing of exterior mortar joints:	\$15000.
Replacement of swale and repairs to north brick wall	\$20000.

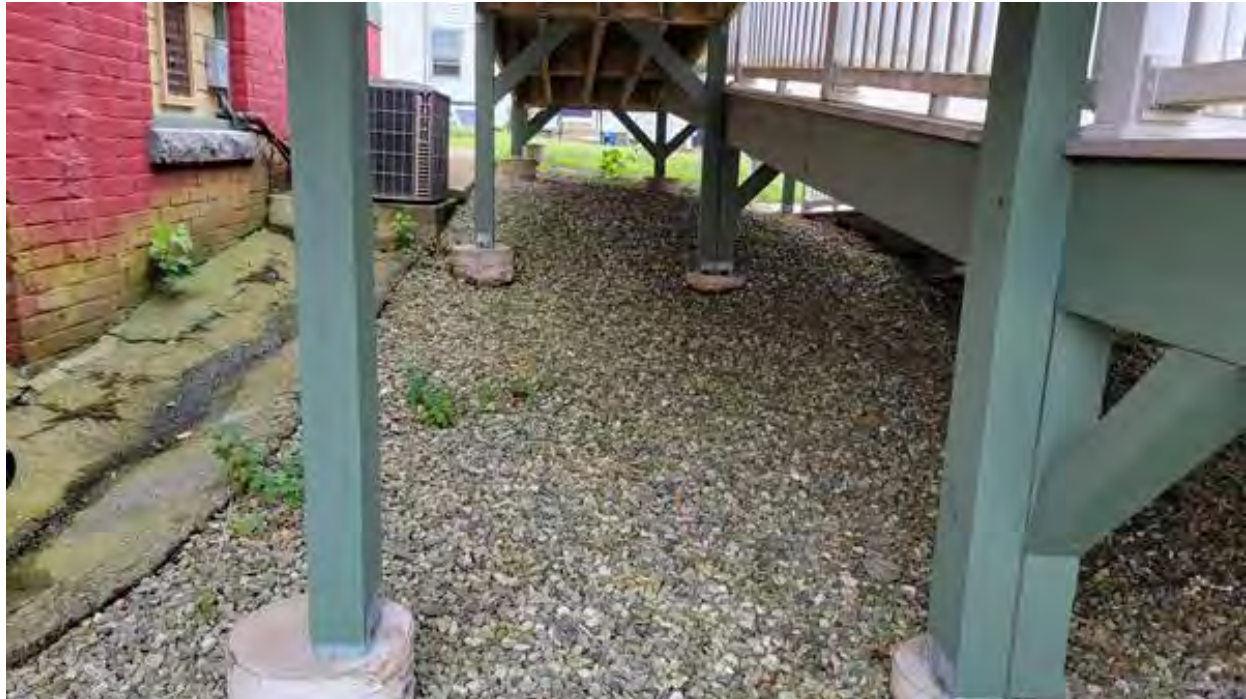
10. Ramp at north side of building in very good condition.

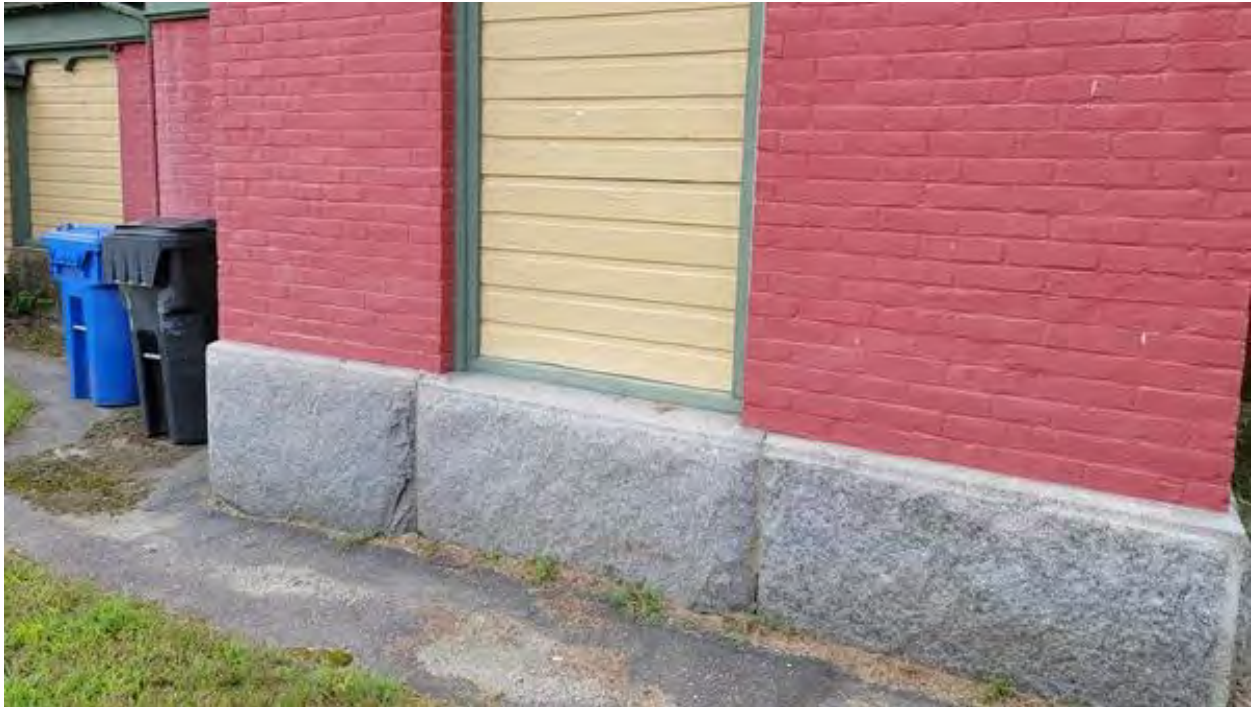
11. Typical granite quarry blocks at north, east and south walls. No sign of movement but vertical mortar joints require repointing.

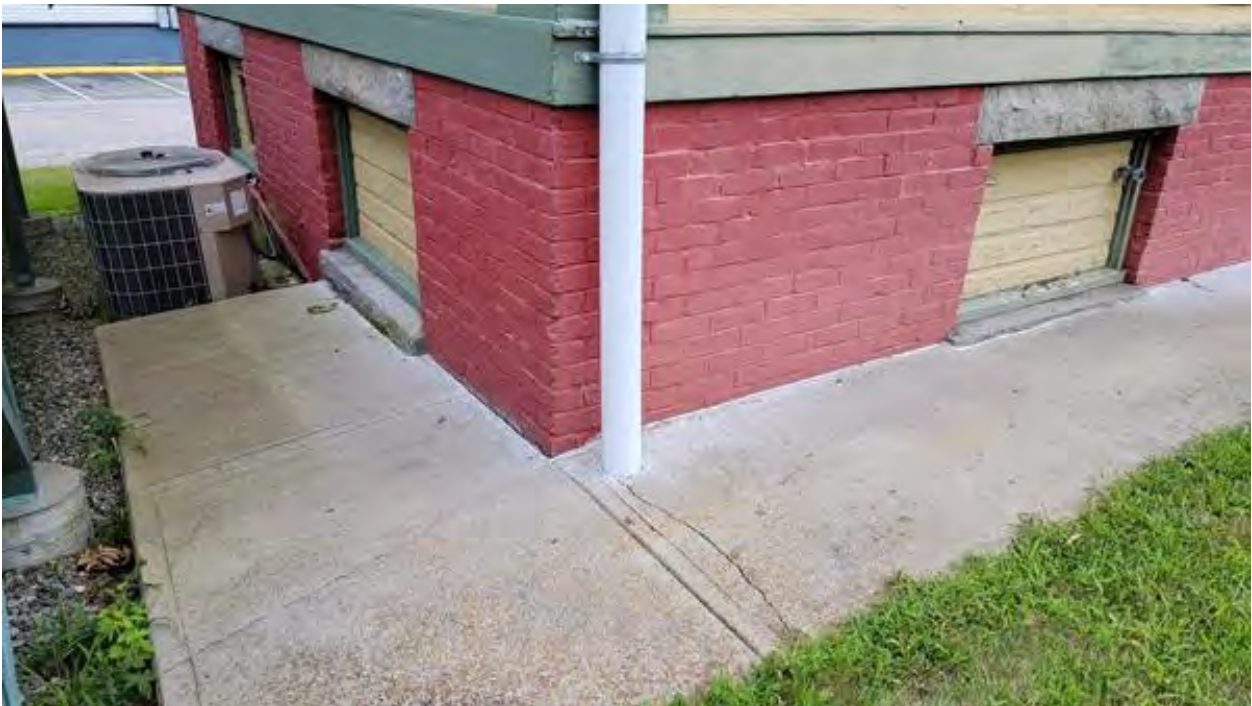
12. Concrete slabs along west wall protect wall from runoff. Concrete slabs should replace the bituminous swale to the northeast corner of the building.

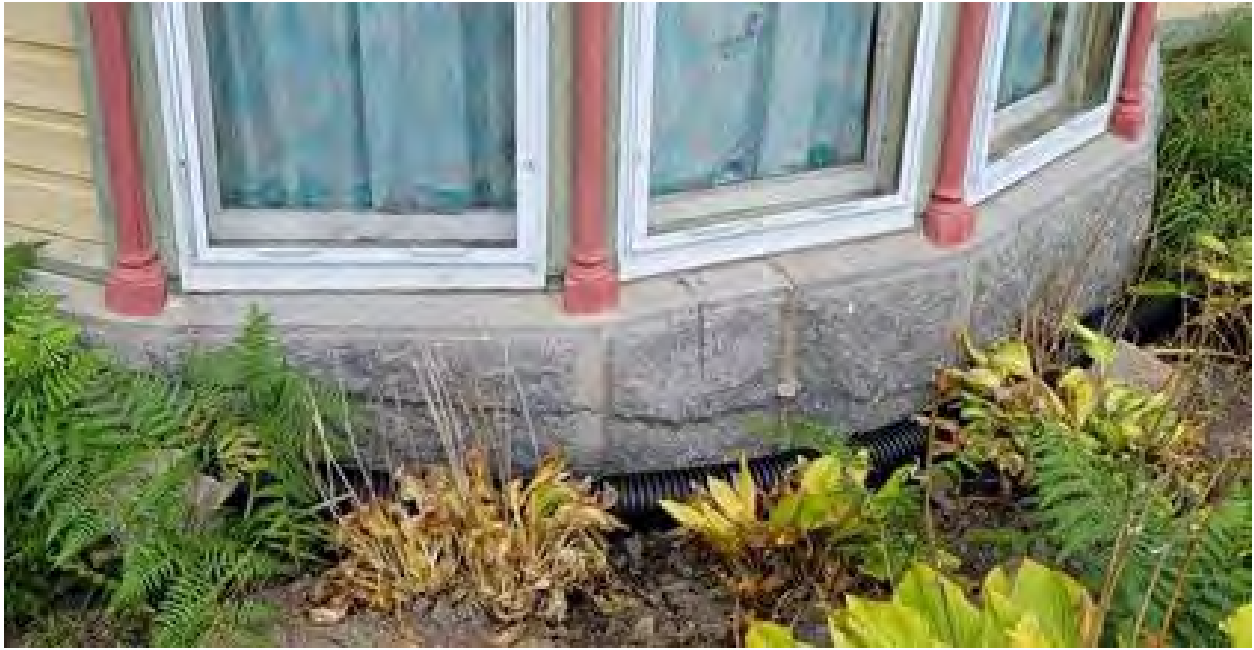
13. Horizontal crack in granite blocks at southeast corner bay window appears to be a fault in the stone. No repair necessary.

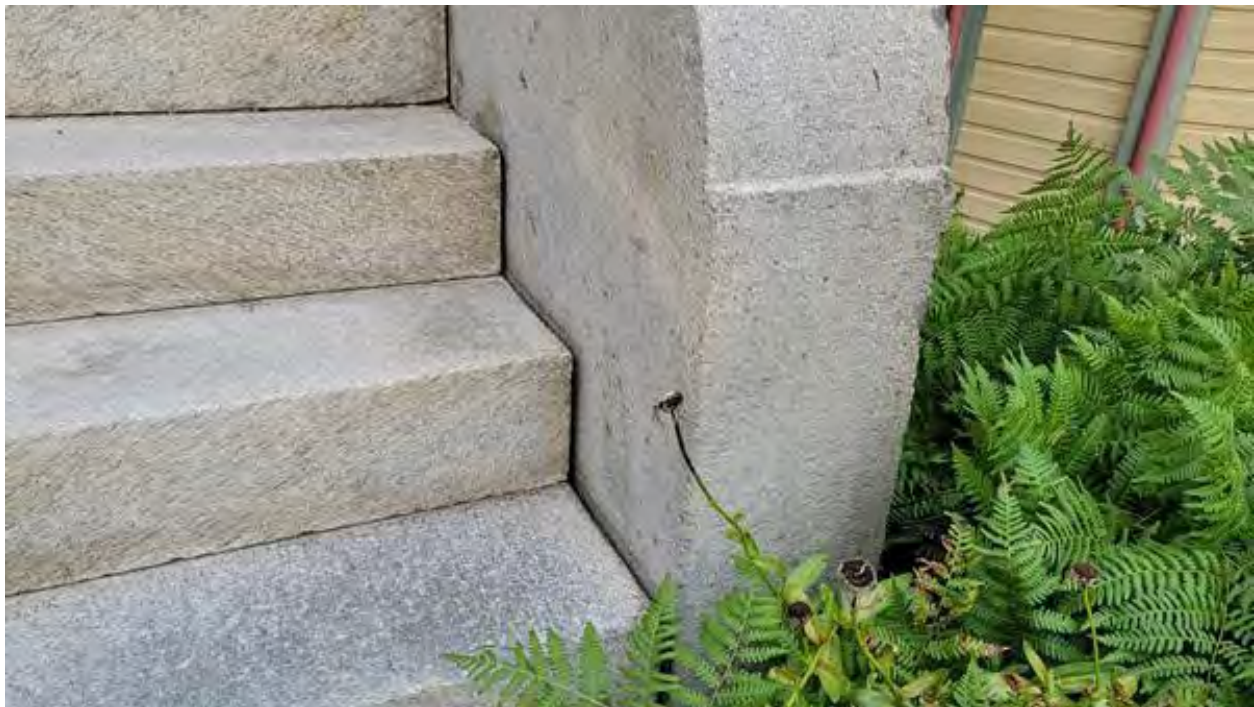
14. Cheekwalls at front steps are spreading slightly. Joints should be sealed to prevent water intrusion and freeze-thaw action.

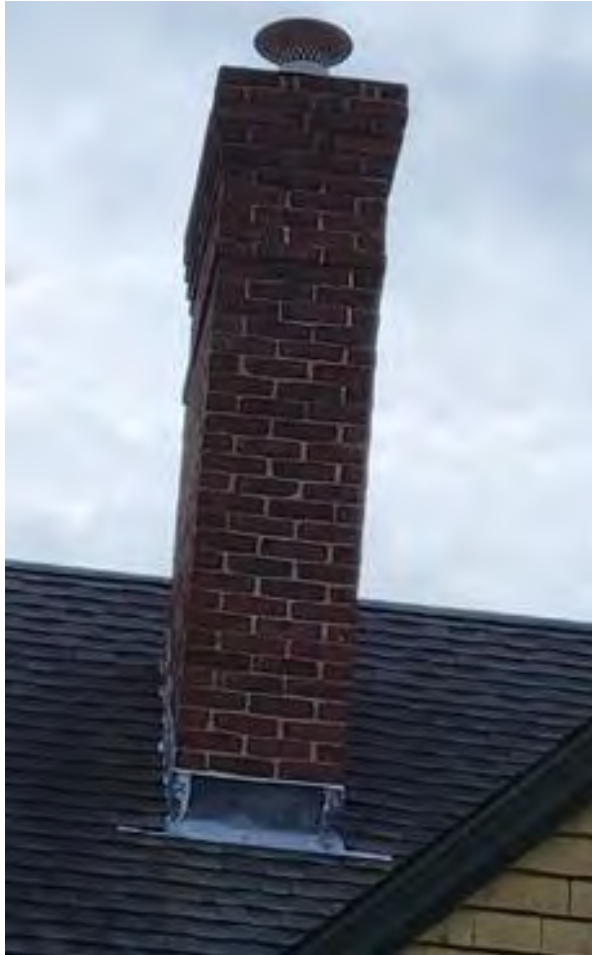
15. North chimney in good condition but needs repointing at top.

Both chimneys should also be inspected internally.

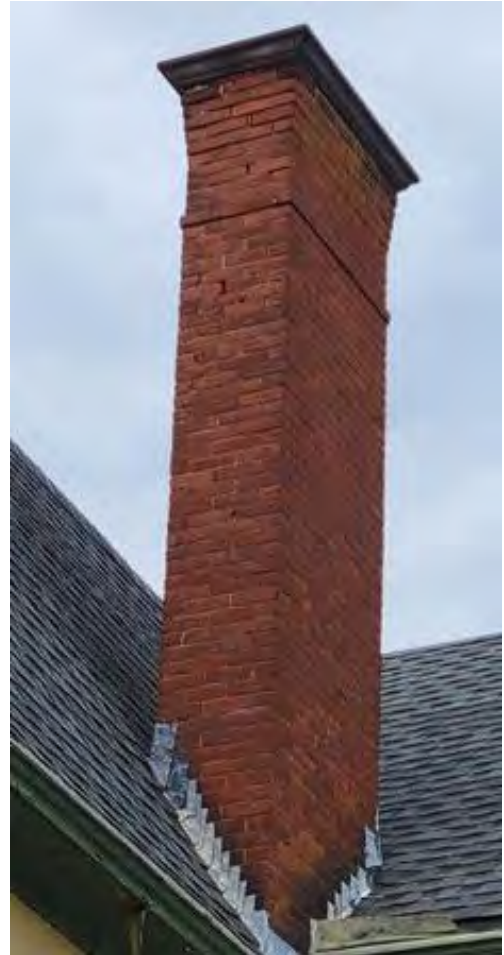
16. East chimney also in good condition but in need of some repointing.

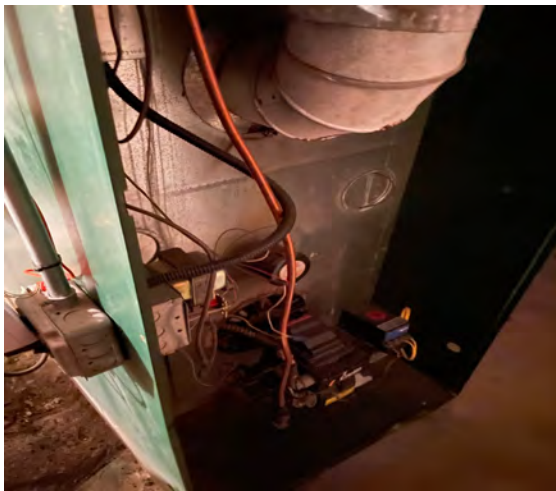
Figure 1 - Air Furnace

The first floor and basement is served by a ducted split system using an oil fired forced air furnace. The furnace is manufactured by Metzger Machine Corp and has a rating of 140,000 BTU/hr input, or 1.0 gallon per hour #2 heating oil. The furnace was manufactured in 1996 and is in fair to poor condition. The furnace is beyond its useful life and should be replaced in the next five years.

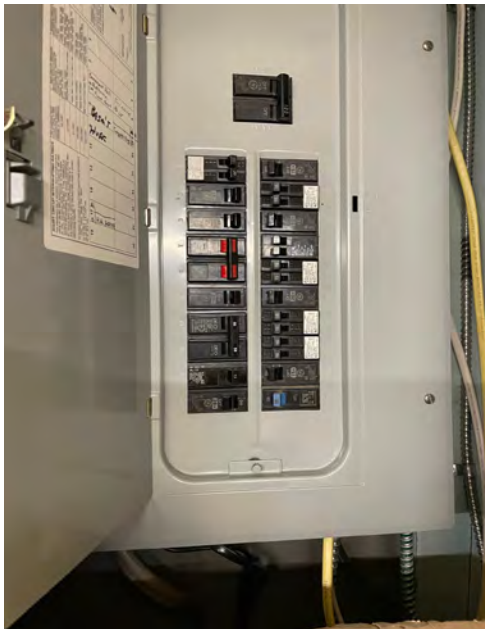
Figure 3 - Electrical Panel

The building has a 100 Amp, single phase 120/240 volt service. The 20-circuit breaker panel appears to be about 15-20 years old and in good condition. All wiring observed is NM type (Romex) and in good condition. Additional receptacles may be required to limit the use of extension cords.
