# PLAINFIELD HIGH SCHOOL ANNEX

PLAINFIELD, CONNECTICUT

## CONDITIONS ASSESSMENT AND FEASIBILITY STUDY

July 2019

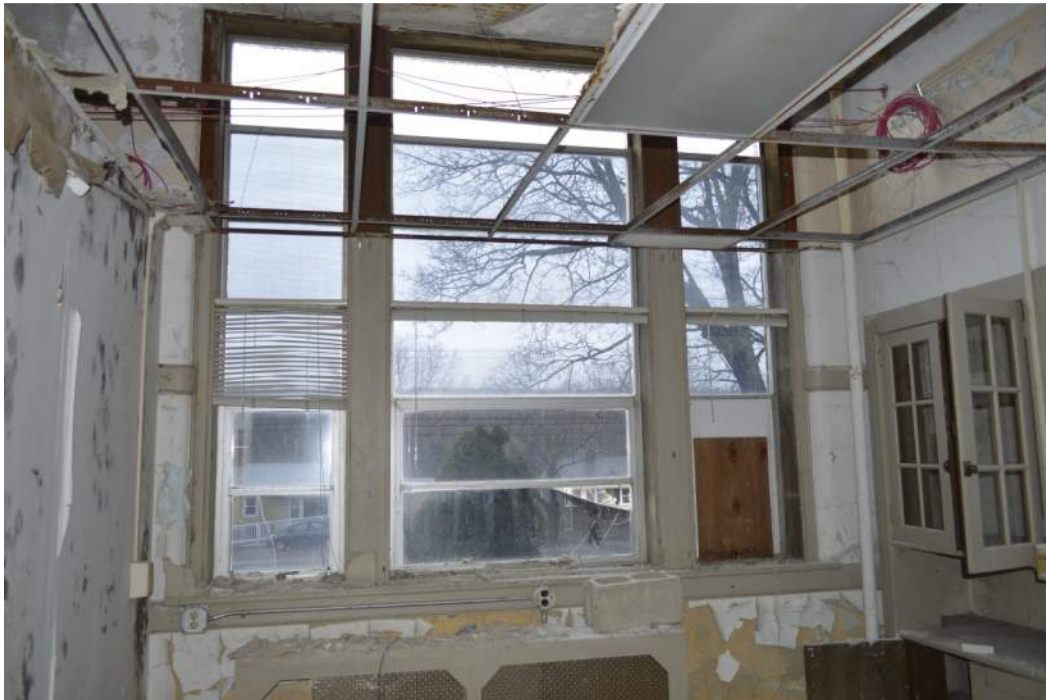
*Photo 13: The height of the window openings has been obscured by a lowered ceiling, changing the proportions of the classroom and office spaces, and limiting natural lighting. The original ceiling height should be maintained. Original cabinetry should be retained to the greatest extent possible.*

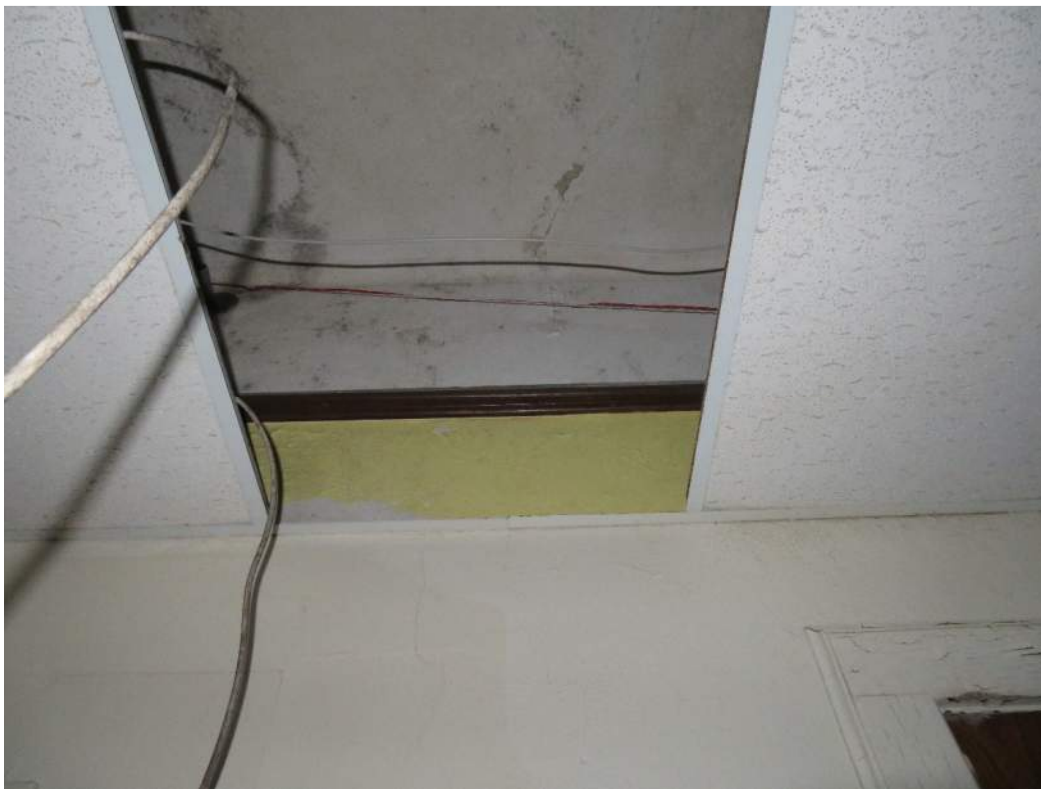
*Photo 15: Picture rail molding has been concealed above the dropped ceiling. The height of the original ceiling in the hallway once provided a sense of the monumental building. This wood trim is one of few interior details in the old school.*

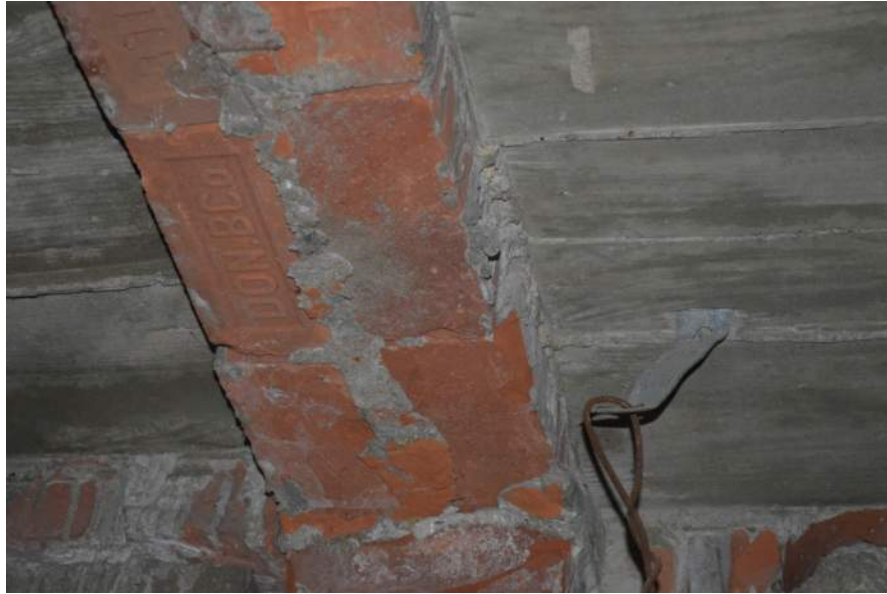
*Photo 20: Unsupported Brick over Newer Elevator Opening*

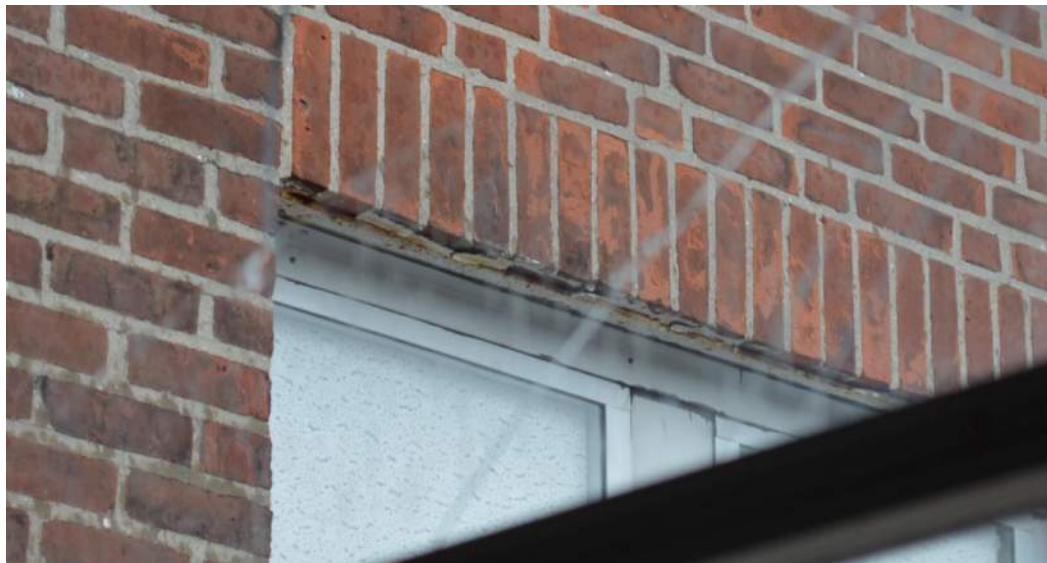
3. Corrosion of Exterior Steel Lintels. In at least one location, steel window lintels corroded, and the expansive forces have caused the lintel to bend. *Typically, the most effective treatment for corroded and warped lintels is to replace them. Care should be taken to add flashing to the new lintels, as well as weep holes in the masonry, to allow water to drain out.*

*Photo 21: Corroded Steel Lintel over Window*

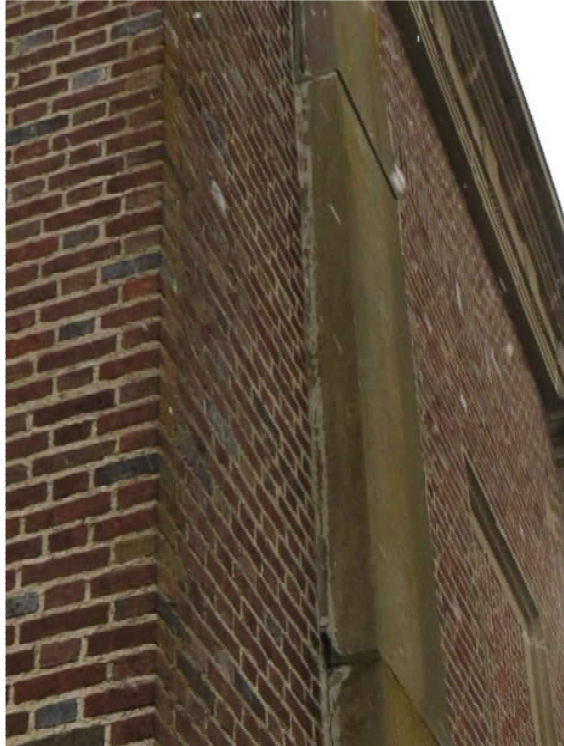
4. Cast Stone in Front becoming Detached. The ornamental cast stone adorning the front façade appears to be attached to the main brick masonry wall using masonry anchors to surface mount the stone. In at least one location, the cast stone appears to be jacking away from the building. *We recommend that the displaced cast stone be removed and rest using stainless steel anchors.*

*Photo 22: Cast Stone Ornamentation Shifting, Front Facade*

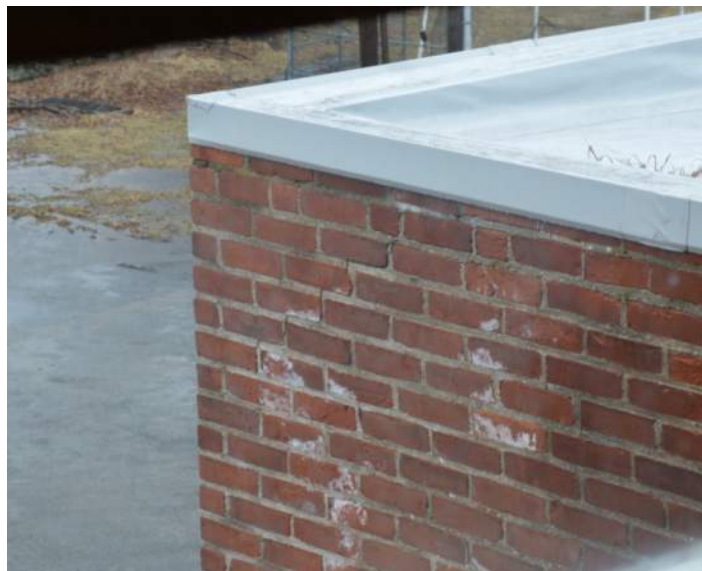
5. Brick Crack. A crack is apparent in the south-west corner brick masonry, in the west addition. *The root cause of the crack should be evaluated and addressed, then the crack repaired with either cutting and pointing or resetting brick along the crack.*

*Photo 23: Stress Crack in the Masonry Wall, Rear Facade.*

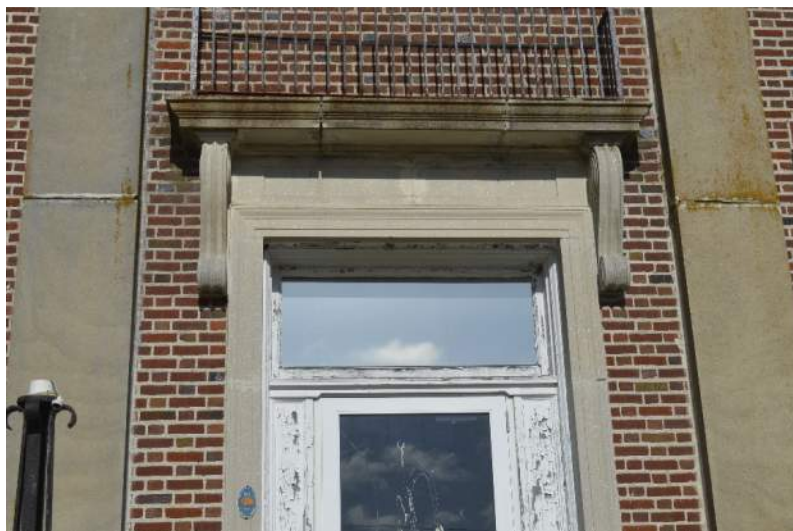
*Photo 25: Horizontal joints at the pilasters need repointing as do the vertical joints in the hood over the front door.*

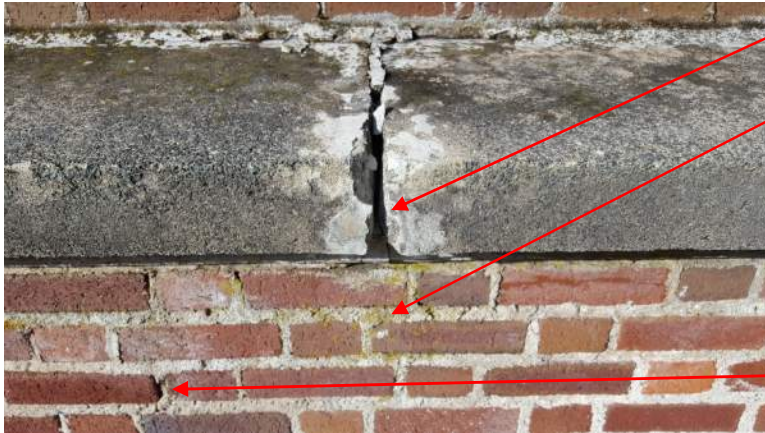
- Failed mortar joint allows water into the cavity wall.
- Algae can withhold moisture and contribute to spalling of masonry materials during the freeze/thaw cycle.
- Selective brick repointing is required.

*Photo 26: Mortar joints between the cast concrete bands that cap the plinth have failed and may be allowing water to infiltrate into the wall structure. A joint sealant rather than mortar laid in a horizontal plane will weather better.*

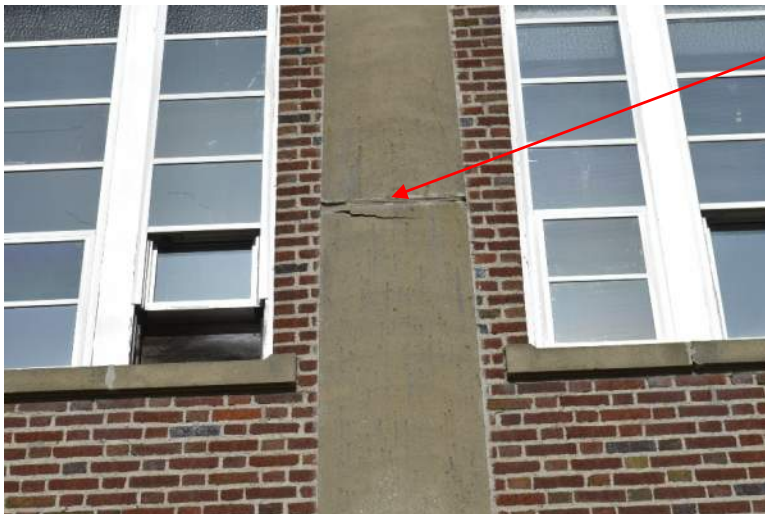
- Spalling concrete will require repair.
- One of the pilasters is pulling away from the wall and will need to be removed and reinstalled.

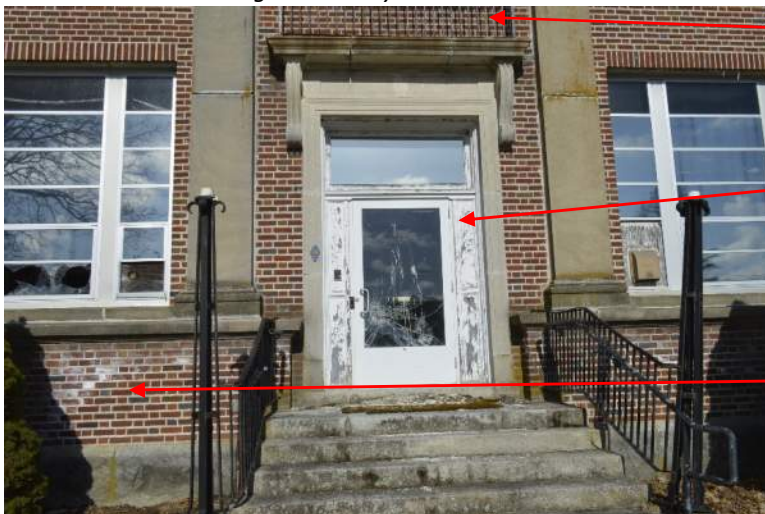
- Cast iron features including the railing above the entrance, the handrails and the lamp posts should be restored.
- A historically appropriate door should replace the existing door.
- The granite steps should be cleaned of moss and algae that will contribute to spalling of the stone.
- Efflorescence (leaching salts) should be removed from the face of the brick and the cause of moisture within the wall alleviated.

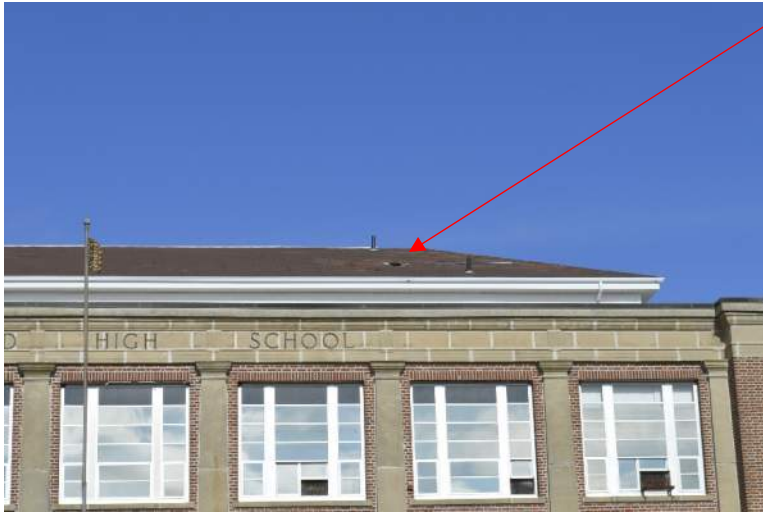
A large hole in the roof sheathing allows water to pond on the original concrete roof deck, and drain into the upper floors through the old interior roof drains which are no longer functionally connected. The shingle roof requires replacement, the sheathing will need some replacement as may some of the rafter framing.

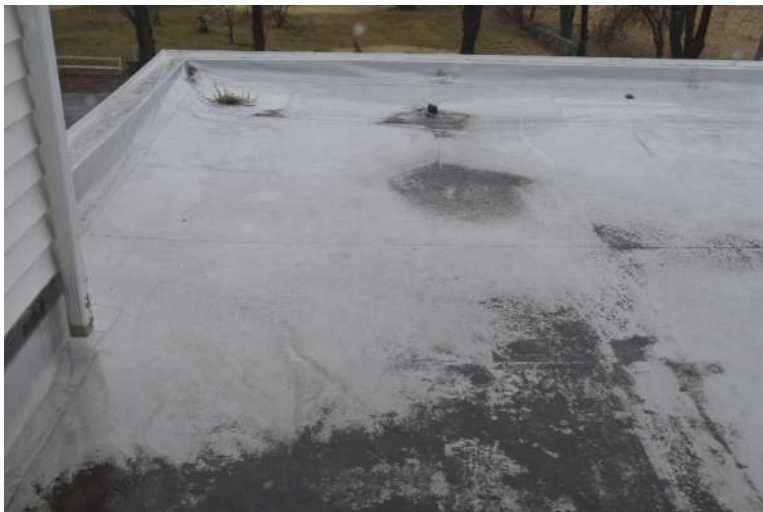
Water transported from the third-floor roof via the leader is directed to the flat, original second floor roof. Since the interior roof drains are either clogged or disconnected, the water ponds in certain areas and was observed to be infiltrating the building through damaged roof flashing along the brick portion of the building.

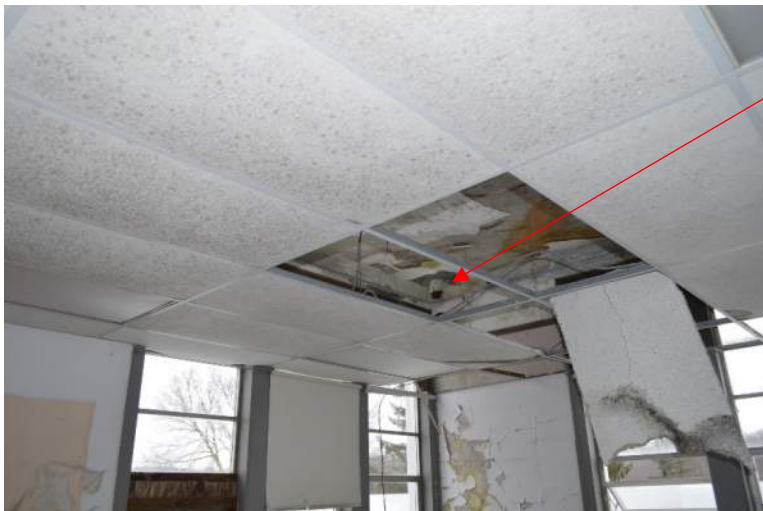
An abandoned roof drain at the original third-floor roof level is now directing water from the hole in the hipped roof into the classroom, damaging finishes and making its way to the first floor of the building.

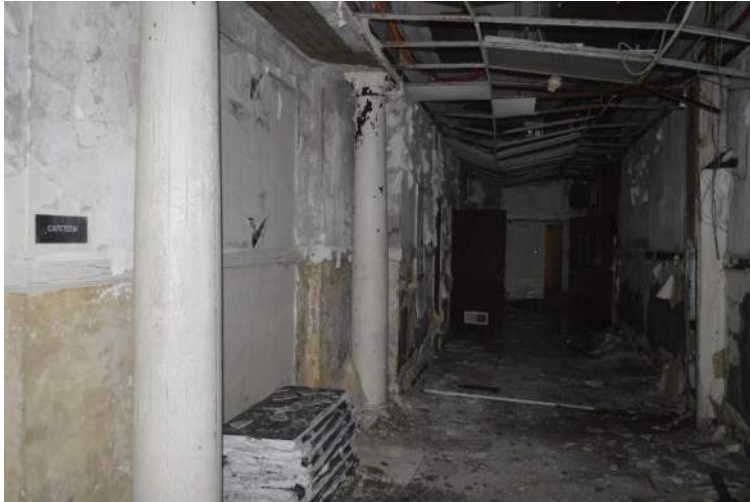
Water infiltration has caused the plaster ceiling to collapse onto the suspended ceiling below. Most plaster wall finishes are compromised by moisture as are wood and tile floor finishes.

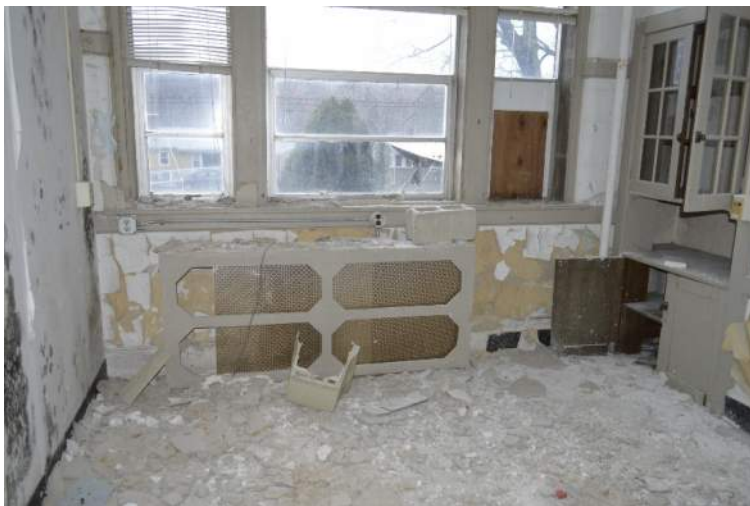
New heating and cooling systems will need to be designed for the new use. The heating plant that served this building was removed during the demolition of the 1961 high school building in 2005. The building has been unheated since then which has contributed to the failure of the finish materials.

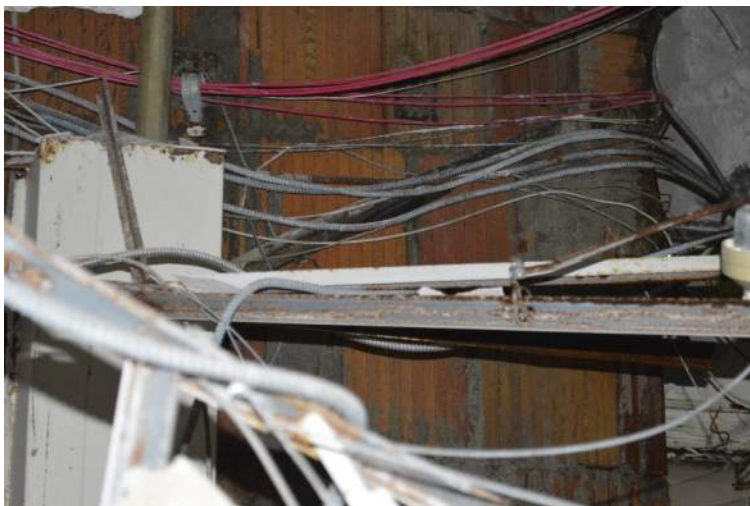
Multiple generations of wiring are present and most likely not trustworthy. Once the debris is removed, the systems should be evaluated for reuse.
