ROAD SAFETY AUDIT

# **ROCHESTER ROAD CORRIDOR**

# **OAKLAND COUNTY**

FINAL REPORT

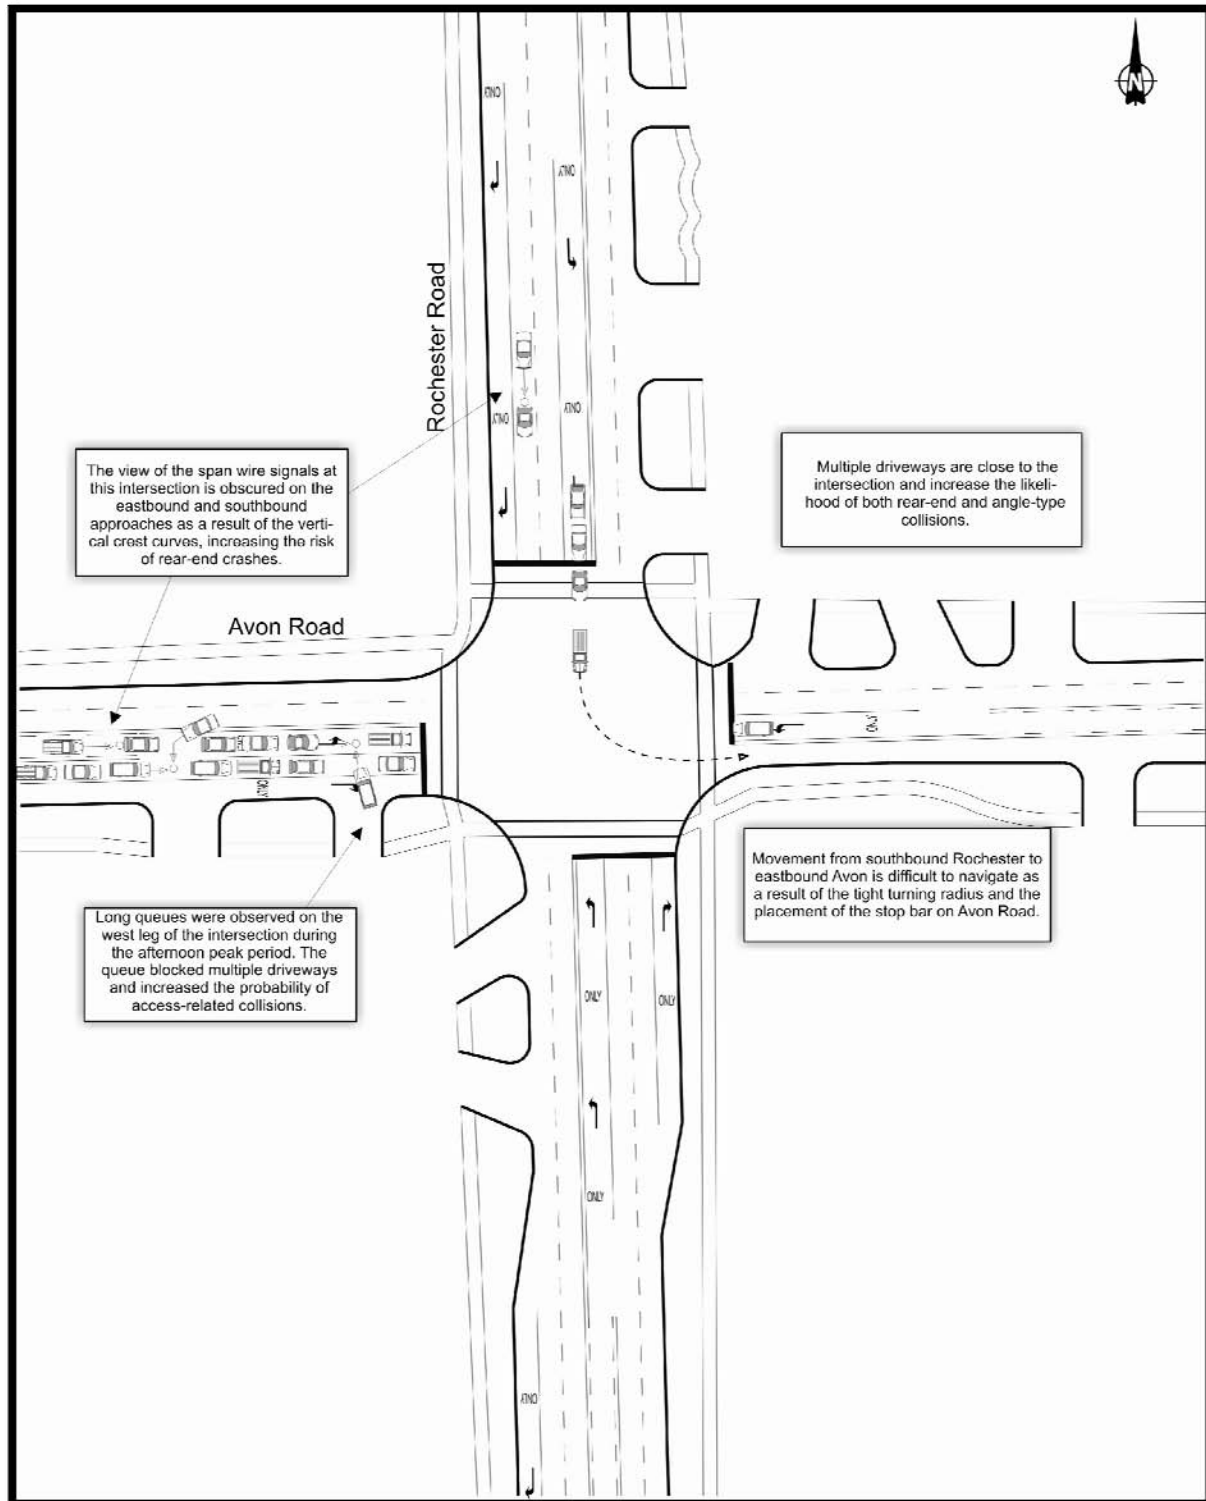
Figure 4-8 ISSUES DIAGRAM: ROCHESTER ROAD AND AVON ROAD

During the site visit, long queues were observed during both the morning and afternoon peak periods. During the A.M peak period (approximately 8:00 AM), westbound through traffic on Avon Road was found to consist in excess of 30 vehicles waiting in the queue. A long queue was observed in the eastbound through lane on Avon Road between 2:45 and 3:00 PM. This afternoon peak hour is likely a result of a number of local schools releasing around the same time. The long queues may have been worse than normal during the field review due to a detour resulting from construction on Hamlin Road. The long queues made it difficult for drivers to make left-turns out of the driveways both near the intersection as well as outside of the intersection's functional area. Long queues at intersections increase the risk of rear-end collisions and driver frustration, leading to red light running. Queuing may also lead to erratic movements as drivers attempt to merge into over-full lanes increasing the likelihood of sideswipe collisions.

The signal visibility on the eastbound and southbound approaches is obstructed by the crest vertical curves resulting in limited stopping sight distance. As was stated in Issue 1, vehicles were observed queuing on several of the approaches during the field review. Vehicles stopped at the top of the crest vertical curve can block the view of the traffic signal for following vehicles. This issue is further aggravated when a taller vehicle such as a large SUV, truck or commercial van are waiting in the queue. Many of the rear end crashes are likely due to a driver's limited stopping sight distance due to the above listed complicating factors. Given the moderate truck volumes at this intersection, drivers may unwittingly follow taller vehicles into the intersection during the red phase. As a result, the obstructed signal visibility leads to an increased frequency in rear-end collisions and increases the risk for red light running.

The southbound left-turn from Rochester Road to eastbound Avon Road is tight and drivers were observed having difficulty completing this maneuver. As a result of the tight left-turn radius, tire tracks and broken curbs were observed on the southeast corner of the intersection. It was noted during the site visit that vehicle tires were over-tracking over the curb. This tight turning radius increases the risk of sideswipe-opposing collisions.

During the afternoon peak hour the eastbound through movement was observed blocking the Avon Road entrances to the Speedway gas station, Genisys Credit Union, and the Sears parking lot. Drivers in the Sears parking lot were observed attempting to both enter and pass through the queue. Drivers attempting making left-turns from the commercial driveways onto Avon Road also face limited intersection sight distance due to the vertical alignment. Driver's view of cross traffic is likely obstructed by the queued vehicles. Drivers who attempt to enter or pass through queues from the commercial driveways on Avon Road increase the risk of causing an angle crash or ancillary rear end crashes.

During the field review it was observed that accessible pedestrian signals, sidewalks and ramps had been provided on all approaches. The ramps on the north side of the intersection lacked the presence of a detectable warning surface. Blind pedestrians using a long cane need a detectable warning surface such as truncated domes to find the crossing. Given the increased likelihood of blind pedestrians at this intersection, complete pedestrian facilities are a necessity. Lack of fully accessible pedestrian facilities, increases the risk of a crash involving a blind pedestrian.

It is also suggested that an advance warning flasher should be considered for the eastbound and southbound approaches of Rochester Road. The advance warning flasher should utilize the message "PREPARE TO STOP WHEN FLASHING." This advance dilemma zone warning device has been found to reduce traffic fatalities and injuries by 39 percent<sup>3</sup>. While some drivers may increase their speeds right when the device starts flashing, the majority of drivers have been found to be more aware of the signal. These devices can be installed either overhead or post mounted. Examples of the two types of mountings are shown below on the following page. Similar installations have been provided within Oakland County on northbound Telegraph (US-24) and 14 Mile Road and on northbound Northwestern Highway (M-10) at Inkster. In both of these cases, vertical curves limit the traffic signal visibility.

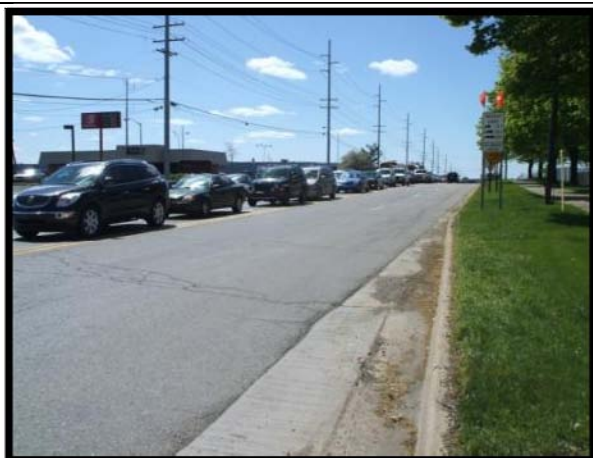
*Eastbound approach of Avon Road during the afternoon peak period*

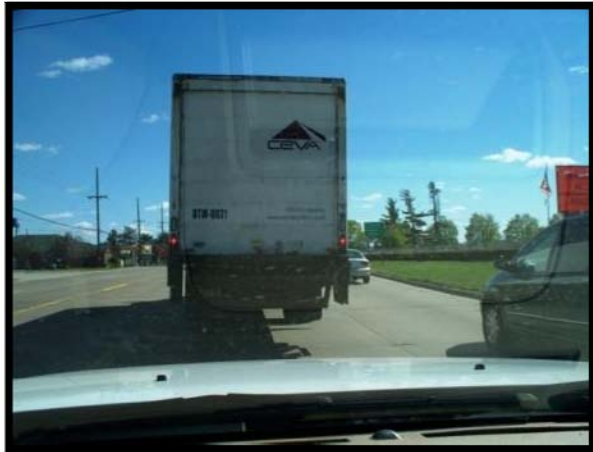
*Eastbound approach of Avon Road.*

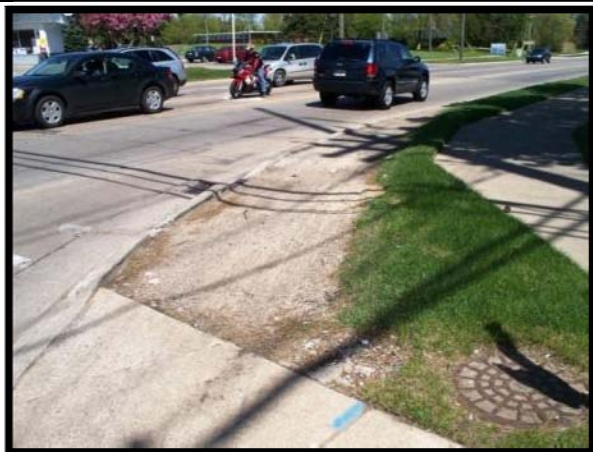
*Westbound approach on Avon Road during the morning peak period.*

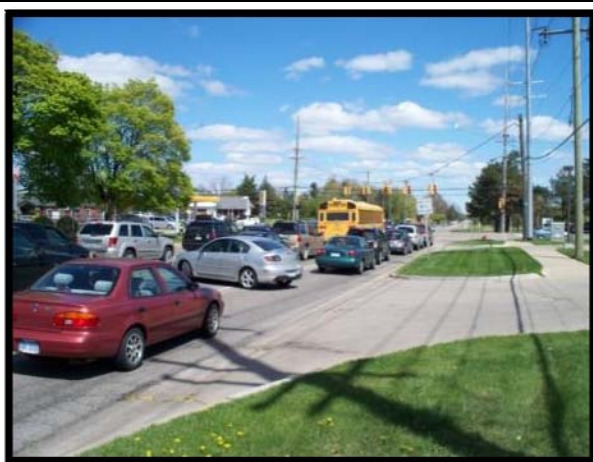
In addition, drivers attempting to turn into the driveways from Avon Road also run the risk of being involved in left-turn opposing collisions. Drivers making left-turning movements, from the aforementioned driveways, must cross three lanes (one left-turn, one through, and one right-turn lane) of eastbound traffic to enter westbound traffic.

*Left –turn movement across traffic from Genisys Credit Union Driveway.*

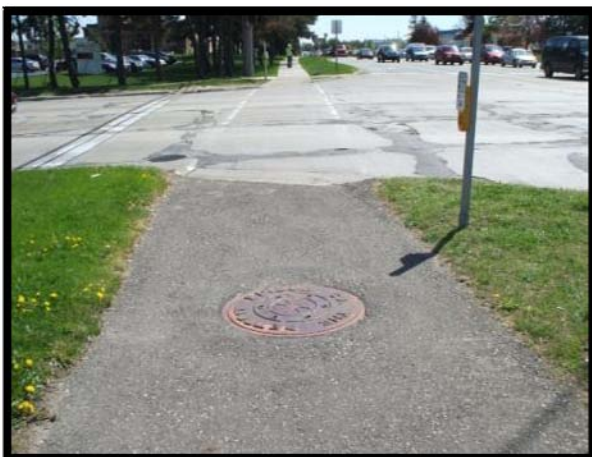
*Pedestrian crosswalk across the west leg of Avon Road.*

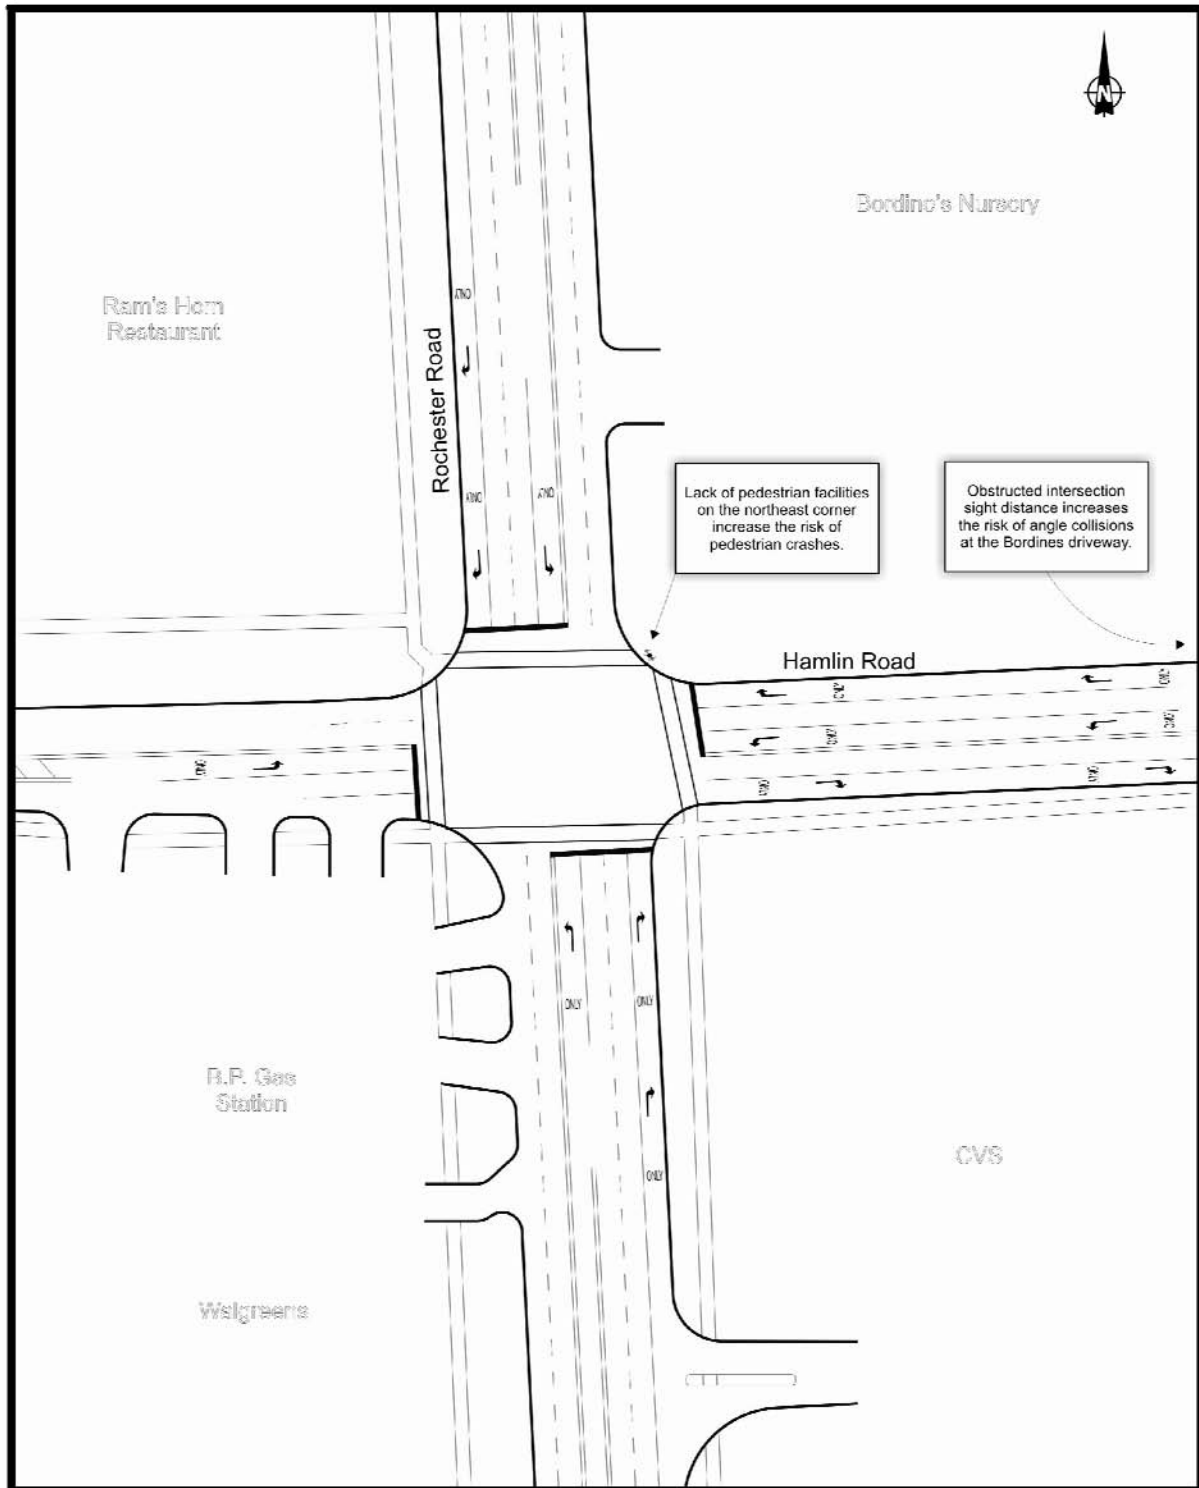
Figure 5-7 ISSUES DIAGRAM: ROCHESTER ROAD AND HAMLIN ROAD

During the site visit, a moderate volume of non-motorized road users was observed travelling through the intersection. Several of the pedestrian connections were observed to be incomplete and not in compliance with current ADA standards. The northeast corner of the intersection has no pedestrian ramps or sidewalks. This was due to the fact that a building used to be located on the corner located within the public right-of-way. As a result, pathways and ramps were not provided within that corner even though pedestrian signals and crosswalks are provided. Additionally, several of the pedestrian ramps are quite steep and are not flush with the roadway surface. Collisions involving pedestrians are more likely to occur where pedestrian facilities are limited.

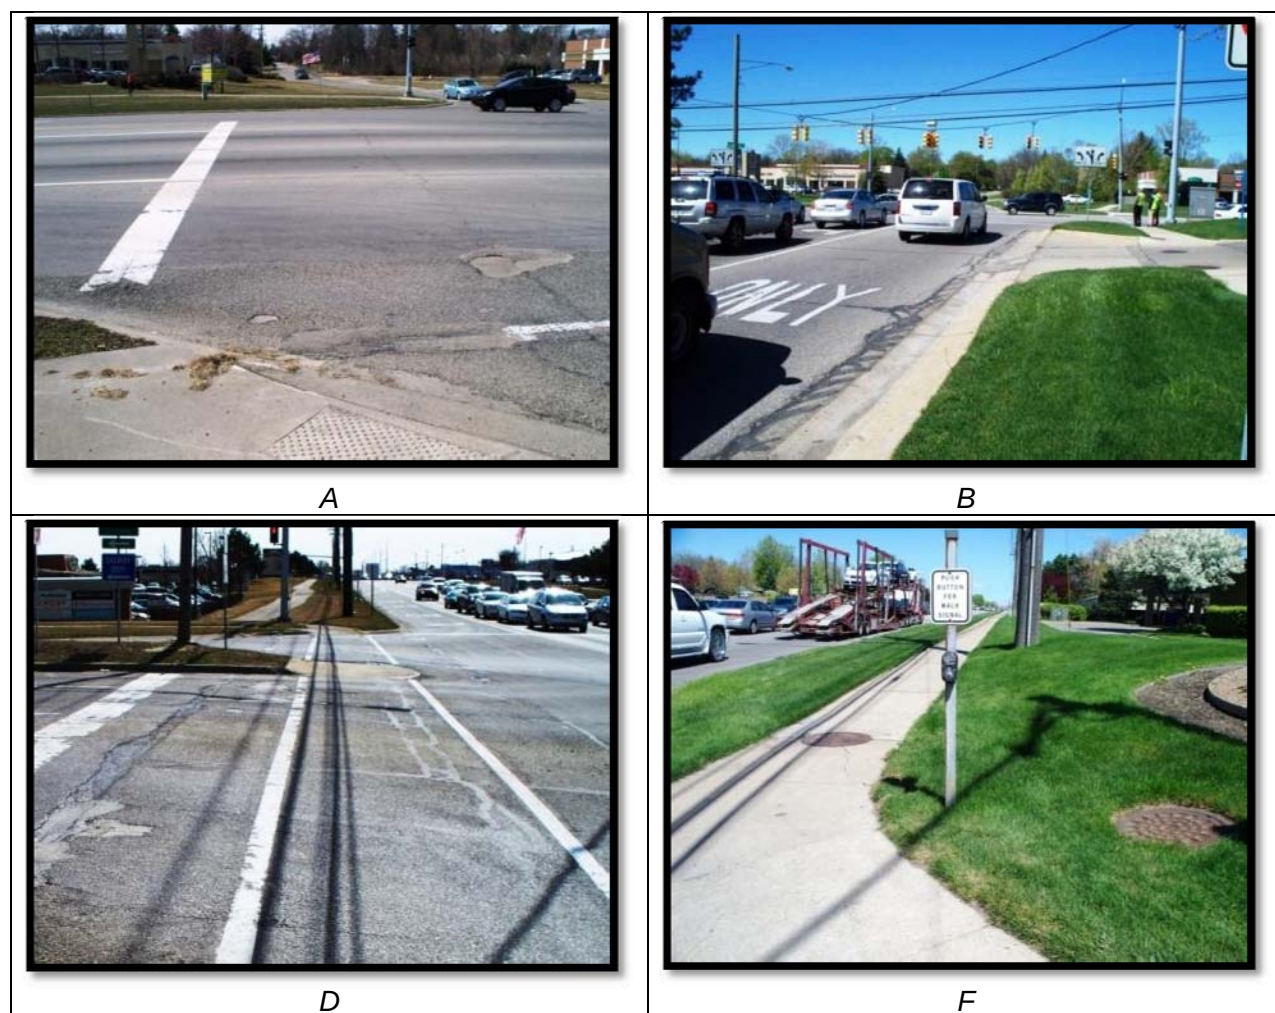
- A. No crosswalk present across the south leg.*
- B. Signal Display on the westbound approach is not consistent with the lane use*
- C. Turn path markings are present for southbound to eastbound left turns.*
- D. Pedestrian refuge is flush with pavement and has no pedestrian push button.*
- E. Left-turns are made from the "right-out-only" VitaminWorld driveway.*
- F. Pedestrian actuated push buttons are provided for the movements across the north, east, and west legs.*

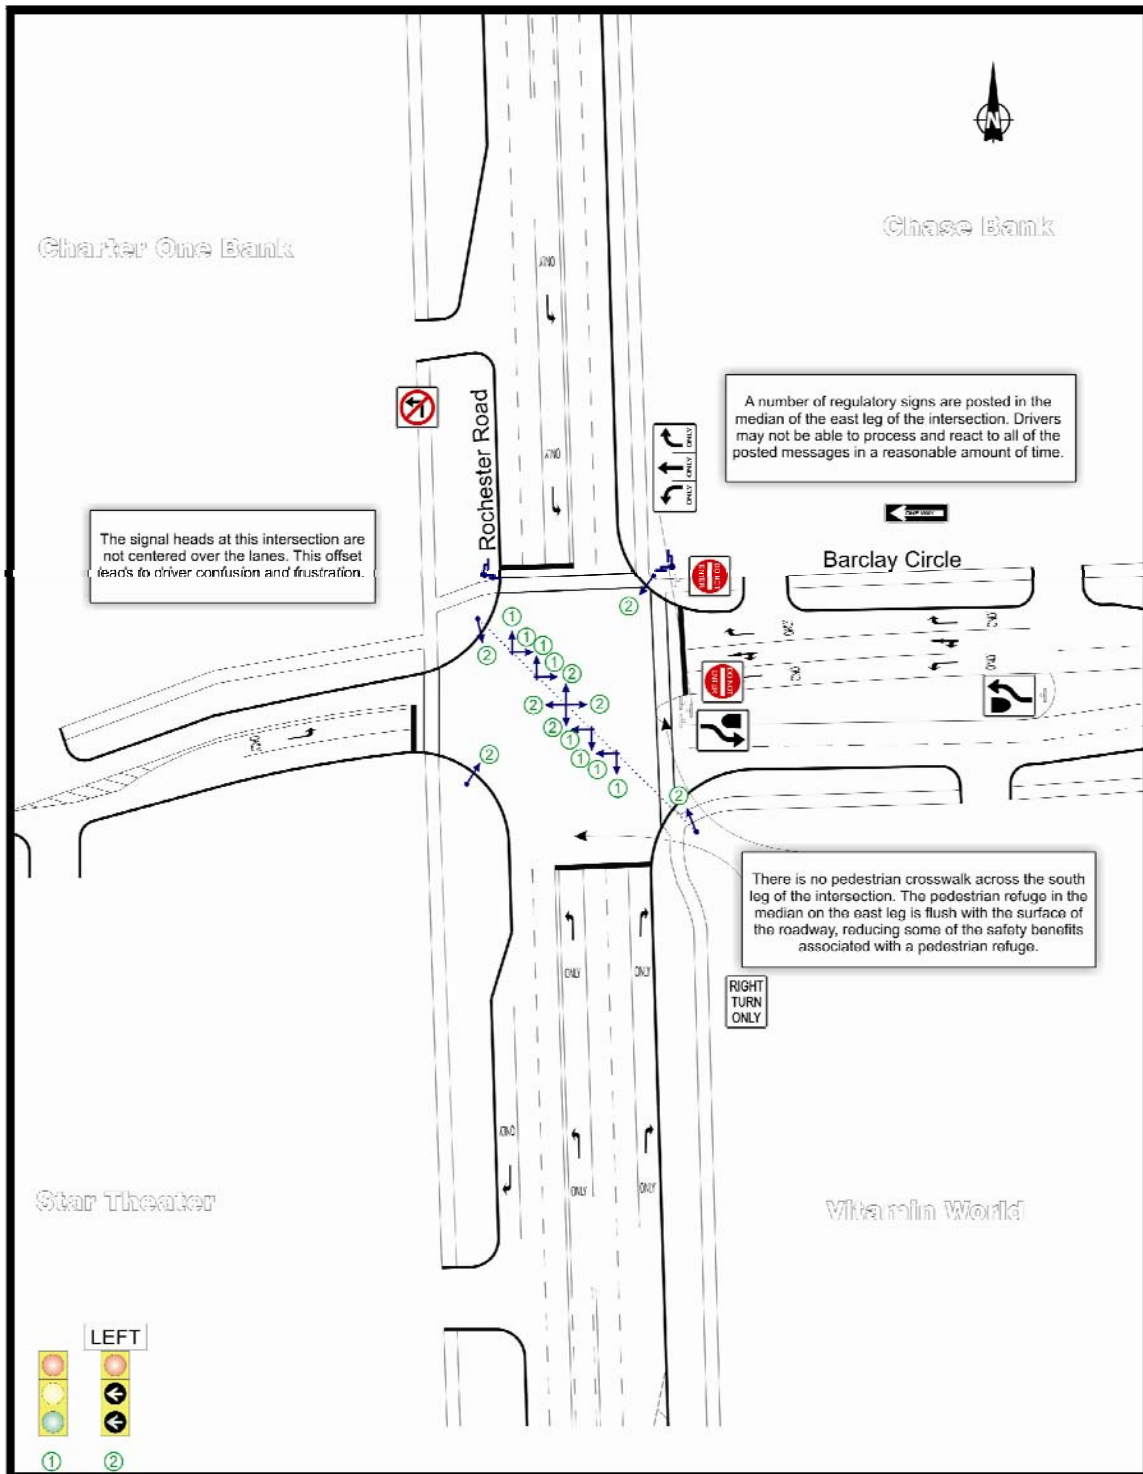
Figure 6-7 ISSUES DIAGRAM: ROCHESTER ROAD AND BARCLAY CIRCLE/WABASH

Furthermore, many of the rear end crashes on Rochester Road are the result of the regular queues which are present at this intersection due to the use of split phasing.

There are also no pedestrian facilities across Rochester Road on south leg of the intersection. Given the pedestrian traffic generators at this intersection, including the Hampton Village Center Shopping Center and condominiums to the east of the intersection, several pedestrians were observed crossing this leg during the site visit.

A private driveway, providing access to the commercial developments on the southeast corner of the intersection, opens onto Barclay Circle/Wabash Road. The driveway lane use is marked as having through or right turn only lanes. During the site visit, many drivers were observed making left-turn maneuvers from the driveway. Drivers disregard for the pavement markings is likely a leading factor in the number of left-turn opposing collisions recorded on Barclay Circle. Additionally, this driveway is located in close proximity to the driveway which provides access to the Hampton Village shopping center. Several conflicts were observed when drivers attempted to exit both driveways simultaneously on to Barclay.

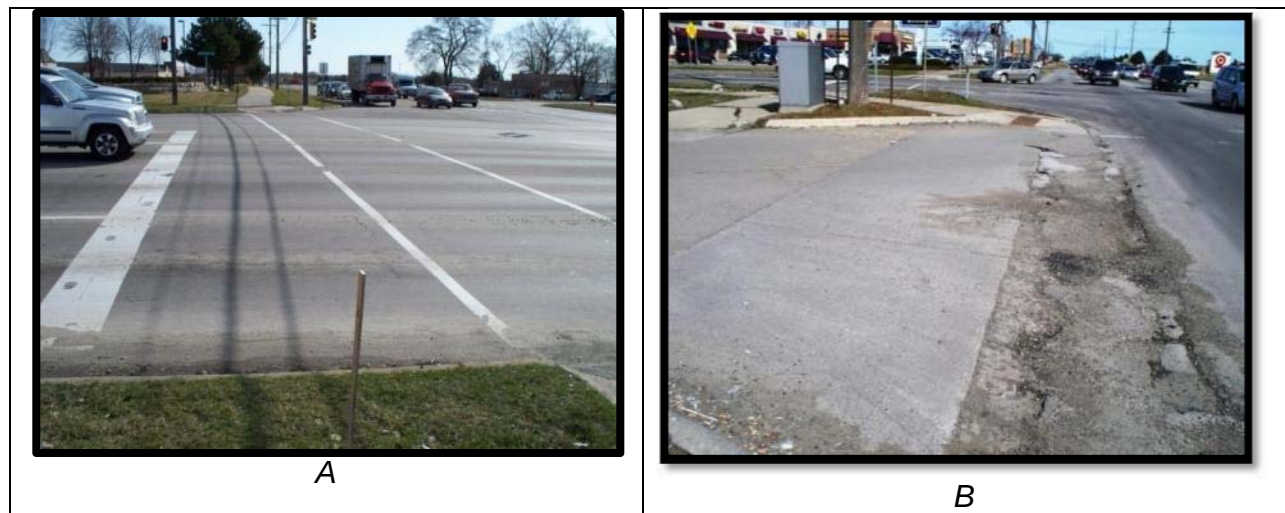
- *Some rutting is present.*
- *There is limited access management in this area.*
- *Red light running was observed on Rochester Road*

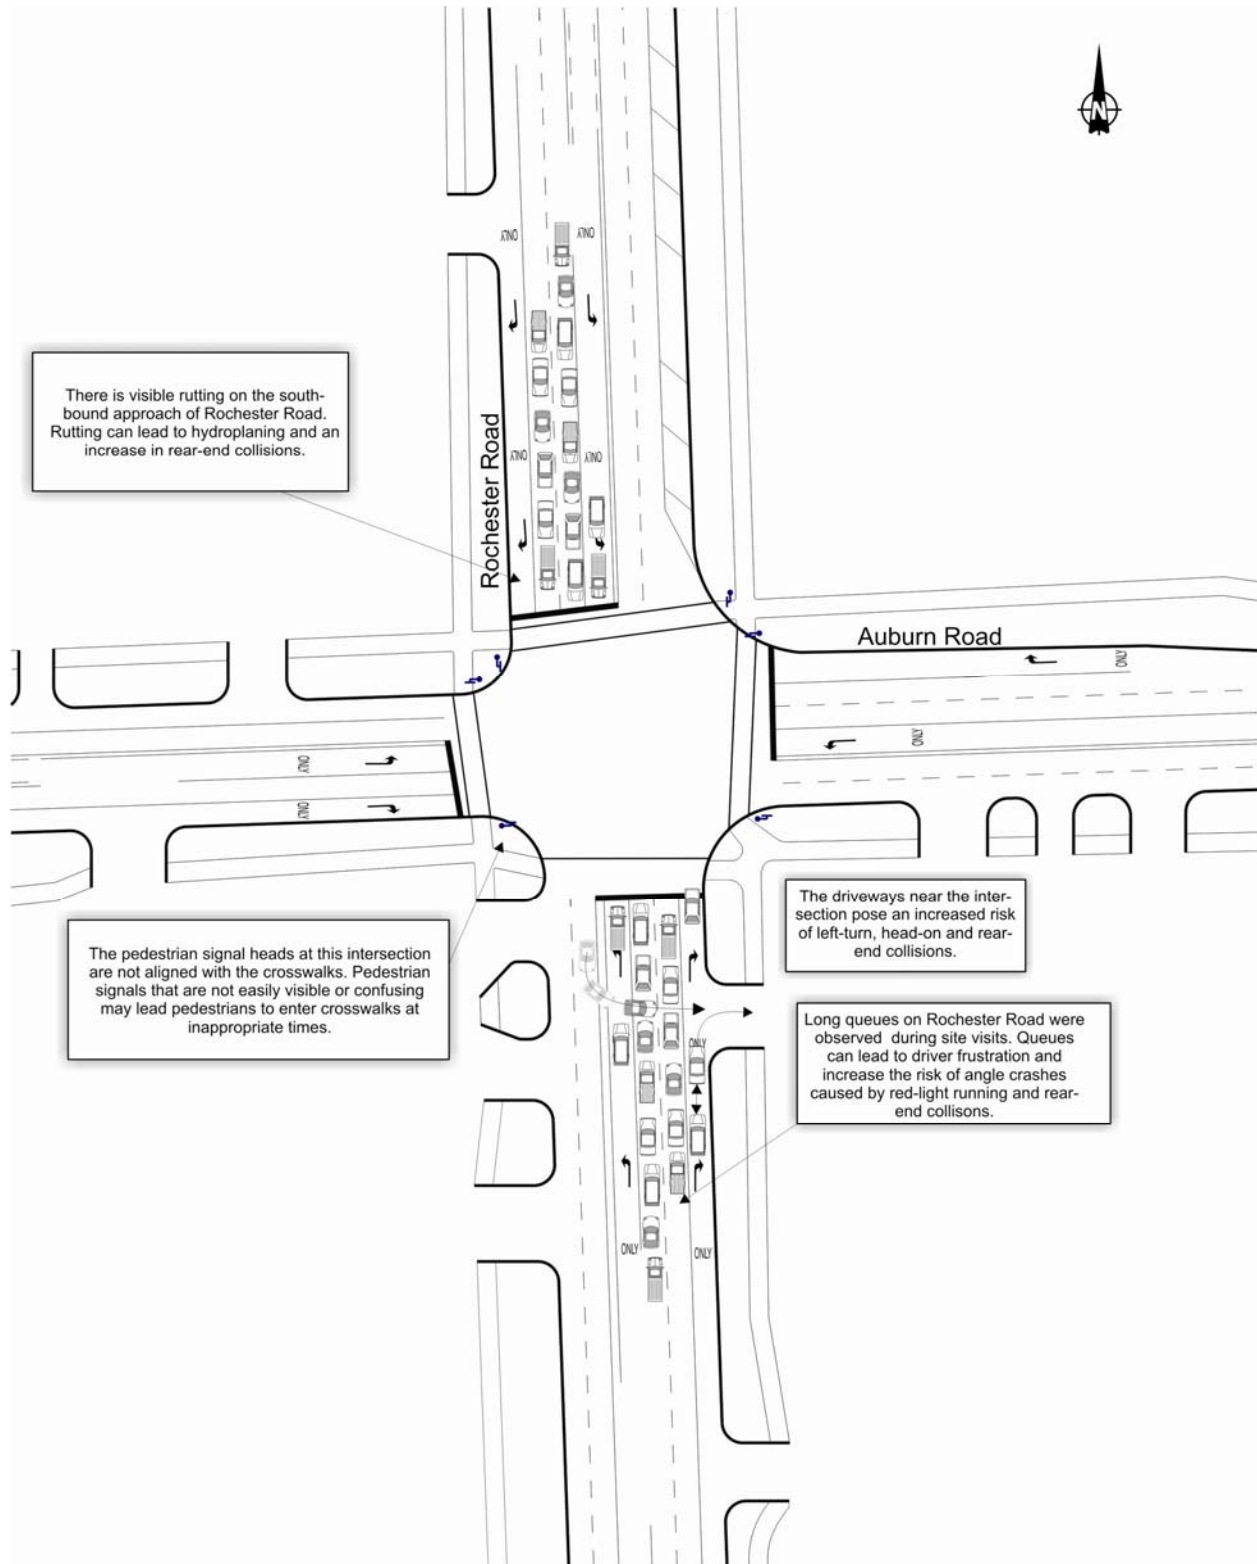
Figure 7-7 ISSUES DIAGRAM: ROCHESTER ROADX AND AUBURN ROAD

During the site visit, long queues were noted on both approaches of Rochester Road during the evening peak hour. Waiting in queues leads driver frustration increasing the risk of both red-light running and rear end collisions.

A number of driveways to private commercial establishments are present near this intersection. As a result of the periodic queuing, driveway entrances are often blocked, leading to driver frustration and choosing inappropriate gaps in the traffic flow. During the site visit, drivers were observed attempting to cut through queues to make left turns or to enter right turn lanes. Cutting

Moderate rutting is present on Rochester Road at the intersection with Auburn Road. Rutting often results in hydroplaning and loss of control under wet or icy conditions. This is justified as a contributing factor as Thirty-one percent of the crashes occurred in wet or icy conditions.

Based on the crash data analysis and the site visit observations, it appears that red-light running is a problem at this intersection. Red-light running often results in more severe angle-type collisions. This issue may come as a result of other issues. Drivers who have been waiting in queues, in combination with long wait times caused by the presence of protected-only left-turn phasing with single left-turn lanes, may run a red light out of aggravation and frustration.

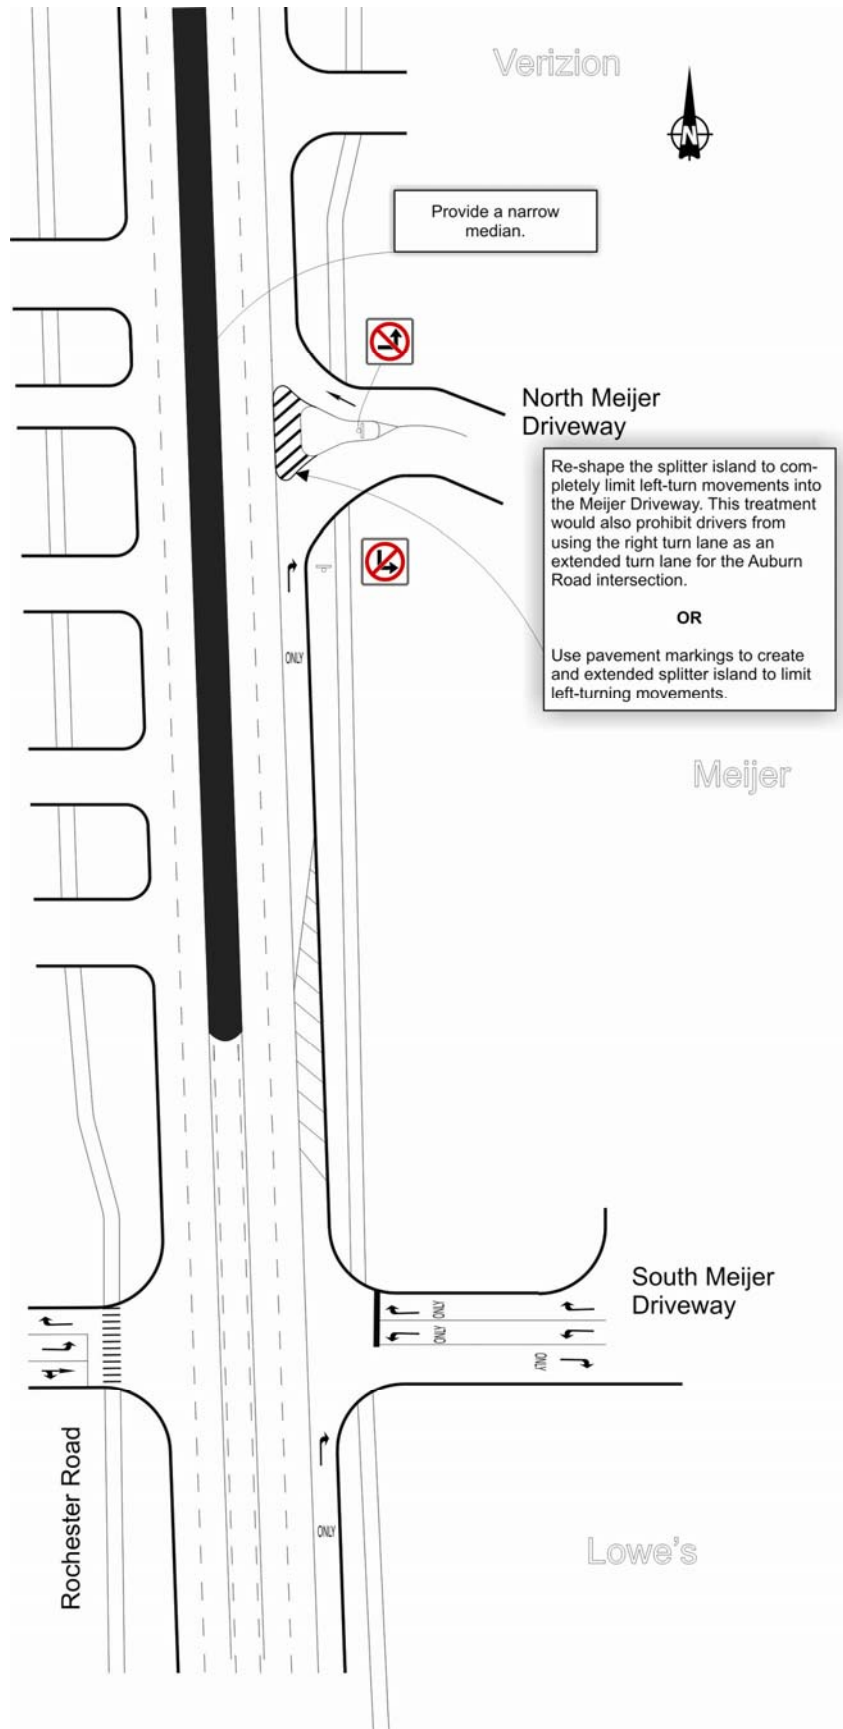
**Figure 8-9 MITIGATION MEASURES DIAGRAM: ROCHESTER ROAD AND MEIJER DRIVEWAYS**

A number of driveways to private commercial establishments are present on the west side of Rochester Road within this segment. As a result of the periodic queuing, driveway entrances are often blocked, leading to driver frustration and choosing inappropriate gaps in the traffic flow. During the site visit, drivers were observed attempting to cut through queues to make left turns or to enter right turn lanes. Cutting through these backups may lead to angle-type collisions as a result of drivers not being able to see oncoming traffic beyond the queue.
