EXECUTIVE SUMMARY THE TOWN OF STAR VALLEY RANCH MASTER ROADS STUDY

US DEPARTMENT OF COMMERCE
ECONOMIC DEVELOPMENT ADMINISTRATION
Project Number 05-079-05292

April 15, 2014

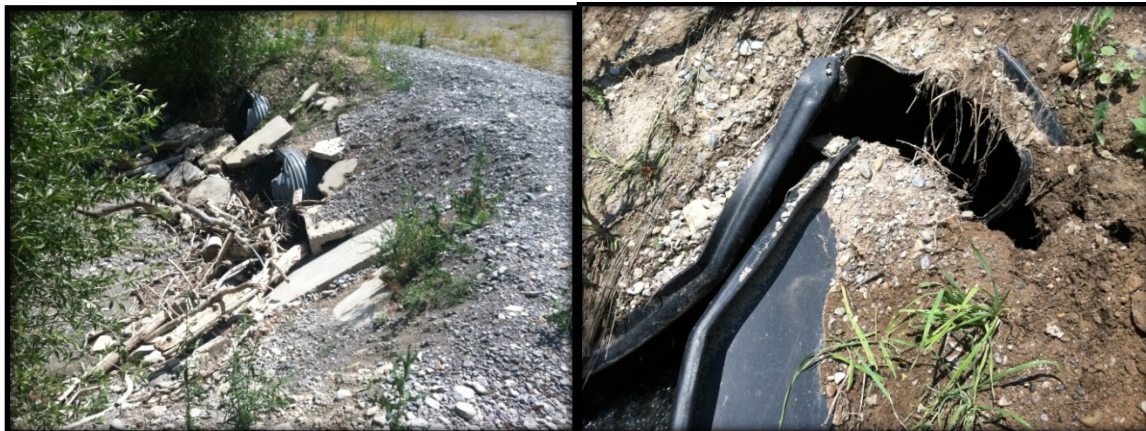
The Town utilizes within its drainage system about 44 major culverts. This does not include the numerous pipes and conduits installed across driveways by homeowners or the Town. Overall the culverts are in good condition with most problems falling in one of the following categories:

- Sedimentation of inlet and/or outlet blocking flow
- Collapsing flares
- Bend or damaged pipe ends
- Woody debris blocking flow

Woody debris at Cedar Creek and Runway & Collapsing flare end treatment
