# **WATER & SEWER COMMISSION**

## **March 26, 2019**

# JANUARY - MARCH OPERATIONS REPORT

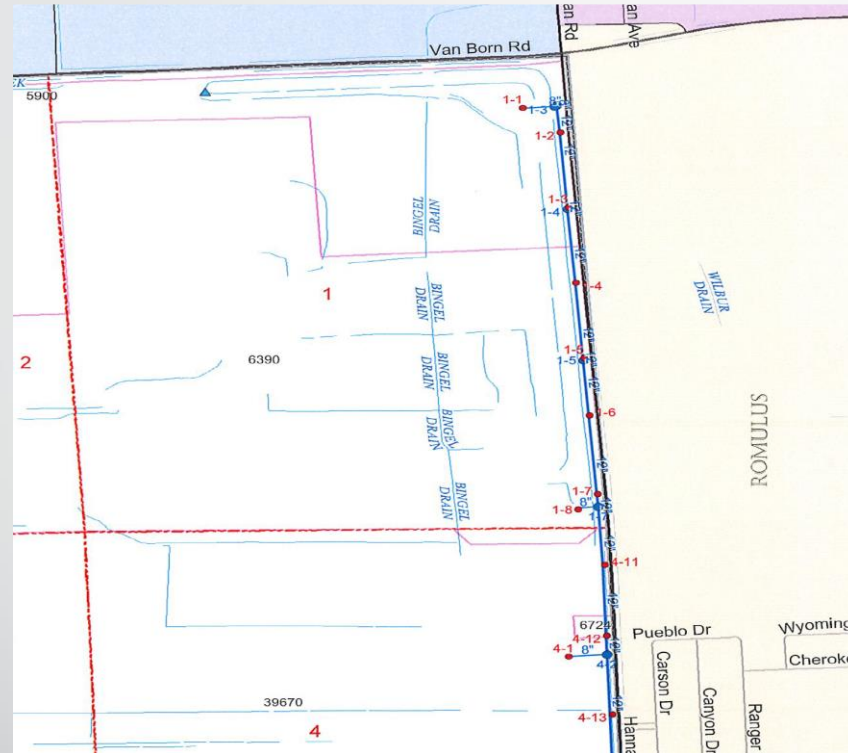
## 6390 HANNAN

- 12" Ductile Iron Pipe – installed 1993 (26 years old)
- Second break in six years
- Severe pitting identified on pipe exterior – not poly-wrapped upon installation
- **Total Repair Cost: \$1,958.64**

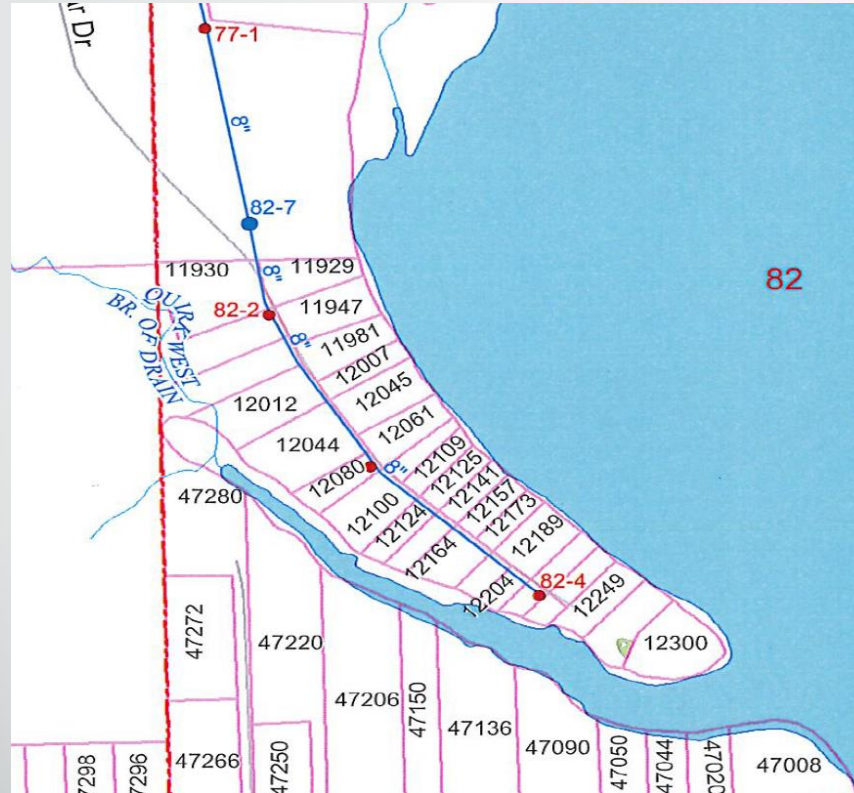
## 12044 Ryznar

- 8" Asbestos Cement Pipe – installed 1967 (52 years old)
- No break history
- Contractor assistance required
- **Total Repair Cost: \$5,855.24**

- 8" Ductile Iron Pipe – installed 1993 (26 years old)
- 3 breaks occurred during event
- Contractor assistance required (light pole removed to complete repair)
- **Total Repair Cost: \$14,311.45**
