# Van Buren Charter Township Wastewater Asset Management Plan

Project No. 171834  
December 16, 2020

**December 16, 2020**  
**Project No. 171834**  
**SAW Grant Project No. 1053-01**

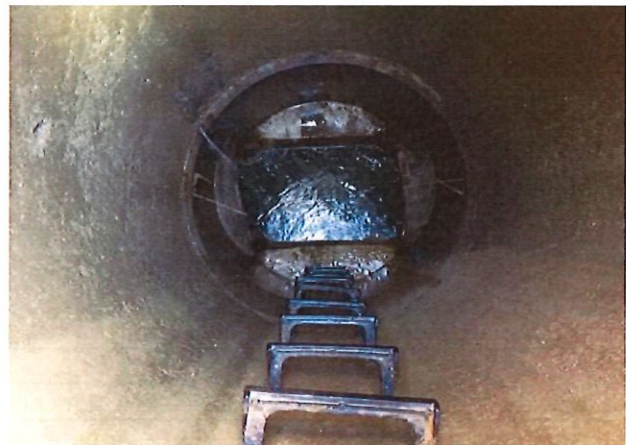
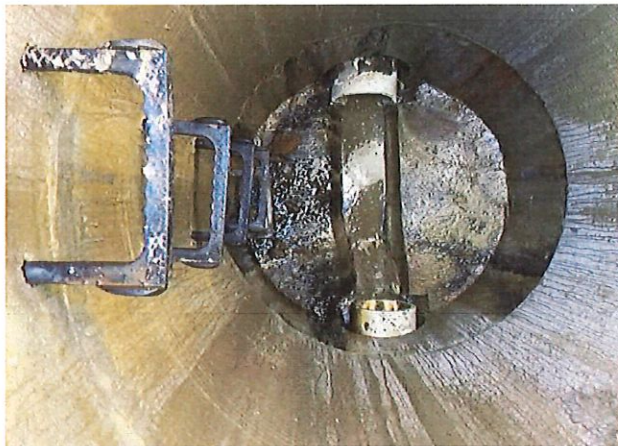
Manhole SMH042006: Infiltration in frame and wall joints, corroded frame, roots in wall joint.

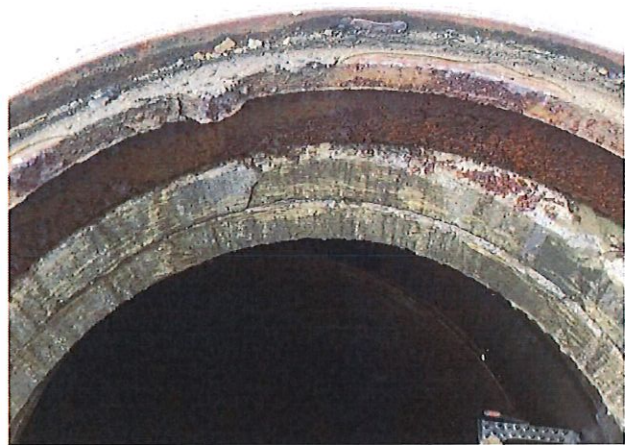
Manhole SMH006030: Infiltration in wall joints, infiltration in chimney, corroded frame.

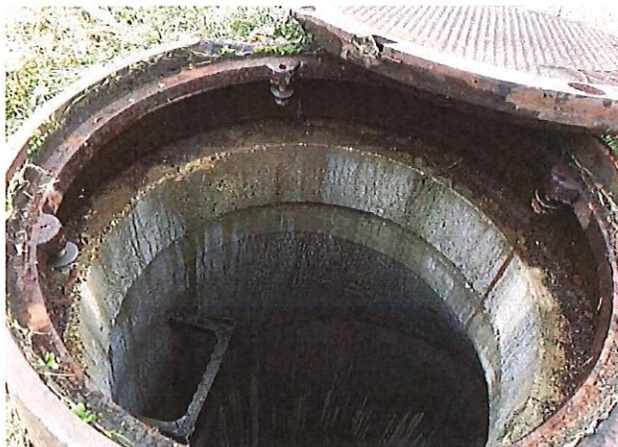
Manhole SMH007010: Infiltration in chimney, wall joints, and frame seal; cracking in chimney.

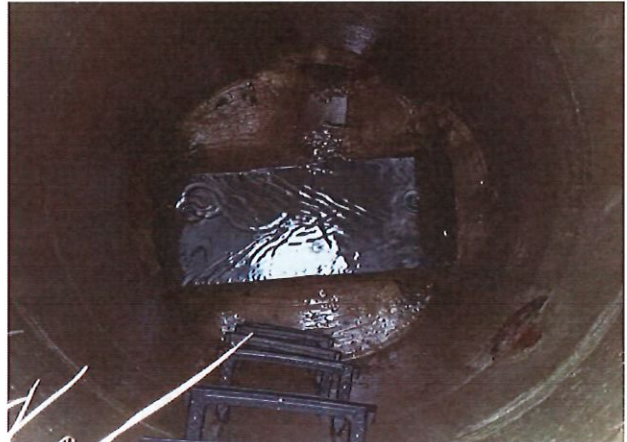
Manhole SMH105022: Broken frame and cover.

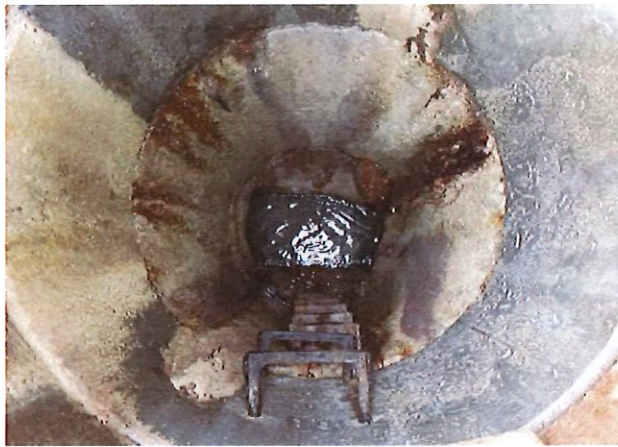
Manhole SMH005002: Cover and frame are missing, infiltration in top of structure and lift holes.

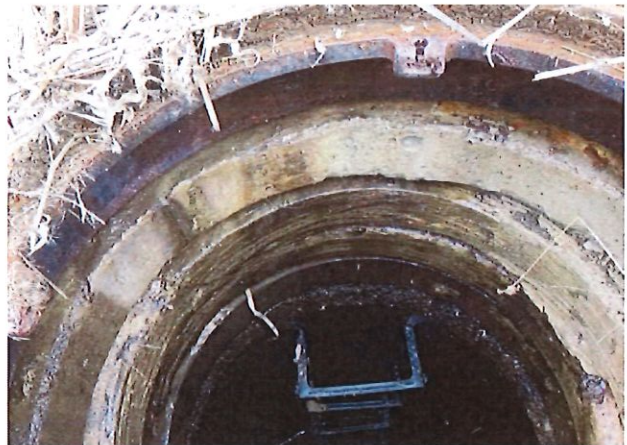
Manhole SMH004014: Encrustation throughout manhole, corroded frame, infiltration in wall joints and bench.

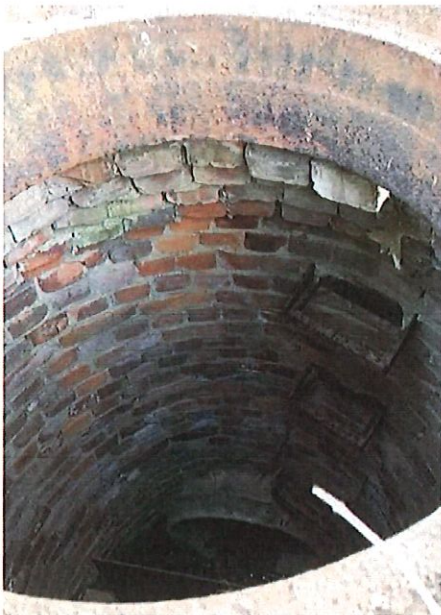
Manhole SMH033010: Infiltration in chimney, frame and roots coming in through chimney.

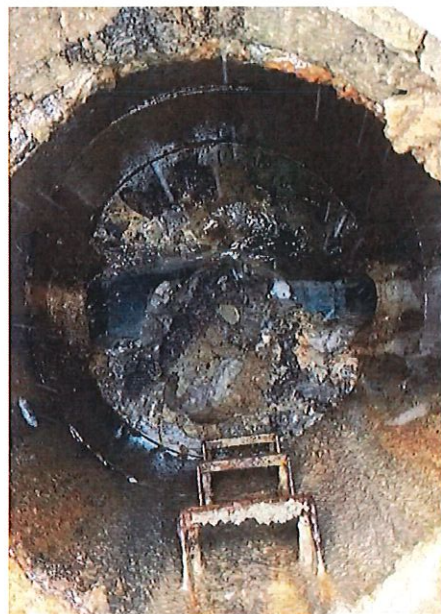
Manhole SMH096043: Frame and cover corroded, chimney bricks falling out near ladder.

Manhole SMH098006: Deposits and cracking in chimney; infiltration in chimney, cone, and wall; encrustation from chimney to wall; channel blocked by debris.

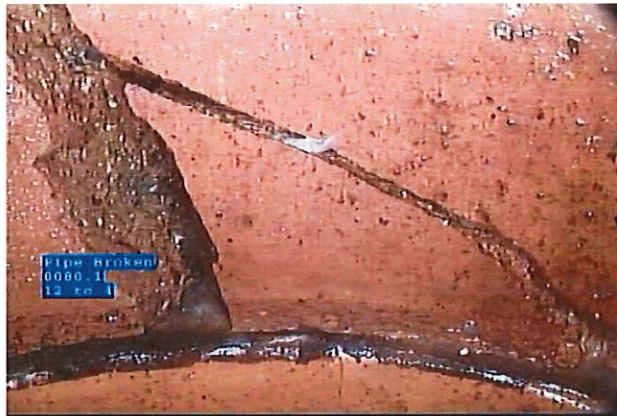
This defect is located in Sewer SGM074005, 80.1 feet downstream of Manhole SMH074007. This clay pipe is 10 inches in diameter. The pipe is broken in this section, and a hole is visible, which could result in infiltration or further structural damage to the pipe. This pipe has a structural rating of 4.35 and an O&M rating of 3.51.

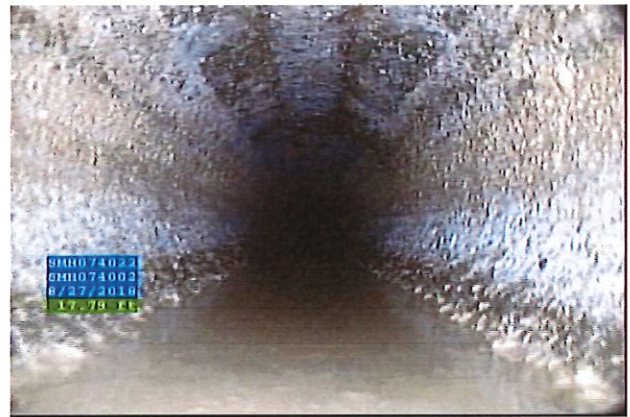
This defect is located in Sewer SGM074023. This concrete pipe is 12 inches in diameter. This pipe has missing aggregate in the pipe wall, which spans the length of the segment. This pipe has a structural rating of 4.20 and an O&M rating of 4.45.

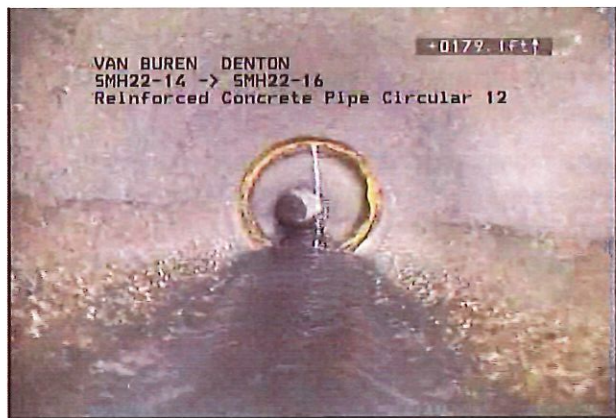
This defect is located in Sewer SGM022017, 183 feet downstream of Manhole SMH022016. This reinforced concrete pipe is 12 inches in diameter. Infiltration is gushing in through the joint. This pipe has a structural rating of 3.32 and an O&M rating of 4.36.

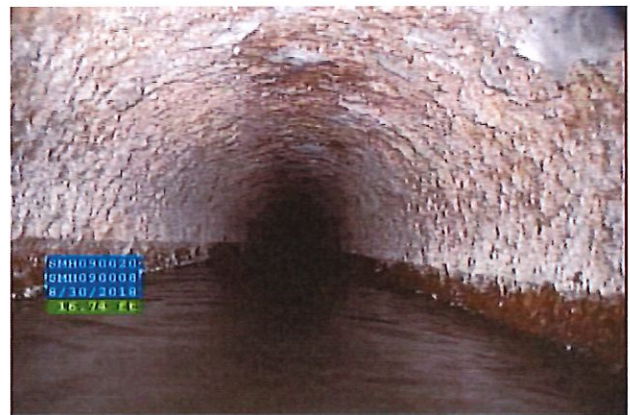
This defect is located in Sewer SGM090010. This reinforced concrete pipe is 30 inches in diameter. Aggregate is missing along the walls of this pipe as a result of H<sub>2</sub>S corrosion. This pipe has a structural rating of 4.19 and an O&M rating of 2.66.

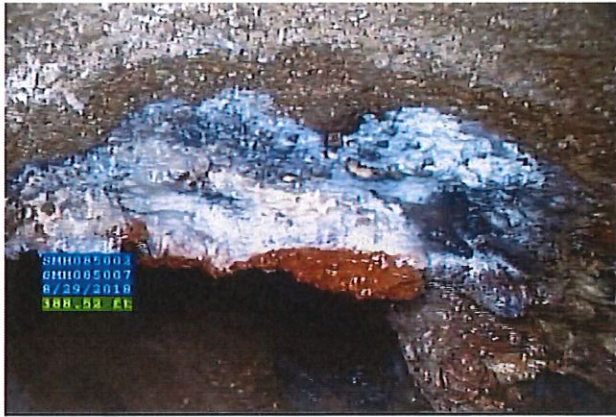
This defect is located in Sewer SGM085011. This reinforced concrete pipe is 30 inches in diameter. Encrustation is forming near the seal of Manhole SMH085007, and running infiltration is coming in at this area 388 feet downstream of SMH085002. This pipe has a structural rating of 2.40 and an O&M rating of 4.37.
