# ALL THINGS WOOD

## Anatomy of an Inherently Dangerous Deck

By Frank Woeste

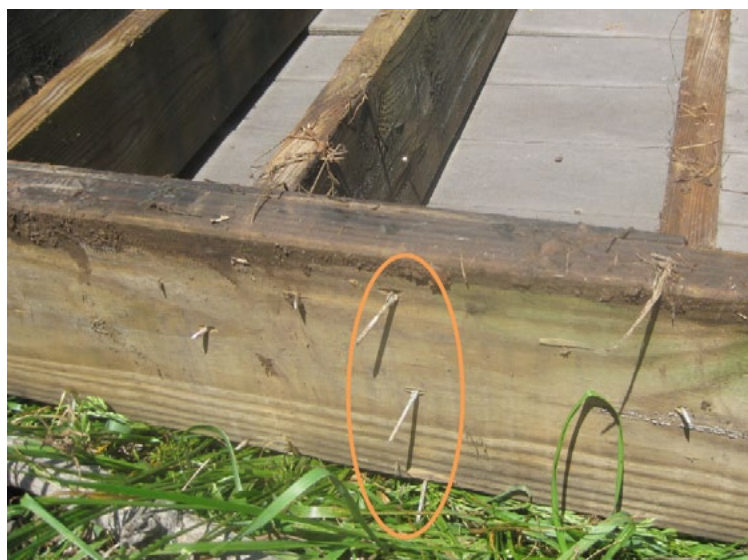
The deck remains shown in Figure 1 depict a case where the deck shifted laterally, away from the structure, and fell to the ground.

Figure 1. Close-up of deck ledger that was connected to a structure with nails only. When lightly loaded by occupants, the deck shifted laterally, pulling the nails out of the supporting structure.

Had the deck fallen vertically at the ledger side of the deck before shifting away from the house, the nails would have bent over. In this case, the nails are essentially straight, indicating that the nails withdrew from the wall before total collapse of the deck floor. Nails used in this application have negligible strength, providing only support for the weight of the deck without sufficient reserve capacity for in-service loading by occupants.

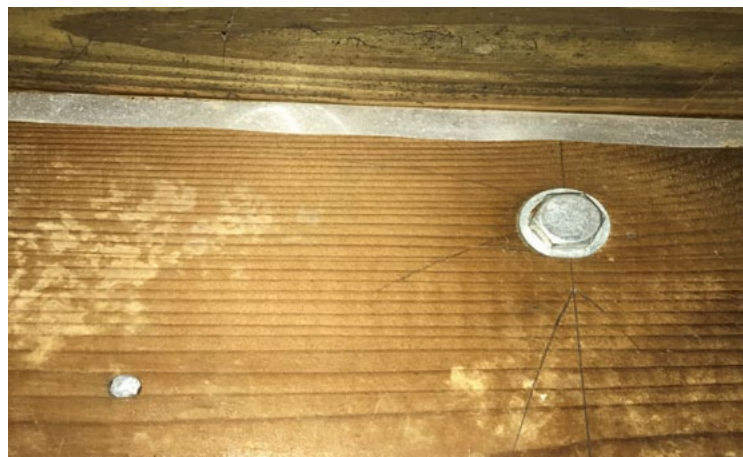
Figure 2. Section of a deck ledger with a nail head and ½" diameter lag screw installed.

The proper lag screw diameter per the IRC can be verified by the fact that ½” lag screws have a hex-head that is ¾” wide. In this case, the contractor used ½” diameter lag screws to connect the ledger to the wall sheathing and house band. (The nail (bottom left) was likely used to position the ledger on the wall while the lag screws were installed.)

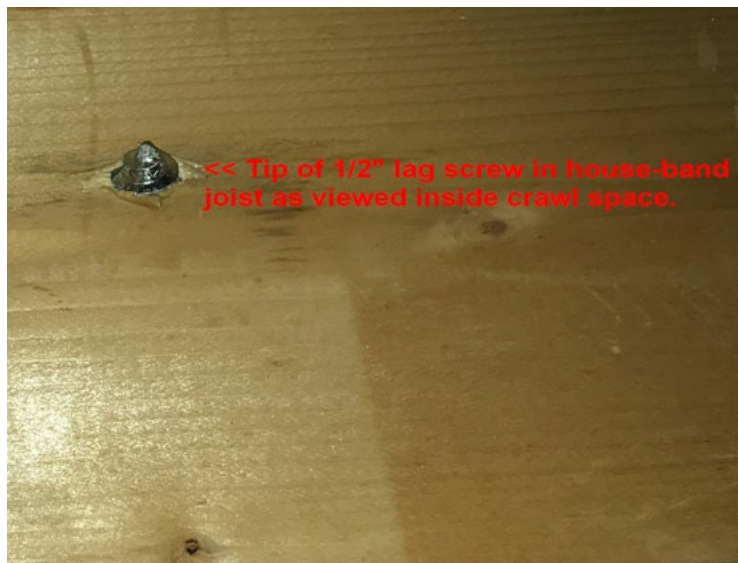
Figure 3. The tip of the lag screw depicted meets the IRC requirement for fully extending beyond the inside face of the band joist.

Because the tip of the screw extends beyond the inside face of the house-band joist, the installed ½” lag screw is clearly the proper length as required by the IRC. Assuming the tips of the lag screws are not present, the installation is not
