**Agenda Item 3
Bank Lane Streetscape
Enhancement Concepts**

Bank Lane Streetscape Enhancement Recommendations
August 28, 2024 Meeting Minutes Excerpt

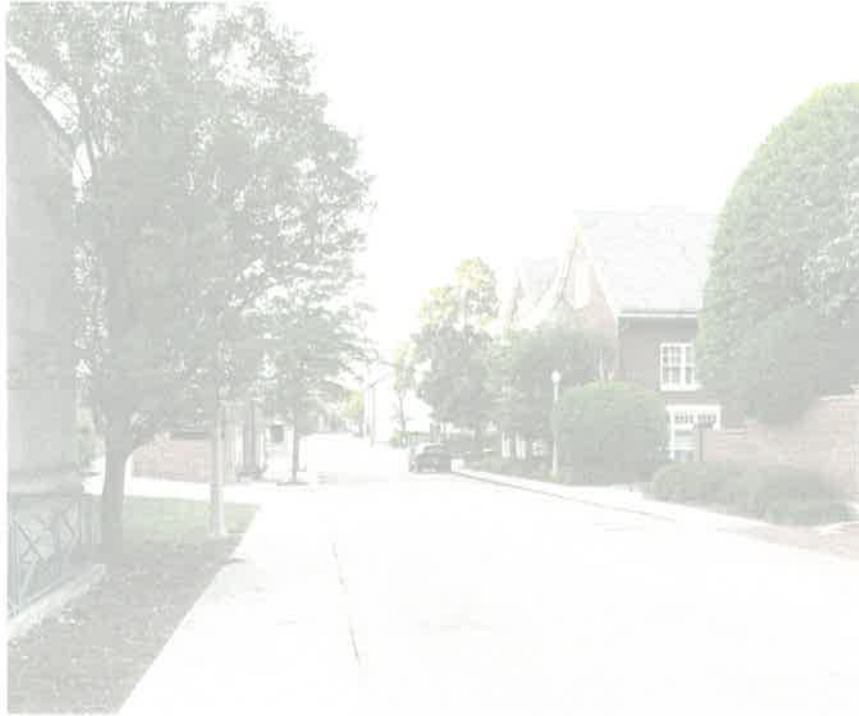
The City of Lake Forest

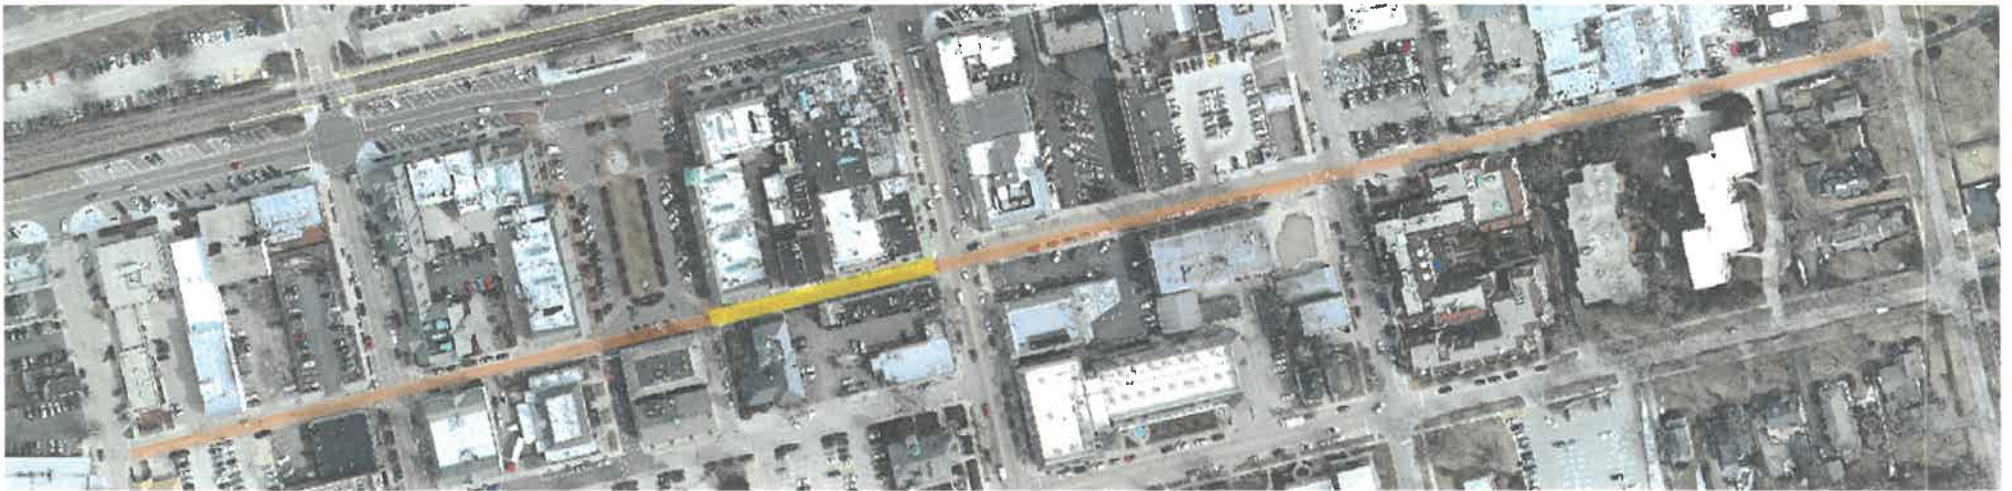
- **Set expectations** for future redevelopment opportunities
- Hardscape improvements that **elevate** the Bank Lane experience and compliment Market Square
- **Preserve** the unique character through the use of simple, uncluttered, and complimentary elements
- Balance and **enhance** pedestrian enjoyment and safety with service needs
- Improved backdrop for special events and business functions that **engage** the community

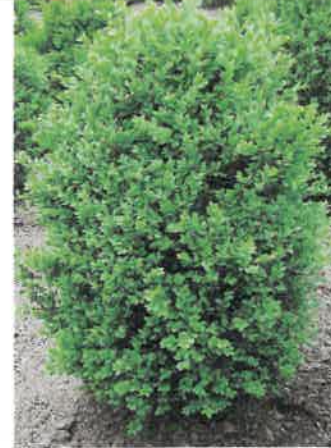
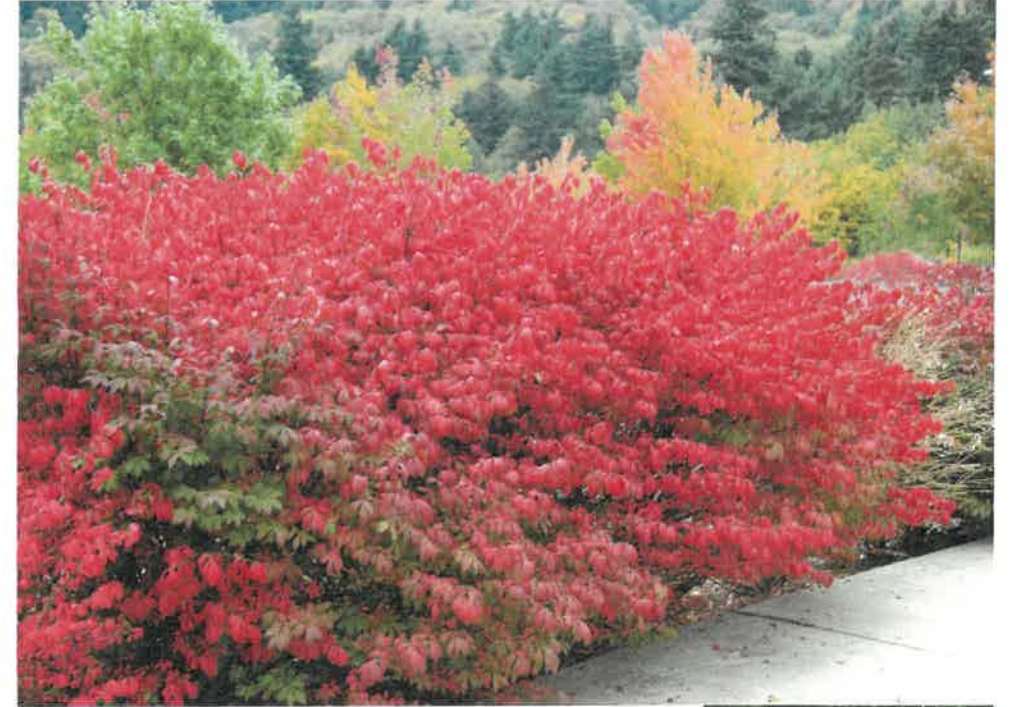
BURNING BUSH - DWARF

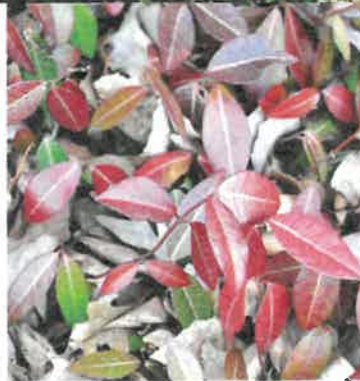
Agenda Item 5
265 E. Deerpath
Replacement Windows for Northern Trust Bank

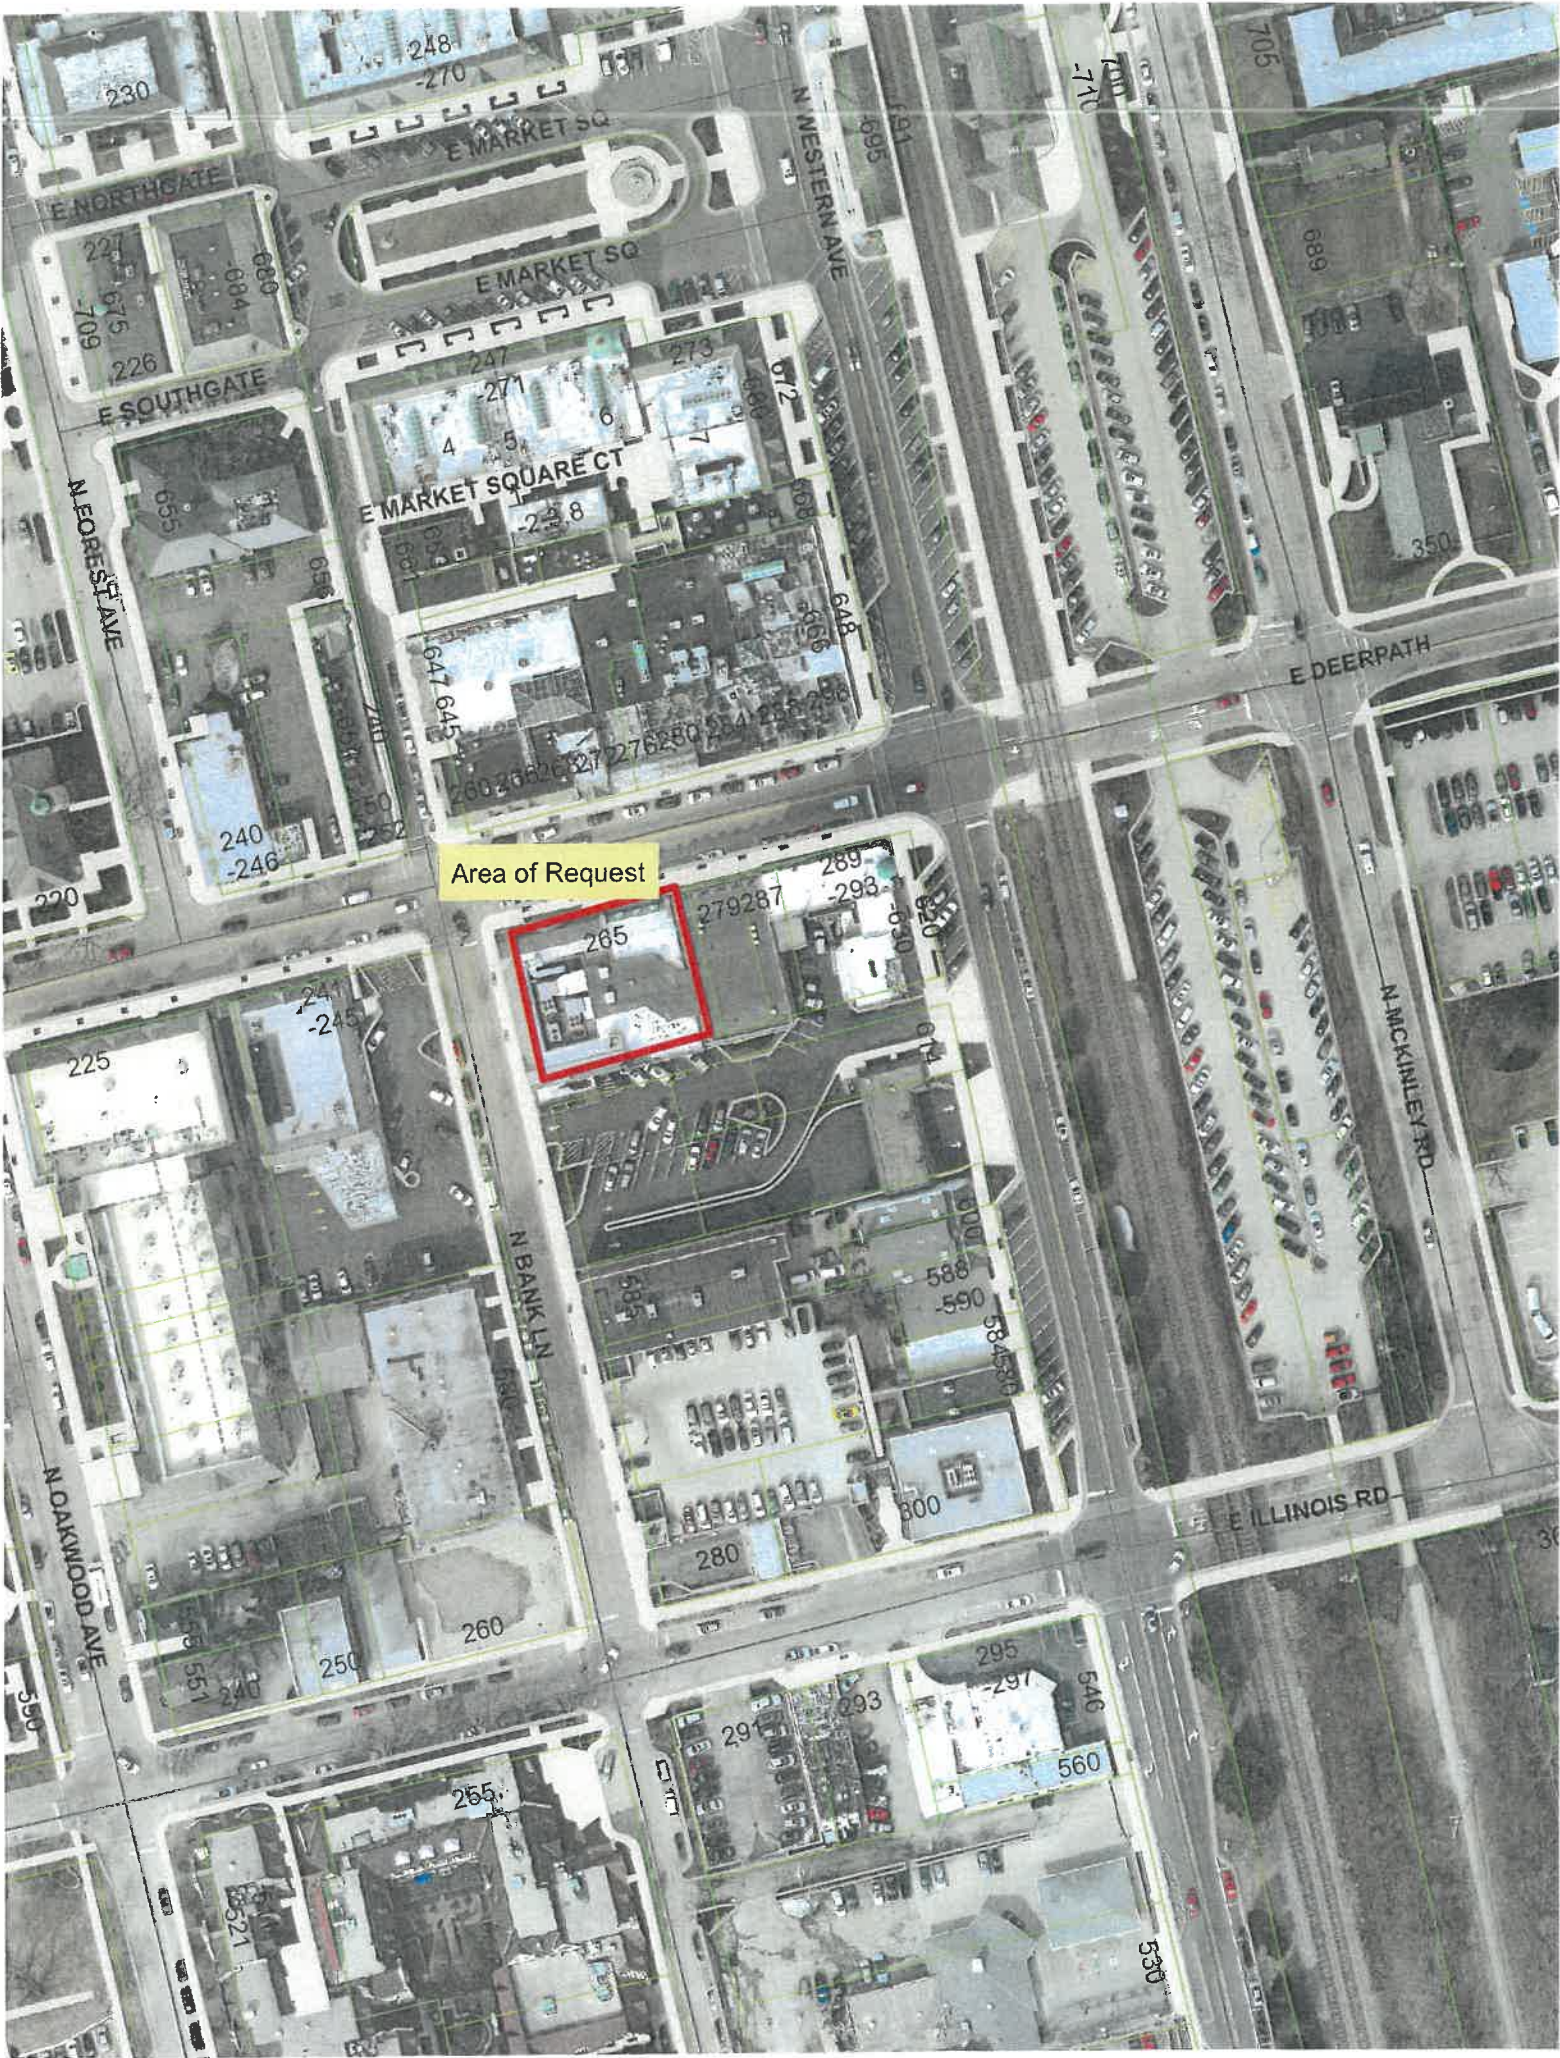
The motion was seconded by Commissioner Petit and approved by the Commission by a 6 to 0 vote.

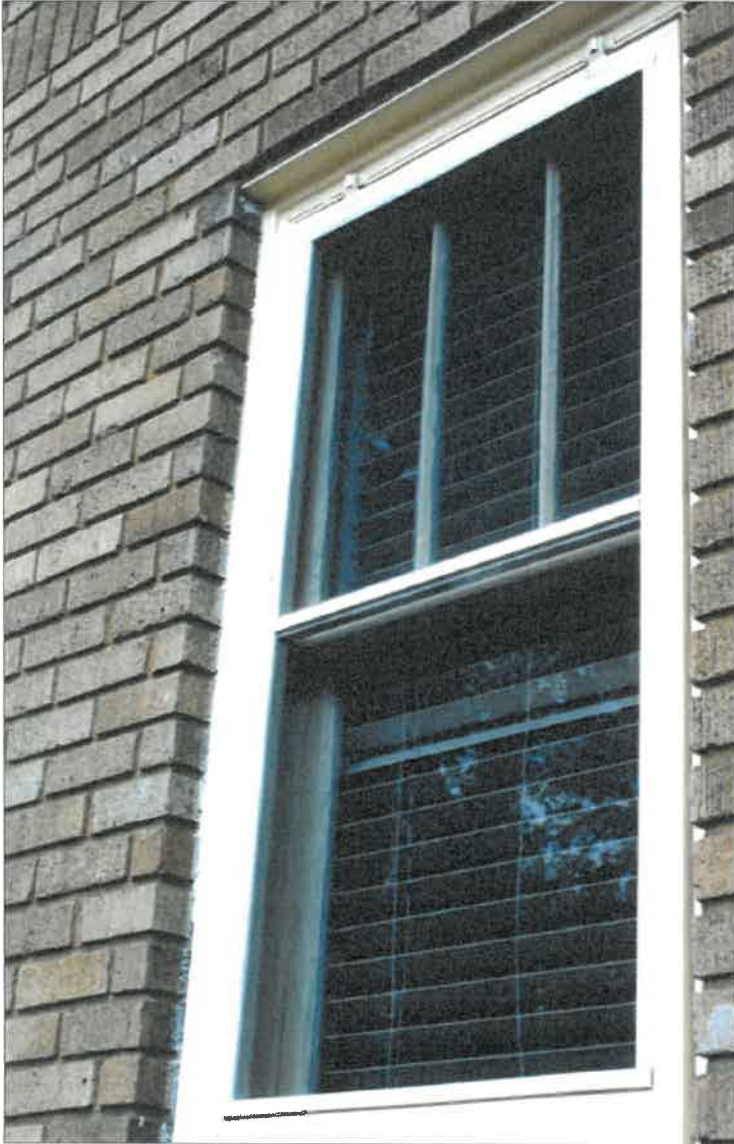
[10] Historic exterior storm windows preserve and help to insulate wood windows.

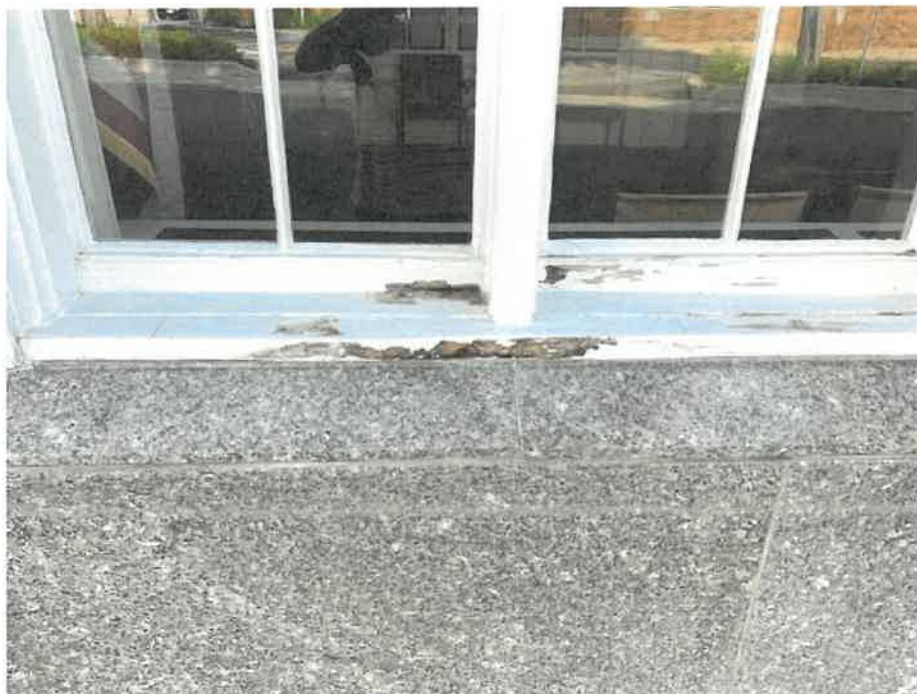
Photo 2 - View of deterioration at Window Type F in 2023 prior to repairs.

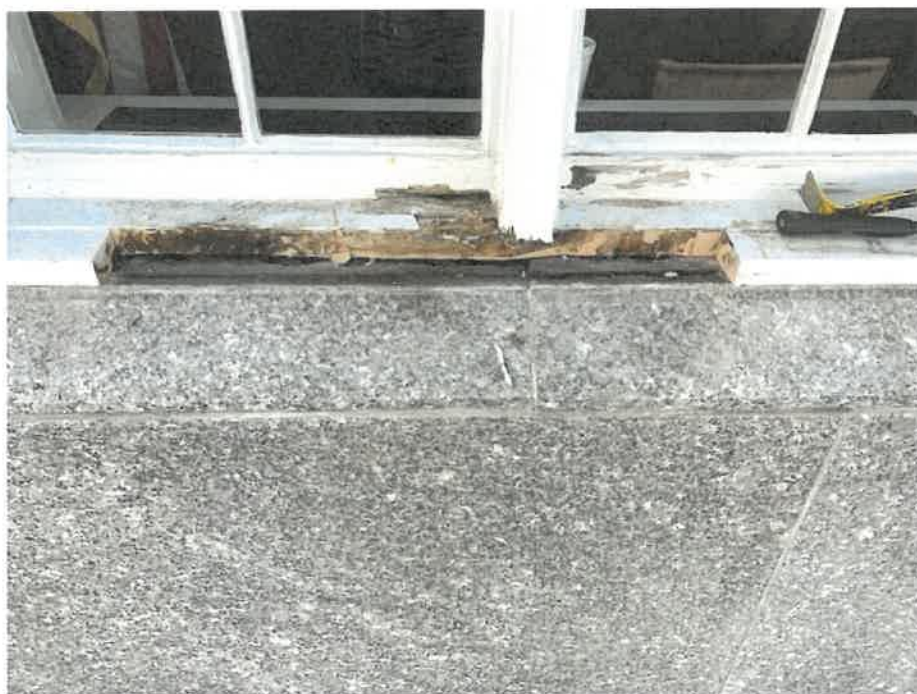
Photo 3 - View of deterioration at Window Type F in 2023 during repairs.

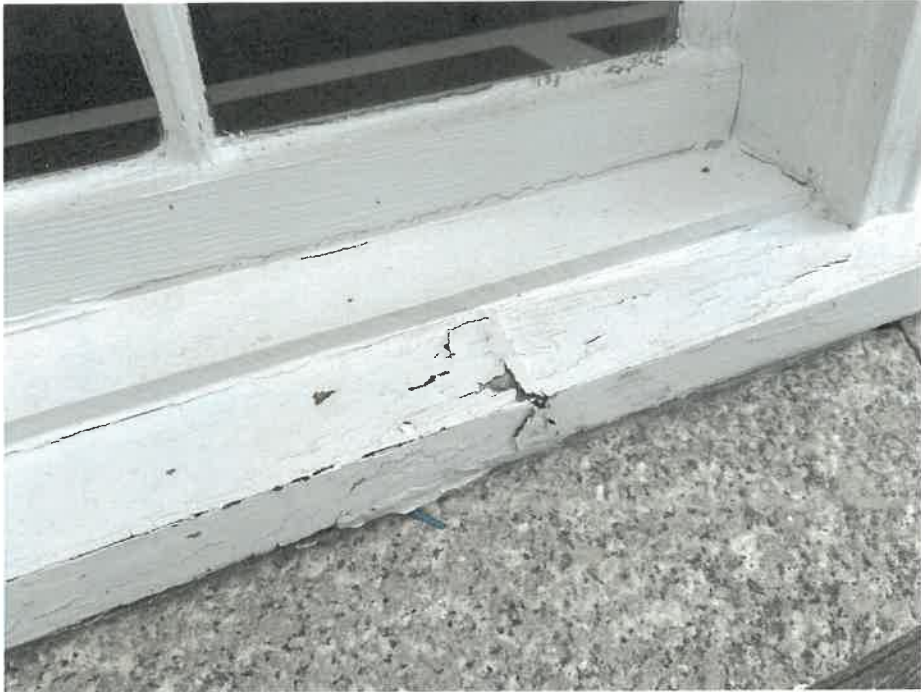
Photo 4 - Example of deterioration at Window Type F in October of 2024.

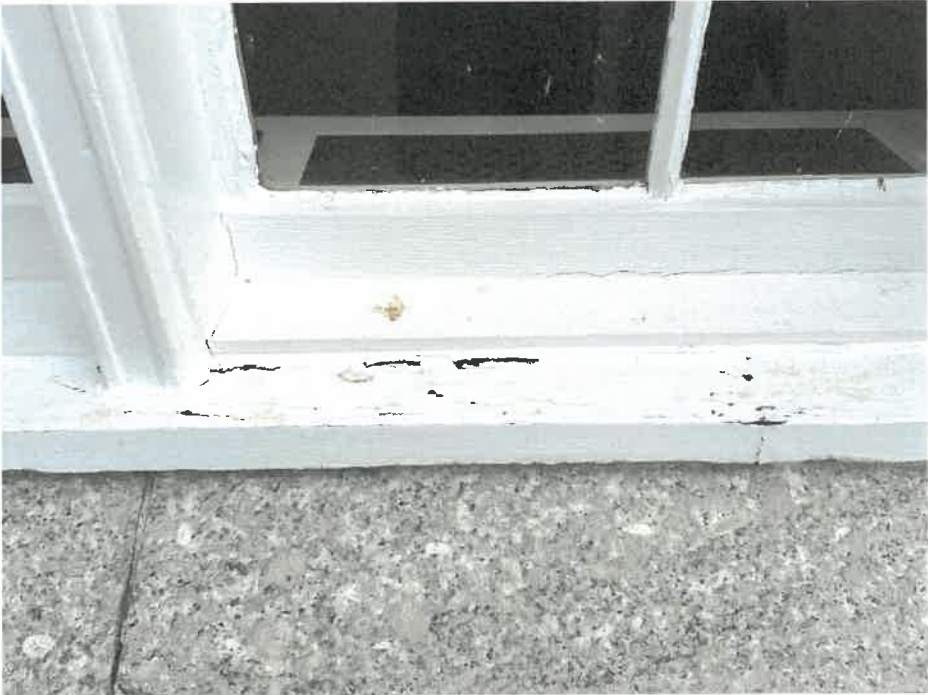
Photo 5 - Example of deterioration at Window Type F in October of 2024.

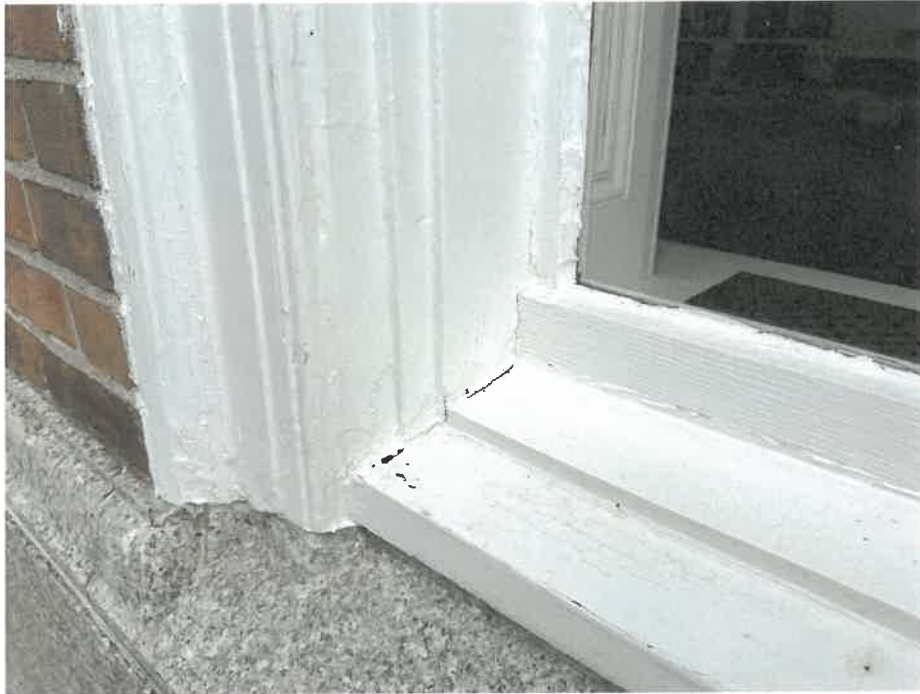
Photo 6 - Example of deterioration at Window Type F in October of 2024.

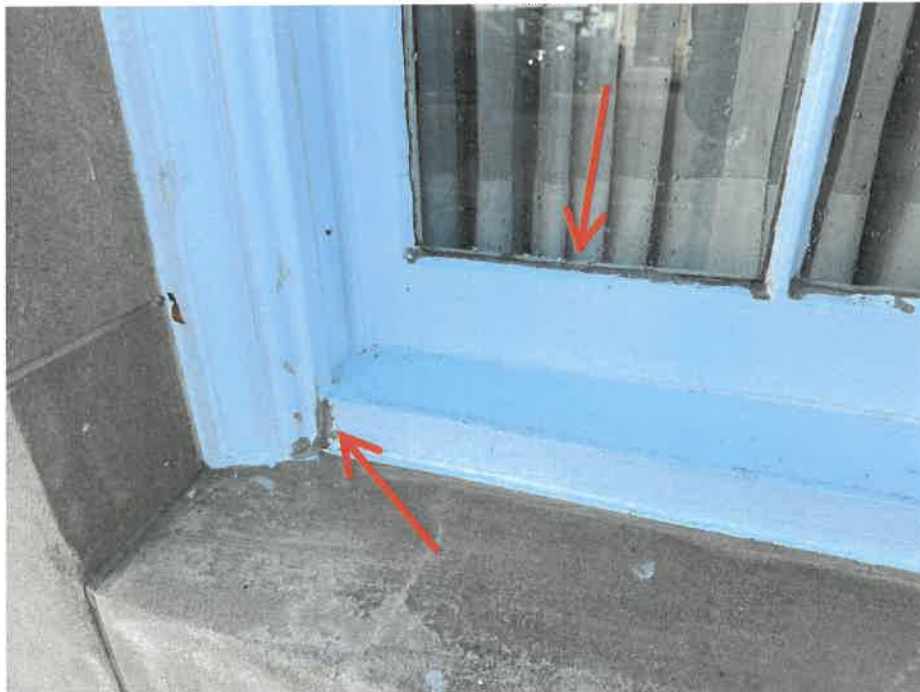
Photo 7 - Example of deterioration at Window Type B in October of 2024. Arrow points to sealant applied after painting was done.

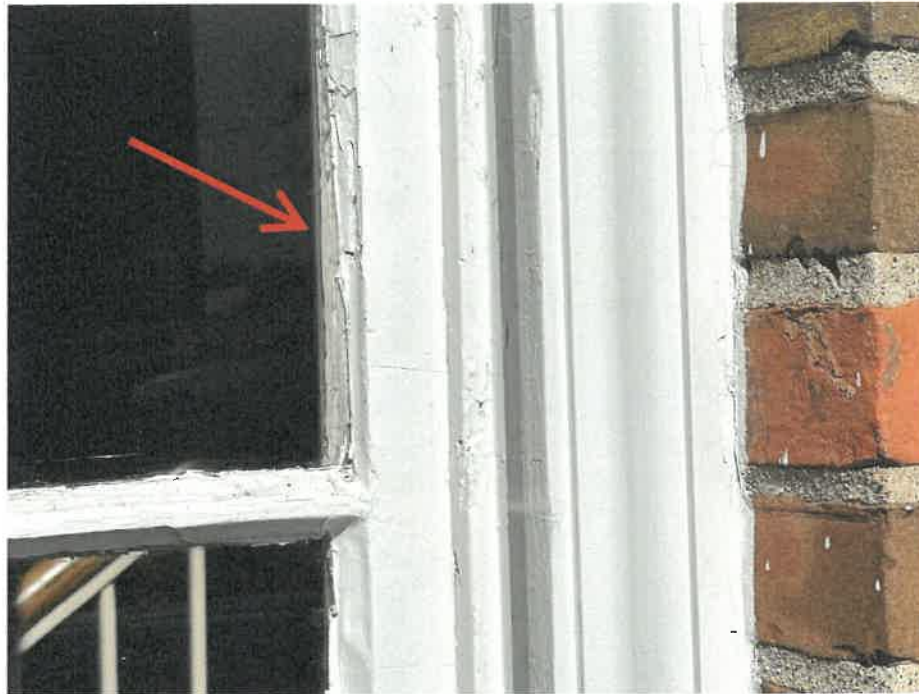
Photo 8 - Example of deteriorated glazing putty in October of 2024.

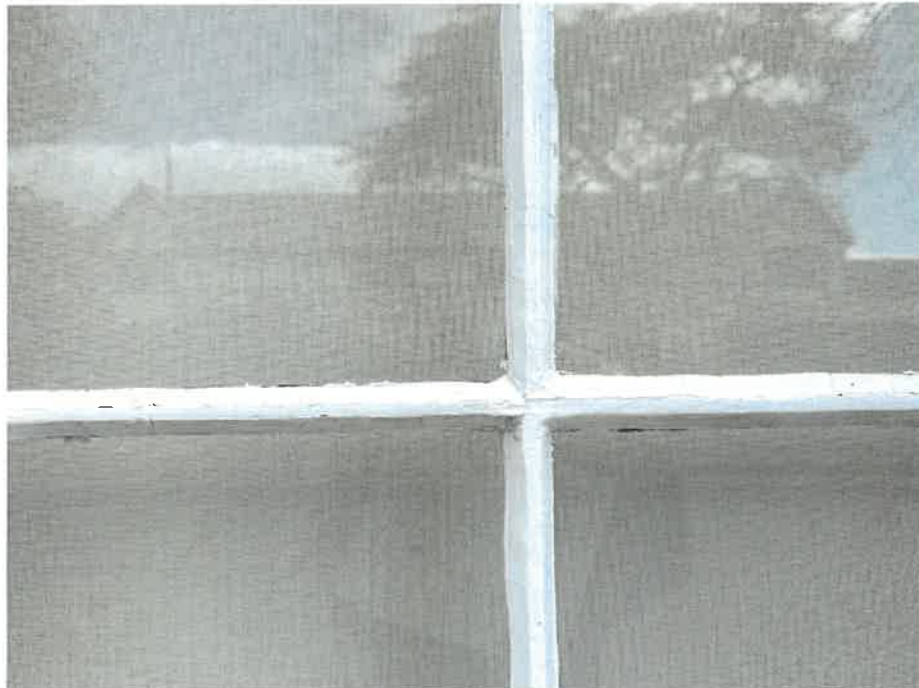
Photo 9 - Example of deteriorated glazing putty in October of 2024.

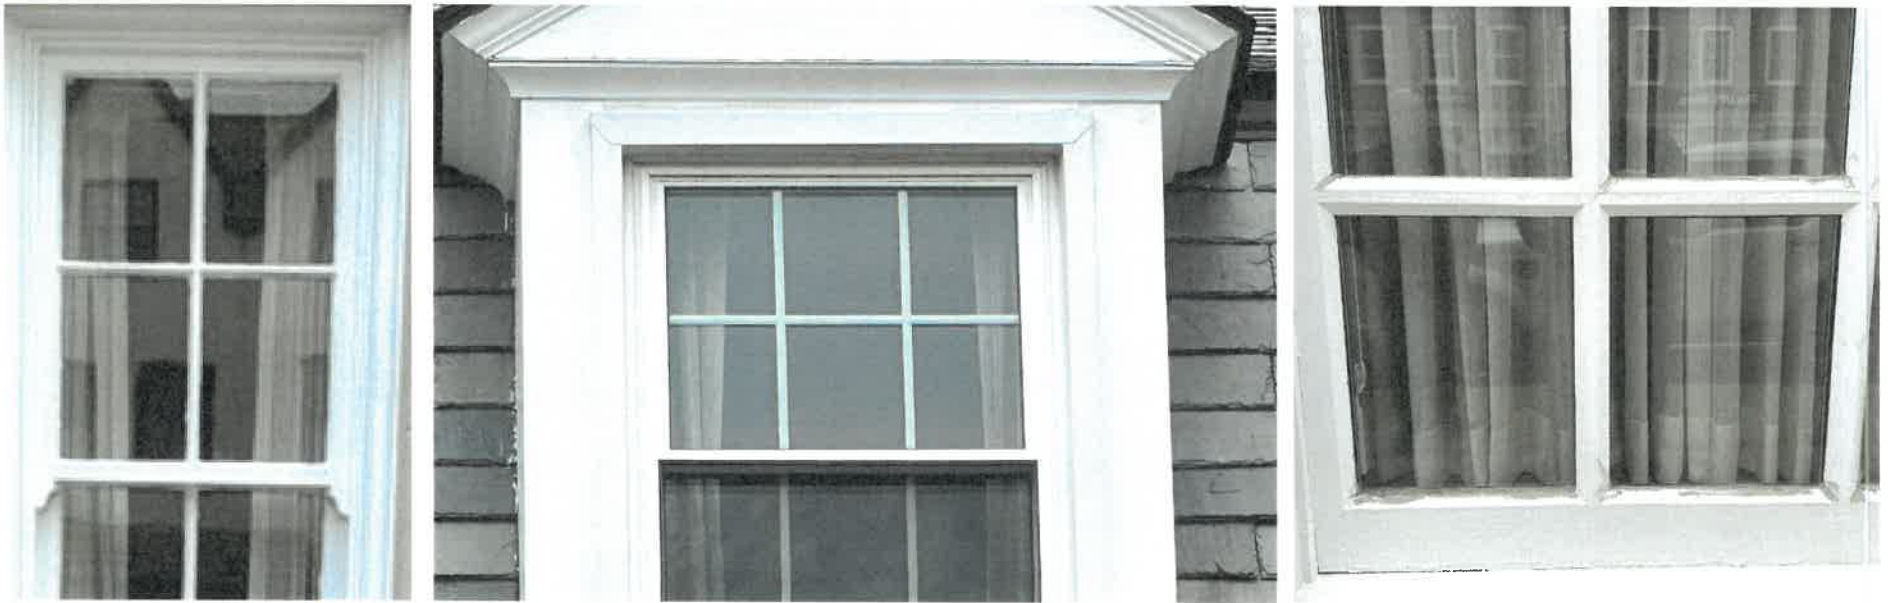
Conditions Observed at Windows

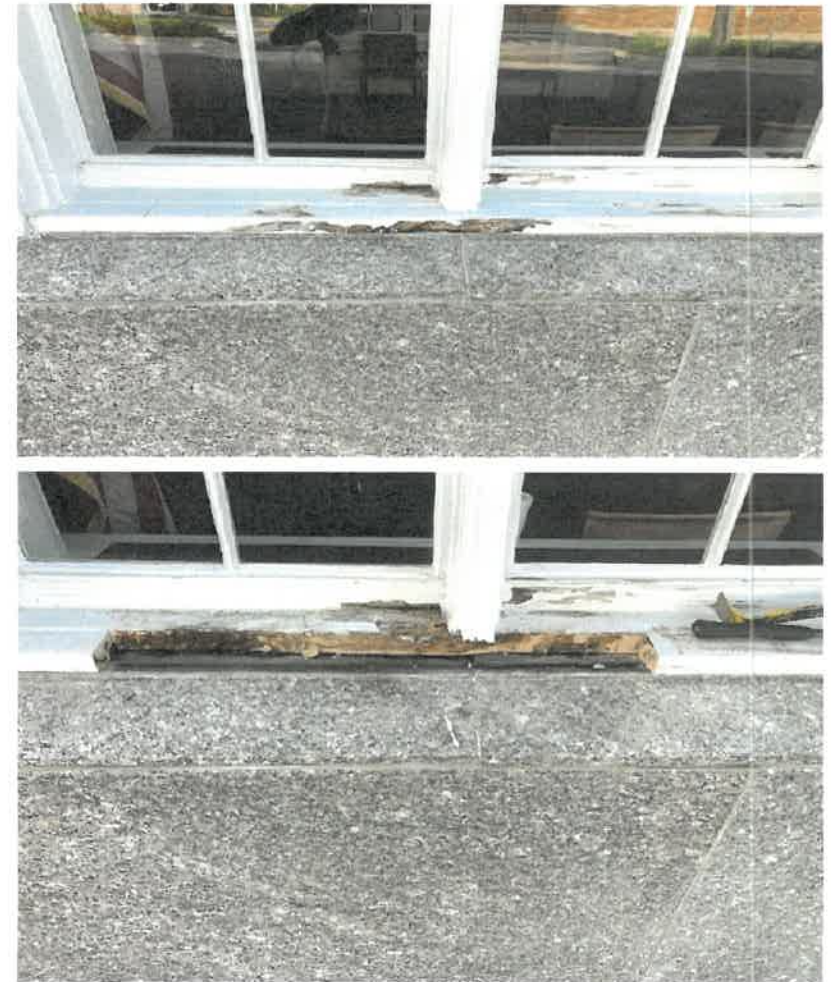
Type A | Existing & Proposed

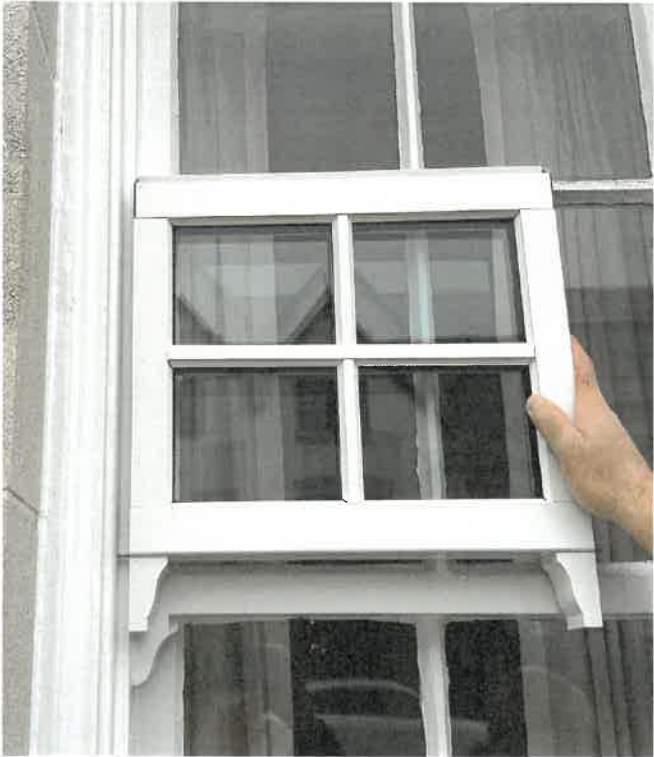
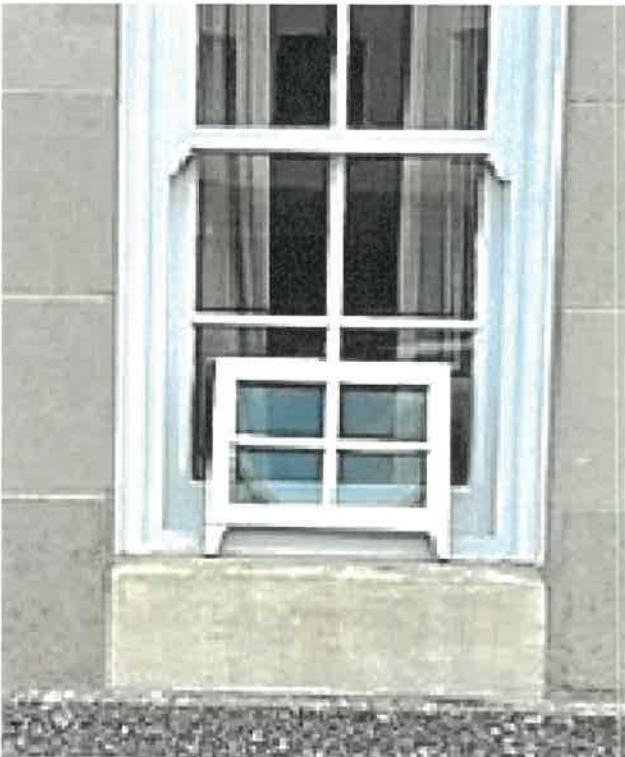
Upper Sash | Existing & Proposed
