Re: Related Companies Branford Manor 37A Mather Avenue, Groton, Connecticut Limited Water Intrusion/Mold Survey

Building 18, Unit 159

Date: September 11, 2022

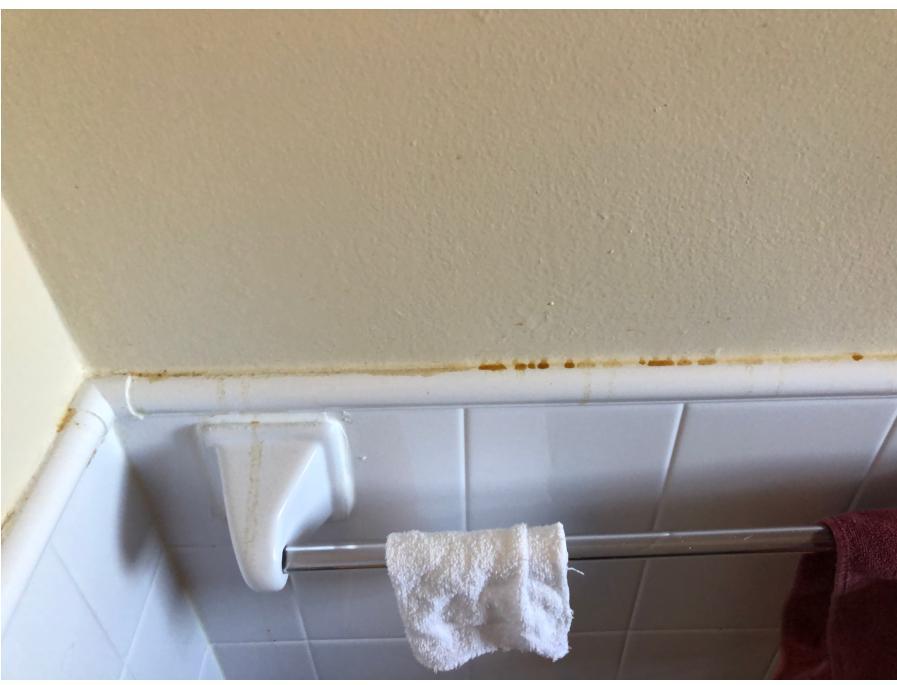
- Condensation of elevated relative humidity levels on bathroom wall, at the tile.
- Dust build-up and condensation on the bathroom vent may result in SMG.
- Dust build-up and condensation on the AC units may result in SMG. Additionally, the tenant reported that the AC units were obtained second-hand from a previous owner, and likely arrived at the unit already exhibiting mold growth.

Water staining above tile in bathroom

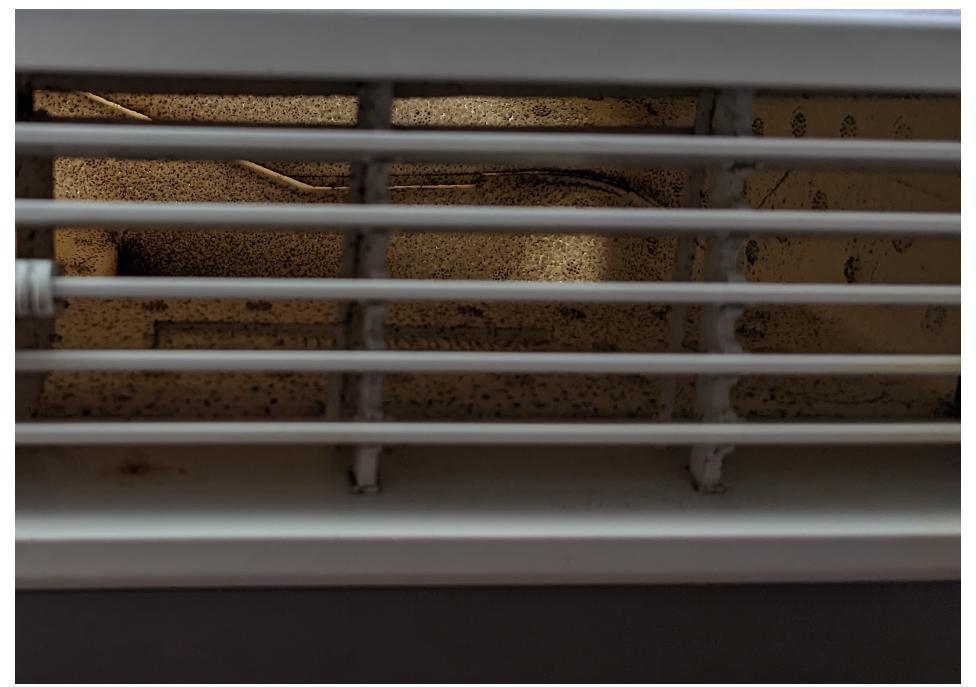
- Although reportedly cleaned regularly by the tenant, the living room AC and upstairs bedroom free-standing ACs did exhibit SMG in the interior of the units, as visible from the exterior.
- Minor water staining (rust) was noted above the tile wall in the bathroom.
- No elevated moisture or major openings or anomalies were noted and confirmed with the handheld moisture\_meter and IR Camera instrumentation.

AC Interior – SMG Inside Unit

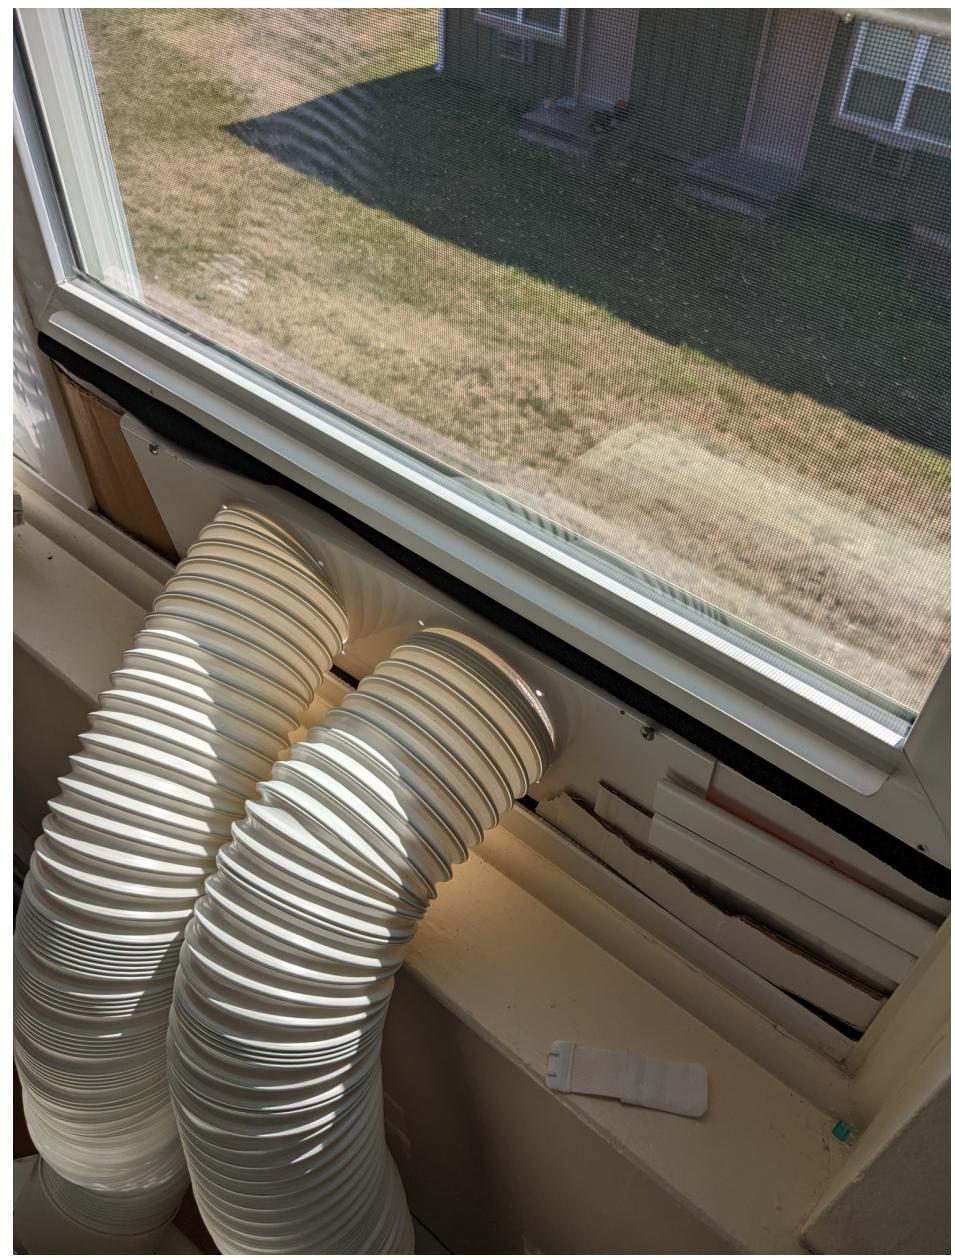
- No SMG was observed
- The air conditioner for the window appears to be of insufficient dimensions to fit into the existing sleeve and the tenant had installed cardboard along the frame to fill the gaps around the AC.

Exhaust lines from Bedroom AC Unit with modifications to fit window opening
