Survey and Planning Grant

Application

The Aldrich Free Public Library Planning and Survey Grant Application 2022

**G. Long Term Preservation Plan/Conditions Assessment completed in
October 2021 by Crosskey Architects**

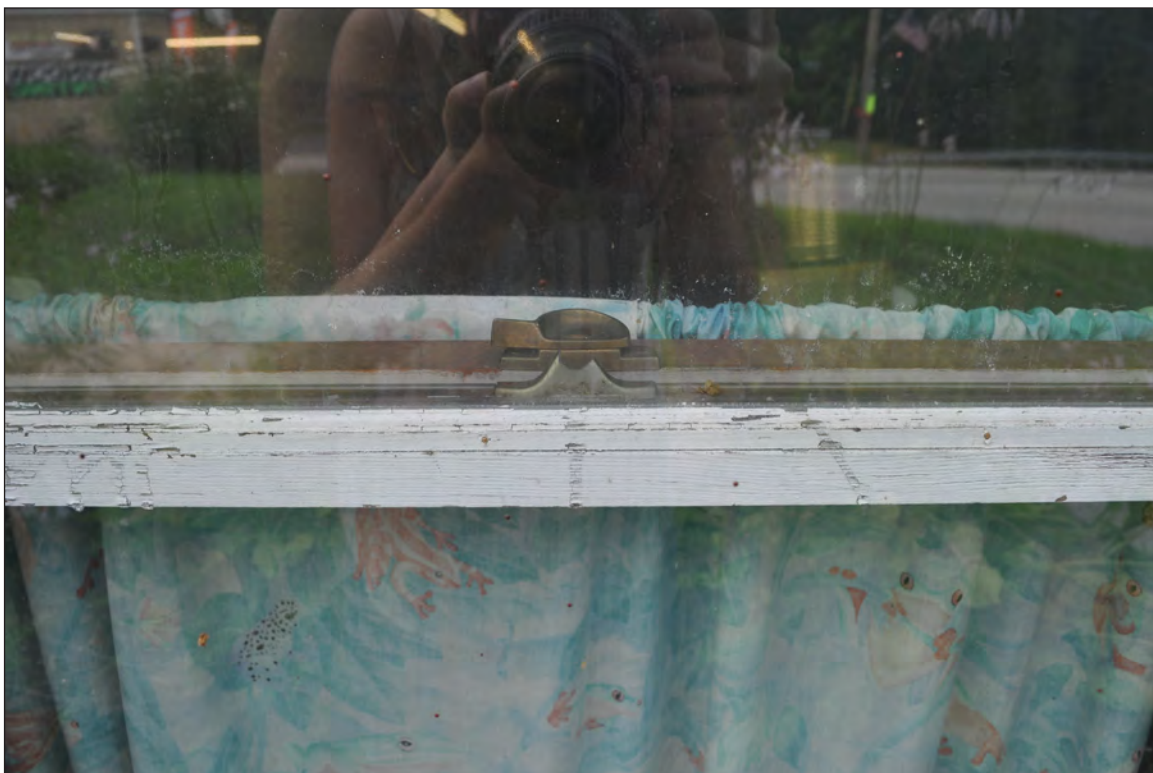
21. South elevation, tower, camera facing down and north. Note deteriorated window sash and sill.

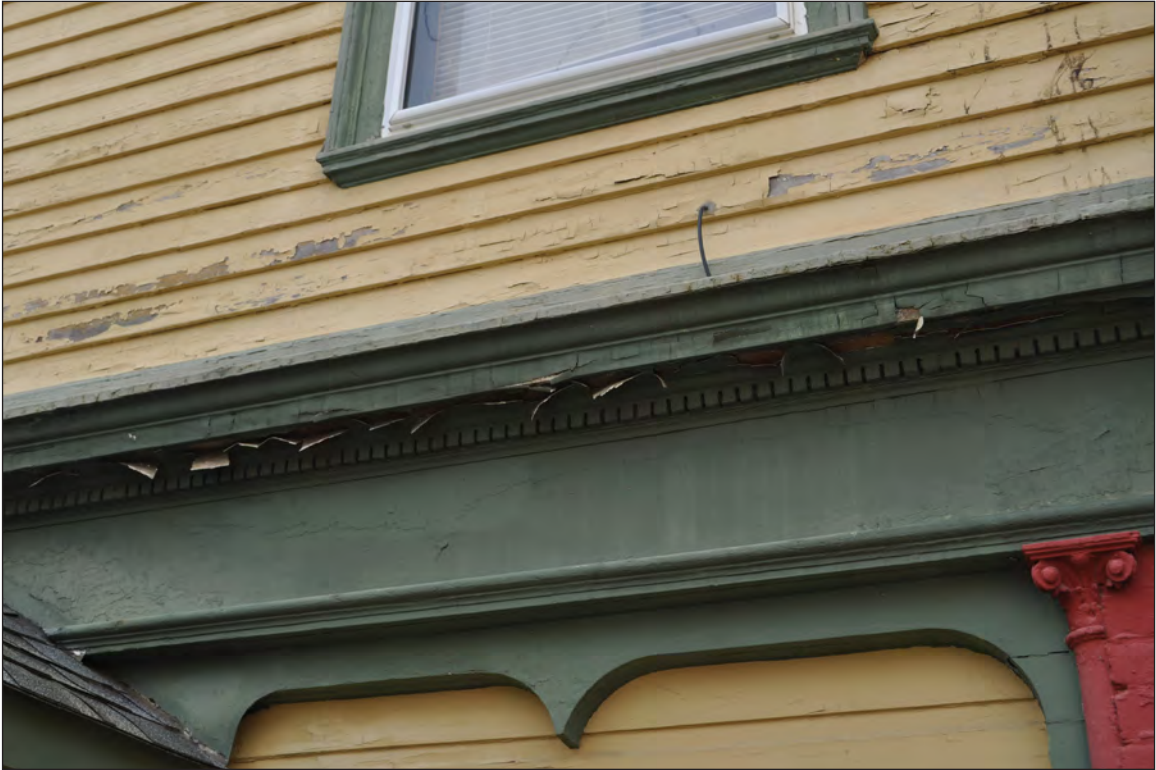
36. East elevation, camera facing northwest. Note condition of clapboards and corner pilasters.

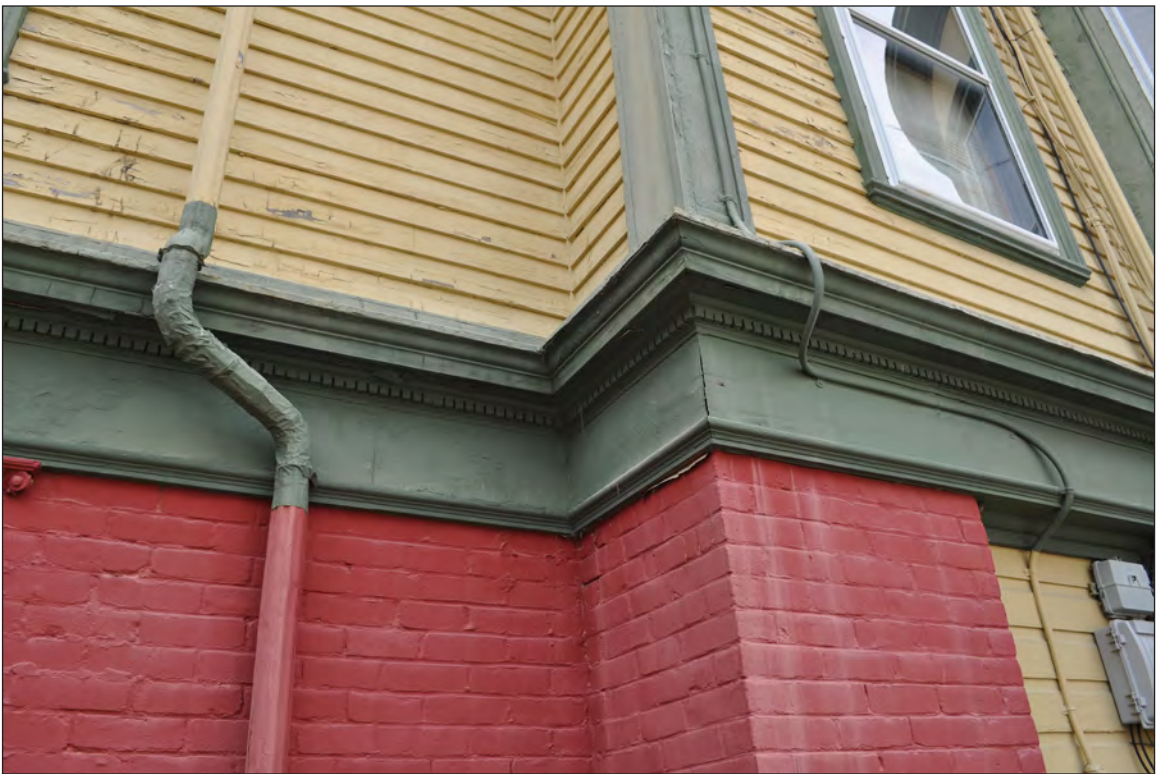
37. East elevation, camera facing southwest. Note conditions of clapboards and cornice components.

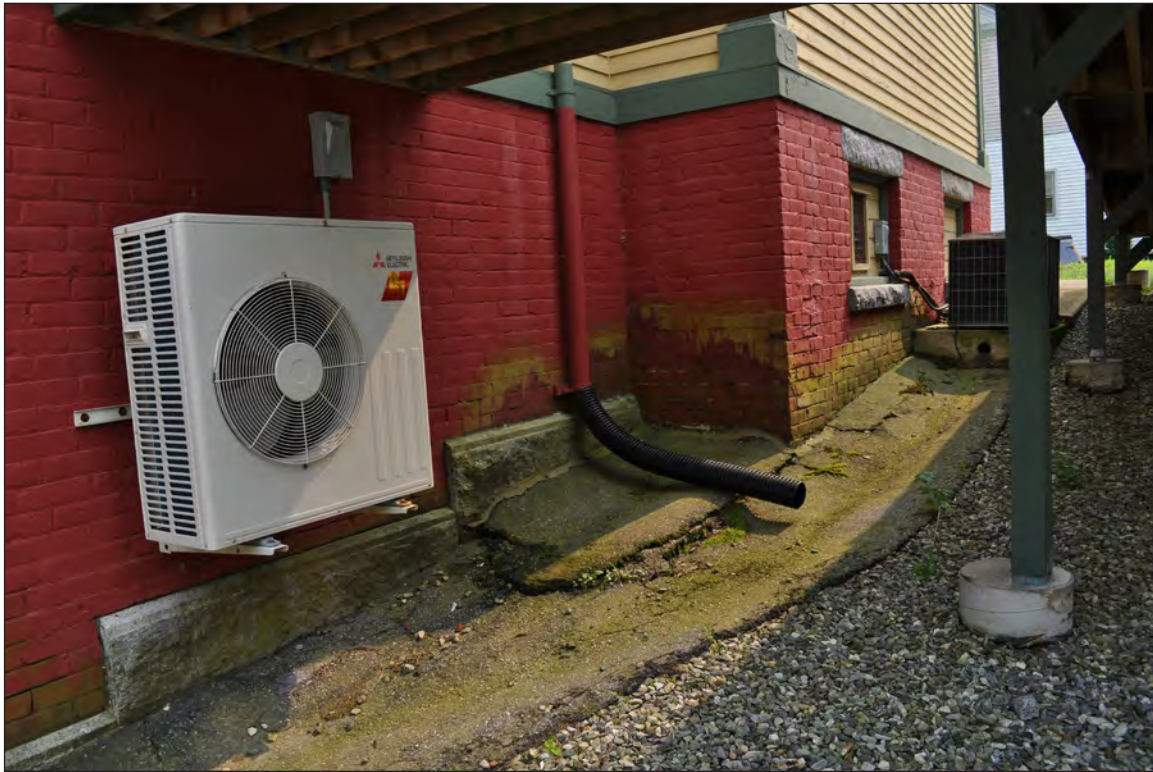
48. North elevation, camera facing down and southwest. Note bio growth and missing mortar.

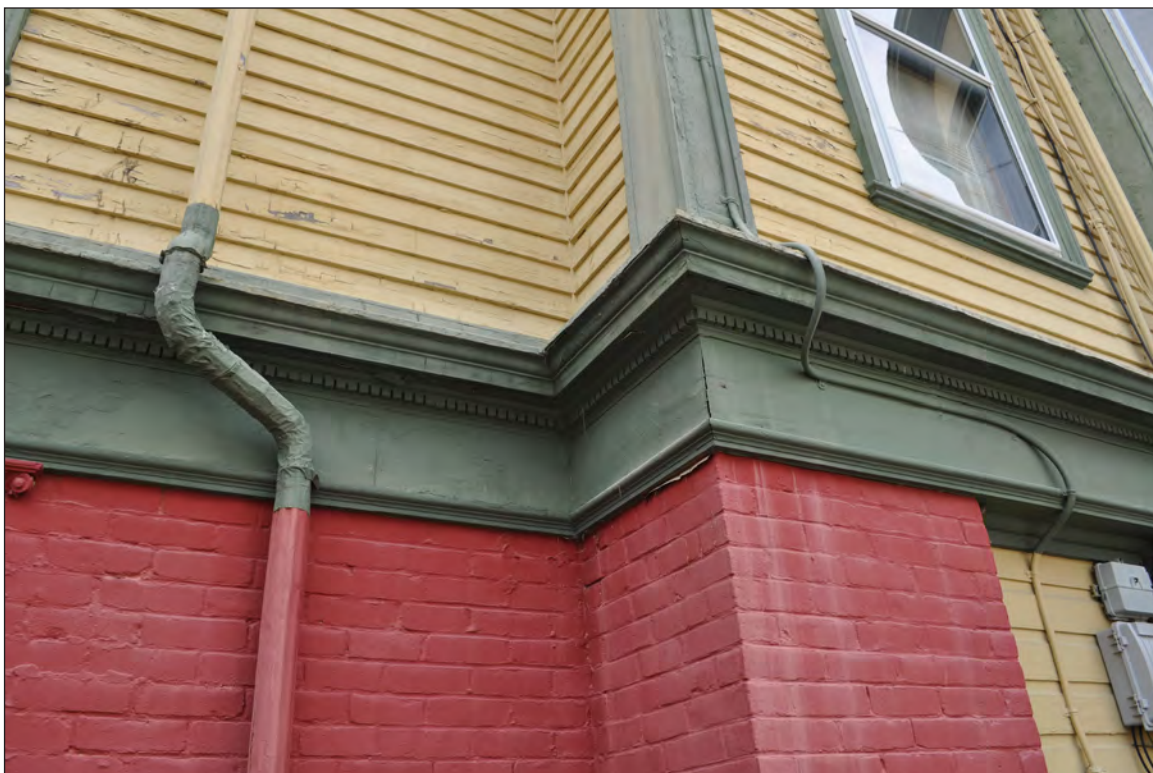
37. East elevation, camera facing southwest. Note conditions of clapboards and cornice components.

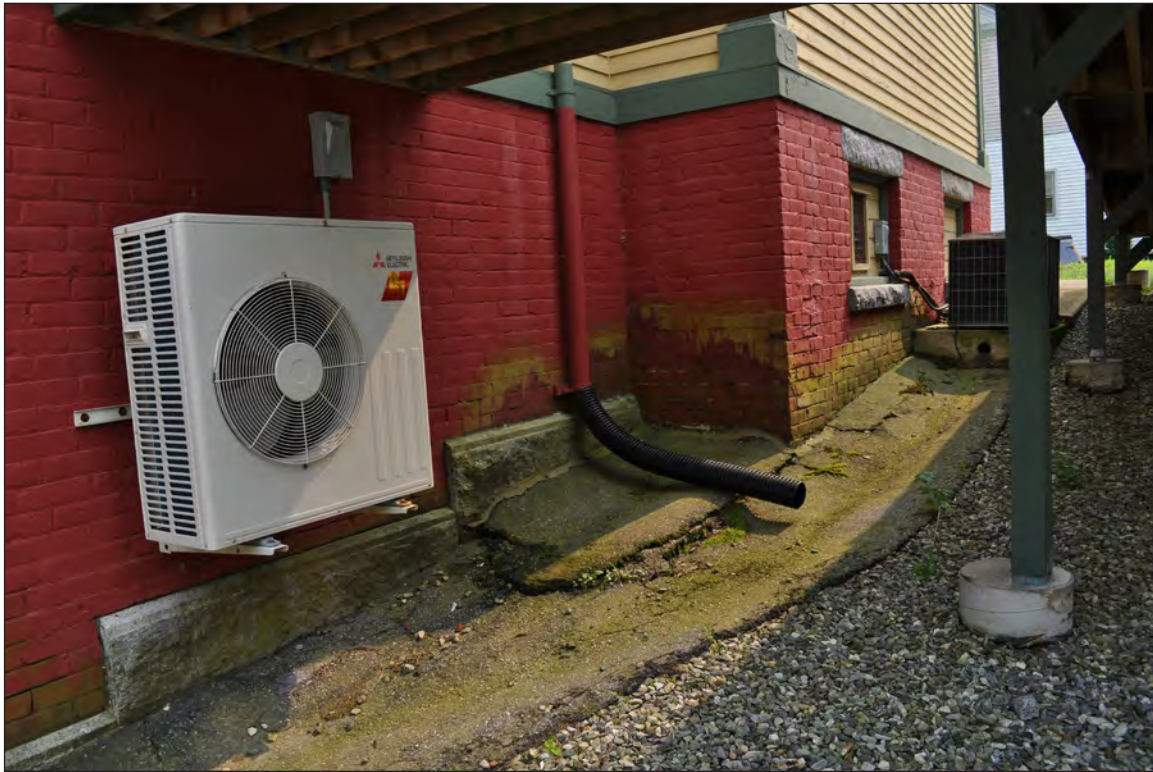
48. North elevation, camera facing down and southwest. Note bio growth and missing mortar.

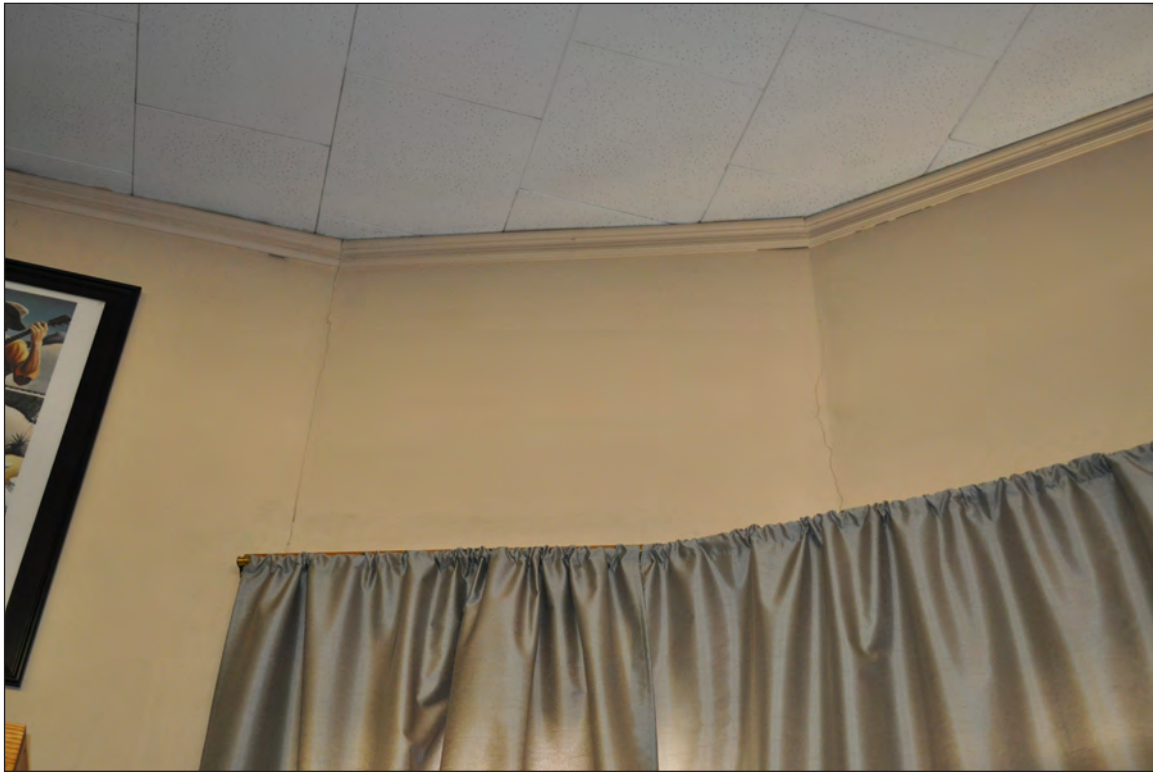
98. First-floor, computer room (201), camera facing southwest. Note staining on panel below window.

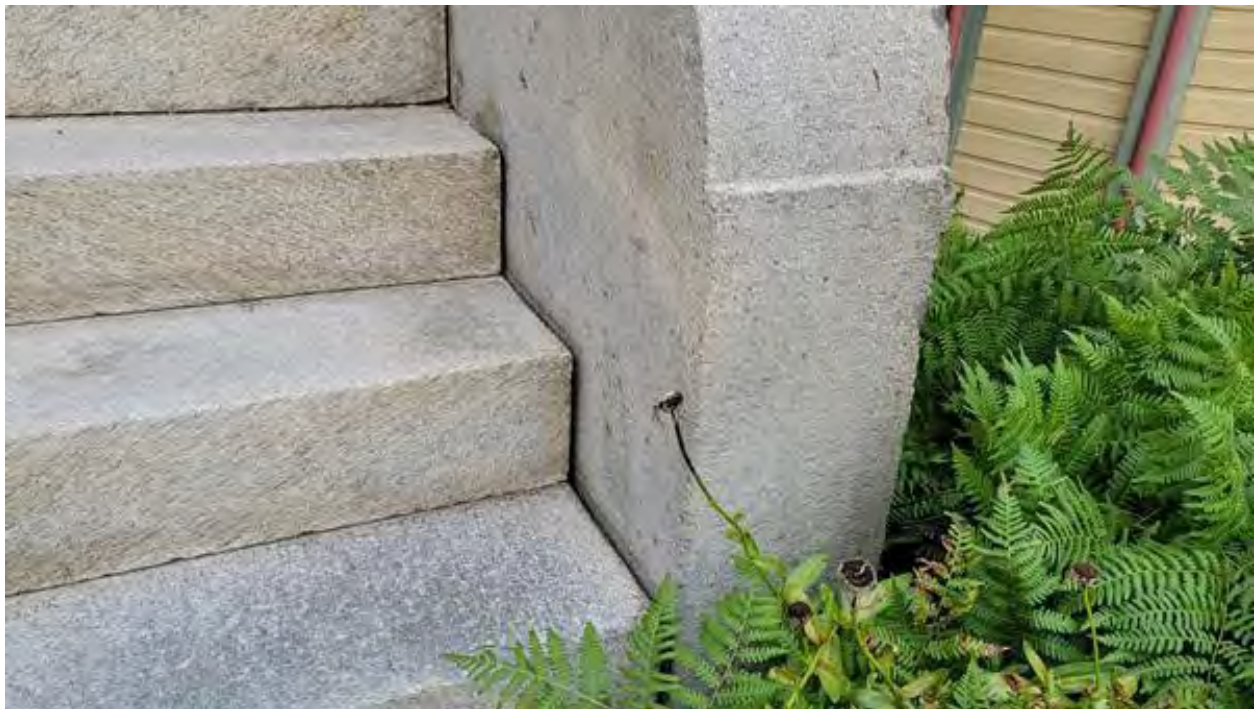
13. Horizontal crack in granite blocks at southeast corner bay window appears to be a fault in the stone. No repair necessary.
