From: Hazen and Sawyer

Town of Culpeper Water Quality Analysis

DRAFT

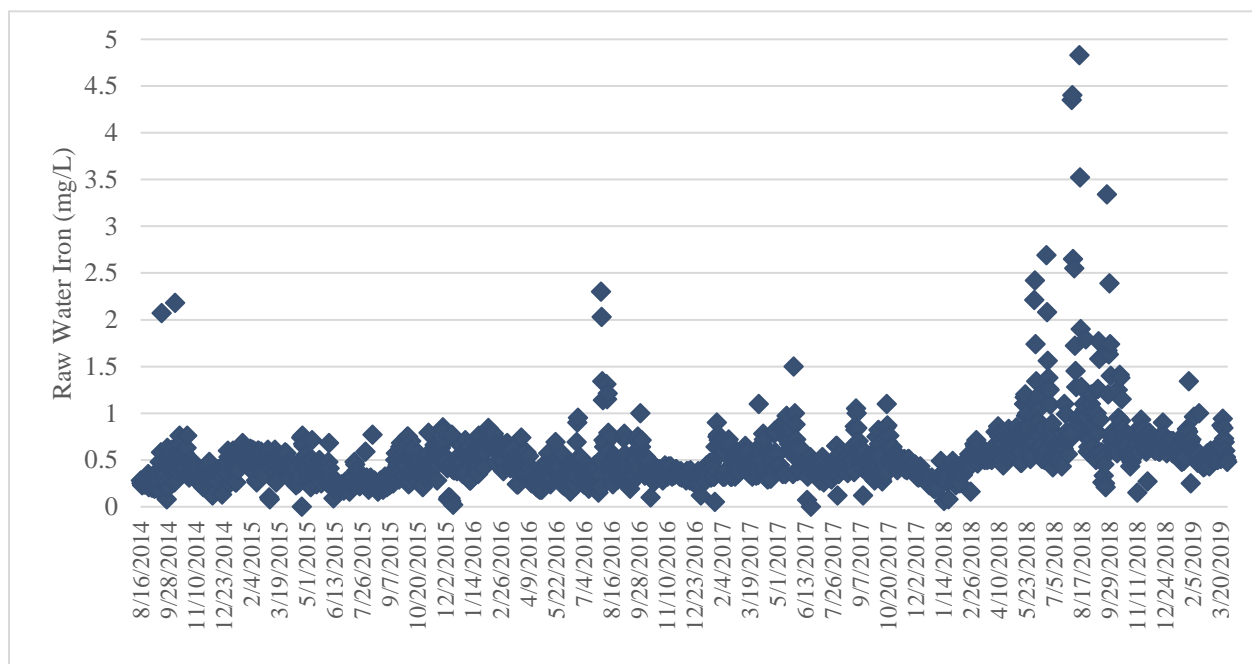
Iron levels in raw water are monitored routinely in the raw water sample point at the WTP. **Figure 3-1** presents historical raw water iron concentrations entering the WTP from Lake Pelham. The average raw water iron concentration is approximately 0.6 mg/L. Generally, iron levels in Lake Pelham are not elevated, although periods of elevated raw water iron levels have occurred, in summer 2018.

Figure 3-1. Raw Water Iron Concentrations at the WTP

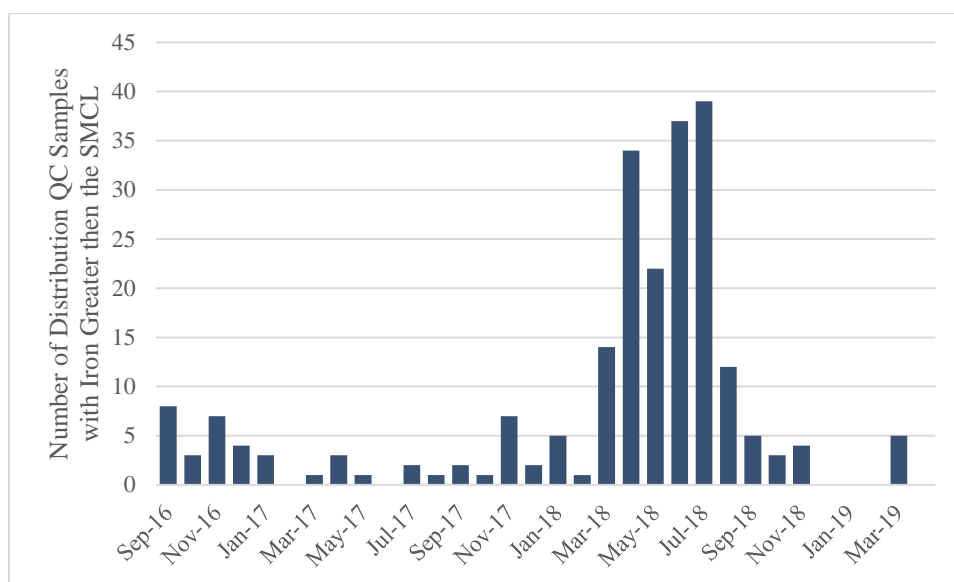
The Town has also collected distribution system water samples in response to customer complaints. Samples are typically collected at the meter to characterize the water in the distribution system. The iron concentrations in this dataset are generally higher than those collected during routine monthly distribution system monitoring. **Figure 3-3** presents the number of samples by the Town in response to complaints with iron concentrations over the SMCL by month. The increased number of samples collected during 2018 coincided with the timing of ice pigging in Oaklawn and conversion to polyaluminum chloride at the WTP, although the quantity of samples may not directly correlate to discolored water episodes due to differences in customer reporting patterns and Town staff responses.

Figure 3-3. Distribution System Samples in Response to Customer Complaints with Iron Concentrations Greater than the SMCL

Table 3-3 presents statistics for the distribution system samples collected in response to customer complaints. Approximately 40% of samples collected in response to customer complaints had iron levels over the SMCL, versus only 0.5% of samples in routine monitoring. The observed levels of iron above the SMCL may cause water discoloration. While iron is not typically present in routine distribution system monitoring, episodic release of iron corrosion byproducts may contribute to customer complaints.

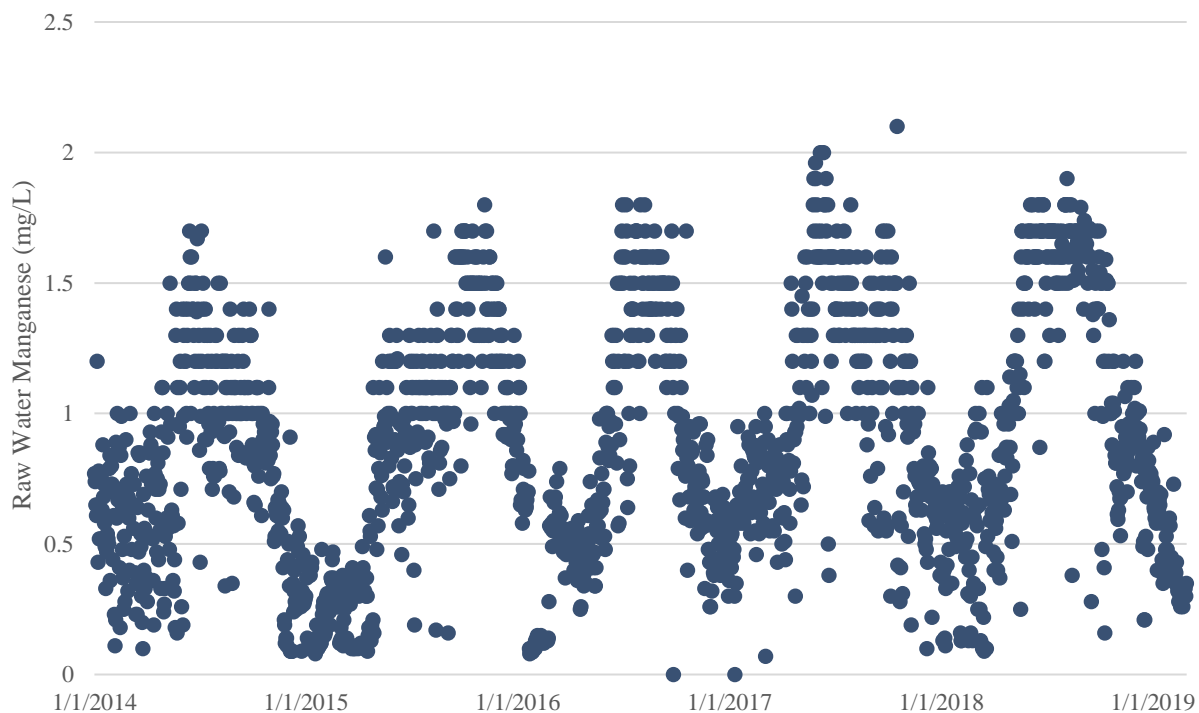
Figure 3-4 presents historical raw water manganese levels at the WTP, which are measured at the WTP using Hach Method 8149. As permanganate contains manganese and is added prior to the raw water sample point, chemical addition influences the observed raw water manganese concentration. Observed raw water manganese levels vary seasonally due to source water changes and permanganate dose changes, and can be very elevated.

Figure 3-4. Raw Water Manganese Concentrations at the WTP

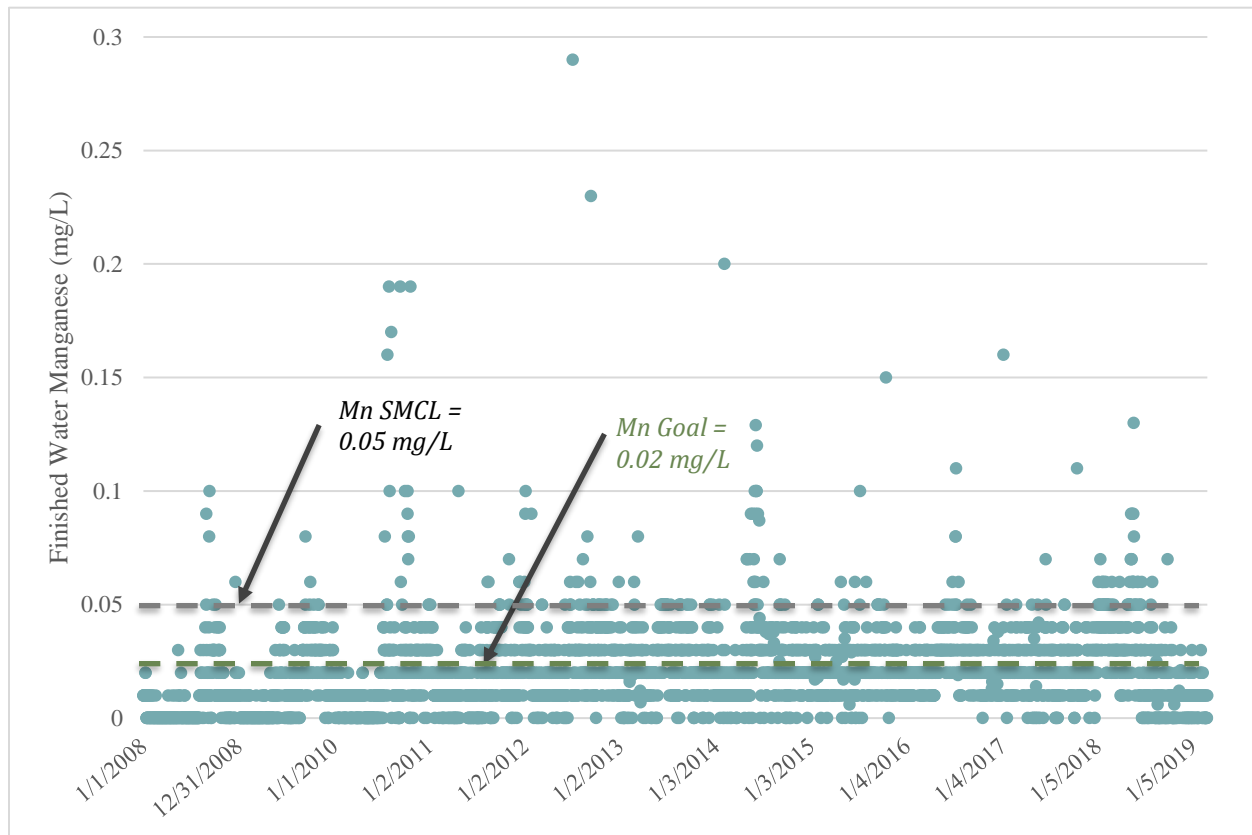
Figure 3-5 presents historical daily average finished water manganese levels recorded at the WTP according to Hach Method 8149. Manganese concentrations have only exceeded the SMCL of 0.05 mg/L on approximately 3% of days since 2008. Observed manganese concentrations in finished water have exceeded the manganese treatment goal of 0.02 mg/L on approximately 37% of days. Manganese levels in 2018 were slightly higher compared to recent years. Based on prior research and industry guidance on

manganese removal, the observed finished water manganese levels could allow episodic water discoloration issues and gradual accumulation of manganese legacy deposits in the distribution system.

Figure 3-5. WTP Finished Water Manganese Levels

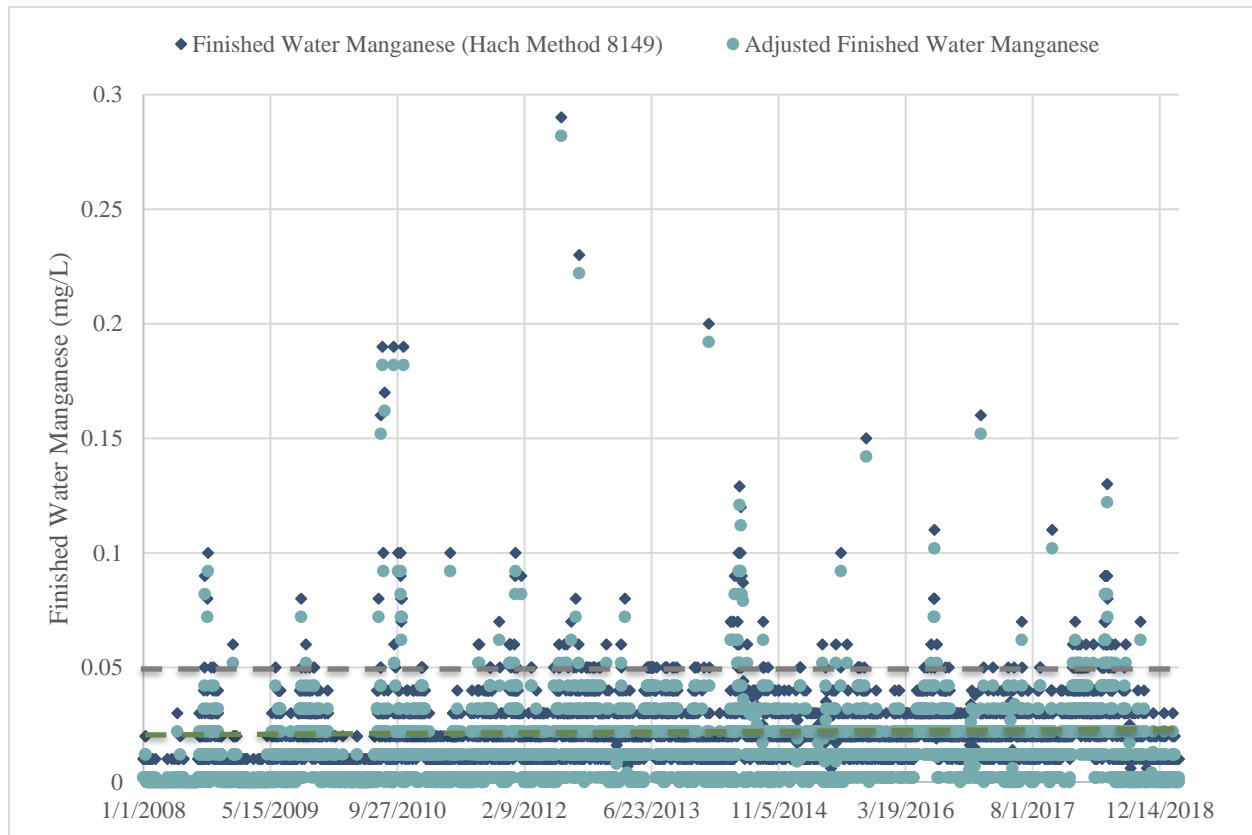
comparison of historical finished water manganese data obtained by Hach Method 8149 and adjusted manganese levels, representative of EPA Method 200.8. The adjusted manganese concentrations exceeded the SMCL of 0.05 mg/L on approximately 2.5% of days and the manganese treatment goal of 0.02 mg/L on approximately 32% of days since 2008. Additional comparative sampling between methods over a longer period of time (e.g. monthly testing for at least 12 months) would be necessary to confirm the magnitude of difference between methods.

Figure 3-6: Comparison of WTP Historical and Adjusted Finished Water Manganese Levels

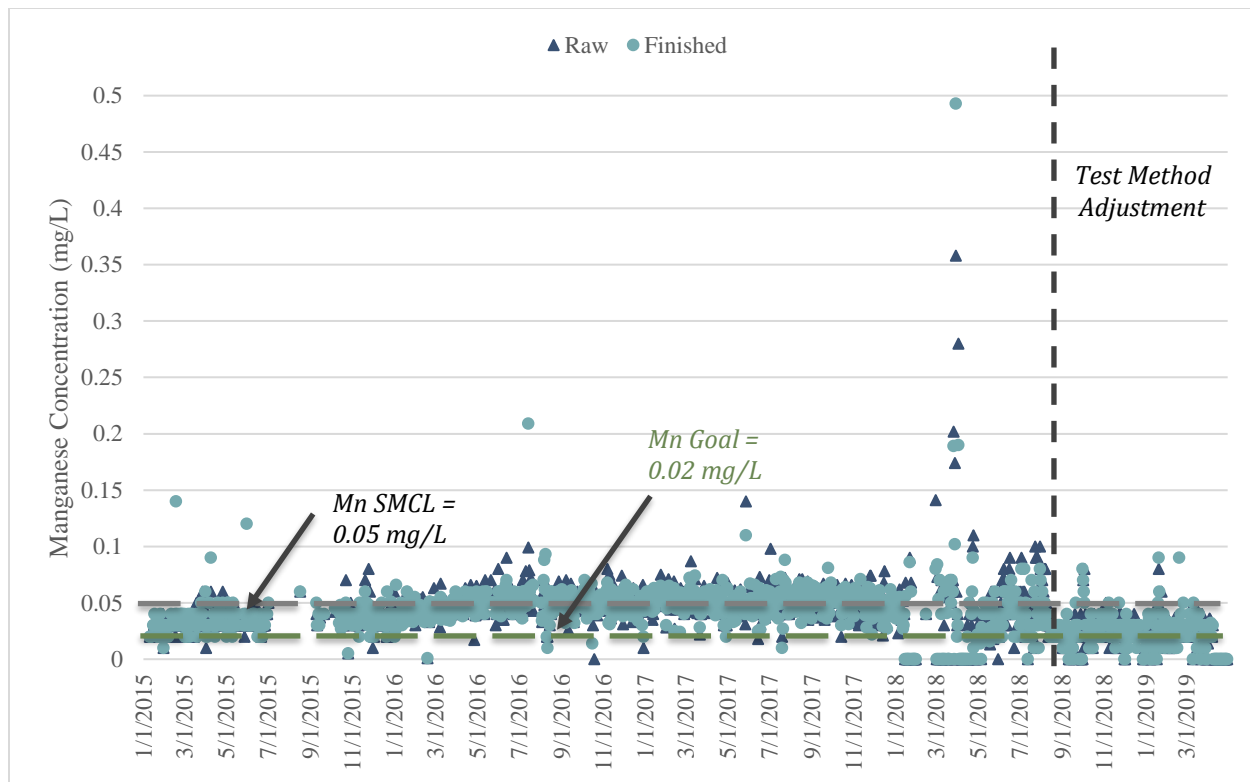
Figure 3-7 presents observed historical manganese concentrations at Chandler Street. Manganese was tested in the Chandler Street groundwater in 2012 during well development, and observed manganese levels were less than 0.008 mg/L.

Figure 3-7. Manganese Concentrations at the Chandler Street Groundwater Facility

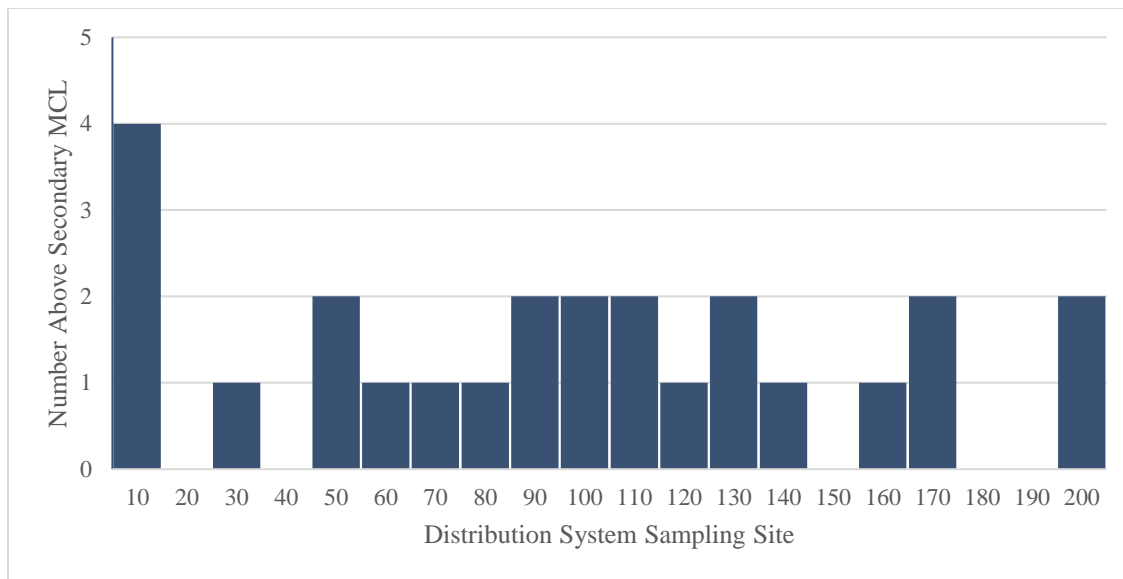
A total of 575 distribution system samples were collected from September 2016 to April 2019 over 20 sites and analyzed for manganese using the Hach 8149 method. Twenty-five distribution system samples (4%) experienced manganese concentrations greater than the SMCL. **Figure 3-8** presents the number of manganese concentrations greater than the SMCL at each distribution system sampling location. **Figure B-1** in **Appendix B** presents a map of manganese SMCL exceedances at these locations, indicating that SMCL exceedances were distributed throughout the system. Fifty percent of the observed manganese concentrations in the Town's monthly distribution system monitoring were greater than the goal of 0.02 mg/L.

Figure 3-8. Number of Distribution System Samples with Manganese Concentrations Greater than SMCL

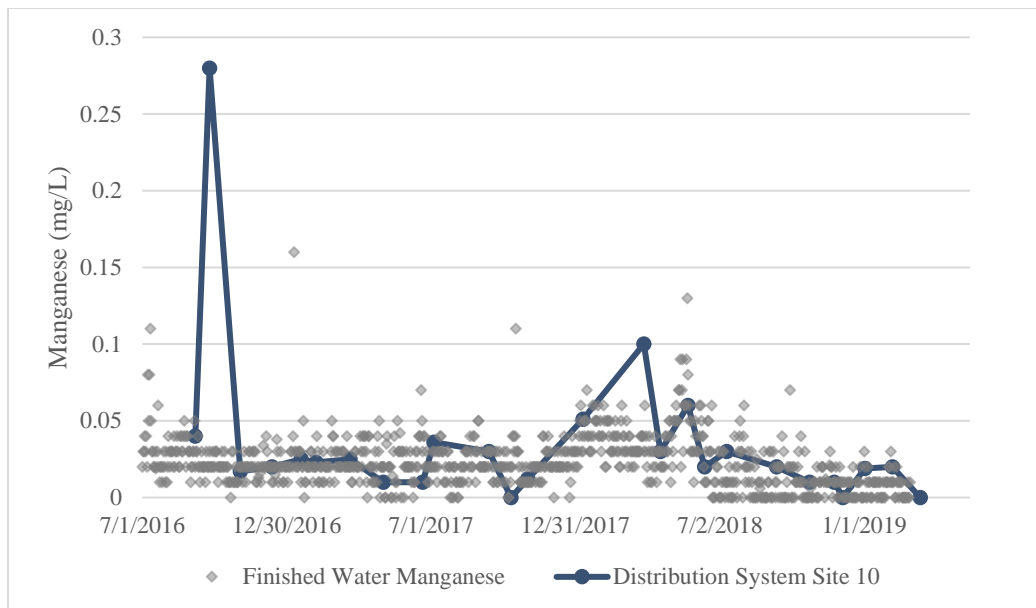
Distribution system sampling site 10 is located near the WTP (**Figure B-1**) and experienced the highest quantity of manganese levels above the SMCL in the Town's routine distribution system monitoring according to Hach Method 8149. **Figure 3-9** presents observed manganese concentrations at Site 10 in comparison to finished water manganese levels at the WTP. Elevated concentrations of manganese above finished water levels were occasionally observed, providing evidence of cyclic manganese accumulation and release in the distribution system. Observed manganese levels at this site have decreased since 2018. Similar trends with infrequent spikes in the manganese concentration were observed at other distribution system sites, and additional data on distribution system manganese levels is presented in **Appendix B**.

Figure 3-9. Manganese Concentrations at Distribution System Site 10

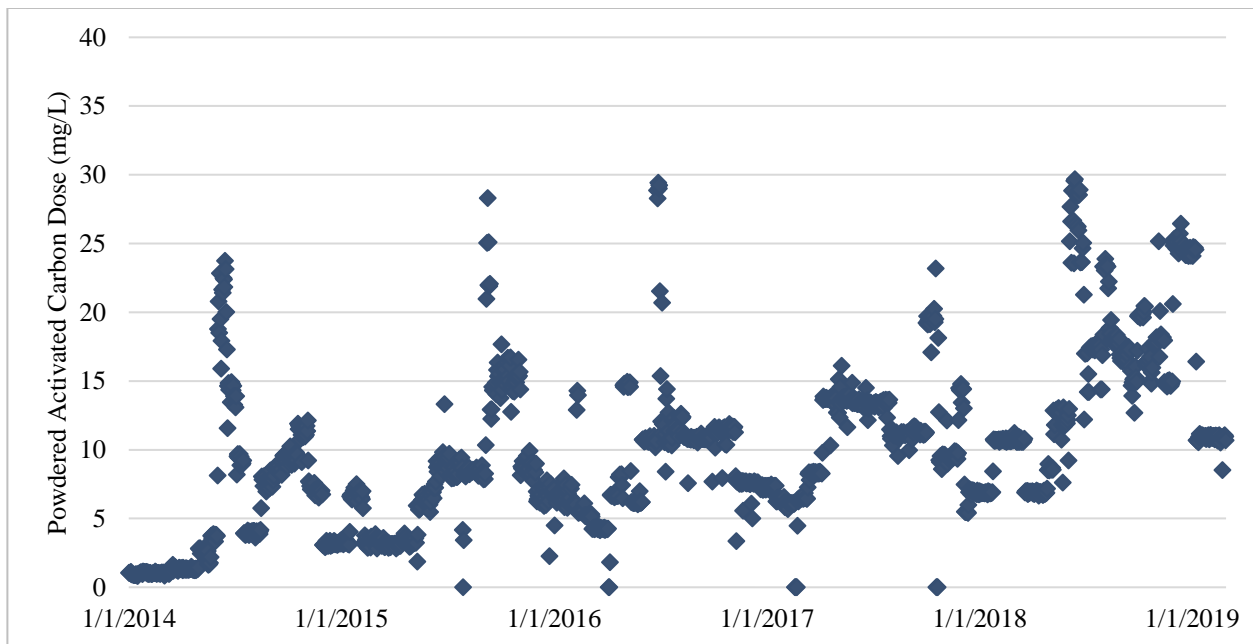
Historical powdered activated carbon doses at the WTP are presented in **Figure 3-11**. Powdered activated carbon has only been added to raw water prior to the rapid mix. Addition of powdered activated carbon may provide benefits for removal of taste and odor compounds from surface water, such as MIB and geosmin. However, additional data would be necessary to analyze the optimal carbon dose and feed location necessary to remove taste and odor compounds from surface water.

Figure 3-11. WTP Powdered Activated Carbon Dose to Raw Water

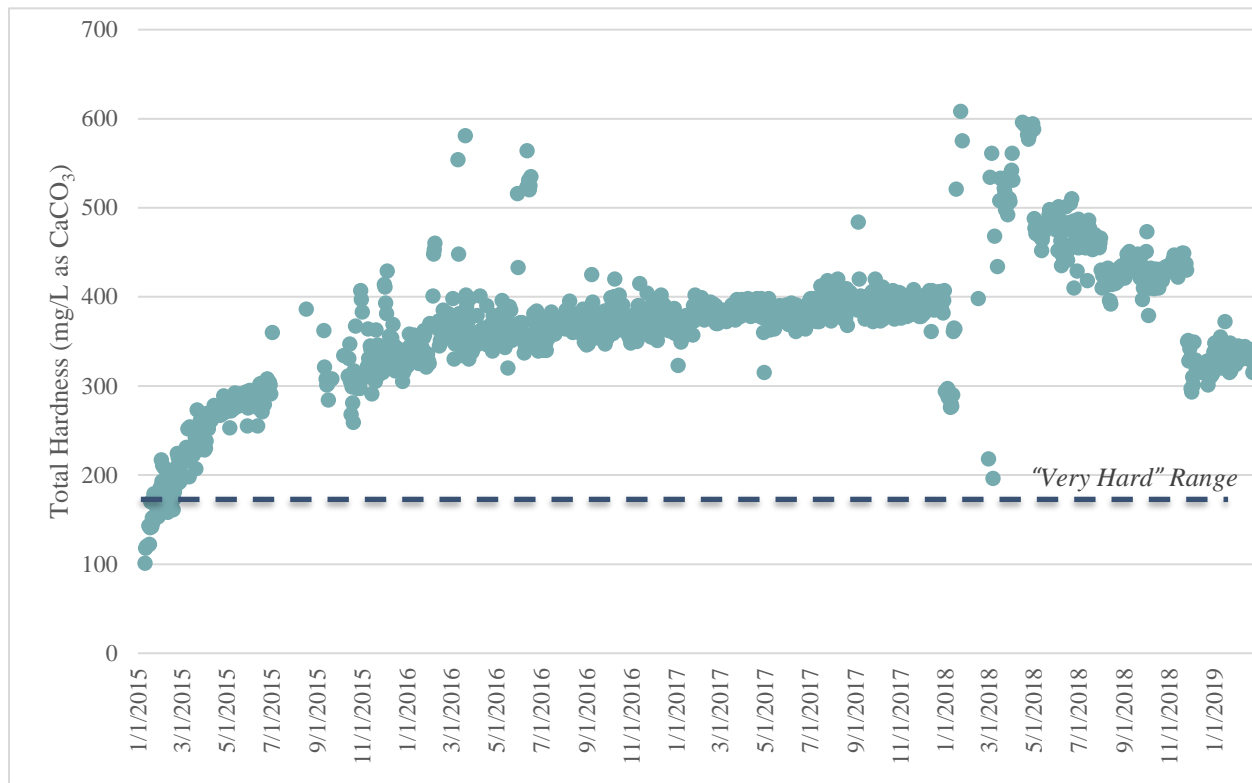
Customers located near the Chandler Street wells are likely to experience the highest hardness levels, although hard water may sometimes enter other portions of the distribution system depending on system operations. **Figure 3-12** presents historical hardness levels in groundwater at Chandler Street. Hardness was tested in Chandler Street groundwater during well development in 2012, and observed hardness levels in the three wells ranged from 110 to 220 mg/L as CaCO_3 . Groundwater hardness levels have increased during operation of the Chandler Street facility.

Figure 3-12. Total Hardness Levels in Groundwater at Chandler Street

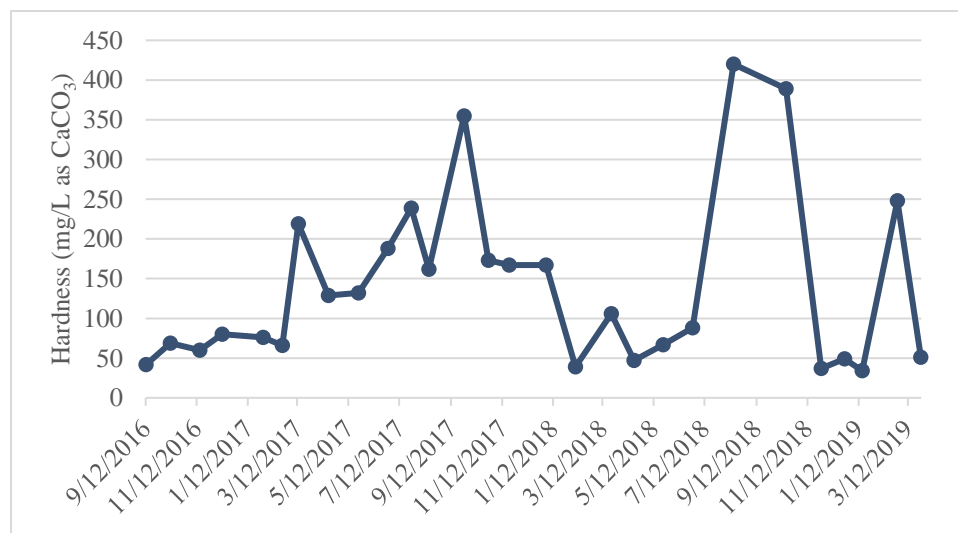
Hardness levels in the distribution system were analyzed as an indicator of blending between surface water, with low hardness, and groundwater, with high hardness. **Figure B-3 in Appendix B** presents average hardness levels at each monitoring location. Lower average hardness levels were generally observed in the western portion of the distribution system near the WTP, and higher hardness levels occur in the eastern portion of the distribution system near the Chandler Street and Nalles Mill facilities. Based on the geospatial analysis of hardness levels, the apparent midpoint of the blending zone between groundwater and surface water occurs in the vicinity of sample sites 80, 100, 110, and 120, located in the downtown area, which show variable hardness levels in monthly sampling. For example, **Figure 3-13** presents observed hardness levels at Site 100 (located near 100 West Davis Street), illustrating fluctuations between low and high hardness levels from different water sources.

Figure 3-13. Total Hardness Levels at Distribution System Sampling Site 100

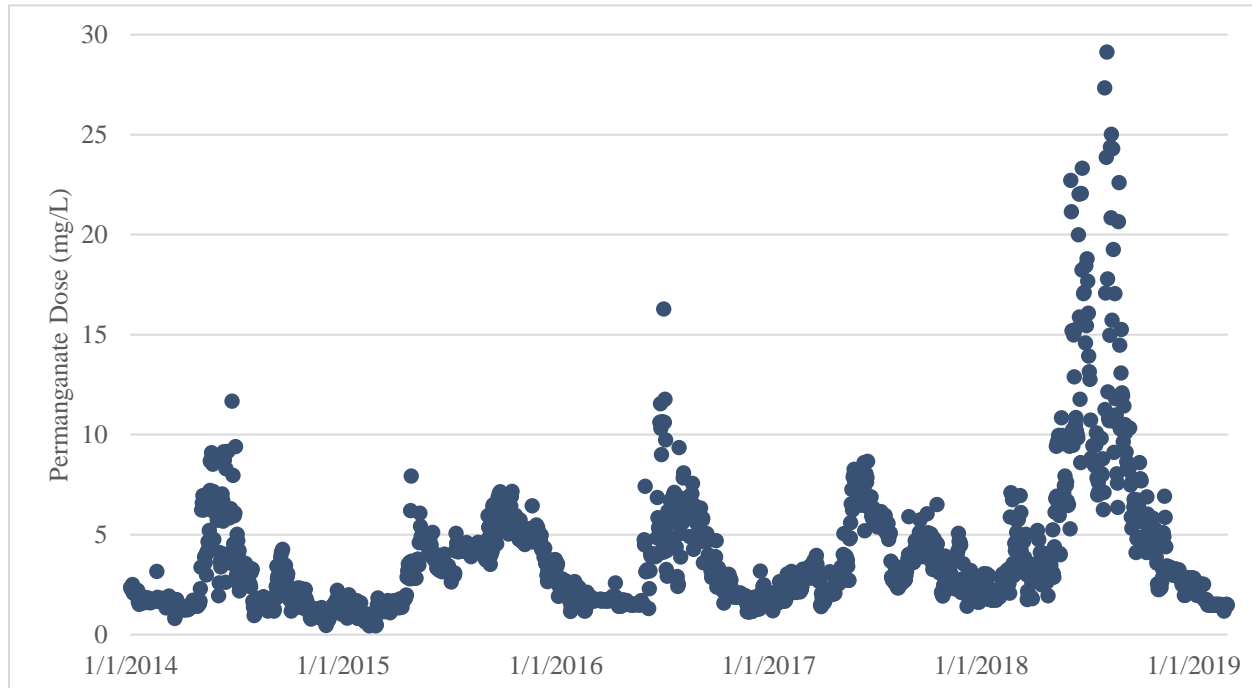
Figure 4-1 presents historical permanganate doses, and these values represent the combined dose added to raw water at both feed locations. Permanganate doses have varied seasonally and exceeded 20 mg/L during the summer of 2018.

Figure 4-1. Historical WTP Permanganate Doses

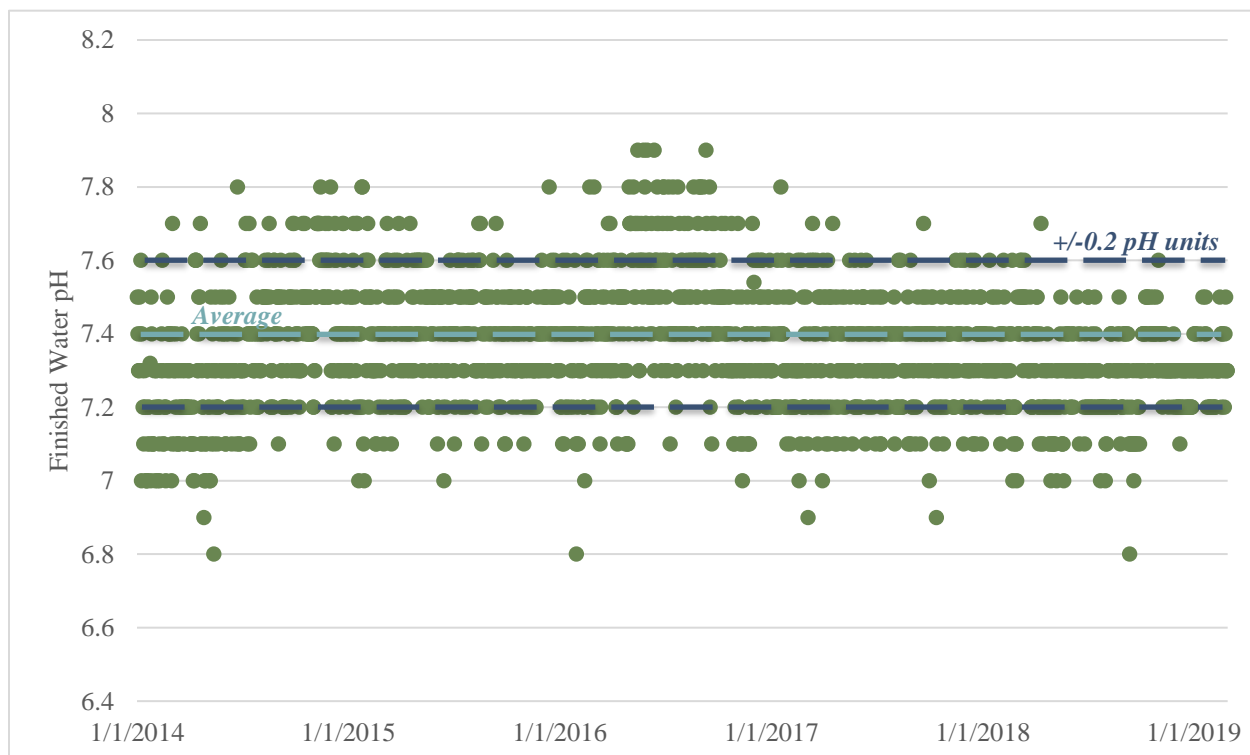
The finished water pH is adjusted at the Town's WTP using lime, and historical lime doses are presented in **Appendix C**. The Culpeper WTP previously used soda ash for pH adjustment, which also increased the DIC of the water. The use of soda ash was replaced with lime in November 2011. Application of lime does not increase DIC and adds a low dose of calcium to the water, which promotes consistency with higher hardness levels in the Town's groundwater sources.

Figure 4-3. Historical WTP Daily Average Finished Water pH

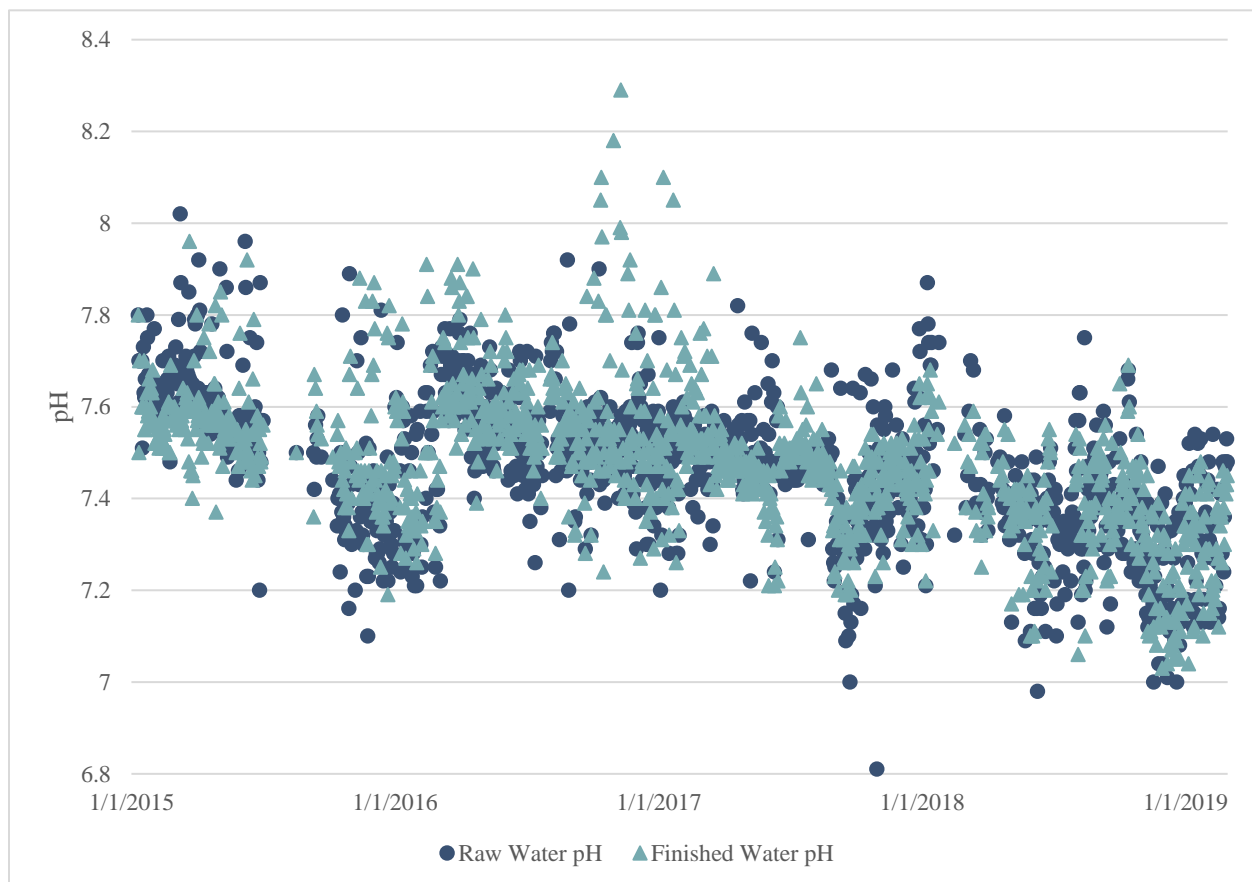
The finished water pH is typically not adjusted at the groundwater treatment facilities, and the pH entering the distribution system is based on natural groundwater characteristics. **Figure 4-4** presents the historical daily average pH values at the Chandler Street groundwater treatment facility, which has the greatest production of groundwater in the system. Similar graphs for Nalles Mill and Rockwater Park facilities are presented in **Appendix E** and **Appendix F**, respectively. The pH at Chandler Street has decreased gradually since initial introduction of groundwater in 2015, and lower pH values in 2018 and 2019 may affect corrosion in the distribution system. The pH values at Nalles Mill and Rockwater Park have often been below 7.2. Although the Rockwater Park facility has been operated less than other groundwater sources, it may have contributed to lower pH levels in the Culpeper system with low finished water pH values (e.g. 6.5 to 7.0) occurring during the summer of 2018 when the facility was operated more consistently (**Figure F-1**). Analysis of groundwater quality using the Rothberg, Tamburini, and Windsor model indicated that the groundwater pH can be increased to at least 7.6 using sodium hydroxide without causing excessive calcium carbonate scaling in the distribution system.

Figure 4-4. Historical Daily Average pH at the Chandler Street Facility

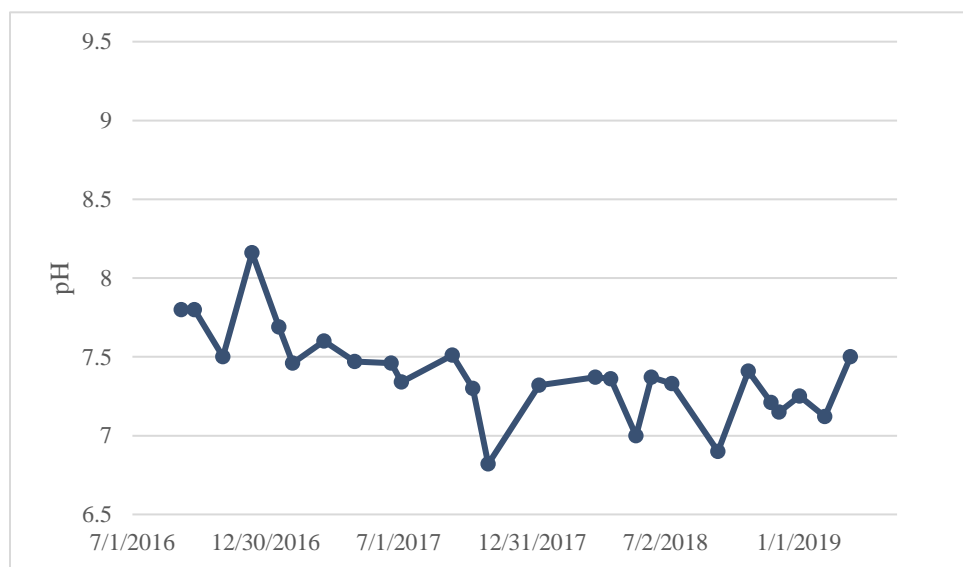
The Town routinely monitors pH in the distribution system at 20 sites on a monthly basis in conjunction with bacteriological testing. **Figure B-2** in **Appendix B** presents average pH values observed at each site in the distribution system. The pH levels in the distribution system are variable and increase slightly in certain areas with higher water age. The lowest observed average pH values typically occur at Site 10, which is supplied primarily by the WTP. Historical pH trends for Site 10 are presented in **Figure 4-5**, indicating that low pH values (e.g. <7.2) have been intermittently observed at this location, and a wide range of pH values from 6.82 to 8.16 was observed.

Figure 4-5. Distribution System pH at Sample Site 10

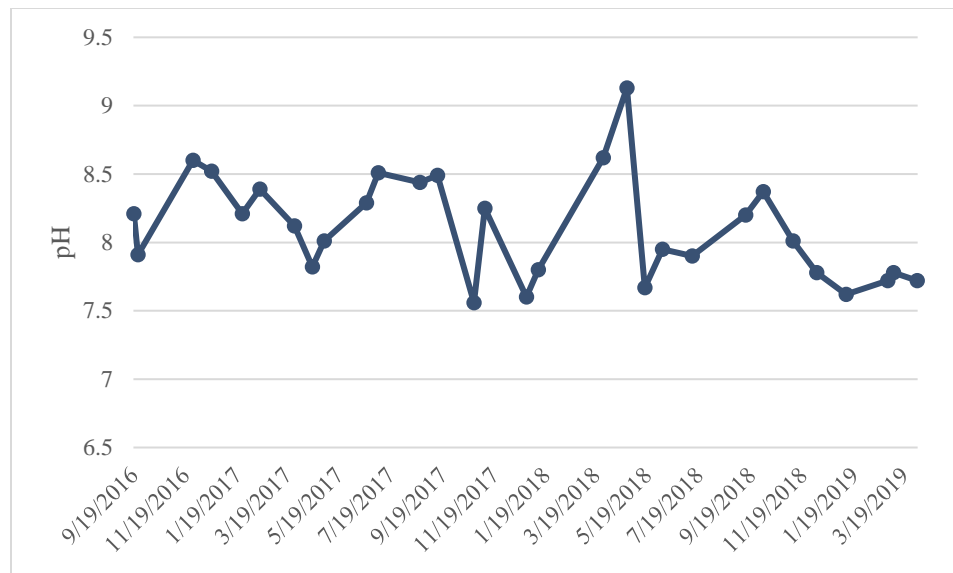
Higher pH values have been observed in areas of the distribution system with high water age. Distribution system sample site 30 is located in the southern portion of the distribution system and experiences consistently higher pH levels. **Figure 4-6** presents measured pH values at sample site 30 in the Town's monthly distribution system monitoring. Higher pH values greater than 8 may reduce the effectiveness of orthophosphate for lead corrosion control. A wide range of pH values (7.56 to 9.13) was also observed at site 30. Higher pH levels in this range (e.g. pH >8.5) may reduce iron corrosion byproduct release but may alter the effects of orthophosphate for lead corrosion control.

Figure 4-6. Distribution System pH at Sample Site 30

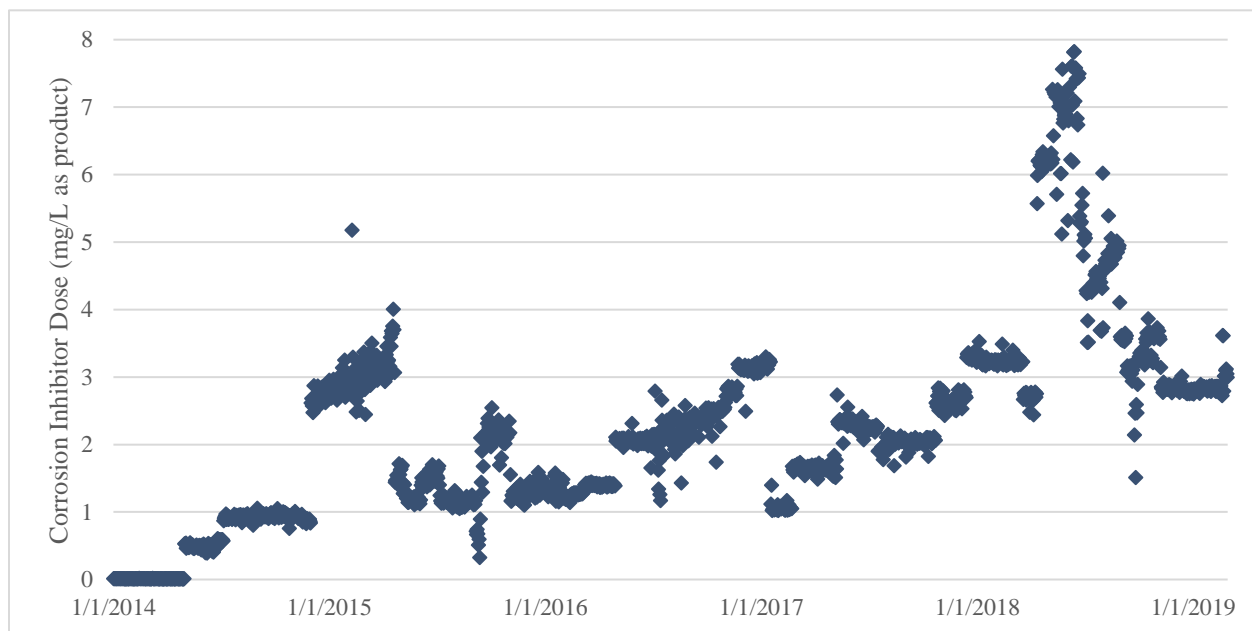
Figure 4-7 presents historical corrosion inhibitor doses at the WTP. Corrosion inhibitor doses have been adjusted multiple times since 2014 and were particularly high in 2018. Prior to 2014, corrosion inhibitor doses added at the WTP were typically minimal (e.g. less than 0.2 mg/L as product).

Figure 4-7. Historical Corrosion Inhibitor Doses at the WTP

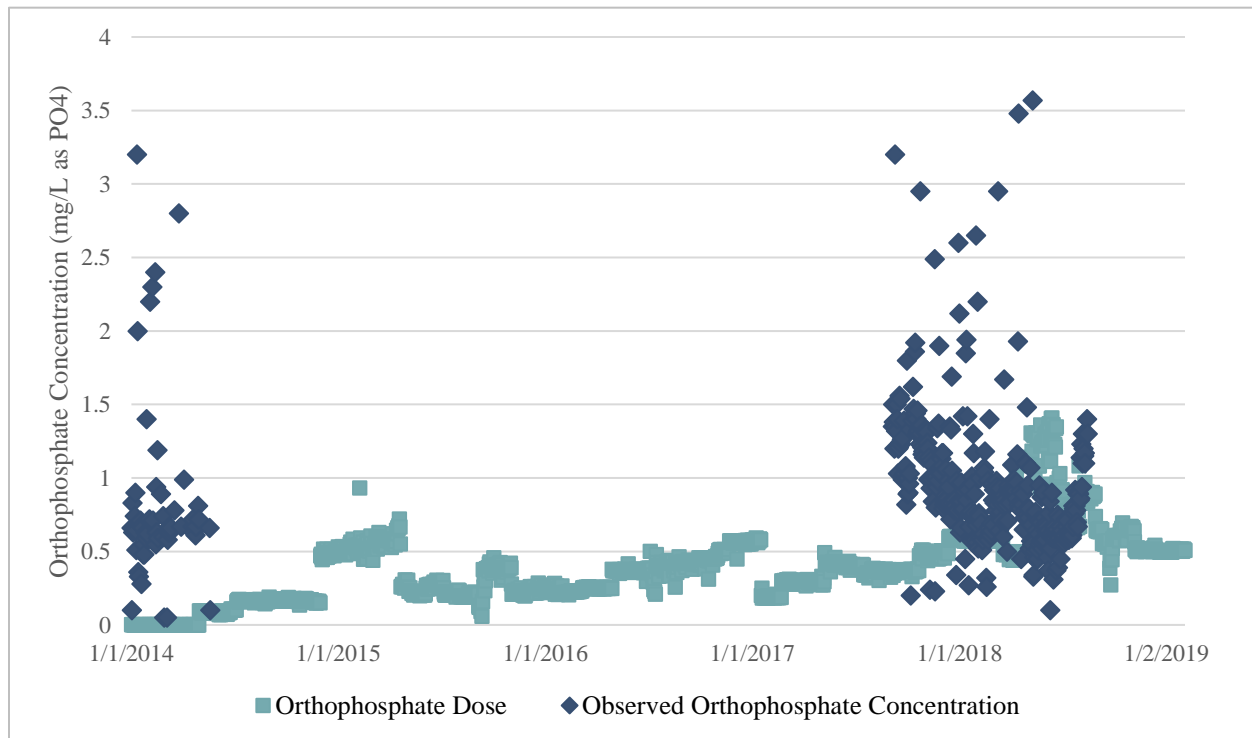
During 2017 and 2018, trends in observed finished water orthophosphate concentrations were not consistent with chemical doses. This finding suggests that limitations in the chemical feed system or orthophosphate monitoring may be present. The Town should review chemical feed and orthophosphate sample tap locations and determine an optimal orthophosphate testing location to ensure consistent and accurate orthophosphate dosing at the WTP.

Figure 4-8. Comparison of Corrosion Inhibitor Doses to Observed Orthophosphate Concentrations at the WTP

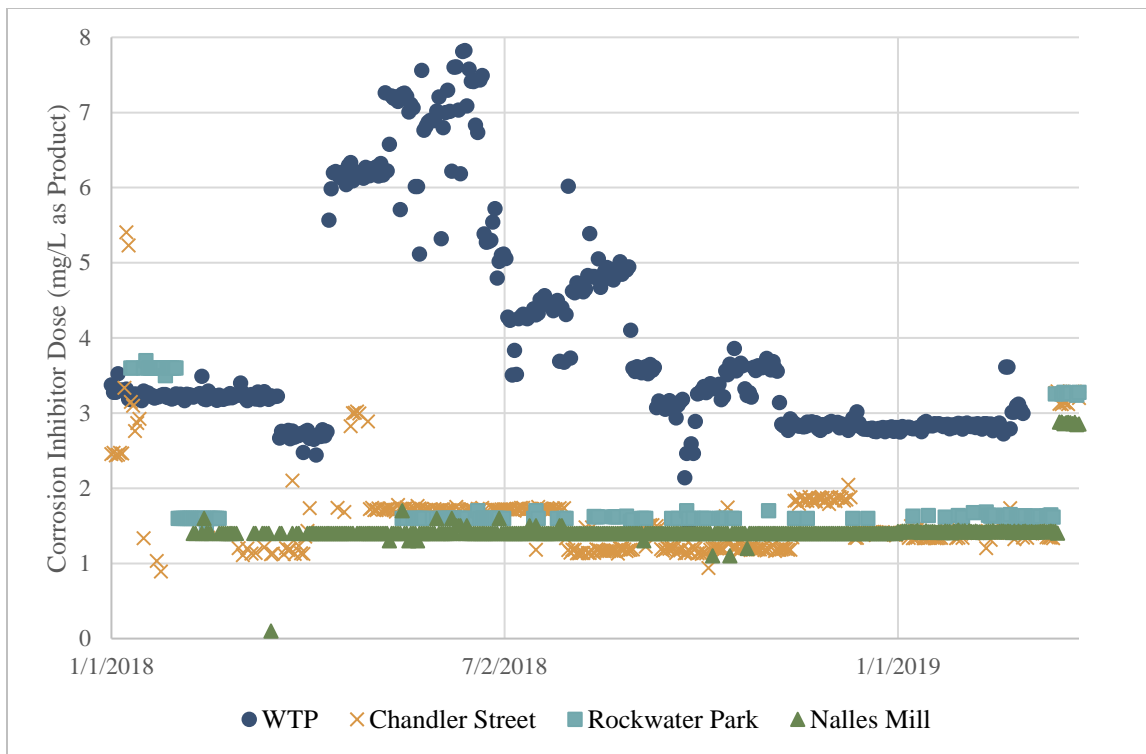
Consistent orthophosphate concentrations in the distribution system can be promoted by ensuring equivalent corrosion inhibitor dosing at each treatment facility. **Figure 4-9** presents a comparison of reported corrosion inhibitor doses at the Town’s four treatment facilities since the startup of the Nalles Mill and Rockwater Park facilities. While corrosion inhibitor doses at the groundwater treatment facilities have been generally consistent, the corrosion inhibitor doses have been considerably higher at the WTP, leading to potential orthophosphate variability in the distribution system.

Figure 4-9. Comparison of Treatment Facility Corrosion Inhibitor Doses

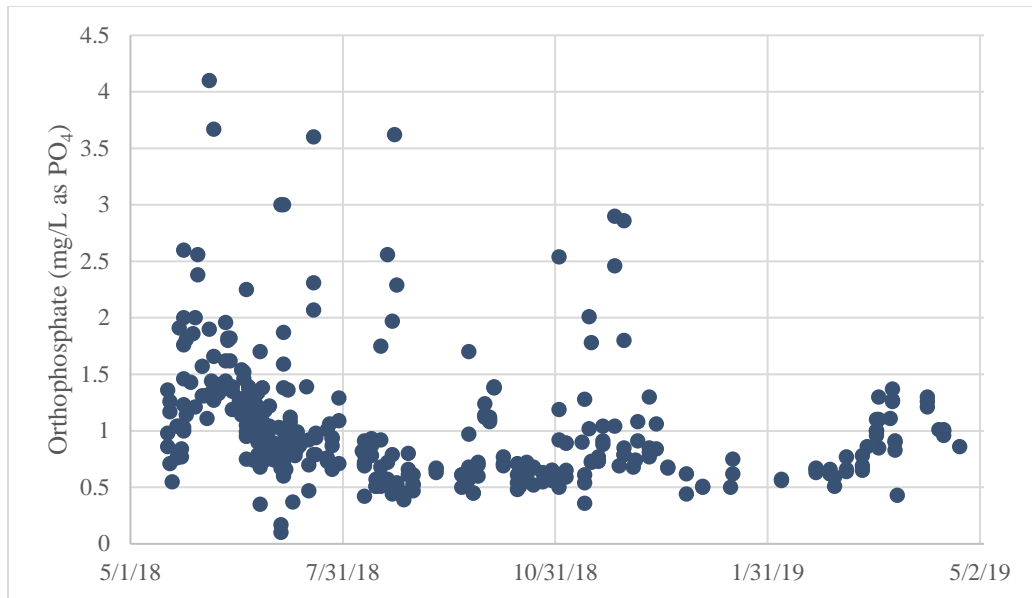
In intermittent sampling performed by the Town in response to customer complaints, orthophosphate was measured starting in May 2018. The Town of Culpeper began performing routine monthly monitoring of orthophosphate concentrations in the distribution system in March 2019. **Figure 4-10** presents historical orthophosphate levels observed in the distribution system when sampling in response to consumer complaints, indicating that orthophosphate concentrations were highly variable. Variable orthophosphate concentrations could interfere with the formation of stable protective phosphate-based scales for lead and iron corrosion control.

Figure 4-10. Distribution System Orthophosphate Data in Samples Collected in Response to Consumer Complaints

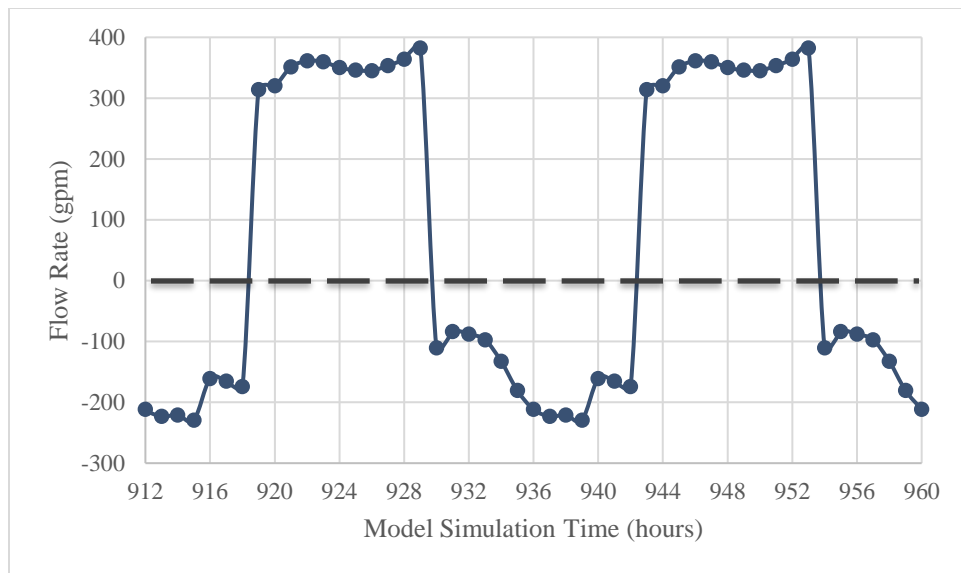
Distribution system hydraulic patterns can also affect accumulation and release of legacy deposits in the distribution system. Hydraulic model results indicated that flow reversals (i.e. an abrupt change in the direction of pipe flow) occur throughout the majority of the distribution system due to blending. **Figure 5-2** presents an example of modeled flow reversals in downtown Culpeper that occur on a daily basis due to distribution system blending.

Figure 5-2. Modeled Flow Rate in 12-inch Pipe on Scanlon Street (226 W Scanlon St)

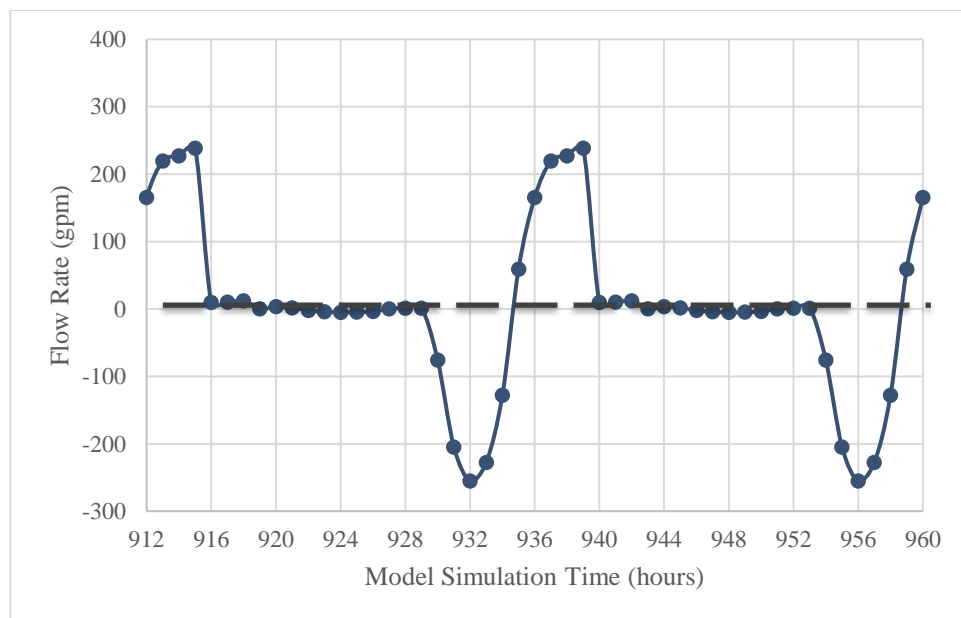
In contrast to pipes with consistent flow velocity, extended low-flow conditions in the distribution system may promote deposition and accumulation of deposits. Daily on/off operation of the WTP contributes to stagnant conditions in portions of the distribution system, followed by sudden velocity changes. **Figure 5-3** presents an example of modeled hydraulic conditions in the 12-inch diameter distribution main on Route 522, which exhibits stagnant conditions followed by sudden flow reversals on a daily basis.

Figure 5-3. Modeled Flow Rate in 12-inch Pipe on Route 522 (1200 Sperryville Pike)

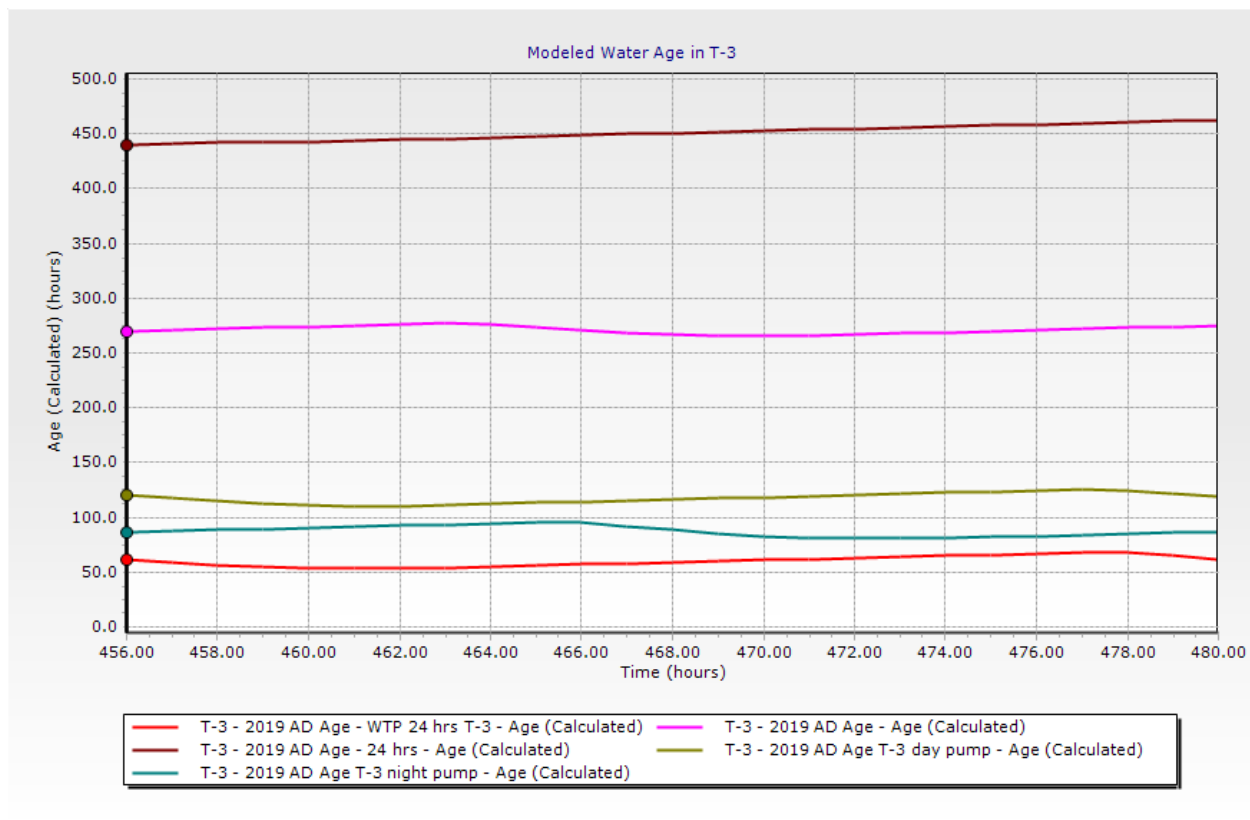
The results of the analysis suggest that pumping, when coupled with plant operating time adjustments, could provide widespread benefits relative to water age in the vicinity of Tank T-3. When moving from 12 hour WTP operation to 24 hour WTP operation, without pumping, the average age of the water in the tank increases from approximately 270 hrs to 440 hours, largely due to the fact that the constant pressure from the WTP over 24 hours limits the turnover in the tank. When pumping operations are added in, the average age of the water in the tank is reduced by approximately 50% for 12 hr WTP operation and by about 85% for 24 hr WTP operation, as compared to the respective no-pumping operation. Refer to **Figure 5-4** below.

Figure 5-4: Modeled Water Age in Tank T-3 for Operating Alternatives
