From: Hazen and Sawyer

Town of Culpeper Water Quality Analysis

DRAFT

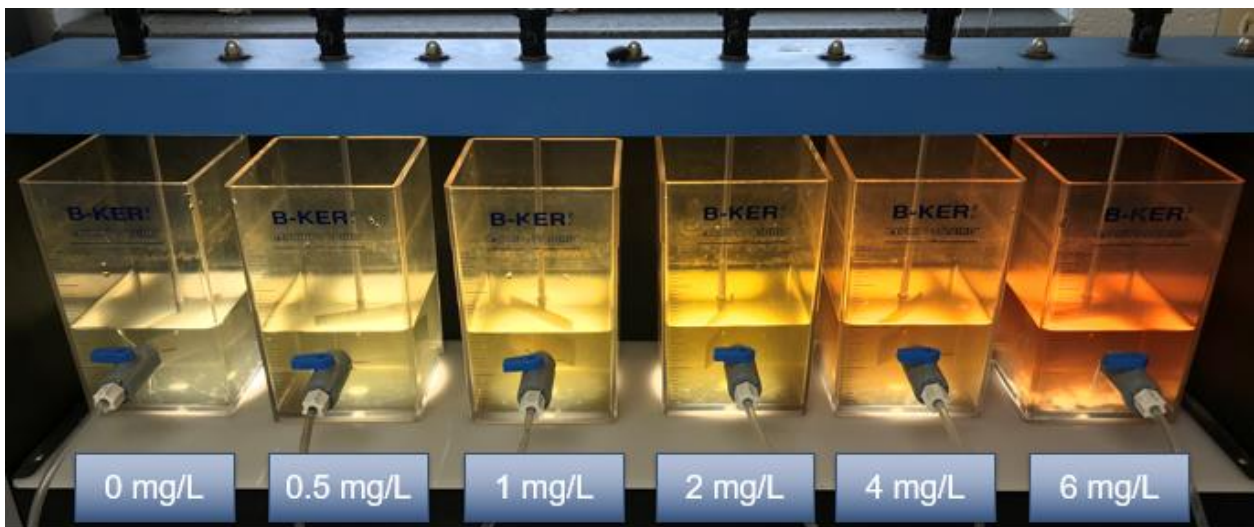
Permanganate dose screening was performed during July 2019 to evaluate the effectiveness of permanganate for oxidation of dissolved manganese in raw water from Lake Pelham. Raw water samples were collected from the reservoir intake structure. As illustrated in **Figure 6-1**, raw water samples were dosed with potassium permanganate ranging from 0 to 6 mg/L, and the full-scale WTP permanganate dose on the date of testing was 6 mg/L. A reaction time of approximately 16 minutes with gentle mixing was provided after addition of permanganate to simulate conditions in the raw water pipeline. Samples from each jar were filtered to quantify particulate and total manganese and determine the concentration of raw water dissolved manganese oxidized by permanganate.

Figure 6-1. Permanganate Screening Testing

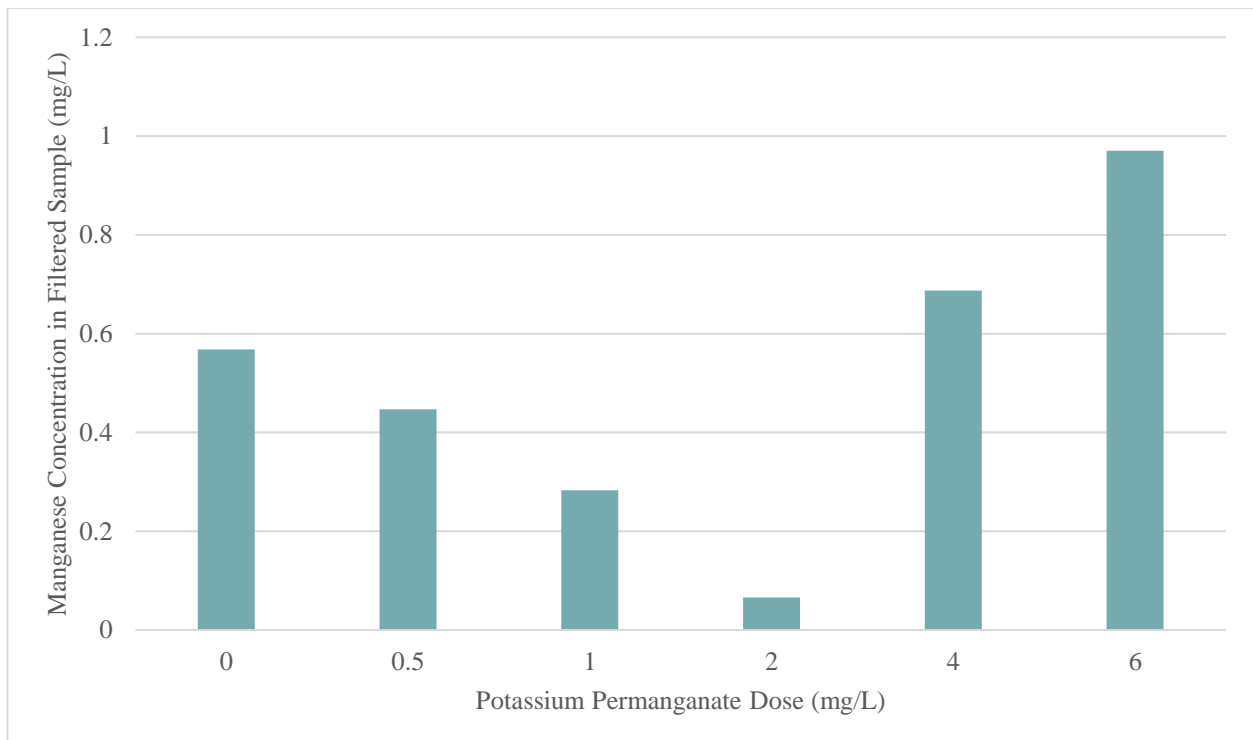
Figure 6-2. Permanganate Screening Test Results (July 11, 2019)

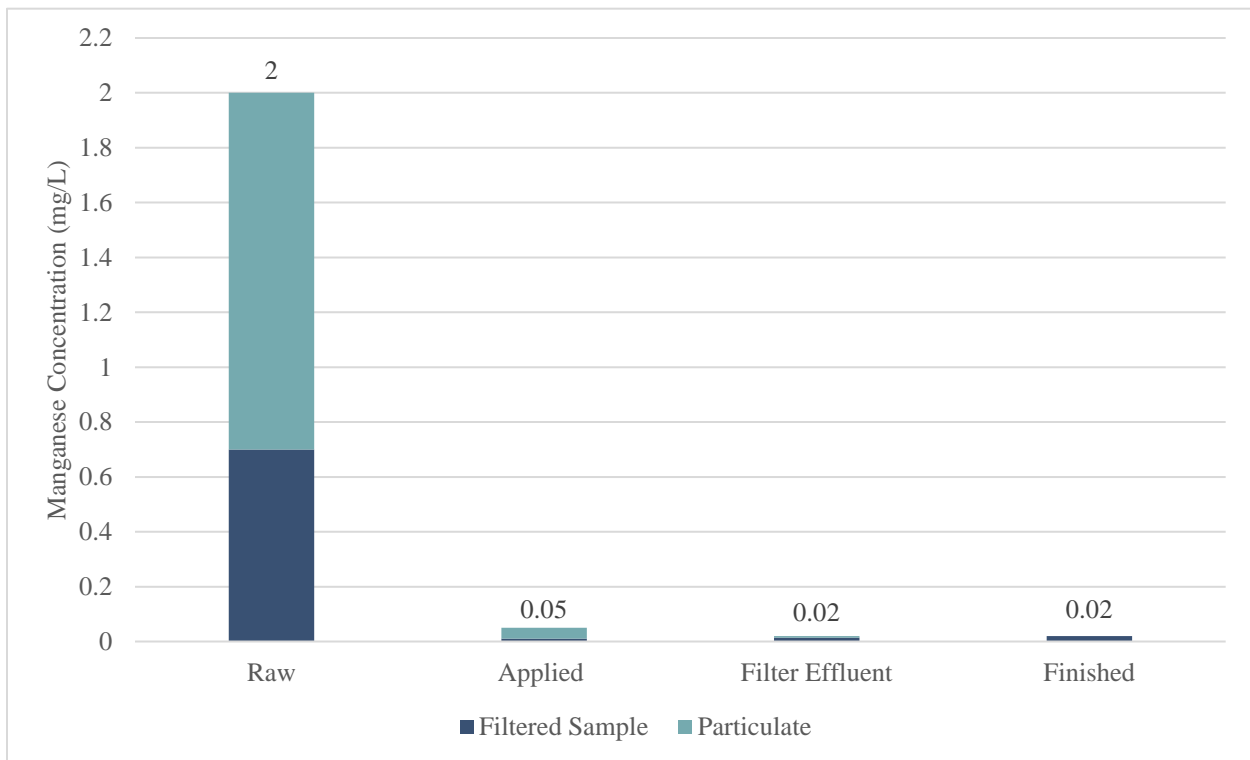
Figure 6-3. WTP Manganese Removal Profile (July 9, 2019)

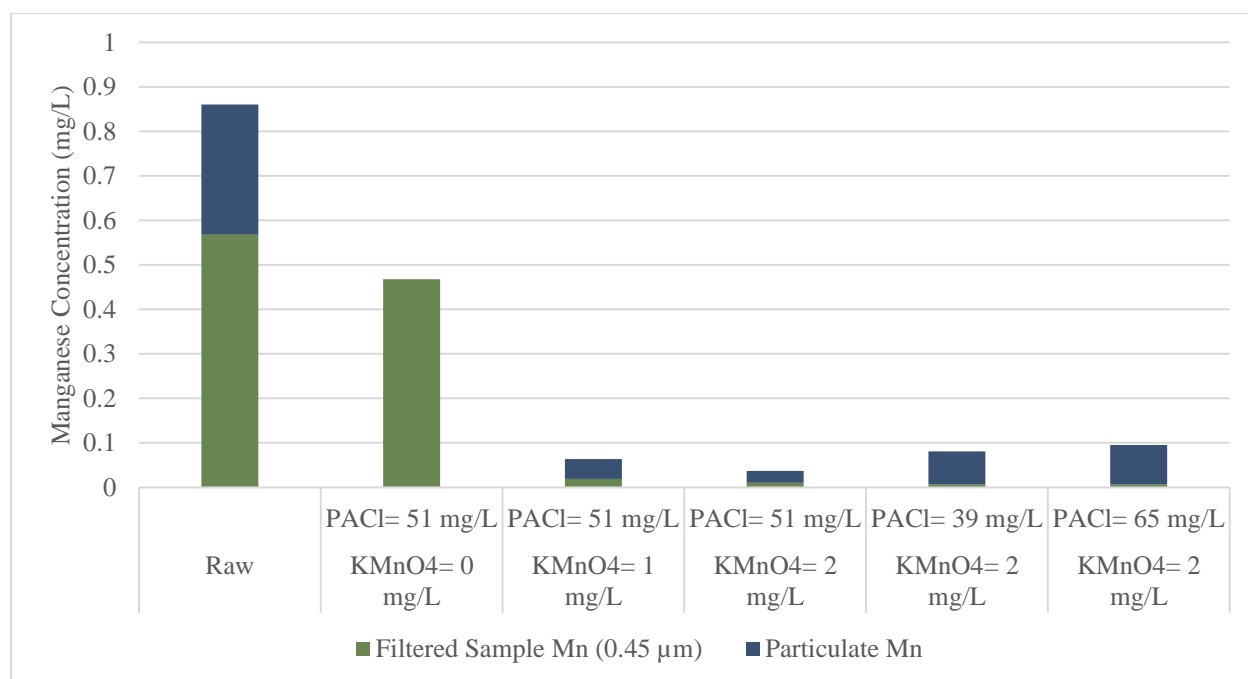
Figure 6-4. WTP Coagulation Testing for Manganese Removal (July 11, 2019)

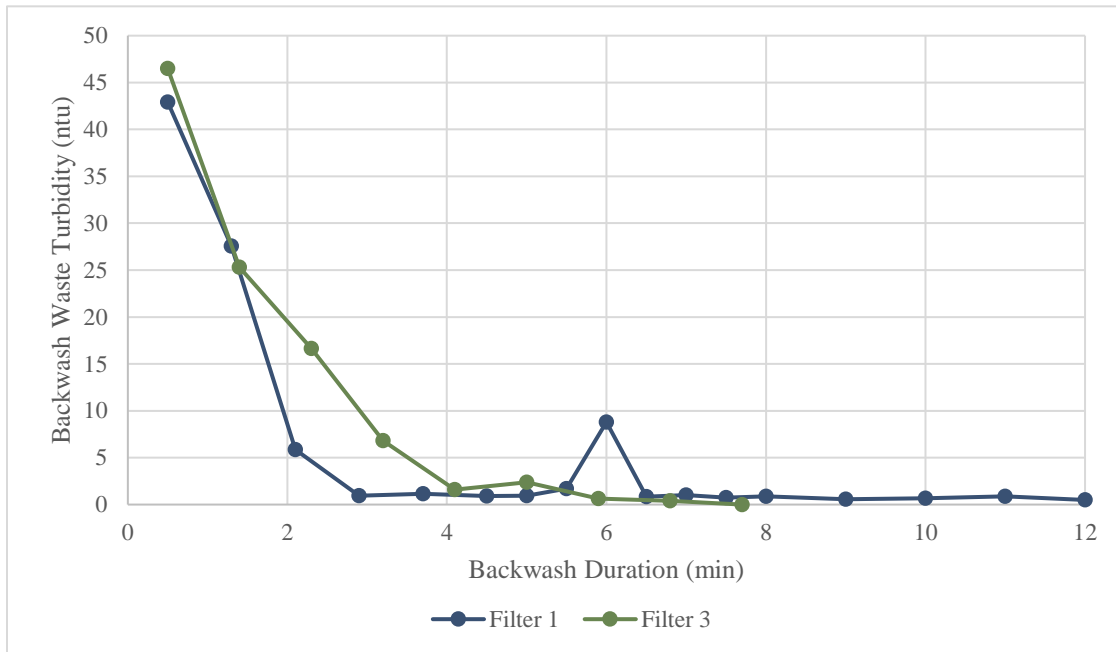
Figure 6-5. WTP Filter Backwash Turbidity Testing (July 31, 2019)
