Dade City 14<sup>th</sup> Street Wetland Evaluation

To: Tim Kelly  
From: Karen Warner  
Date: October 10, 2011  
Re: Dade City 14<sup>th</sup> Street Wetland Evaluation

Figure 1  
Dade City  
14th Street Parcel  
Preliminary Wetlands Evaluation

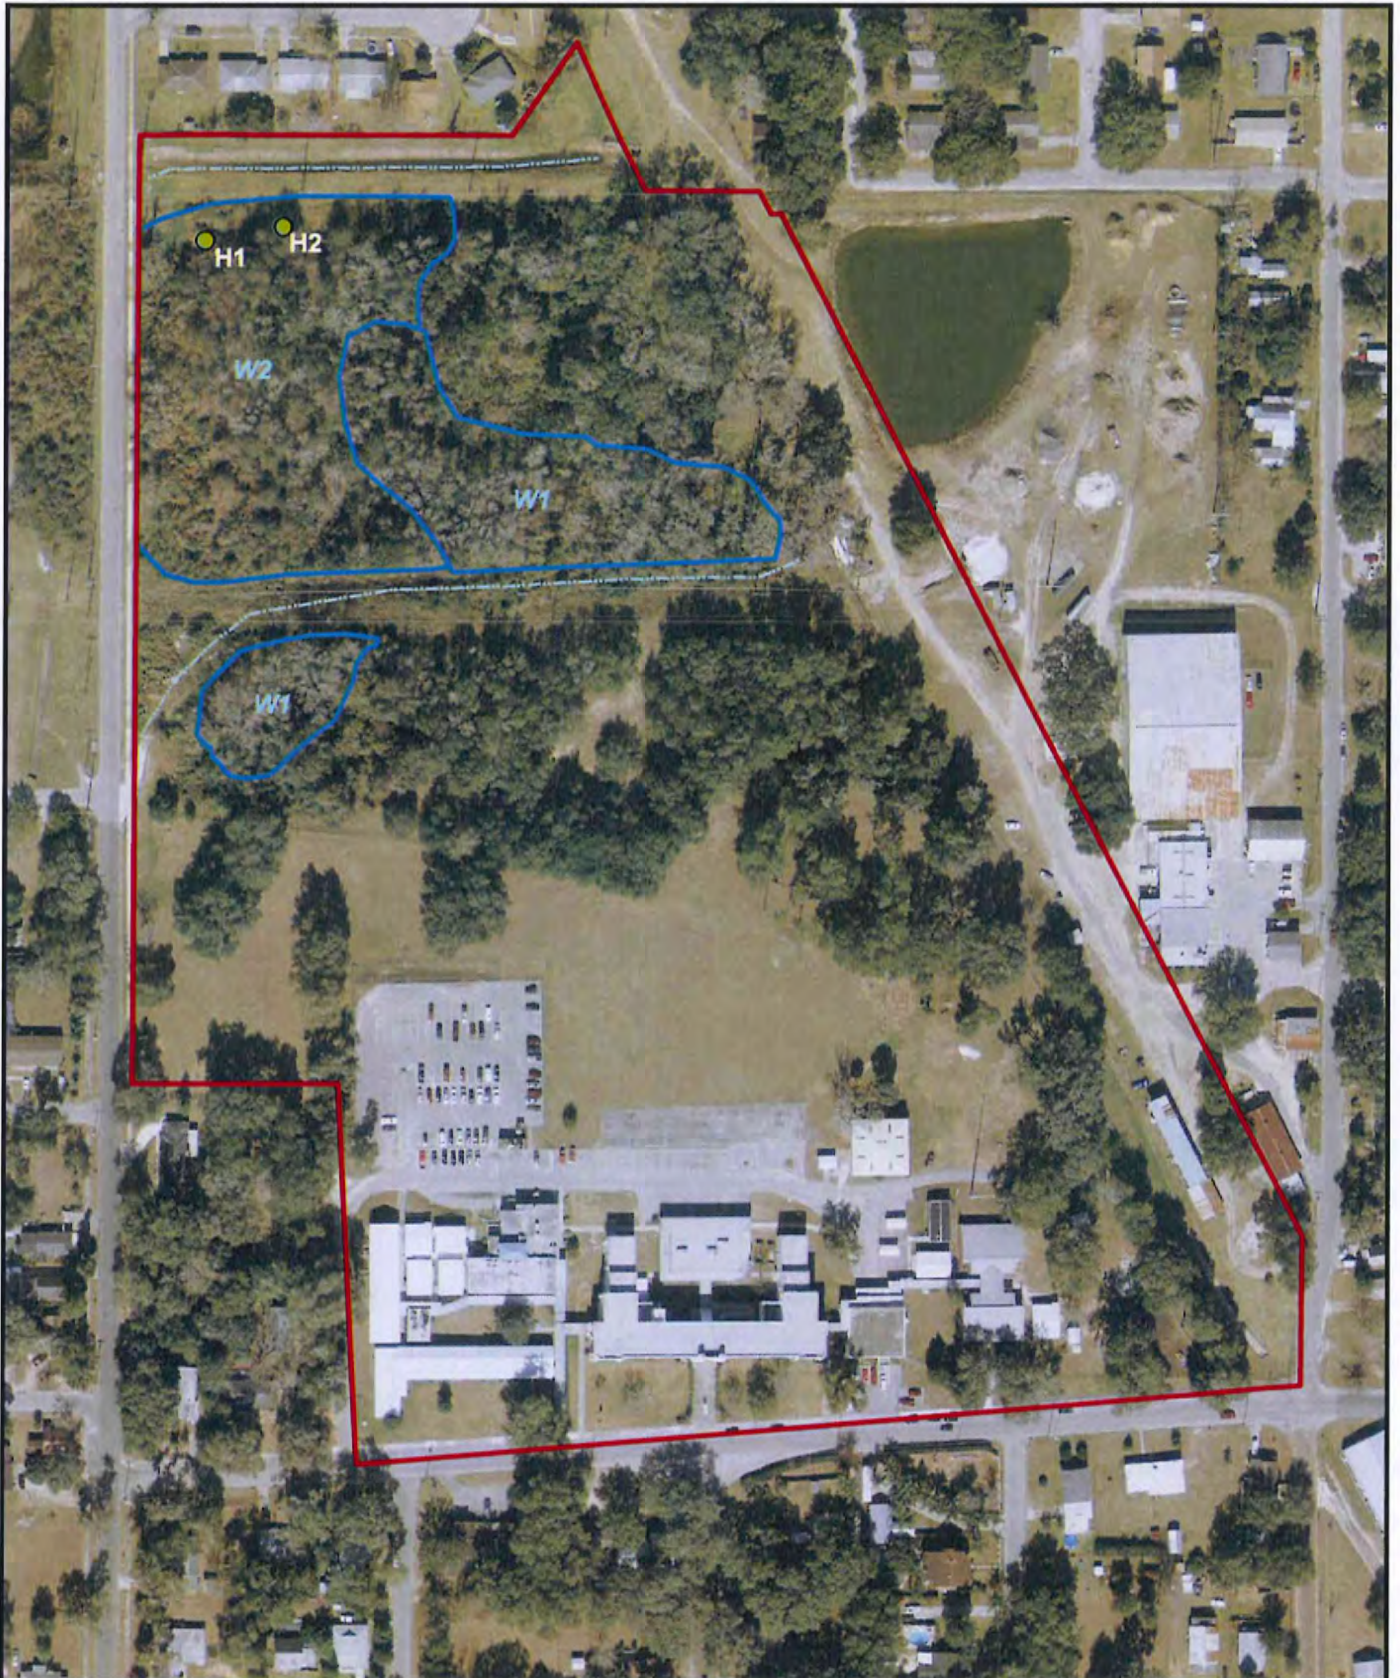
A Site evaluation was recently performed on the Dade City property located east of 14<sup>th</sup> Street, and north of the public school property at Martin Luther King Blvd. The site evaluation was conducted on September 13, 2011, and was limited to the northern forested portion of the property separated from public school grounds by chain-link fence. The evaluation area consists of forested wetlands and upland communities, with two lateral east-west ditches influencing drainage. One of the ditches is situated at the far northern extent of the property and the other crosses at the southern third of the site mostly within an existing cleared and maintained utility easement (**Figure 1**).

tree line south of and between the first two power poles closet to 14<sup>th</sup> Street (approximated on **Figure 1**). The first of these poles is concrete and the second is wooden. Care should be taken in use of these elevations as the design wetland seasonal high elevation, particularly due to the lack of trend observation and reliability with the indicators. At this early conceptual stage, it may be advantageous to install a water level recorder for a more accurate understanding of the wetland hydroperiod. Such a well can be installed by in-house staff, with automatic datalogger and barallogger deployed to record water levels.

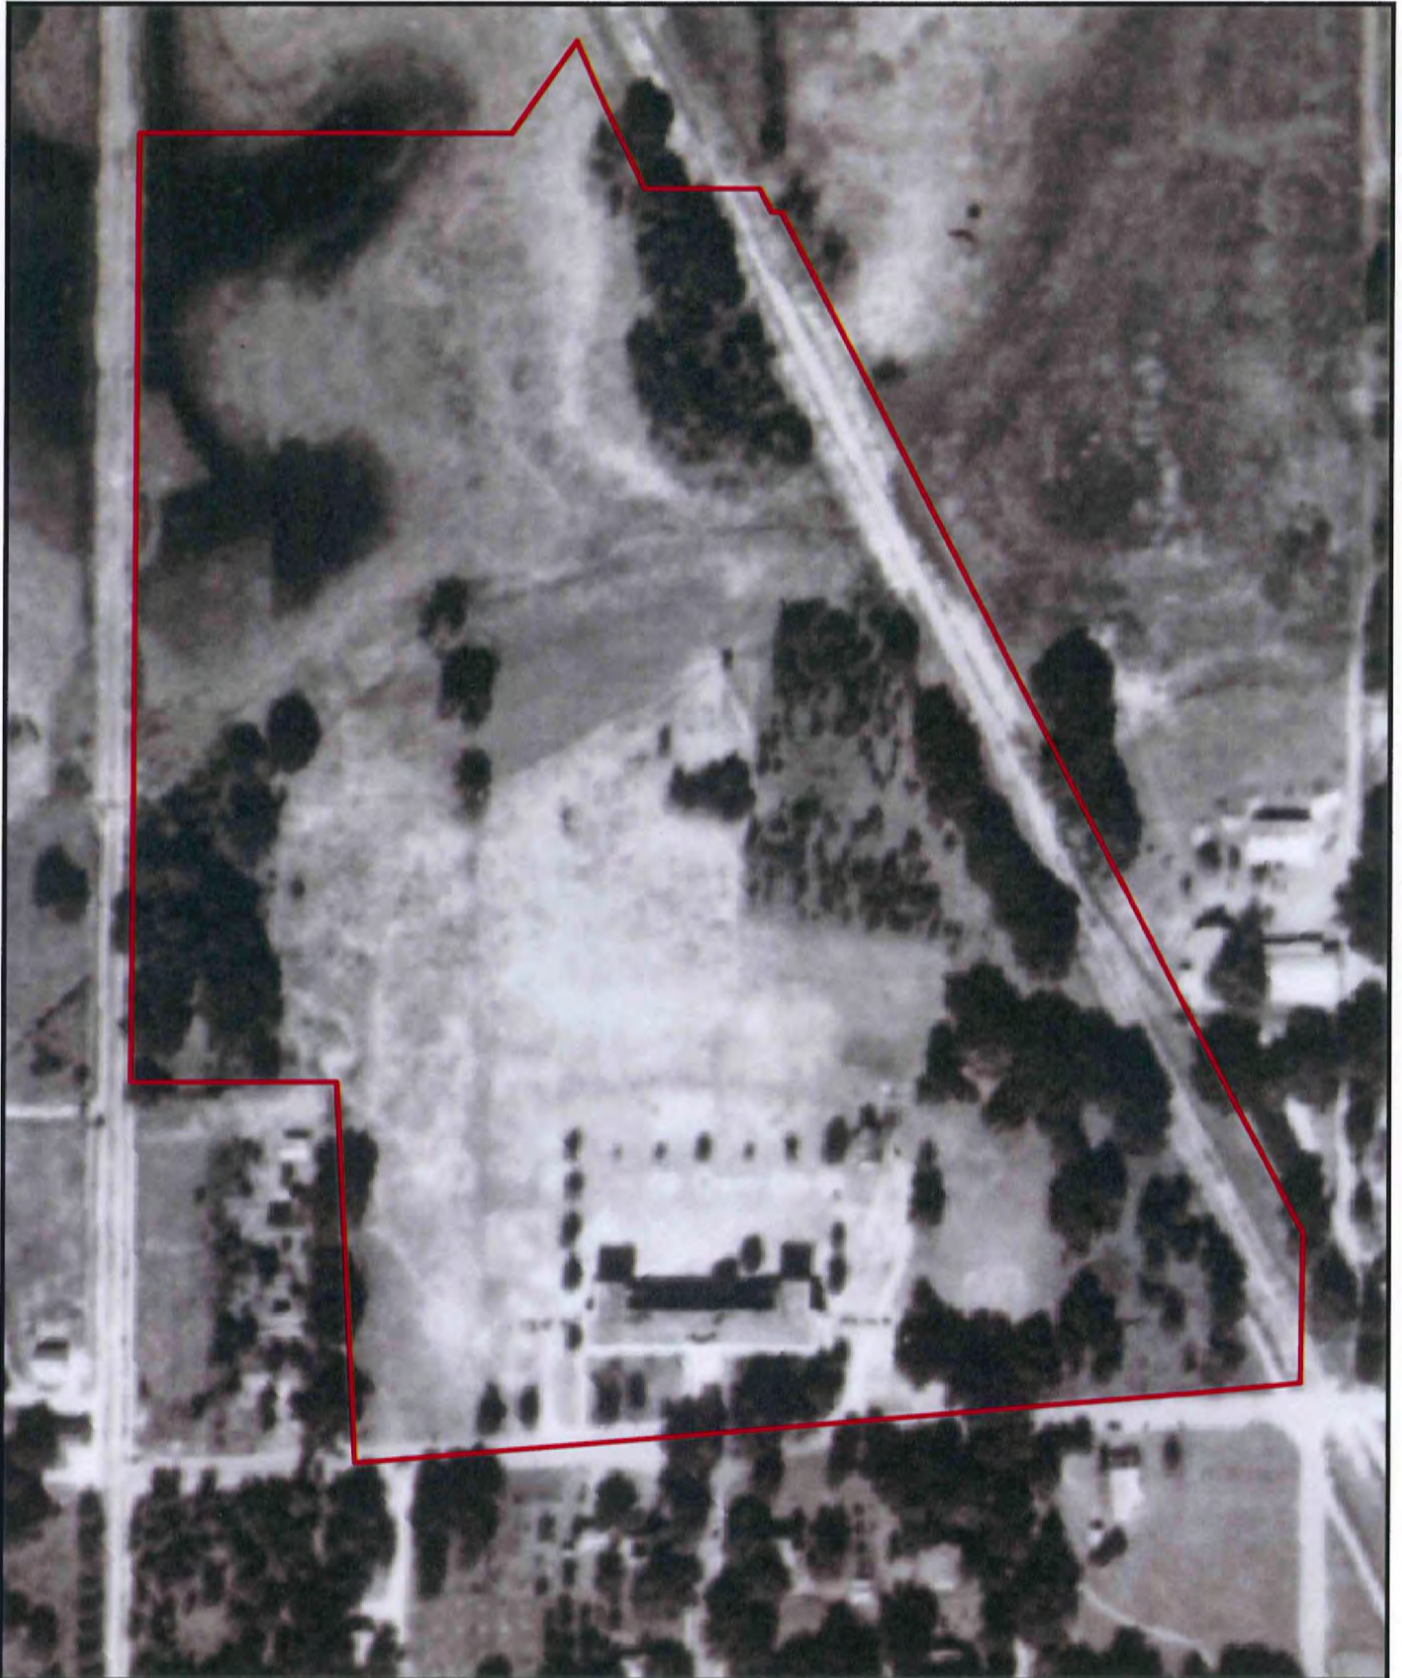
Figure 2  
Dade City  
14th Street Parcel  
Historic Aerial

Review of historic aerials from the 1940s indicates a large deep marsh previously occupied a portion of the project site and beyond (**Figure 2**). The marsh appears to have possibly been historically isolated, though ditching observed in these early photographs renders this difficult to confirm with certainty. The historic marsh was fragmented by 14<sup>th</sup> Street, and later further drained by the construction of drainage conveyances (ditches) maintained over time as observed on-site. Though severely altered and drained, wetlands remain at the northwest portion of the site within the former extent of historic marsh and within the corresponding topographic contours of the historic wetland (**Figure 3**). Other jurisdictional wetland communities exist on-site extending outward from this area (toward the east and south), though the extent of these wetlands is likely reduced due to lack of sufficient hydrology.
