**City of Manassas, Virginia  
Architectural Review Board Meeting**

**Special Worksession - Annaburg Manor, 9201 Maple St.**

**SUBJECT:** Technical Memo - Annaburg Manor

## Follow-up Site Observations

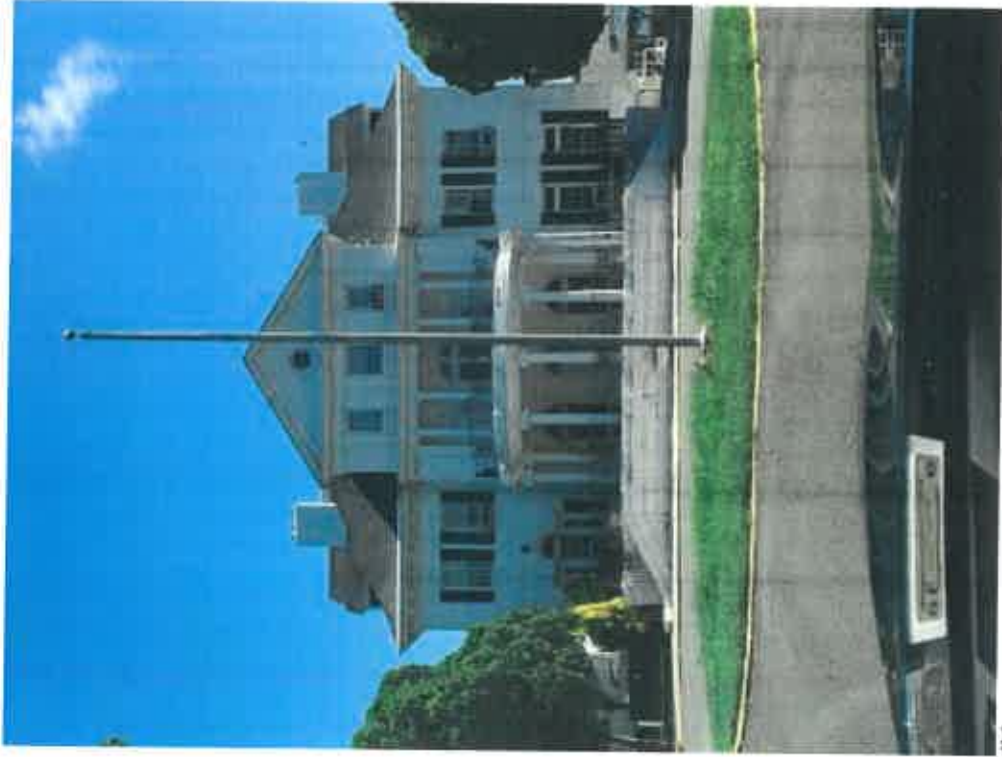
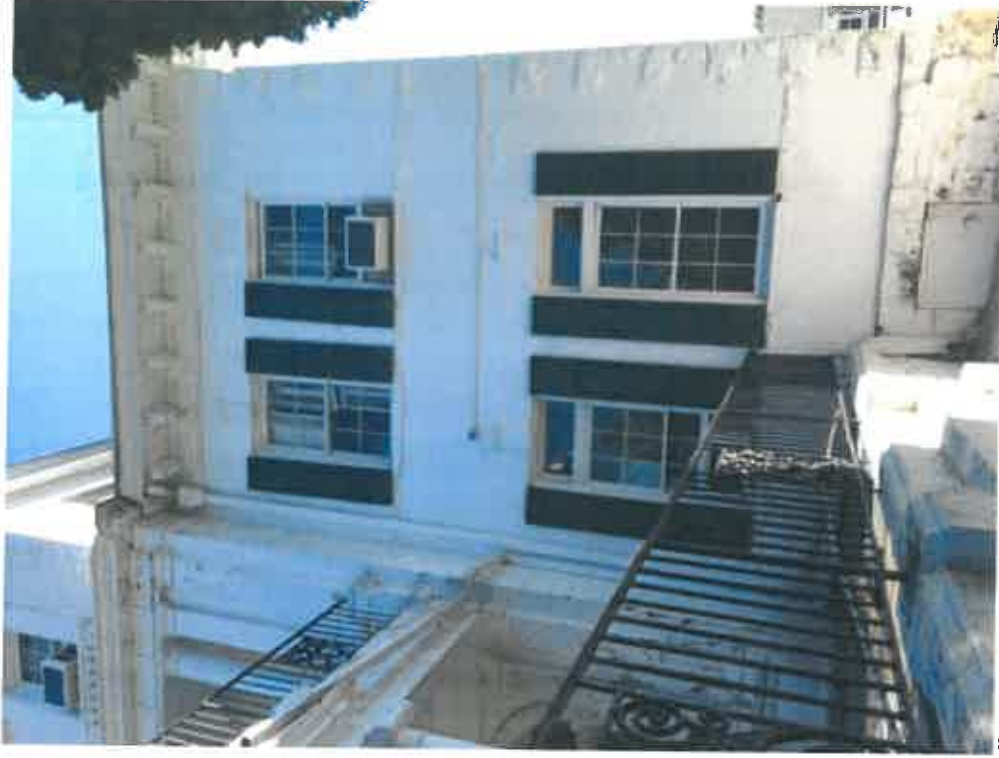
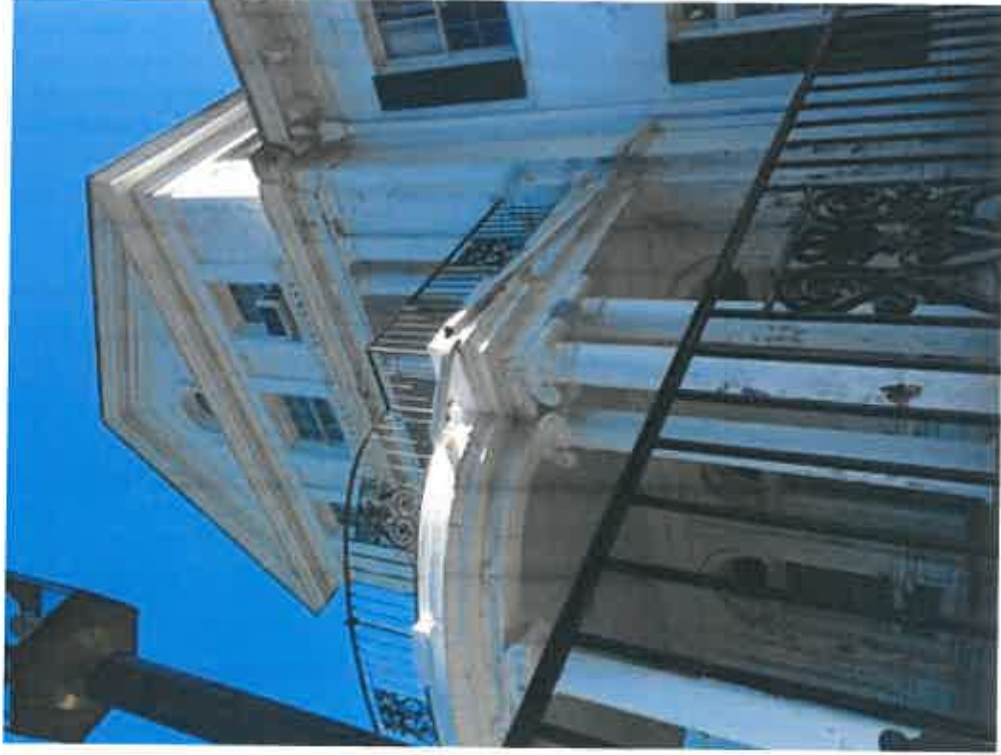
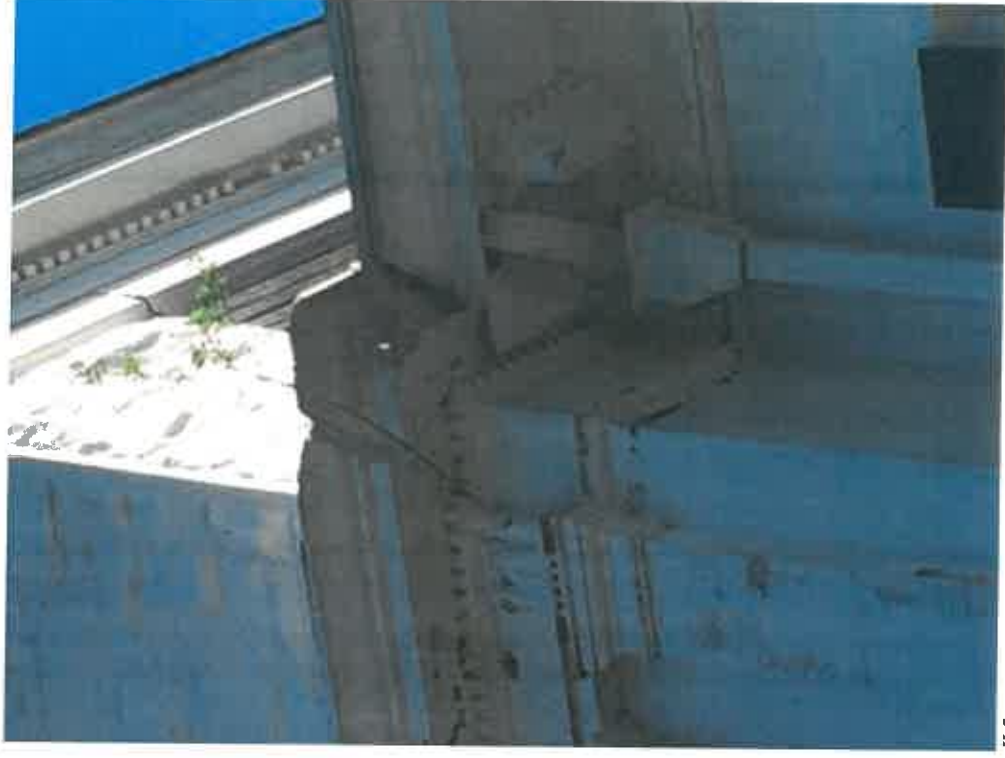
Photographs Numbered 1 through 4 identify the front elevation of the building. We were quite surprised to see the amount of deterioration on the cut stone portions of the façade as well as on the columns that support the terrace above. Photographs Numbered 5 through 12 show a closer view of some of this deterioration where it appears that water that is in the brownstone components is resulting in failure of the coatings, resulting in an extremely undesirable appearance of these areas.

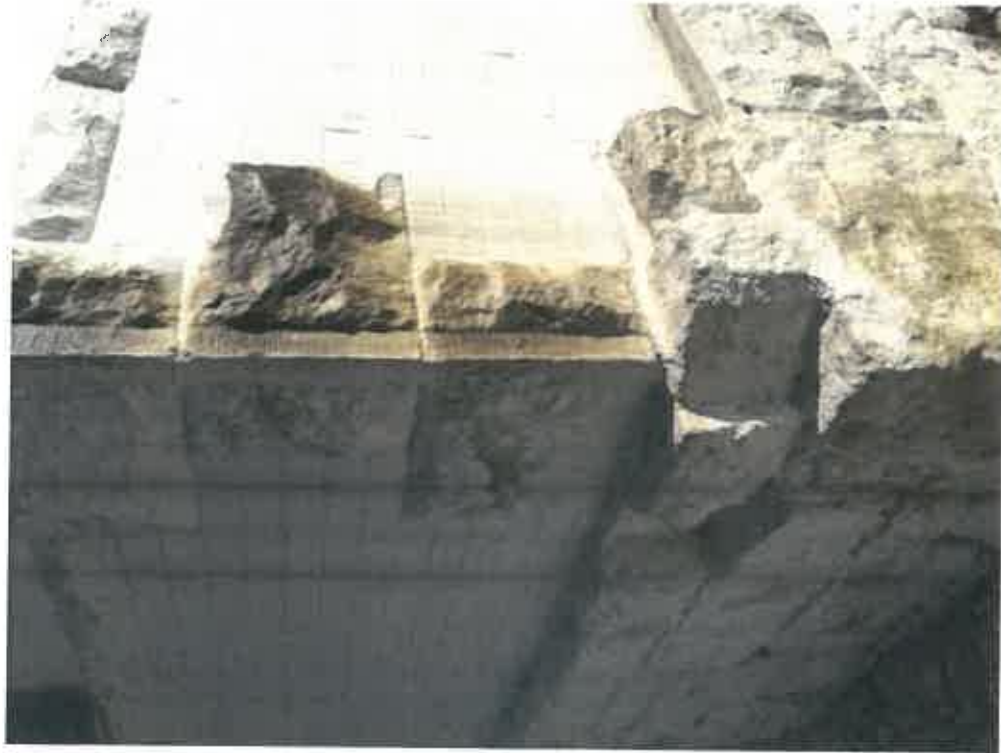
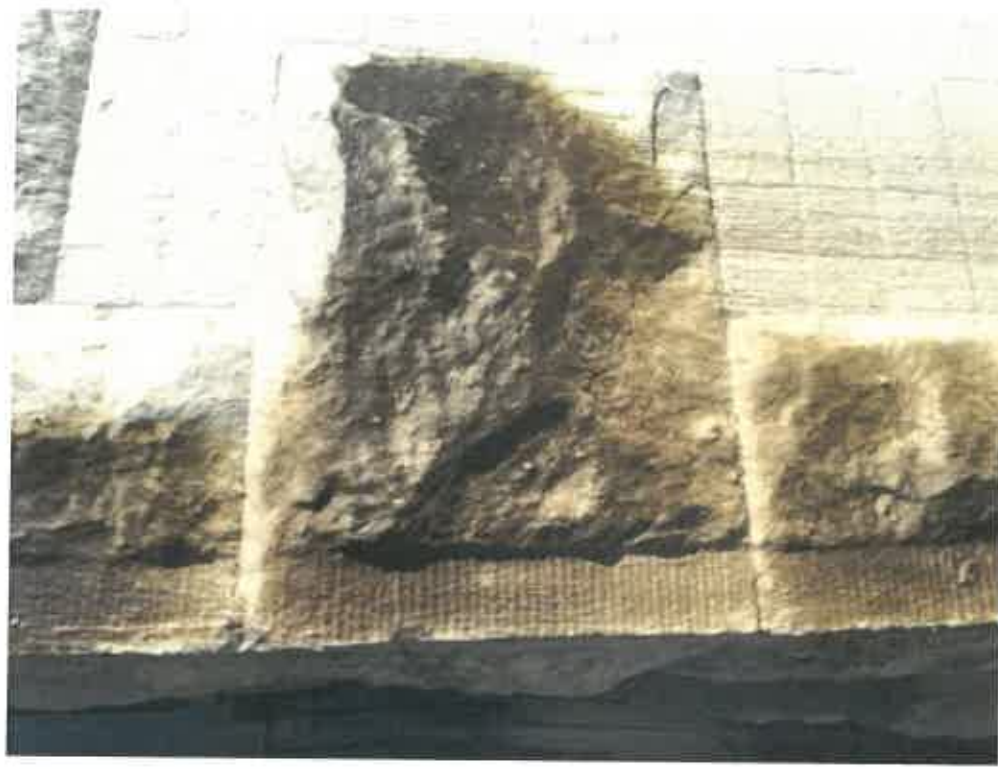
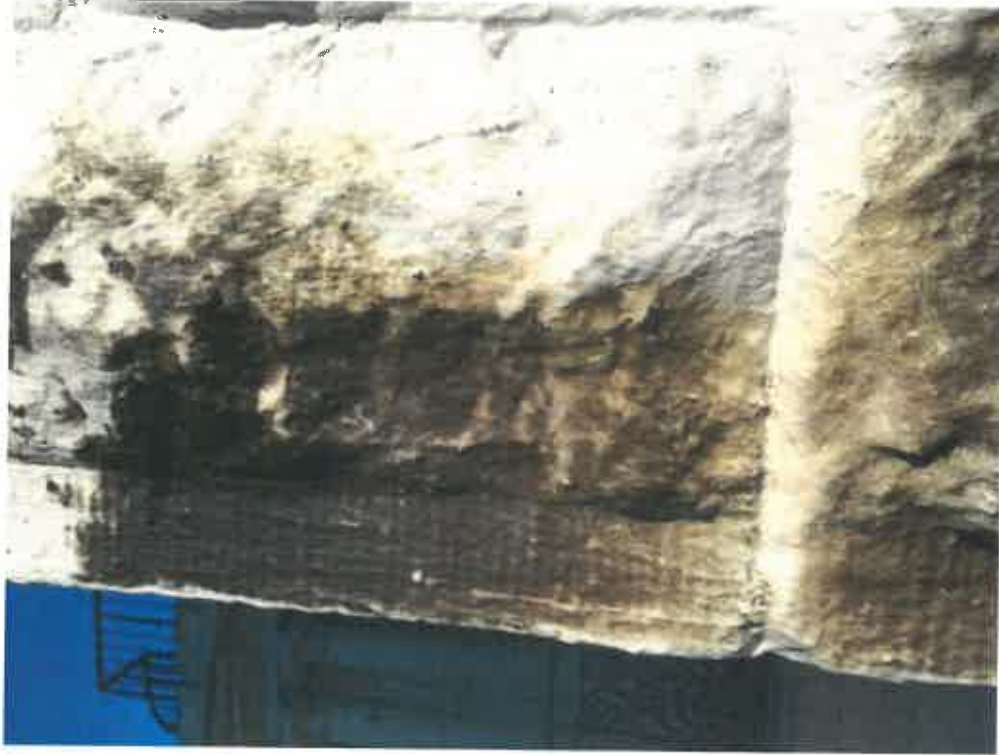
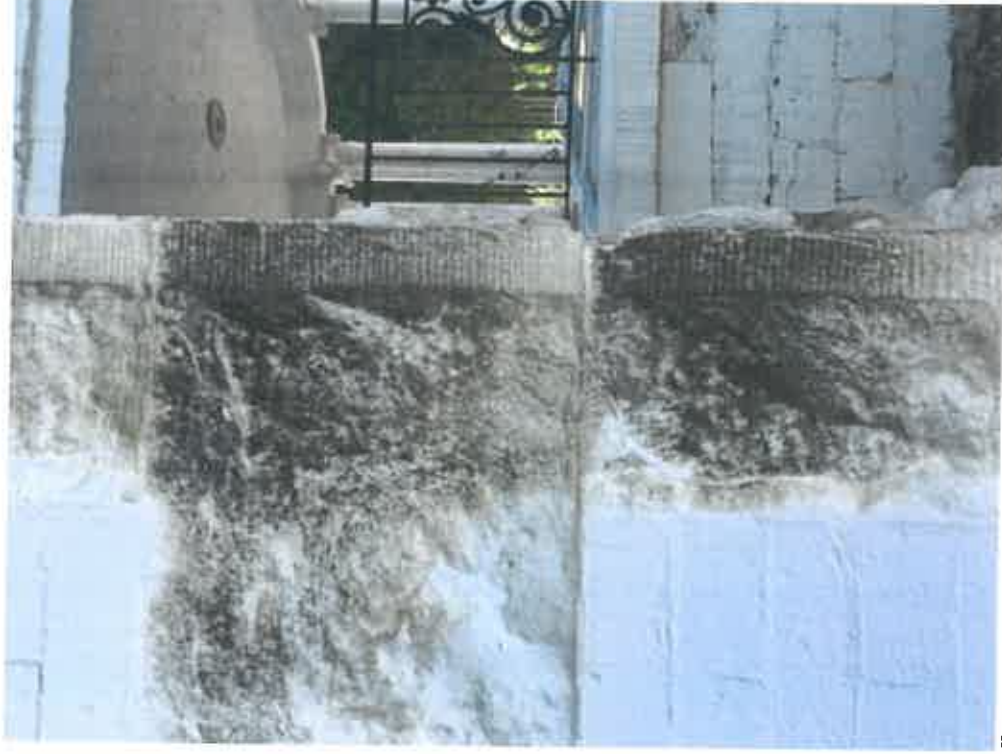
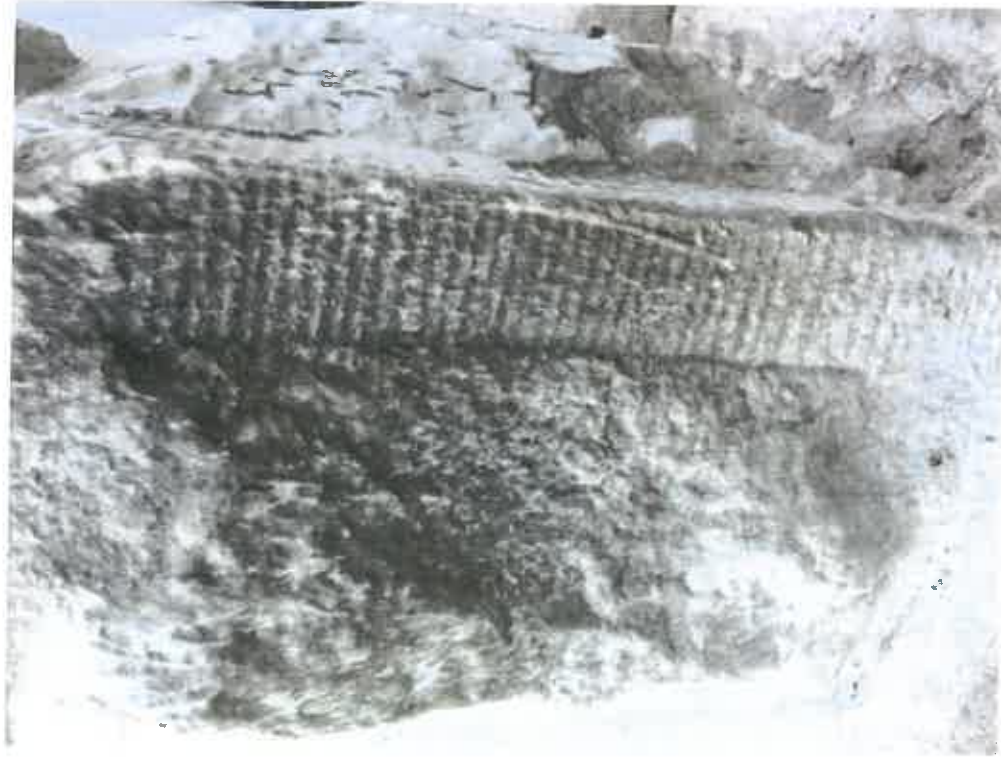
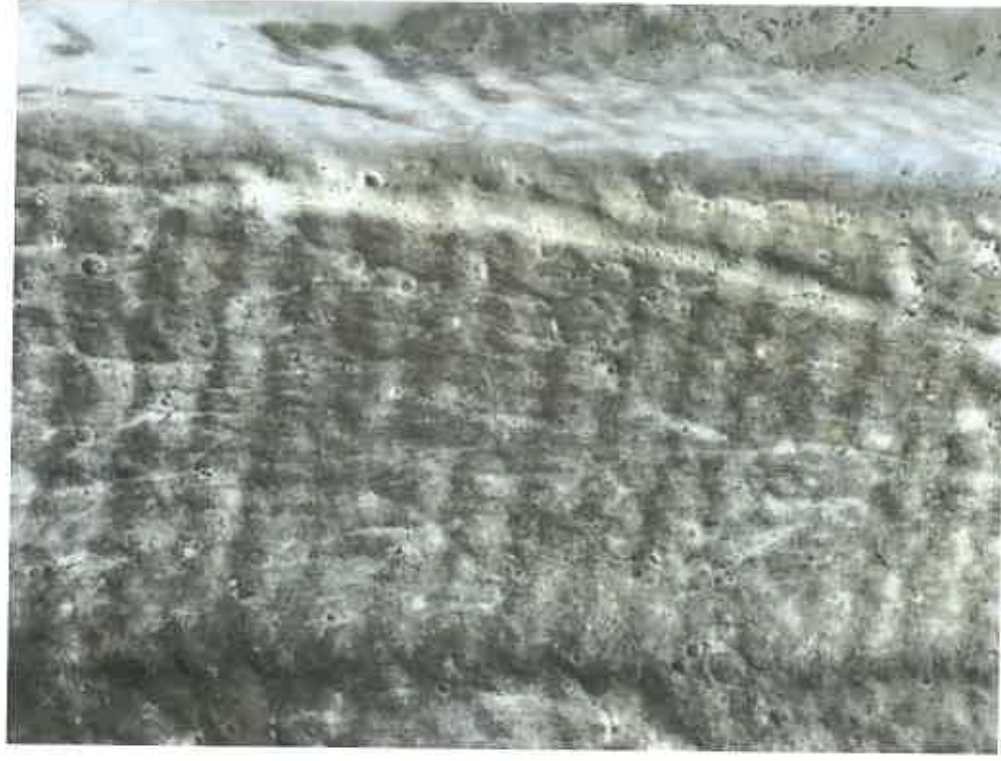
Photographs Numbered 13 through 18 identify the brownstone cornerstones in which some of them exhibited severe staining on the surface of the coating. The cause of this staining appears to be dirt pick up from water cascading down the corners as opposed to water that is behind the cornerstones. As seen in photographs later in the report, it does not appear that the coating has been compromised relative to its ability to protect brownstone in these areas.

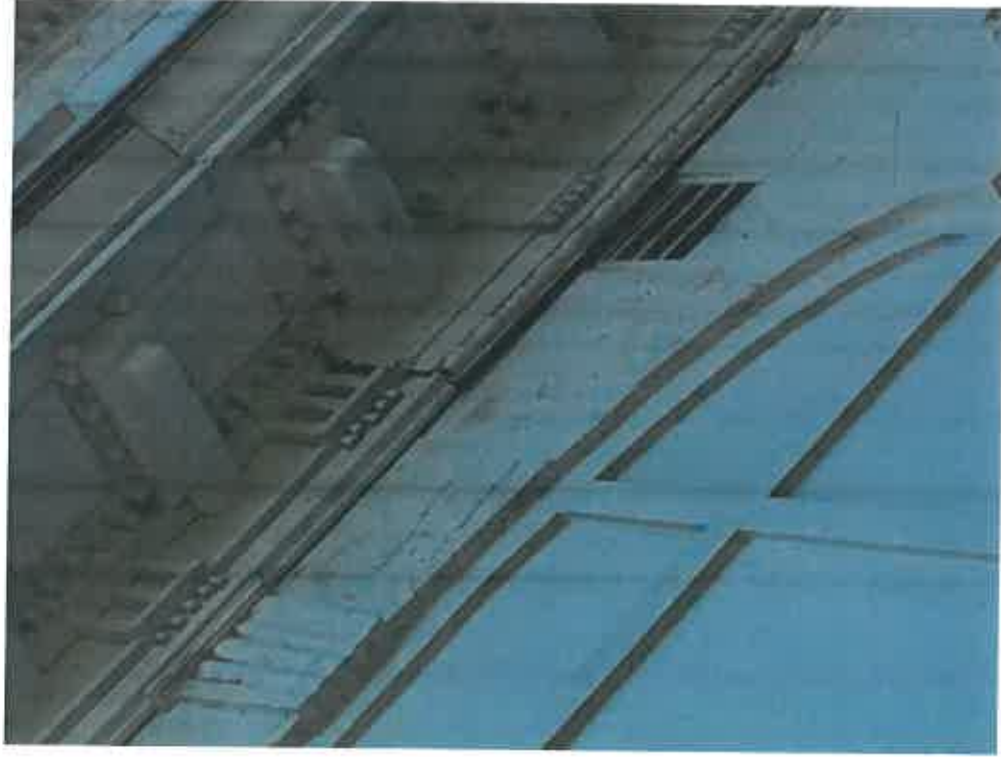
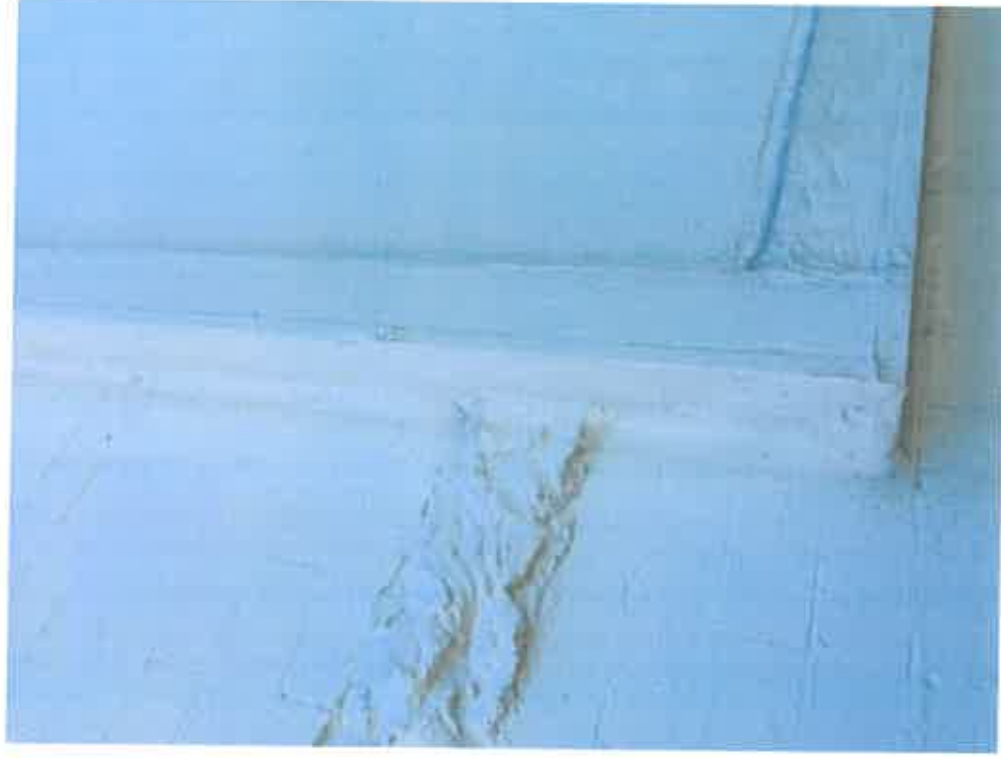
Photographs Numbered 19 through 26 identified the sides and rear of the building that largely appear to be in good shape with some minor exceptions. Photographs 25 and 26 of that group show infill panels that were installed where major leaking has previously occurred. Both the joinery and the coating appear to be good and functioning properly. There were a couple of areas as seen in Photographs 27 and 28 where the cornice at the roof level, as well as some of the brownstone eyebrows were exhibiting some deterioration. We were unable to access the areas to determine the cause.

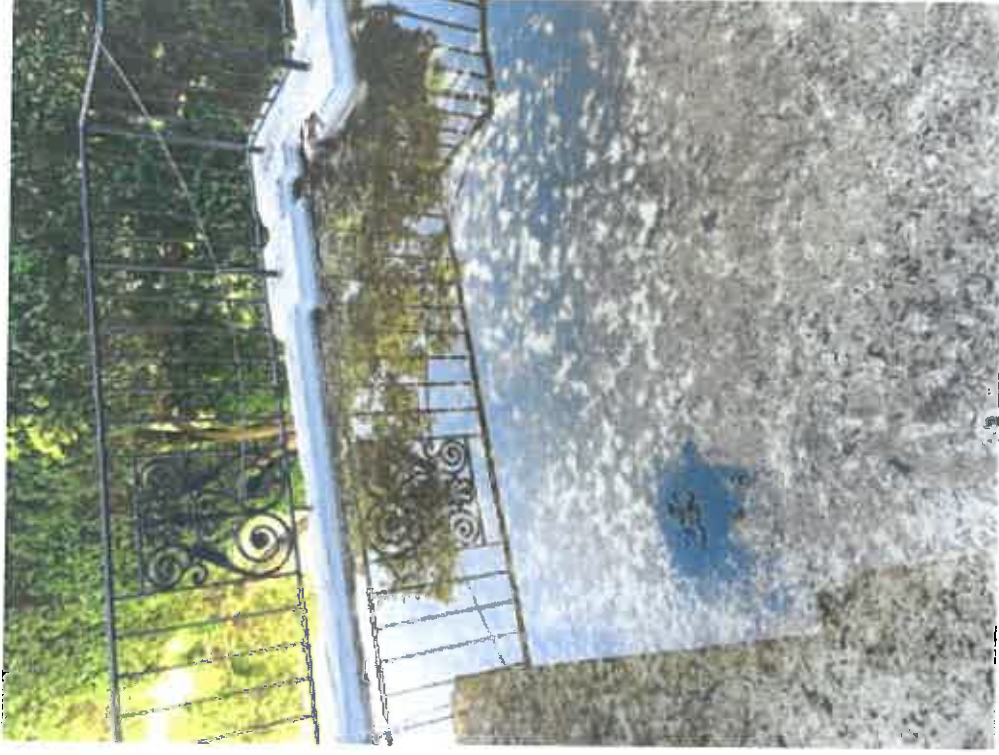
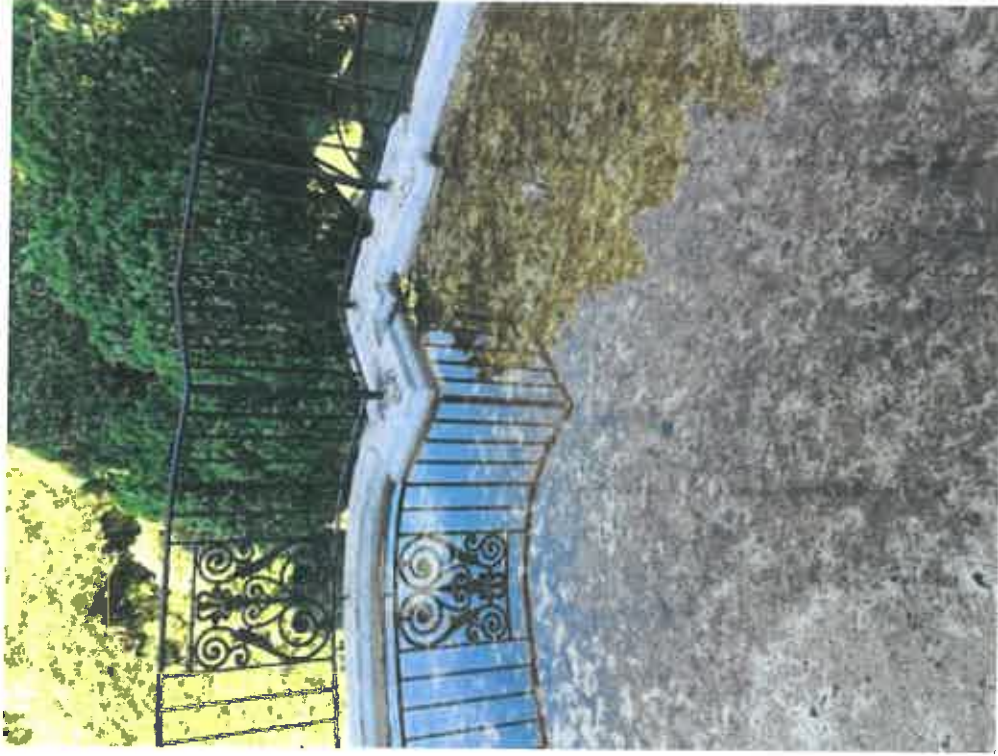
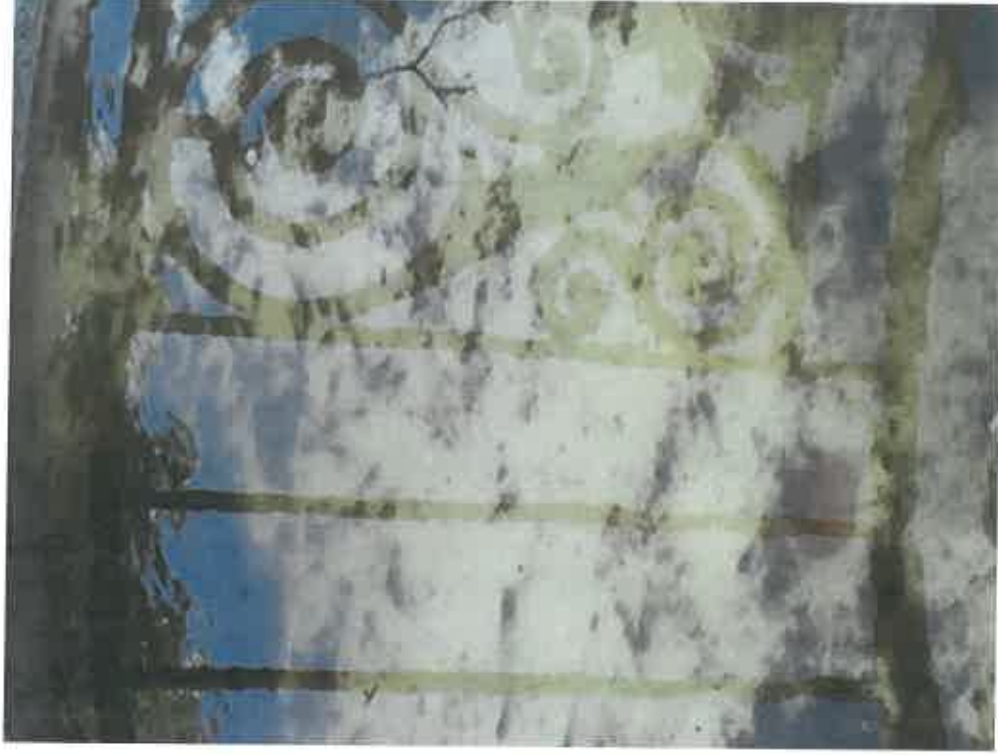
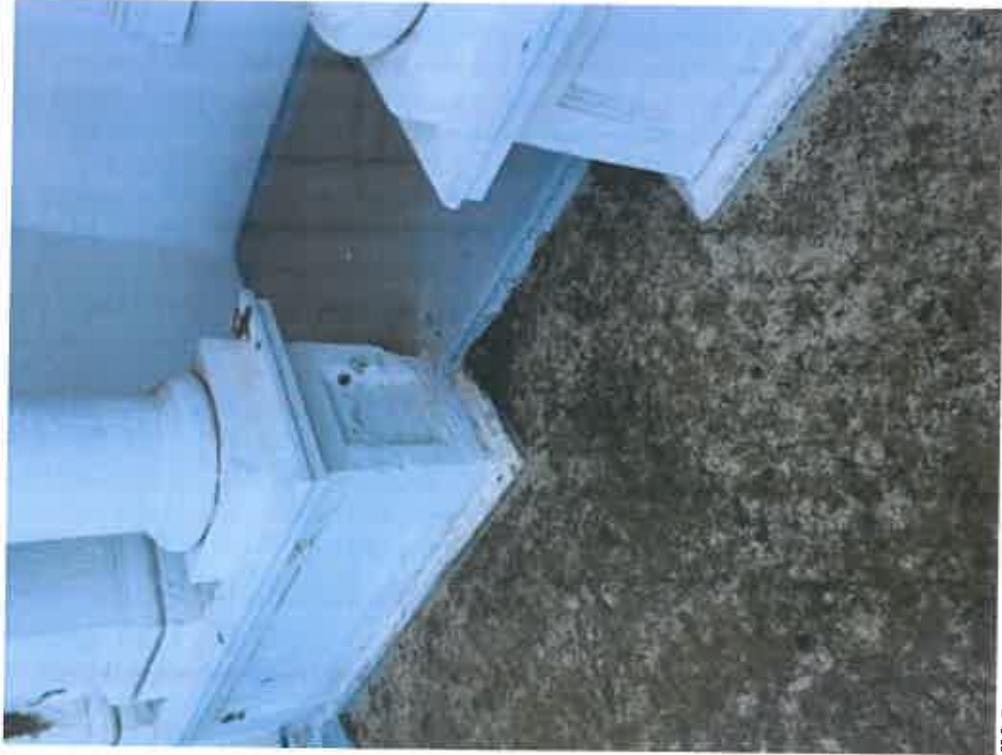
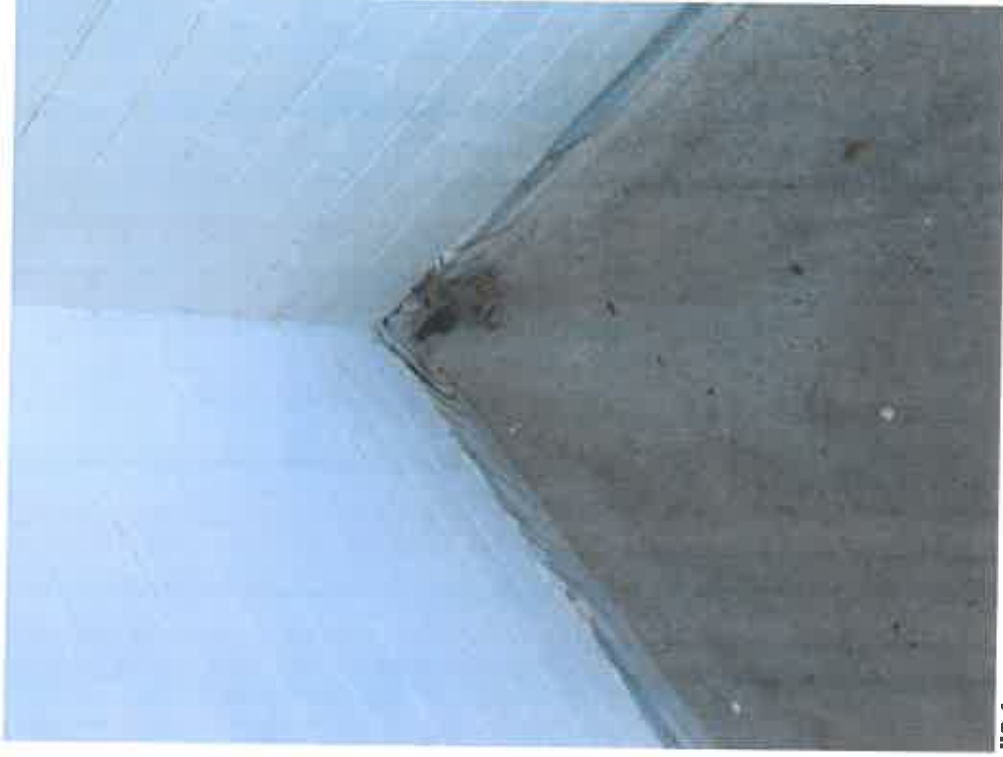
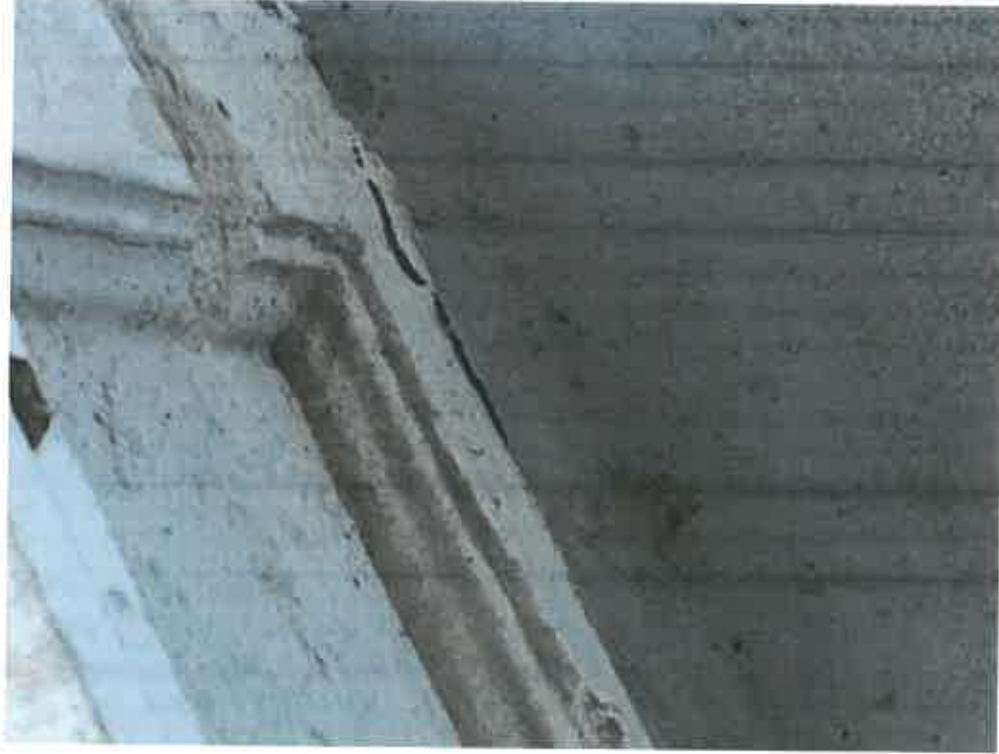
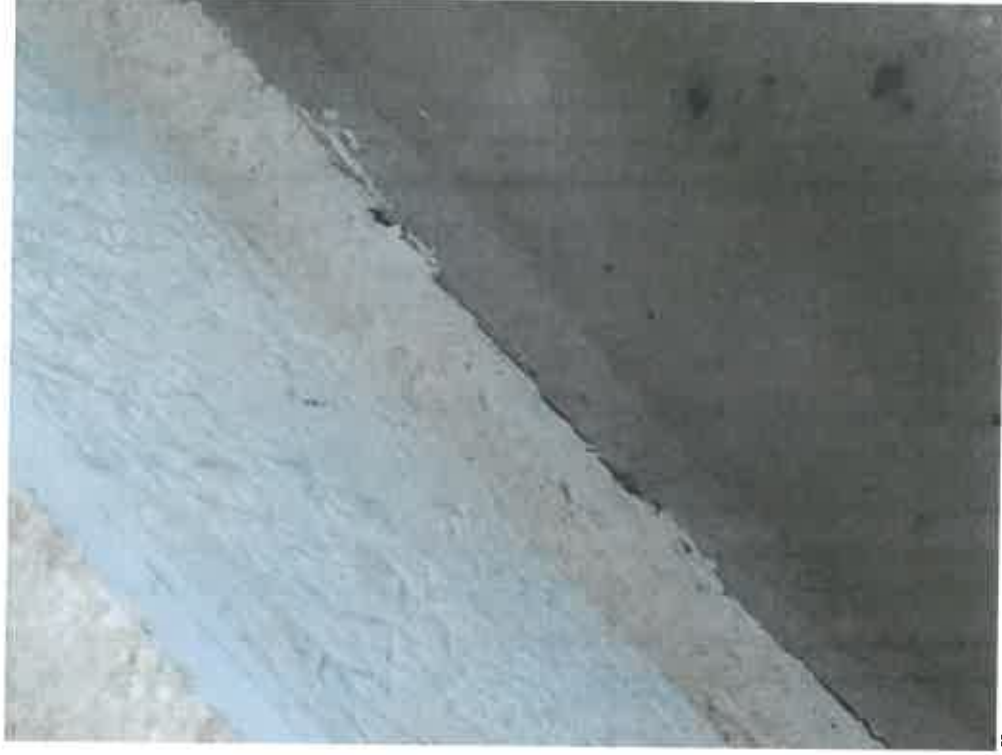
Photographs Numbered 29 through 38 are of the Terrace that is above the main entry on the front of the building. The drains in this area had become obstructed which was resulting in significant amounts of water ponding on top of the terrace for prolonged periods of time, to the extent that it was damaging the coating that had been installed on this terrace as well as the perimeter conditions where it ties into vertical surface. We believe that water is getting through the perimeter conditions of the terrace and migrating down into the brownstone below exacerbating the deterioration that is seen on the front of the building, primarily isolated to the area underneath the terrace. The water that is giving underneath the Terrace has also started deteriorating the plywood portion of the Terrace between the columns and the entry door that will need to be re-built prior to recoating. The plywood portion is the raised area seen in Photograph Number 33. Photographs Numbered 34 through 36 show the perimeter conditions where water has gotten behind the deck coating because the water has gotten deep enough to saturate these areas.

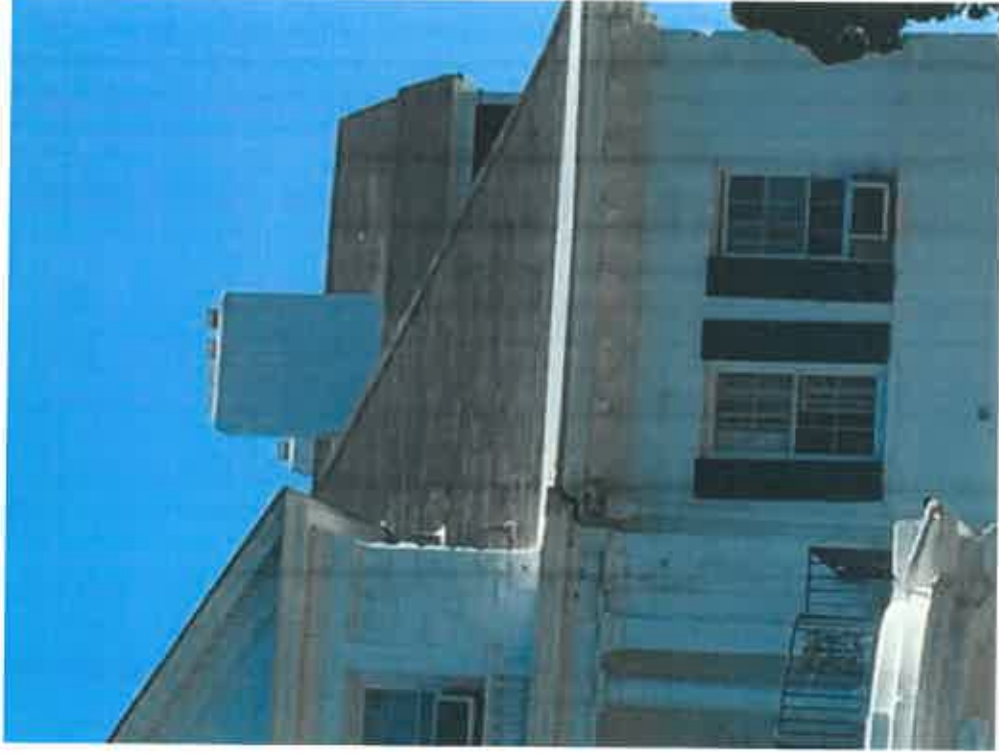
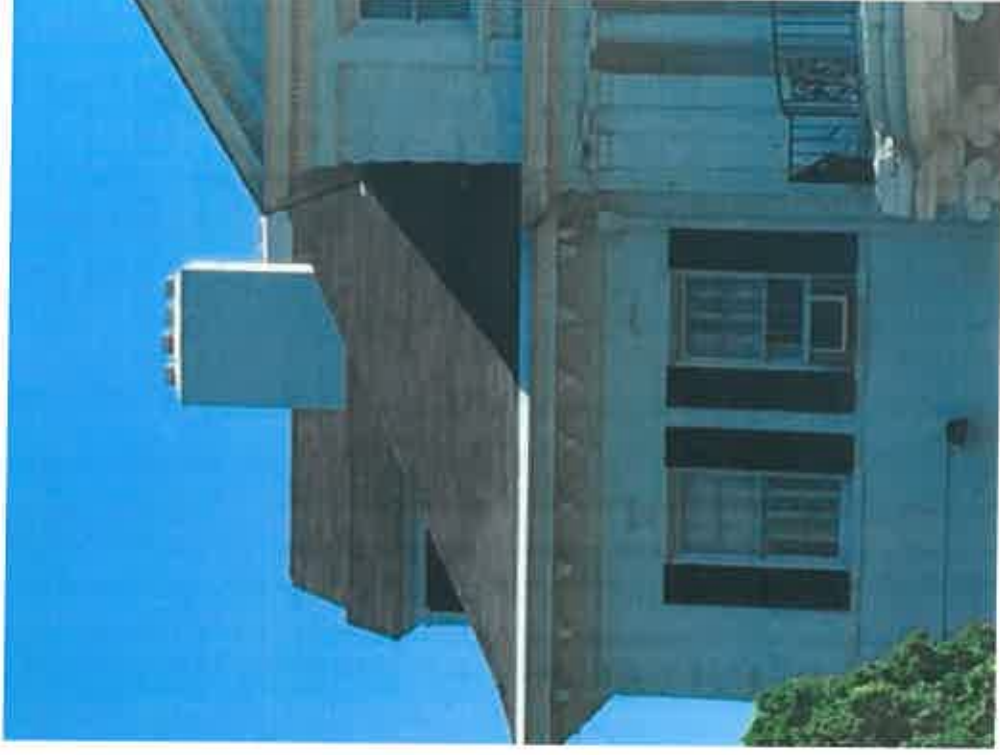
Photographs number 39 through 42 show the asphalt shingle roof that we were unable to access from a vantage point to determine any damage. The overall appearance did appear to be good from where we could see it, however we found several shingles on the ground that we do not know if came from the roof or from somewhere else.

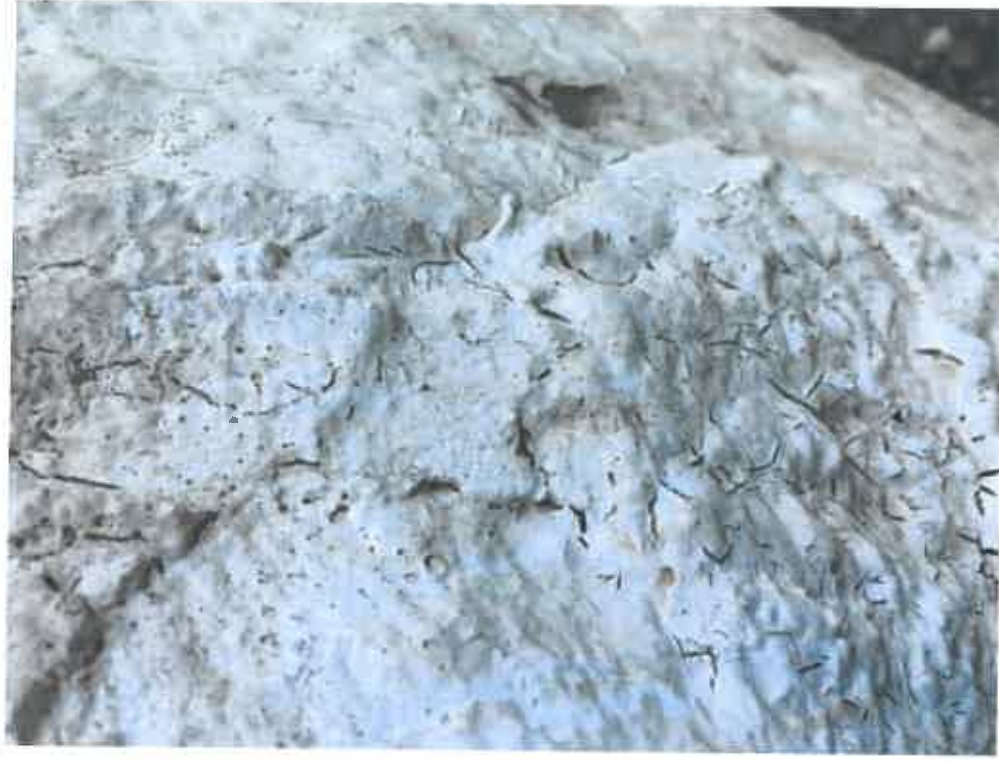
#44

Photographs Numbered 43 through 56 show a closer review of some of the conditions that are contributing to the problems. Photographs numbered 43 and 44 show where cracking or checking the previously installed coatings are resulting in the newer coating, rupturing as well. Once water gets into these areas, it causes the coating in the surrounding areas to delaminate due to the moisture that gets trapped into the masonry and/or brownstone.

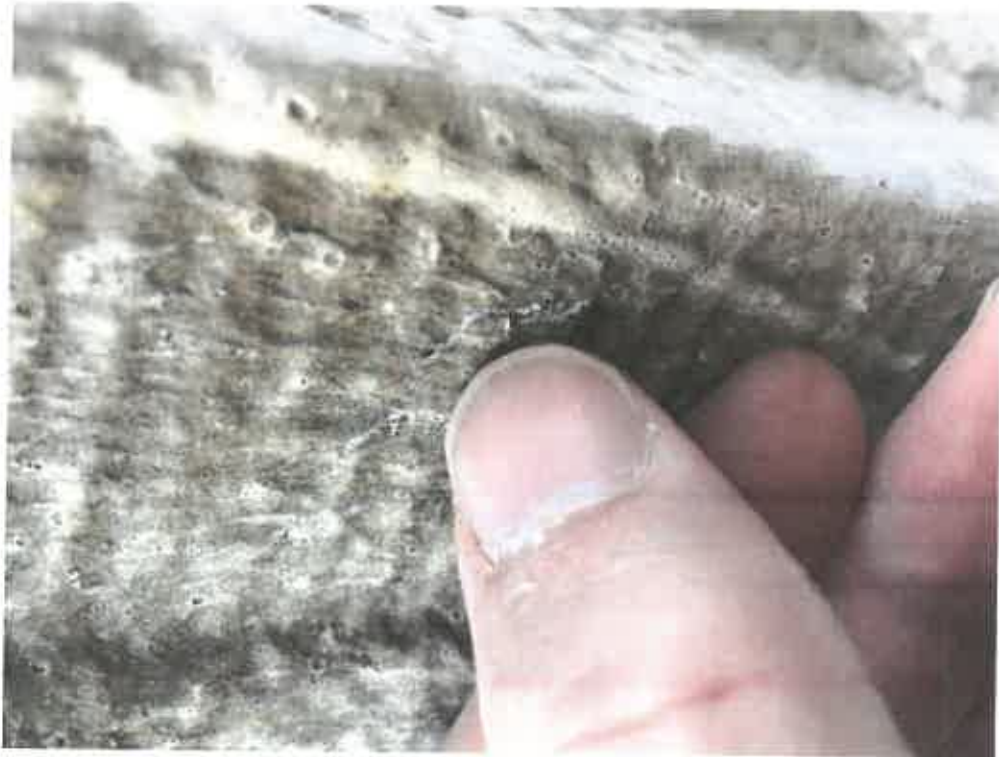
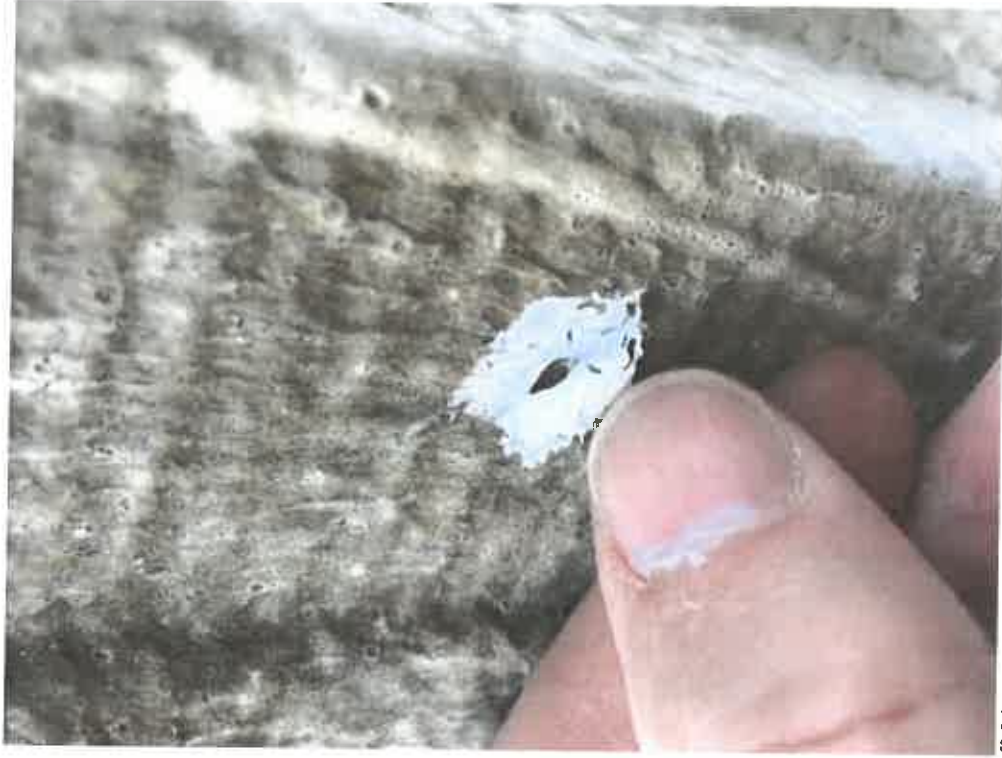
Photographs Numbered 45 and 46 shows staining on the brownstone cornerstones however where we sliced the coating at these locations, the underlying coating was still intact and bonded, and performing as intended.

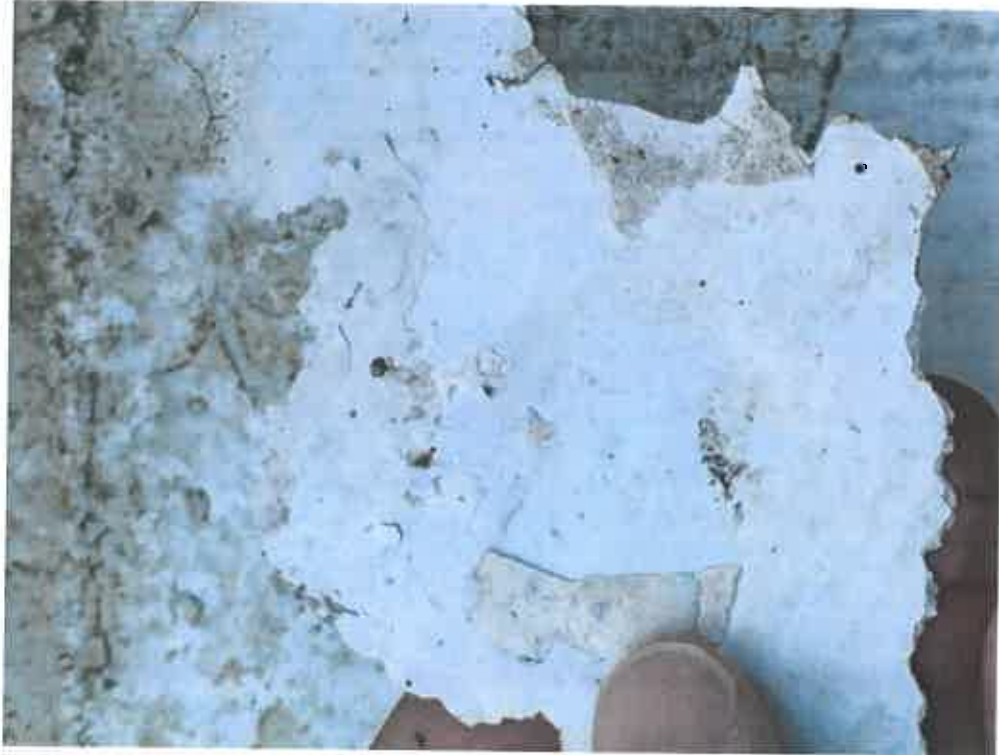
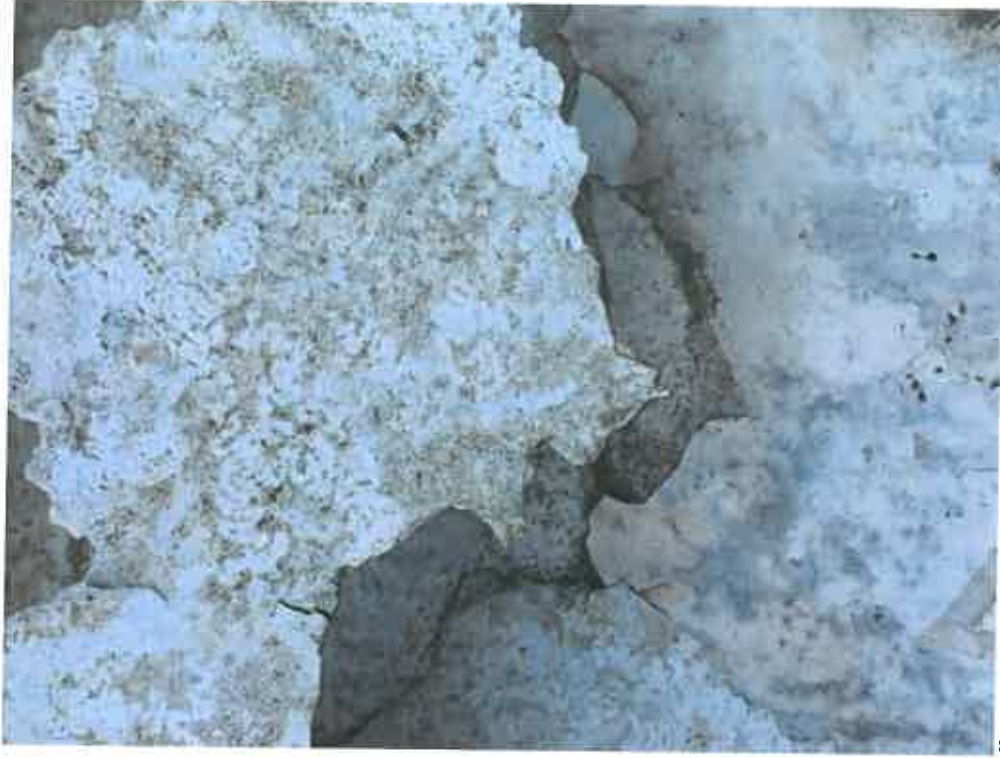
Photographs Numbered 47 and 48 identify where sections of the previously installed coating have delaminated from the substrate, due to moisture behind it.

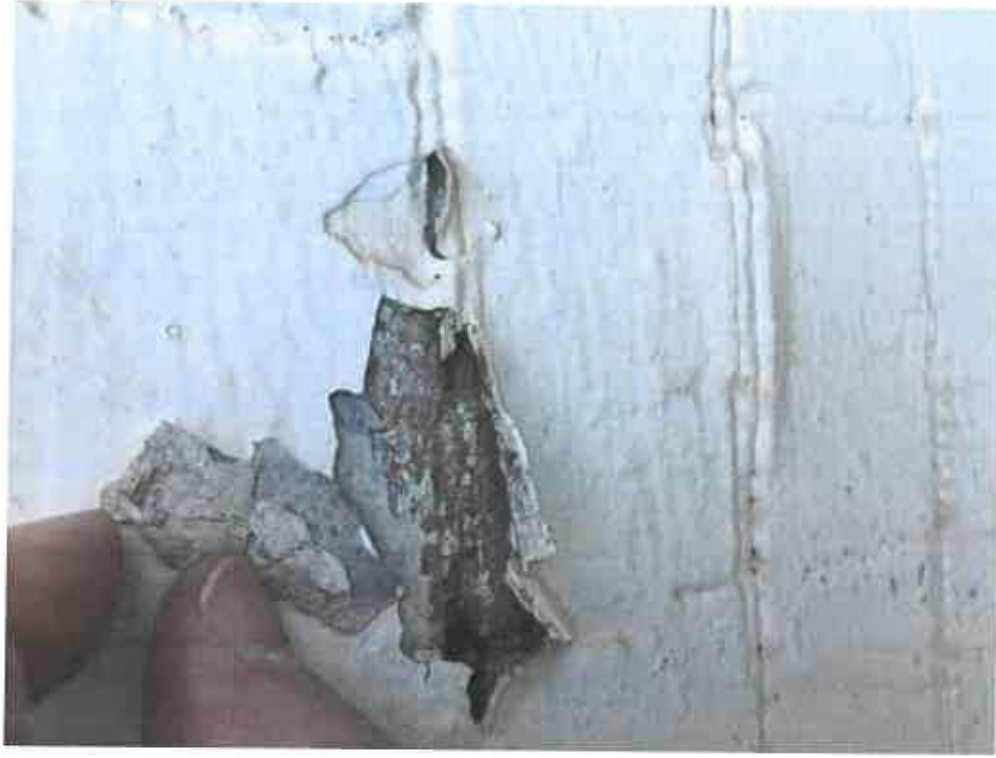
#50

Photographs Numbered 49 and 50 show where a small breach in the coating results in moisture being trapped behind the coating and subsequently losing adhesion. We did not see where this was occurring on any locations other than where the previously installed coatings were left in place. That is due largely to the fact that the older coatings do not have the same moisture vapor transmission rate as the Newark coatings, and peels off.

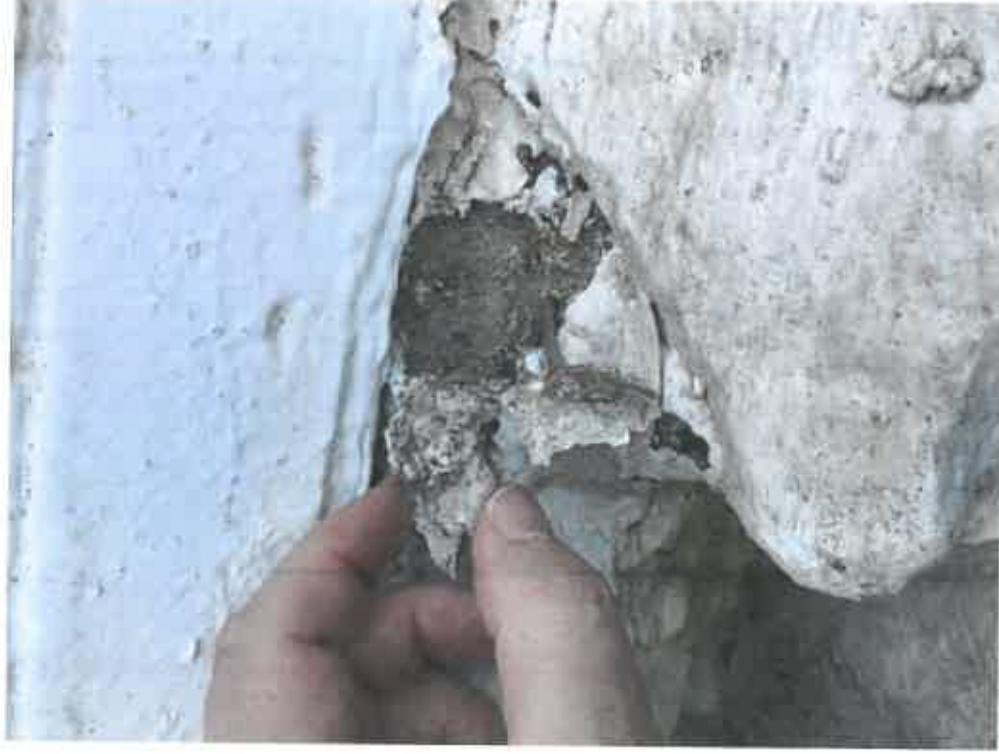
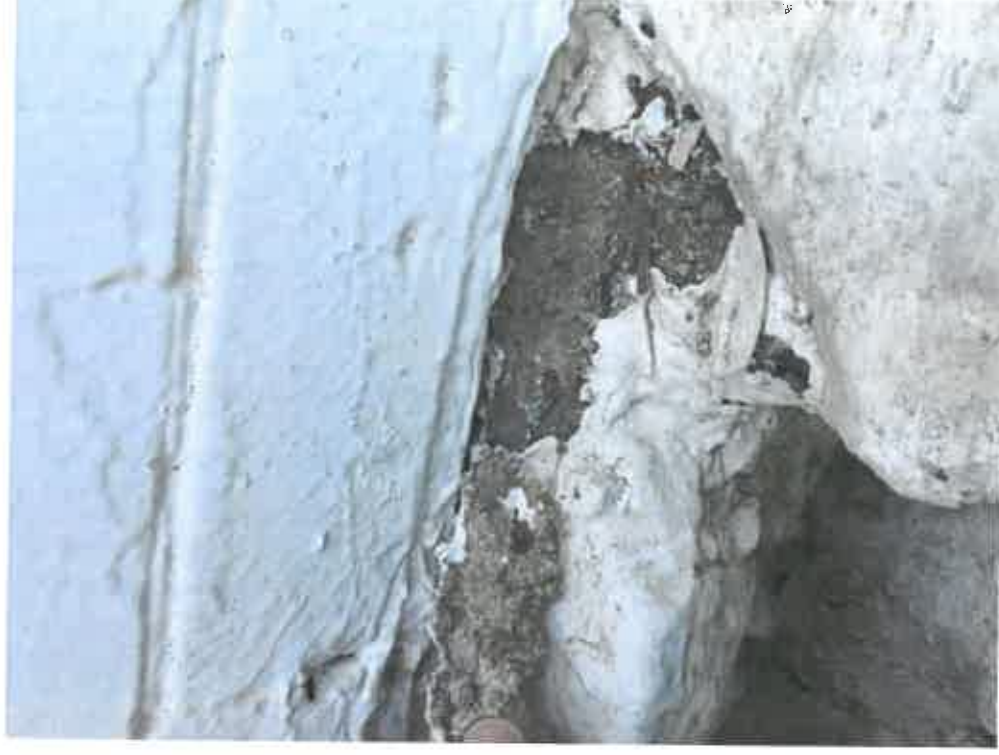
Photographs Numbered 53 and 54 identify where mortar is disintegrating behind where sealants have been installed, where again once this substrate becomes saturated causes the sealant and coating to lose adhesion.
