**City of Manassas, Virginia  
Architectural Review Board Meeting**

**Special Worksession - Annaburg Manor, 9201 Maple St.**

**SUBJECT:** Technical Memo - Annaburg Manor

## Follow-up Site Observations

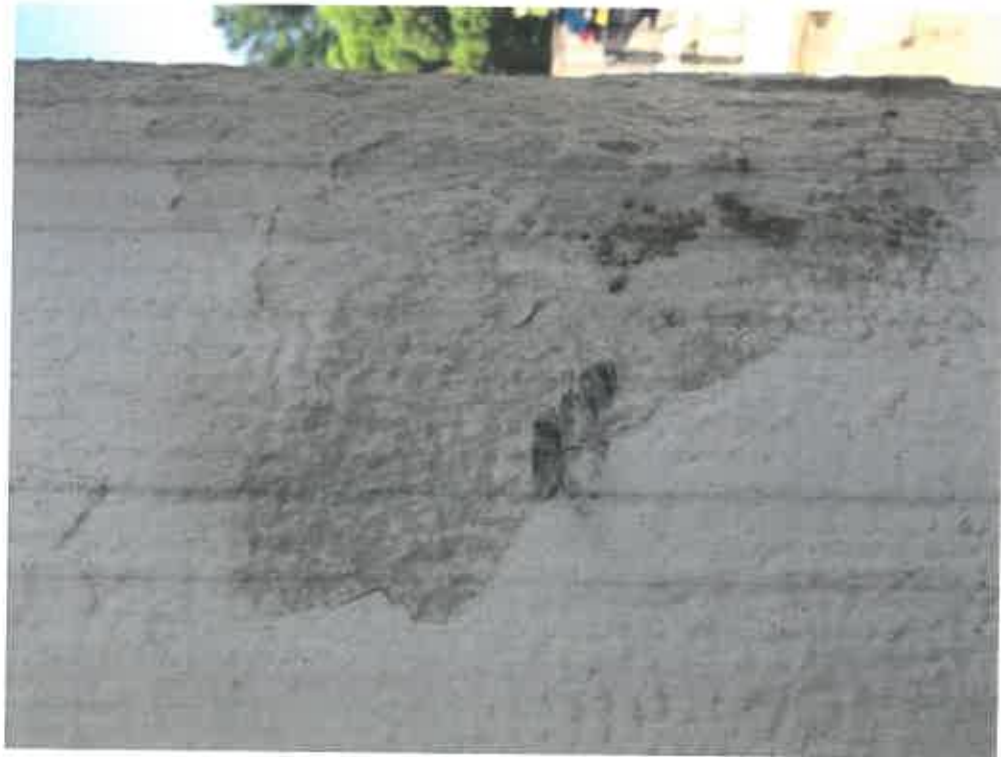
#55

Photographs Numbered 55 and 56 shows deterioration of the coating, as well as further deterioration of the brownstone columns where water is getting into the columns.

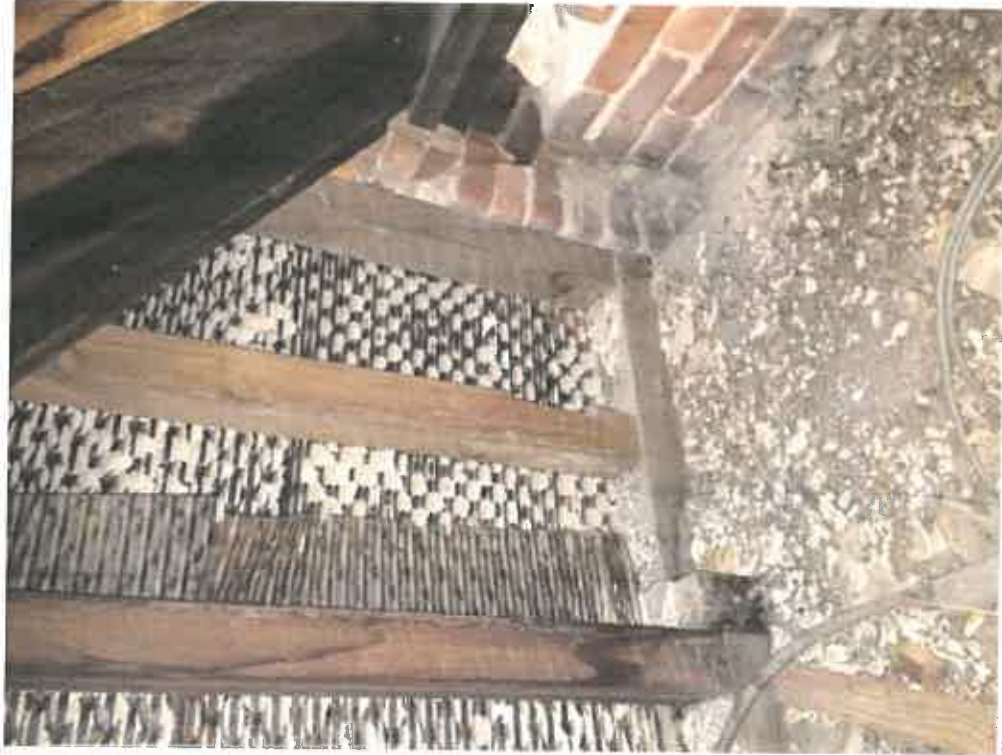
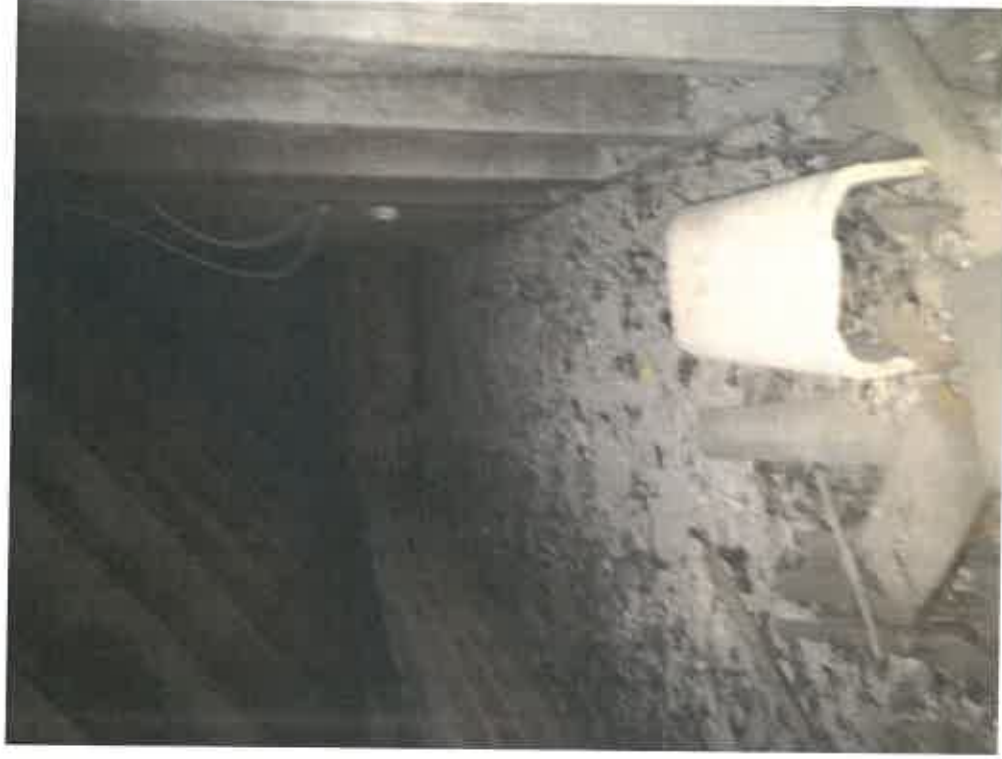
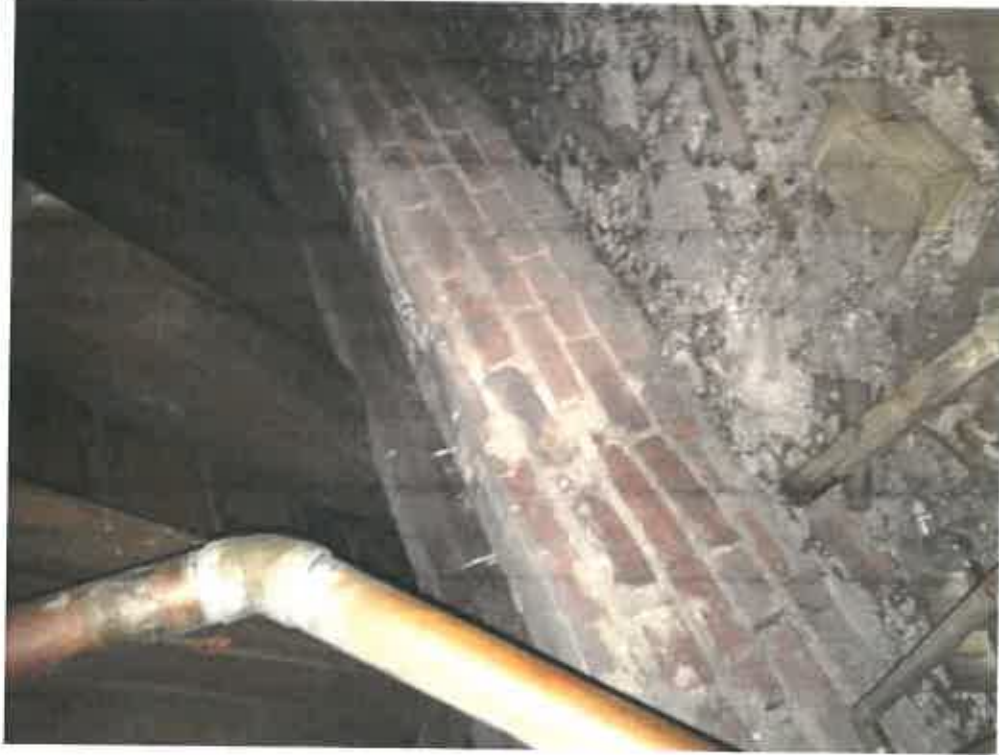
Photographs Numbered 57 through 59 show concealed areas on the interior that were known to have water leaks previously. In viewing these areas we did not find any of them with the apparent moisture, and believe the major leaking has still been stopped.

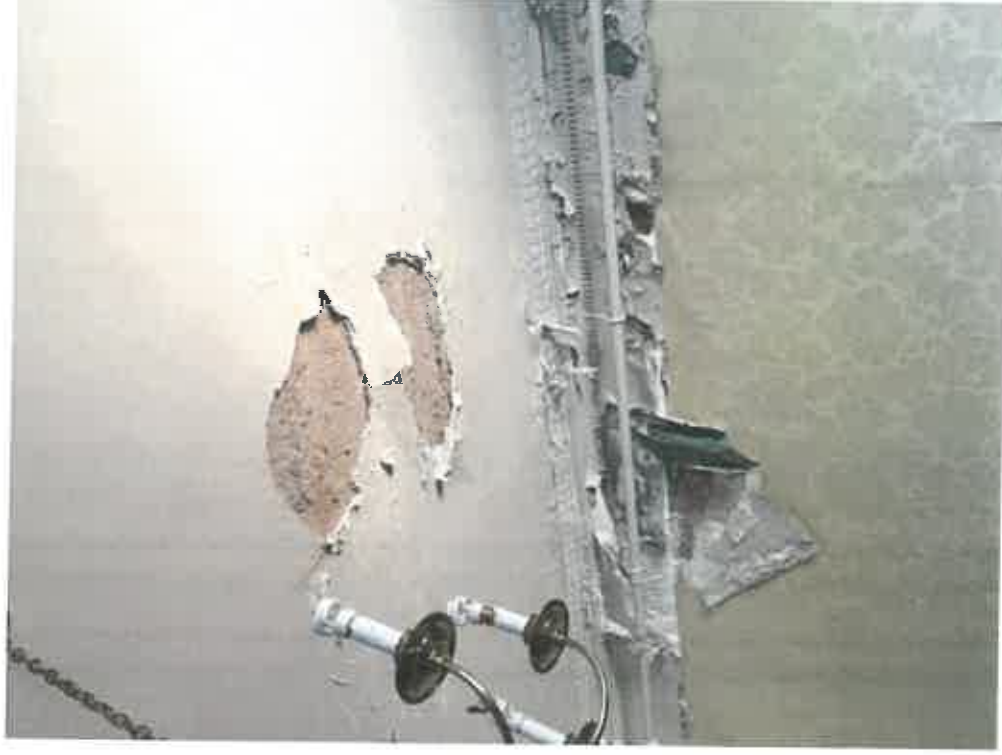
#60

Photograph number 60 shows one of the interior conditions that were compared to previous photographs on reports done earlier and do not appear to be significantly different.

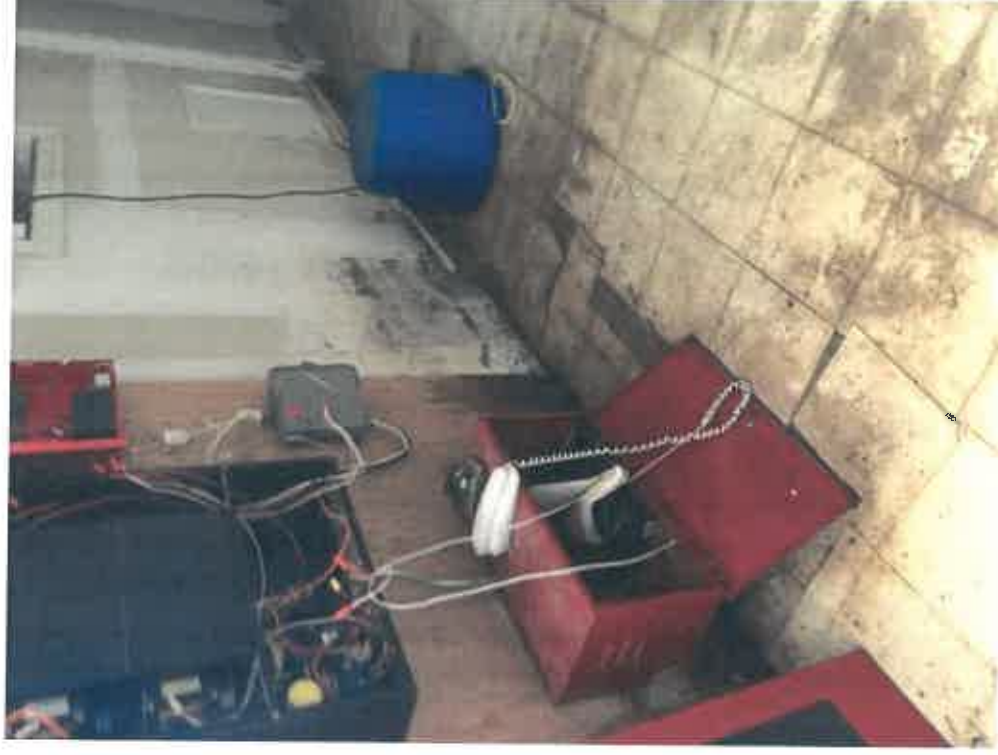
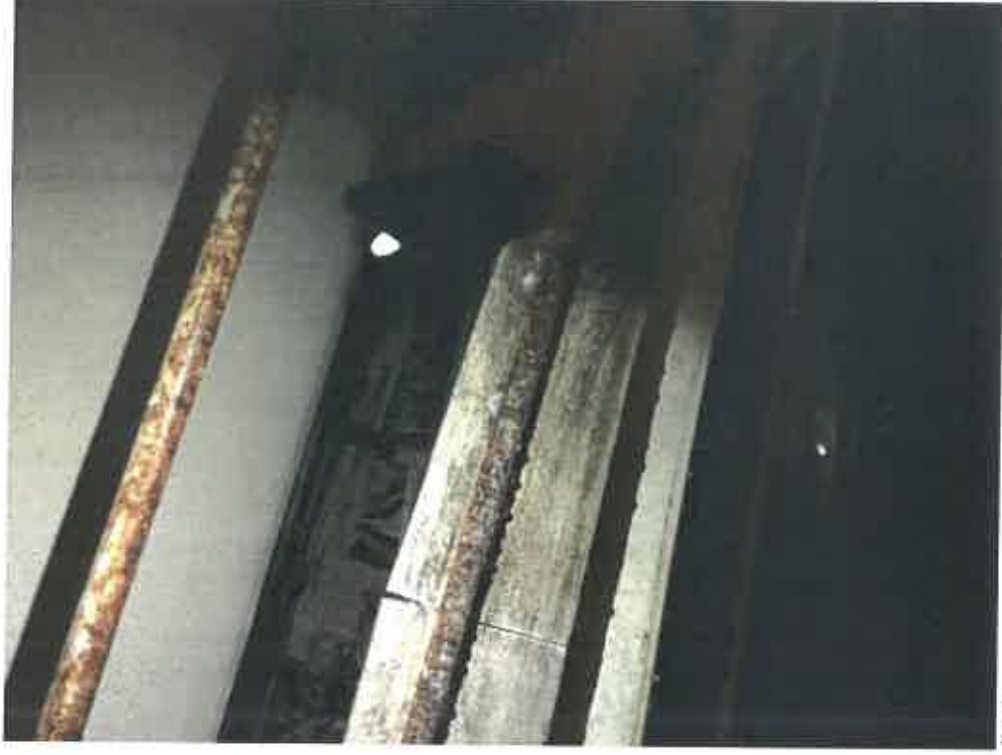
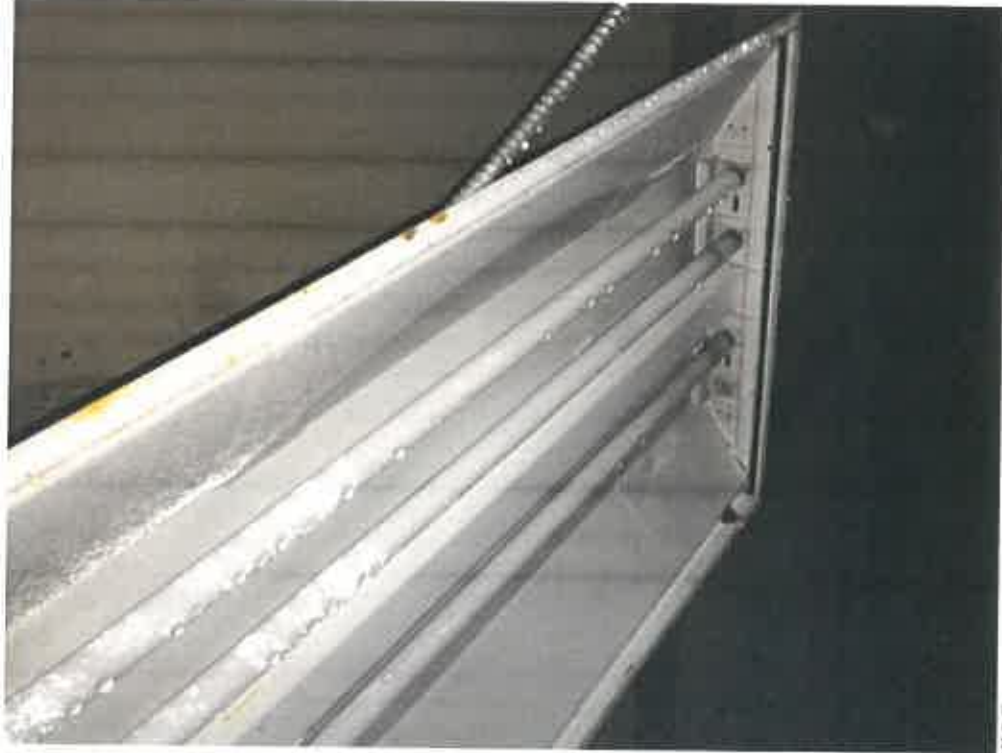
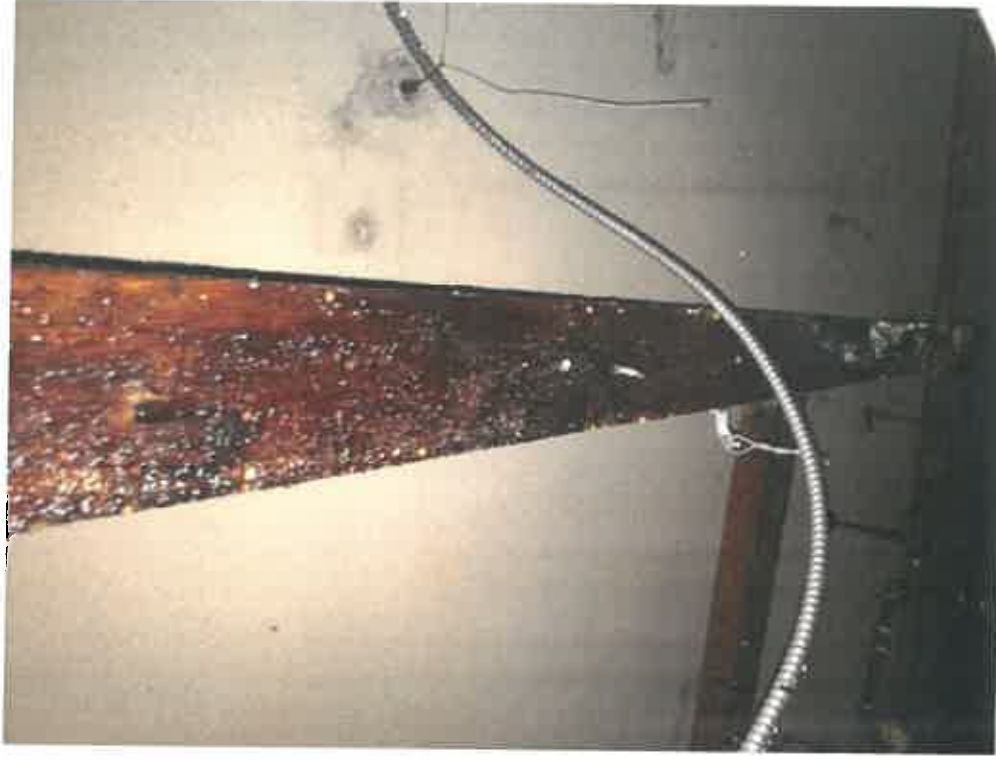
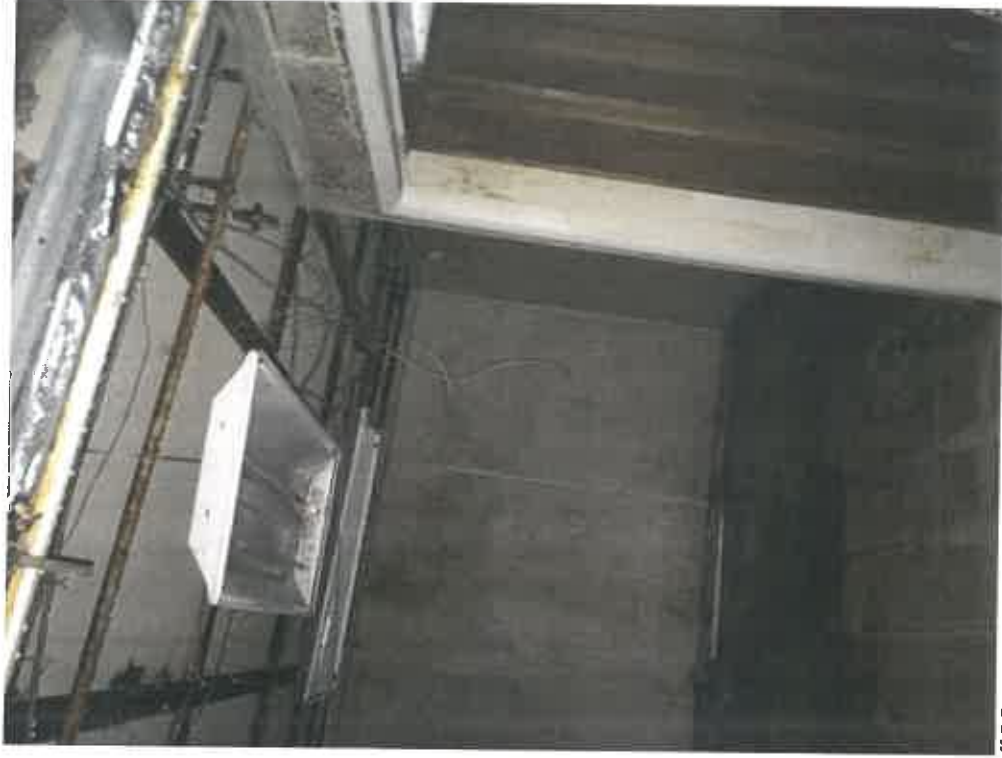
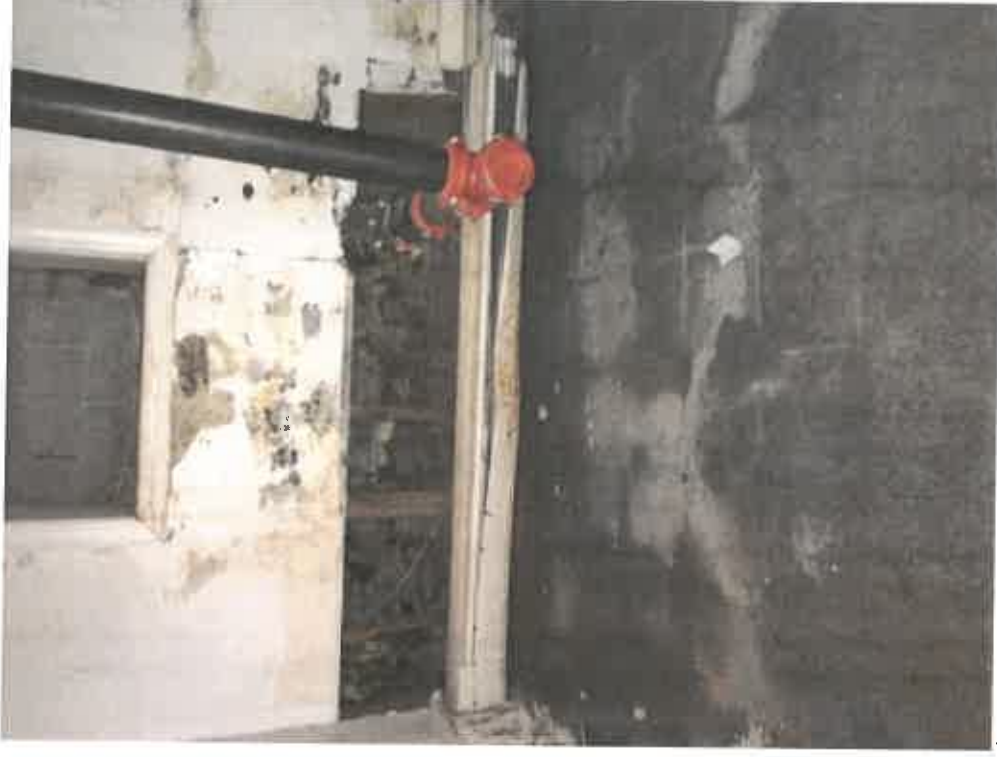
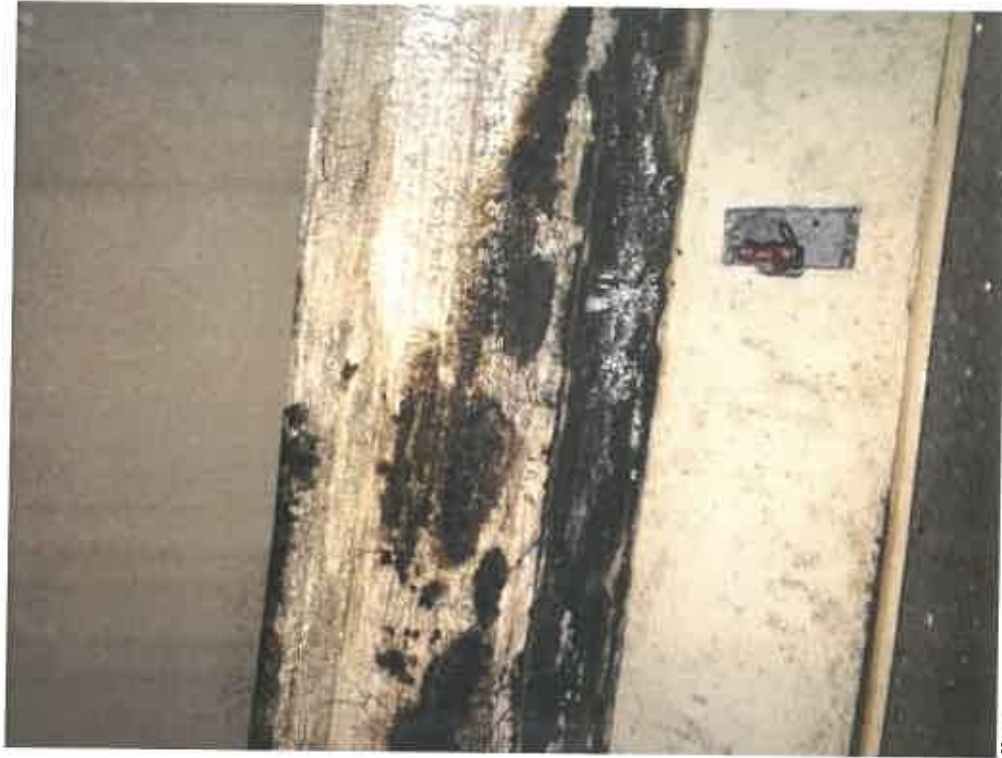
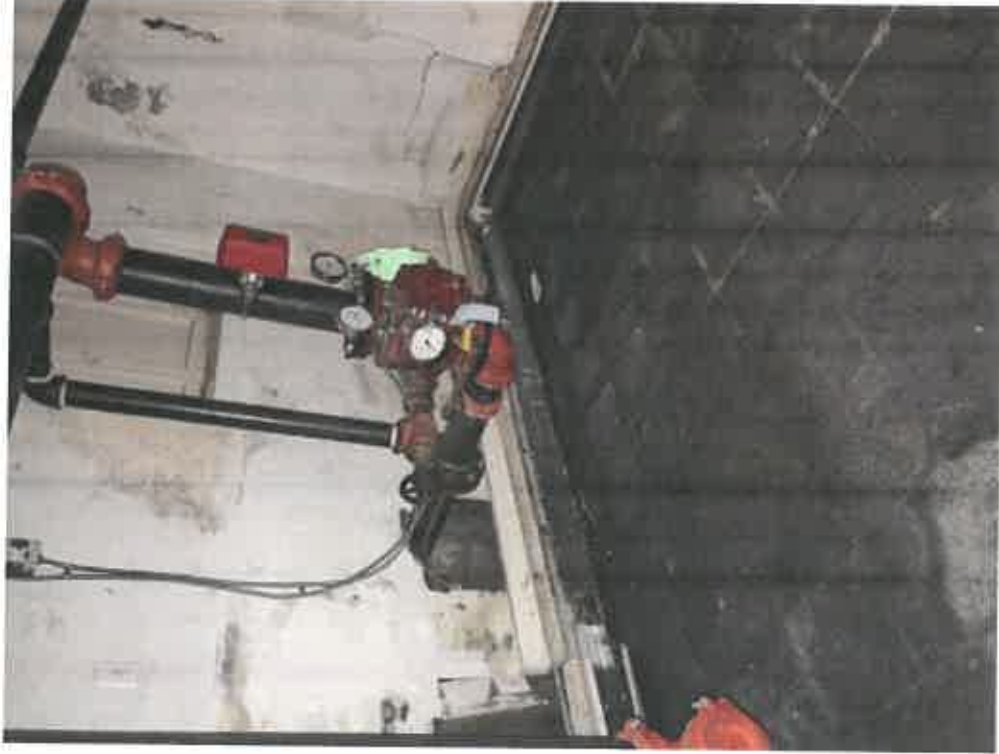
Photographs Numbered 61 through 74 show conditions on the sub grade portion of the building. There are extreme levels of moisture in this area as well as water that is running in around the perimeter of the basement. There is such a high level of humidity in this space that all of the overhead substrates and surfaces are dripping water. Water was dripping off of old light fixtures, steel beams, ceiling tile and other overhead surfaces. This is by far the worst condition that is affecting the building. Although no testing was done, we feel extremely confident that the mold present would not be conducive to having people in this area and would urge you to keep people out of here until such time as environmental test reports either confirm or refute this suspicion. The basement was one of the areas that was not addressed previously because of the significant cost associated with the remediation.

In reviewing previous budgets, which do not take into account damage that has occurred to the basement walls over the last couple of years, the hard costs exclusive of professional fees was in excess of \$300,000.00. We think this number would be higher today and any efforts going forward to attempt to salvage the building would need to be done after this has been accomplished, or it would not be wisely spent in our opinion. Once you have a direction on where you think they are going with this building long term, we could get some updated costs should you desire. We are preparing some order of magnitude budgets relative to bringing the portions of the building above grade back to where it was a couple of years ago and will send that under separate cover. Currently with the pricing that we have gotten back from firms who worked on this building previously, we are already at just over \$53,000.00 to correct the deficiencies from damage to the work that was completed a couple of years ago. This would need to have added to it, a budget for ongoing maintenance once this has been implemented, should they desire to have this done.
