City of Manassas, Virginia
Architectural Review Board Meeting

Architectural Review Board Meeting
9027 Center Street
Manassas, VA 20110
Second Floor Conference Room
Tuesday, November 14, 2017

Follow-up Site Observations

Project: Annaburg Manor Update Evaluation
Site Visit # 1

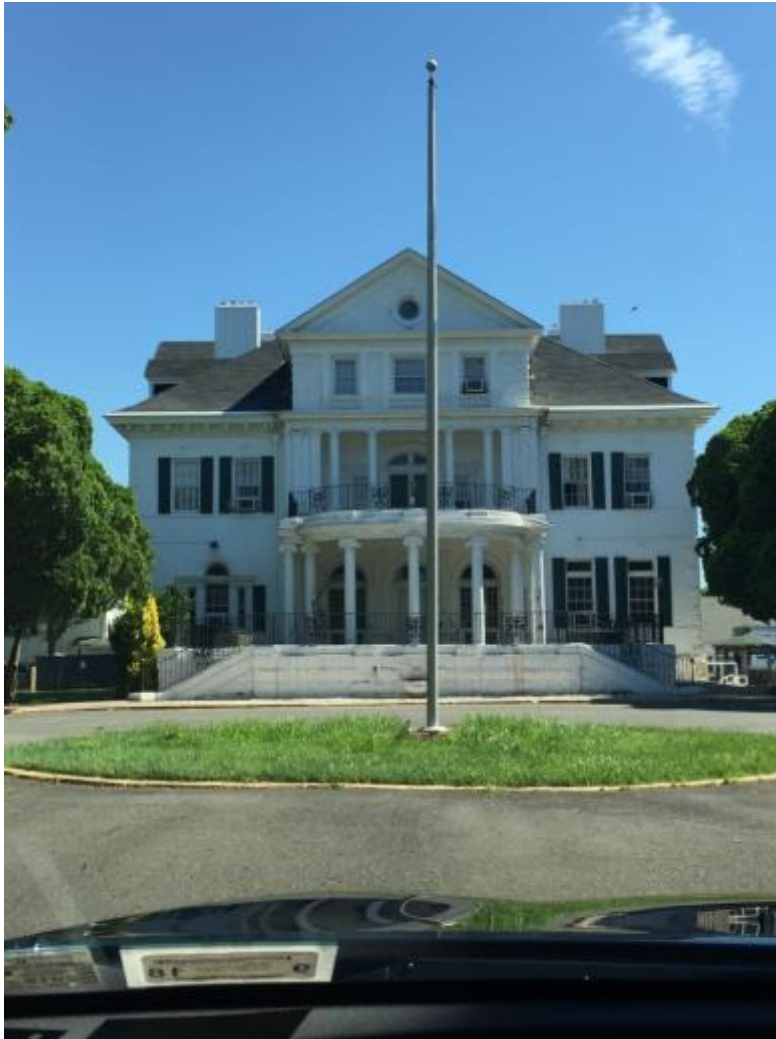
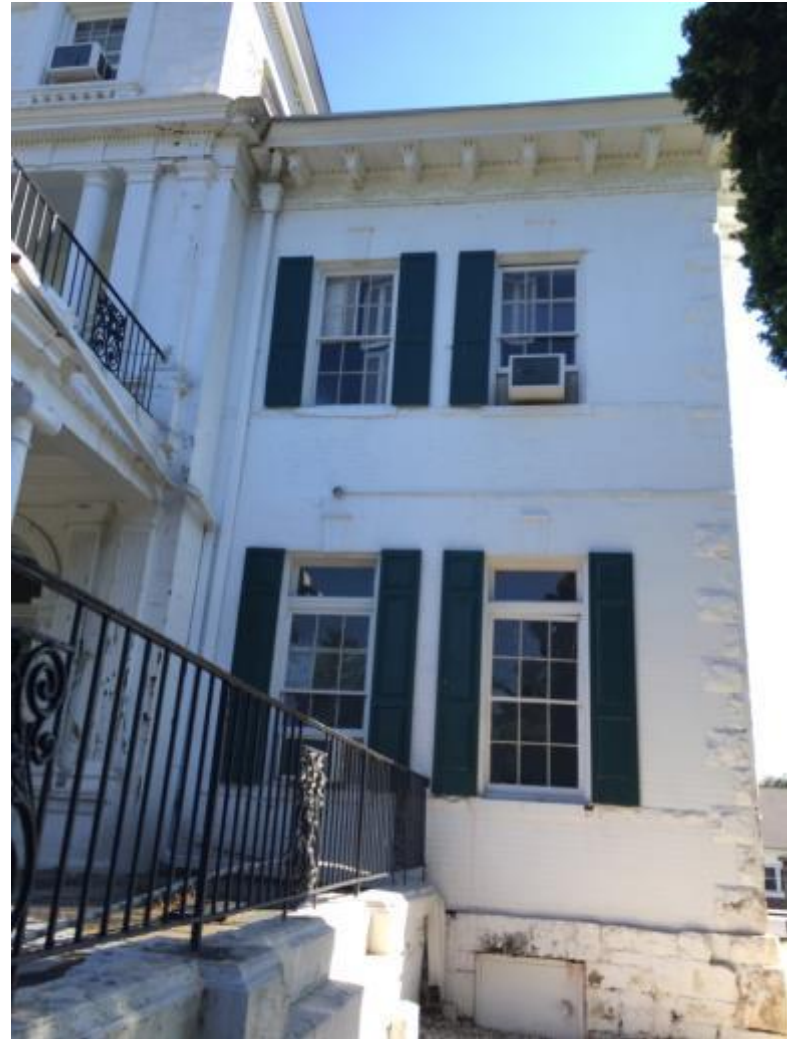
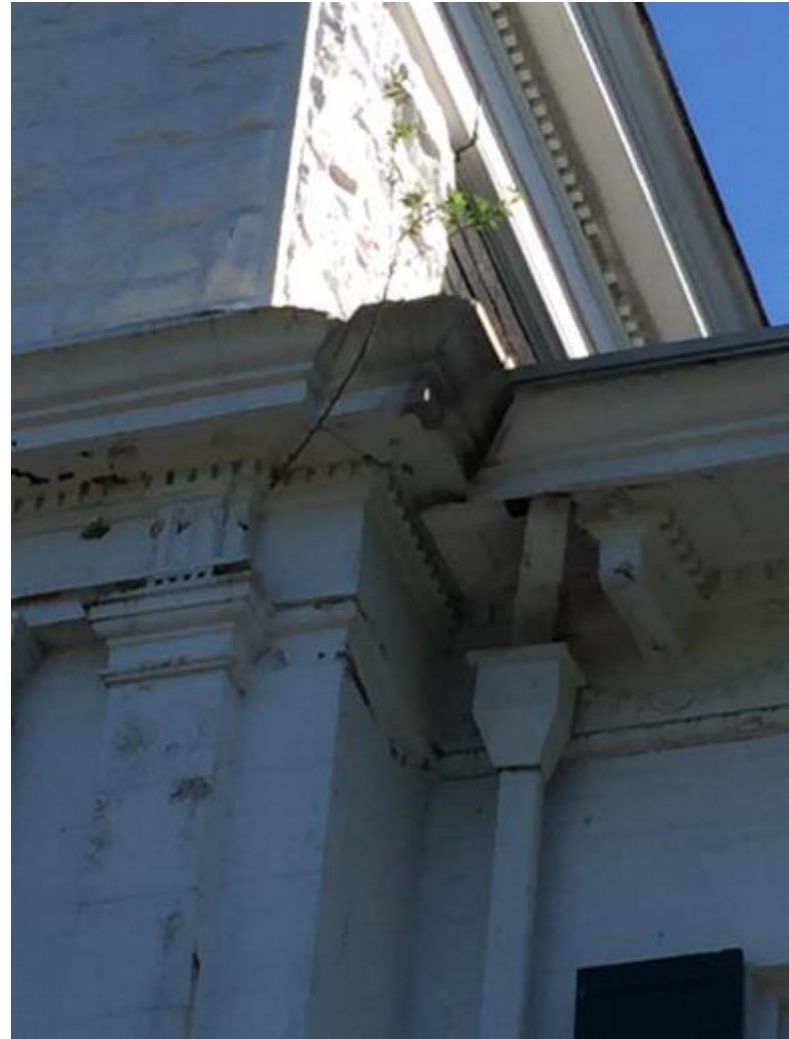
Photographs Numbered 1 through 4 identify the front elevation of the building. We were quite surprised to see the amount of deterioration on the cut stone portions of the façade as well as on the columns that support the terrace above. Photographs Numbered 5 through 12 show a closer view of some of this deterioration where it appears that water that is in the brownstone components is resulting in failure of the coatings, resulting in an extremely undesirable appearance of these areas.

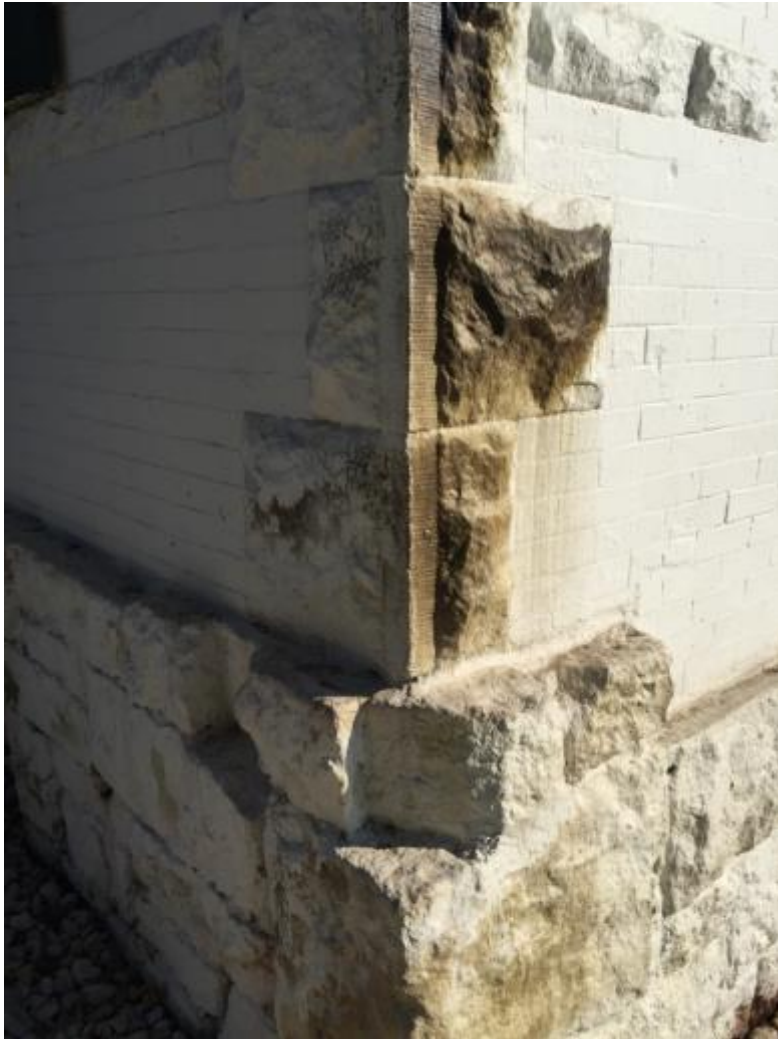
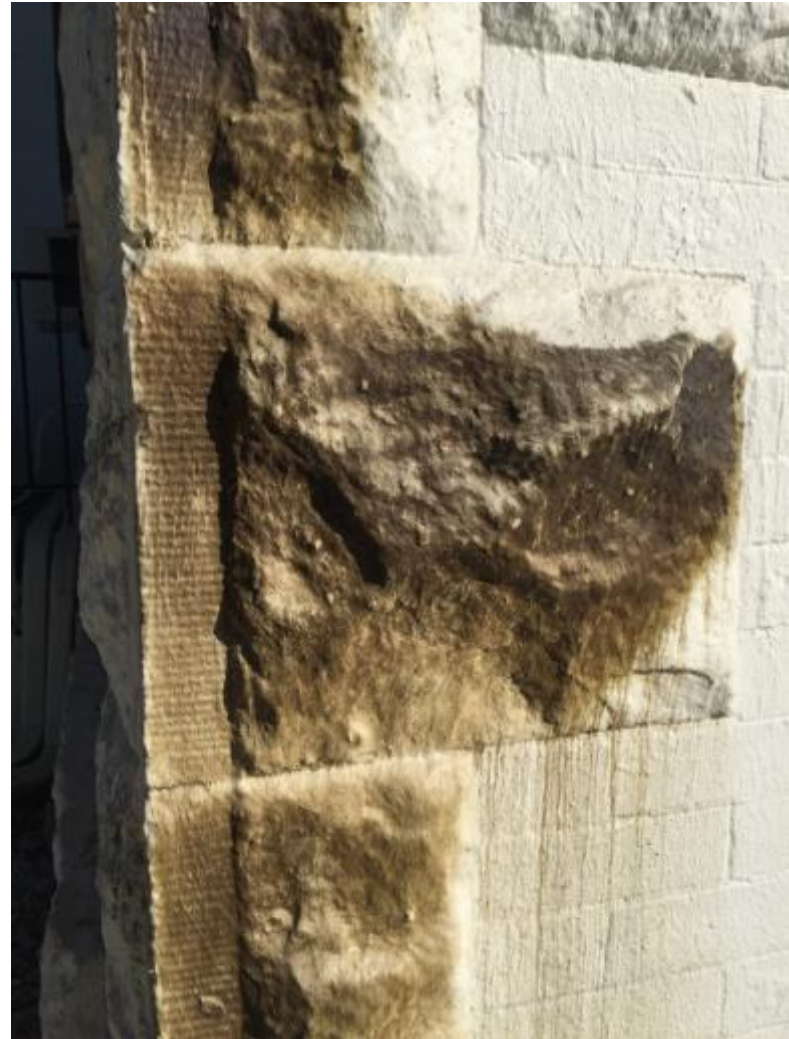
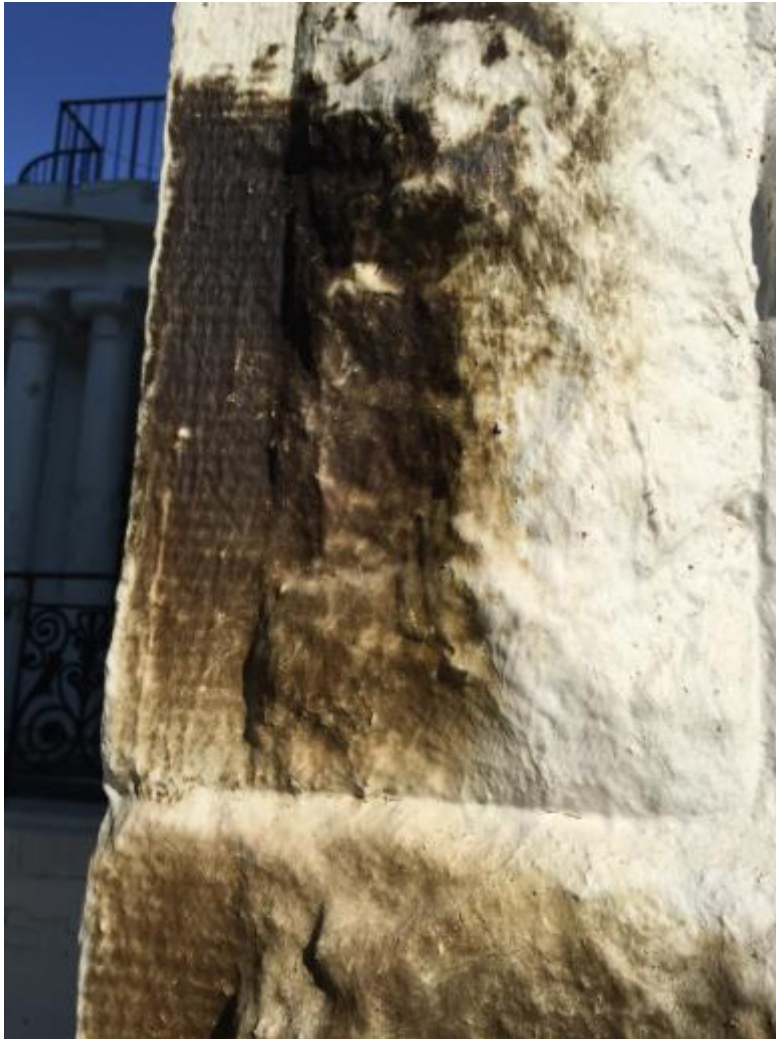
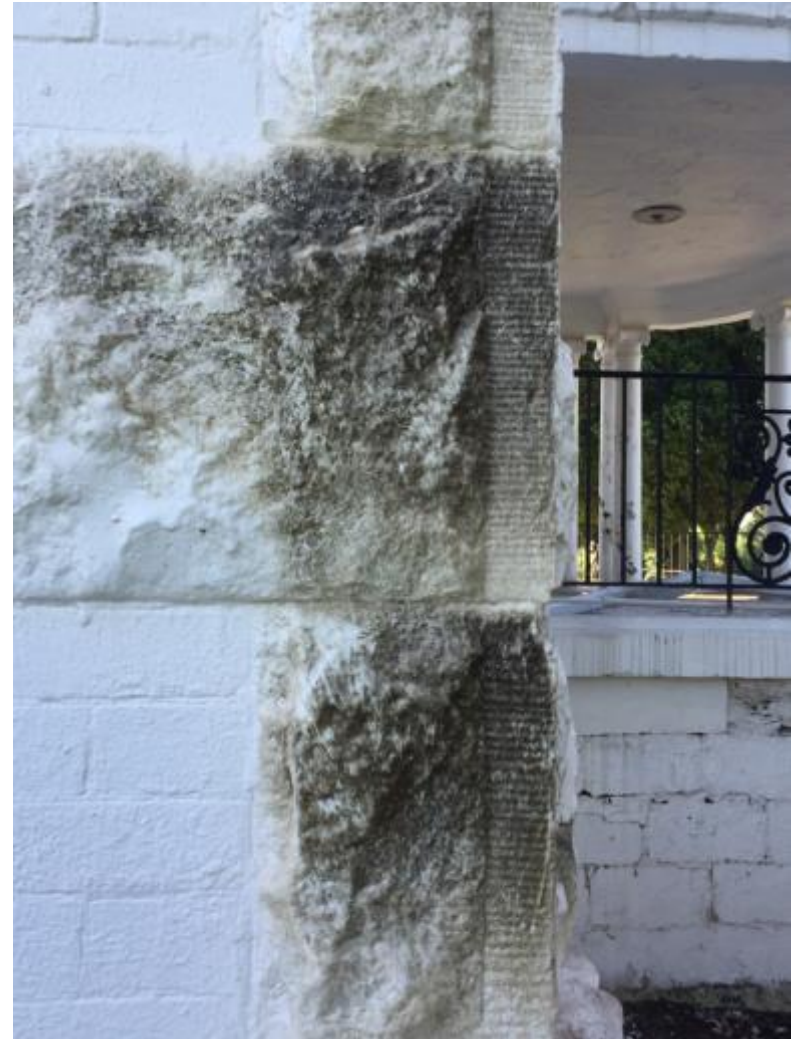
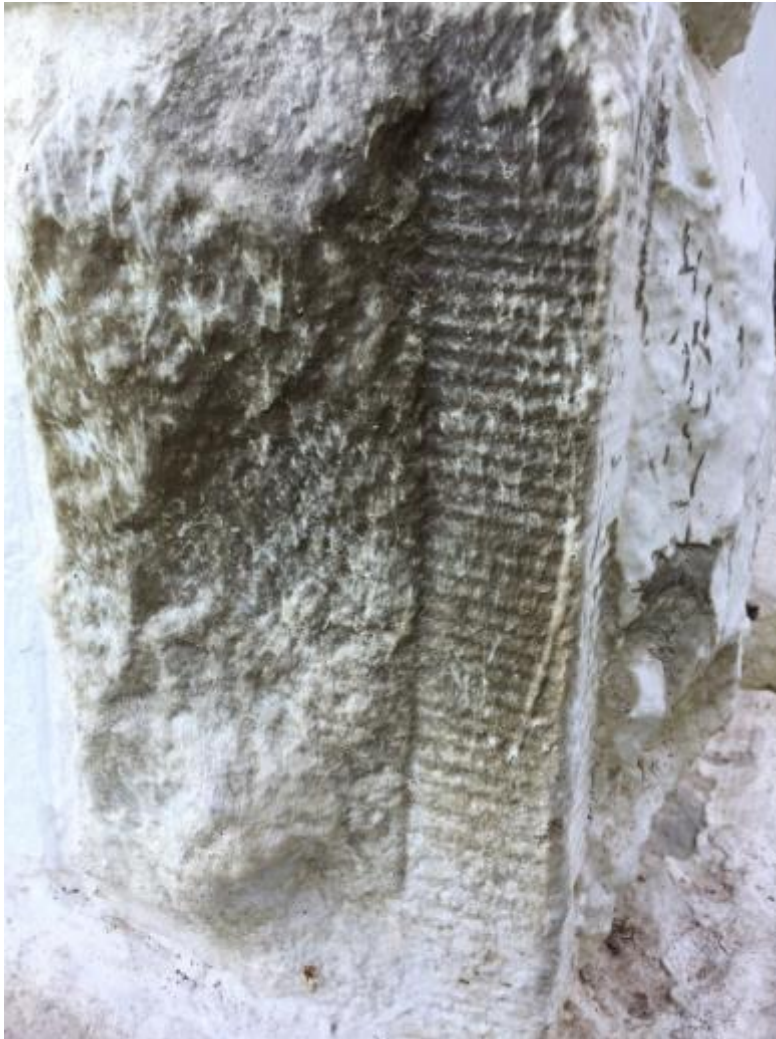
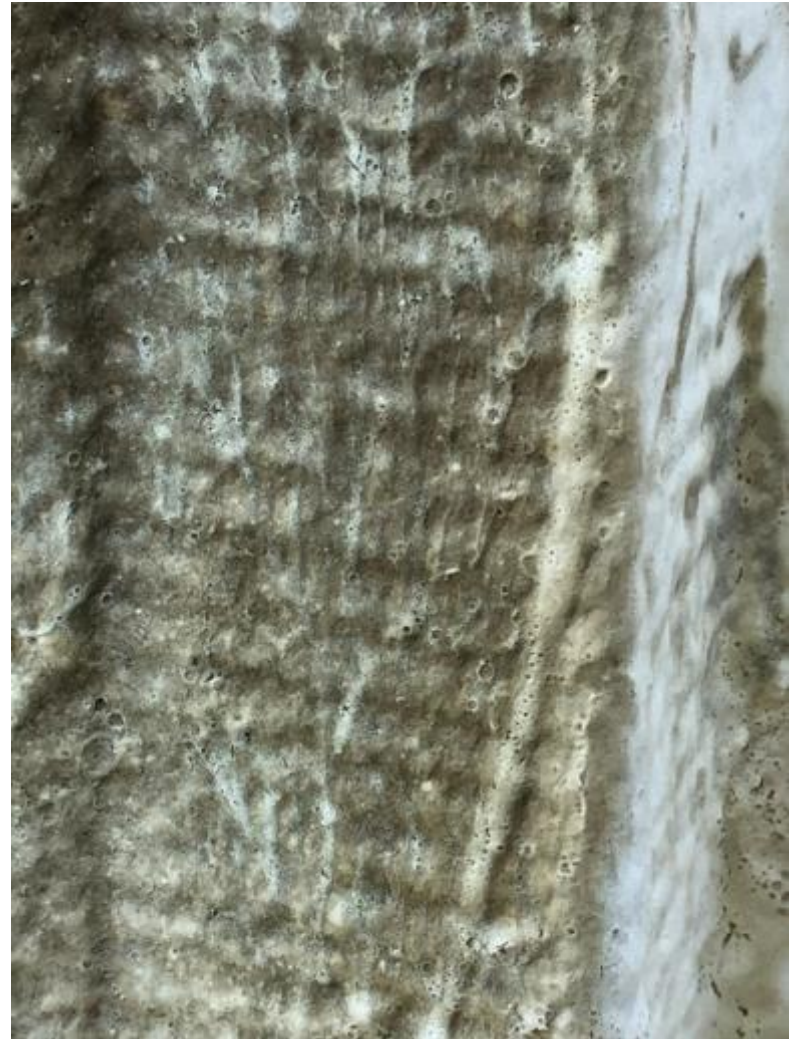
Photographs Numbered 13 through 18 identify the brownstone cornerstones in which some of them exhibited severe staining on the surface of the coating. The cause of this staining appears to be dirt pick up from water cascading down the corners as opposed to water that is behind the cornerstones. As seen in photographs later in the report, it does not appear that the coating has been compromised relative to its ability to protect brownstone in these areas.

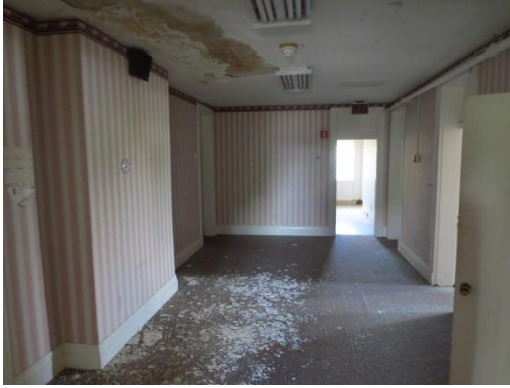
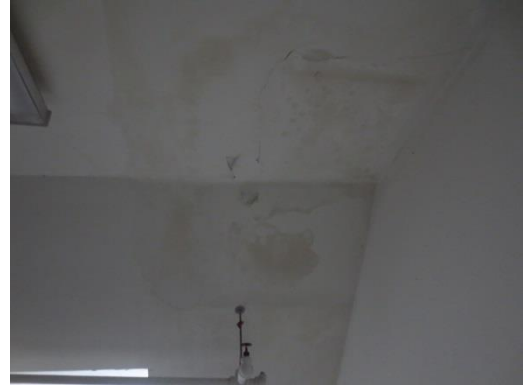
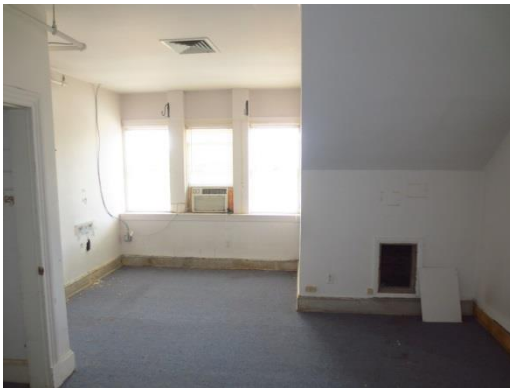
Evidence of water infiltration of the floors above the basement included observation of various areas of delaminating wall and ceiling plaster throughout the building primarily near the exterior walls. On the third floor, larger patches of ceiling plaster were delaminating and water stains were observed on carpeting indicating potential roof leaks. Water and mildew staining and was observed on the wood beams and ceiling of the attic. It is unclear if these conditions have worsened since the 2013 inspection.

Third Floor

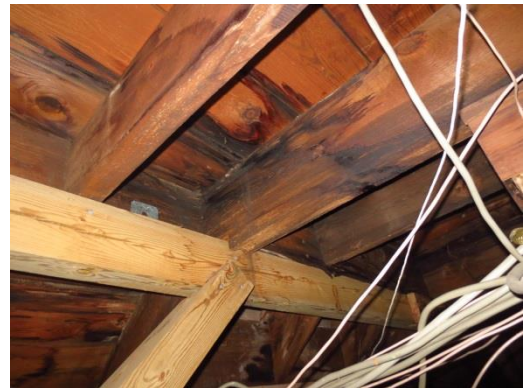
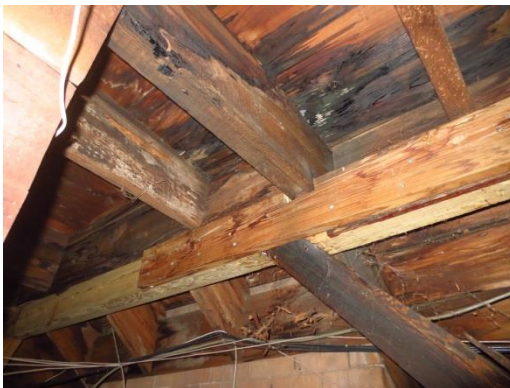
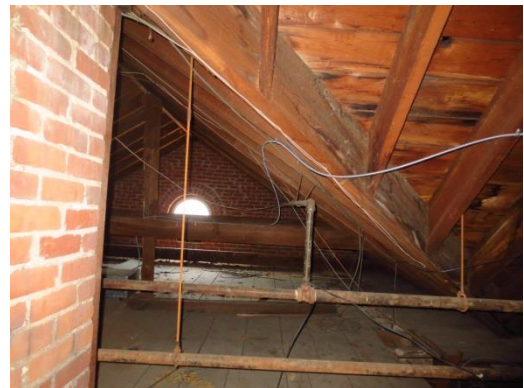
Attic roof wood sheathing and wood beams at the highest point adjacent to the brick chimney were identified wet through the use of the IR camera. The affected area is several square feet in area and visibly appears water stained and discolored.

Attic

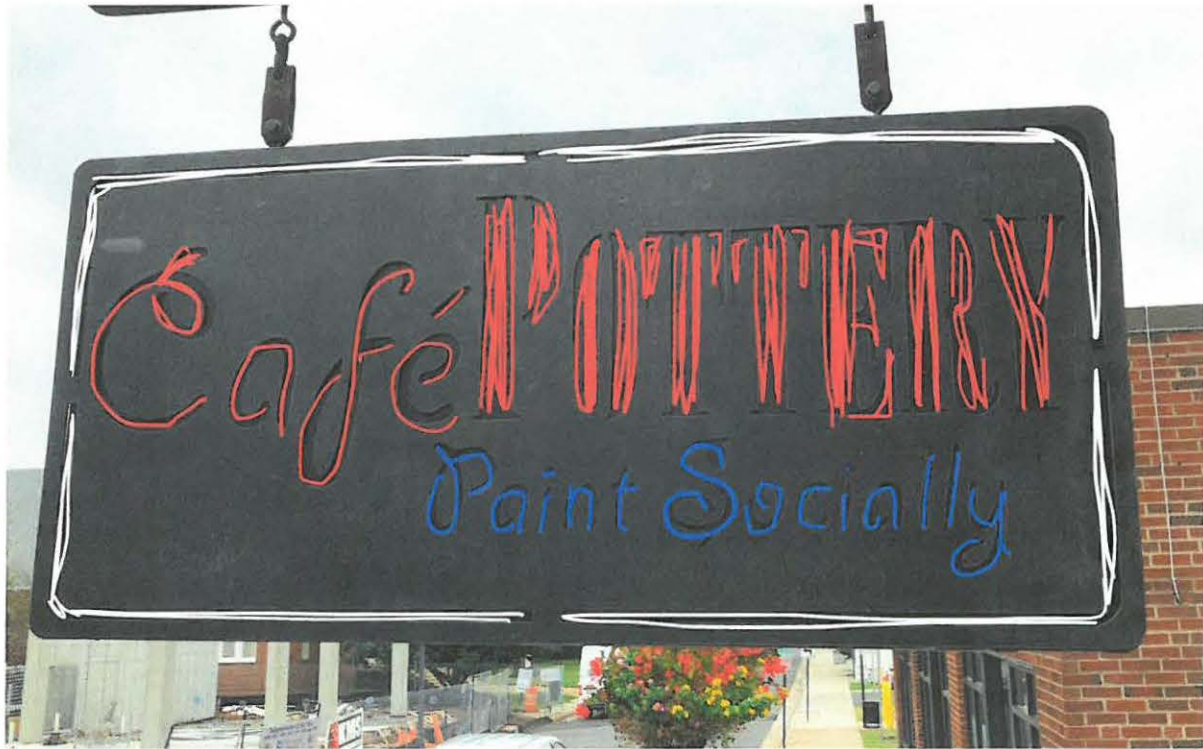
Cafe Pottery Signage

Proposed color changes to make sign readable from the road.

The current ARB approved hanging sign installed by Cafe Pottery at 9019 Center St. appears to be too dark and the lettering is not adequately visible for passing traffic. Above is a rough rendering of the proposed color changes. A white boarder, red to fill 'Cafe Pottery' and blue to fill 'Paint Socially'. The color chips are attached of actual colors to be used. I am seeking Administrative Approval for this request.
