City of Manassas, Virginia  
Architectural Review Board Meeting

AGENDA

Architectural Review Board Meeting  
9027 Center Street  
Manassas, VA 20110  
Second Floor Conference Room  
Tuesday, September 12, 2017

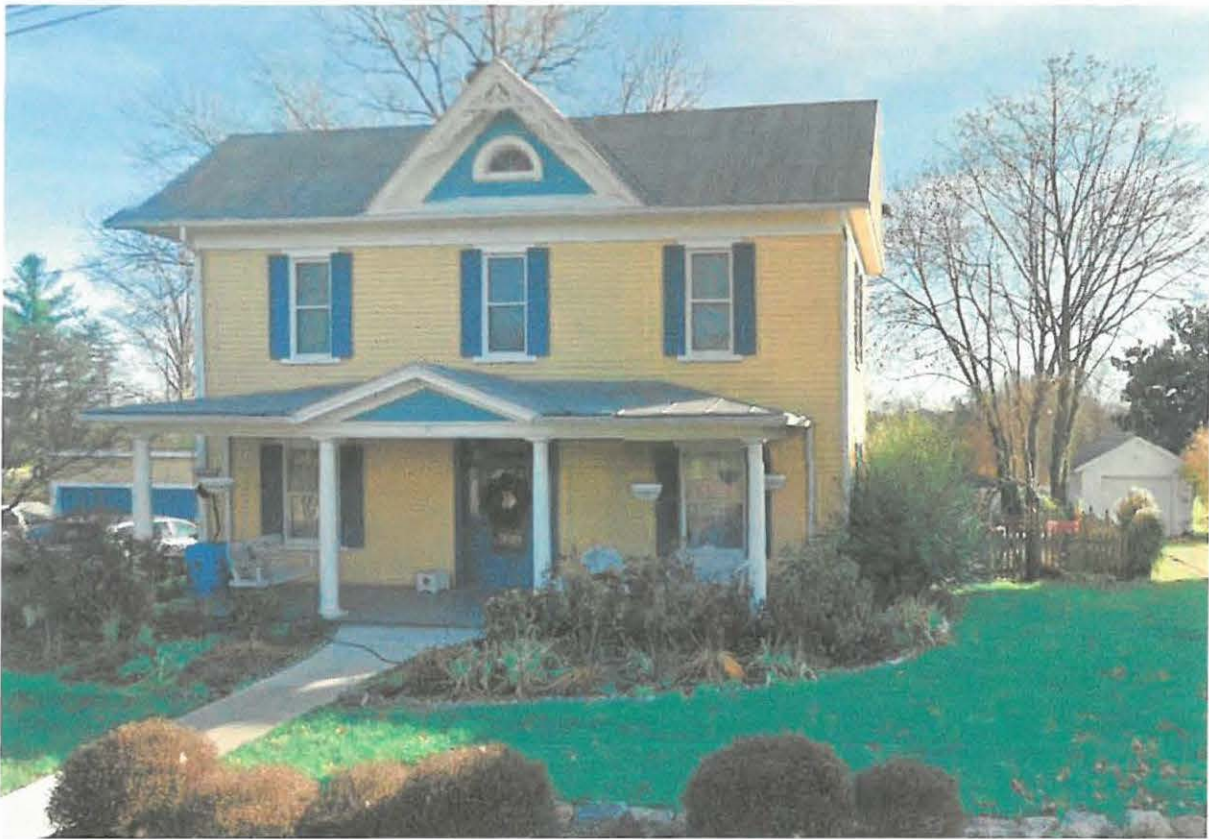
EXISTING FRONT ELEVATION

Siding: Hardy Smooth Lap  
 Trim: Hardy Smooth Plank  
 Windows: Pella Imperva  
 Doors: Pella French  
 Roof: Atlas International Staing Seam  
 Foundation: Ply Gym Cut Cobblestone

Note: All new materials will match existing texture, color, finish, and size.

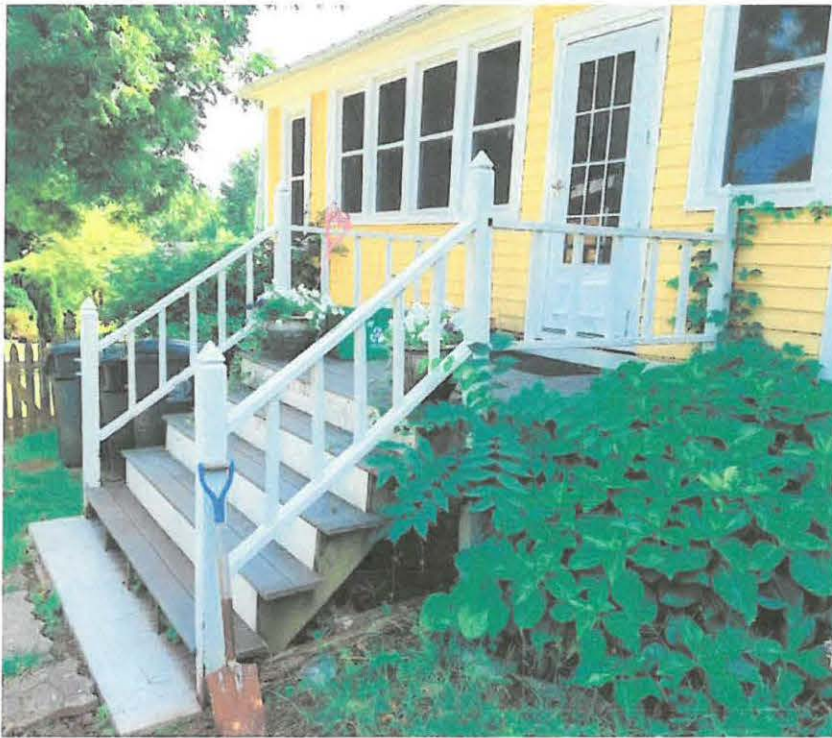
EXISTING PORCH TO BE COVERED

EXISTING RIGHT ELEVATION
