City of Manassas, Virginia
Architectural Review Board Meeting

Architectural Review Board Meeting
9027 Center Street
Manassas, VA 20110
Second Floor Conference Room
Tuesday, July 11, 2017

ARB Case: 2017-36
Applicant: Rob Posch
Address: 9325 Battle Street

Rehabilitation of 9325 Battle Street

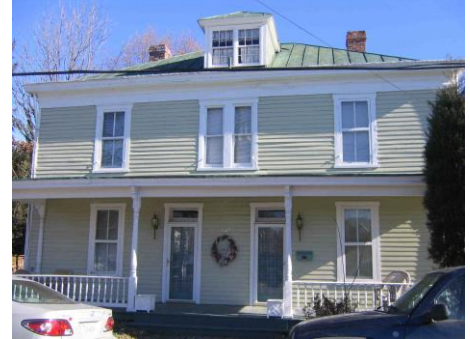
The applicant is requesting approval for several items, included replacement of the existing wood siding, modification of the exterior elevations, including door, window and light placements. In addition, the request includes modifications to the rear addition, to include the modification of the roof line, removal of an enclosed porch and the addition of a deck. The applicant is also evaluating modifications to the structures trim work and guttering system. Items that may be the subject of additional Board review in the future include the roof and front porch columns.

Historical Significance – Set on a stone foundation, the two-and-one-half story, four-bay twin house is ornamented with minimal Queen Anne-style detailing and Colonial Revival-style adornments. It is wood framed construction clad in weatherboard siding. It is covered by a standing-seam metal roof with two symmetrically located brick chimneys and one hipped dormer. The overhanging eaves have a boxed cornice with a molded, double frieze. The one-story, four-bay porch is covered by a flat roof with overhanging eaves, ogee cornice, and plain frieze. It is supported by turned posts and balusters. Fenestration consists of 2/2 and 6/6 double hung wood sash windows and a 1-light transom overt the two wood panel entrance doors. A one-story, four bay wood frame addition is asymmetrical, and attached to the rear, east elevation. It is covered by a shed roof and has tripartite window with 8-light fixed wood windows flanking a 6/6 double hung wood sash window. An excellent, intact, example of a twin dwelling, the building is ranked notable and is contributing to the National Register historic district.

For the benefit of the Board, staff wanted to provide a brief summary of this project. The applicant is undertaking a significant rehabilitation project of the structure, which has fallen into disrepair. Currently, the site has been issued a demolition permit for interior non-structural work, providing the applicant the opportunity to begin demolition work and further evaluate the condition of the structure. As with any residential project containing interior alterations, building plans and permits from the City will need to be secured by the applicant to complete the rehabilitation of the interior of the structure.

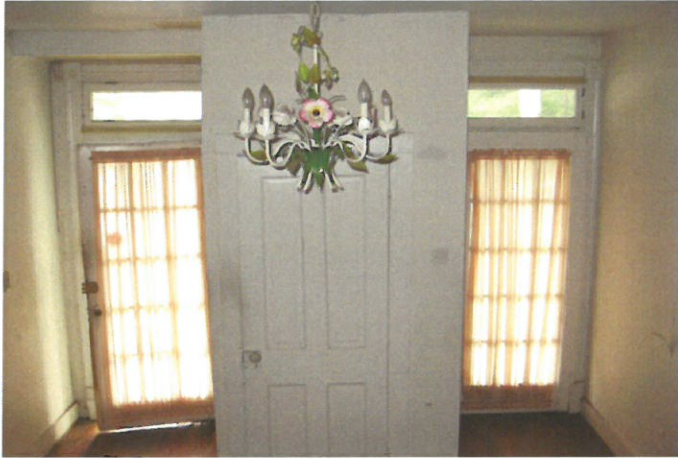
Front Door (transoms taped, floor rot, door rot)

- **Doors** – The application proposes modification and replacement of both the front and rear doors. Action for the Board at this month's meeting is for approval to modify the front elevation from a dual entry to single entry, and modification of the location of the rear entry. The applicant has discussed reuse of an existing 15-light door for the rear entry; however the specifics of the door units will be brought back before the Board for approval at a later meeting. The applicant has indicated the trim work around the existing dual front doors would be saved and reused to trim the new single front door.

The applicable design guidelines for doors are found on pages 64-66 of the City of Manassas Historic District Handbook. The guidelines generally state that doors should only be replaced when they are missing and beyond repair. Original doors should be retained and can be weather-stripped. With the function of the structure changed from a duplex to a single family home, the applicant has proposed a new single entrance that is sympathetic to the structure. This includes the use of a paneled door with transom above respecting the existing doors, as well as the placement being centered on the elevation respecting the symmetry of the home. While the applicant is proposing to removal of the original dual entrance, staff believes the design of the door that has been submitted by the applicant is appropriate from a design perspective. The applicant will need to come back to the Board with the manufactures specification for the door at a later meeting date to gain final approval.

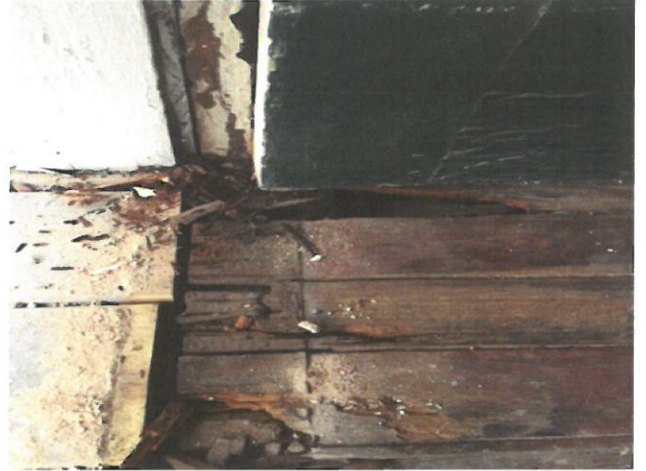
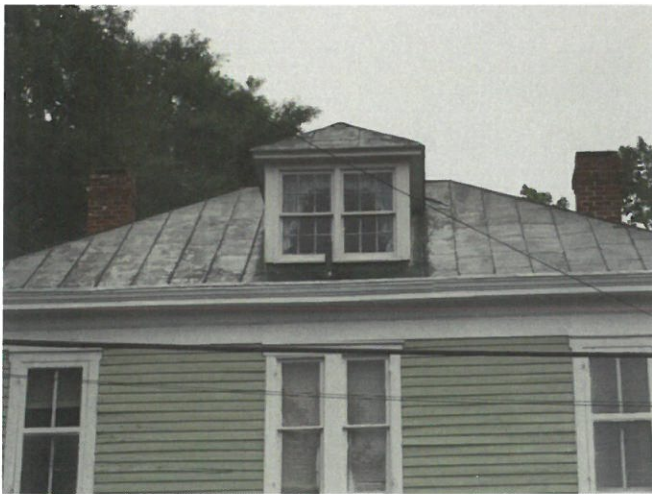
Both the roof and flashing is rusty beyond repair. Additionally, there are leaks at all the flashing which has caused extensive water damage in the home. We are proposing to replace the roof. We are currently in the research and discovery phase and will share recommendations at this or the next board meeting when we have finalized our research.

Roof

- **Roof** - The roofing material of the rear addition is currently proposed to be changed from the existing corrugated sheet metal to a standing seam metal to match the primary roof. The applicant is still exploring options for roofing material on the primary roof. A like for like replacement would be considered maintenance and not require Board approval, however if the applicant were to change the design, material, etc., it would need to be brought back to the Board for approval and coordinated with the rear addition.

Recommendations for roofs can be found on pages 51-54 of the Historic District Handbook. The applicant is proposing changing the roofing material of the rear addition from the existing corrugated sheet metal to a standing seam metal to match the primary roof. While the guidelines recommend keeping the roof material unchanged, the existing roof to the non-original addition would not be original to the structure as it does not match the existing standing seam metal roof on the majority of the structure. Staff finds the proposal to change the existing standing seam metal roof to match the balance of the structure to be in keeping with the Historic District Design Guidelines.

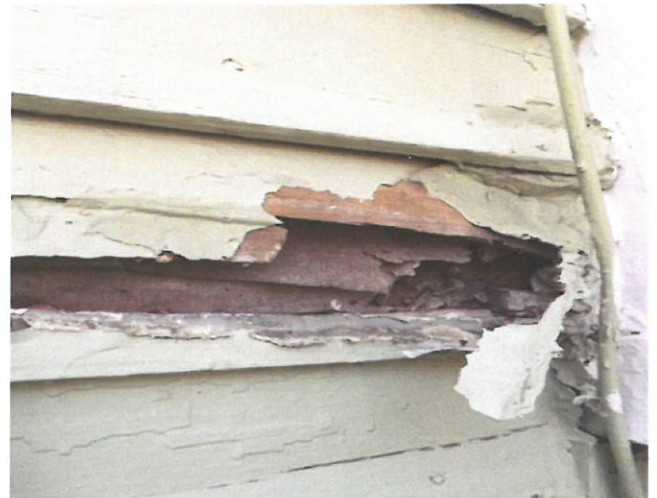
The home in its current state is inhabitable. Over the years, this home has fallen into serious disrepair. Exteriorly, the majority of the wood siding is rotten and animals have gained entry creating holes that go through the interior of our home. Interiorly, there is a great deal of damage to the home. The property "as-is" does not add appreciating value to the community, or to other homeowners in the area. Additionally, our home is in close proximity (one block) to the downtown shops and restaurants and many visitors park along the residential portion of Battle Street. We want to ensure that they see beauty and history in every part of the town. In our short week at the house, we have had numerous neighbors and other local homeowners stop by and thank us for fixing up the home.

Siding

- **Siding** - The structure's existing wood siding is in significant disrepair in several locations. The applicant is proposing to replace the wood siding with HardiPlank. In addition, the applicant is proposing the addition of a band board along both side elevations that tie in the front porch and rear addition roof line.

Recommendations for building materials can be found on pages 91-110 of the Historic District Handbook. The applicant is proposing the removal of the existing wood weatherboard siding, to be replaced with Hardi Plank Siding. Based on information from the application on the structures exterior siding is in a deteriorated condition. The proposed Hardi Plank siding has previously been approved in the Historic District. The clapboard style is in keeping with the current wood weatherboard. The applicant is proposing a band board along both side elevations that tie in the front porch and rear addition roof line. Staff finds the applicants proposal to be in keeping with the Historic District Design Guidelines and Clapboard Supplement. The applicant is continuing to explore the condition of the structure's trim to discuss in more detail at the meeting. In speaking to the applicant, it sounds as though the existing wood trim can be retained around the doors and windows, but other elements of trim are in poor condition. Staff would recommend as part of the discussion, the Board consider the consistency of material (i.e. if the Board would permit different sections of fascia using different materials).

We are proposing to replace the siding with Hardie Plank. As we understand, the ARB is familiar with this material. We are also proposing to do a two-color scheme (two tones of same color – to be determined). The front porch will be the dividing line of color in the front of the home.

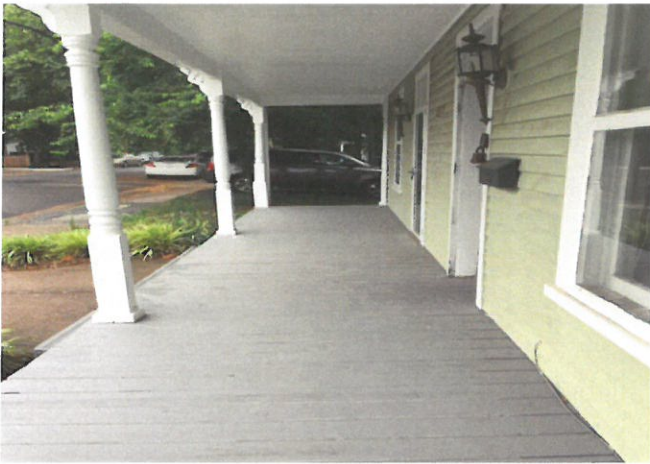
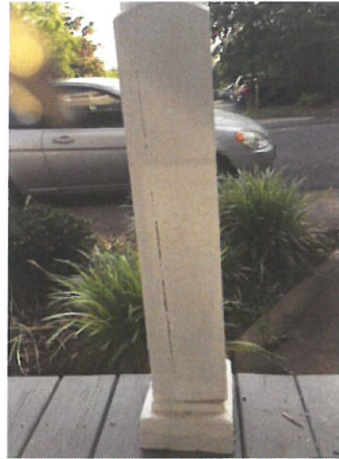
It is our intention to salvage these columns. However, we also wish to note that there are several cracks running through them and they have been repaired a number of times including reinforcing the bottom of two of them. These columns also support the roof of the front porch – one of the columns on the left appears to be sinking causing the left side of the roof to sag. We would like to revisit this once we have determined whether or not we will need to replace them.

Columns

- **Lighting** - The existing front porch lights would be relocated, as show on the plans, to flank the new single door entry.
- **Porch Columns** – The applicant is currently evaluating the condition of the front porch columns. If it is determined the scope of work would be more than just repair/maintenance, changes would need to be brought before the Board for approval.

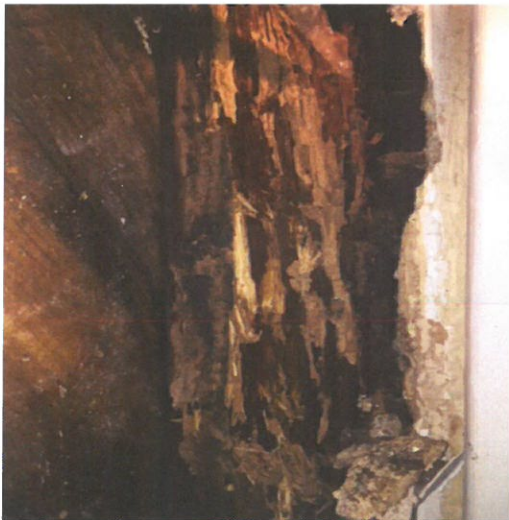
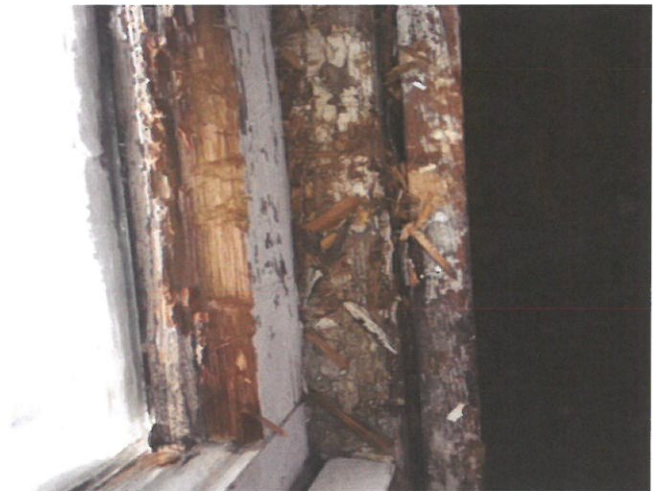
The majority of the windows have wood rot or are simply falling apart and we are proposing to replace them. We are currently in the research and discovery phase and will share recommendations at the next board meeting when we have finalized our research.

Windows – support beam adjacent to window water damaged and rotting – another window with wood rot

- **Windows** – The applicant has indicated the structure's existing wood windows are in disrepair. Action for the Board at this month's meeting is for approval of window sizes and placements (including window removals along the rear elevation). The specifics of the actual window replacement and units will be brought back to the Board for approval at a later meeting.

The building is not new construction, so applicable design guidelines for Windows can be found in the Historic District Handbook, pages 55-63. The guidelines indicate that original windows should be repaired and should only be replaced when they are missing or beyond repair. The applicant has indicated the existing windows are in need of replacement. The applicant has also submitted some photos which show a deteriorated condition. While the specifics of window replacements will be discussed in more detail at a later meeting date for final approval, staff would like to get approval for the location of the window openings, specifically the removal of windows along the rear elevation. The windows proposed for removal are located on a rear addition that is not original to the house, nor readily visible from the public street. Staff finds the proposal to remove the rear windows to be in keeping with the Historic District Design Guidelines and Window Supplement.

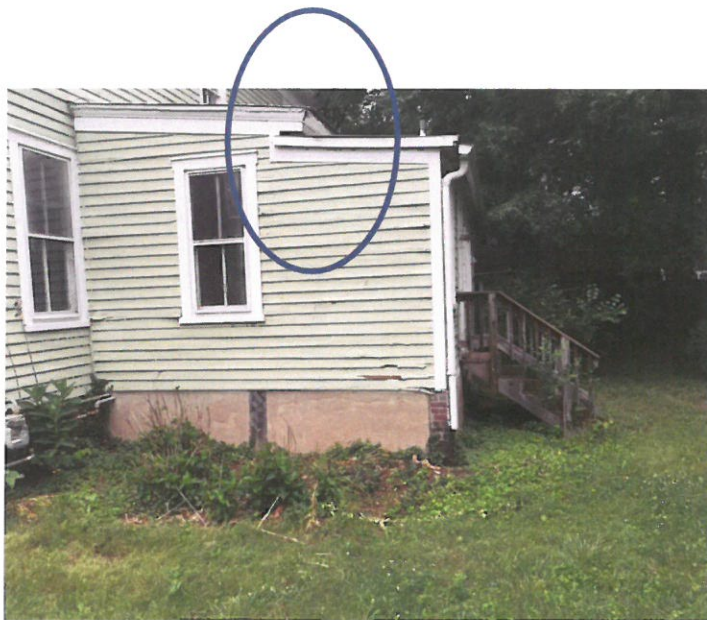
Two additions were constructed in the rear of the home. Because they were built at two different times, the roofline is has a step. The roof is currently corrugated metal over plywood and is leaking. We propose to create one single roof line.

Stepped Roof

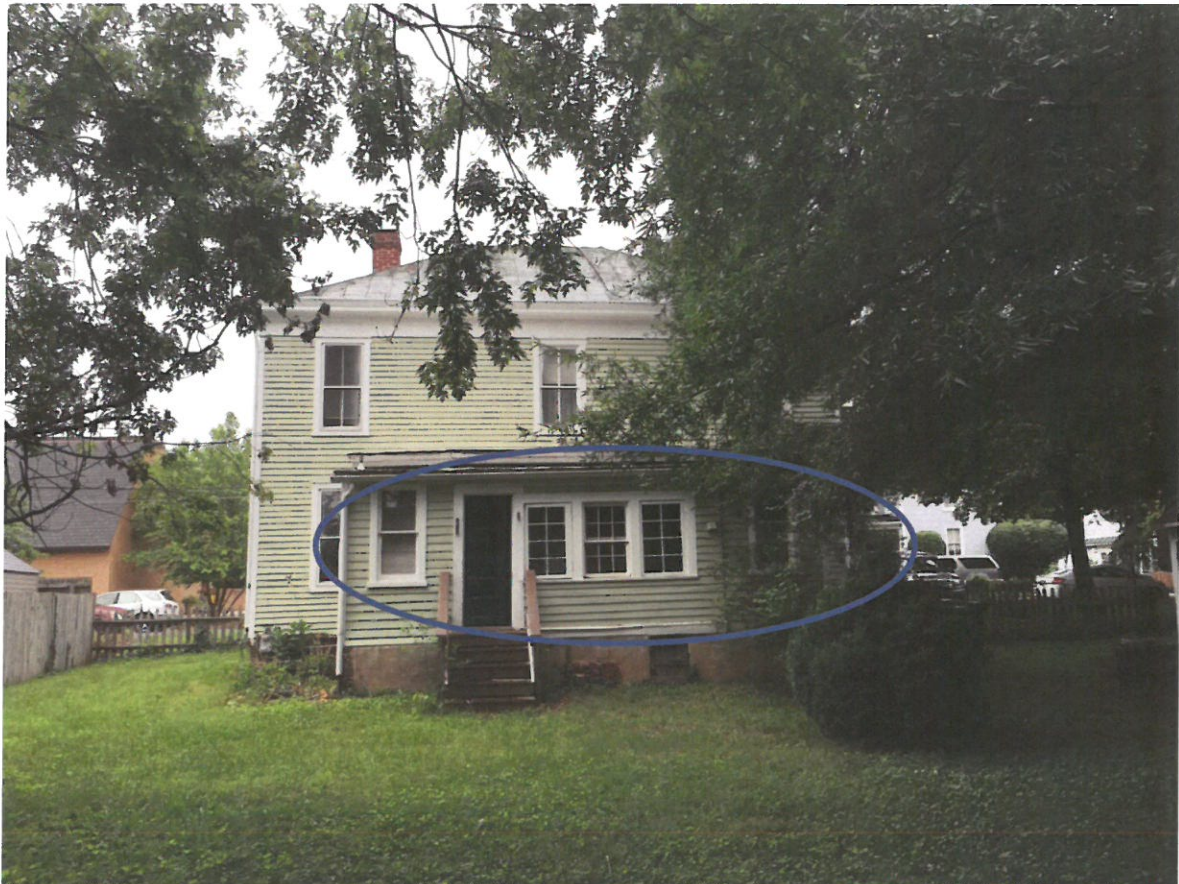
We proposed to remove two windows from one of the additions made to the home. This is not part of the original circa 1900 structure and the windows do not match the original structure. One window is in a closet; the other in a utility room - both which are not practical.

Rear photo of home – mismatched newer windows (1/1, 4/4 and 6/6)

Recommendations for porches can be found on pages 72-75 and recommendations for additions can be found on pages 111-112 of the Historic District Handbook. The existing rear addition that would be altered does not appear to be original to the structure. The alterations to the addition include a slight adjustment to the roof line to create a single line profile. In addition the existing enclosed porch in the center of the addition would be removed to make room for a 12' x 12' deck. The 47' rear setback, as well as the location in the center of the structure, meeting zoning requirements. An existing 15-light entry door that is currently inside the enclosed porch would become the entry door to the structure, which will be discussed further when the applicant comes back with the door details. While the entry door is not in a centered location, it represents an existing door in an existing opening on a rear elevation and matches the location of the existing exterior door. The applicant has noted moving the door to the center of the elevation would cause a conflict with the interior kitchen plans of the structure.

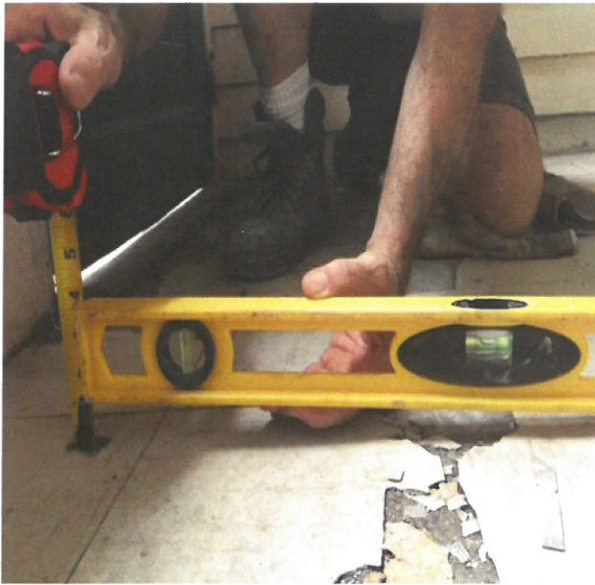
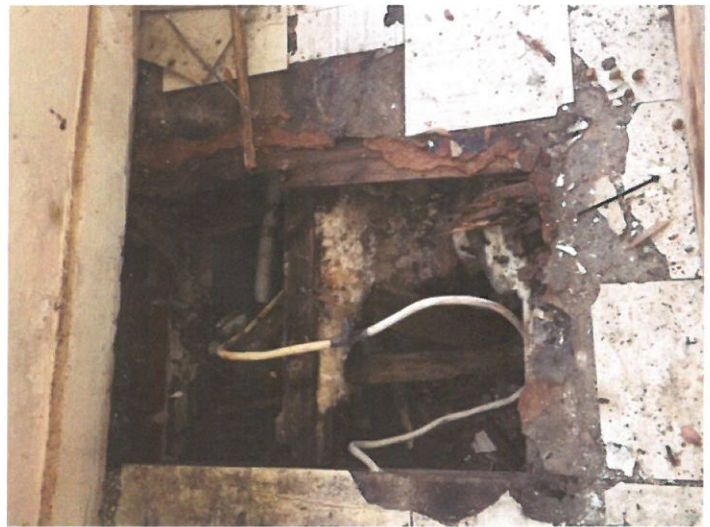
Enclosed Porch Addition
Sloping and rotten support under the floor

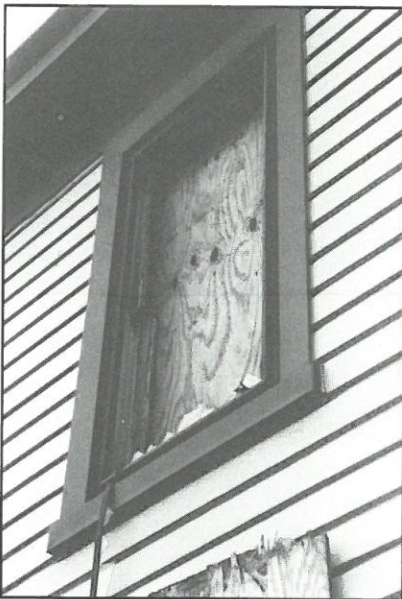
This window has been blocked in and the loosely applied plywood allows water infiltration.

1. Uncover and repair covered-up windows. If a window is no longer needed for its intended use, the glass should be retained and the back side frosted, screened, painted black, or shuttered so that it appears from the outside to be used.

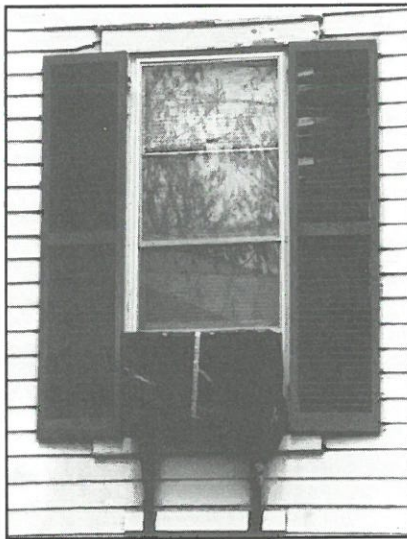
Avoid using aluminum storm windows, especially when the sash height differs from that of the panes. Also take care not to damage the window frame when attaching features such as air conditioners.

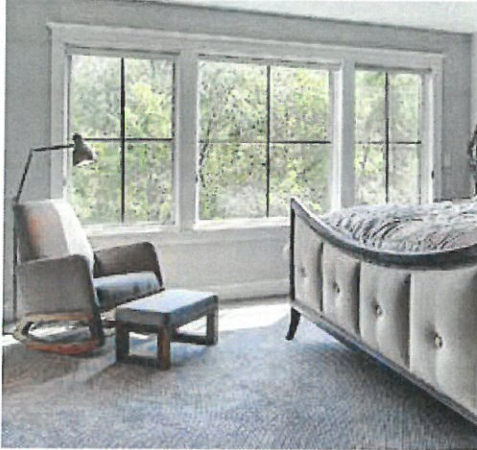
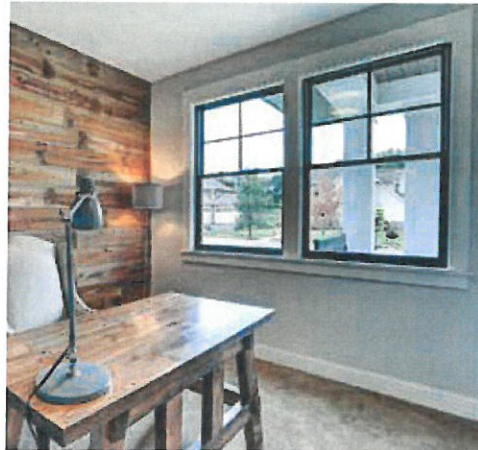
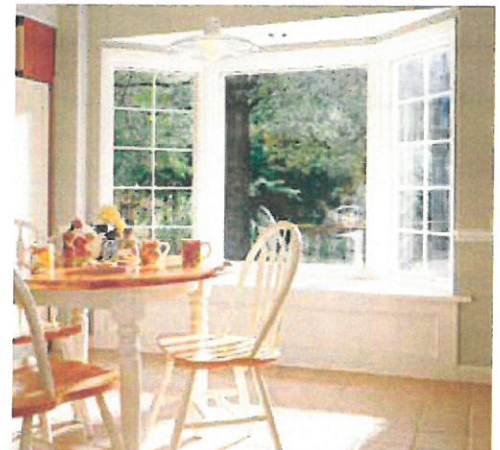
Casement and Awning Windows

Smooth openings and closings.
Stainless steel operating arms and hinges resist rust and corrosion.

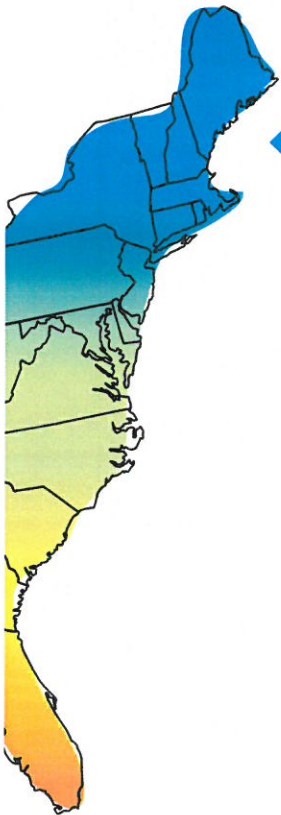
GLASS TYPE: AdvancedComfort
Low-E Insulating Glass with Argon²

Unique Low-E technology delivers balanced insulation for colder winters and moderate summers.
