Technical Memorandum

To: Bryan Foster
City of Manassas
Manassas, VA 20110

Date: January 18, 2019

Subject: Micron Pond Odor Evaluation

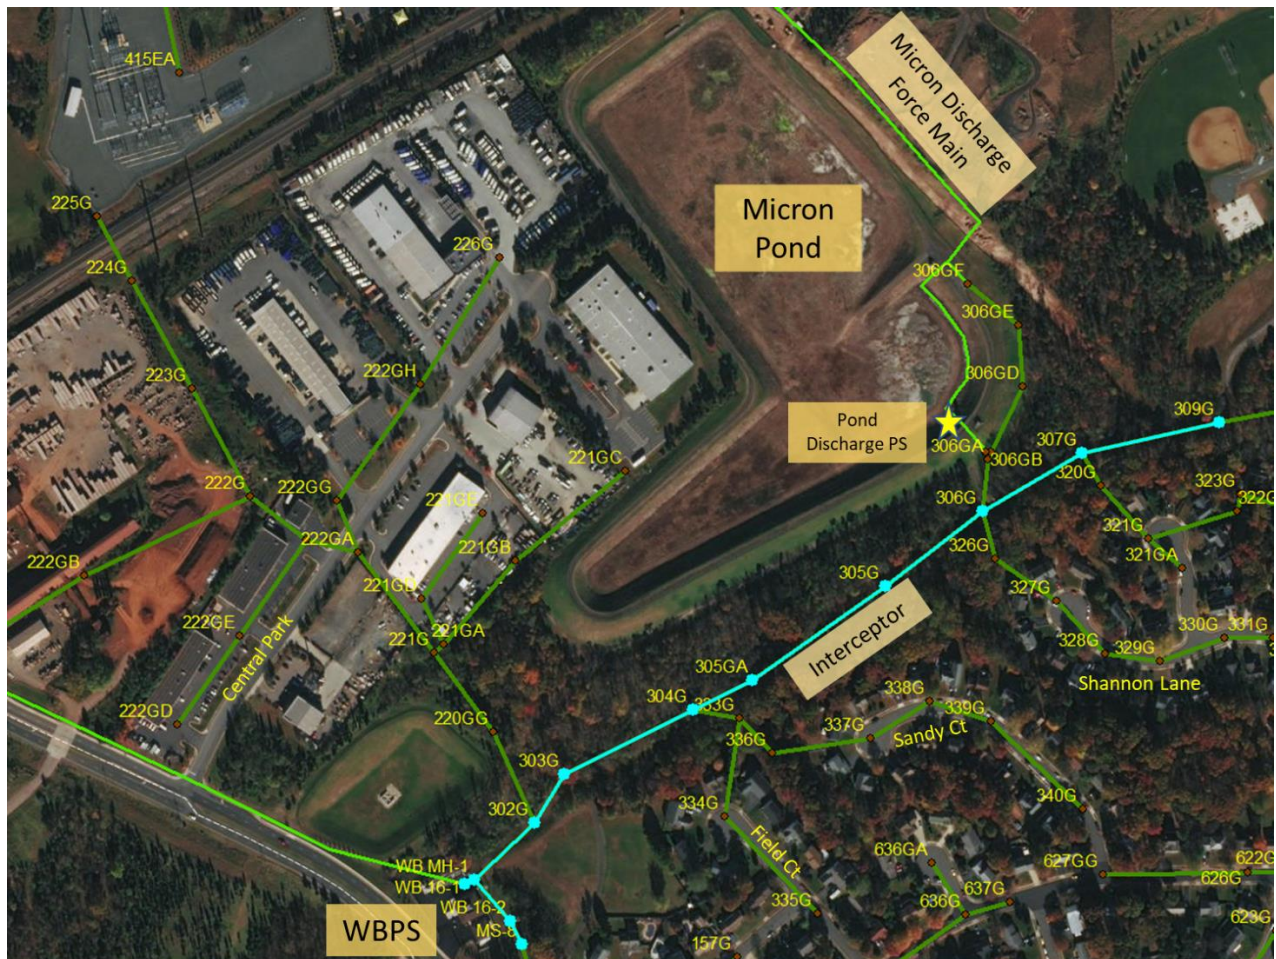
Figure 1 Study Area

The City typically directs the Micron effluent into its gravity sewer interceptor, which conveys the flow to the Winter's Branch Pump Station (WBPS) operated by the Upper Occoquan Service Authority (UOSA). The City has capacity limitations for the quantity of wastewater it discharges to UOSA based on a 30-day rolling average. During peak flow conditions in the City's sewer network, the City diverts Micron's discharge to the holding pond (Micron Pond) to equalize flows and stay within allowed UOSA capacity limits. The effluent within the pond can either discharge by gravity to the City's interceptor or be pumped directly to the WBPS. An overview of the system is shown in Figure 1.

Kimley-Horn visited the UOSA WBPS in September 2018. During the visit, the manhole shown as WB MH-1 on Figure 1 (the first manhole upstream of the pump station) was surcharged. No other facilities within the pump station itself were surcharged as sewage passed through the station. The station includes a ventilation system and an activated carbon odor control system to collect and treat odors from sewer gases collecting within the pump station.

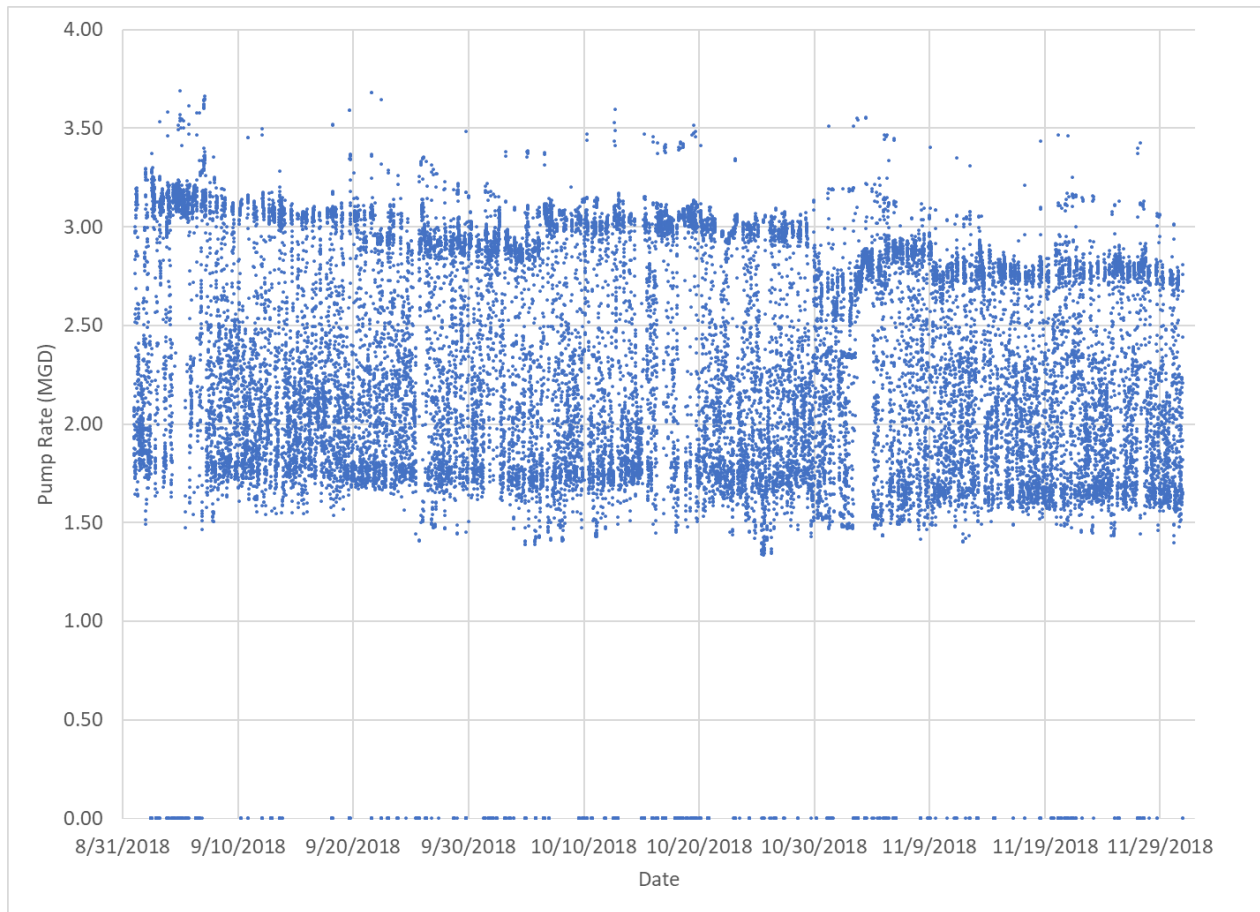
Figure 2 Micron Discharge Rate

Micron generates industrial wastewater from its manufacturing process. Micron has an industrial pretreatment discharge permit and pretreats its wastewater onsite prior to discharge to the City’s system. Site inspection of Micron’s pretreatment facility identified a chemical stabilization process to neutralize the effluent (i.e., adjust pH) prior to discharge. Micron can temporarily divert its wastewater to holding tanks onsite if further treatment is required prior to discharge. A sample of Micron’s pumping discharge rate data (recorded every 5 minutes) shows variation from zero to greater than 3.5 MGD (see Figure 2).

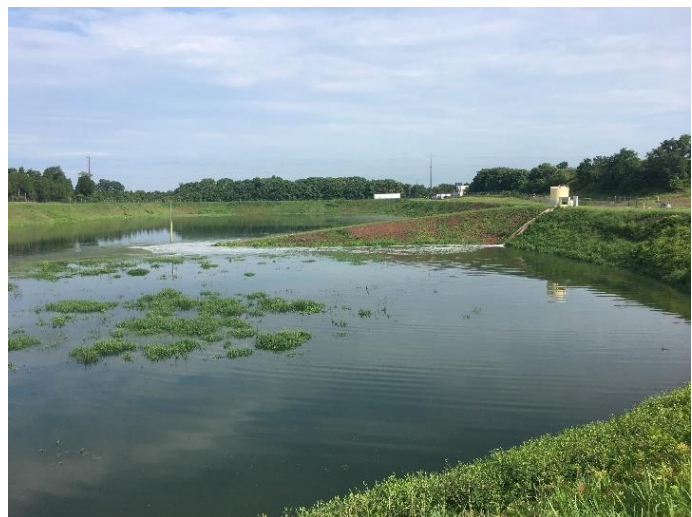
City staff indicated it has maintained the pond by scraping the bottom to bedrock at least once a year. However, historically there has been vegetative growth in the Micron pond. During the August 2018 site visit, vegetation was observed growing in the pond as it was being filled (Figure 3).

The City has initiated installing a reinforced polyethylene liner for the Micron pond. The addition of a pond liner will reduce the potential for vegetative growth and decay in the pond and therefore limit the presence of bacteria responsible for the potential conversion of sulfates to sulfides. The lined bottom of the pond will still require routine maintenance to remove wind-blown dirt and debris to prevent accumulation and the potential buildup of bedding material for vegetative growth.

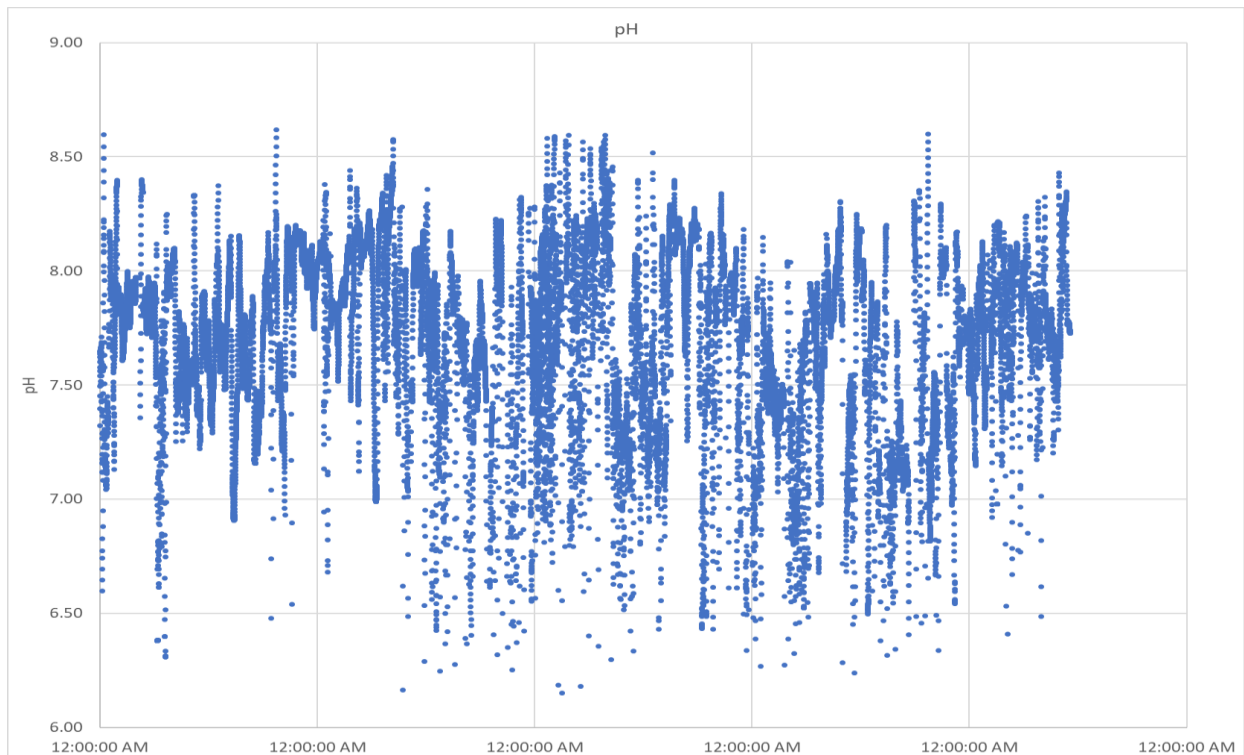
Figure 4 Micron pH Data

Sampling results provided by Micron for permit compliance showed evidence of high levels of sulfates and recently provided pH data from Micron recorded a range from 6.25 to 8.6. The majority of pH results were above 7.0 (Figure 4).

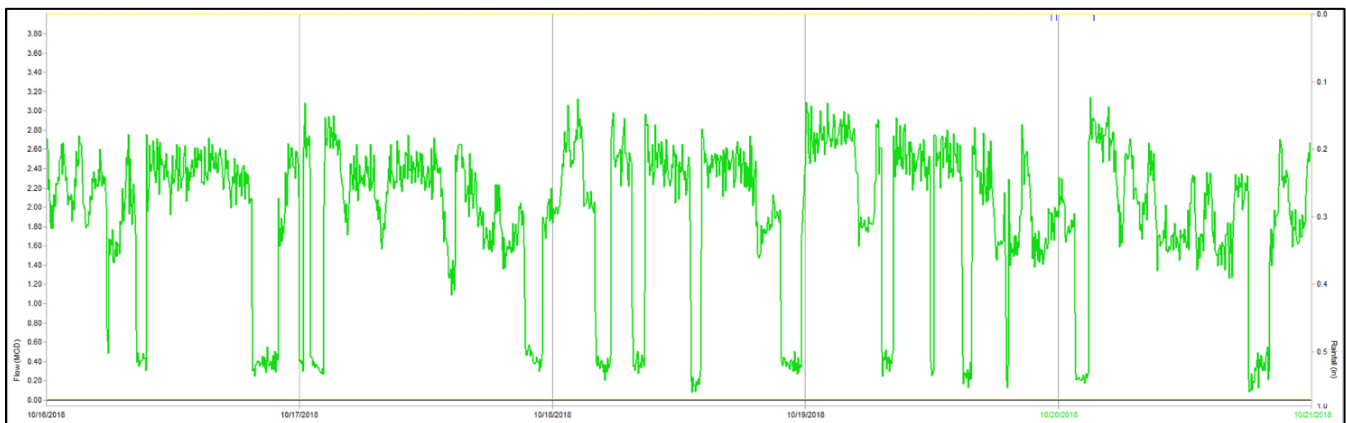
Figure 5 Approximate Micron Flows (MGD)

Metering data was reviewed to verify how Micron flow rates vary. The difference in flow rates between the Manhole 309G and 305G approximates the flows from the Micron facility (some residential flows from Field Court, Sandy Court, and part of Shannon Lane are included in this difference). A sample of the resulting flows during the monitoring period are shown in Figure 5 and are consistent with flow metering data provided by Micron. Based on this data, flows stopped for periods of up to 3 hours several times a day (shown where flows drop to around 0.2 MGD) with no discernable pattern. When Micron was discharging, instantaneous rates varied from approximately 1.3 MGD (900 gpm) to 3.2 MGD (2,220 gpm).

Based on discussions with Micron, Micron cannot predict the timing or duration of when pumping to the City is stopped. Flows are diverted to onsite holding tanks for further treatment only if a permit violation could result. Once the effluent is appropriately treated, Micron resumes pumping. Discussions with City staff have indicated significant odors primarily when pumping resumes; however, sampling has not confirmed the presence or intensity of odors.

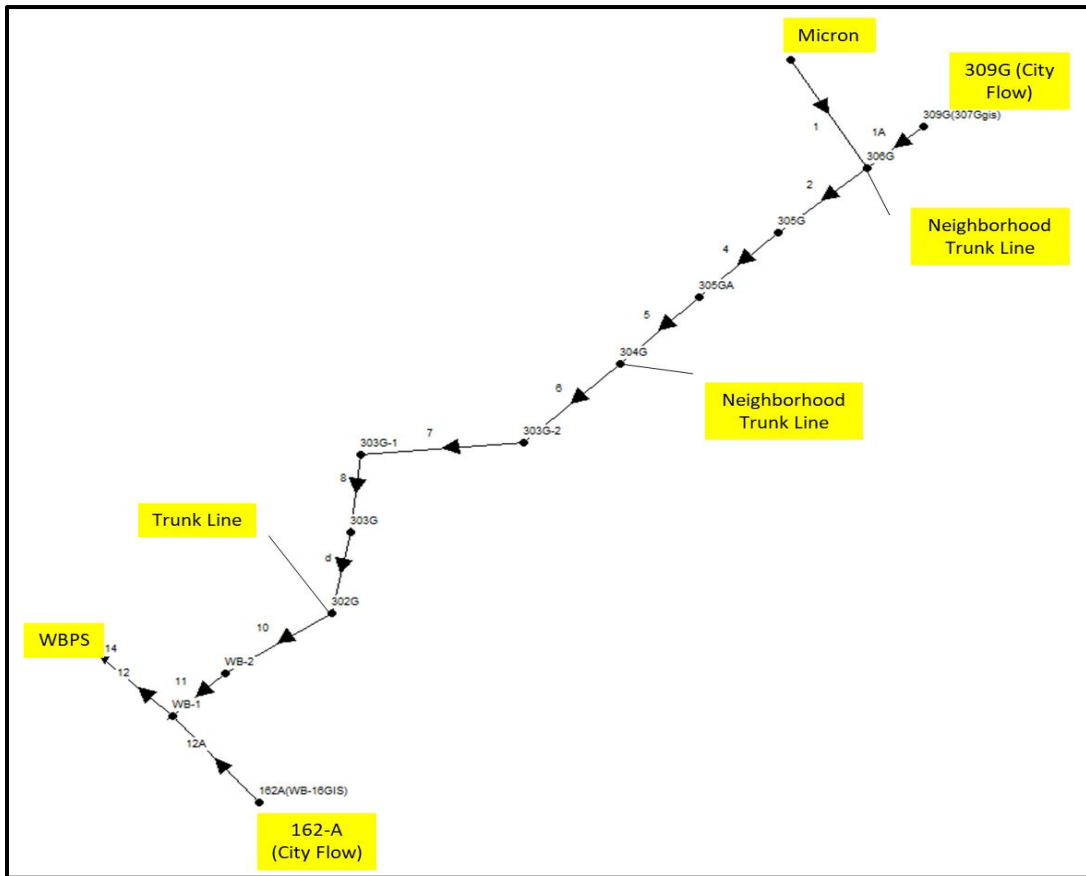
Figure 6 SWMM Model Configuration

A model of the local sewer system was developed using EPA SWMM v 5.1 to evaluate conditions in the City’s interceptor sewer to the WBPS. The system configuration was developed from survey provided by the City (the survey configuration does not match the City’s GIS shown in Figure 1). The modeled system schematic is presented in Figure 6. Key manholes are highlighted in the model structure and are noted as follows:

- 306G: Micron flow into the City interceptor where another neighborhood trunk line enters
- 304G: Neighborhood trunk line enters
- 302G: Trunk line from the Central Park drive commercial complex enters

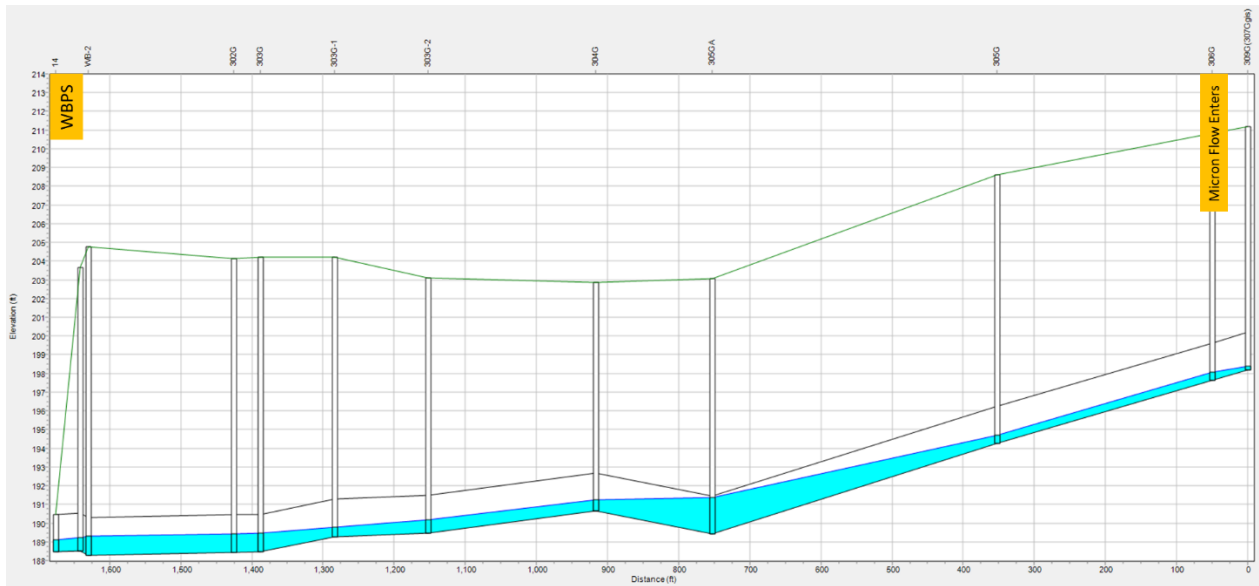
Figure 7 Minimum Flow Conditions (Micron at 1.5 MGD)

Various combinations of flows as described below were input into the model to include flows from Micron, flows from 309G, and 162-A per the City’s flow metering data. The results are shown in the graphics that follow. The graphics show the sewer system profile with the modeled water depth shown in cyan. If the sewer surcharges in the model, the dark blue line represents the surcharge level.

Combinations of flow as taken from the table of flows above were modeled (for existing conditions) to represent minimum (Figure 7), average (Figure 8), and peak flow (Figure 9) conditions. In all cases, except the minimum flow conditions (with Micron flow at 1.3 MGD), the City interceptor receiving flows from Micron surcharged at the manhole just upstream of 304G. The figures clearly depict the reverse slope in the sewer between Manholes 304G and 305GA as identified by the survey provided by the City (Manhole 304G receives flow from Sandy Court and Field Court residences). Additionally, a flat or reverse slope can be observed in the existing sanitary sewer near the WBPS.

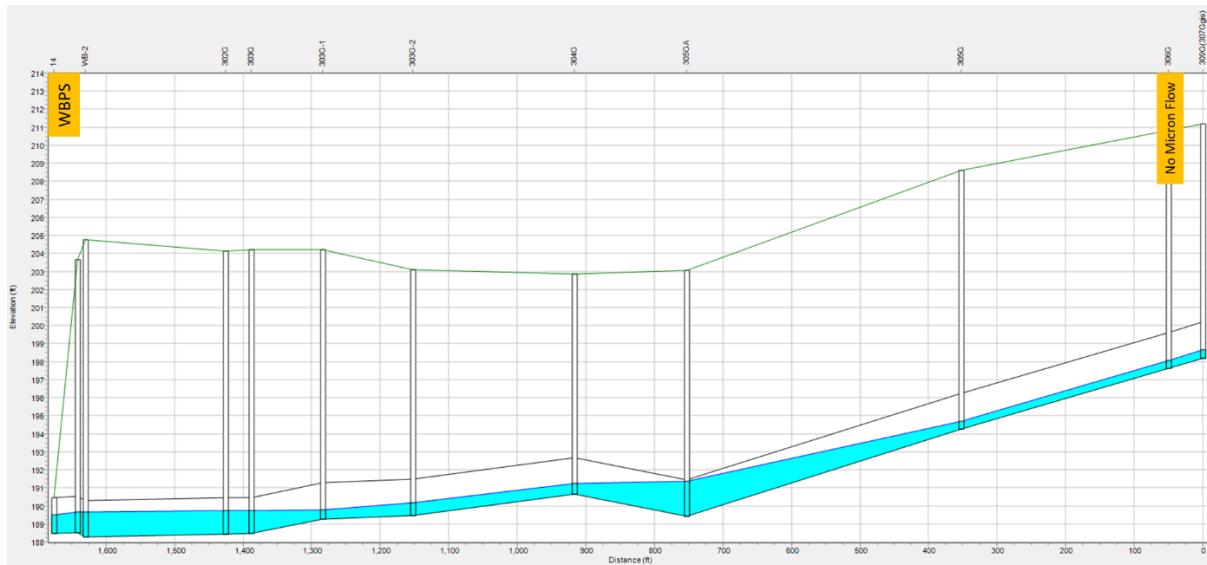
Figure 10 Peak Flow, Zero Micron Flow

Hydraulic analysis of the City’s interceptor confirms surcharging occurs within the gravity system. In addition to preventing the proper ventilation of gases in the system and exacerbating the odor issue, it is also indicative of inadequate capacity. Capacity improvements in the interceptor or diversion of Micron flows around the sewer should be considered. Analysis using the sanitary sewer model shows that removal of the Micron flows from the City’s interceptor result in a full pipe flow condition during peak flow periods (as determined from the City’s flow monitoring and shown in Figure 10).

While the City's downstream interceptor does not appear to be a source of hydrogen sulfide gas formation, the system hydraulics may prevent any odors generated from moving downstream where they can be treated. To evaluate alternatives to address potential issues with the interceptor, survey-grade invert and rim elevations of the interceptor are required. Alternatives such as diverting all Micron flows off of the City's interceptor directly to the WBPS (via an independent gravity line, extended force main, etc.), increasing the capacity of the City's interceptor, or routine use of the pond for equalization with pumped discharge to WBPS by the City's pump station may be considered. Each alternative will require coordinating with the City's ultimate wet weather and buildout needs as well as maximum flexibility to accommodate future Micron flows.

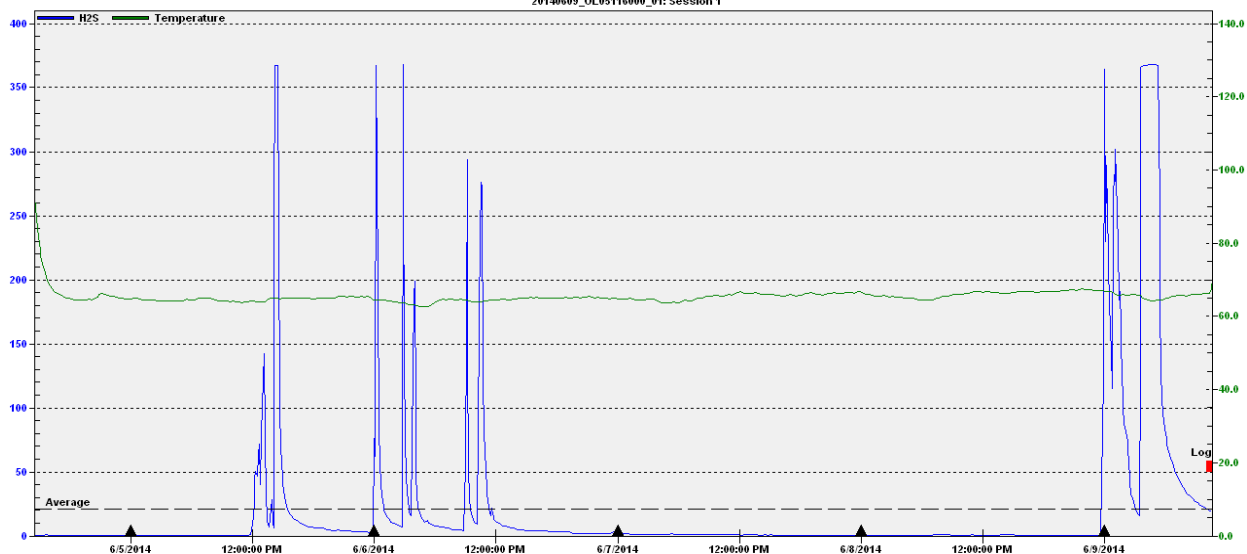
MH 333G Bottom of Hill from Sandy Court
20140609_OL05116000_01: Session 1

Period Displayed: - 6/9/2014 (Oda File: 20140609_OL05116000_01.oda -- Serial Number: OL05116000)

Legend: Average 21PPM ▲ Month Transition Min 0PPM Max 368PPM (Use Screen Data Only)

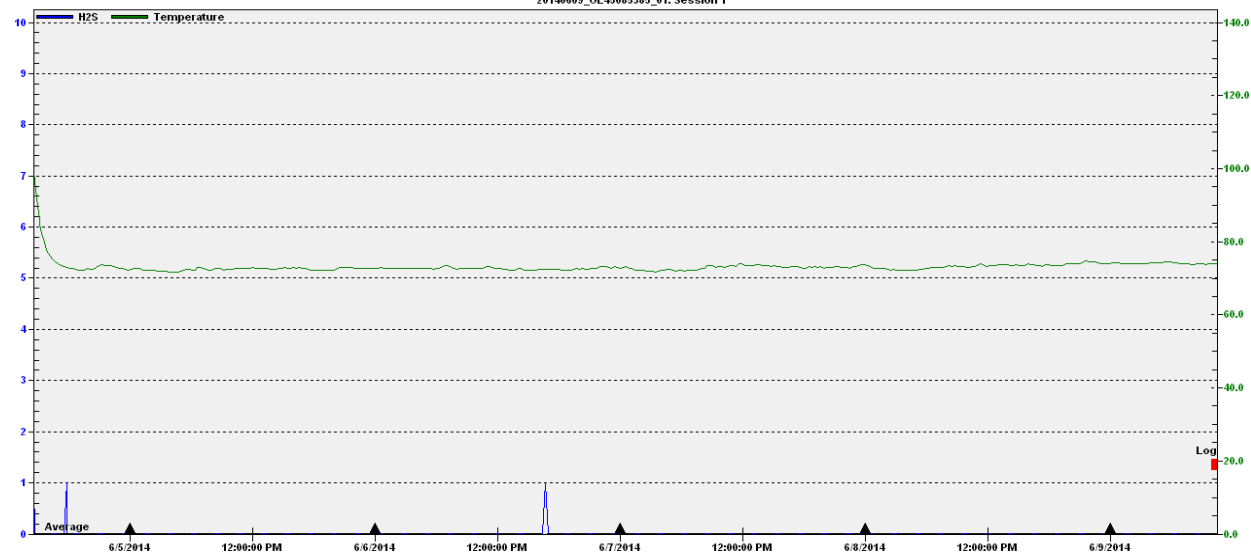
MH 337G Sandy Court MH
20140609_OL45085385_01: Session 1

Period Displayed: - 6/6/2014 (Oda File: 20140609_OL45085385_01.oda -- Serial Number: OL45085385)

Legend: Average 0PPM ▲ Month Transition Min 0PPM Max 1PPM (Use Screen Data Only)

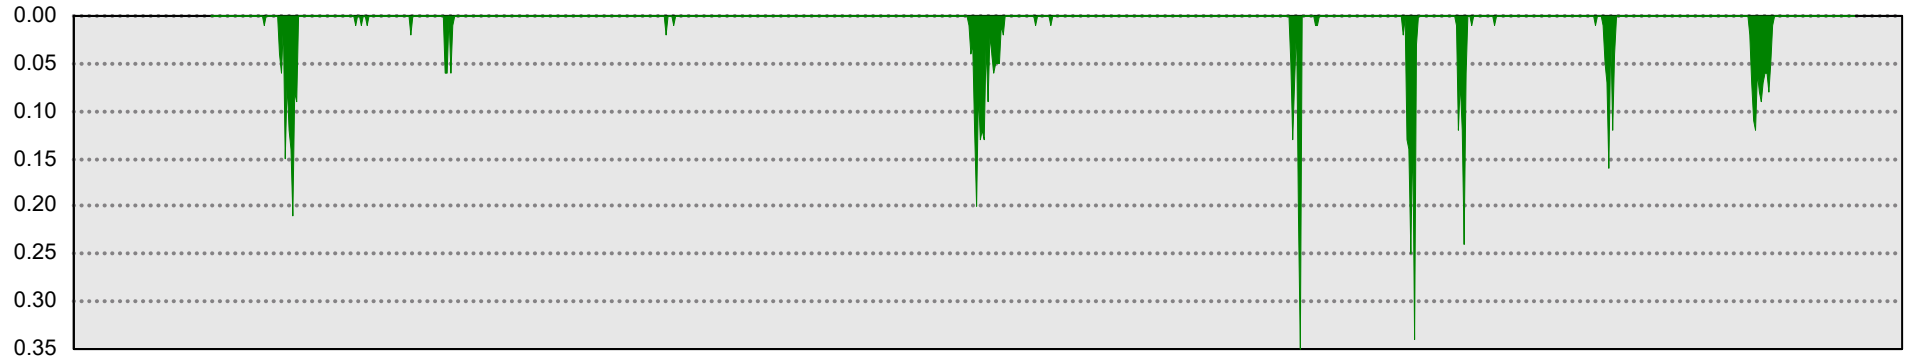
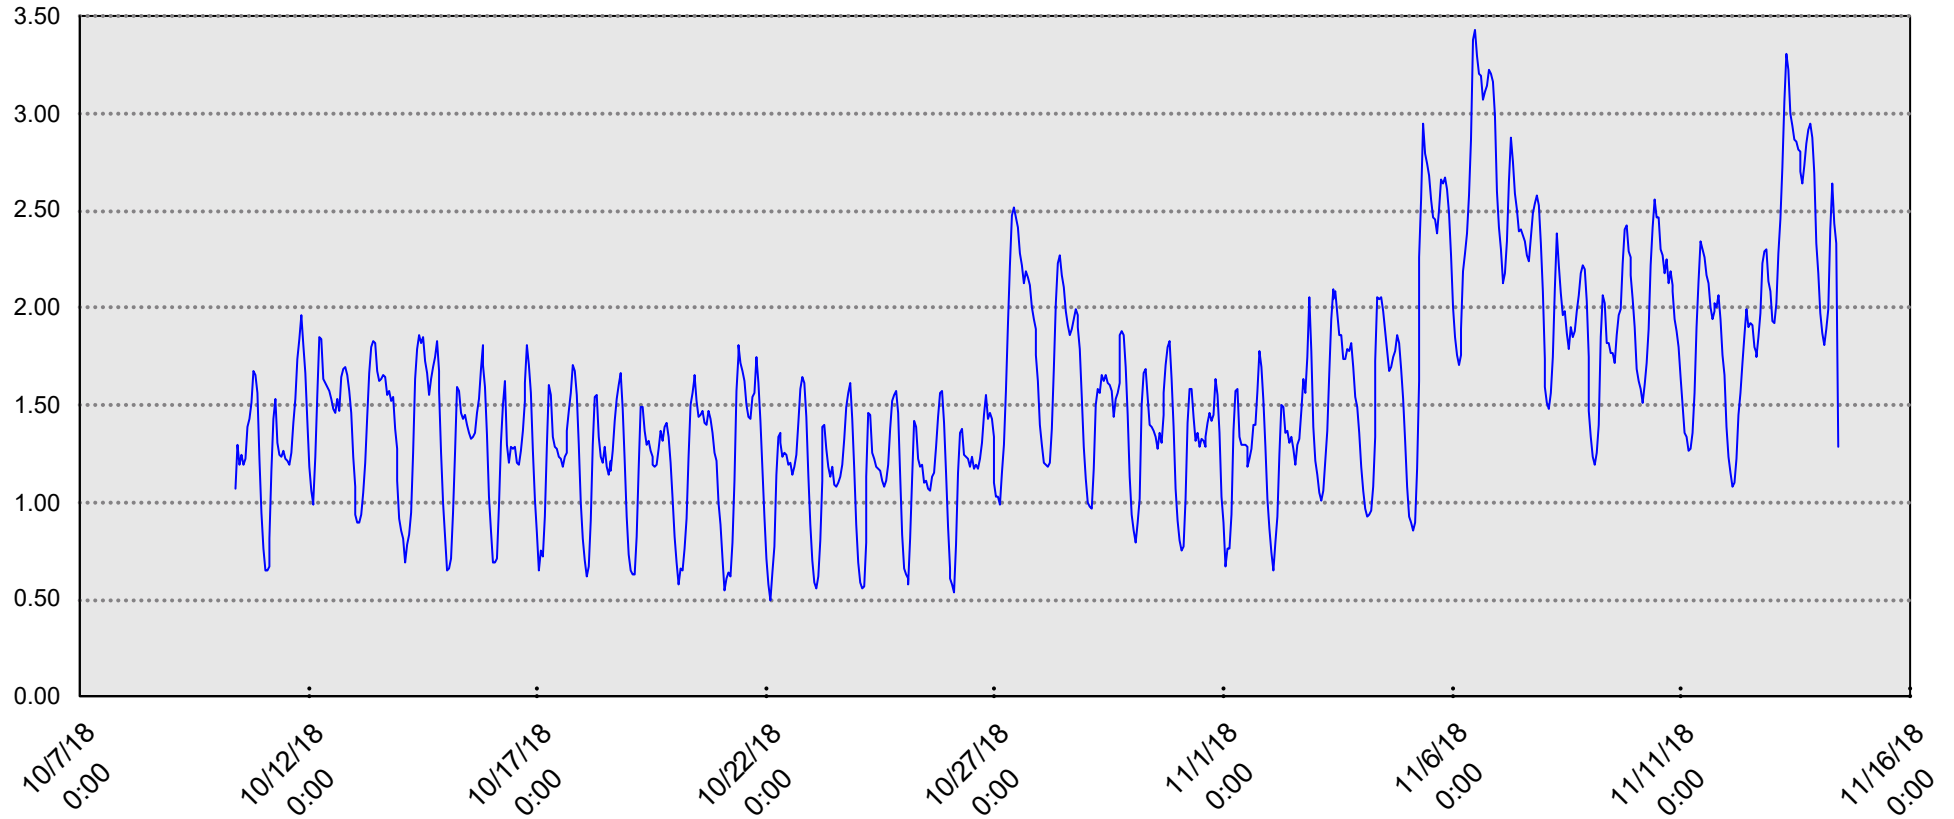
Site:
162A
Hastings Drive R.O.W.

Rain (in) Printed on: 11/21/2018 Period Covered: 10/10/2018 - 11/15/2018 Every 1 Hour

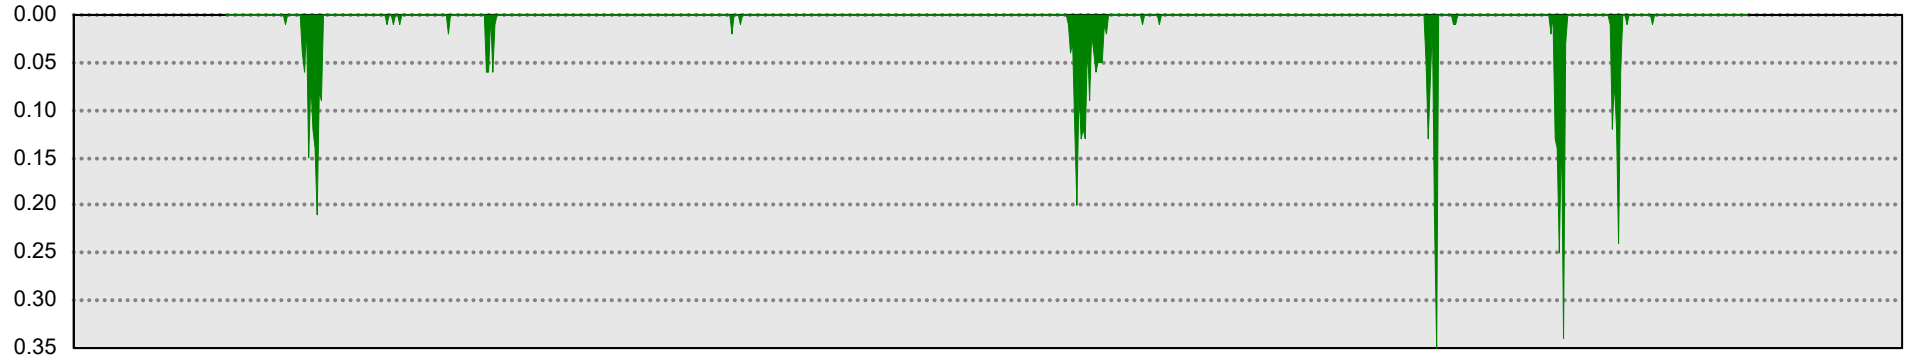
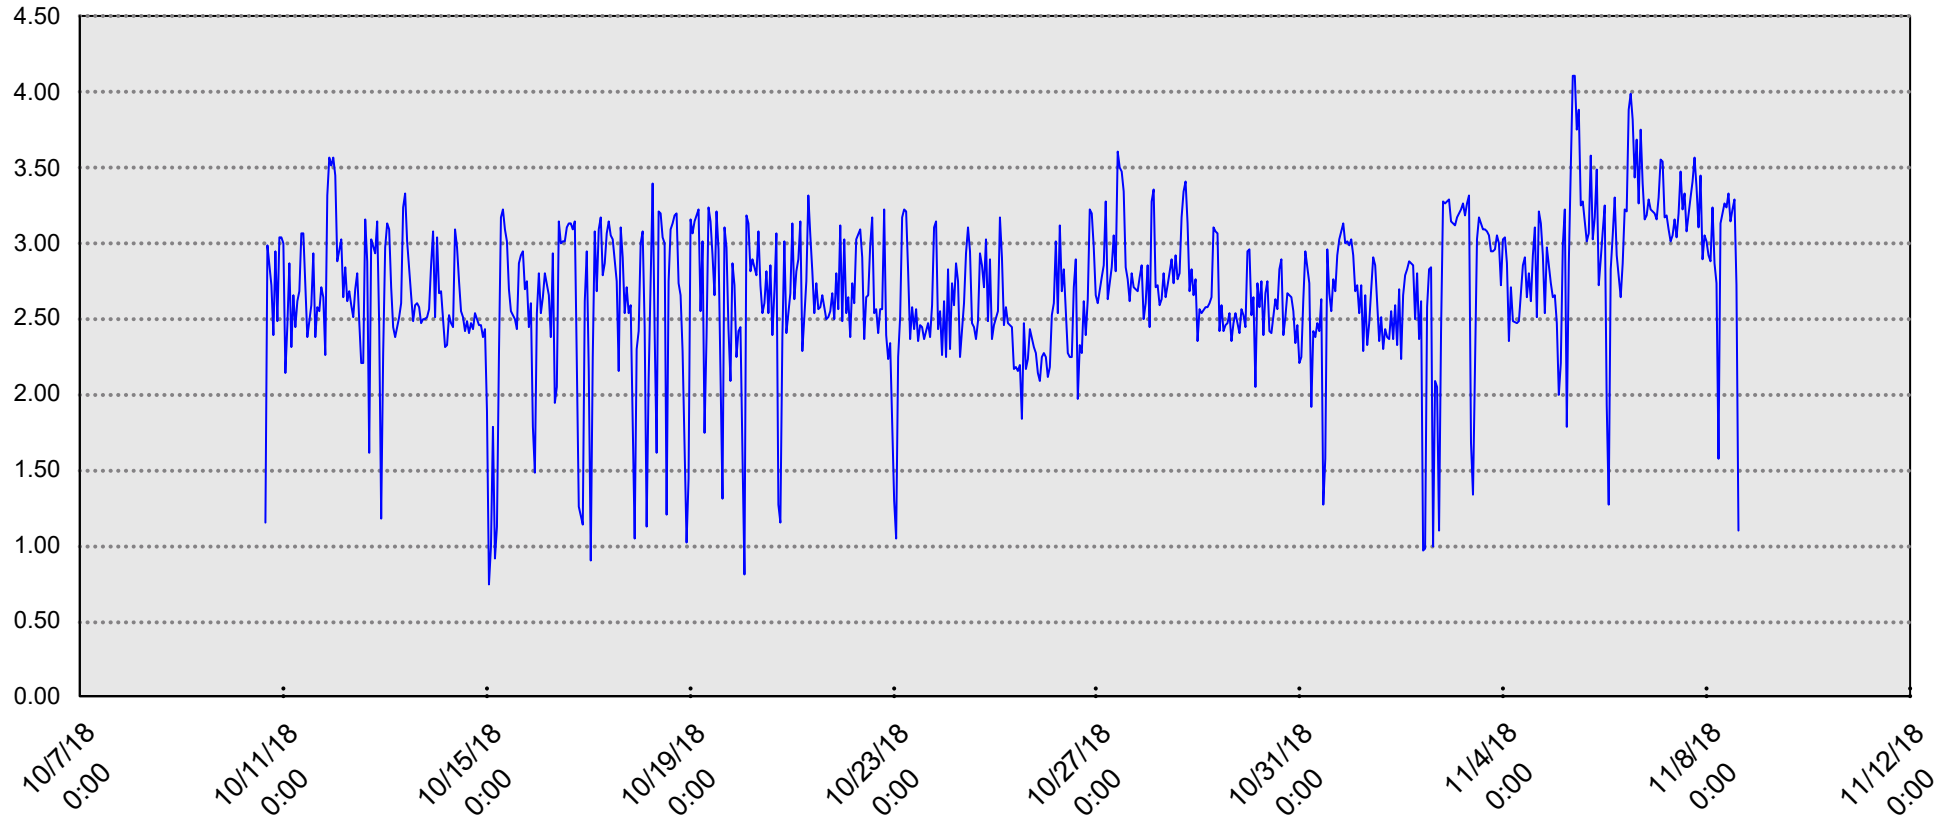
Site:
305G
Hastings Drive R.O.W.

Rain (in) Printed on: 11/21/2018 Period Covered: 10/10/2018 - 11/09/2018 Every 1 Hour

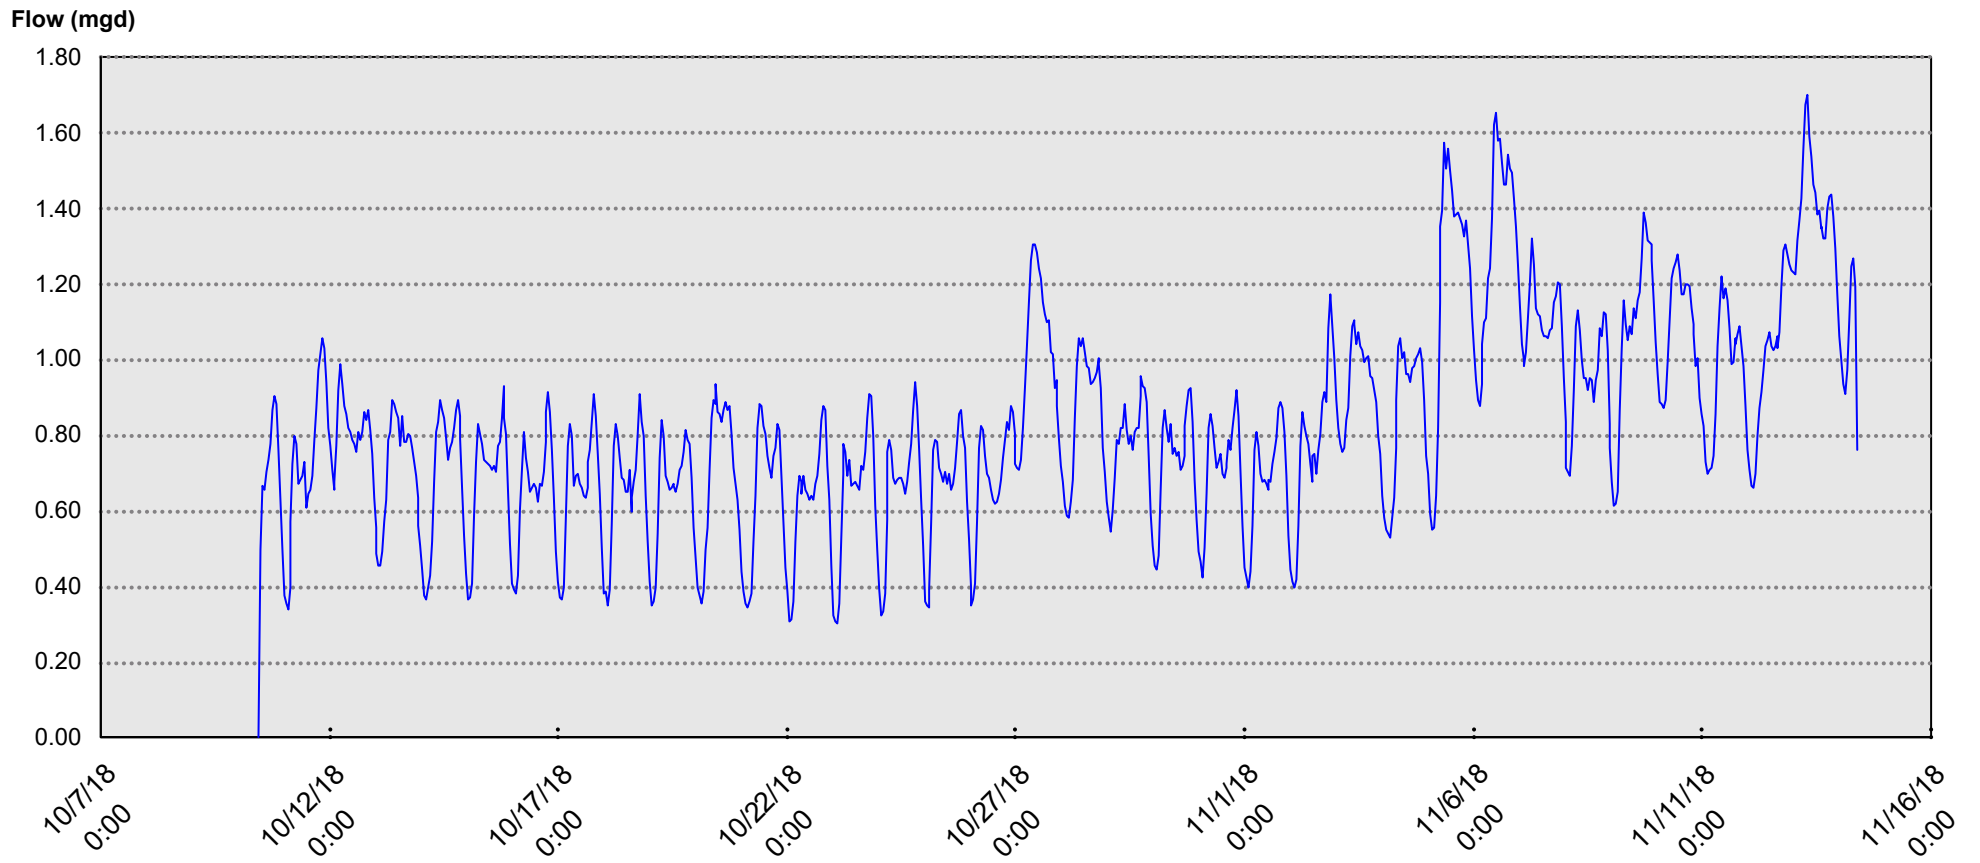
Site:
309G
Hastings Drive R.O.W.

Rain (in) Printed on: 11/21/2018 Period Covered: 10/10/2018 - 11/15/2018 Every 1 Hour
