MARTIN COUNTY COURTHOUSE

DOMES + ROOF REPAIR UPDATE

August/September 2021

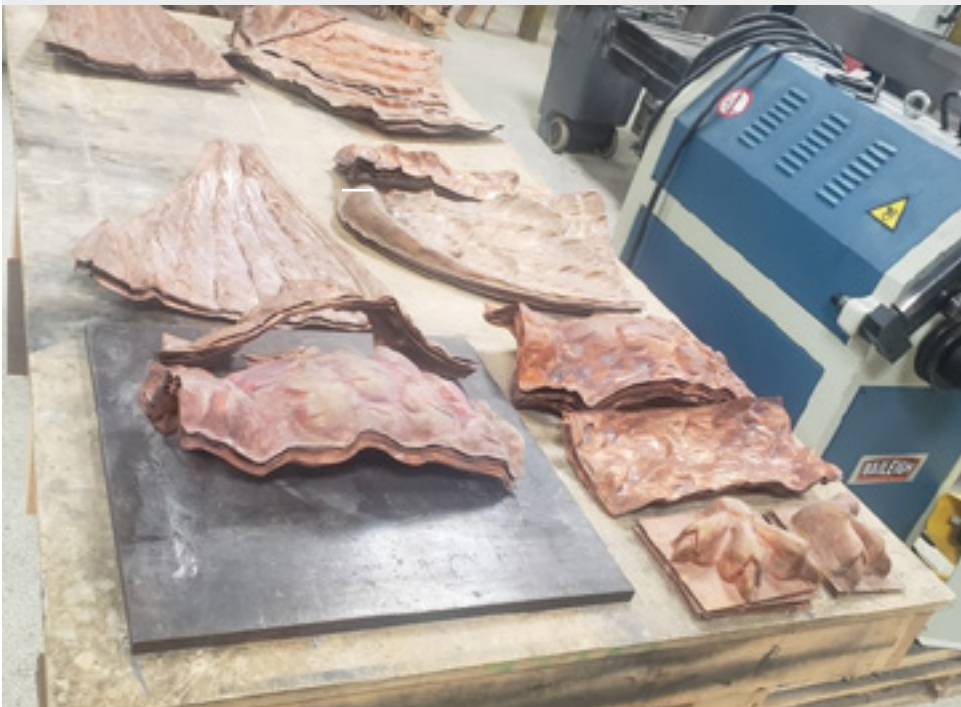
Copper mold stamping of the eagle statues.

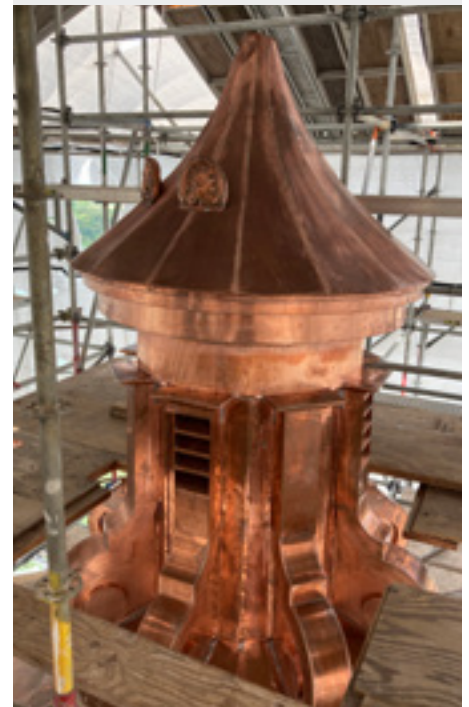
Top of the new copper dome lantern.

Copper dome work is nearing completion and scaffolding will be removed from the dome in late August. The copper eagle statues will be installed in mid to late September. Scaffold will then be used to help remove the asbestos containing roofing material, for installation of the new roofing material, and to serve as fall protection until next spring. The goal is to get the majority of the main courthouse roof installed before winter sets in. Due to some material procurement time frames, the main roof will be completed around June of 2022.

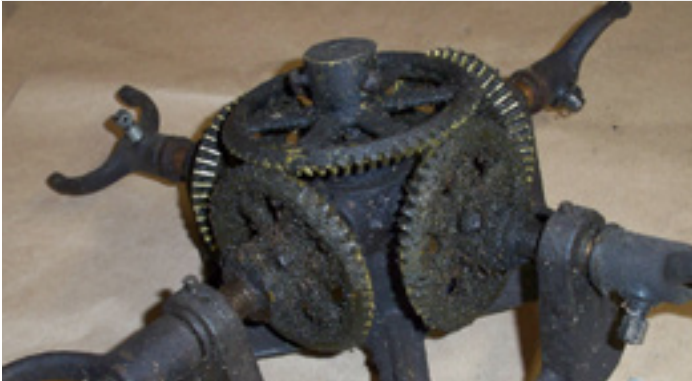
Clock four-way mechanism before restoration.

Clock restoration is complete and required a dismantling and restoration of each component separately, including the central four-way mechanism, clock frames, machining hour wheel, motion works, name plate, and setting dial (see back). New clock hands, gear hub, and dial assembly were commissioned for the restoration.

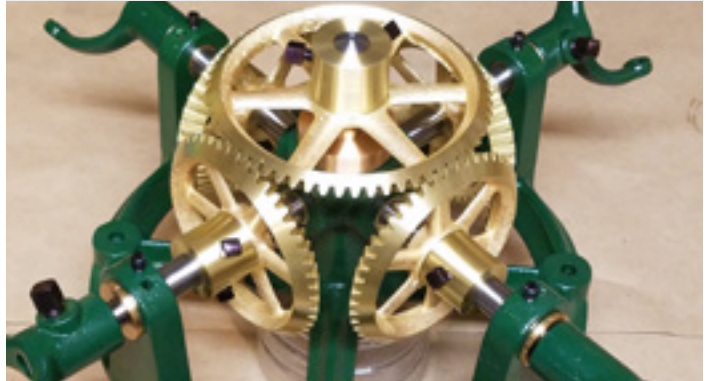
Clock four-way mechanism after restoration.

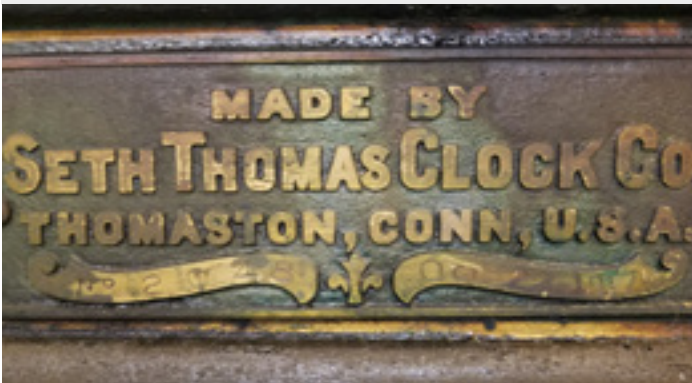
Clock nameplate before restoration.

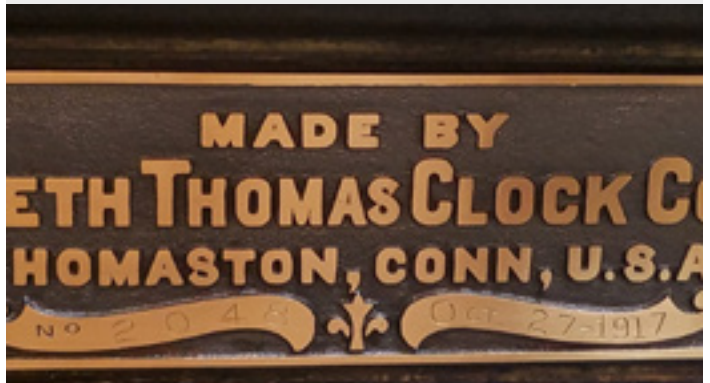
Clock nameplate after restoration.

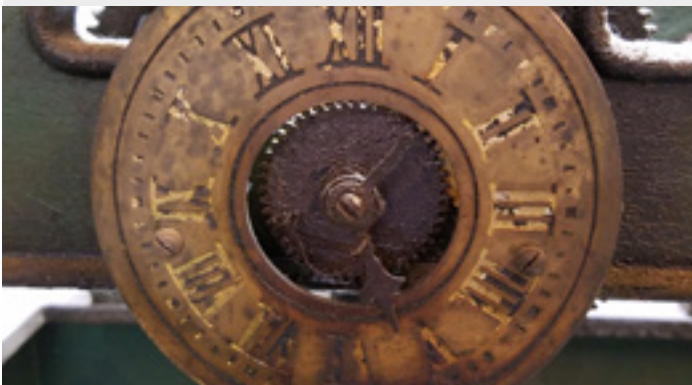
Setting dial before restoration.

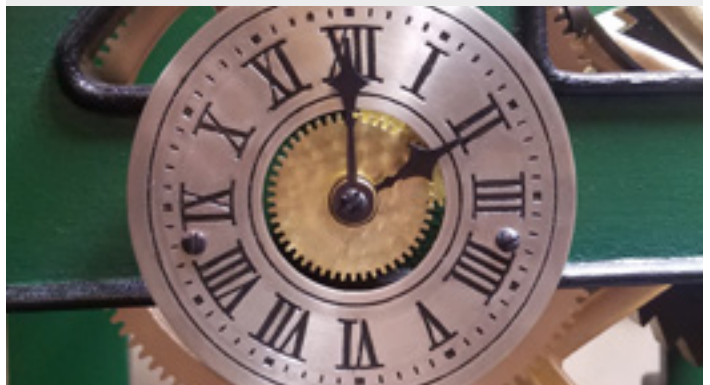
Setting dial after restoration.
