# MARTIN COUNTY COURTHOUSE

## DOME AND ROOF REPAIR UPDATE

January 2021

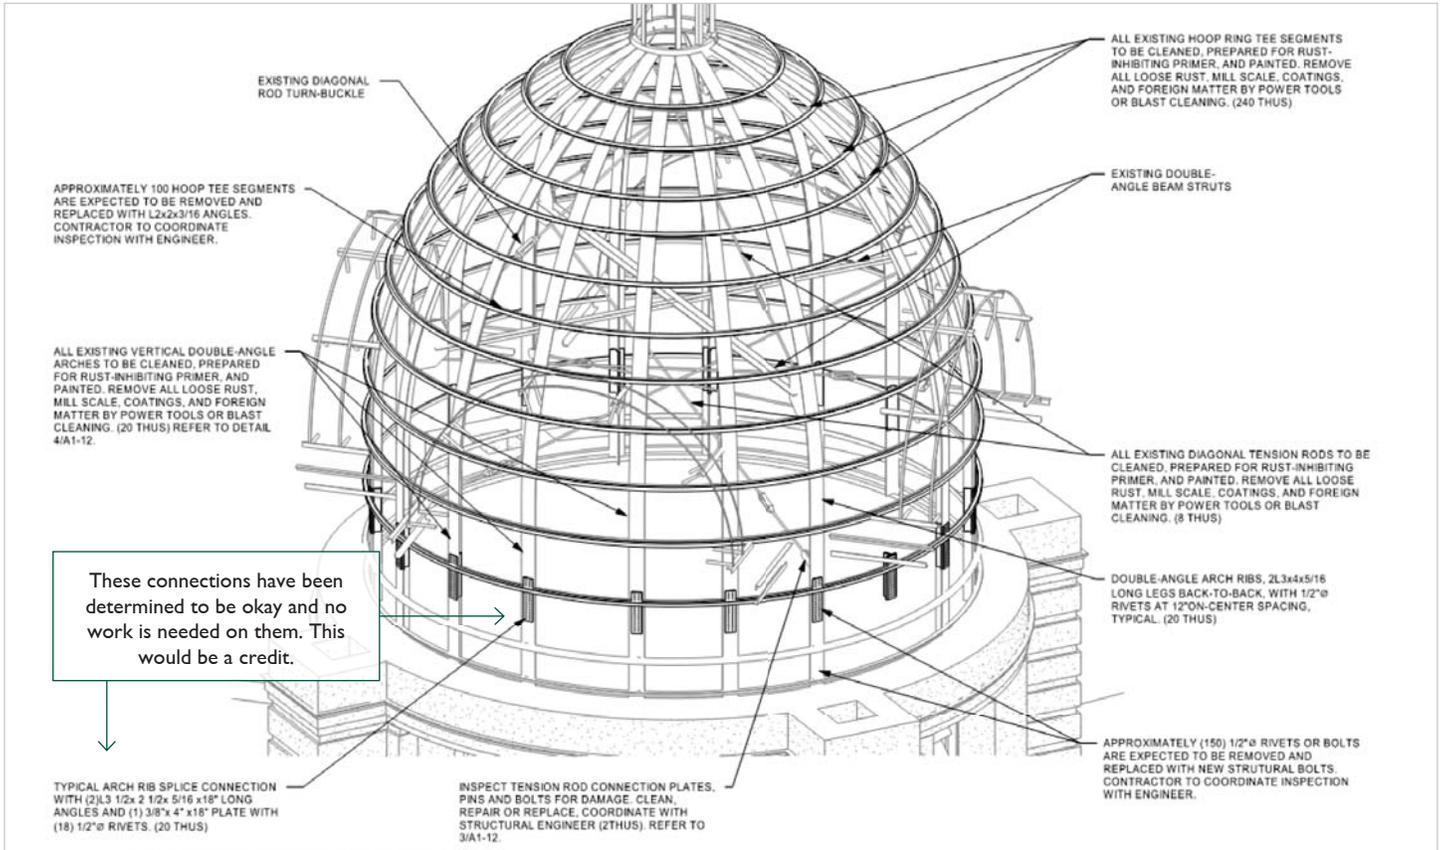
Isometric structural view of dome framework.

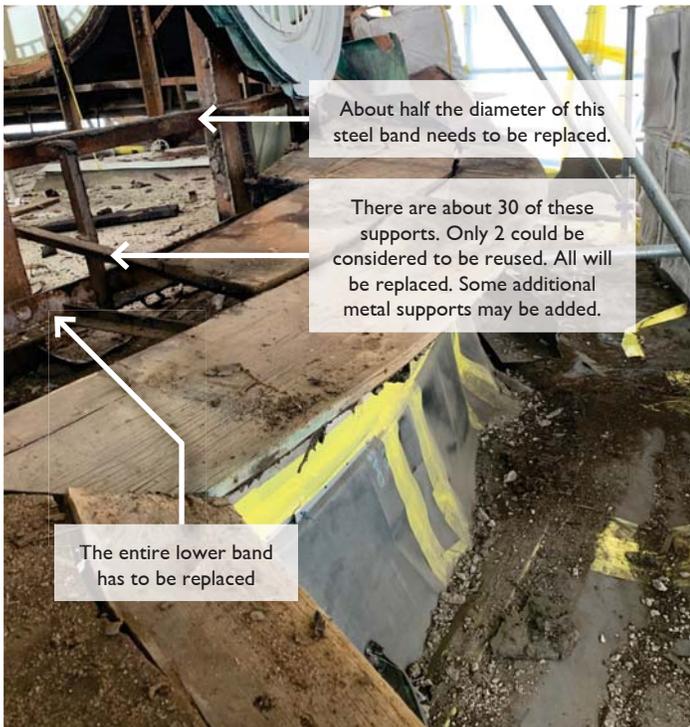
Base boards will be replaced during reconstruction.

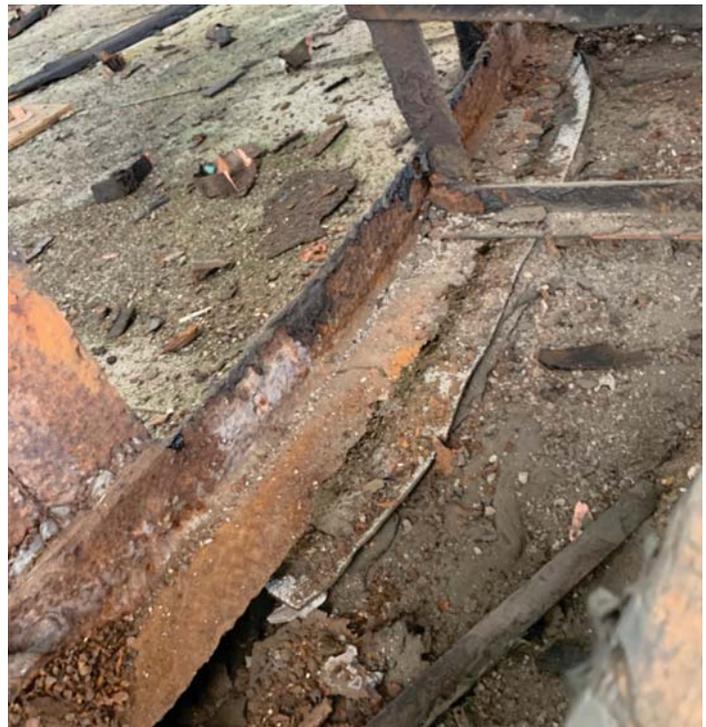
Deteriorated steel at the base of the dome.

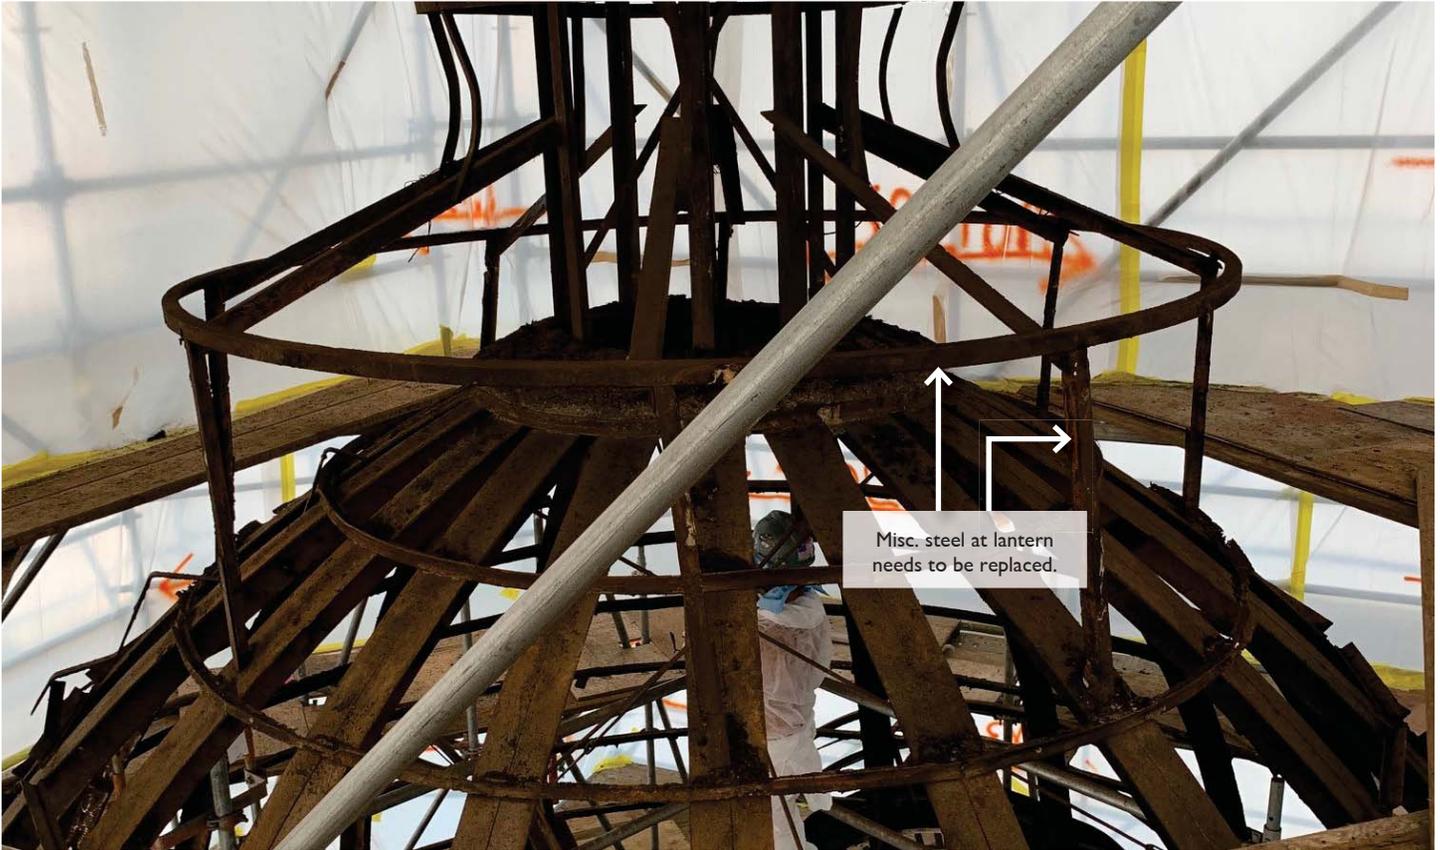
Lantern framing shows corroded steel requiring repair and replacement of sections.

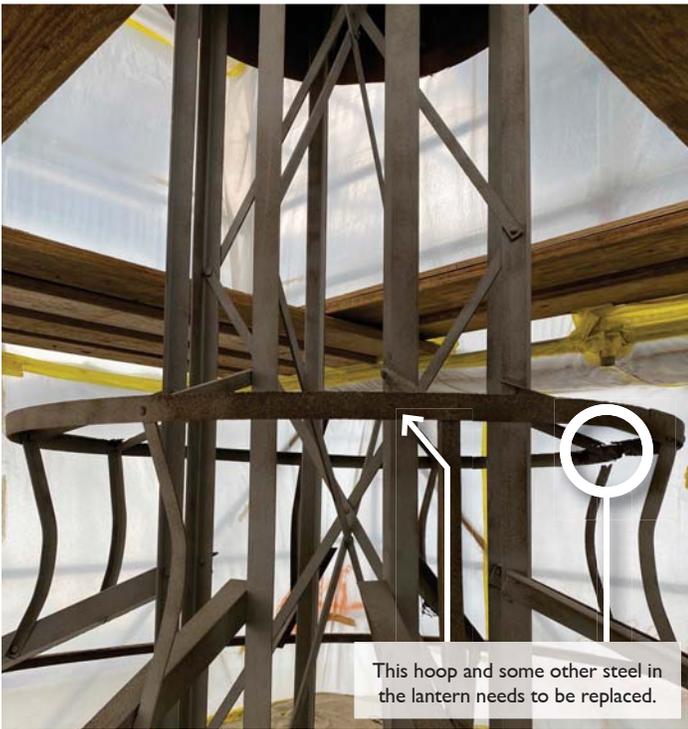
Lantern framing requires some steel replacement.

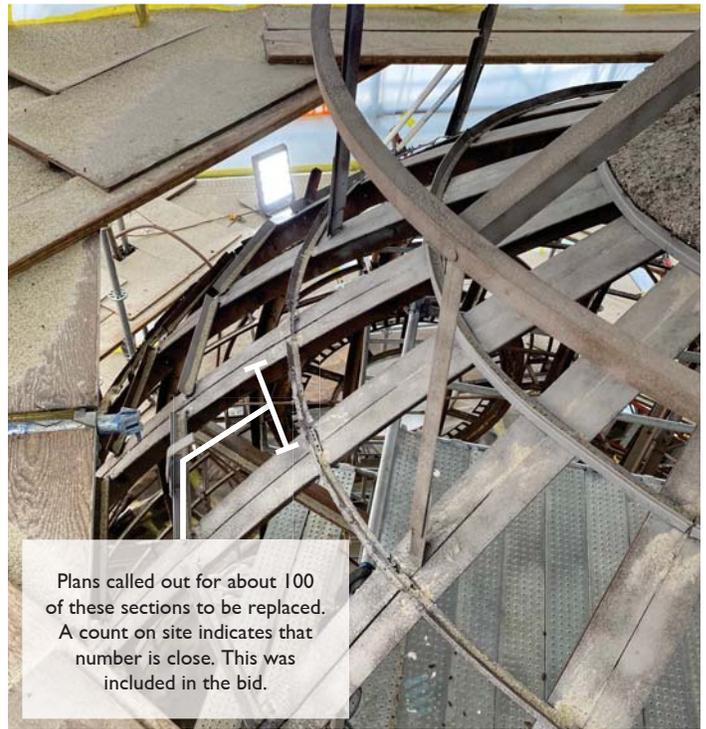
Steel framing during cleaning process.

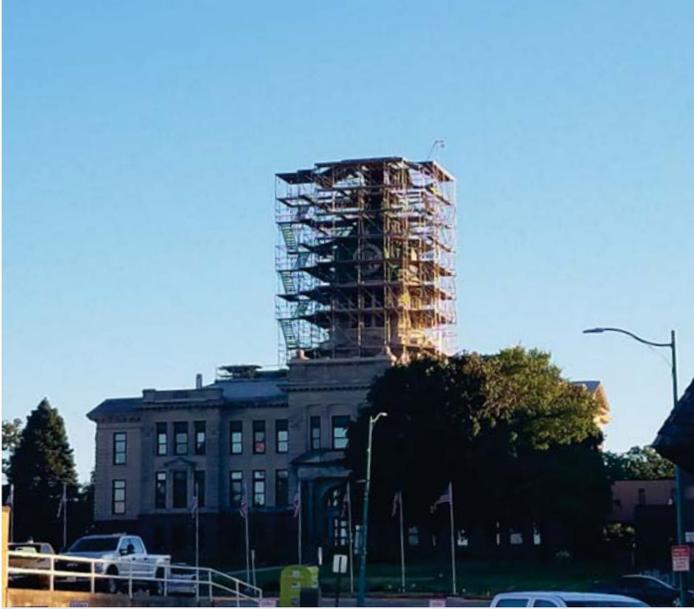
Scaffold installed to complete the dome work. Photo taken prior to it being covered with tarps to allow work through the winter.

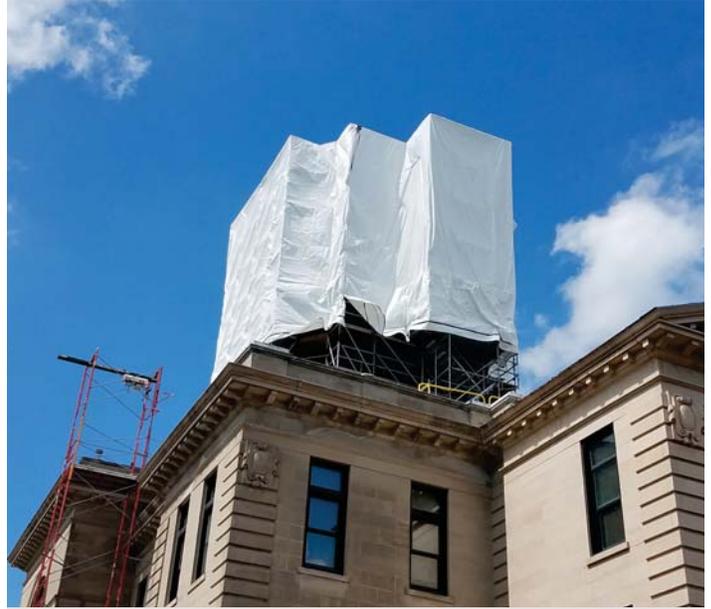
Tarp covered scaffold.

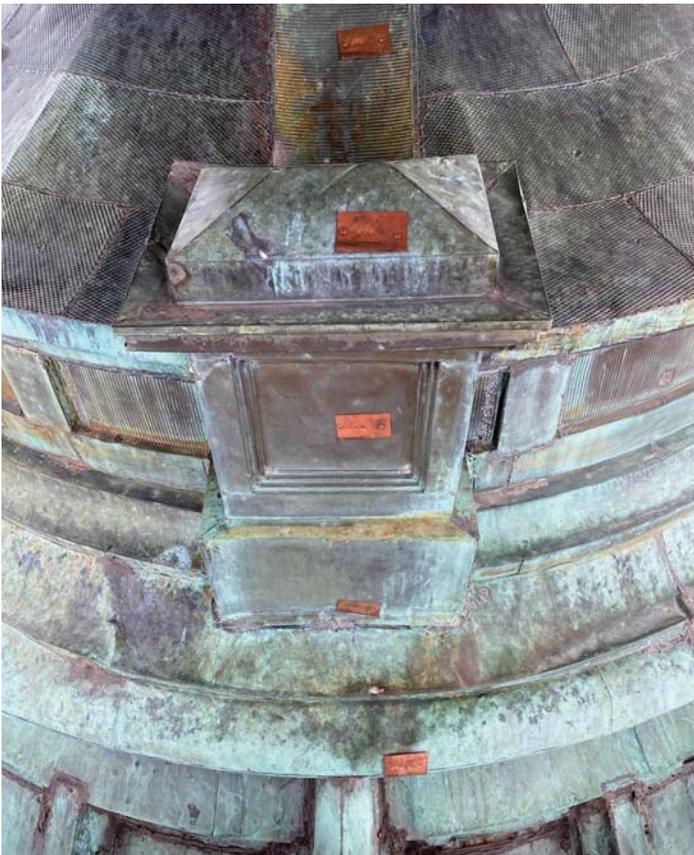
Original copper used as a pattern to replicate the new copper parts. Note the newer copper tags that are affixed to the original copper. A number was assigned to each part and cataloged for reference.

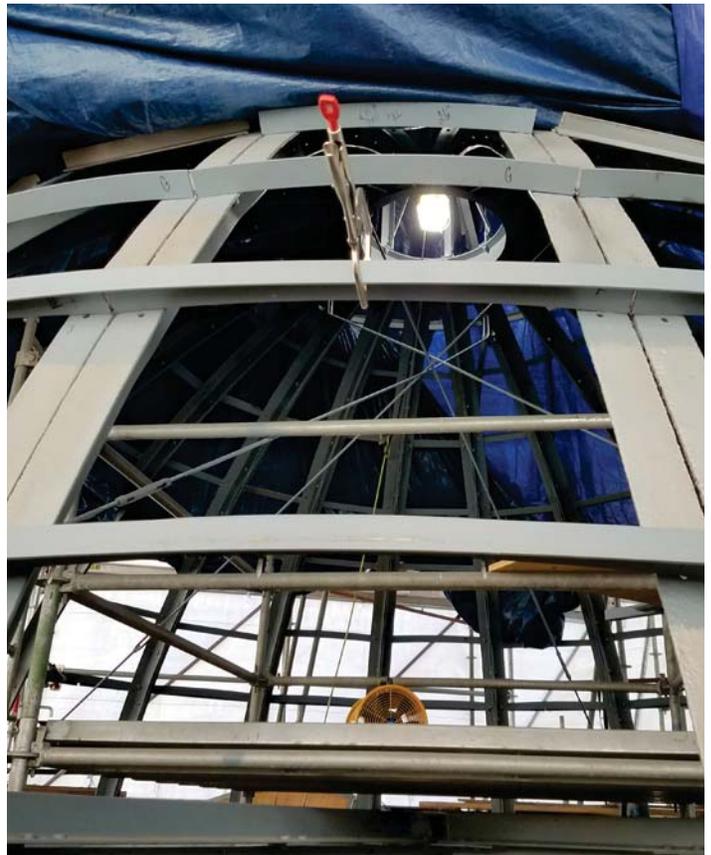
Horizontal bands replacement. Roof sheathing will attach to the horizontal bands.

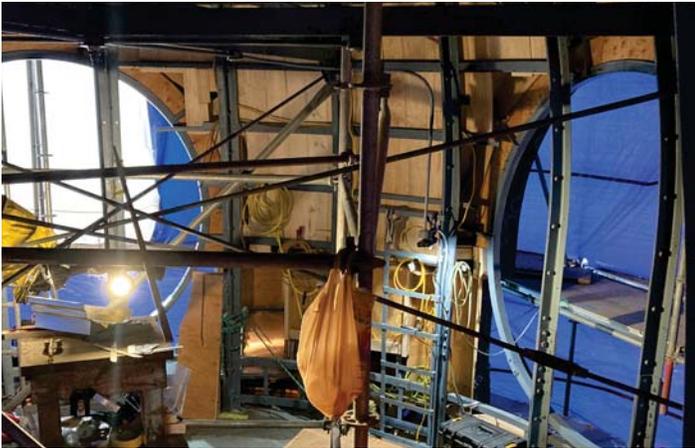
New wood sheathing in the dome interior.

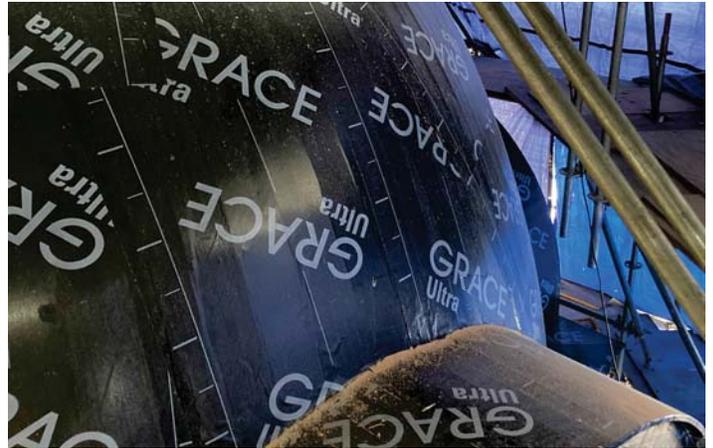
Ice and water shield applied to the dome exterior.

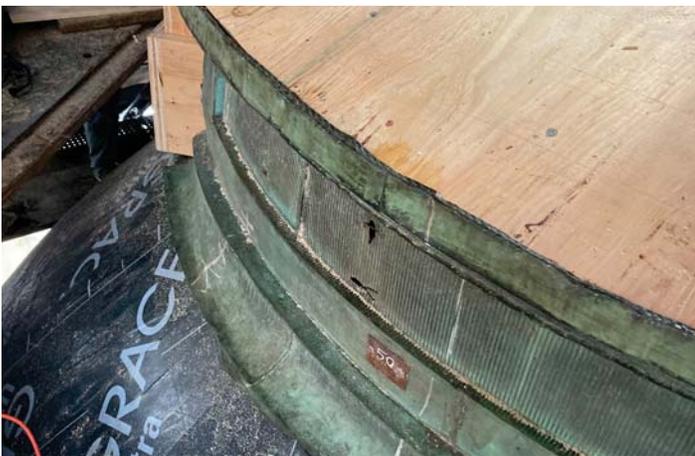
An original, single piece of copper used as a band around the dome.

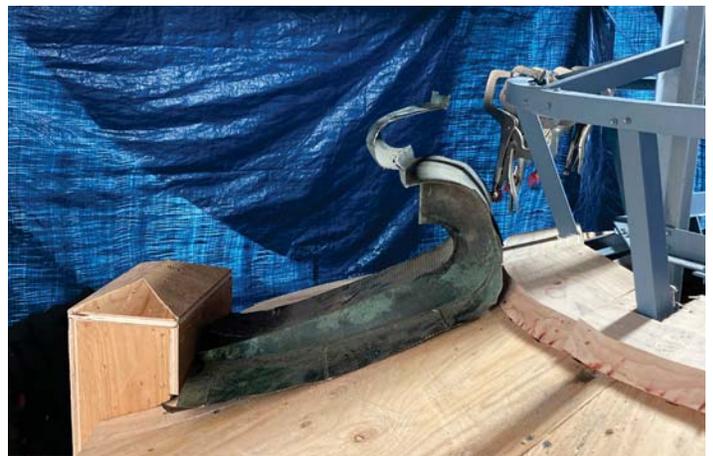
An original piece of copper used as a pattern at the base of the lantern.

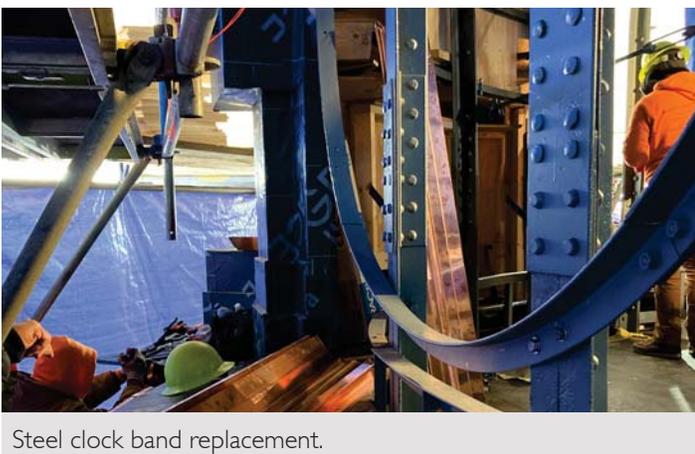
Steel clock band replacement.

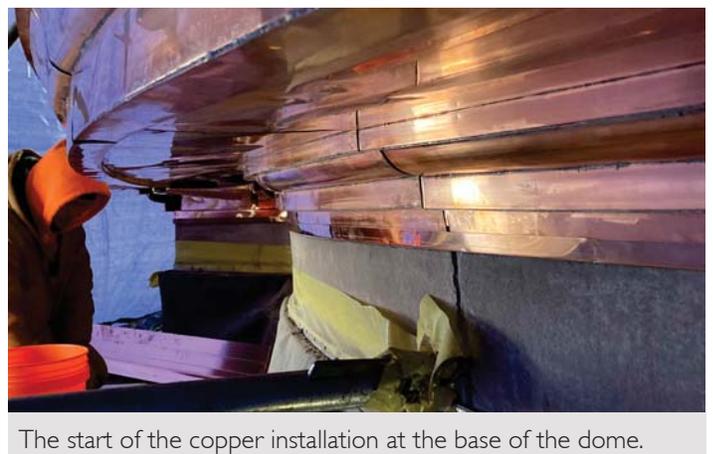
The start of the copper installation at the base of the dome.
