MARTIN COUNTY COURTHOUSE

DOMES + ROOF REPAIR UPDATE

May 2021

COPPER DOME RECONSTRUCTION

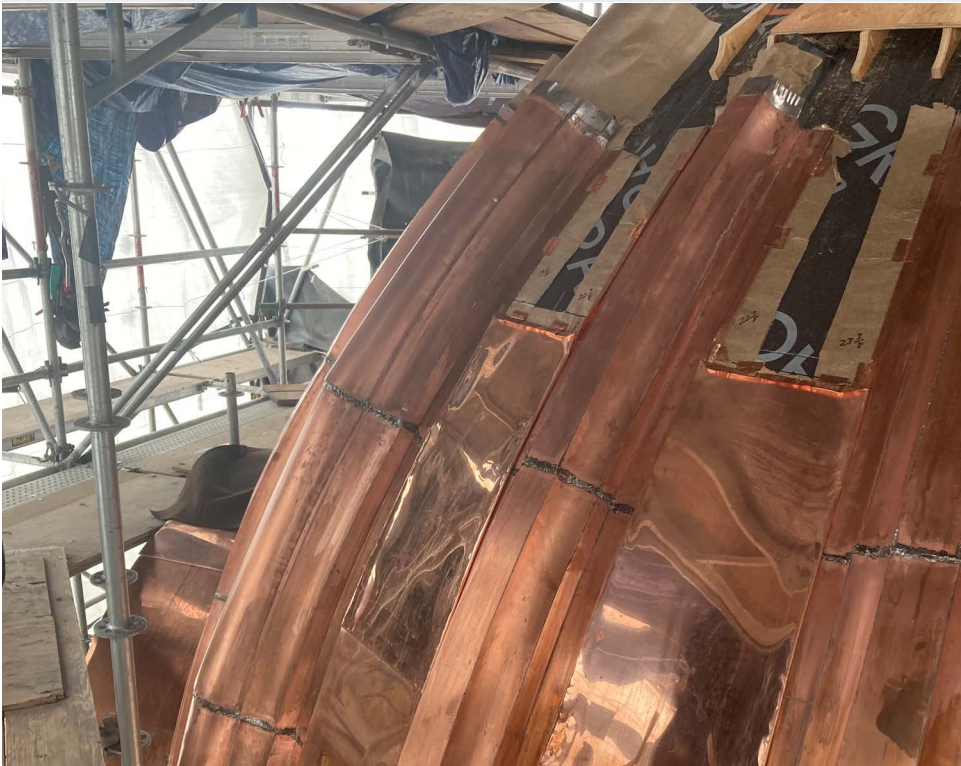
Below: Ribs of the dome are installed. Flat panels are located between each rib.

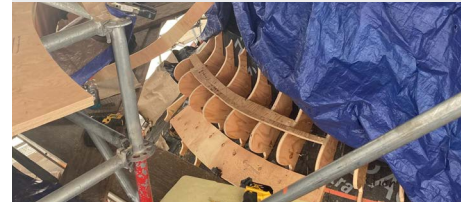
Below: wood blocking to support copper.

Installation of the copper dome is progressing with restoration services being provided by Renaissance Roofing based out of Rockford, Illinois. While sections continue to be fabricated in Illinois, completed sections are being installed on-site. Wood blocking at the base of the lantern supports the copper at the top of the dome. Work on the copper dome will continue through May and June with an anticipated completion by the end of July.

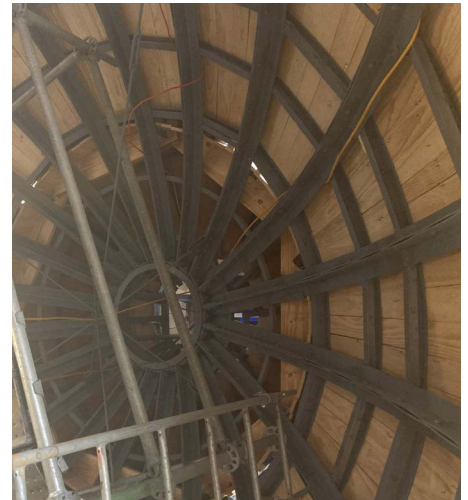
Above: Interior dome framing.

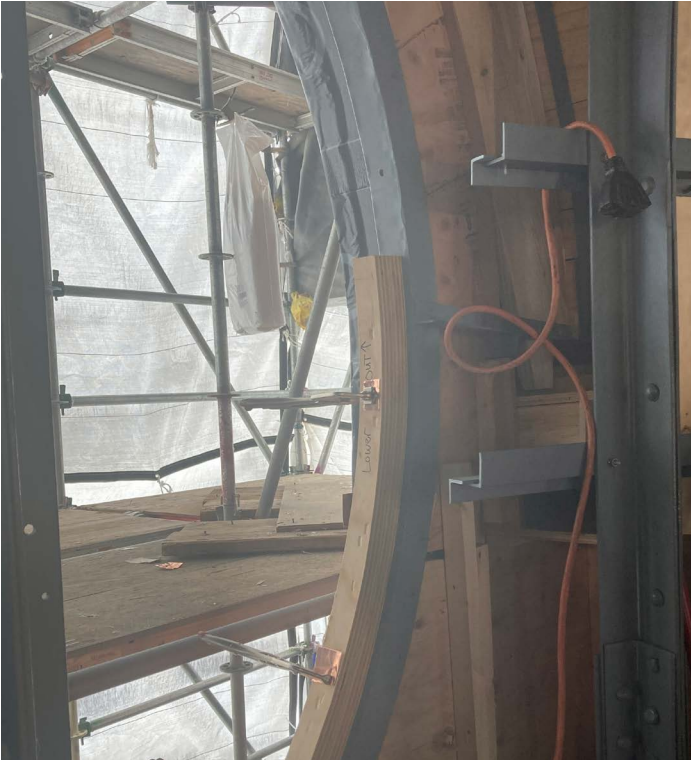
Fitting of the clock dials.

Roof replacement will begin when the dome work is completed. Plans were recently issued to contractors for bidding of the main courthouse roof replacement project. Mechanical Watch Supply, based out of Minneapolis completed work on the clock dials and restoration of the clock movement is now underway.

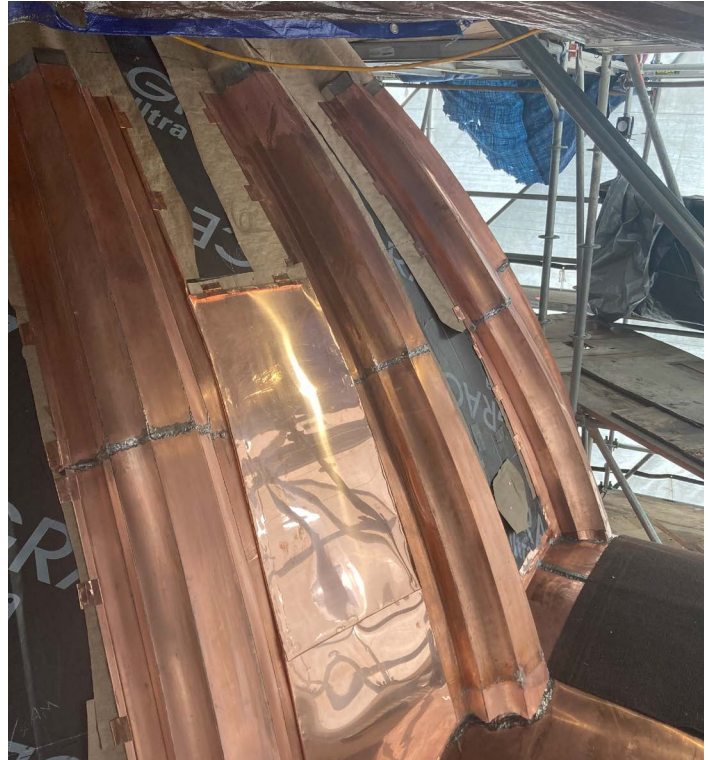
Copper secondary ribs on the dome.

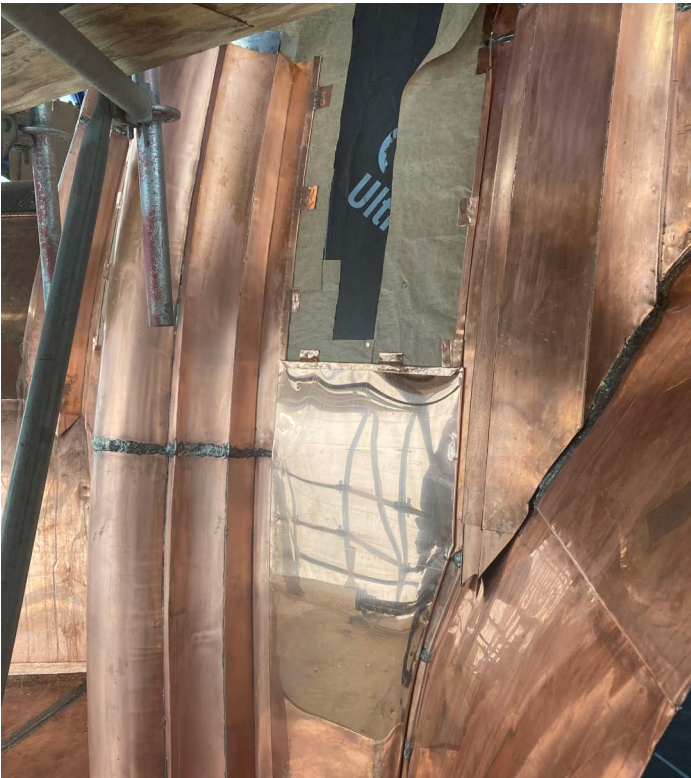
Primary copper rib on the dome.

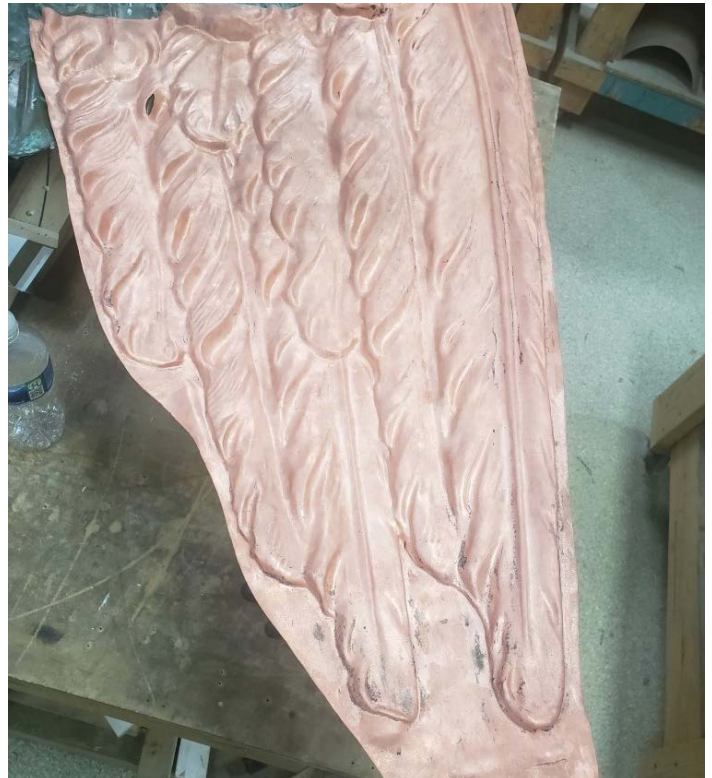
The first copper stamping of the eagle wing portions.
