# MARTIN COUNTY COURTHOUSE

## DOMES + ROOF REPAIR UPDATE

January 2022

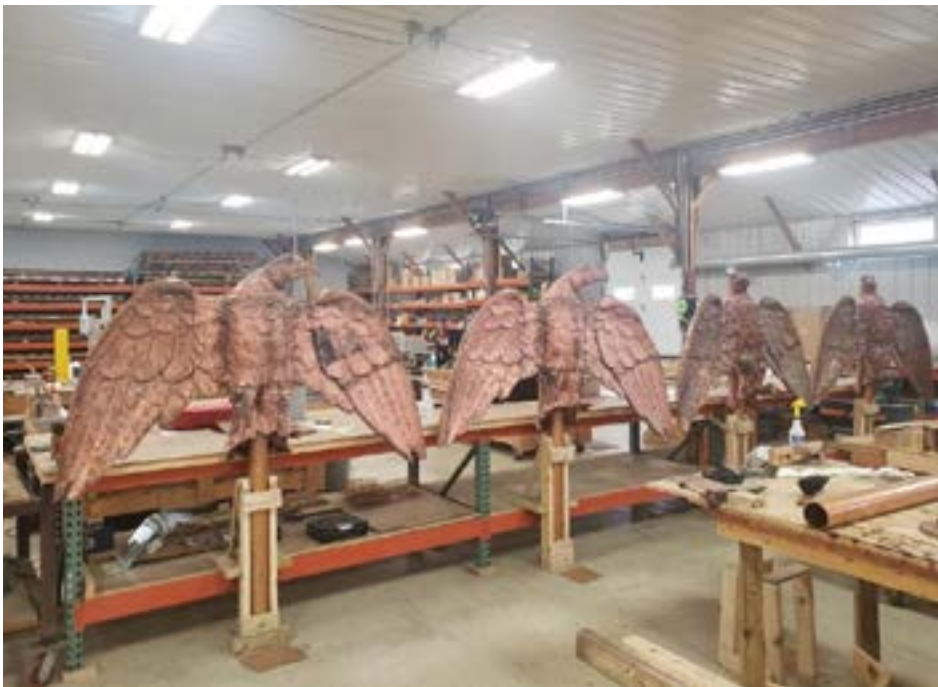
Eagles ready to be installed in Spring 2022.

Replacement of the copper eagle statues has been completed by restoration services provider Renaissance Roofing based in Rockford, Illinois. The copper eagles will be installed in the spring to once again adorn the dome of the historic Martin County Courthouse. The wing span of each statue is approximately six feet. Over forty molds were created to replicate the original copper eagle statues.

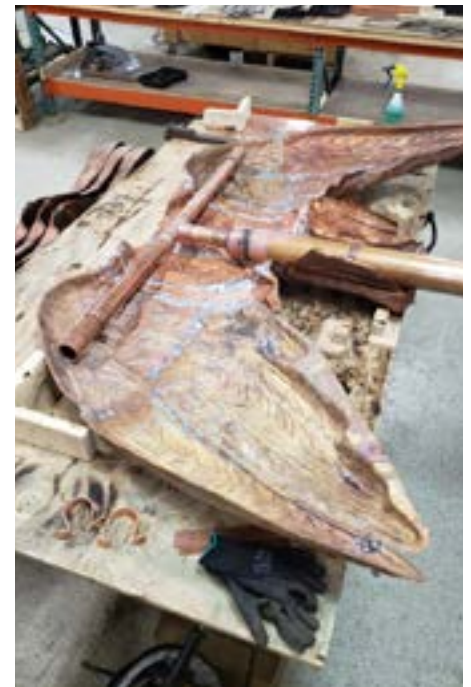
Additional support was incorporated into the new eagles to prevent them from blowing off like two of the previous eagles did.

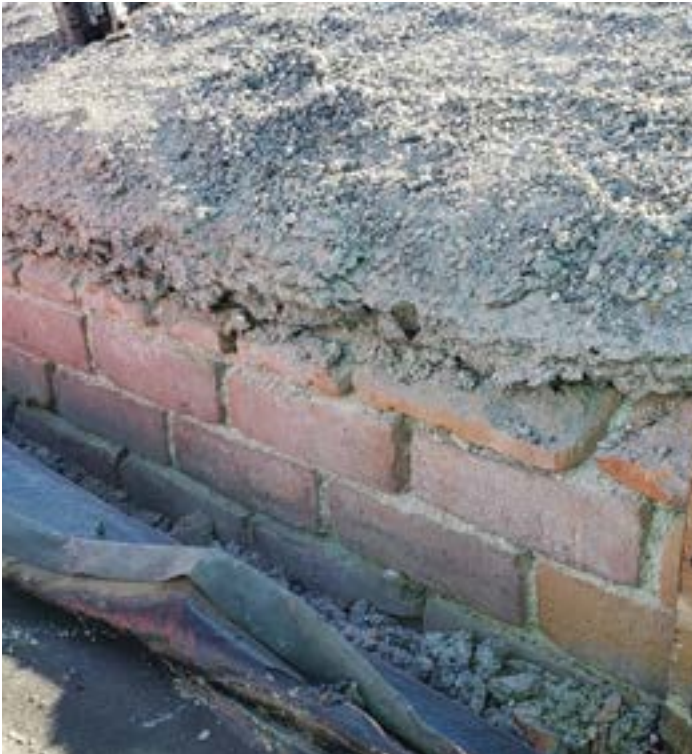
The concrete roof deck was diminished to a crumbled gravel-like condition in some locations as a result of decades of freeze-thaw cycles. Solutions include reducing dependence on the concrete roof deck for support of the roofing by adding a furring system. Steel supports will be installed underneath the concrete roof deck for additional support.

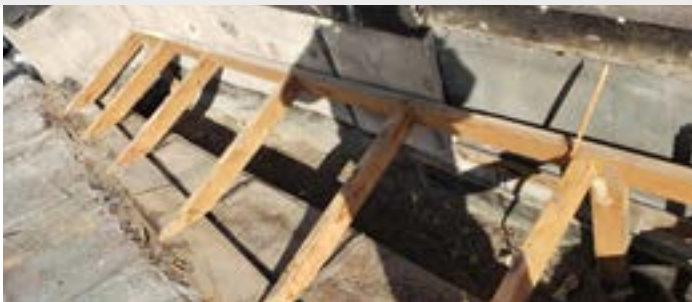
### PARAPET WALLS

Parapet walls had some work that was expected to be performed. Further inspection of the parapets once the old roofing was removed revealed they were in very poor condition. Mortar used to layup the back up walls was reduced to almost sand. Solutions include installation of new block walls and stone anchors.

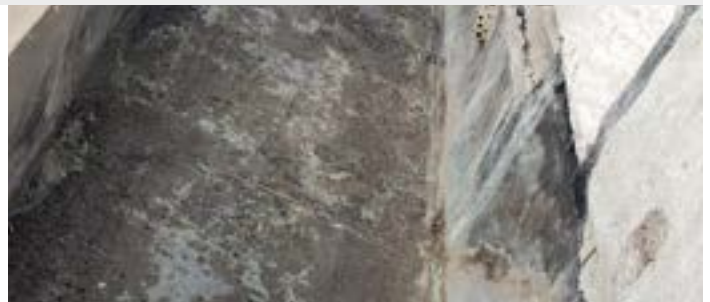
### GUTTER SYSTEM

The original gutter system was revealed during the removal of the old asphalt roofing material and will be once again utilized for roof drainage for the new roof system. Improved details and materials will be utilized for the new installation.
